**UPDATED REPORT OF
GEOTECHNICAL INVESTIGATION
SOUTH MISSION BEACH GREEN
INFRASTRUCTURE PROJECT
CITY OF SAN DIEGO**

AGE Project No. 190 GS-18-D

March 8, 2019
(Updated August 15, 2019)

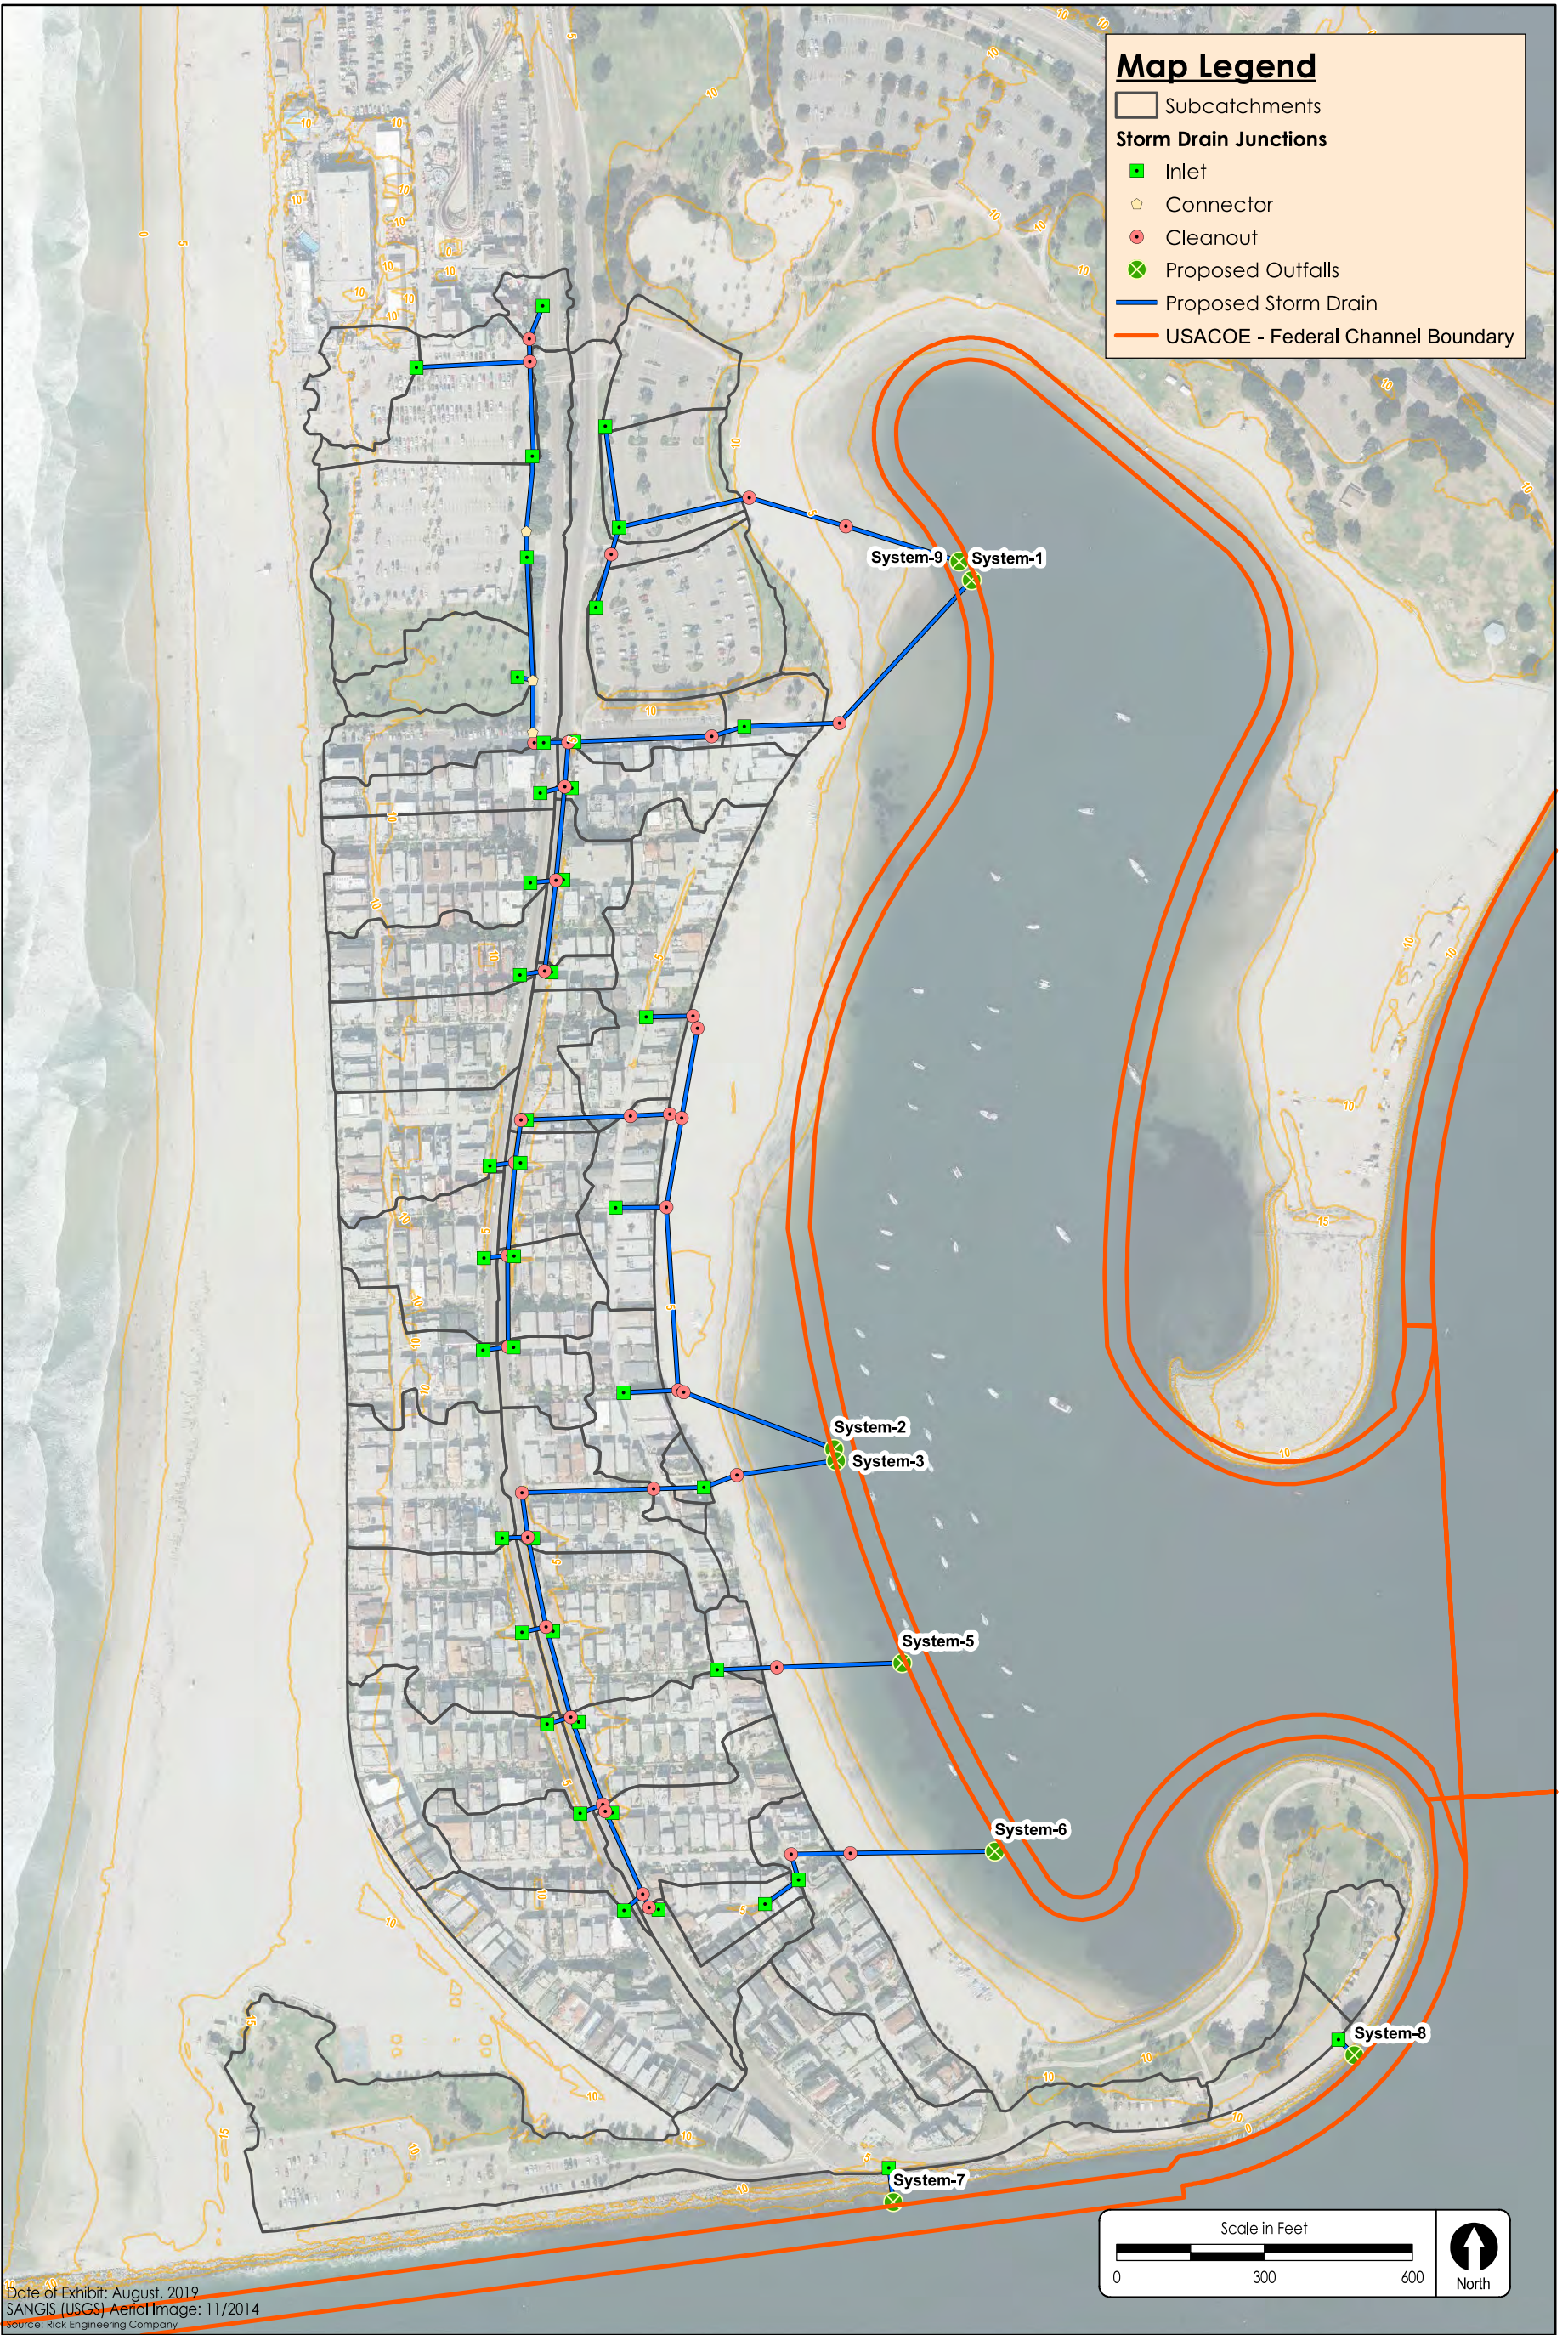
SOUTH MISSION BEACH GREEN INFRASTRUCTURE PROJECT
ALIGNMENTS MAP

South Mission Beach - Storm Drain Improvements and GI
Storm Drain Alignment - System Outfalls

Figure 1	Alignments Map
Figures 2 through 5	Location Map
Figure 6	Photograph
Figure 7	Lateral Pressures for Cantilever Walls
Figure 8	Lateral Pressures for Restrained Walls
Figure 9	Foundation Induced Wall Pressures
Figure 10	Traffic and Surcharge Pressures

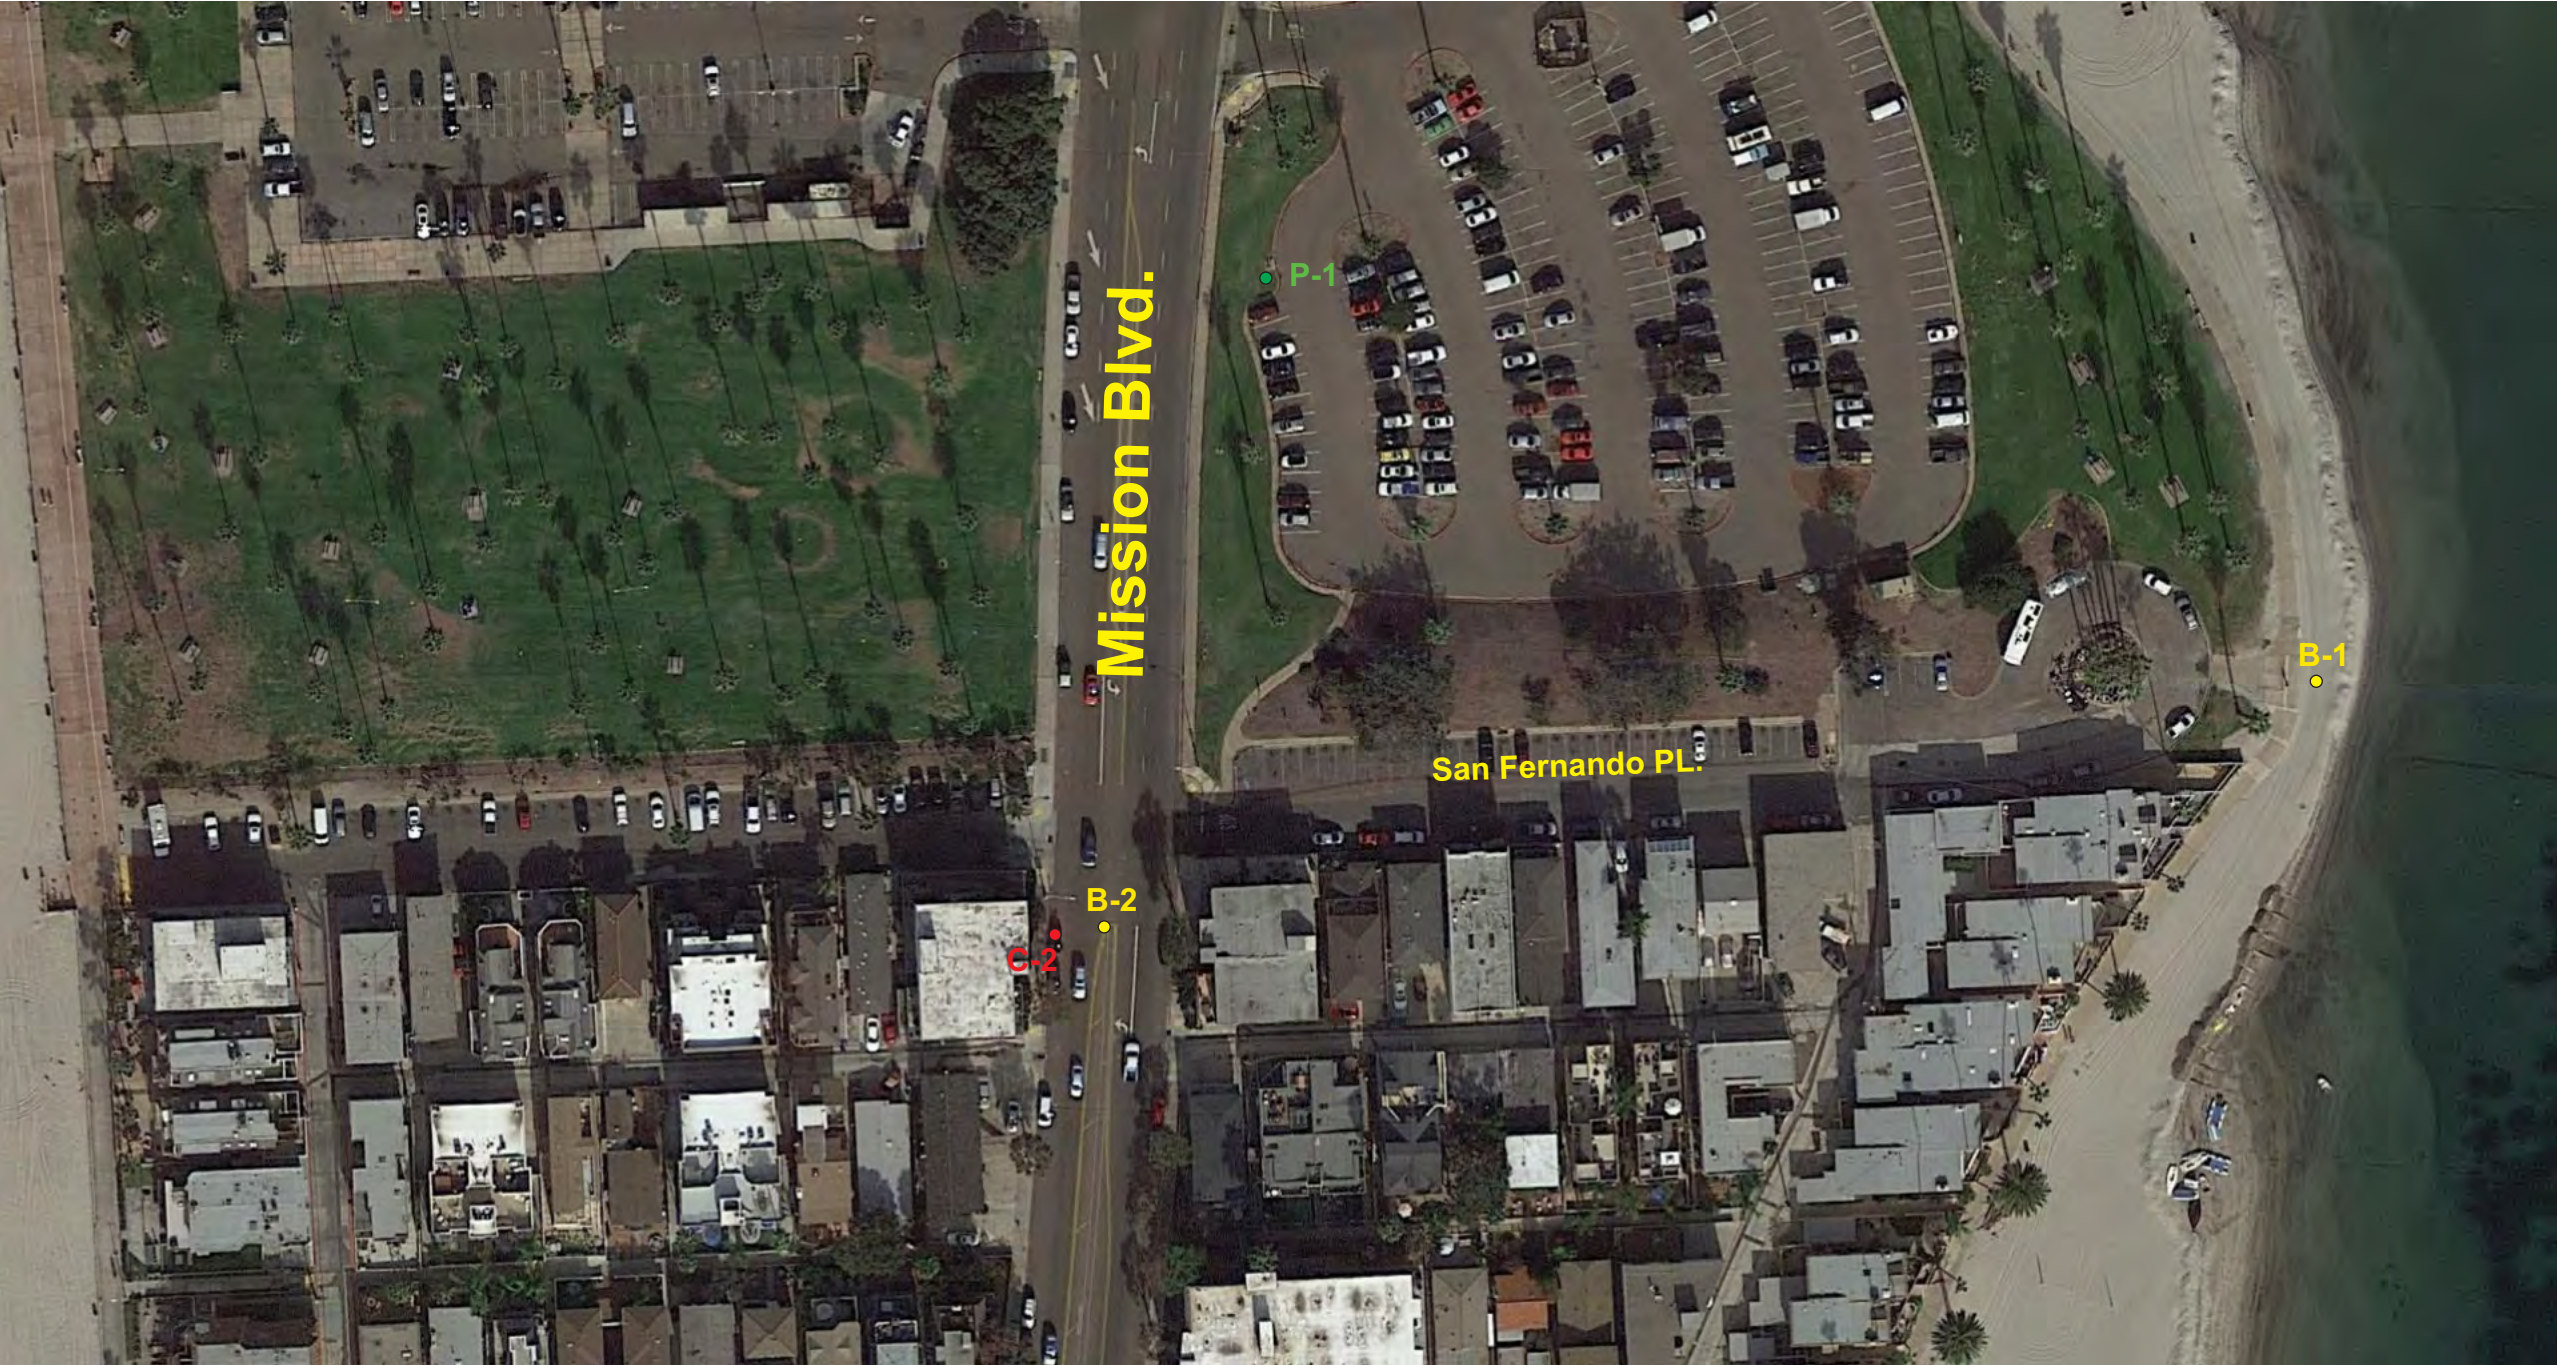
SOUTH MISSION BEACH GREEN INFRASTRUCTURE PROJECT		LOCATION MAP	
PROJECT NO. 190 GS-18-D	ALLIED GEOTECHNICAL ENGINEERS, INC.		FIGURE 2

- P-1 Approximate Infiltration Test Hole Location
- B-2 Approximate Boring Location
- C-2 Approximate Pavement Core Location

The field exploration program for this project was performed on February 11 and 12, 2019. A total of four (4) soil borings, four (4) infiltration test holes, and two (2) pavement corings were performed at the approximate locations shown on Figures 2 through 5. In addition, AGE attempted to perform infiltration testing inside an existing weep sump located on the west side of Mission Boulevard, at the entrance of an alley located between Brighton Court and Capistrano Place. The soil borings were advanced to depths ranging from 15 feet to 16.5 feet below the existing ground surface (bgs). The infiltration test holes were hand-augured to depths ranging from 36 inches to 63 inches bgs. A brief description of the location and depth, pavement sections, groundwater level, and subsurface conditions encountered in the borings and infiltration test holes is presented in Table 1.

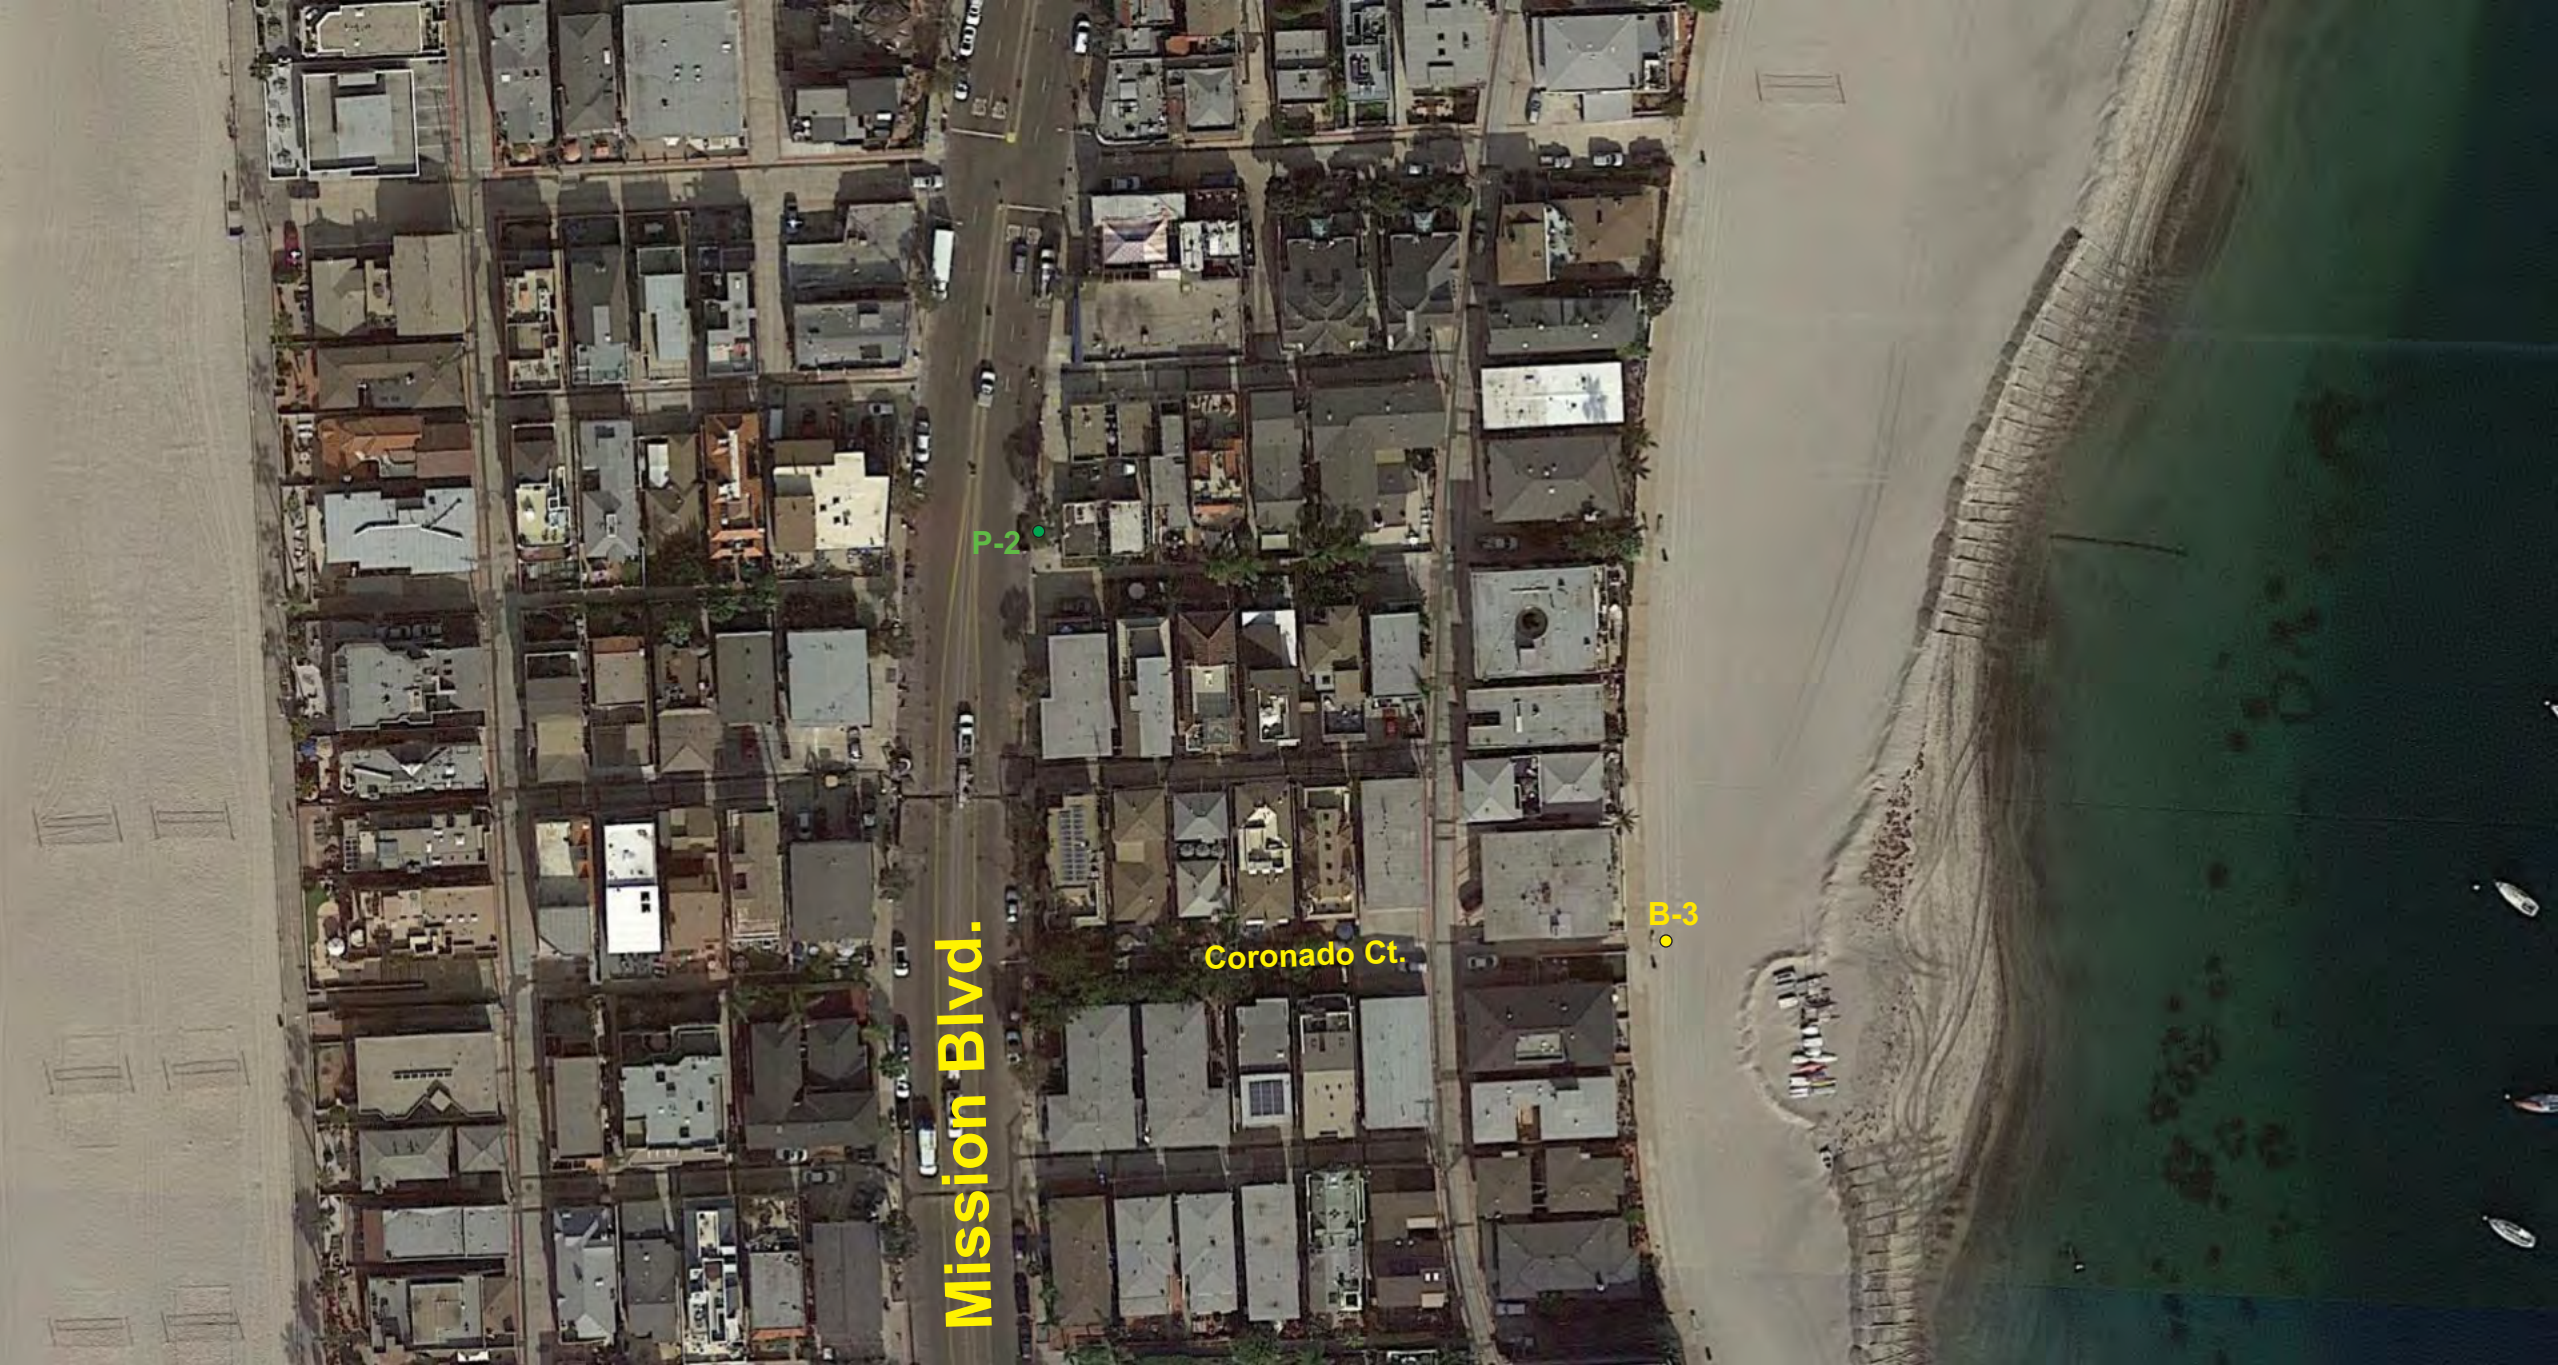
SOUTH MISSION BEACH GREEN INFRASTRUCTURE PROJECT		LOCATION MAP	
PROJECT NO. 190 GS-18-D	ALLIED GEOTECHNICAL ENGINEERS, INC.		FIGURE 3

- P-1 Approximate Infiltration Test Hole Location
- B-2 Approximate Boring Location
- C-2 Approximate Pavement Core Location

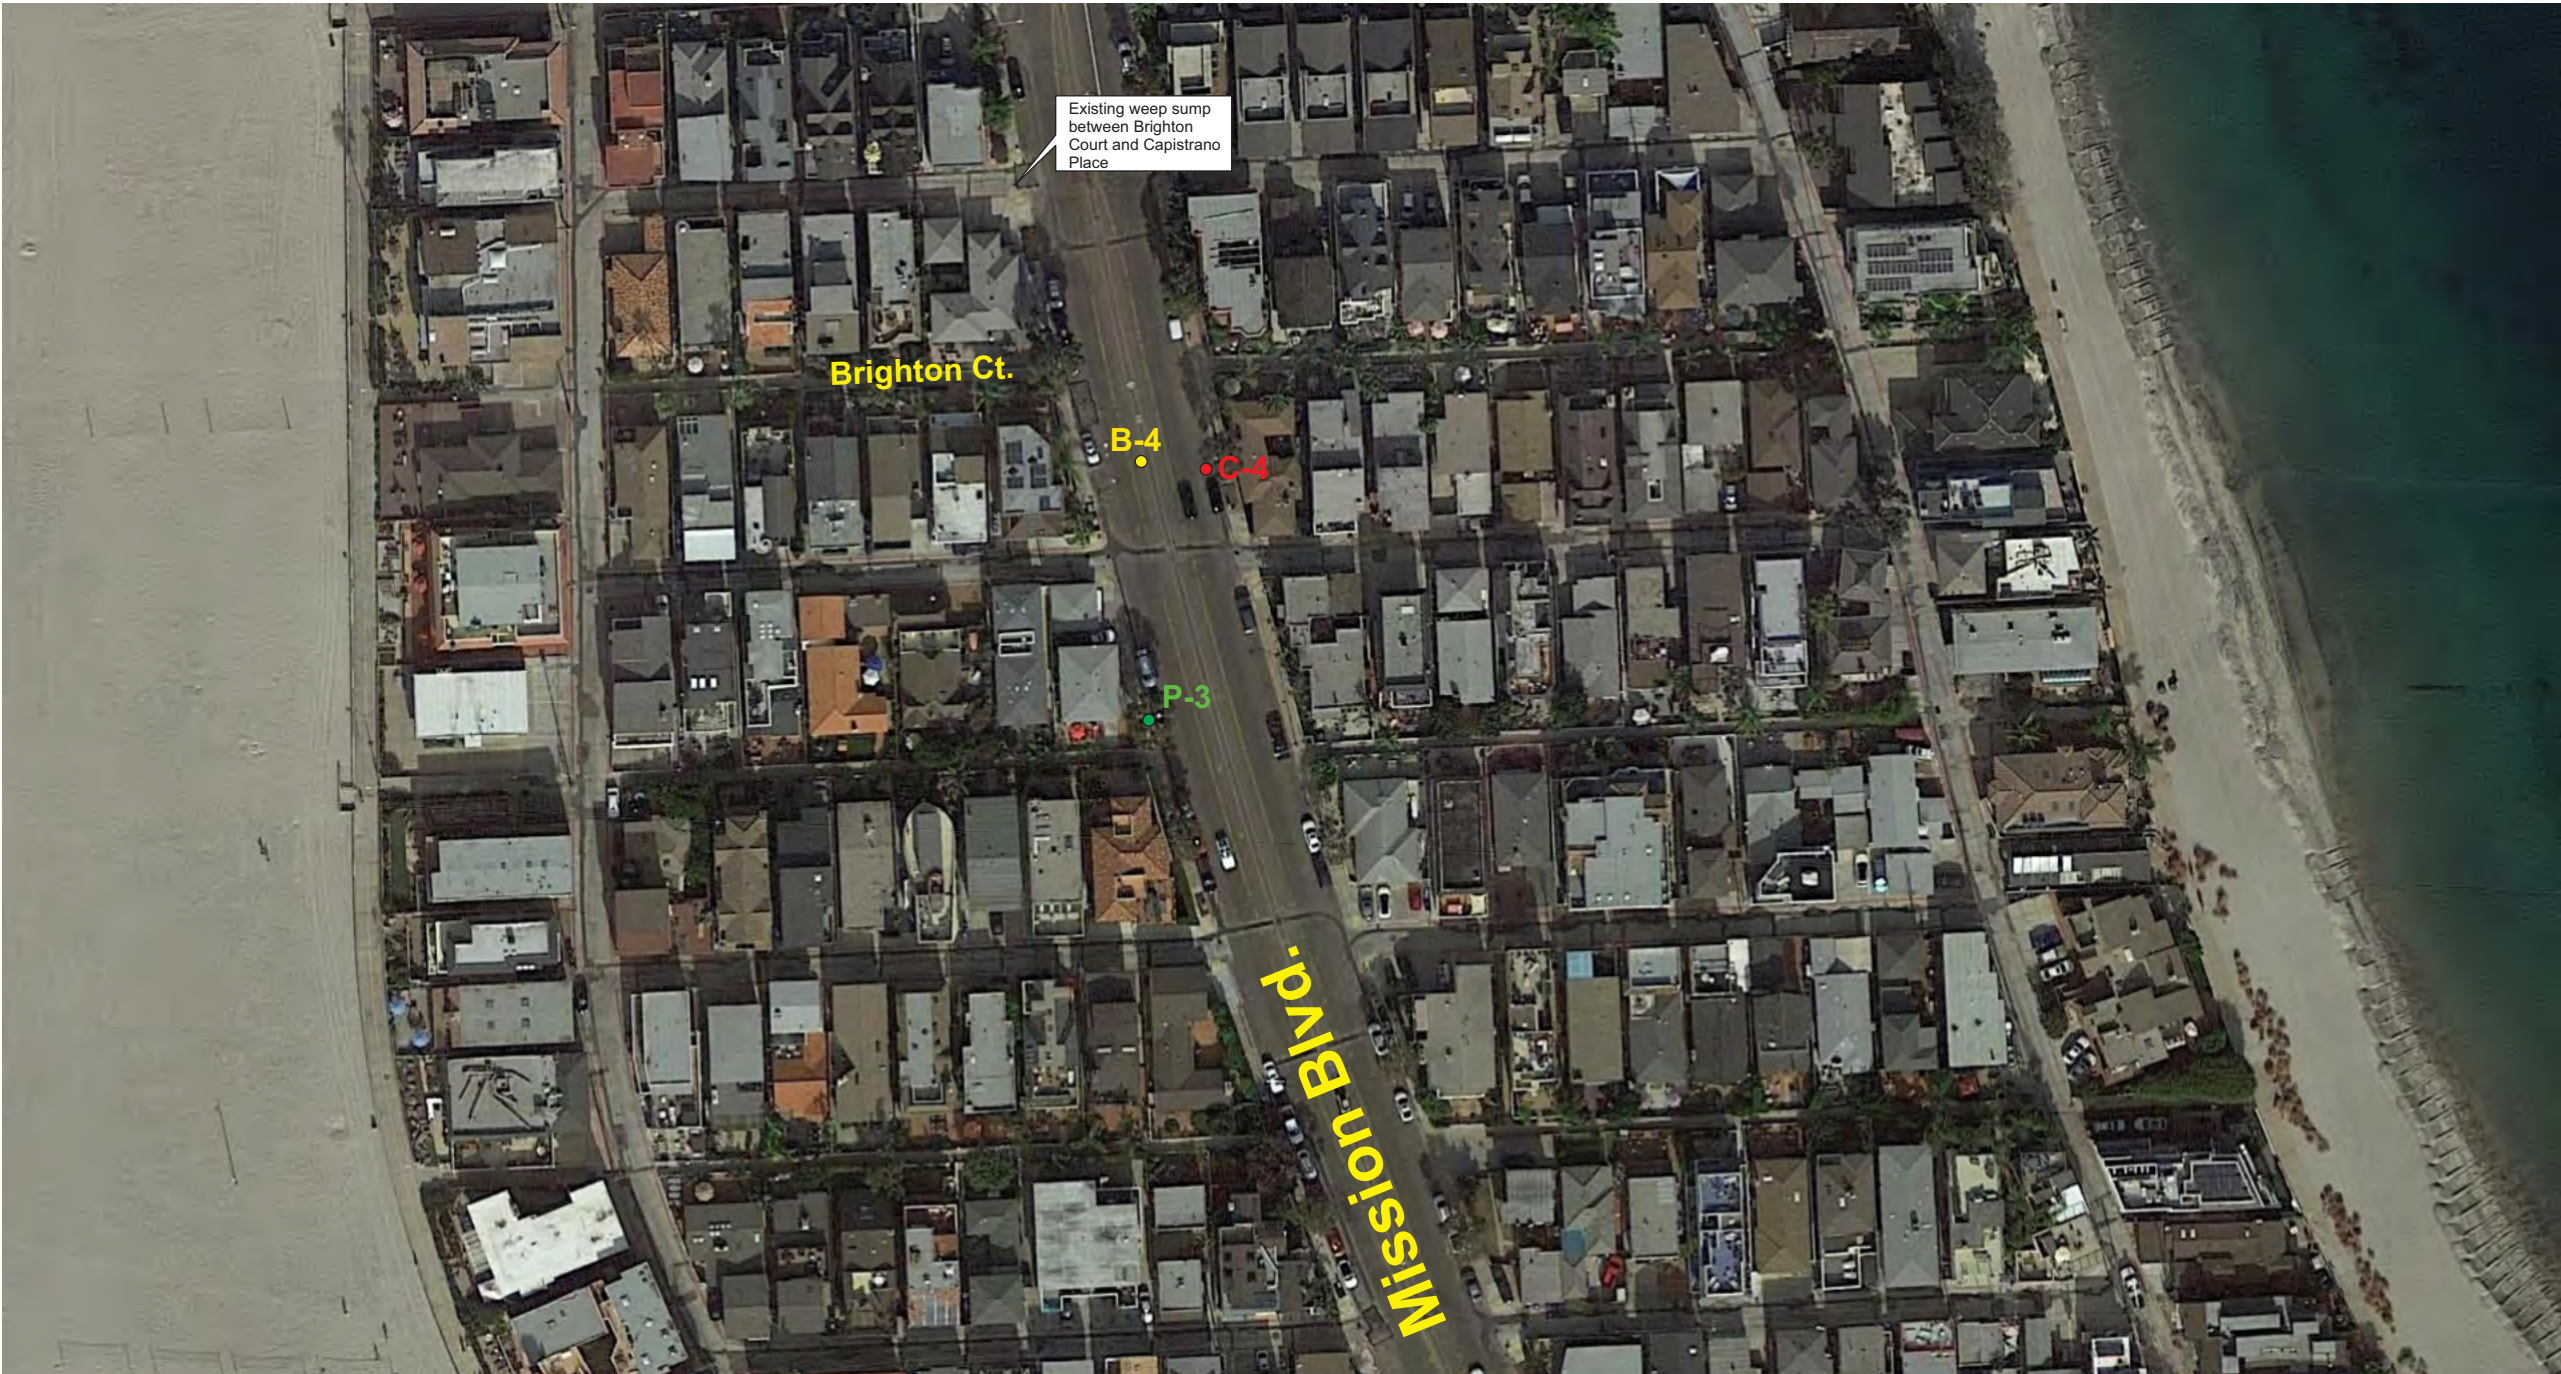
SOUTH MISSION BEACH GREEN INFRASTRUCTURE PROJECT		LOCATION MAP	
PROJECT NO. 190 GS-18-D	ALLIED GEOTECHNICAL ENGINEERS, INC.		FIGURE 4

- **P-1** Approximate Infiltration Test Hole Location
- **B-2** Approximate Boring Location
- **C-2** Approximate Pavement Core Location

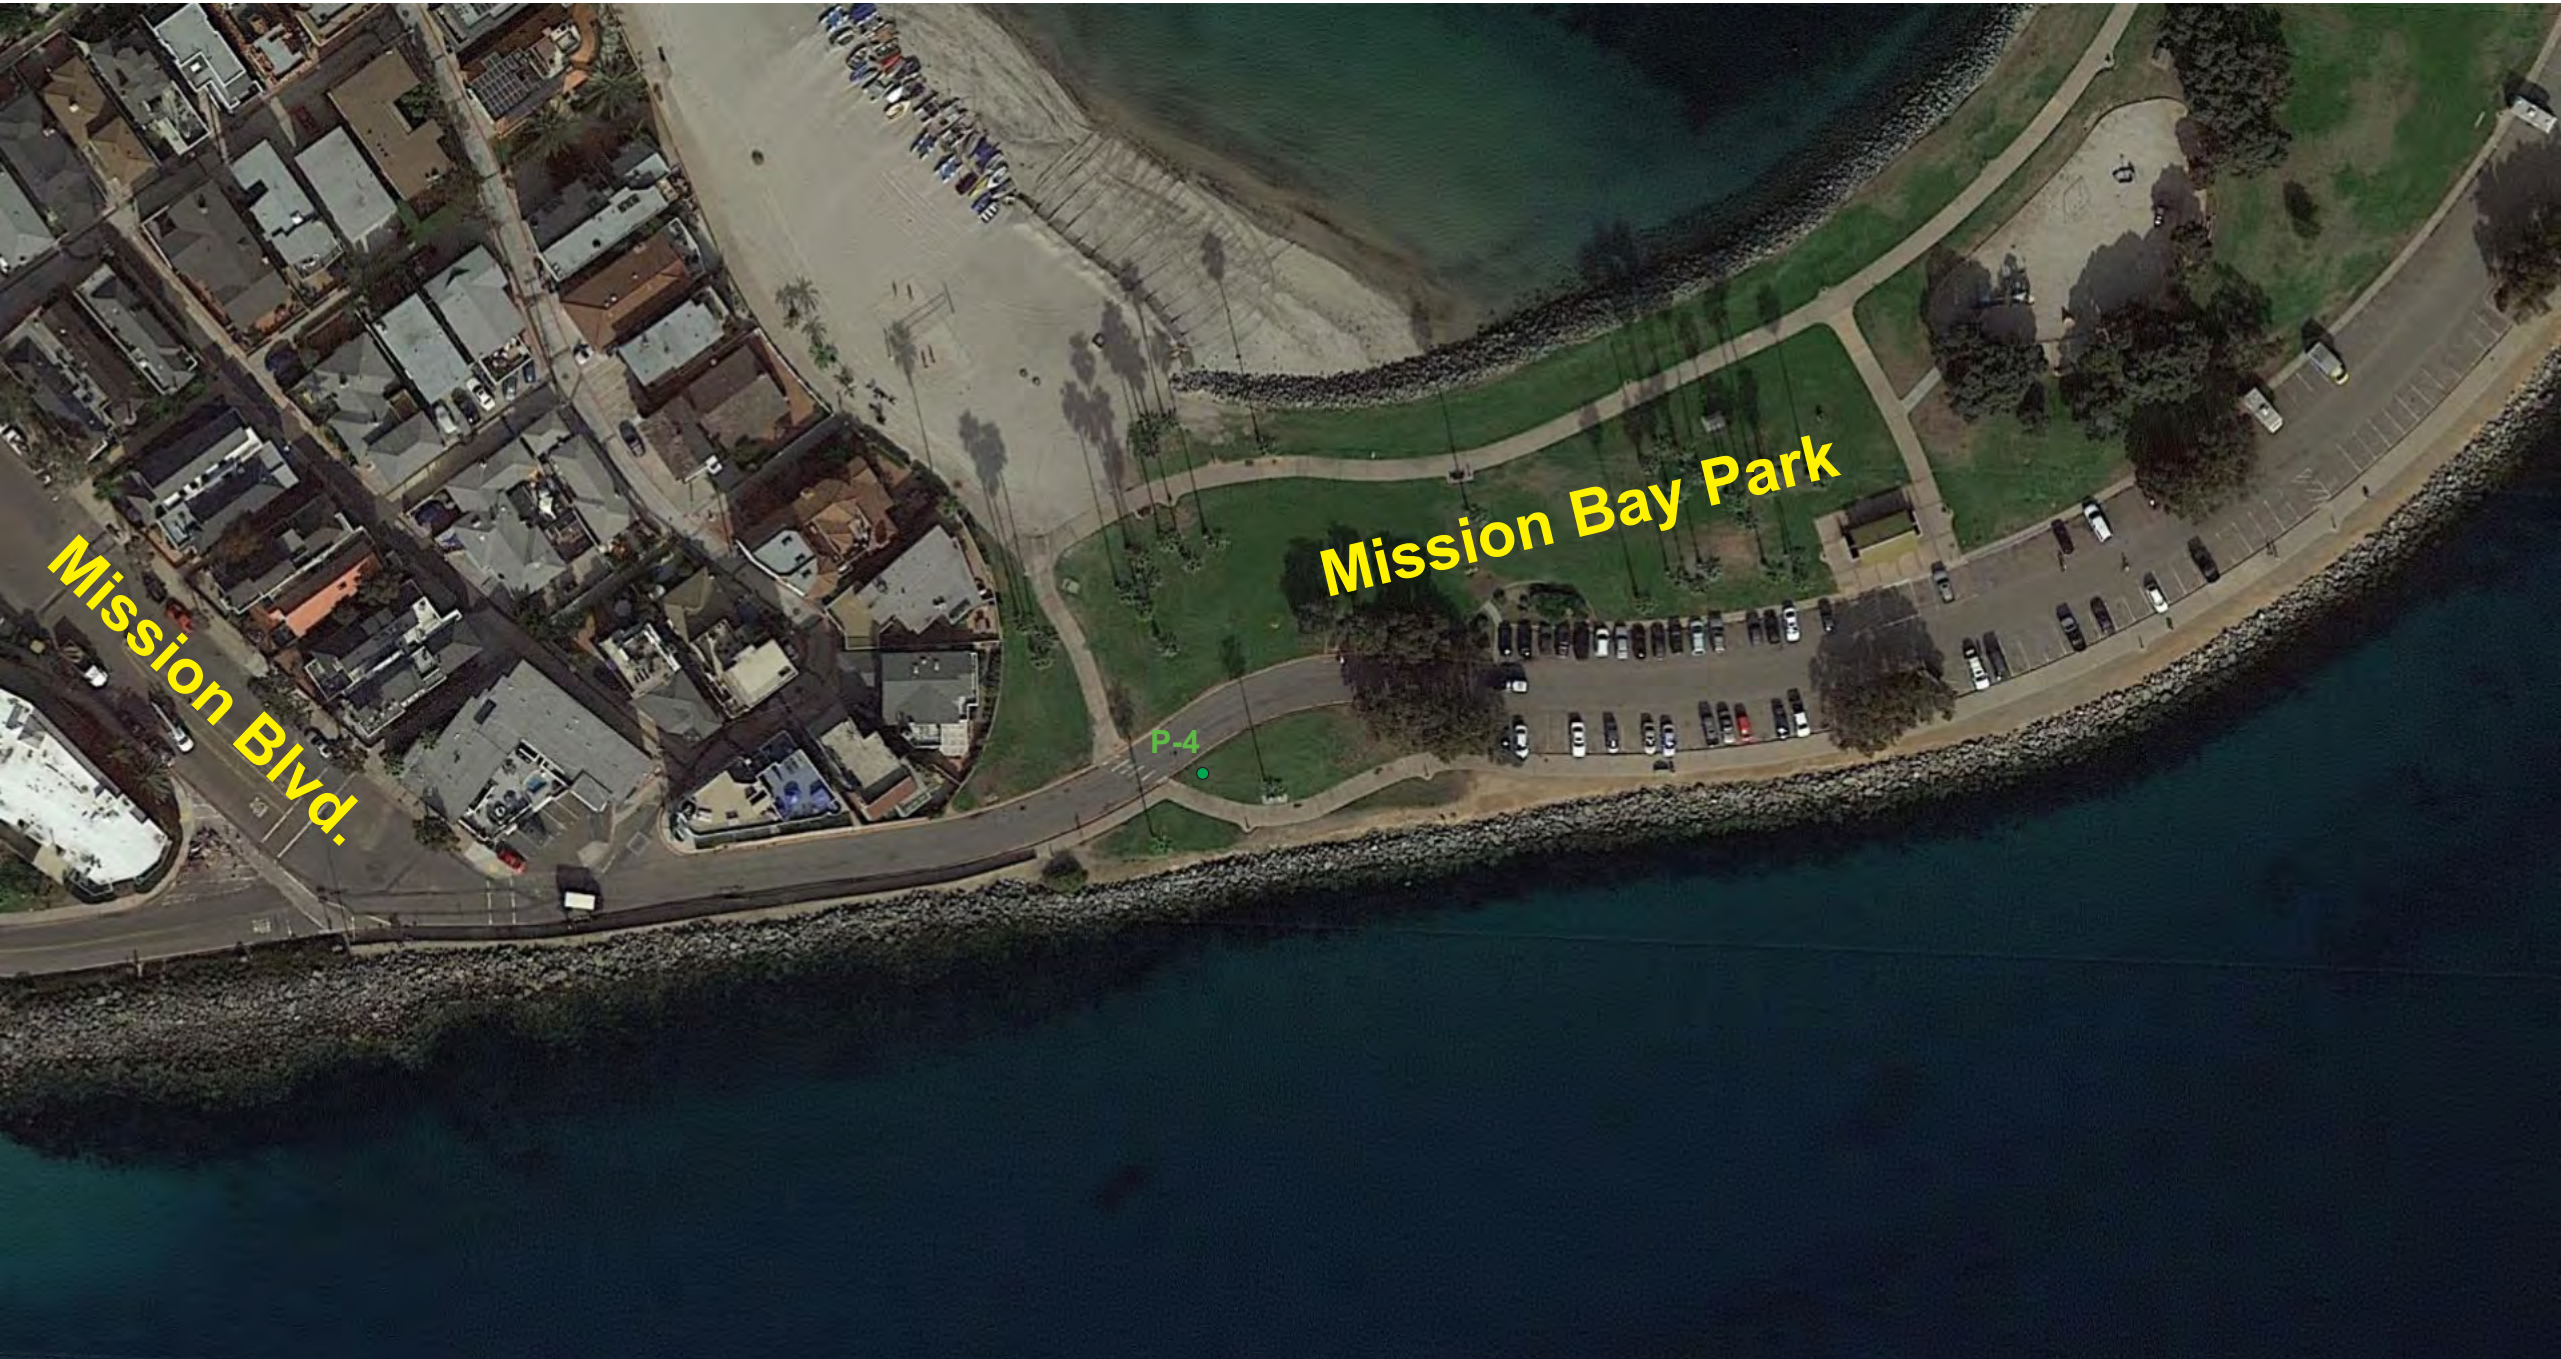
SOUTH MISSION BEACH GREEN INFRASTRUCTURE PROJECT		LOCATION MAP	
PROJECT NO. 190 GS-18-D	ALLIED GEOTECHNICAL ENGINEERS, INC.		FIGURE 5

- P-1 Approximate Infiltration Test Hole Location
- B-2 Approximate Boring Location
- C-2 Approximate Pavement Core Location

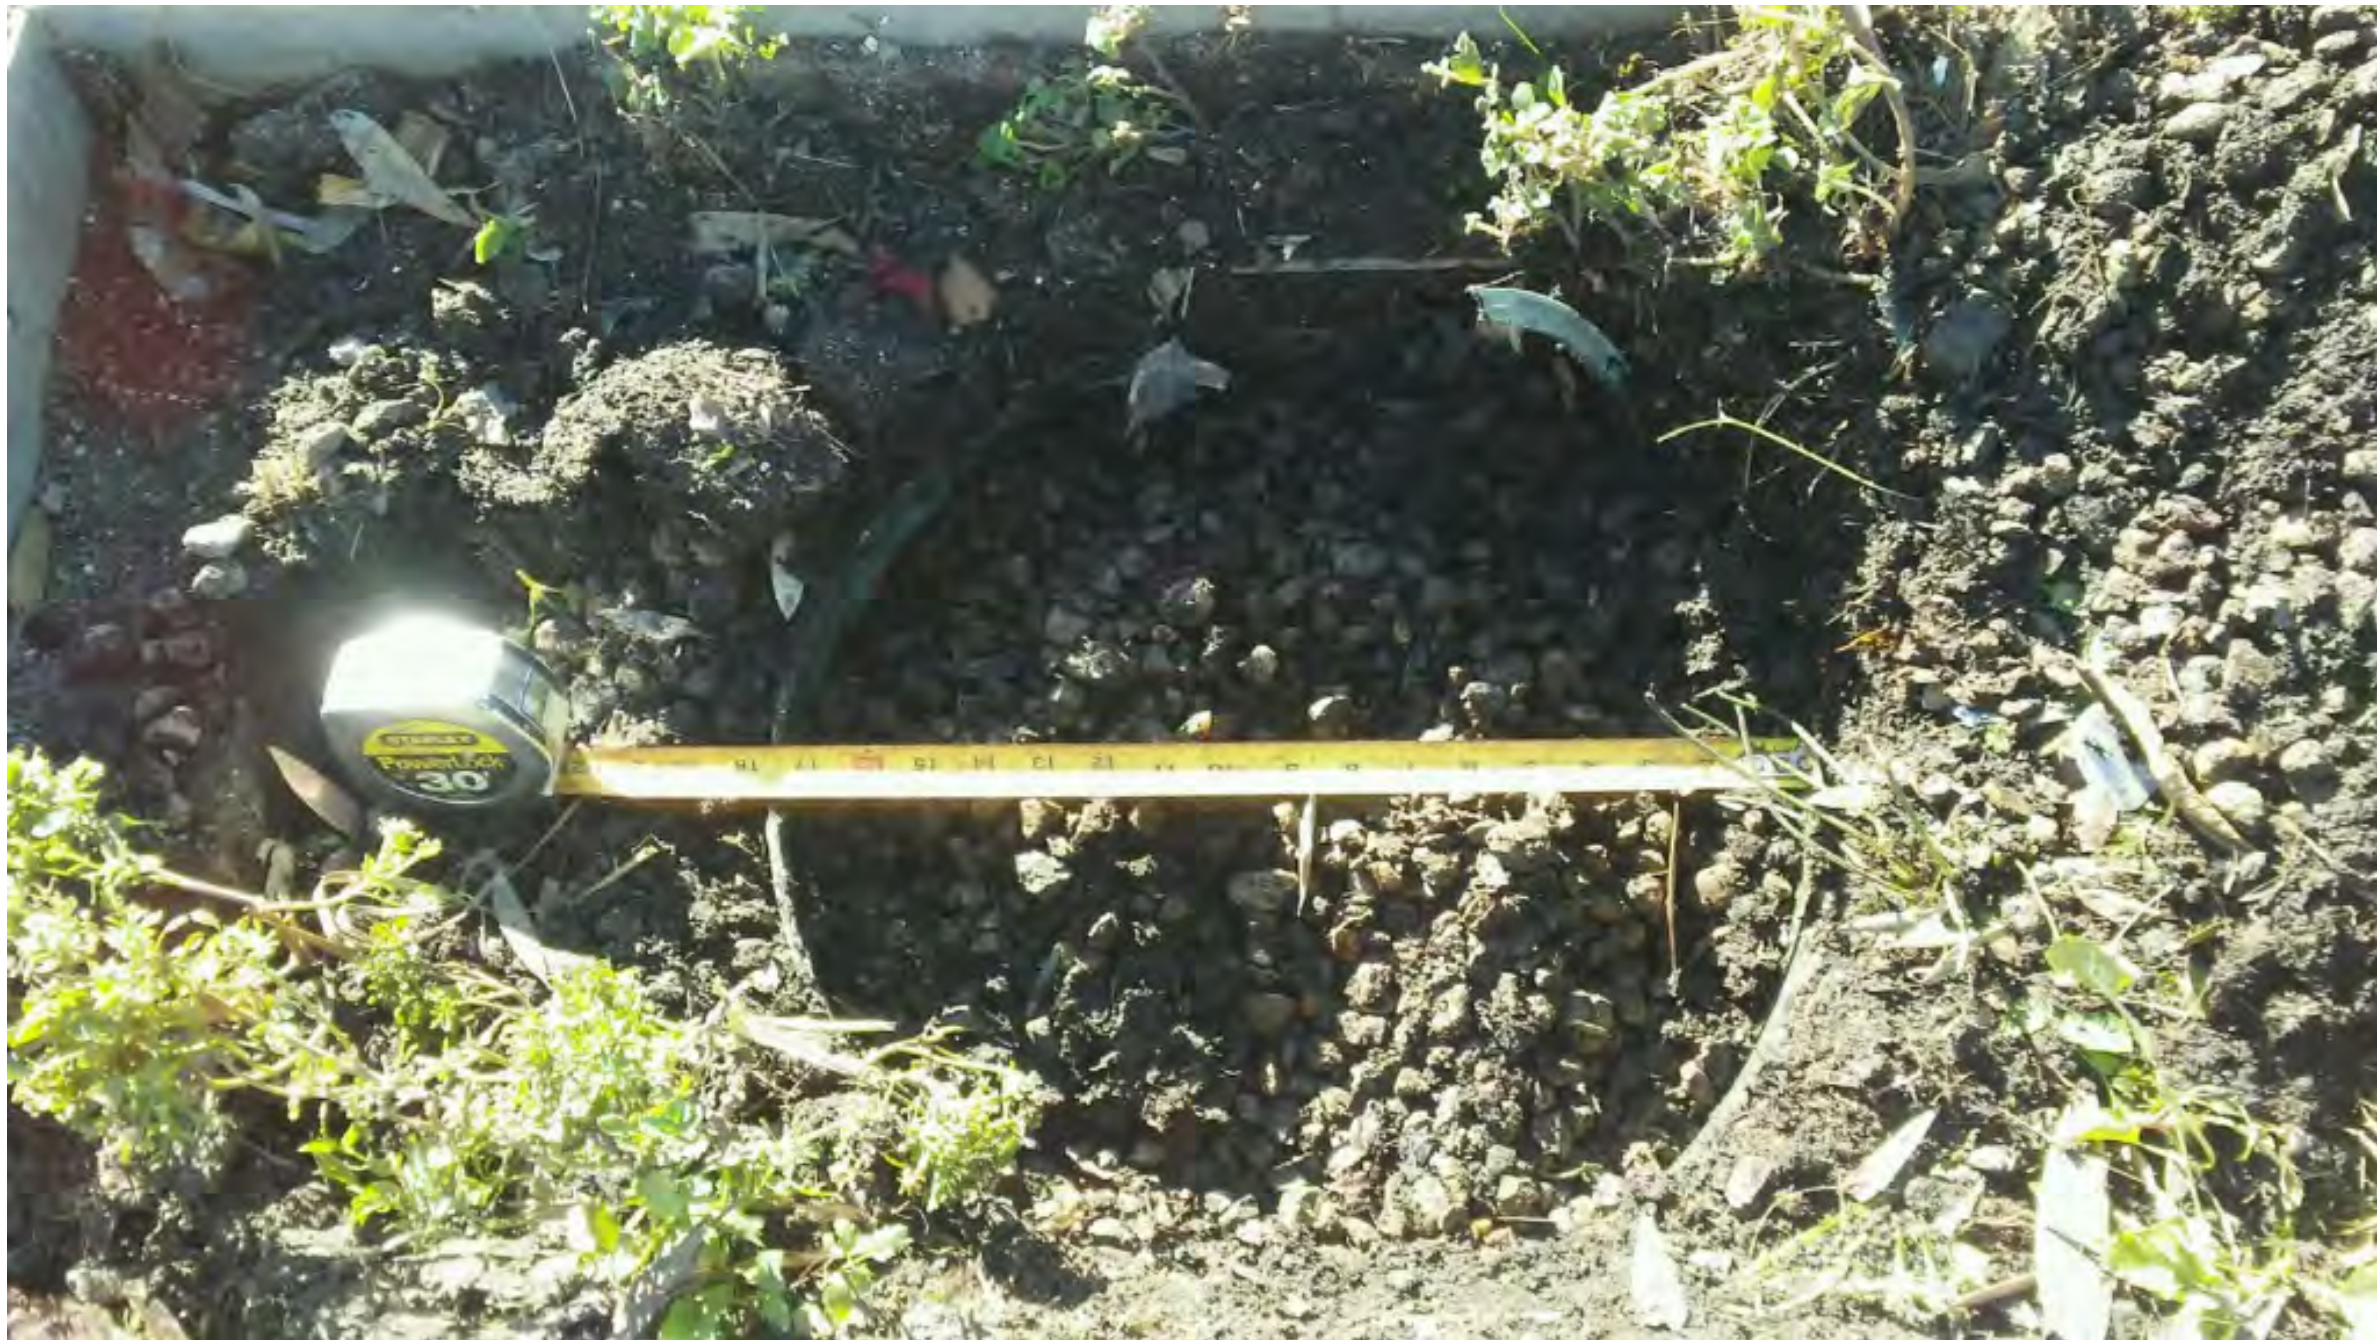
FIGURE 6

WEEP SUMP PHOTOGRAPH

Due to the presence of shallow groundwater inside test holes P-1, P-2 and P-3, AGE was unable to perform infiltration testing inside these holes. The existing weep sump was installed on top of an existing City of San Diego sewer trench. Furthermore, when AGE attempted to perform the infiltration testing, AGE uncovered an 18-inch diameter green PVC pipe filled with 3/4-inch crushed rock (see photograph in Figure 6). Therefore, AGE was unable to perform infiltration testing inside the weep sump. Infiltration testing was only performed in test hole P-4.
