REVISED GEOTECHNICAL AND
GEOLOGIC RECONNAISSANCE
MORENA CORRIDOR SPECIFIC PLAN
SAN DIEGO, CALIFORNIA

Prepared for
RECON ENVIRONMENTAL, INC.
San Diego, California

Project No. 2882
May 15, 2018

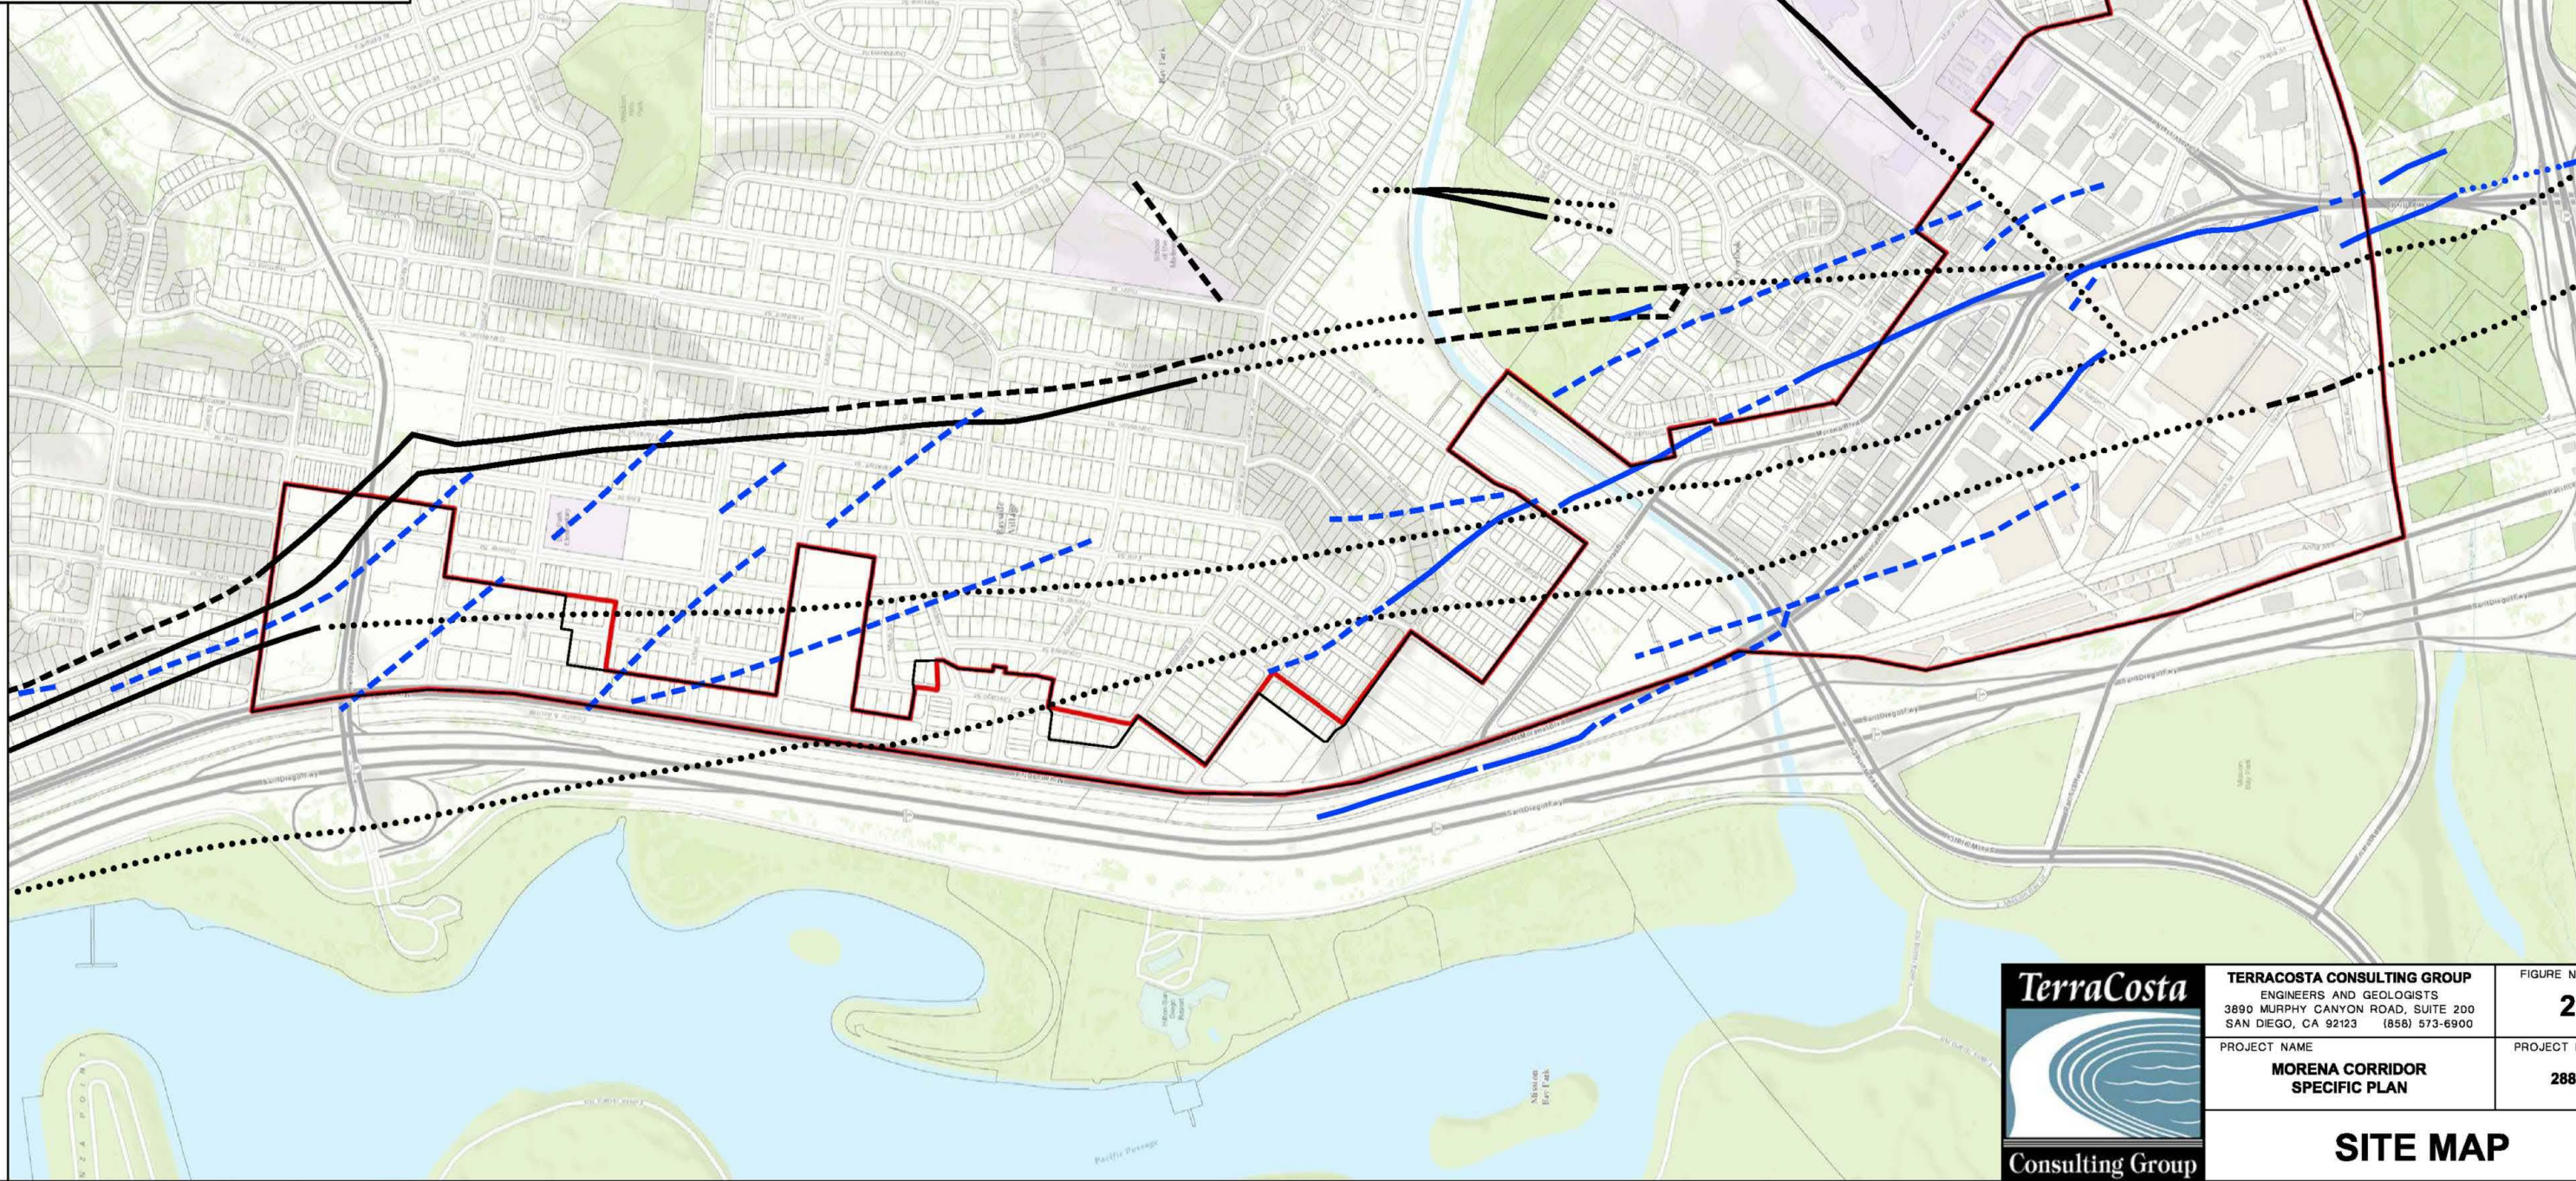
TERRACOSTA CONSULTING GROUP ENGINEERS AND GEOLOGISTS 3890 MURPHY CANYON ROAD, SUITE 200 SAN DIEGO, CA 92123 (858) 573-6900	FIGURE NUMBER 2
	PROJECT NAME MORENA CORRIDOR SPECIFIC PLAN	PROJECT NUMBER 2882
	SITE MAP

- FAULT
- INFERRED FAULT
- CONCEALED ZONE
- ACTIVE FAULT LOCATED BY
AECOM, 2017

While not located within a delineated APEFZ, numerous fault zones (City of San Diego, 2008) have been identified and are referenced as Geologic Hazard Category No. 12, and are shown on Figure 9. The fault zones shown on Figure 9 are labeled “Potentially Active,” “Inactive,” “Presumed Inactive” or “Activity Unknown.” A study prepared by SANDAG (SANDAG, 2013) presented the results of aerial photographic interpretation by Kleinfelder, Inc. of various geomorphic features, such as suspected faults, drainages, side slope bench lineaments, scarps, pressure ridges, and landslides. Also, AECOM (AECOM, 2017) reported finding an active fault strand located near the proposed pump station. The location of the offset identified by AECOM is shown on Figure 2. City-identified fault zones and suspected fault traces identified by Kleinfelder (SANDAG, 2013) are shown on Figures 2, 3, and 4.

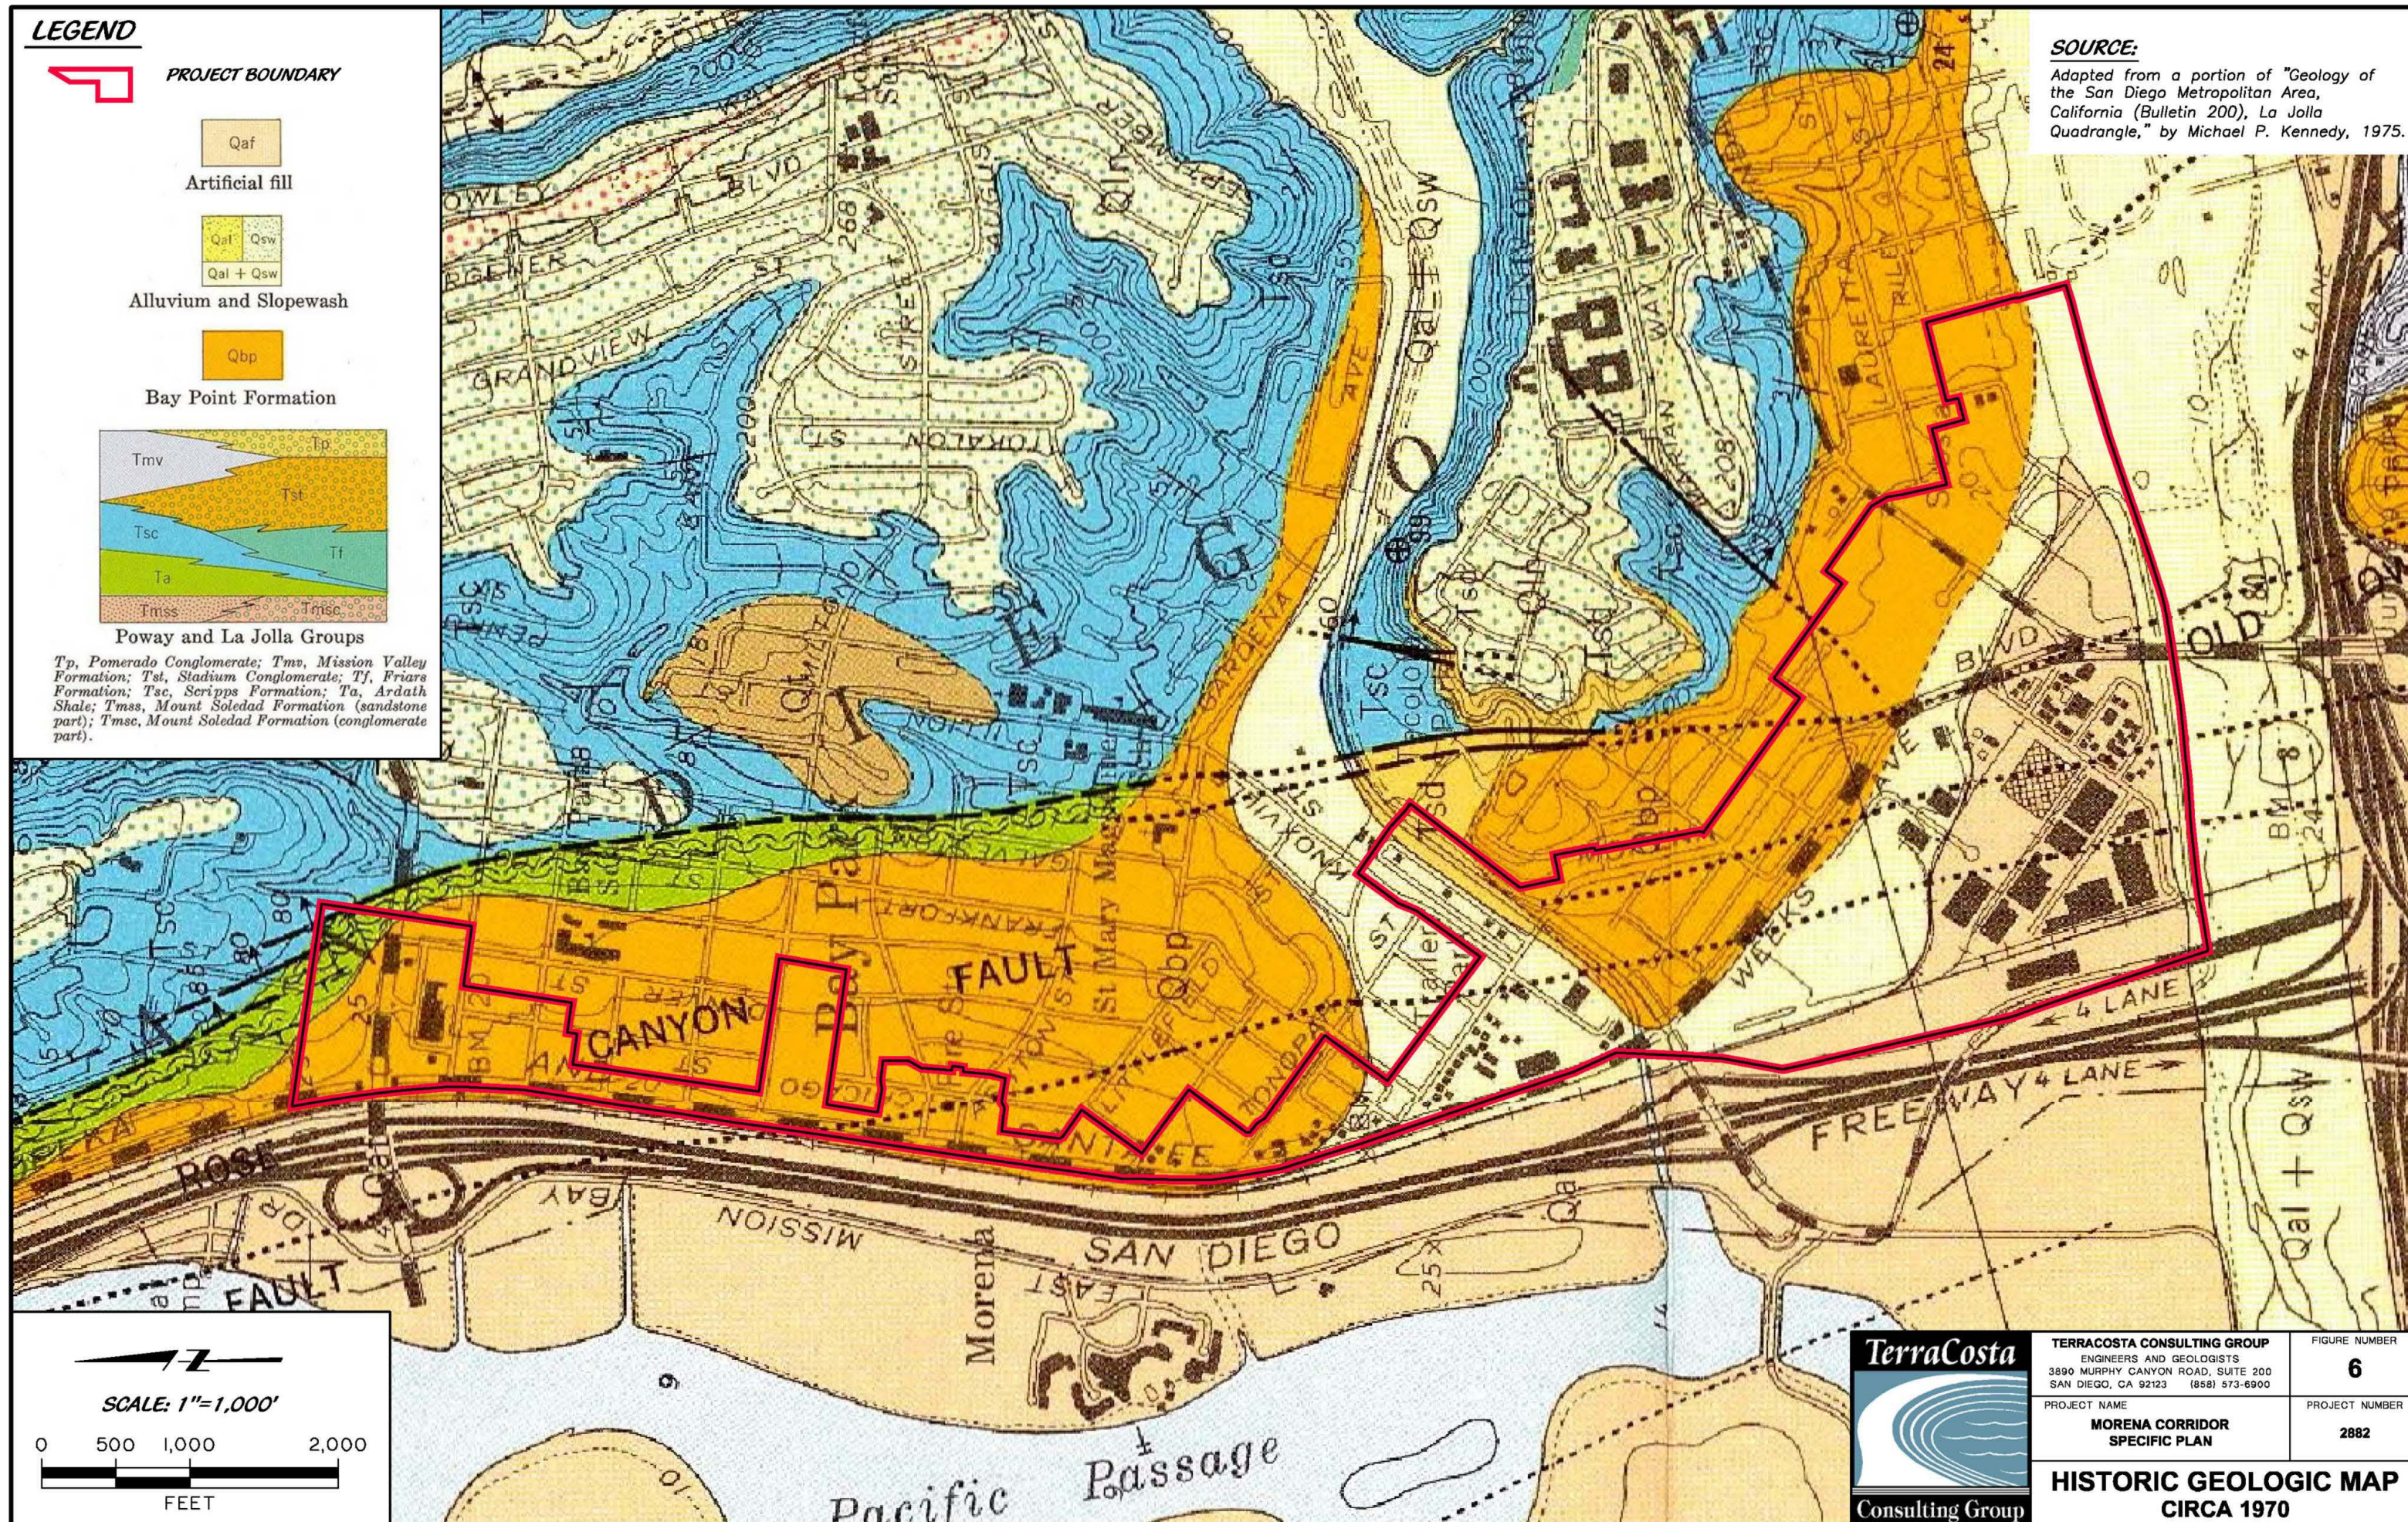
Tp, Pomerado Conglomerate; Tmv, Mission Valley Formation; Tst, Stadium Conglomerate; Tf, Friars Formation; Tsc, Scripps Formation; Ta, Ardath Shale; Tmss, Mount Soledad Formation (sandstone part); Tmsc, Mount Soledad Formation (conglomerate part).

Adapted from a portion of "Geology of the San Diego Metropolitan Area, California (Bulletin 200), La Jolla Quadrangle," by Michael P. Kennedy, 1975.

Historically the geologic characterization of surface conditions changes over time. For example, the geologic conditions within the study area, as understood prior to our current understanding, are shown in Figure 6. The current map of geologic conditions within the project area is shown in Figure 7. Explanations of the geologic units shown on Figure 7 are presented on Figure 8.

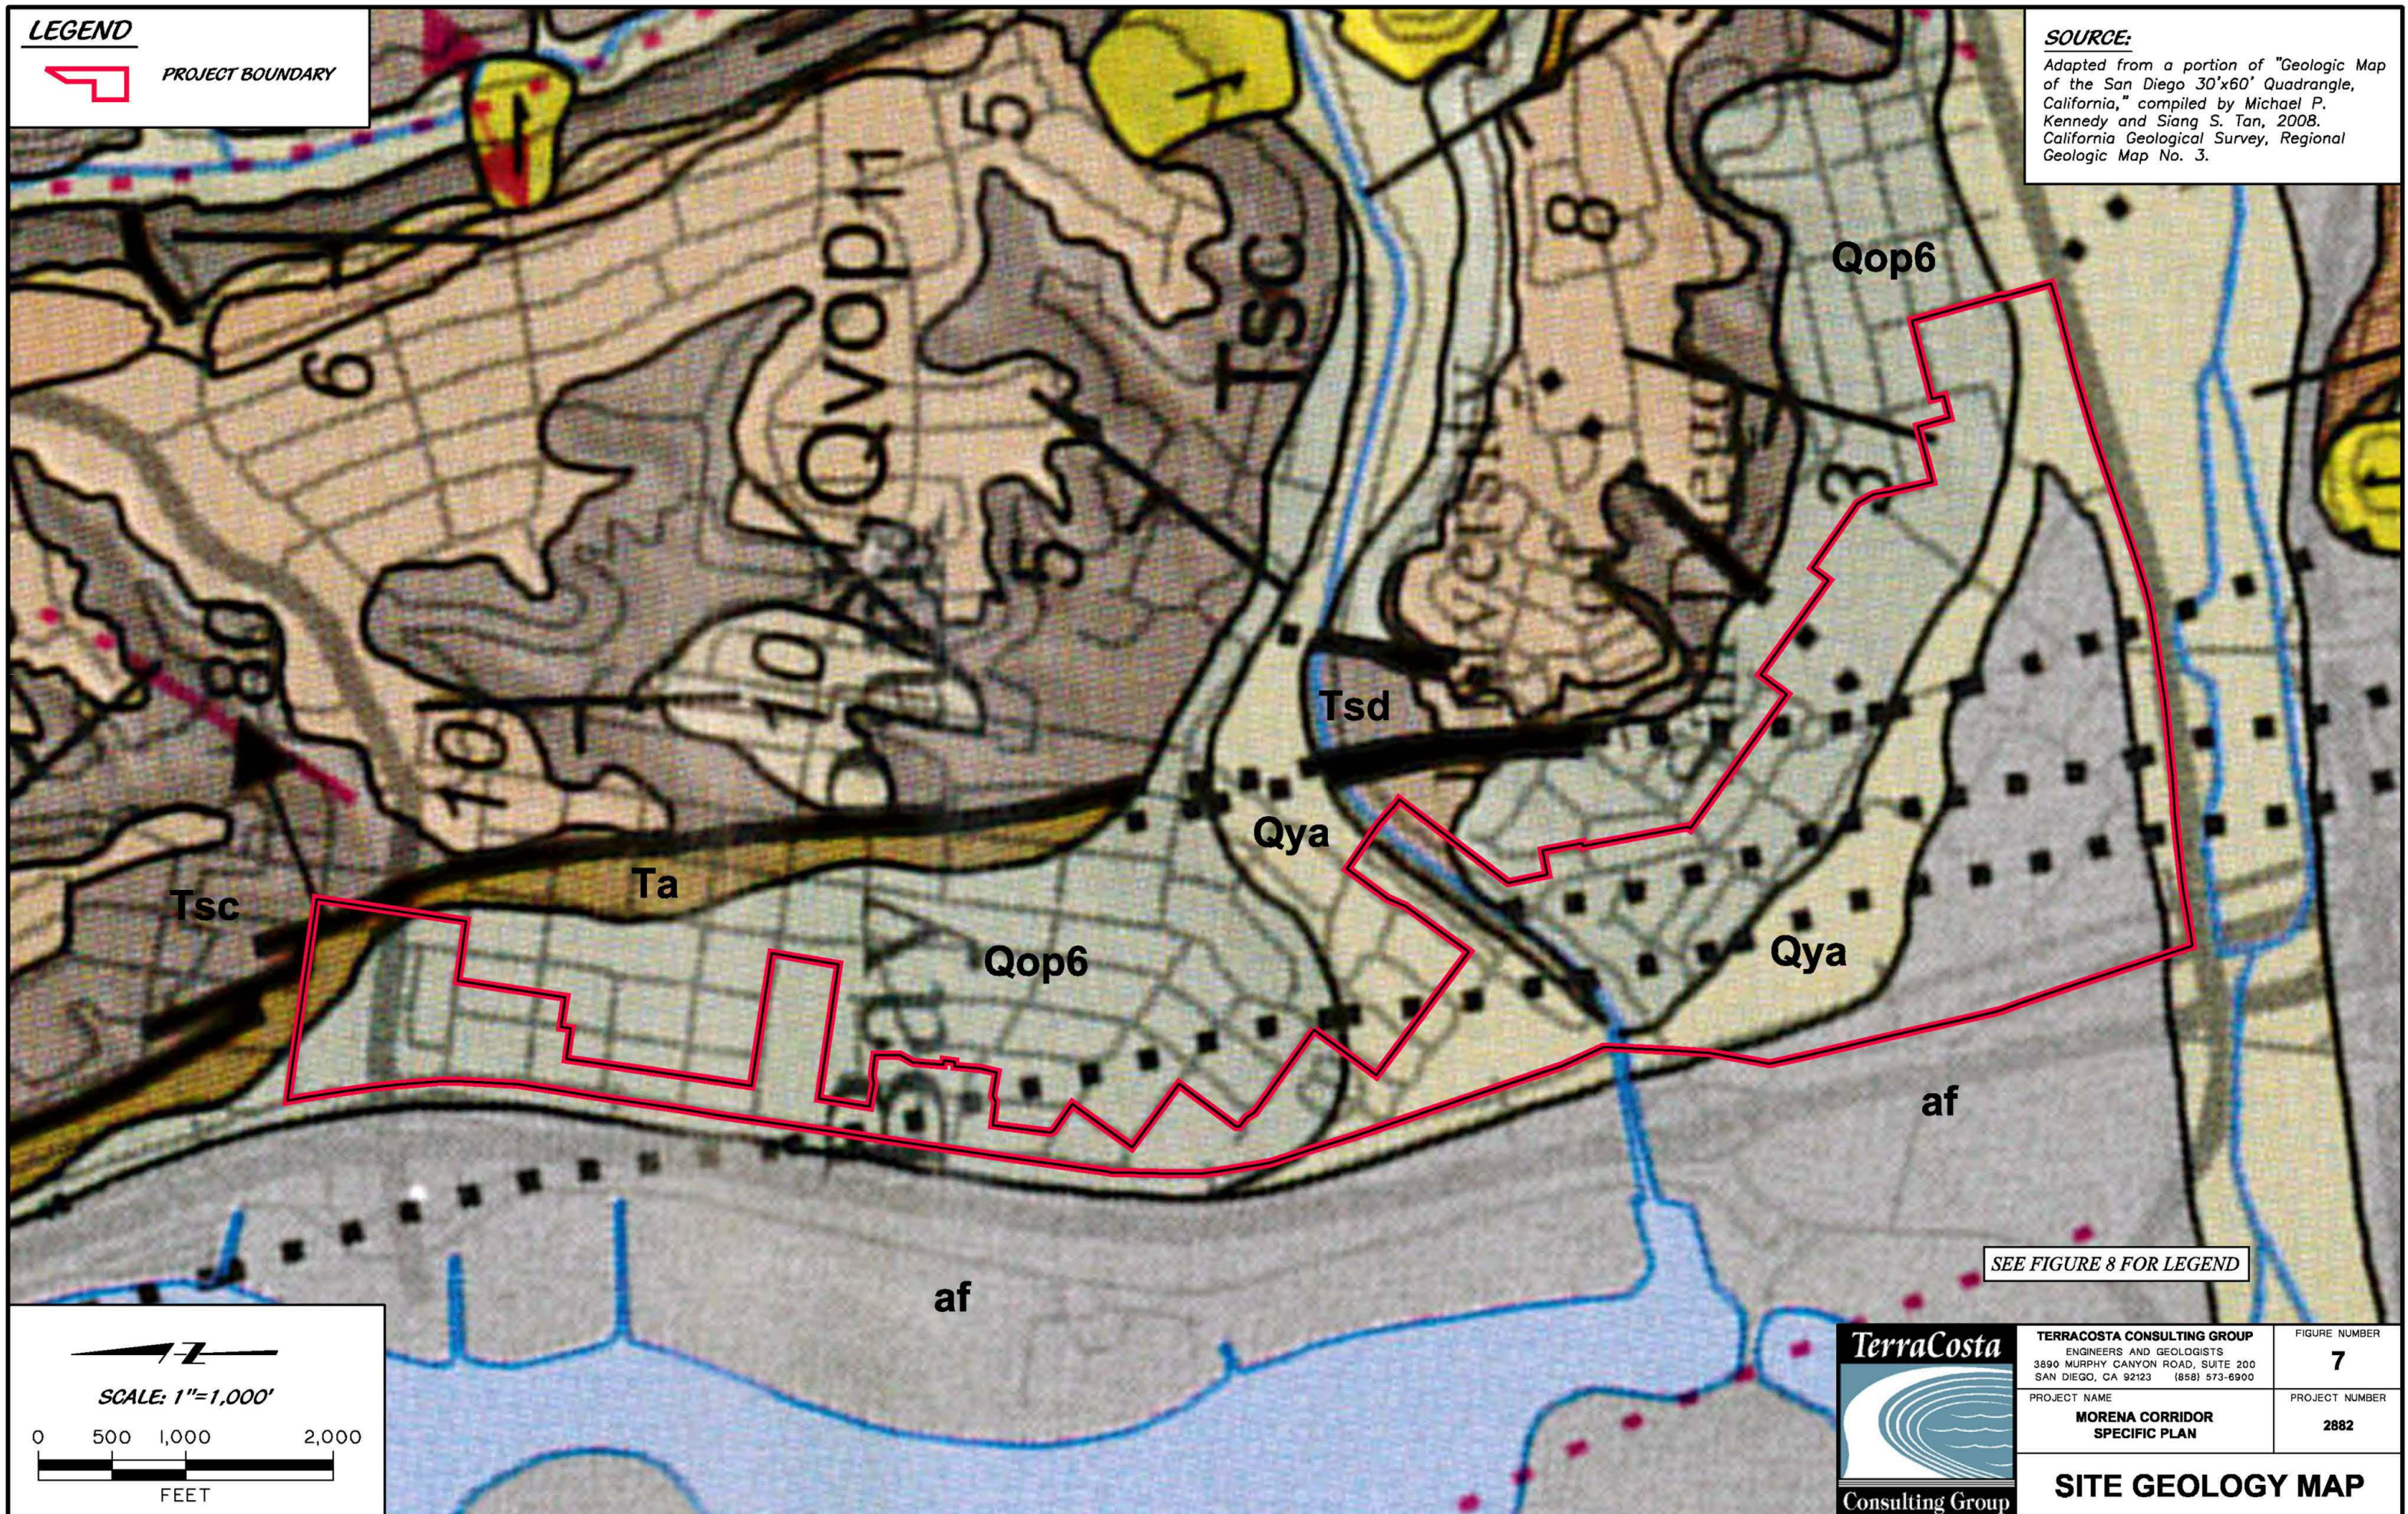
SEE FIGURE 8 FOR LEGEND

Adapted from a portion of "Geologic Map of the San Diego 30'x60' Quadrangle, California," compiled by Michael P. Kennedy and Siang S. Tan, 2008. California Geological Survey, Regional Geologic Map No. 3.

- Scripps Formation (Tsc) – The Scripps Formation is a middle Eocene deposit that is mostly pale yellowish-brown, medium-grained sandstone containing cobble-conglomerate interbeds. Middle Eocene molluscan fauna are found within the unit. The Scripps Formation is exposed locally along the southern boundary of Tecolote Creek and is very limited in exposure.

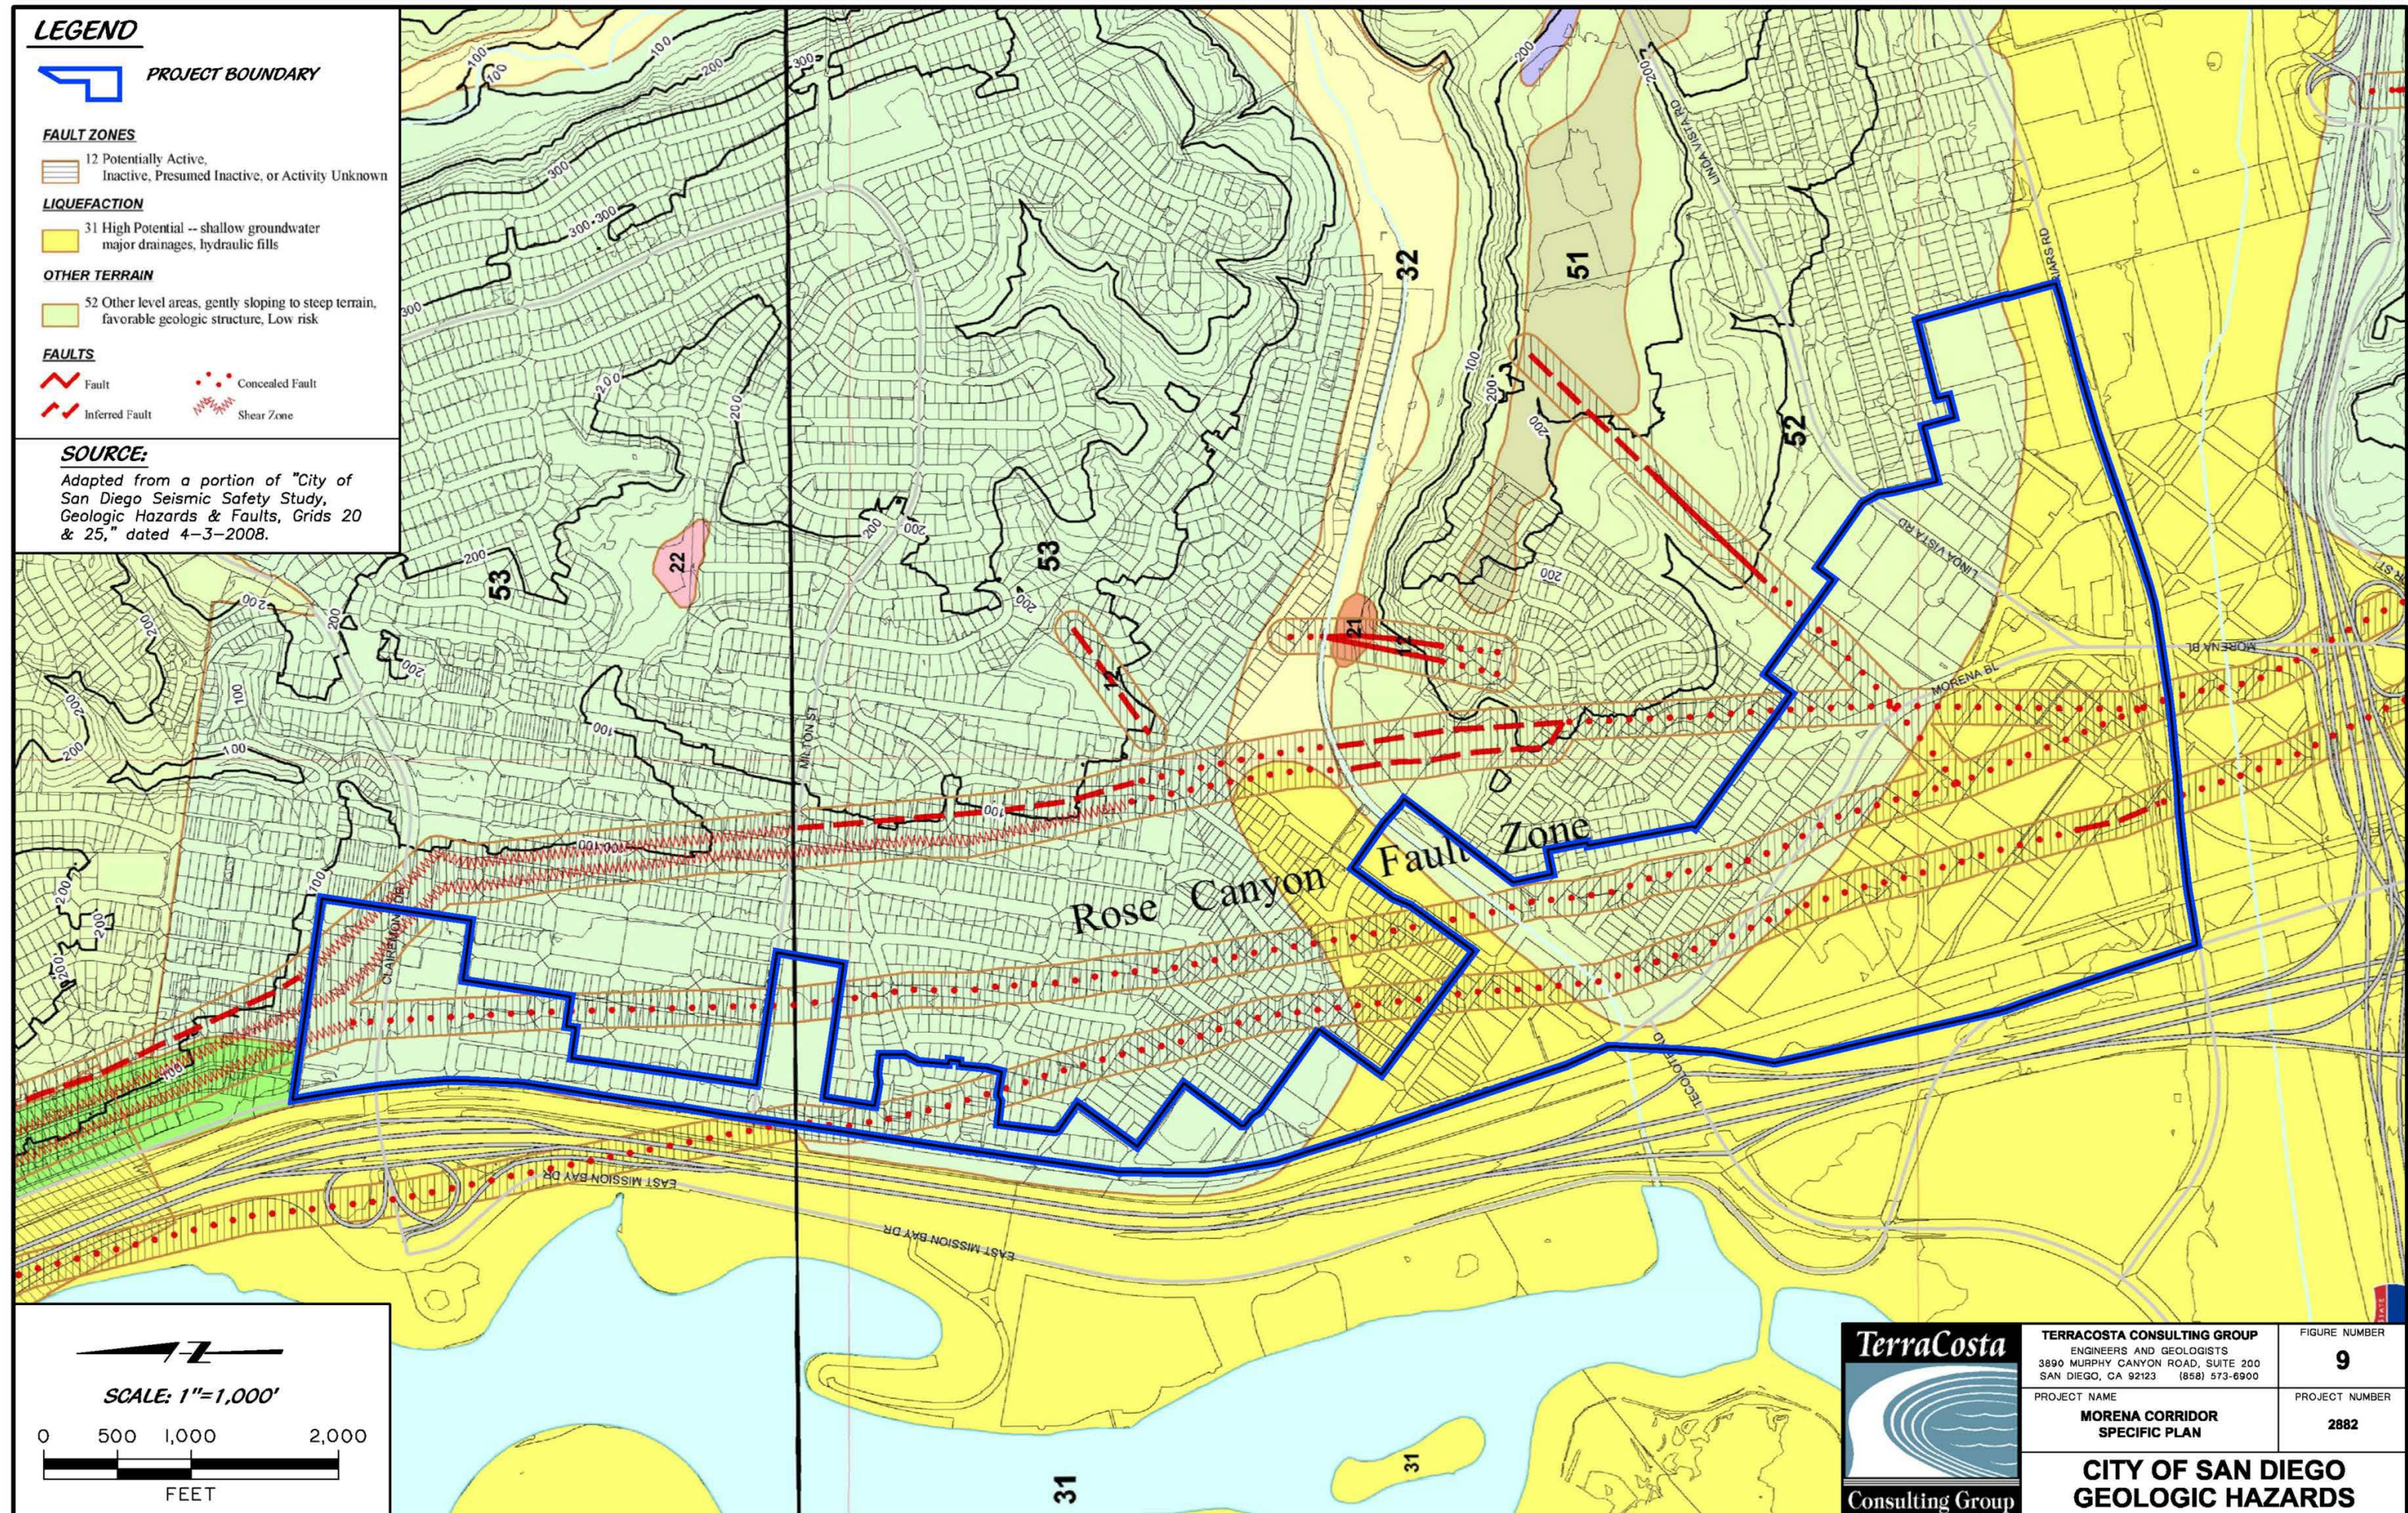
Adapted from a portion of "City of
San Diego Seismic Safety Study,
Geologic Hazards & Faults, Grids 20
& 25," dated 4-3-2008.

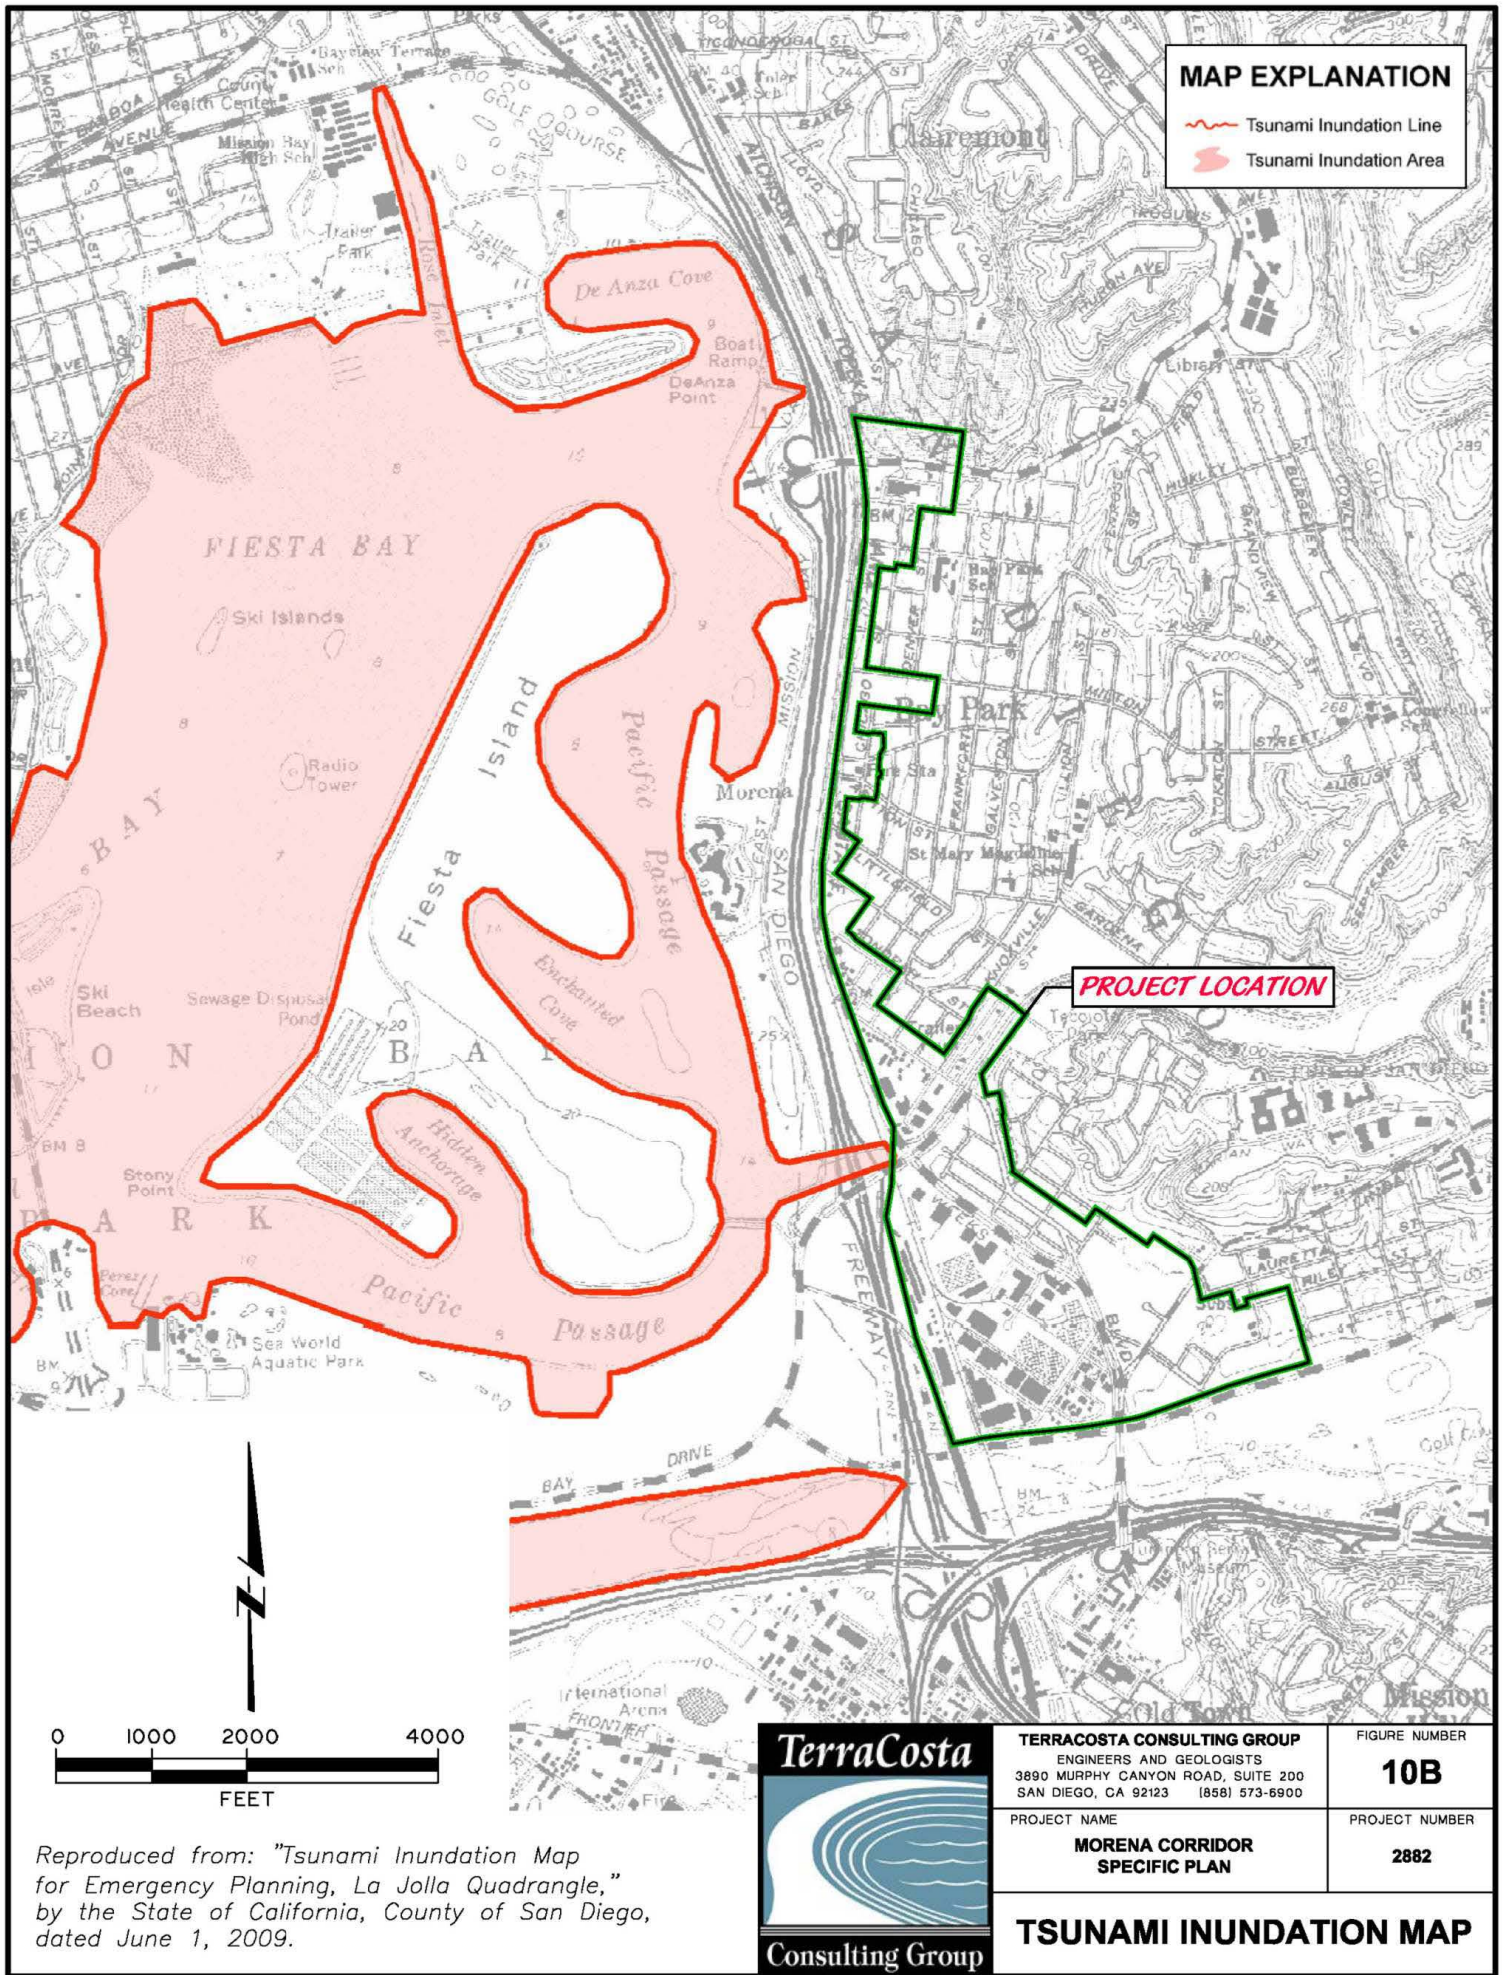
SUNAMI INUNDATION MAP LA JOLLA

- Tsunami Inundation Line
- Tsunami Inundation Area
