***PRELIMINARY GEOTECHNICAL INVESTIGATION AND FOUNDATION RECOMMENDATIONS
PROPOSED ADDITIONS AND REMODEL TO THE EXISTING RESIDENCE AND PROPOSED NEW RESIDENCE
LOCATED AT 7687 HILLSIDE DRIVE
SAN DIEGO, CALIFORNIA 92106***

EDG Project No. 175728-1

October 31, 2017

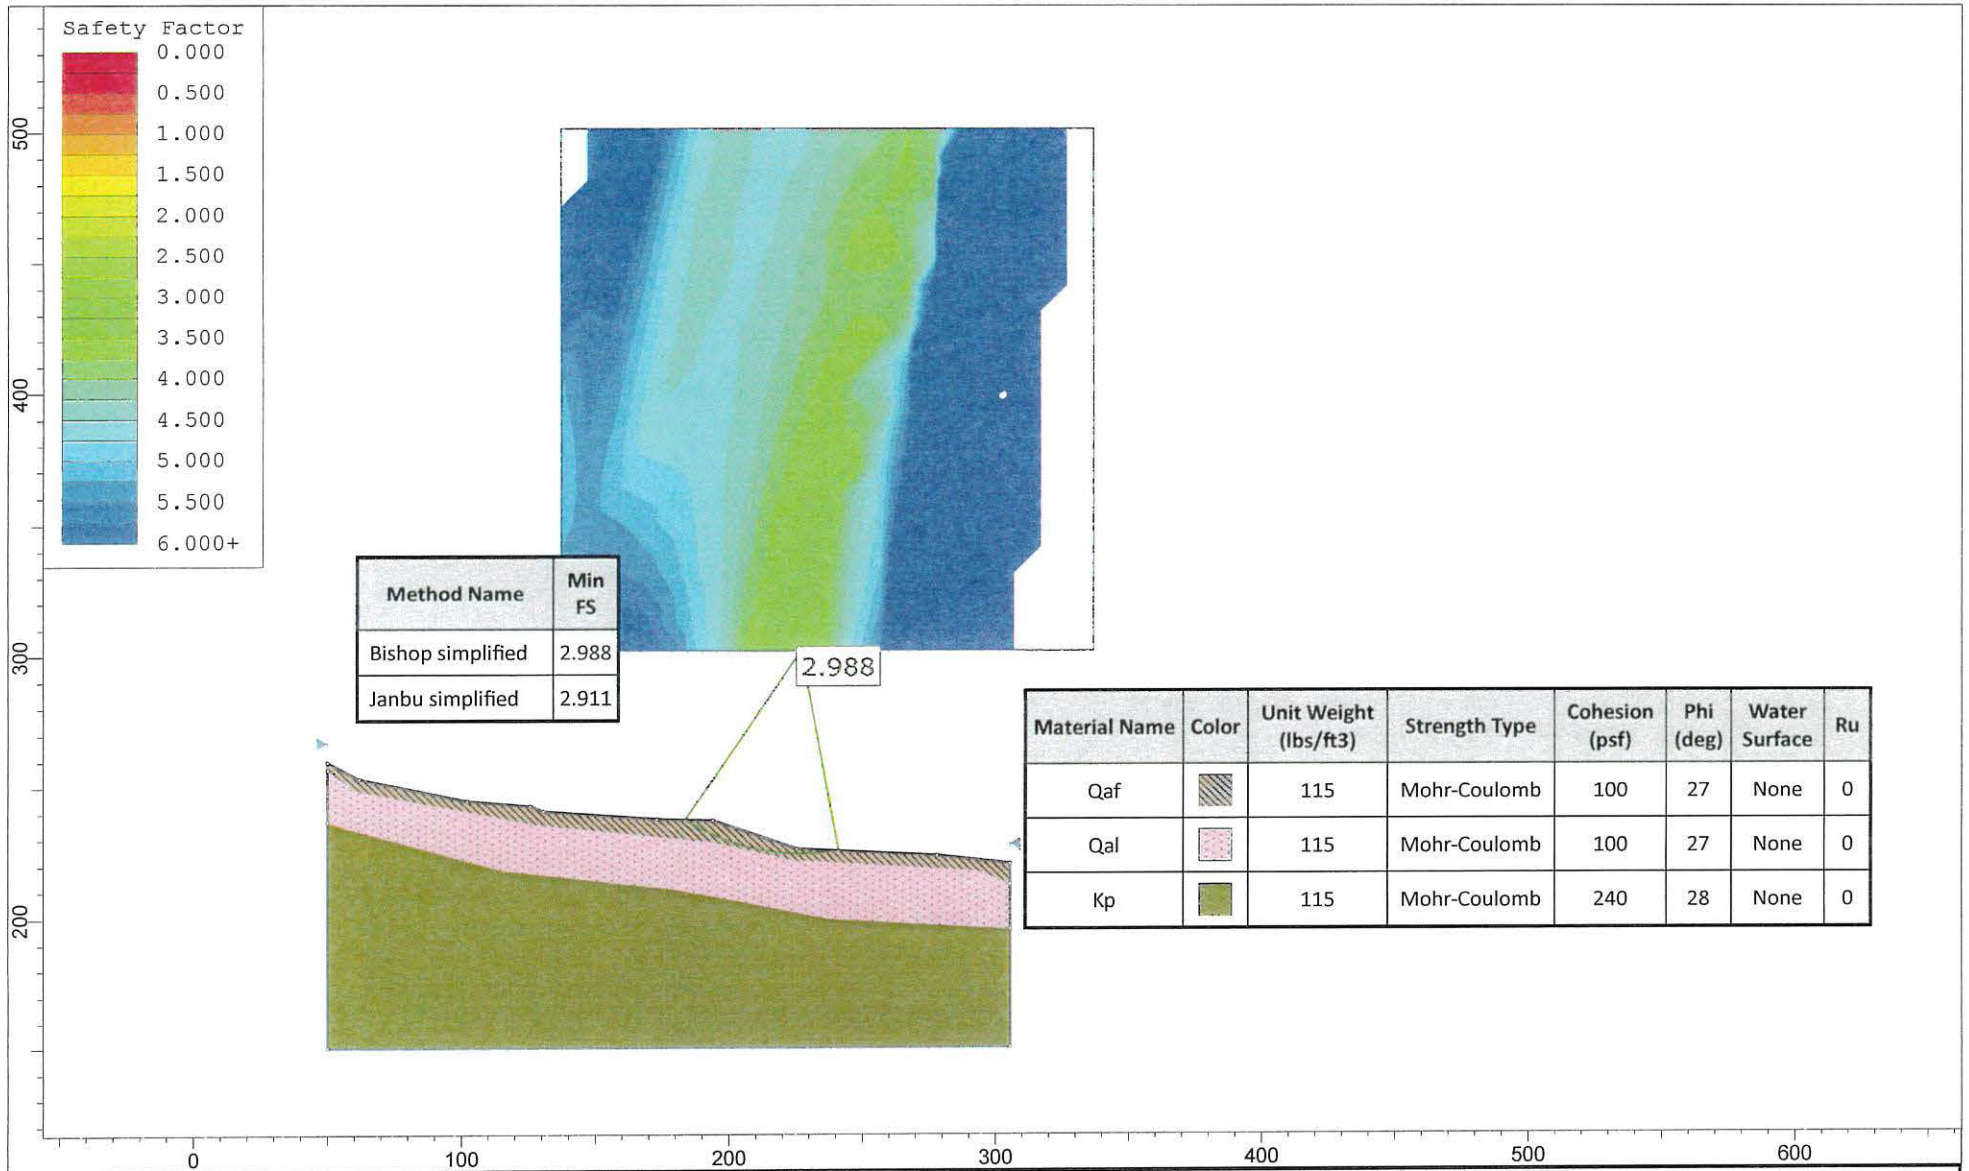
SLIDEINTERPRET 7.026

Project		SLIDE - An Interactive Slope Stability Program	
Analysis Description			
Drawn By	Scale	1:836	Company
Date	3/13/2018, 11:20:40 AM		File Name
			A-A - STATIC - KP28.slim
