**GEOTECHNICAL INVESTIGATION
RADY CHILDREN'S HOSPITAL
MAIN CAMPUS MASTER PLAN
SAN DIEGO, CALIFORNIA**

Project No. SD689

August 25, 2021

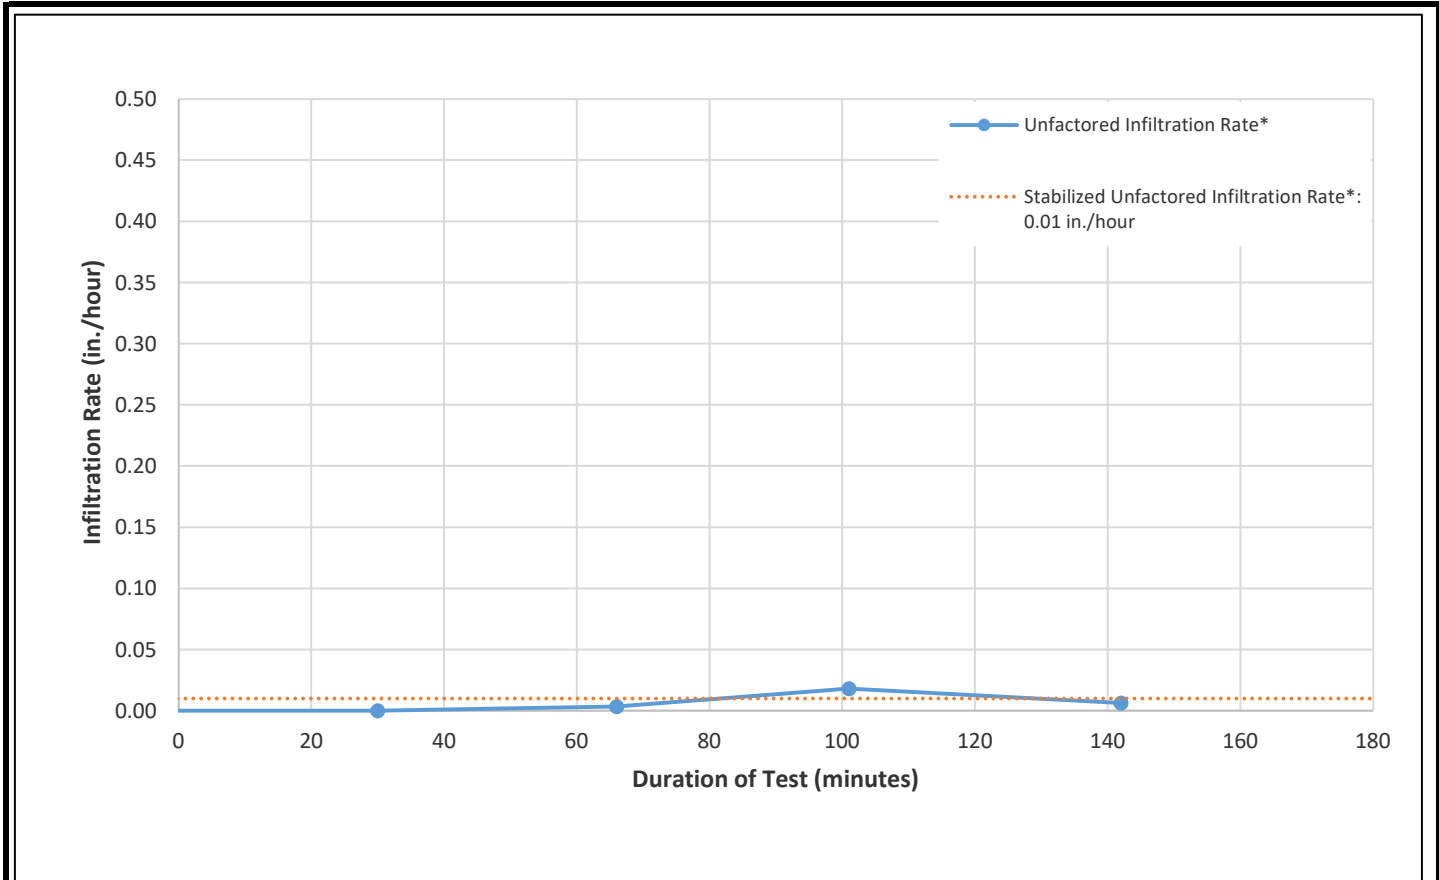
Project Name: <u>Rady Children's</u>	Date Drilled: <u>6/5/2021</u>	Borehole Radius (*r): <u>3 in.</u>
Project Number: <u>SD689</u>	Date Tested: <u>6/6/2021</u>	Casing Diameter: <u>3 in.</u>
Test Hole Number: <u>I-3</u>	Tested By: <u>T. Herrera</u>	Depth of Hole: <u>4.8 ft</u>
Drilling Method: <u>Hollow Stem</u>	Average Water Temperature: <u>68 F</u>	Average Test Depth: <u>2.4' - 4.8'</u>

UNFACTORED INFILTRATION RATES* DURING TEST

Preliminary Factored Infiltration Rate¹: 0.00 in./hr.

Feasibility Screening Factor of Safety, F.S.²: 2

The field testing indicated preliminary factored infiltration rates ranging from about 0.00 to 0.03 inches per hour and averaging 0.01 inches per hour (see Figures C-1.1 to C-4.2). Note that a Factor of Safety of 2.0 is recommended for BMP design. A threshold of 0.50 inches per hour is commonly considered the minimum rate for effective "Full Infiltration" measures. A threshold of 0.05 inches per hour is commonly considered the minimum rate for "Partial Infiltration" measures. The test results at this site are indicative of a "No Infiltration" condition per BMP guidelines.

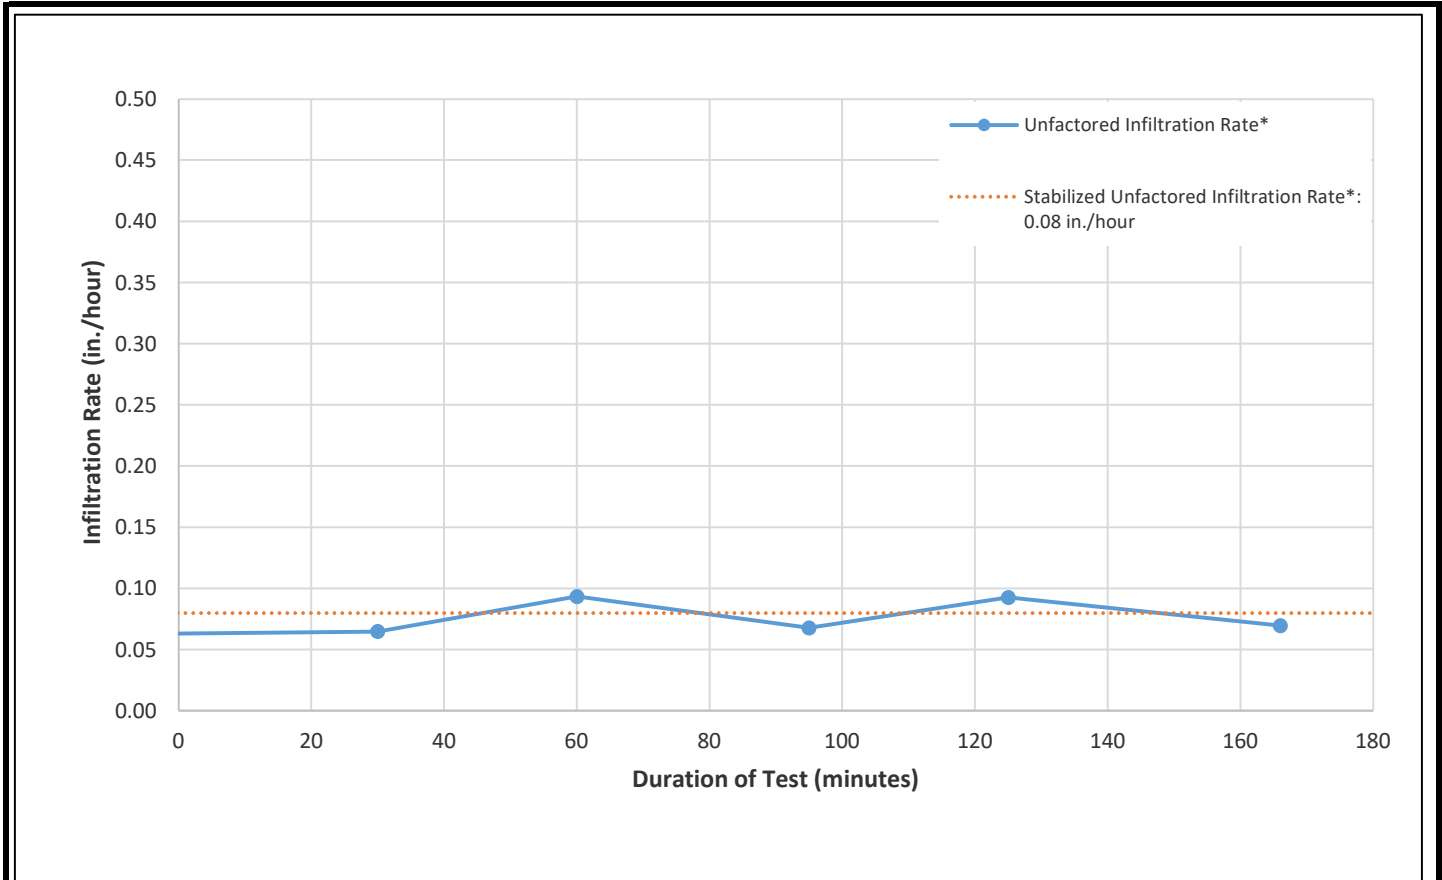
Project Name: <u>Rady Children's</u>	Date Drilled: <u>6/5/2021</u>	Borehole Radius (*r): <u>3 in.</u>
Project Number: <u>SD689</u>	Date Tested: <u>6/6/2021</u>	Casing Diameter: <u>3 in.</u>
Test Hole Number: <u>I-4</u>	Tested By: <u>T. Herrera</u>	Depth of Hole: <u>5.2 ft</u>
Drilling Method: <u>Hollow Stem</u>	Average Water Temperature: <u>75 F</u>	Average Test Depth: <u>2.1' - 5.2'</u>

UNFACTORED INFILTRATION RATES* DURING TEST

Preliminary Factored Infiltration Rate¹: 0.03 in./hr.

Feasibility Screening Factor of Safety, F.S.²: 2
