# GEOTECHNICAL AND FAULT RUPTURE HAZARD INVESTIGATIONS

PROPOSED RESIDENCES – 7248 ENCELIA DRIVE AND 7231 ROMERO DRIVE

La Jolla, California

**SCST No. 180385N**  
**Report No. 4**

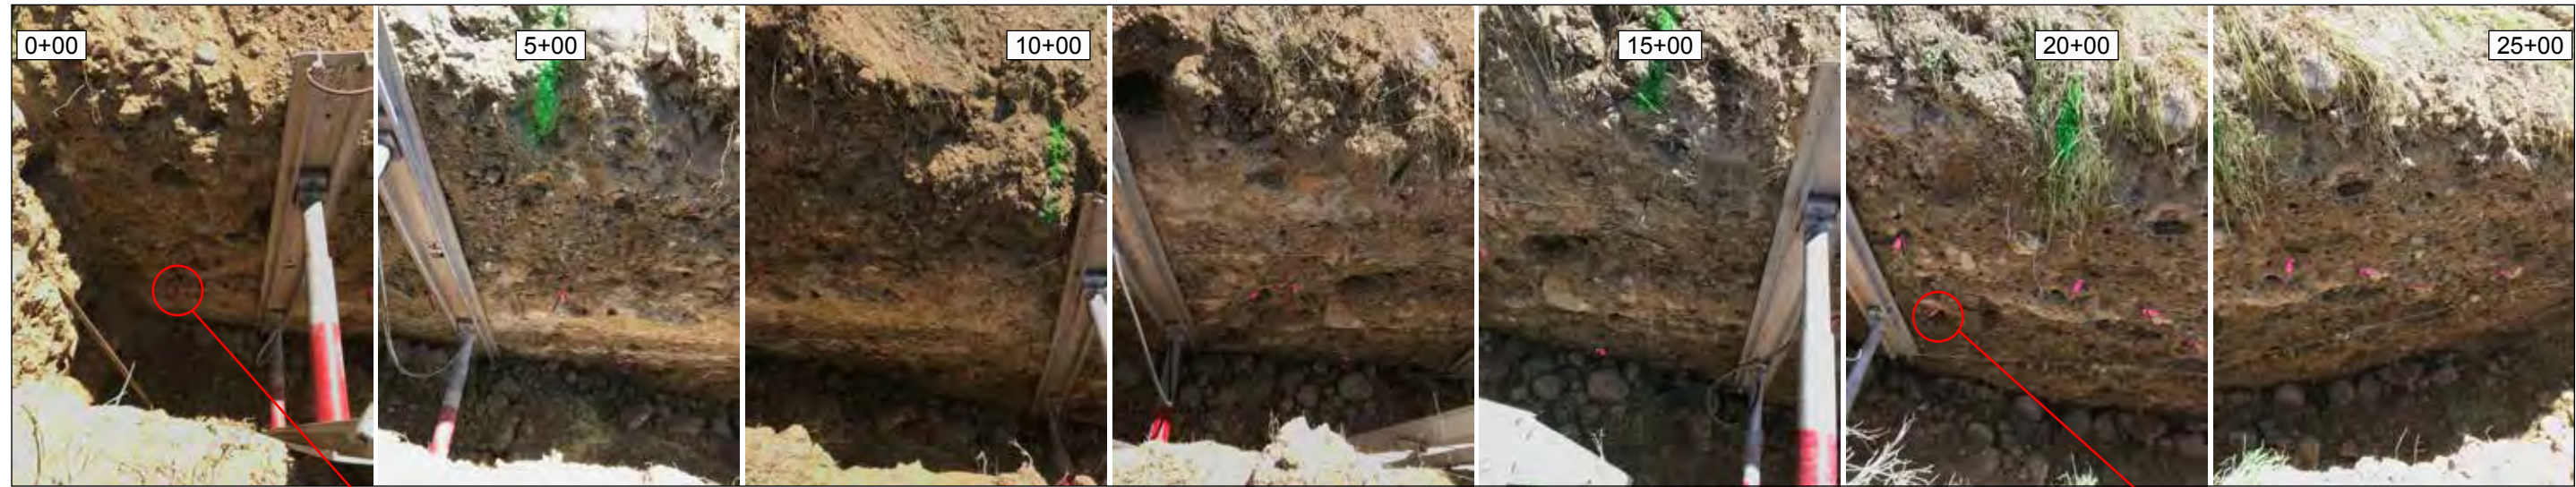
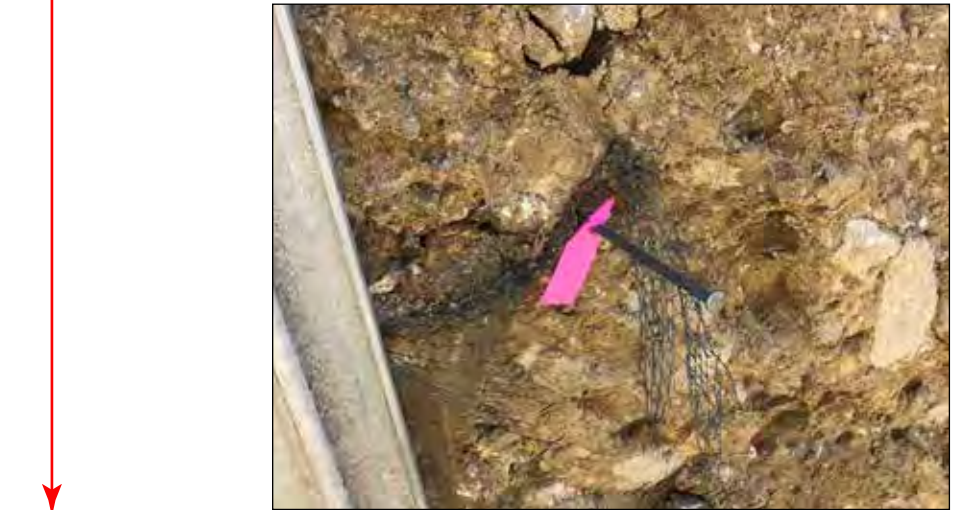
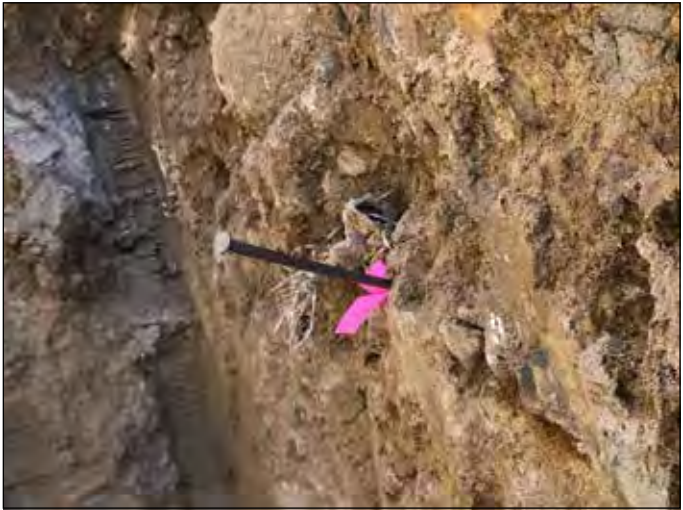
T-1 MOSAIC (facing SW)

Examples of trash/debris in fill.

Plate 1 .....	Trench T-1 Log and Photographs
Plate 2 .....	Trench T-2 Log and Photographs
Plate 3 .....	Test Pit TP-1 Log and Photograph
Plate 4 .....	Boring 2 Log and Photographs

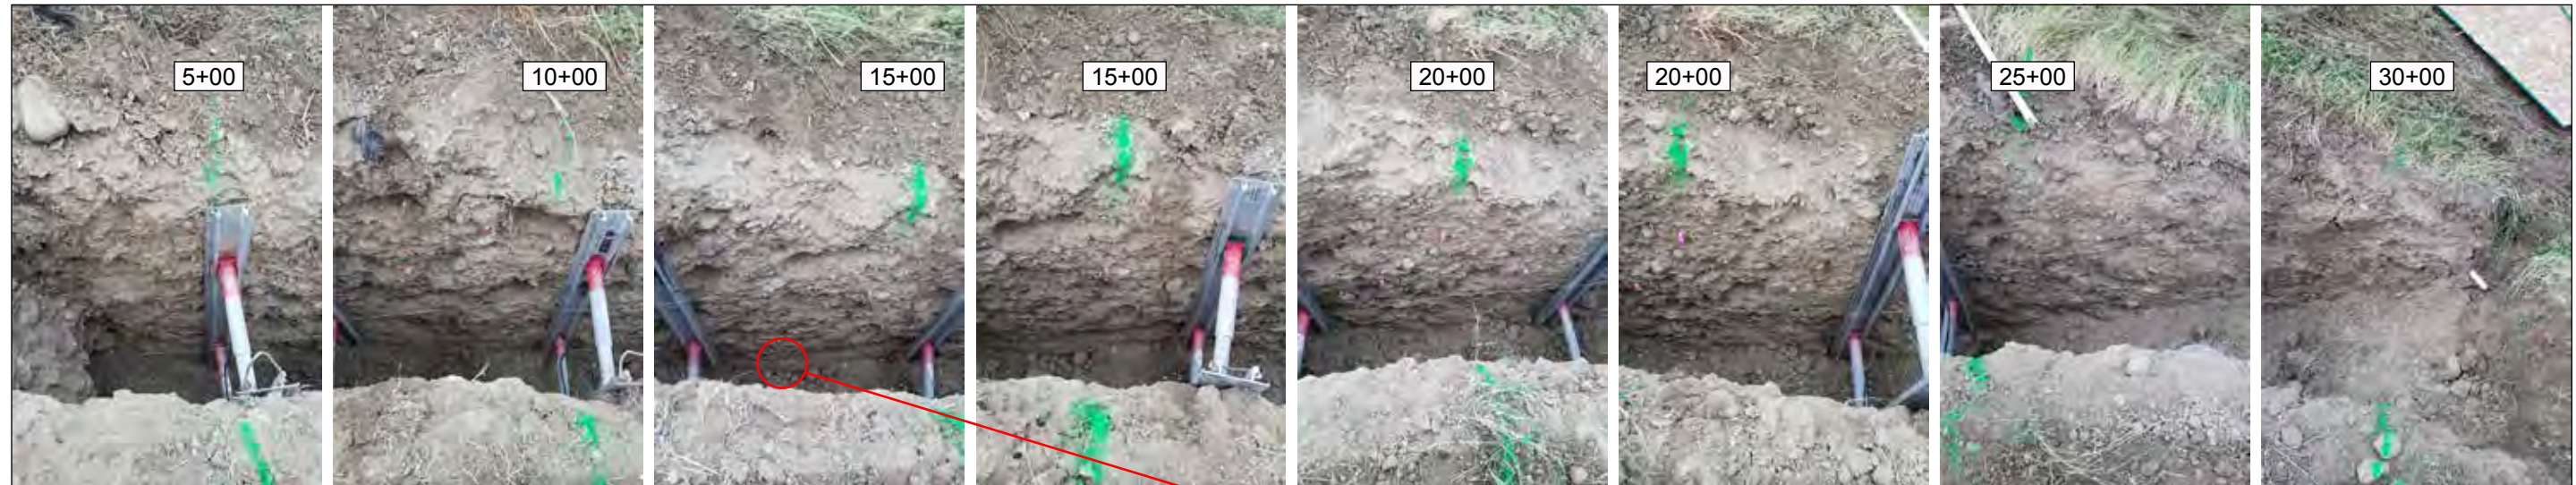
Plate:  
2

T-2 MOSAIC (facing SW)

T-2 TRENCH LOG

Contact between Fill and the Cabrillo Formation.

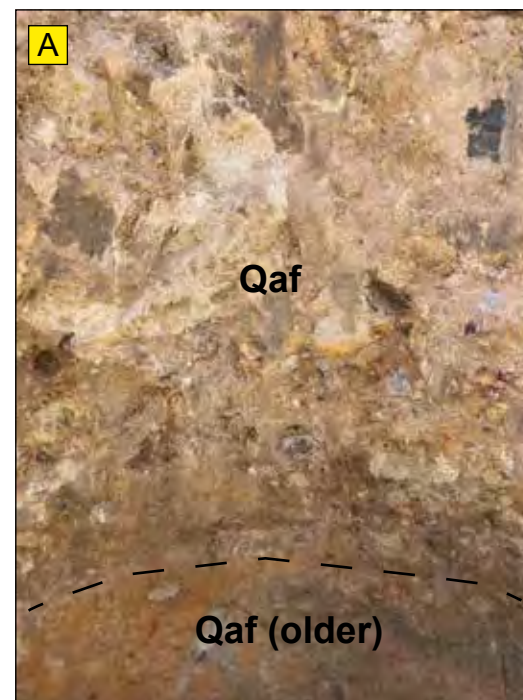
A) Looking downward towards Artificial Fill materials.

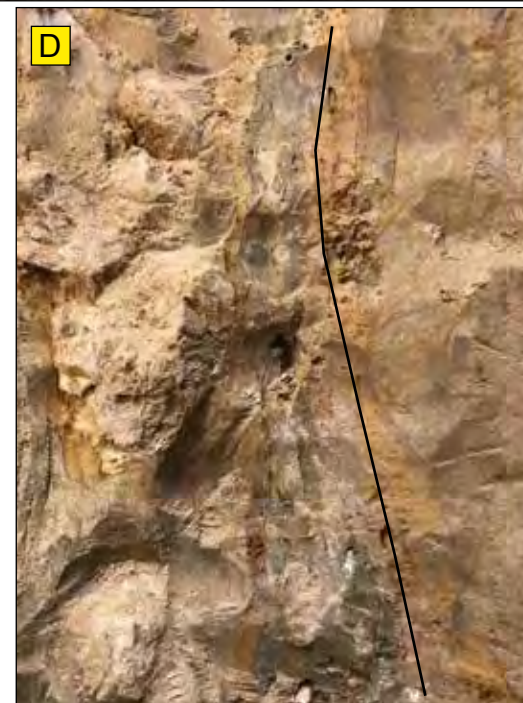
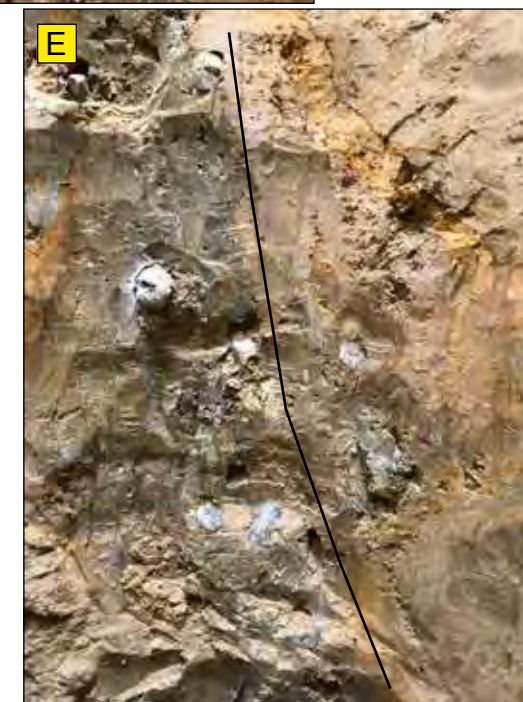
C - E) Close up of the Principal Slip Surface and aligned gravels in the Damage Zone.

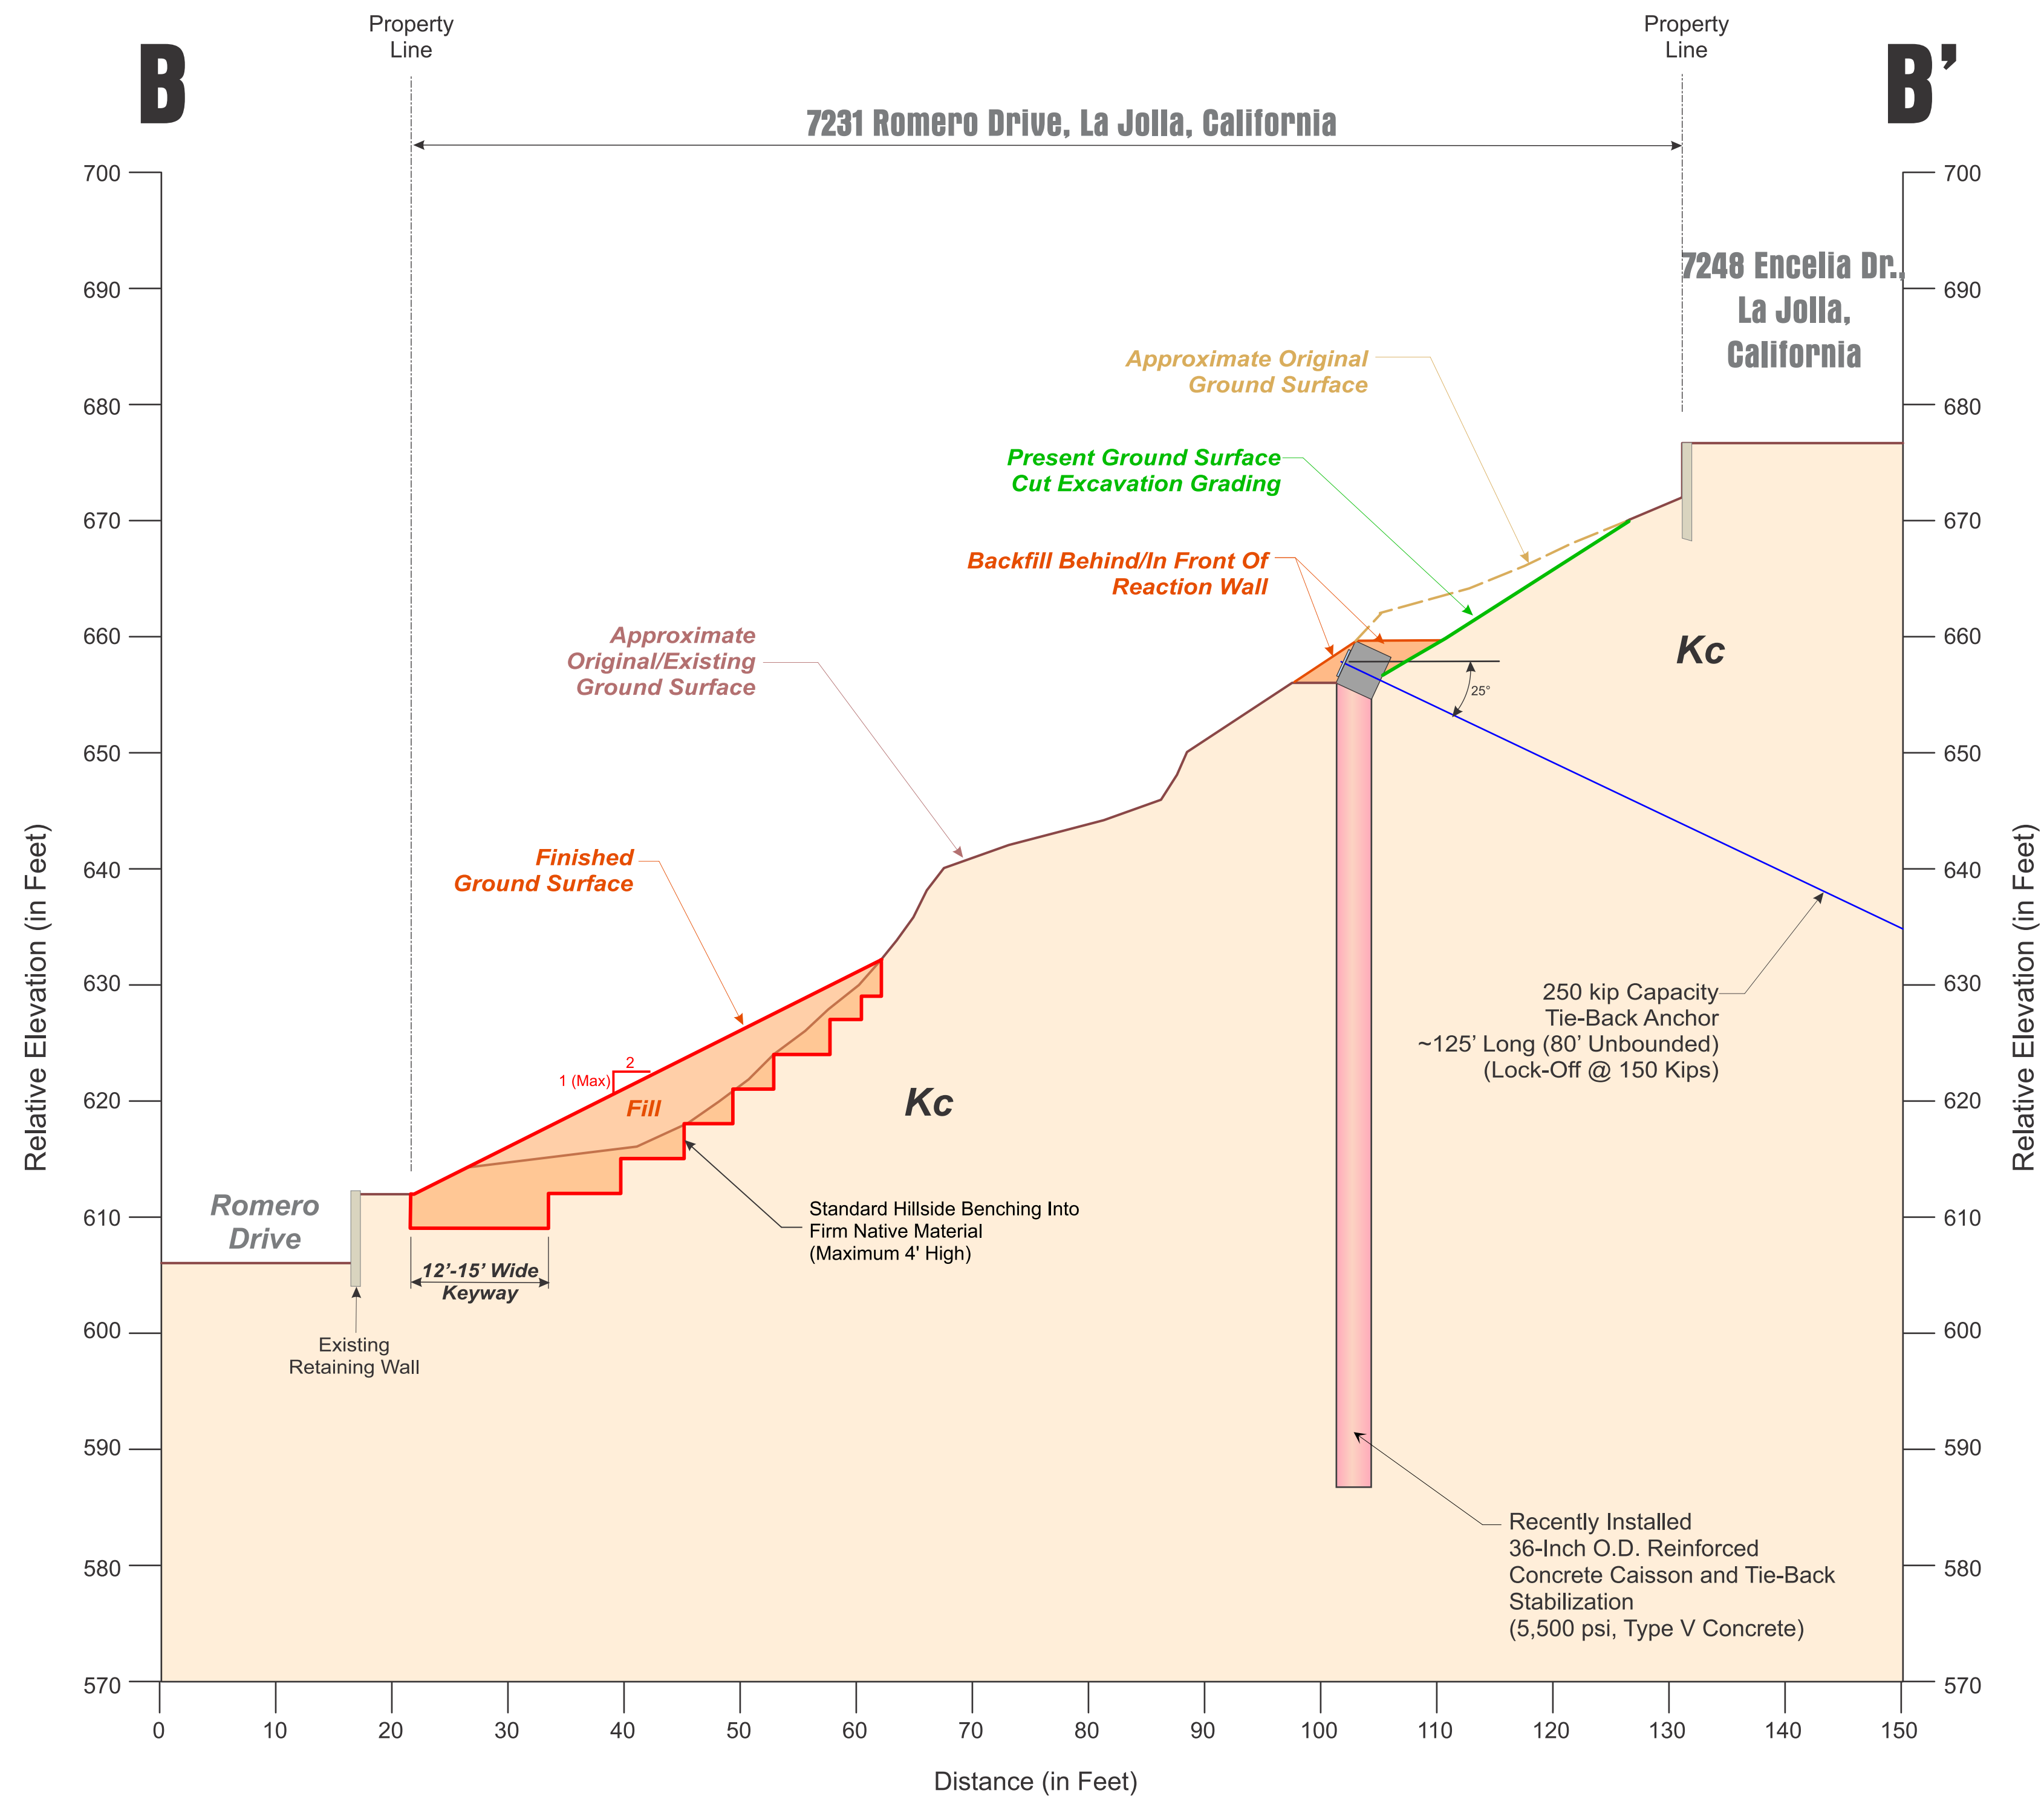
***As-Built Grading Plan, Cross-Section  
& Caisson Depths***
