### GEOTECHNICAL REPORT THE INN AT SUNSET CLIFFS SAN DIEGO, CALIFORNIA

Prepared by TERRACOSTA CONSULTING GROUP, INC. San Diego, California

> Project No. 2317-01 December 24, 2020

TerraCosta Consulting Group, Inc. (TerraCosta) is pleased to submit this geotechnical report addressing the recently proposed tied-back secant pile wall landward of and along the eastern edge of the existing lower deck at The Inn at Sunset Cliffs (Inn) in the Ocean Beach area of San Diego, California.

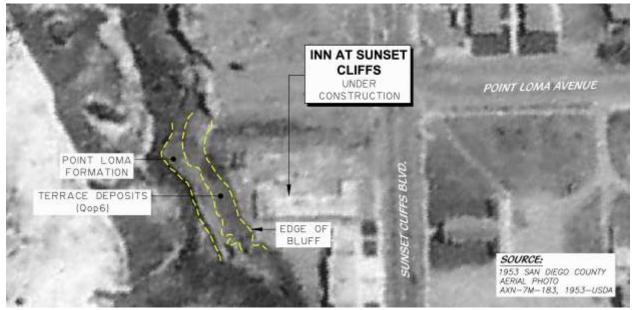
We have reviewed several historical photos dating back to 1939. The below 1953 aerial photo shows The Inn under construction and the seawall and lower viewing area constructed concurrently (Photo 1). Thus, all of the existing improvements pre-date the California Coastal Act.

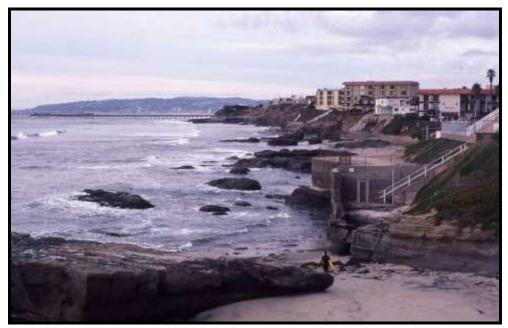
Photo 2

Photo Date: 1982

Photos taken from 1978 through 1982 during the construction of the Sunset Cliffs Shoreline Stabilization Project show the lower cliff-forming bedrock unit (Photos 2 and 3), the top of which is estimated to be near elevation +5 to +12 feet (MSL), on top of which the variable height masonry block wall was constructed in 1953. Although relatively erosion-resistant, marine erosion has continued to cause the lower cliff-forming geologic unit to retreat, undermining the existing wall foundation in 1990, in 2003, 2015, and again in 2018, causing the localized loss of wall backfill and necessitating the previously described foundation/wall maintenance.

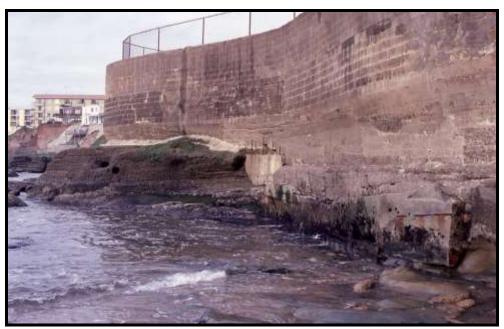
Photo 3

Photo Date: 1982

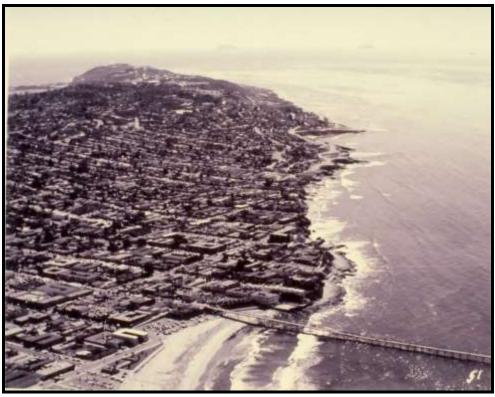
Photo 4

Photo Date: 1974

Point Loma is a 6-mile-long peninsular promontory (Photo 4), extending southerly from the low land adjacent to the mouth of the San Diego River. The Point Loma coastal bluffs are bordered by a narrow wave-abraded Quaternary-age terrace or bench, with elevations ranging from 25 to 95 feet MSL. Wave impact erosion has etched out the less resistant rock along faults and fractures in the coastal bluff, creating the shallow coves and sea caves that punctuate the Point Loma coastline. The more resistant rocks of the Point Loma Formation form the lower cliffed section of the coastal bluff and shore platform, which extends seaward. The relatively flat surface of the modern-day abrasion platform is interrupted by isolated remnants of more erosion-resistant rock, which have formed "sea stacks" and topographic highs. Further seaward, the abrasion platform becomes progressively deeper, and is locally incised by surge channels formed along the trends of major joint sets or faults.

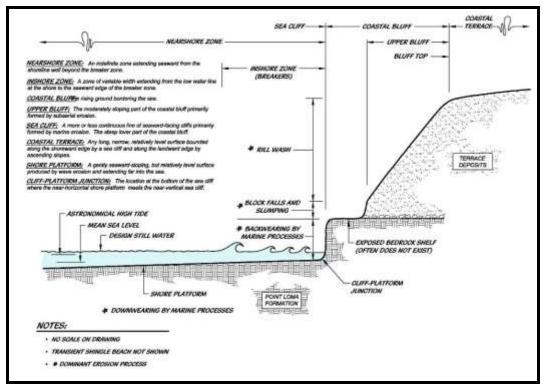
Figure 8. Typical Coastal Bluff Profile (Looking North up the Coast).

the waves begin to break (Figure 8). This boundary varies with time because the point at Within the nearshore zone is a subdivision designated as the inshore zone, beginning where

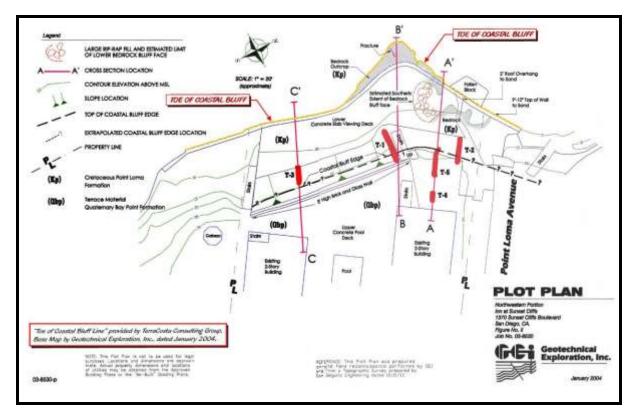
Figure 9. GEI Plot Plan.

below as Figure 9 coastal bluff edge shown on Figure 9. geotechnical report prepared by GEI, which in part form the basis for the location of the Three representative geologic cross sections are contained in the attached February 2004 located the top of the coastal bluff that has been reproduced from GEI's report and shown It is our opinion that the GEI test pits most accurately

GEI also corroborated their bluff edge location by reviewing aerial photographs from 1939, 1950, 1953, 1960, and 1972. While we have also reviewed the available photographs that GEI referenced, we have also independently reviewed additional aerial photographs dated 1953, 1964, 1972, 1980, 1981, 1990, 2003, and 2005 to again corroborate the location of the bluff edge originally determined by GEI.

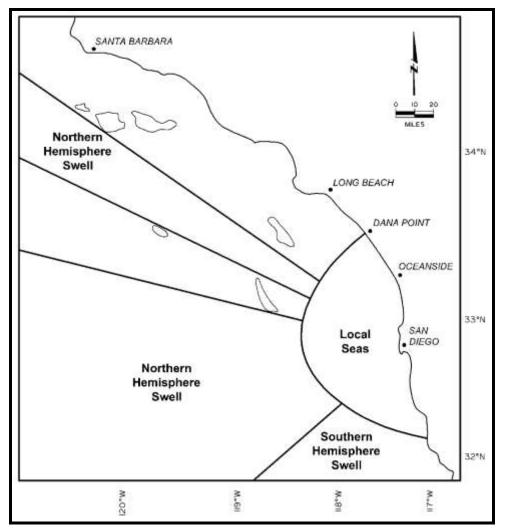
Figure 10. Map Showing Generalized Wave Exposure for Southern California.

(Figure 11). complex bathymetry of southern California greatly complicate the wave climate at the coast through the area. is more important in the summer. Ocean dominate the winter wave conditions off California, while southern hemisphere swell and locally short-period generated seas. coast fall into three main categories: Longer period northern and southern hemisphere swell, California coast. As illustrated in Figure 10, incoming waves along the southern California Waves provide nearly all of the energy input that drives shoreline processes along the The offshore islands, shallow banks, submarine canyons and generally Short-period seas are produced by storms North hemisphere swell from the North Pacific sweeping

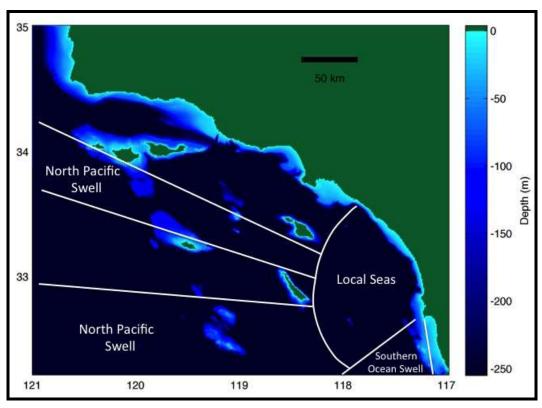
Figure 11. Map Showing Generalized Bathymetry in the Southern California Bight and Wave Exposure Windows at Oceanside.

Coastal orientation, and the islands and banks greatly influence the swell propagating toward shore by partially sheltering southern California, including Point Loma, especially from directions north of west. Figure 11 shows the approximate directions from which incoming swell is blocked by the islands. The Point Loma coastline faces west and is therefore also relatively exposed to southern hemisphere swell. Because of the complicated effects of bathymetry and island shadowing, the wave height at the shoreline is sensitive to relatively small changes in the incoming direction of the deep ocean waves.

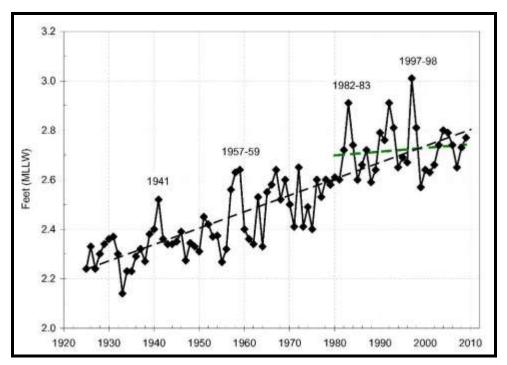
Figure 13. Annual Average Sea Level History at La Jolla, 1925-2007. Broken Line Shows Linear Trend of 0.7 Feet/Century Rise.

Figure 13 is a plot of the annual mean sea levels measured at the La Jolla tide gauge starting in 1925. The linear trend indicates the approximate 0.7 foot per century sea level rise. Also noticeable are the enhanced sea levels during the El Niño episodes of 1941, 1957-59, 1982-83, and 1997-98 (respectively labeled).

A notable feature of the sea level history at La Jolla is the leveling-off of sea level rise since about 1980 (Figure 13). The green broken line shows a much reduced trend of about 0.15 foot per century between 1980 and 2009, or about 4.5 times smaller than the overall trend of 0.67 foot per century. A similar reduction in the rate of sea level rise has been noted at San Francisco, which has a similar overall appearance as the La Jolla record, but is a much longer record extending back to 1856.

the eastern Pacific, extending from Central America north to Washington State, have fallen at a rate of 0-3 mm per year (0-30 cm per century, or 0-1 foot per century). This may explain the coastal tide gauge observations (La Jolla sea level history; Figure 13) described above.

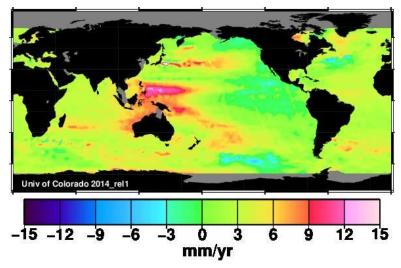
Figure 14. Global Sea Level Change Rates 1993-2012 as derived from satellite altimetry measurements, following University of Colorado (2012).

Figure 14 shows the global distribution of the rate of sea level change for the period of 1993-2012 (University of Colorado, 2012). Note that warm colors (yellow-orange-red) show areas of sea level rise (positive rates), while cool colors (green- blue) indicate falling sea level (negative rates) over the record. Inspection of the North Pacific reveals that sea levels in the western Pacific, especially in the lower latitudes, have risen at a rate of 3-9 mm/year (equivalent to 30-90 cm per century, or about 1-3 feet per century). Conversely, sea levels in

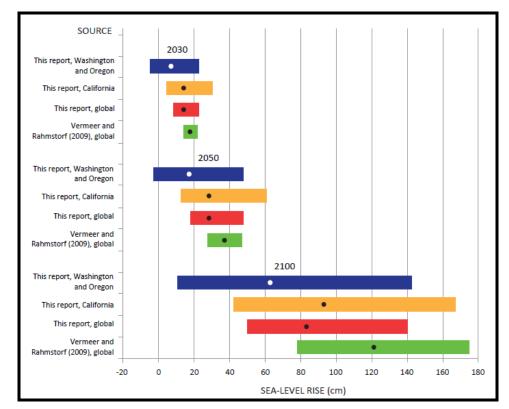
Figure 15. NAS (2012) summary of global, Washington, Oregon, and California (south of Cape Mendocino) MSLR projections for 2030, 2050, and 2100 relative to 2000.

When considering the effects of future sea level rise, the National Academy of Sciences (NAS, 2012) presents a possible global, west-coast, and state-wide future Mean Sea Level Rise (MSLR) for California, Oregon, and Washington (Figure 15, dots) and its range (Figure 15, bars). These are based on the IPCC (2007) mid-range Green House Gas emissions scenarios for the ocean steric (warming) expansion component added to the results of new research projecting the likely contributions of future ice-melt. The resulting projected *global* MSLR relative to 2000 ranged from 0.08-0.23 m (0.26-0.75 ft) by 2030; 0.18-0.48 m (0.59-1.6 ft) by 2050; and 0.50-1.4 m (1.6-4.6 ft) by 2100 (Figure 15, red bars). The global estimates were adjusted for vertical crustal movement (uplift north of Cape Mendocino and

down-drop in the south) resulting in the orange bars, also shown in Figure 15. The State of California (2013) used these results of NAS (2012) shown as the updated MSLR guidance in Table 2.

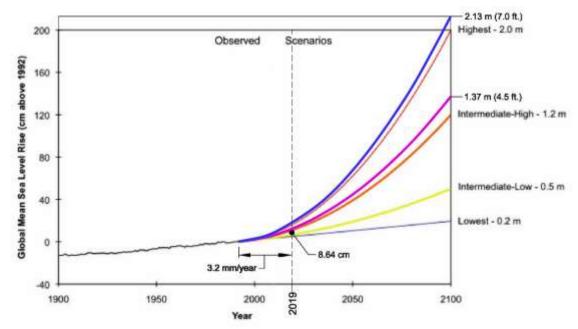
### FIGURE 16

Modified from Figure 5 of the California Coastal Commission Sea Level Rise Policy Guidance document adopted August 12, 2015.

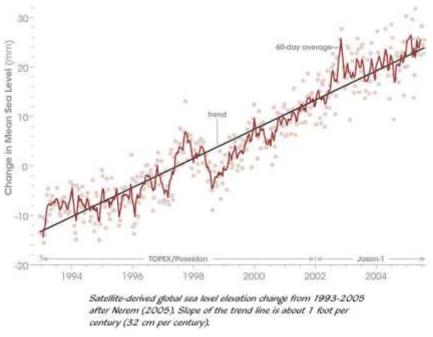
Global mean sea level rise rate over the past two decades has increased over the rate observed for the past century, and has reached about 1 foot per century (32 cm per century). This is indicated from satellite data reporting and trend analysis shown in Figure 17 (Nerem, 2005).

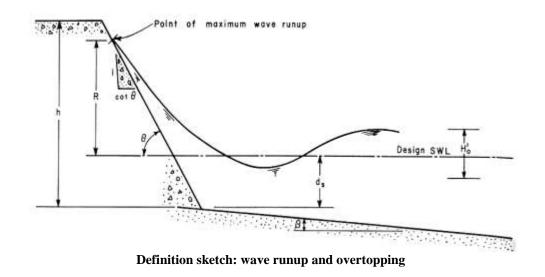
The following definition sketch for both wave runup and overtopping, reproduced from the 1984 SPM, graphically illustrates the point of maximum wave runup for a particular design condition.

It should also be clear from the sketch that any wave runup exceeding the height of the structure then represents overtopping.

We evaluated both the maximum height of runup and volume of overtopping based on the U.S. Army Corps of Engineers 2006 Coastal Engineering Manual (CEM) for a total of three design conditions. We assumed a design scour elevation of -5 feet, a foreshore slope of 1 on 60, and wave periods ranging from 6 to 18 seconds.

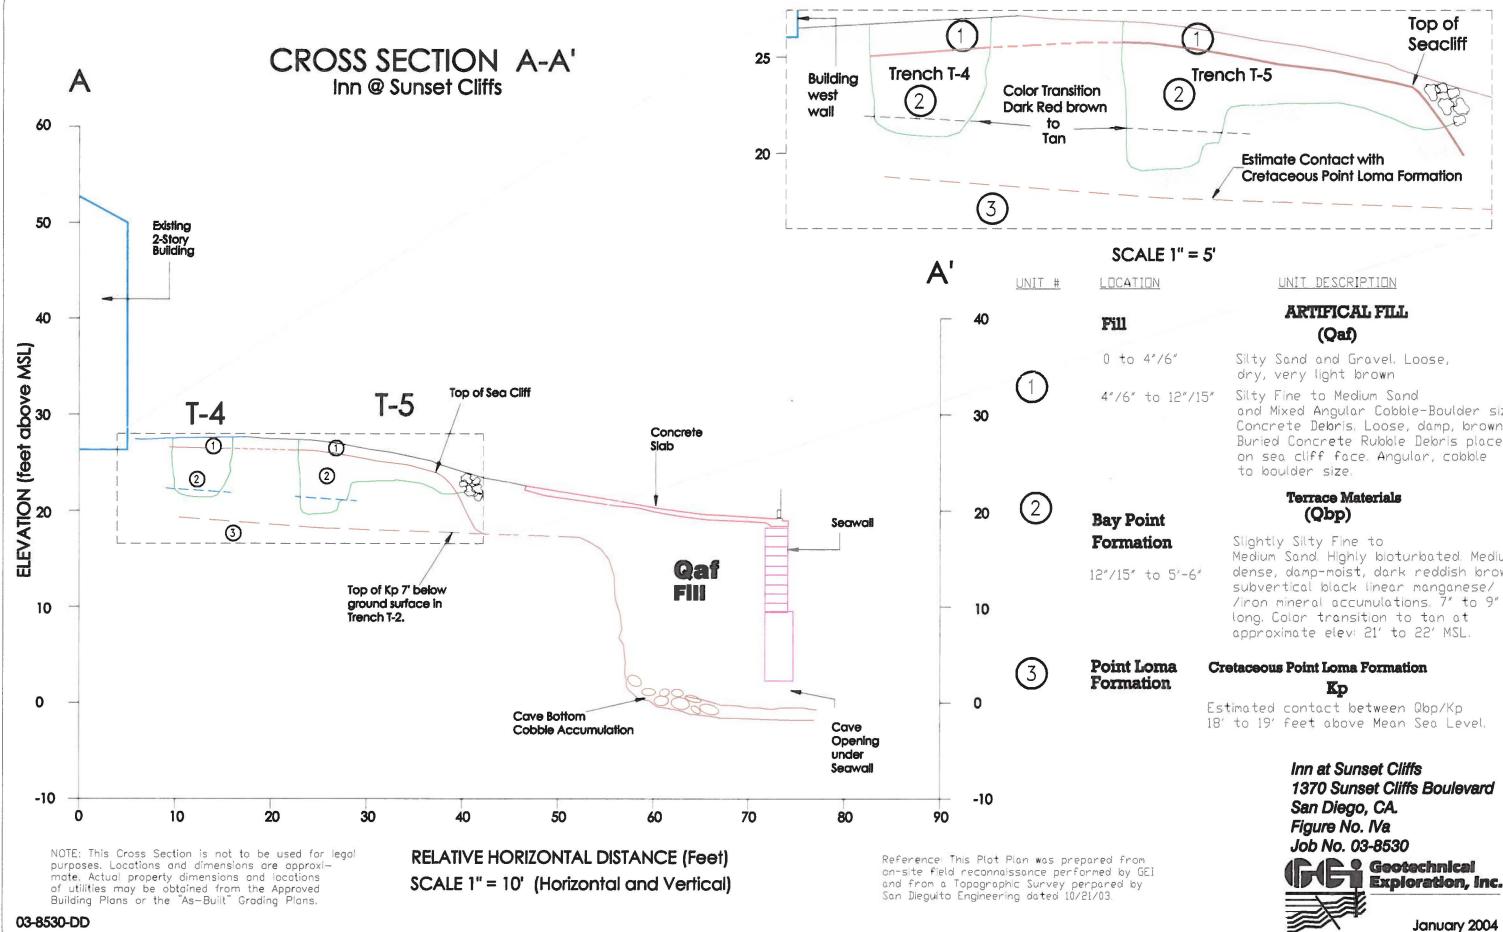
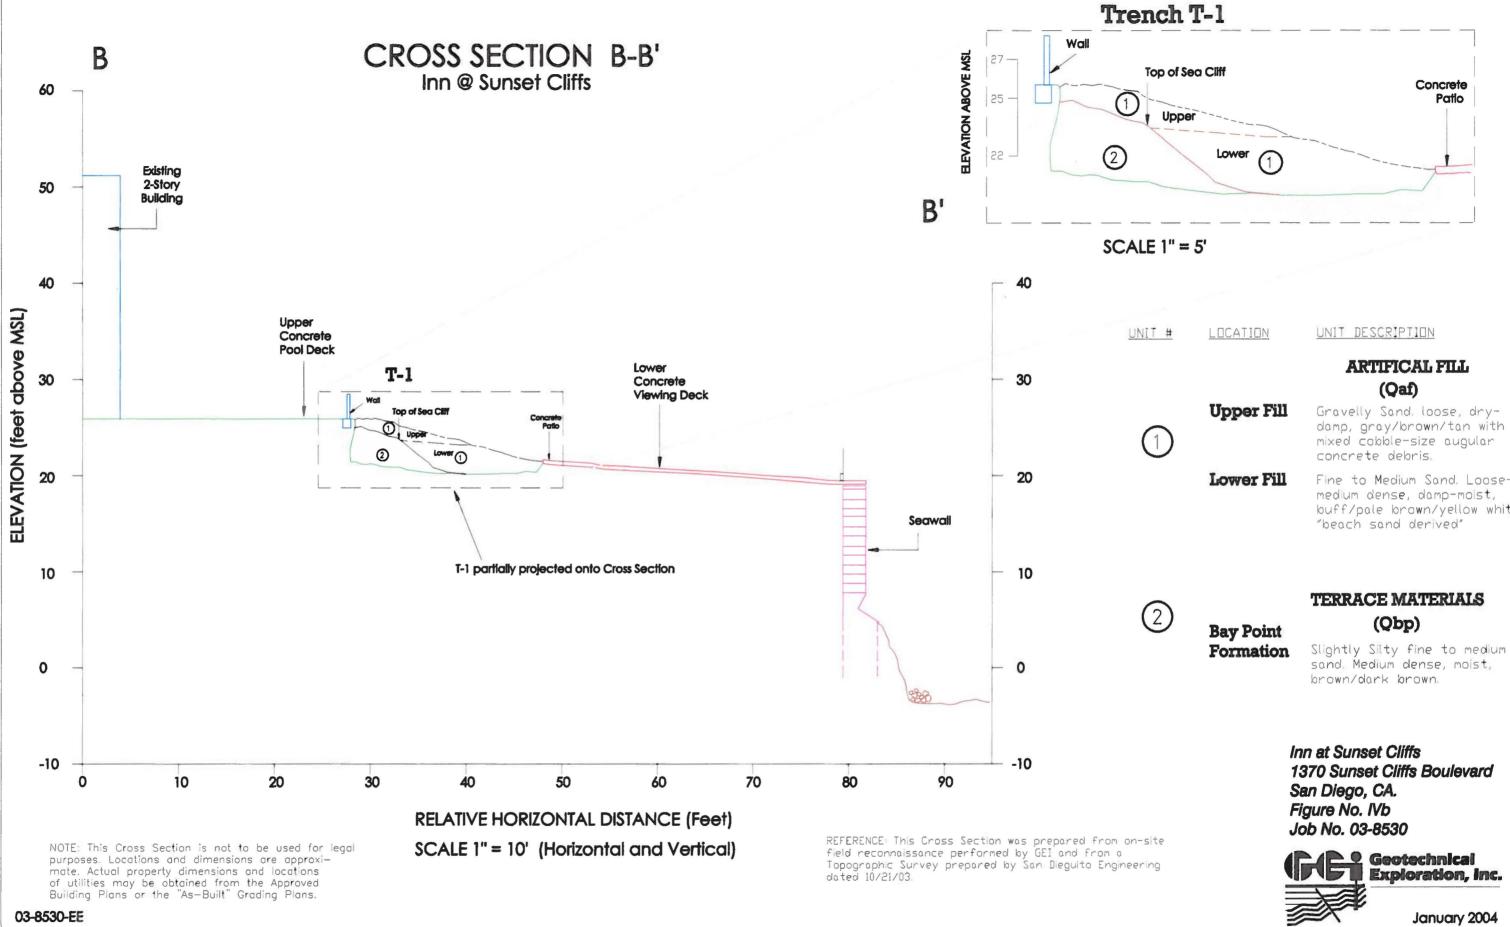
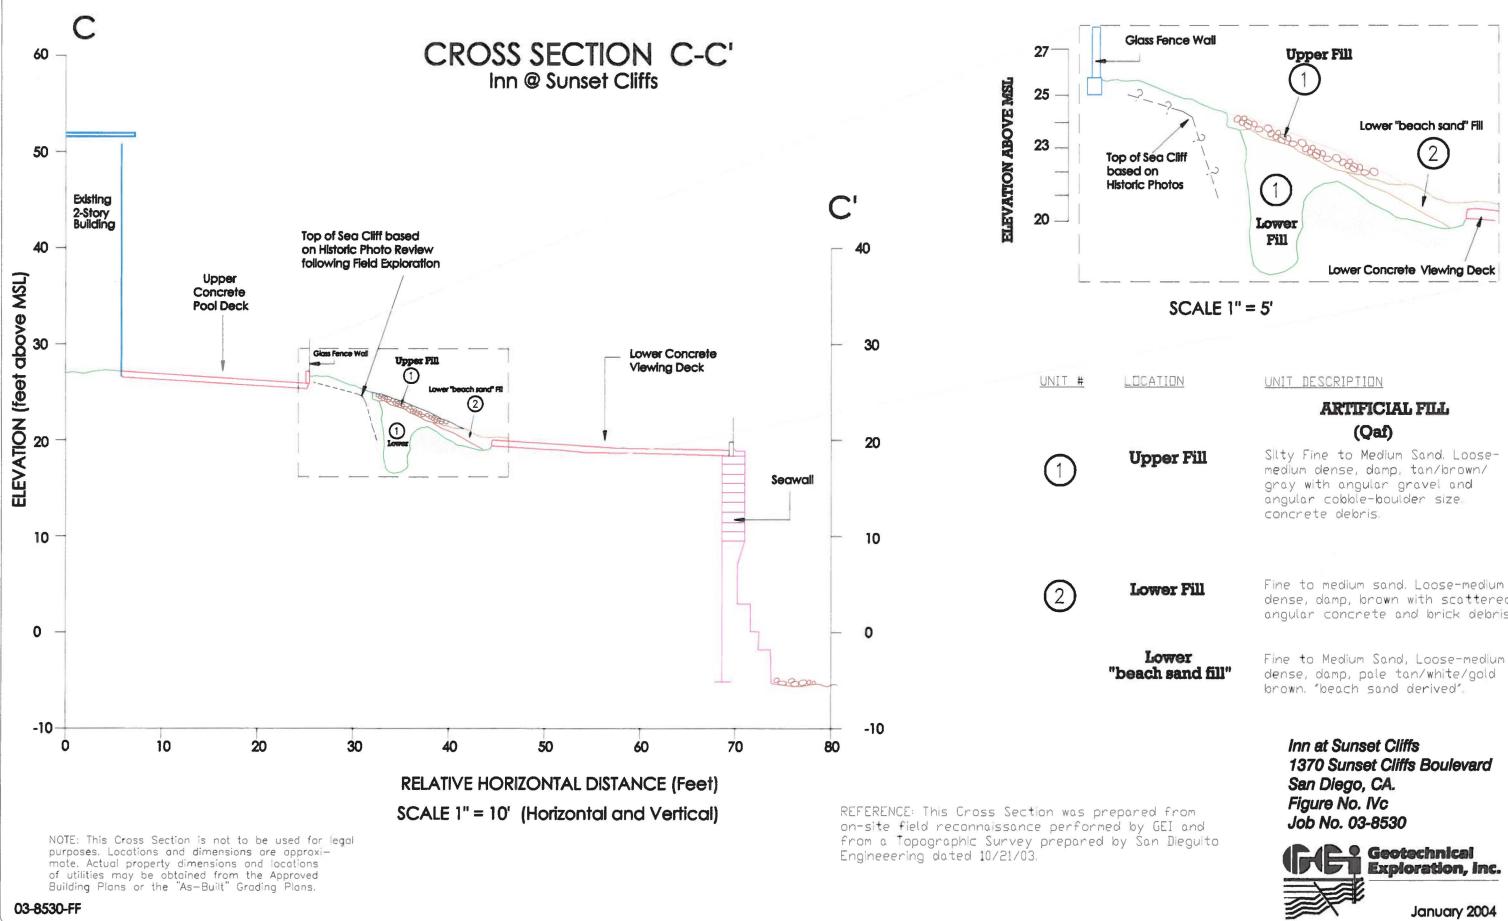
- and Mixed Angular Cobble-Boulder size Concrete Debris. Loose, damp, brown Buried Concrete Rubble Debris placed

Medium Sand Highly bioturbated Medium dense, damp-moist, dark reddish brown.

UNIT #	LUCATION	UNIT DESCRIFTIDIN
		ARTIFICAL FILL (Qaf)
1	Upper Fill	Gravelly Sand, loose, dry- damp, gray/brown/tan with mixed cobble-size augular concrete debris.
	Lower Fill	Fine to Medium Sand, Loose- medium dense, damp-moist, buff/pale brown/yellow white. "beach sand derived"
(2)		TERRACE MATERIALS

dense, damp, brown with scattered angular concrete and brick debris.

The exploratory excavations exposed minor thicknesses of debris-laden silty sand and clayey sand fill soils overlying natural formational materials. Formational material consisted of a 4- to 7-foot thickness of Quaternary Bay Point Formation marine terrace deposits overlying the Cretaceous Point Loma Formation. The Point Loma formational materials are exposed at the western base of the sea wall, forming natural near-vertical and benchlike (sub-tidal) outcrops. These materials are identified as the Upper Cretaceous-age Point Loma Formation (Kp) on geologic maps of the site (Bulletin 200 of the California Division of Mines and Geology). Point Loma Formation outcrops were also observed beneath the lower deck during sea wall/sea cave evaluation (Appendix B, Photo 1). The primary purpose of placing the exploratory excavations was to observe the nature of the contact

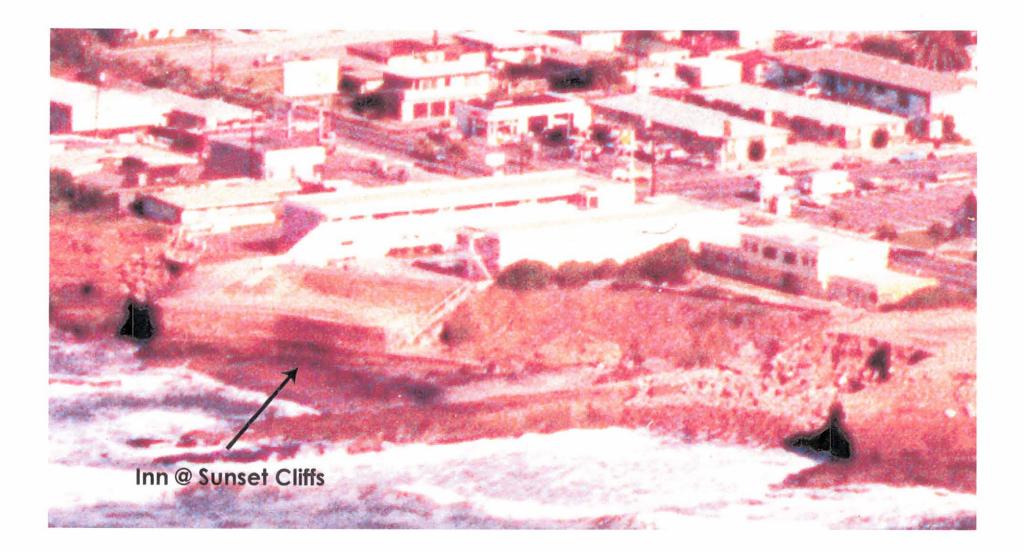
San Diego Historical Society Eberhardt Collection 1972

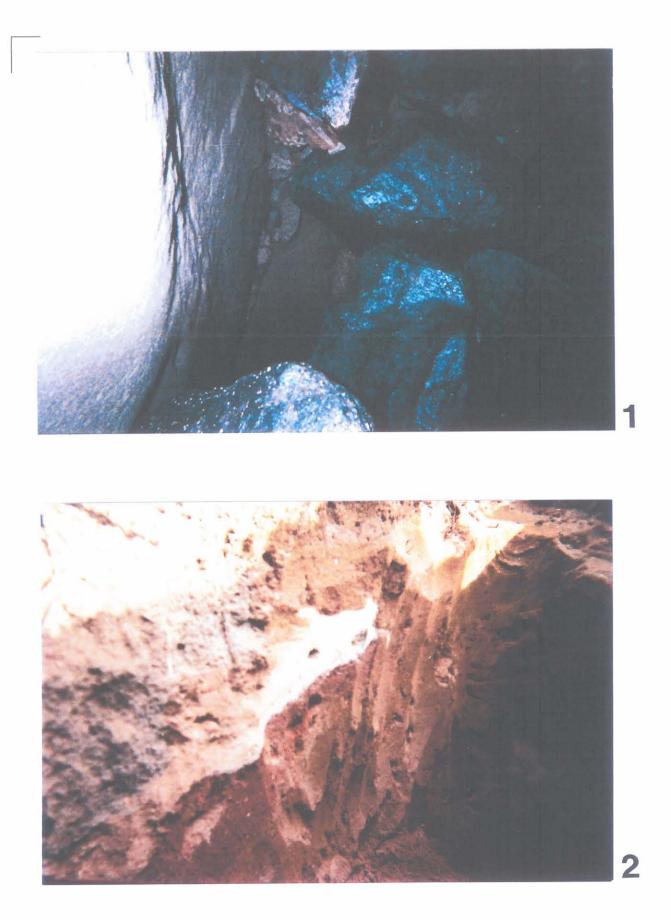
- 1. Point Loma Formation and rock infill observed below lower deck.
- 2. Shallow fill soils over Bay Point Formation in Trench T-5.
- 3. Concrete debris in fill soils, east end of Trench T-3.
- 4. Bioturbation in Bay Point Formation in Trench T-5.
- 5 & 6 Sublinear iron/manganese accumulations in Bay Point Formation in Trench T-5.
