**REPORT OF PRELIMINARY GEOTECHNICAL
INVESTIGATION**

Lot 31, Rancho del Sol
APN 305-060-18-00
San Diego, California

JOB NO. 19-12420

16 October 2019

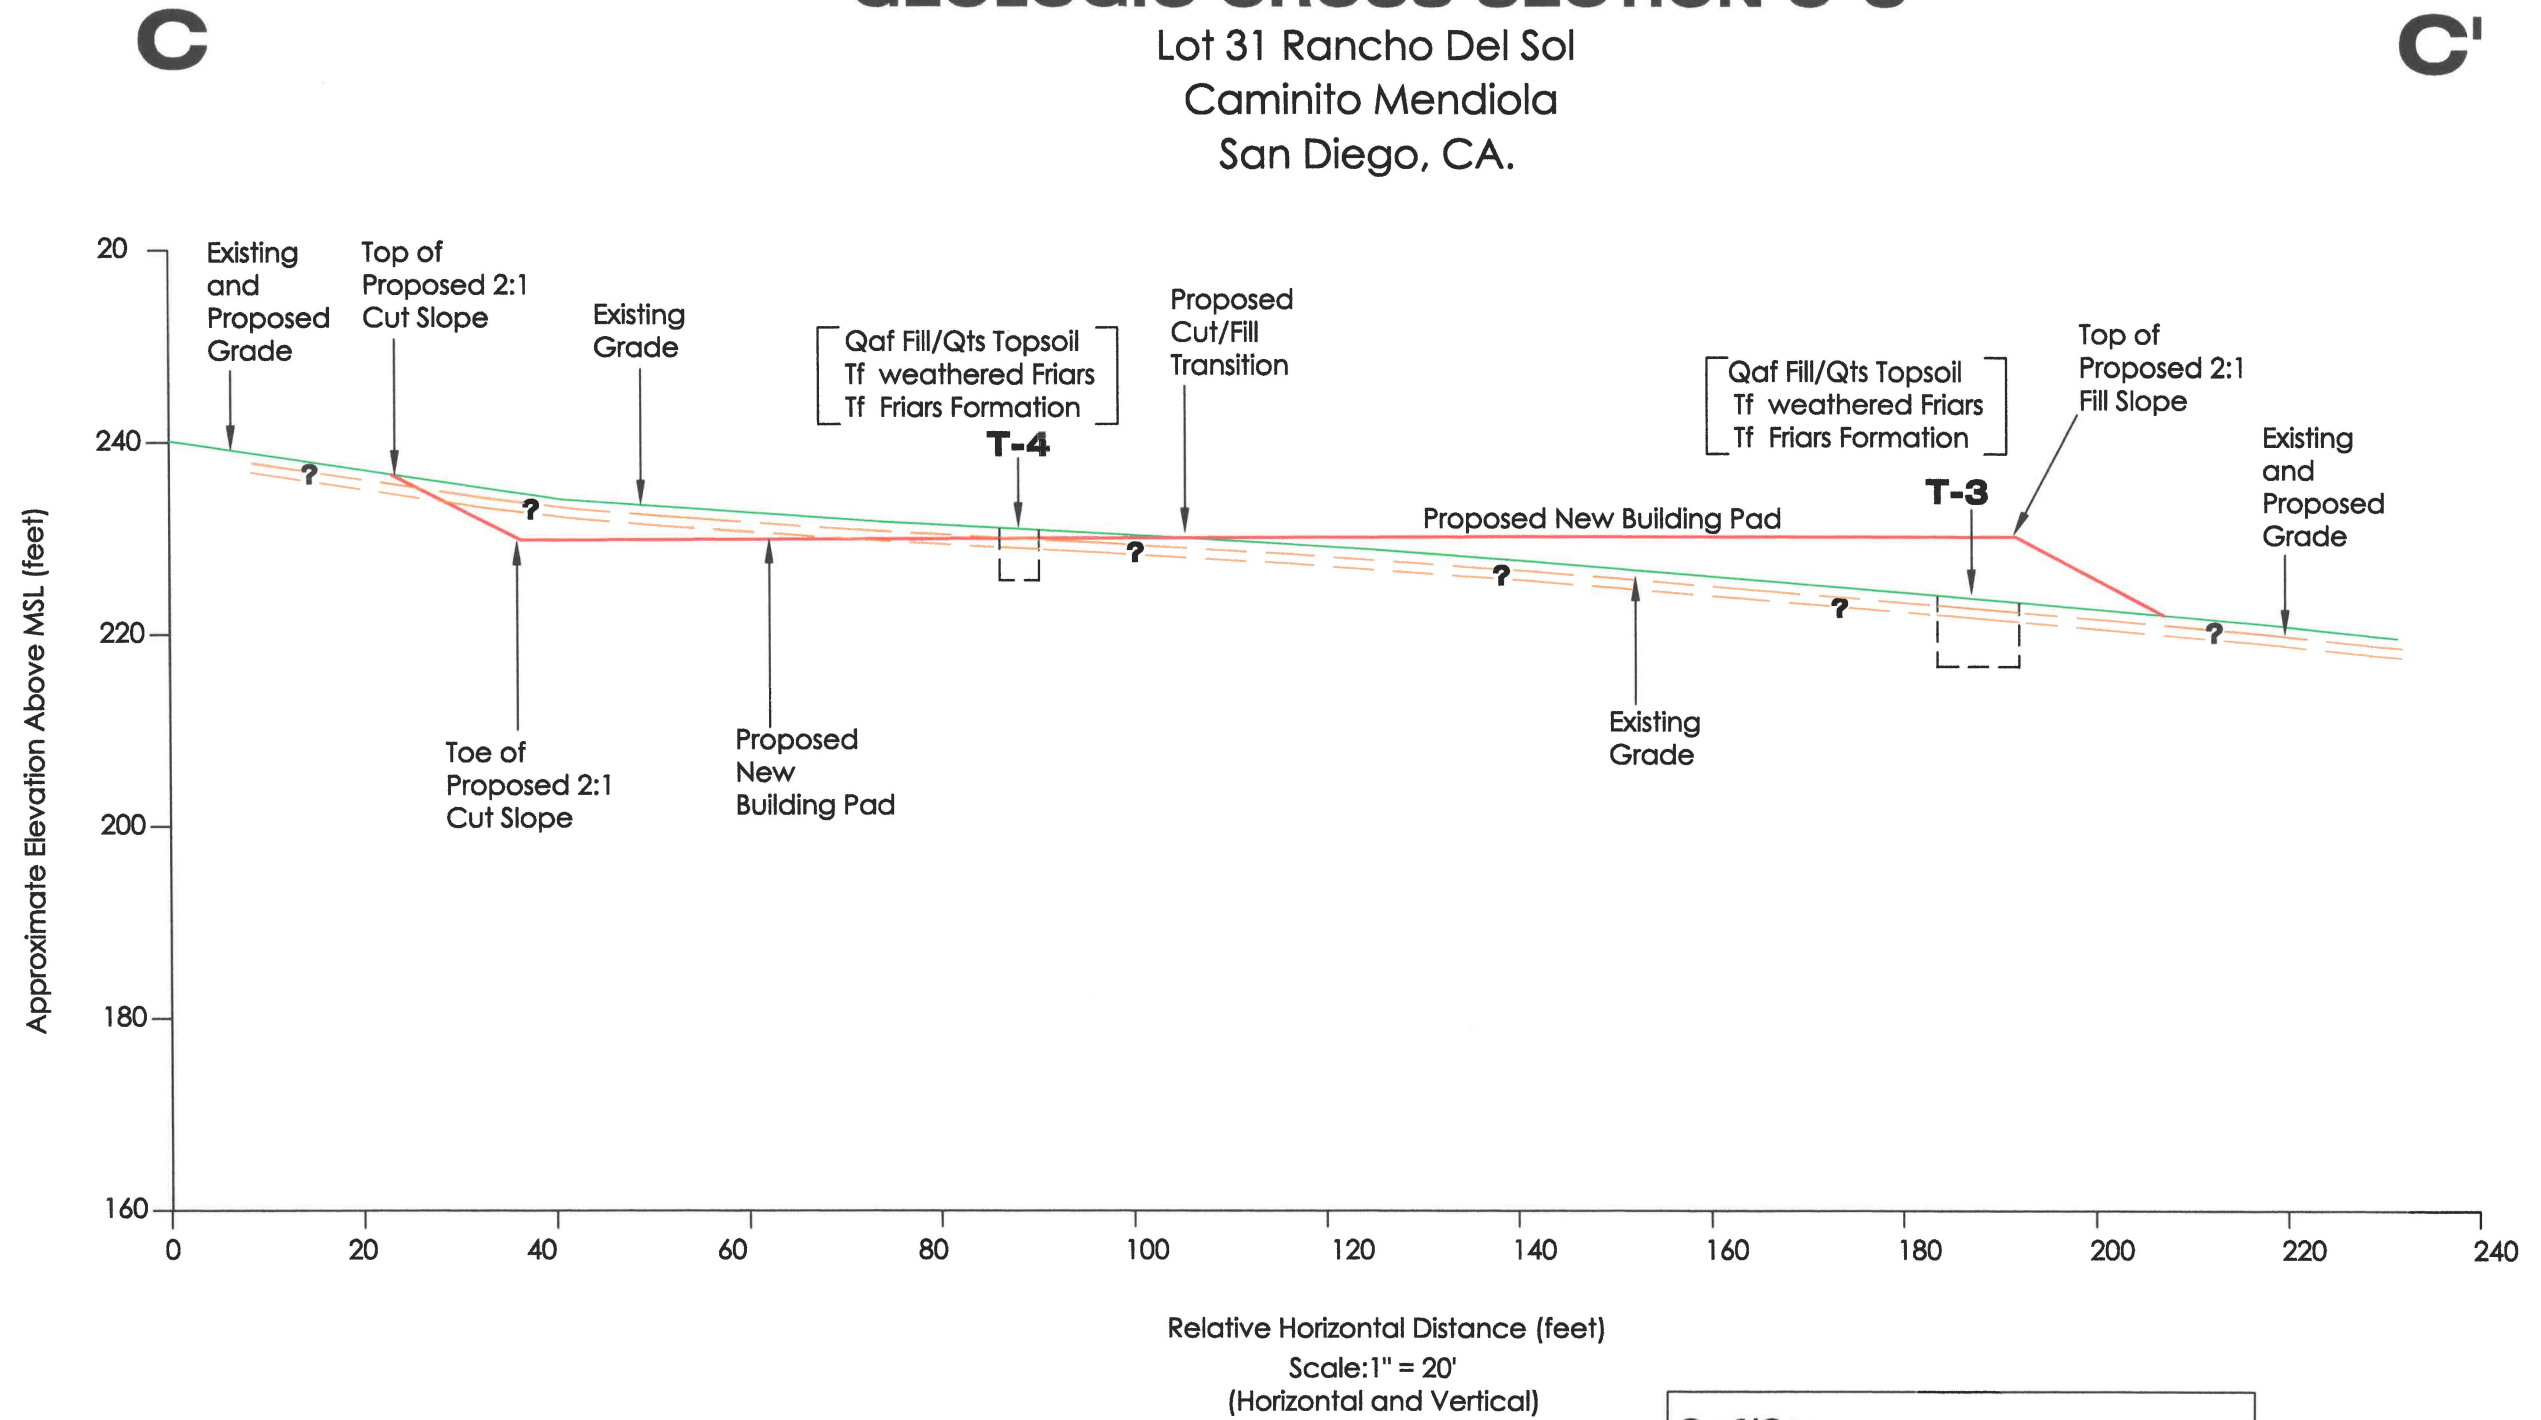
GEOLOGIC CROSS SECTION C-C'

Qaf/Qts	Fill/Topsoil (1 Foot)
Tf	Weathered Friars Formation (1 Foot)
Tf	Friars Formation
	Approximate Geologic Contact

Figure No. VIIc
Job No. 19-12420
GEI Geotechnical Exploration, Inc.
October 2019

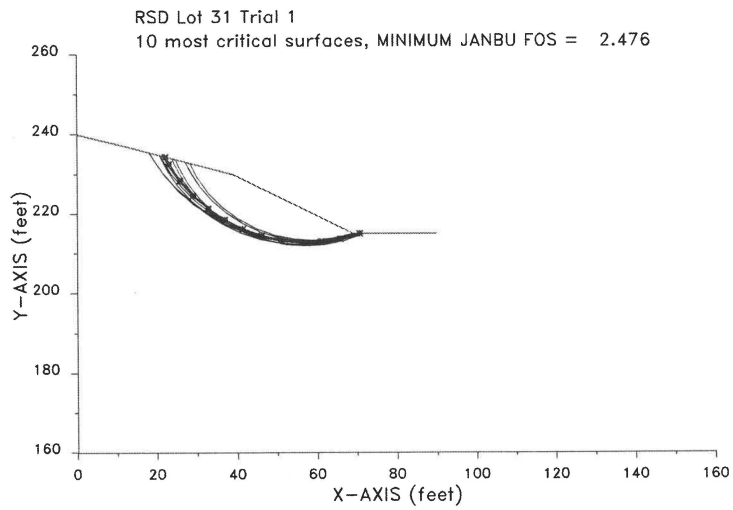
SECTION A-A'

Soil Unit No.	Unit Weight (pcf)	Moist Sat. (pcf)	Weight Cohesion (psf)	Friction Angle (deg)	Pore Pressure Parameter Ru
1	115.0	125.0	250.0	27.50	.

Failure surface No. 1 specified by 13 coordinate points

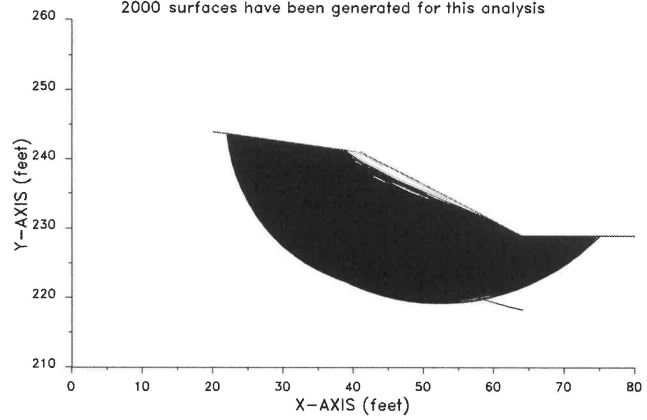
Rancho Del Sol Lot 31 Section B
2000 surfaces have been generated for this analysis

Rancho Del Sol Lot 31 Section B
10 most critical surfaces, MINIMUM JANBU FOS = 2.752

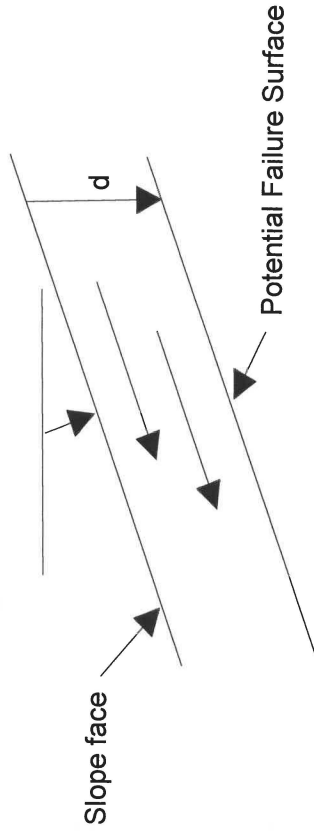
SURFICIAL STABILITY CALCULATIONS FOR PROPOSED CUT AND FILL SLOPES

slope ratio
2 to 1

phi(deg)= 27.5
c(psf)= 250
gamma Sat(pcf)= 125
gamma Buoy(pcf)= 62.6
slope angle(deg)= 26.6
depth= 5

FS= 1.52
