**REPORT OF PRELIMINARY GEOTECHNICAL
INVESTIGATION**

Proposed Fanelli-Huber Residence
1851 Spindrift Drive
La Jolla, California

JOB NO. 21-13237

03 June 2021

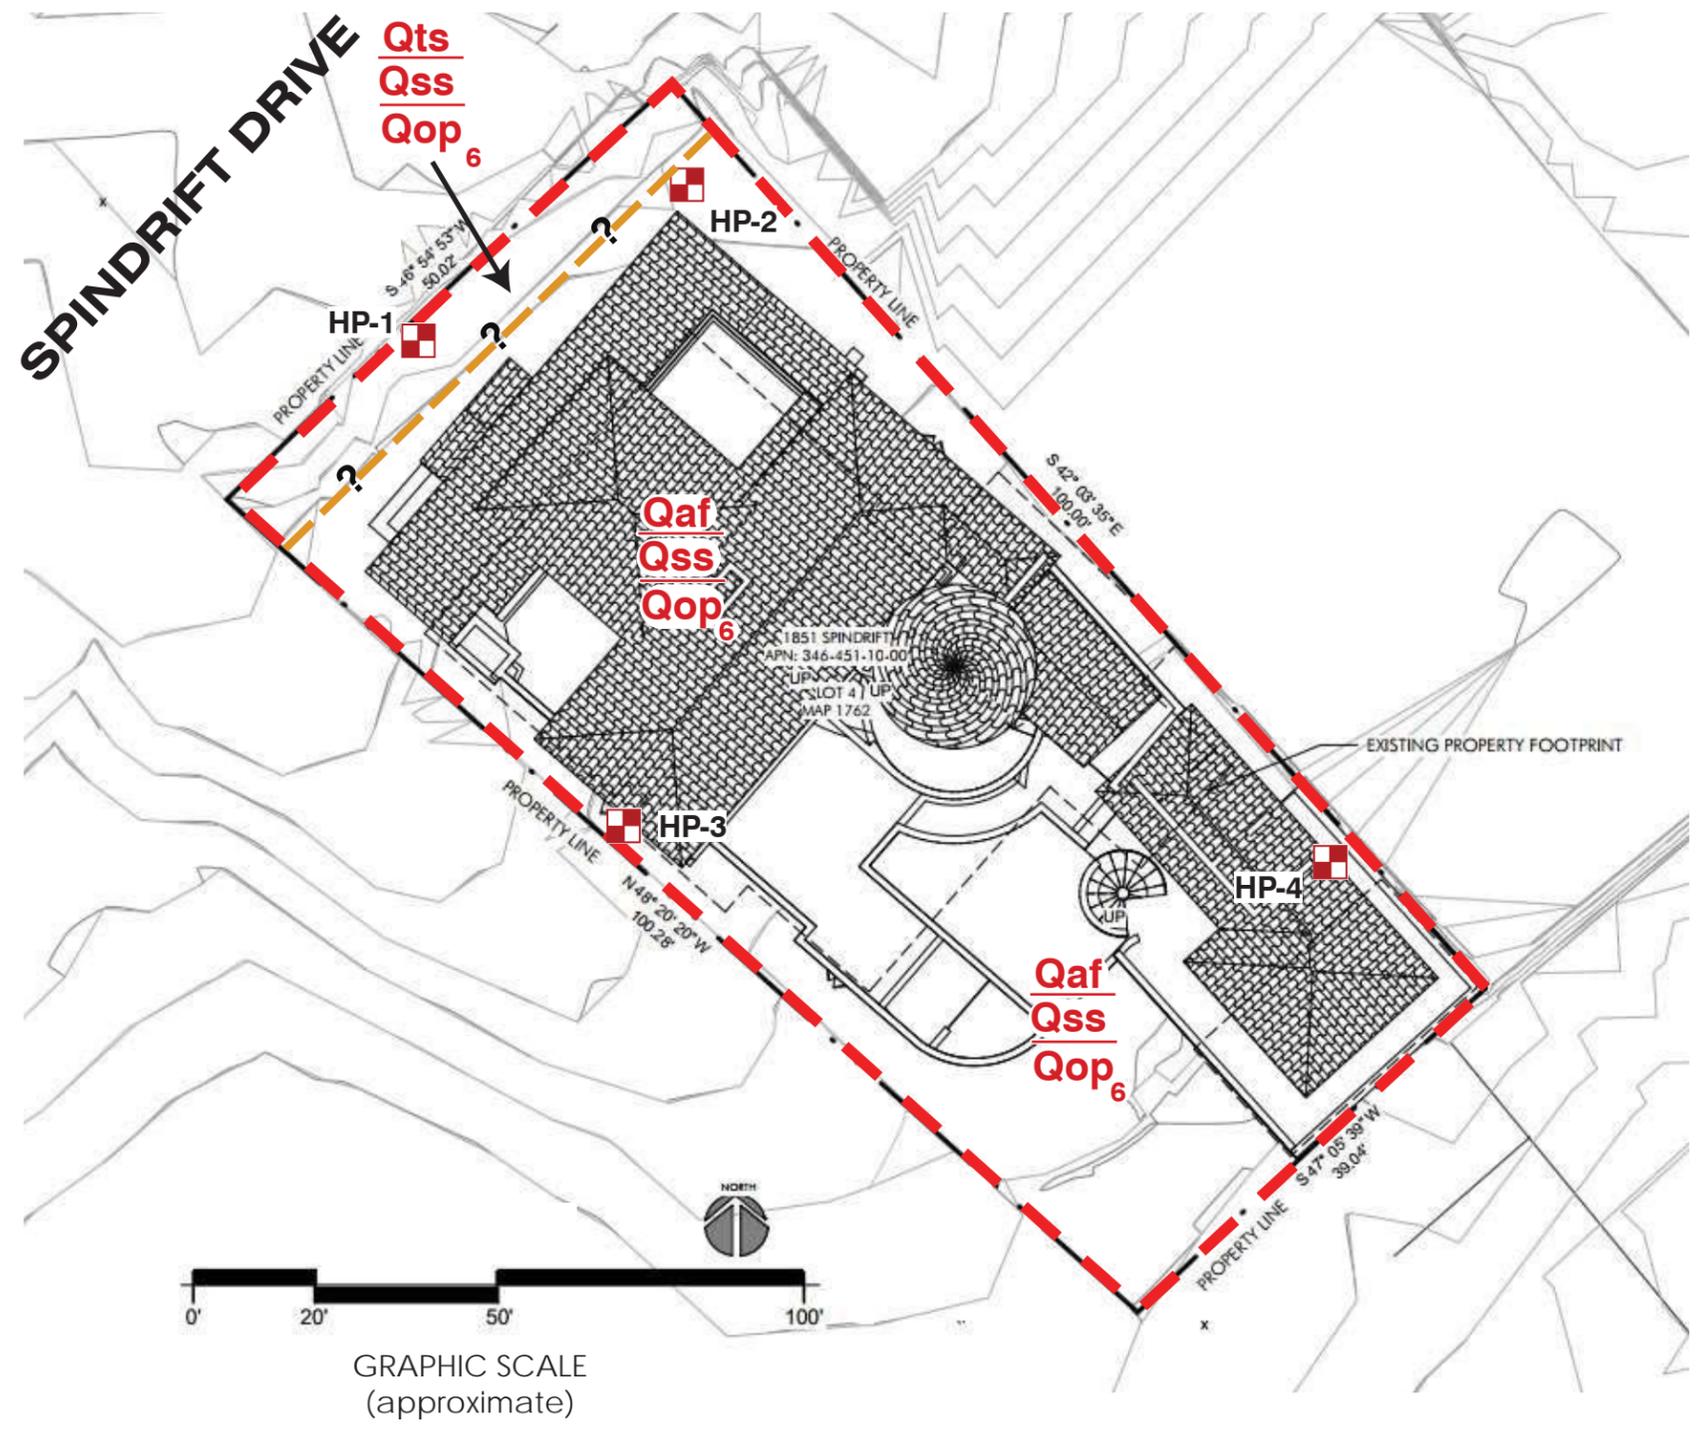
- LEGEND**
- HP-1** Approximate Location of Exploratory Handpit
 - Approximate Anticipated Limits of Grading
 - Approximate Geologic Contact

- GEOLOGIC LEGEND**
- Qts** Landscape Topsoil
 - Qaf** Artificial Fill
 - Qss** Subsoil
 - Qop₆** Old Paralac Deposits (unit 6)

The exploratory handpit logs and related information depict subsurface conditions only at the specific locations shown on the plot plan and on the particular date designated on the logs. Subsurface conditions at other locations may differ from conditions occurring at these locations. Also, the passage of time may result in changes in the subsurface conditions due to environmental changes.

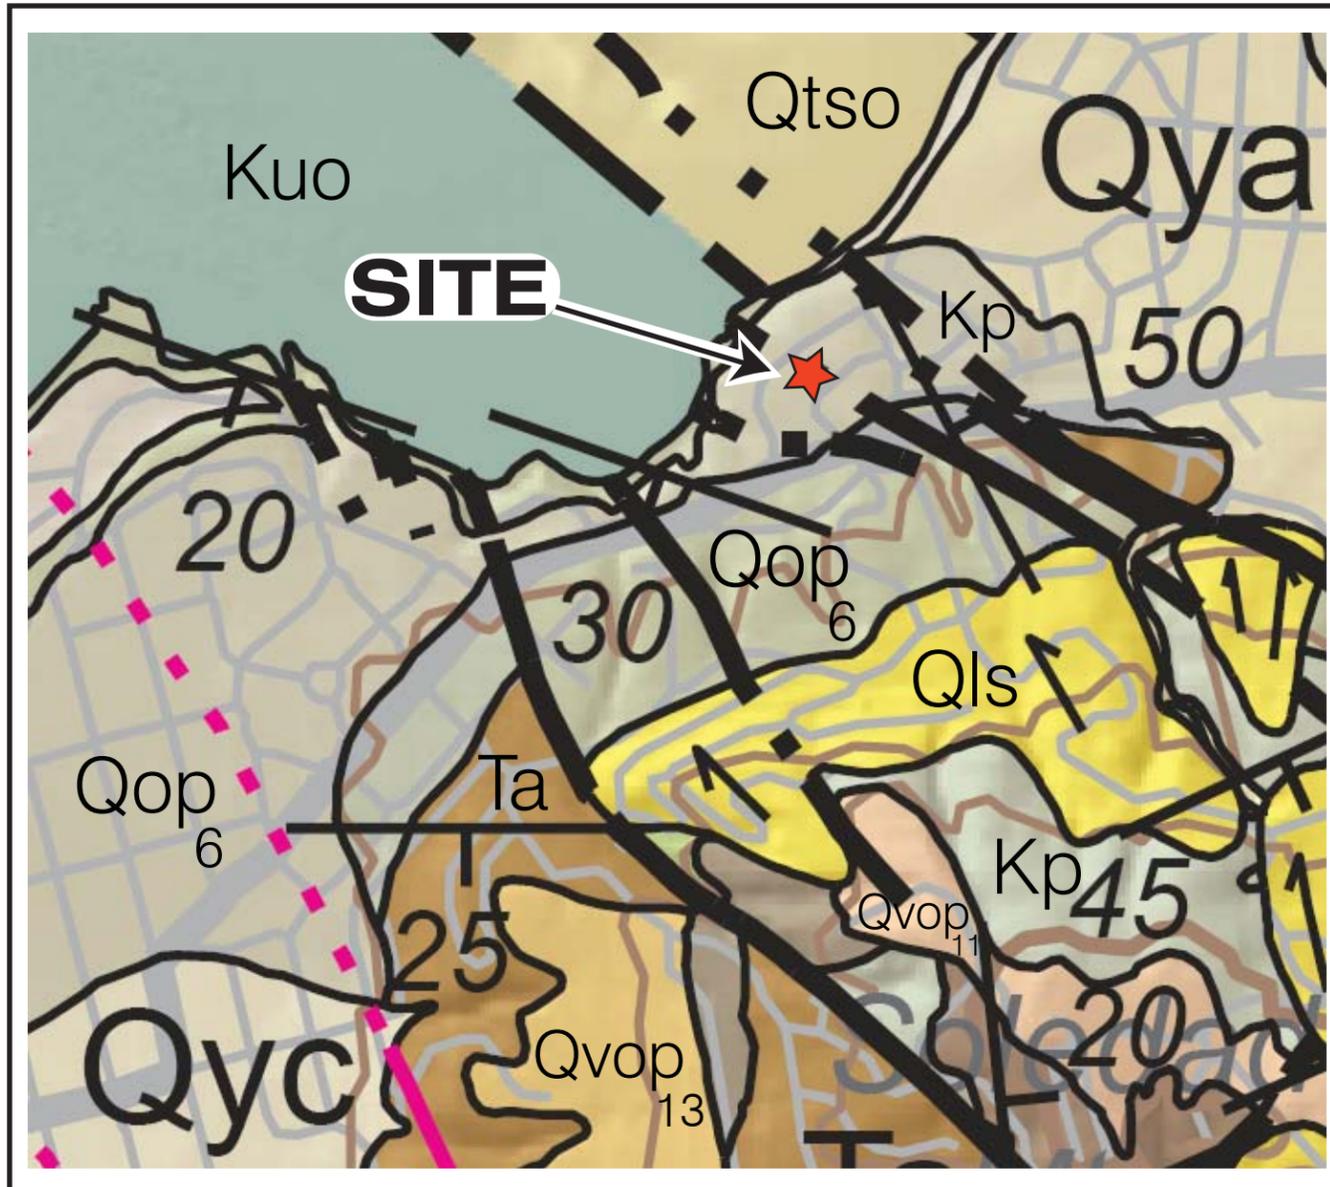
Fanelli-Huber Residence
1851 Spindrifft
La Jolla, CA.

EXCERPT FROM
GEOLOGIC MAP OF THE SAN DIEGO 30' x 60' QUADRANGLE, CALIFORNIA

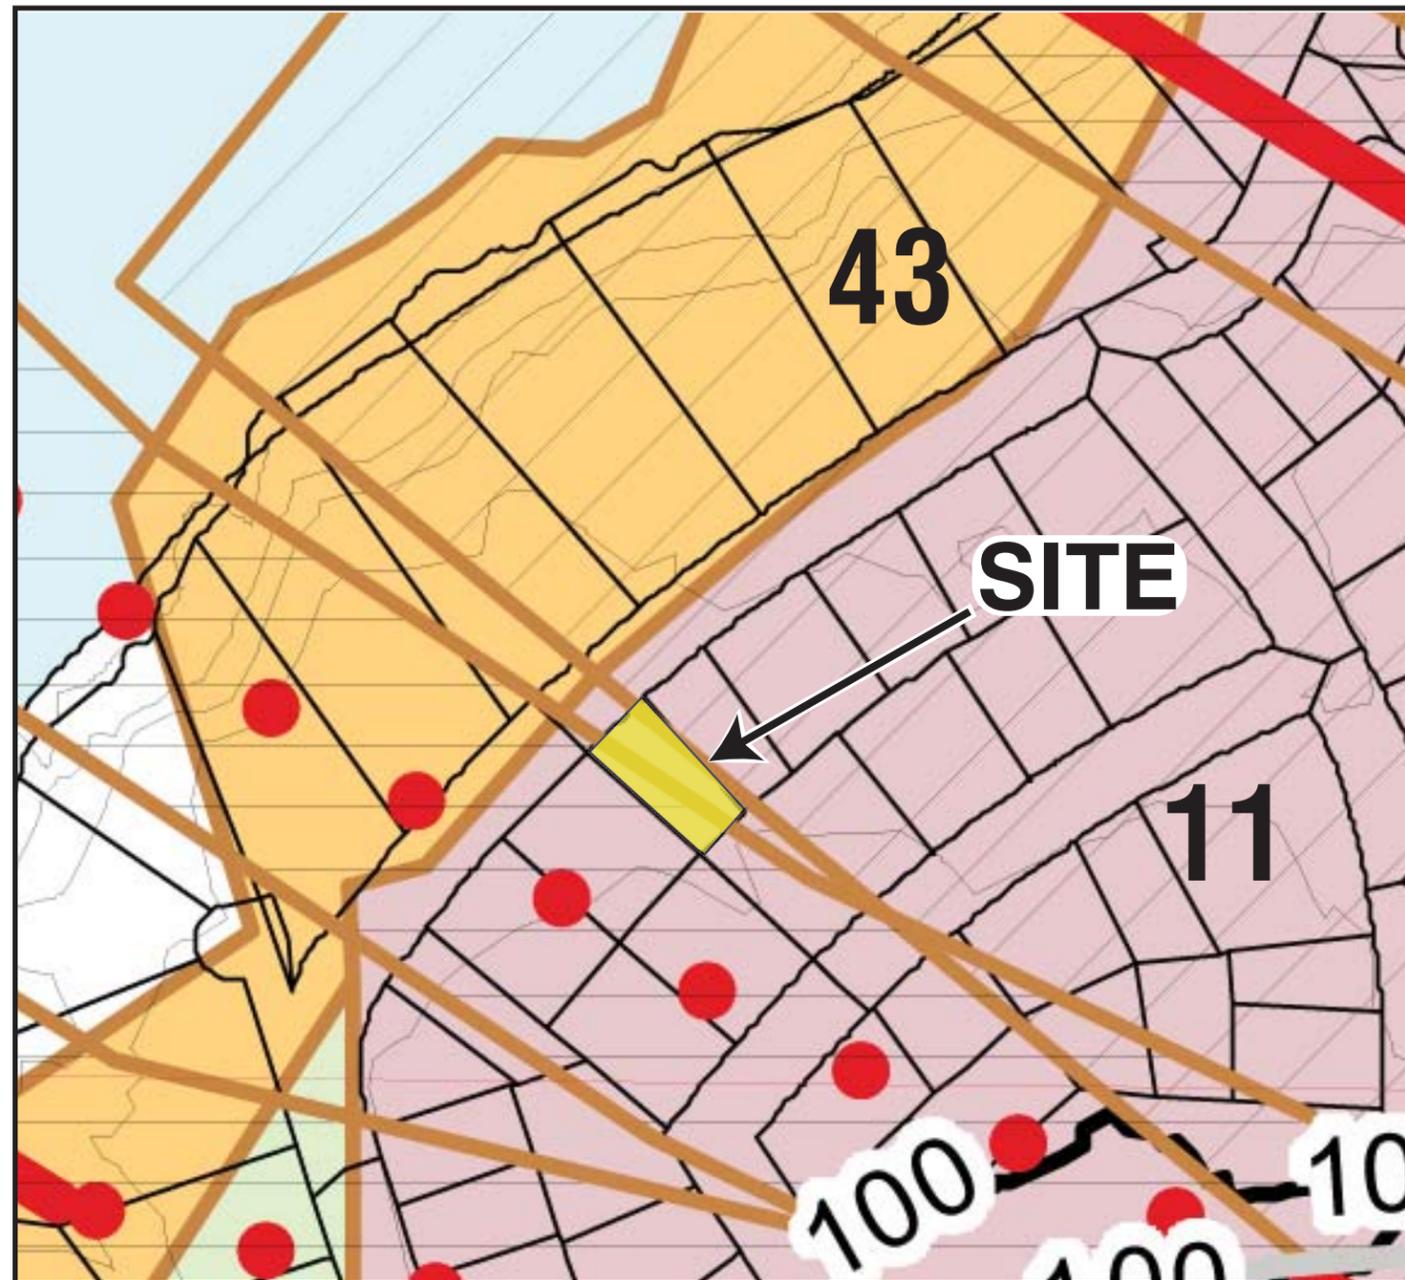
Figure No. Vb
Job No. 21-13237

Fanelli-Huber Residence
1851 Spindrift Drive
La Jolla, CA.

LEGEND

- Fault
- Inferred Fault
- Concealed Fault
- Shear Zone

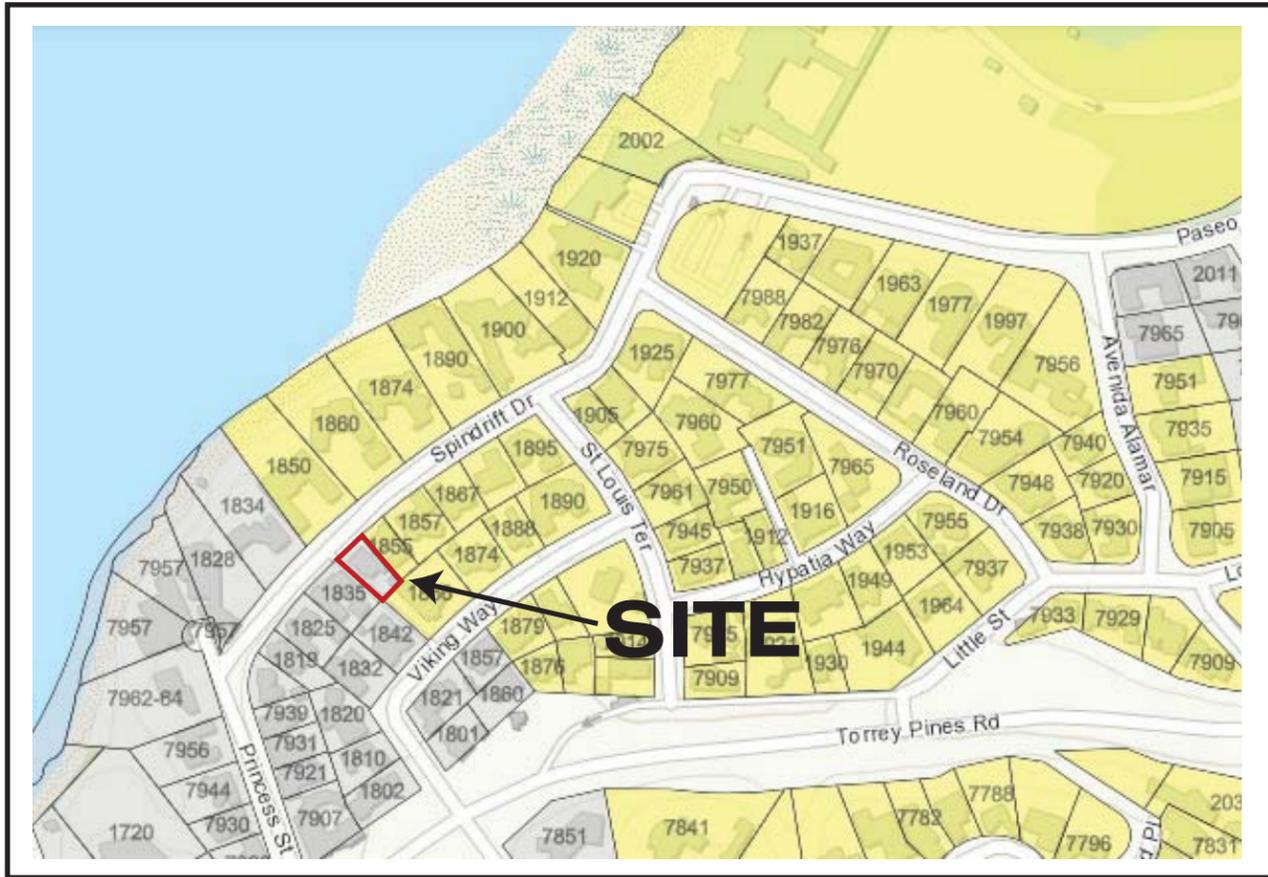
Fanelli-Huber Residence
 1851 Spindrift Drive
 La Jolla, CA.

EXCERPT FROM
**STATE OF CALIFORNIA
 SPECIAL STUDIES ZONES**

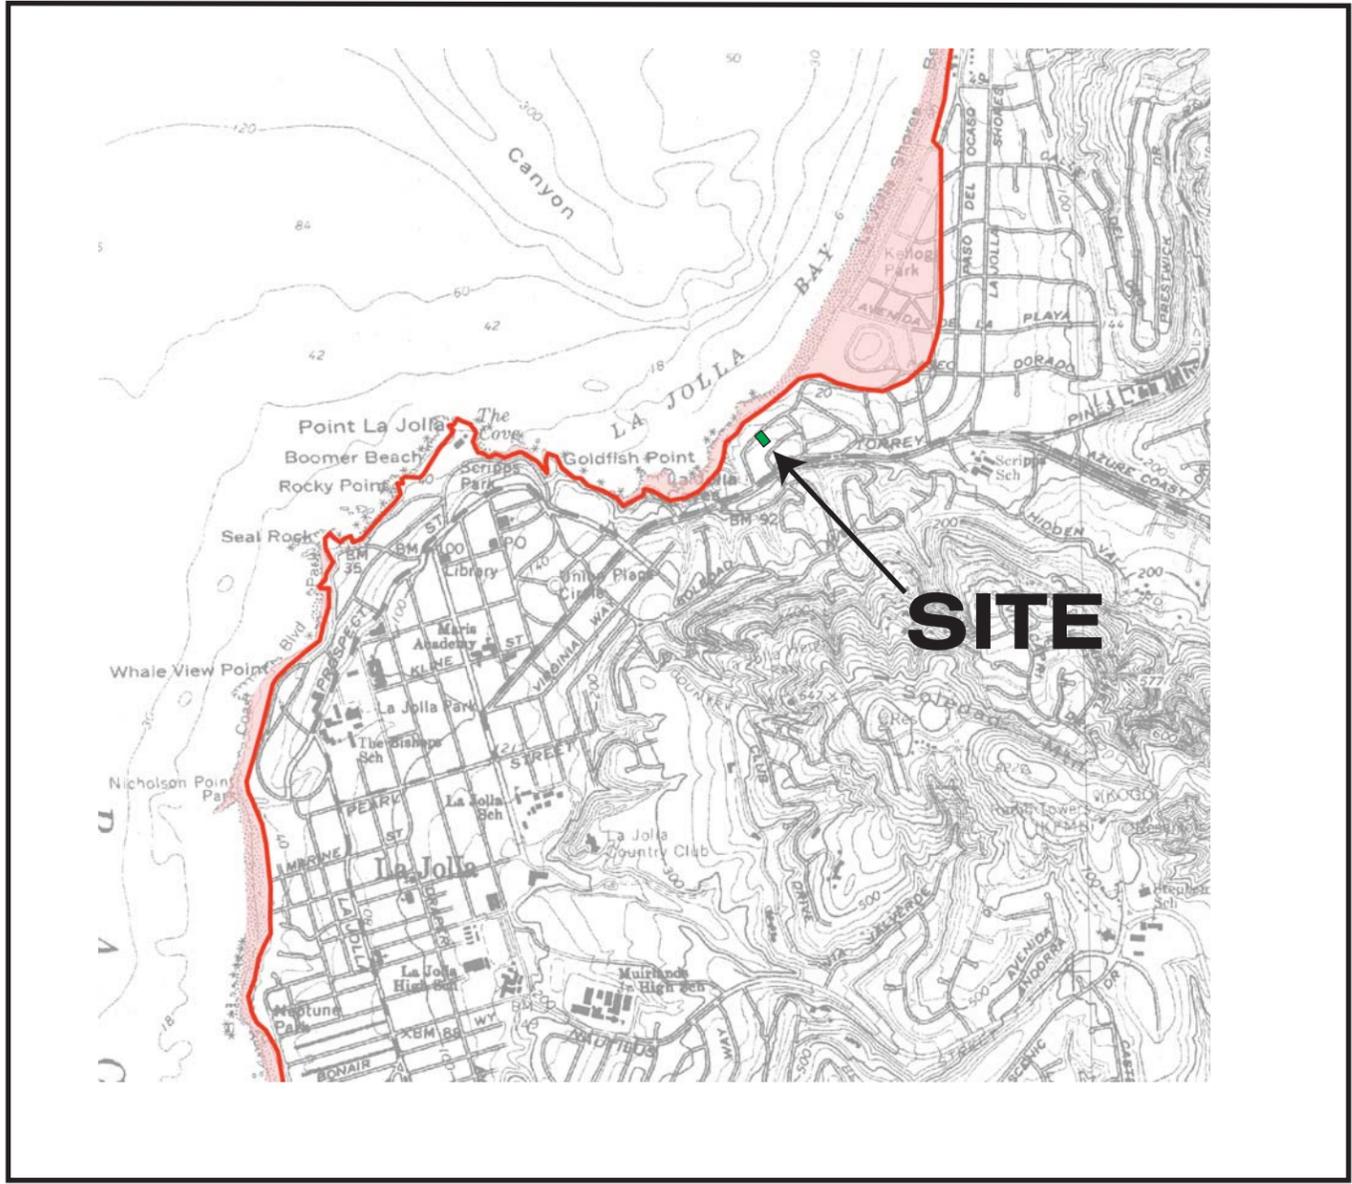
EXCERPT FROM
**TSUNAMI INUNDATION MAP
 FOR EMERGENCY PLANNING**

State of California ~ County of San Diego
LA JOLLA QUADRANGLE
 June 1, 2009

Fanelli-Huber Residence
 1851 Spindrifft Drive
 La Jolla, CA.

MAP EXPLANATION

- Tsunami Inundation Line
- Tsunami Inundation Area

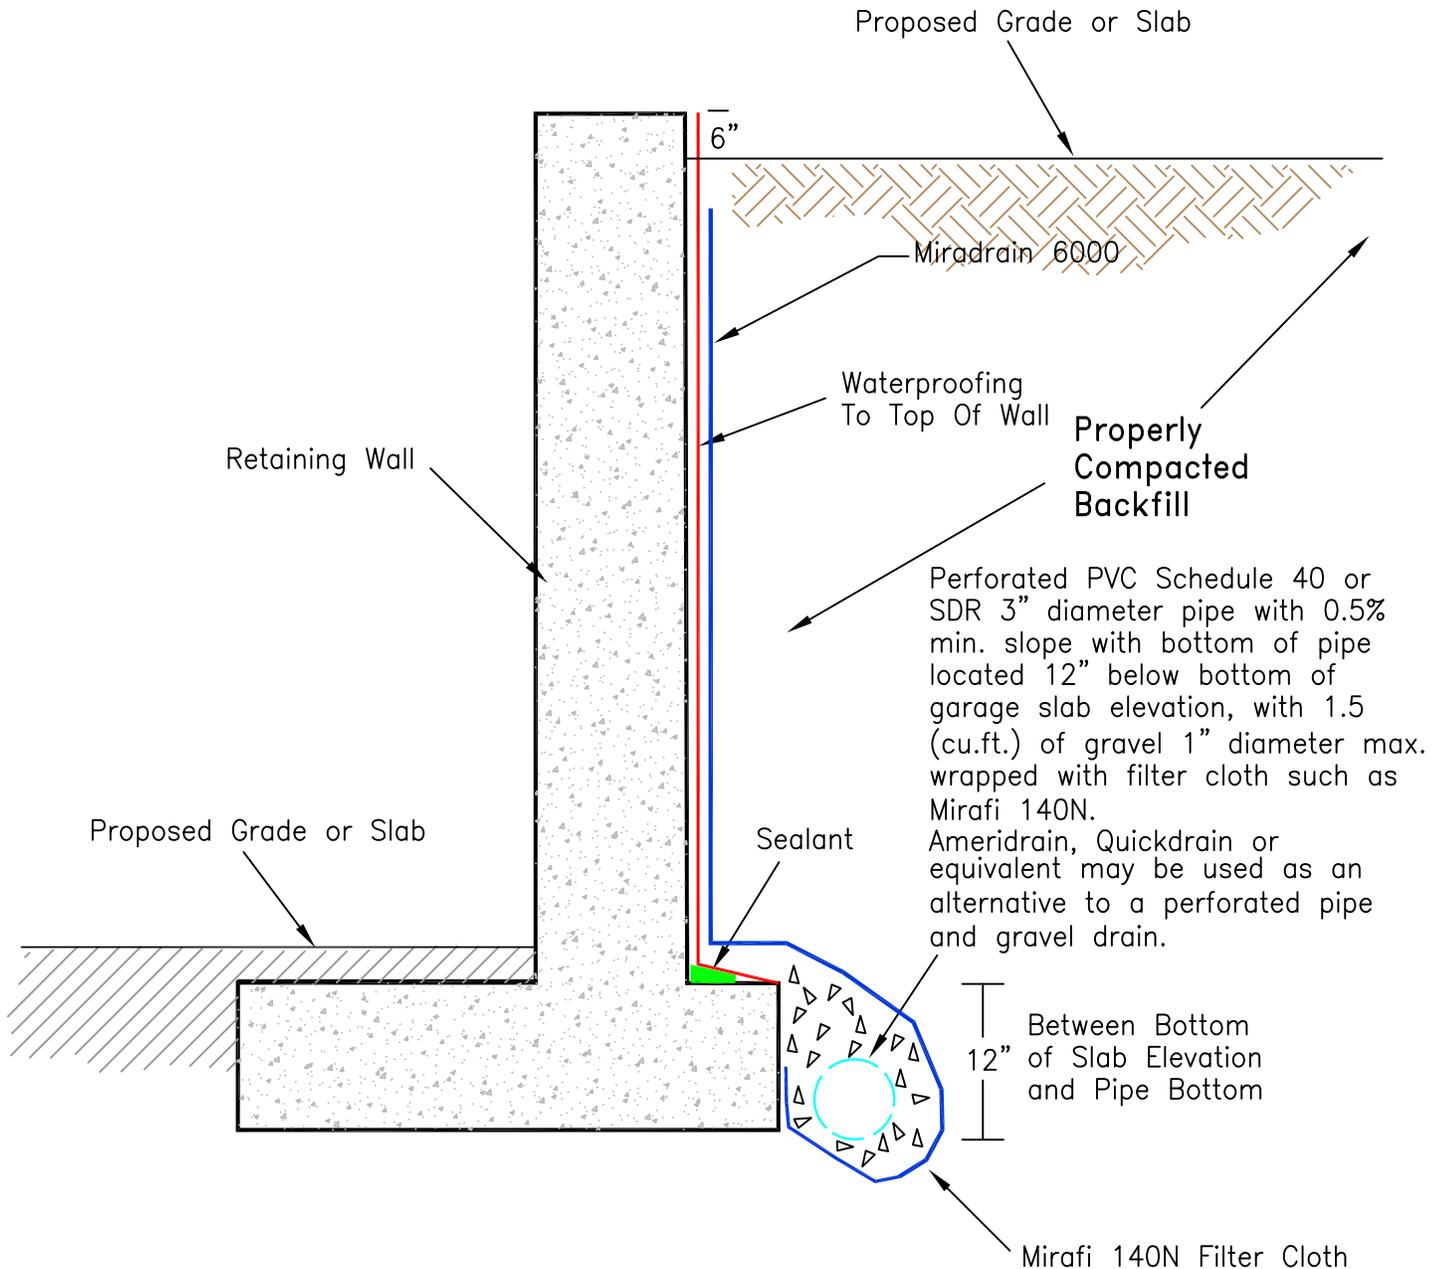
Figure No. VIII
Job No. 21-13237

SCHEMATIC RETAINING WALL SUBDRAIN RECOMMENDATIONS

NOT TO SCALE

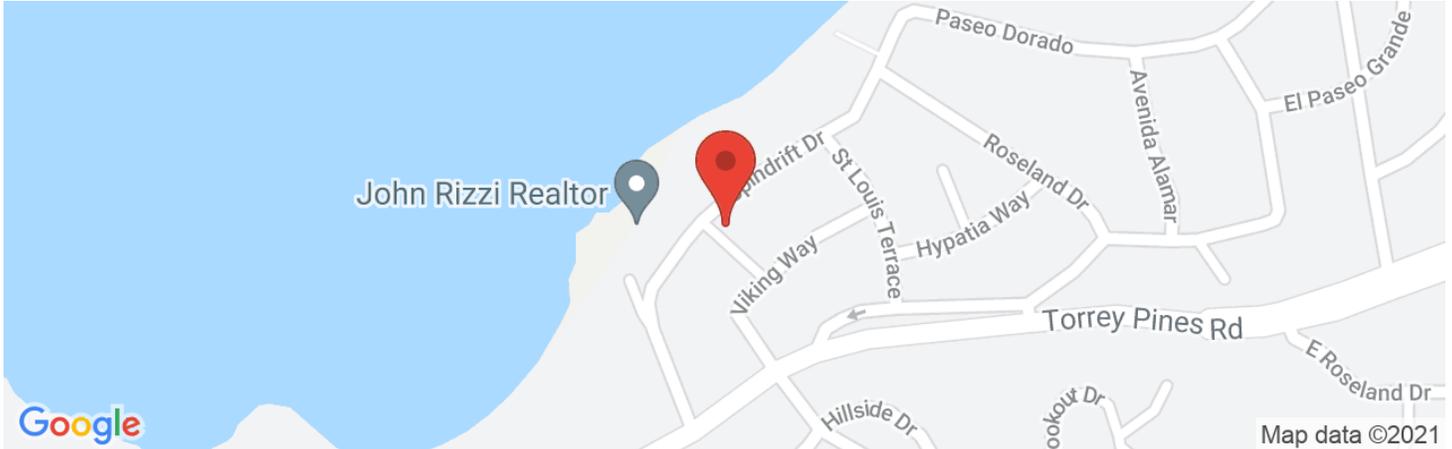
1851 Spindrift Drive, La Jolla, CA

Latitude, Longitude: 32.8506, -117.2622

Date	6/4/2021, 11:38:53 AM
Design Code Reference Document	ASCE7-16
Risk Category	II
Site Class	D - Stiff Soil

Type	Value	Description
S_S	1.403	MCE_R ground motion. (for 0.2 second period)
S_1	0.491	MCE_R ground motion. (for 1.0s period)
S_{MS}	1.403	Site-modified spectral acceleration value
S_{M1}	null -See Section 11.4.8 0.889	Site-modified spectral acceleration value
S_{DS}	0.936	Numeric seismic design value at 0.2 second SA
S_{D1}	null -See Section 11.4.8 0.592	Numeric seismic design value at 1.0 second SA
