## Preliminary Geotechnical Investigation

City of San Diego Task 15GT14 - College Area Sewer  
and AC Water Main Replacement  
54<sup>th</sup> Street & Campanile Way  
San Diego, California

February 26, 2018

Project No.: 180004.2

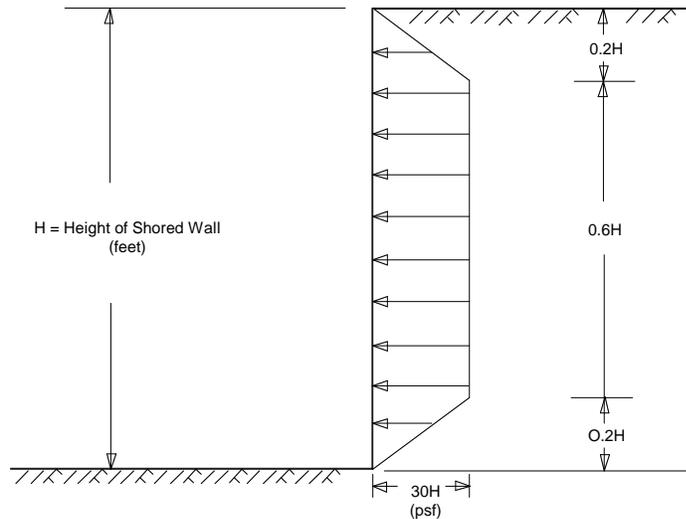
For excavations greater than 15 feet, tied-back or braced shoring is recommended. Tied-back or braced shoring should be designed to resist a trapezoidal distribution of lateral earth pressure. The recommended pressure distribution, for the case where the grade is level behind the shoring and groundwater levels are below the bottom of the excavation, is illustrated in the following diagram with the maximum pressure equal to 30H pounds per square foot. H is the height of the shored wall in feet. The loads will need to be modified if adverse bedding is present.

Surcharge from live loads including traffic and dead loads including adjacent structures that are located within a 1:1 (horizontal to vertical) plane drawn upward from the base of the shored excavation should be added to the lateral earth pressures. The lateral contribution of uniform surcharge loads located immediately behind the temporary shoring may be calculated by multiplying the vertical surcharge pressure by 0.35. Lateral load contributions of surcharge loads behind the shored wall may be provided once the load configurations and layouts are known. As a minimum, 250 pounds per square foot vertical uniform surcharge is recommended to account for nominal construction and/or traffic loads.

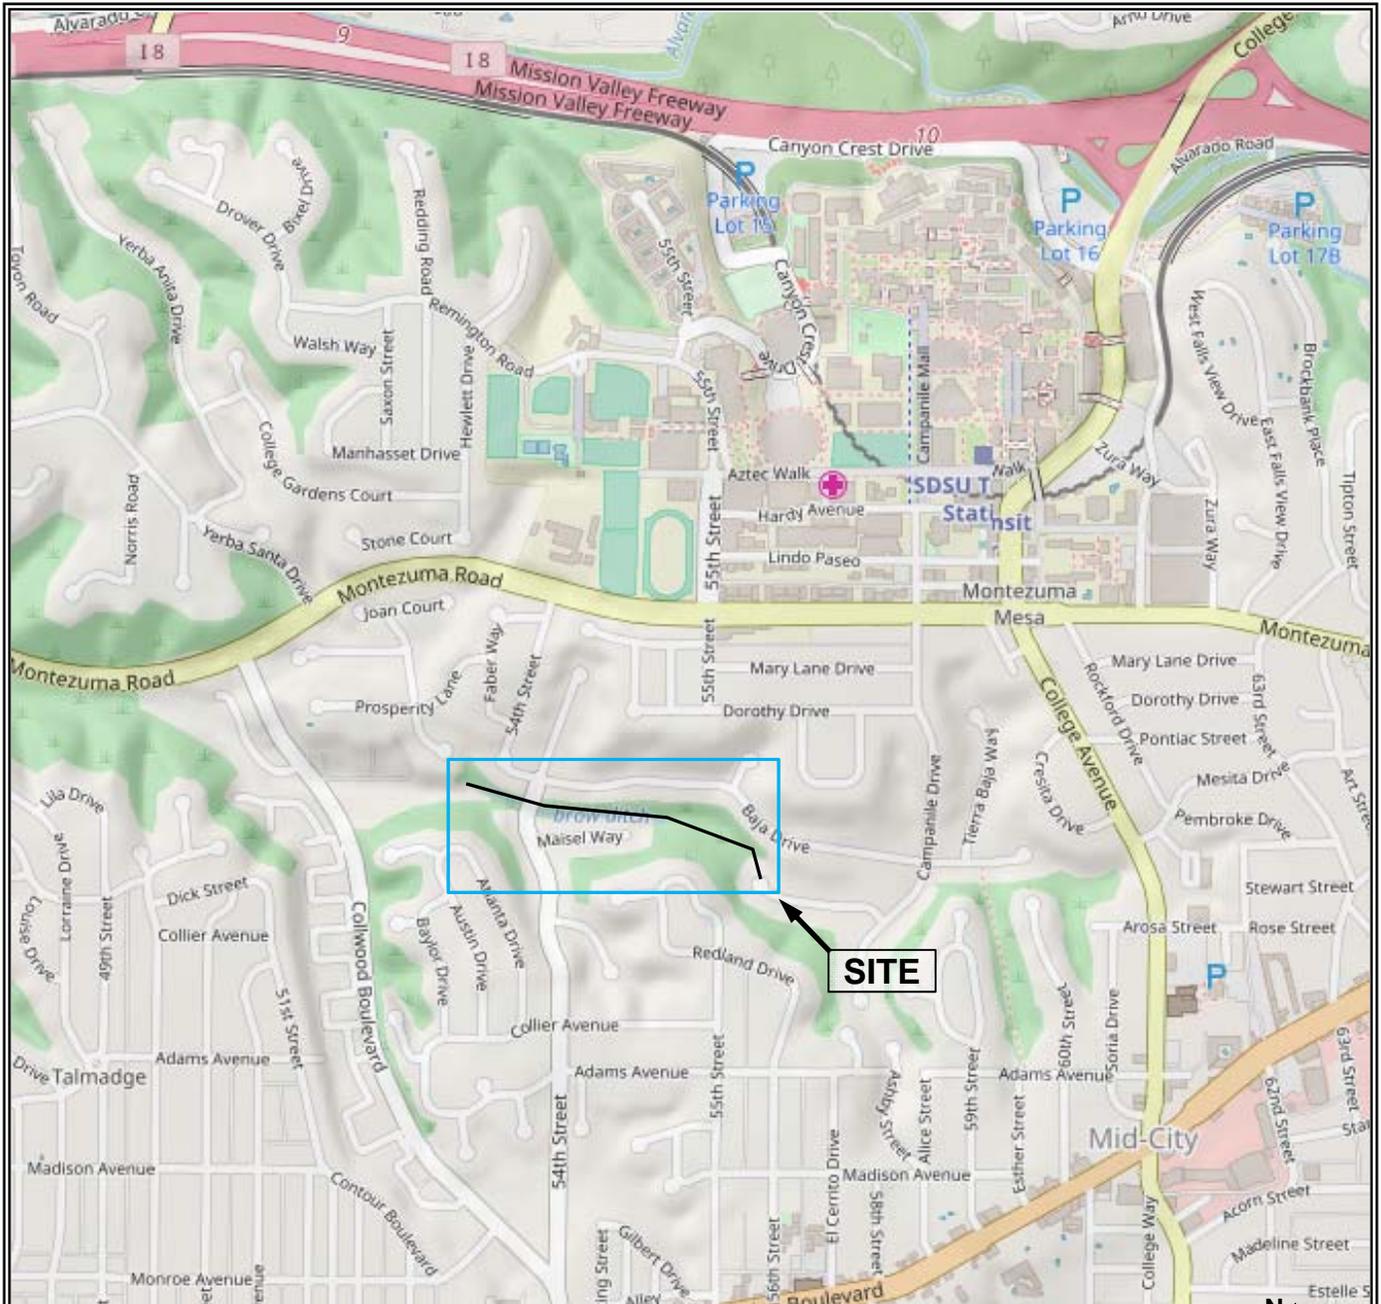
FIGURE 1

— PIPE ALIGNMENT

This report presents the results of our preliminary geotechnical investigation performed for the College Area Sewer and Water Main Replacement project within the College Area neighborhood of the City of San Diego, California. The approximate locations of the proposed sewer pipelines are shown in Figure 1, Project Location Map. The purpose of this study was to evaluate the subsurface conditions at the project site and provide geotechnical engineering recommendations for the design and construction of the proposed sewer and water mains.

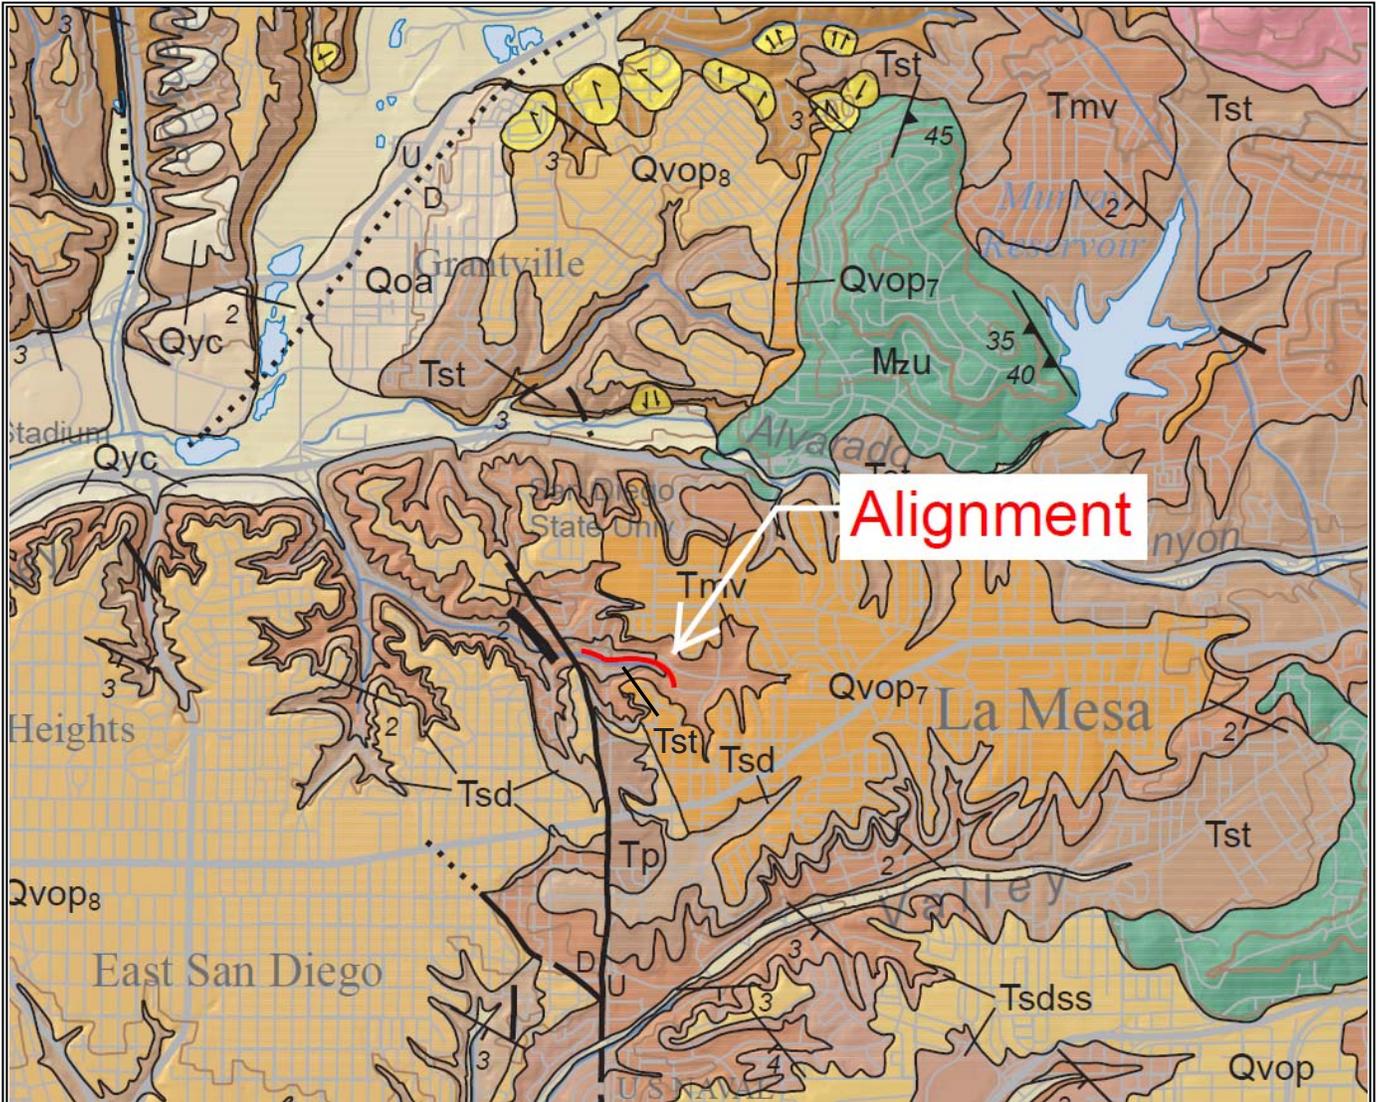
FIGURE 3

- Tsd     SAN DIEGO FORMATION
- Qoa     OLD ALLUVIAL FLOOD PLAIN DEPOSITS
- Qvop<sub>8</sub>     VERY OLD PARALIC DEPOSITS (Unit 8)
- Qvop<sub>7</sub>     VERY OLD PARALIC DEPOSITS (Unit 7)
- Tst     STADIUM CONGLOMERATE
- Tmv     MISSION VALLEY FORMATIONS

(2008). At the exploratory locations, the alluvial and formational materials are mantled by artificial fill soils likely associated with residential streets and utility construction. The regional geology is presented in Figure 3. The geologic units observed are described below from youngest to oldest.

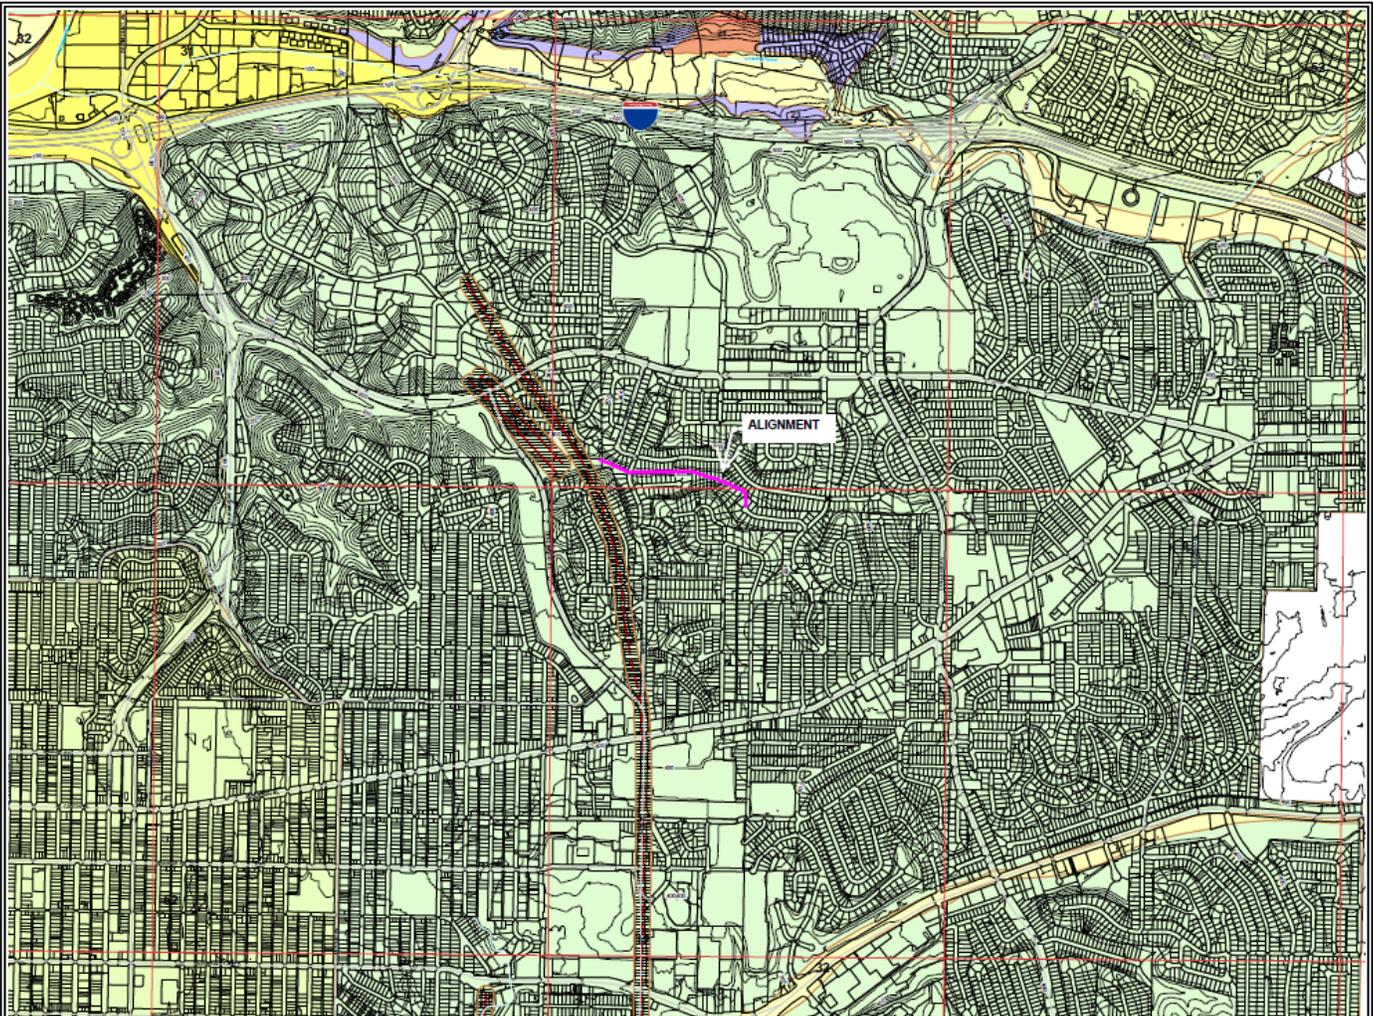
FIGURE 5

- 51 Level mesas -- underlain by terrace deposits and bedrock nominal risk
- 52 Other level areas, gently sloping to steep terrain, favorable geologic structure, Low risk
- 53 Level or sloping terrain, unfavorable geologic structure, Low to moderate risk
- 54 Steeply sloping terrain, unfavorable or fault controlled geologic structure, Moderate risk
- 55 Modified terrain (graded sites) Nominal risk
- 31 High Potential -- shallow groundwater major drainages, hydraulic fills
- 32 Low Potential -- fluctuating groundwater minor drainages
- 11 Active, Alquist-Priolo Earthquake Fault Zone
- 12 Potentially Active, Inactive, Presumed Inactive, or Activity Unknown
- 13 Downtown special fault zone

The City of San Diego Seismic Safety Study designates the project area as "Zone 53: Level or sloping terrain, unfavorable geologic structure. Low to moderate risk." as shown in Figure 5, Seismic Safety Map.

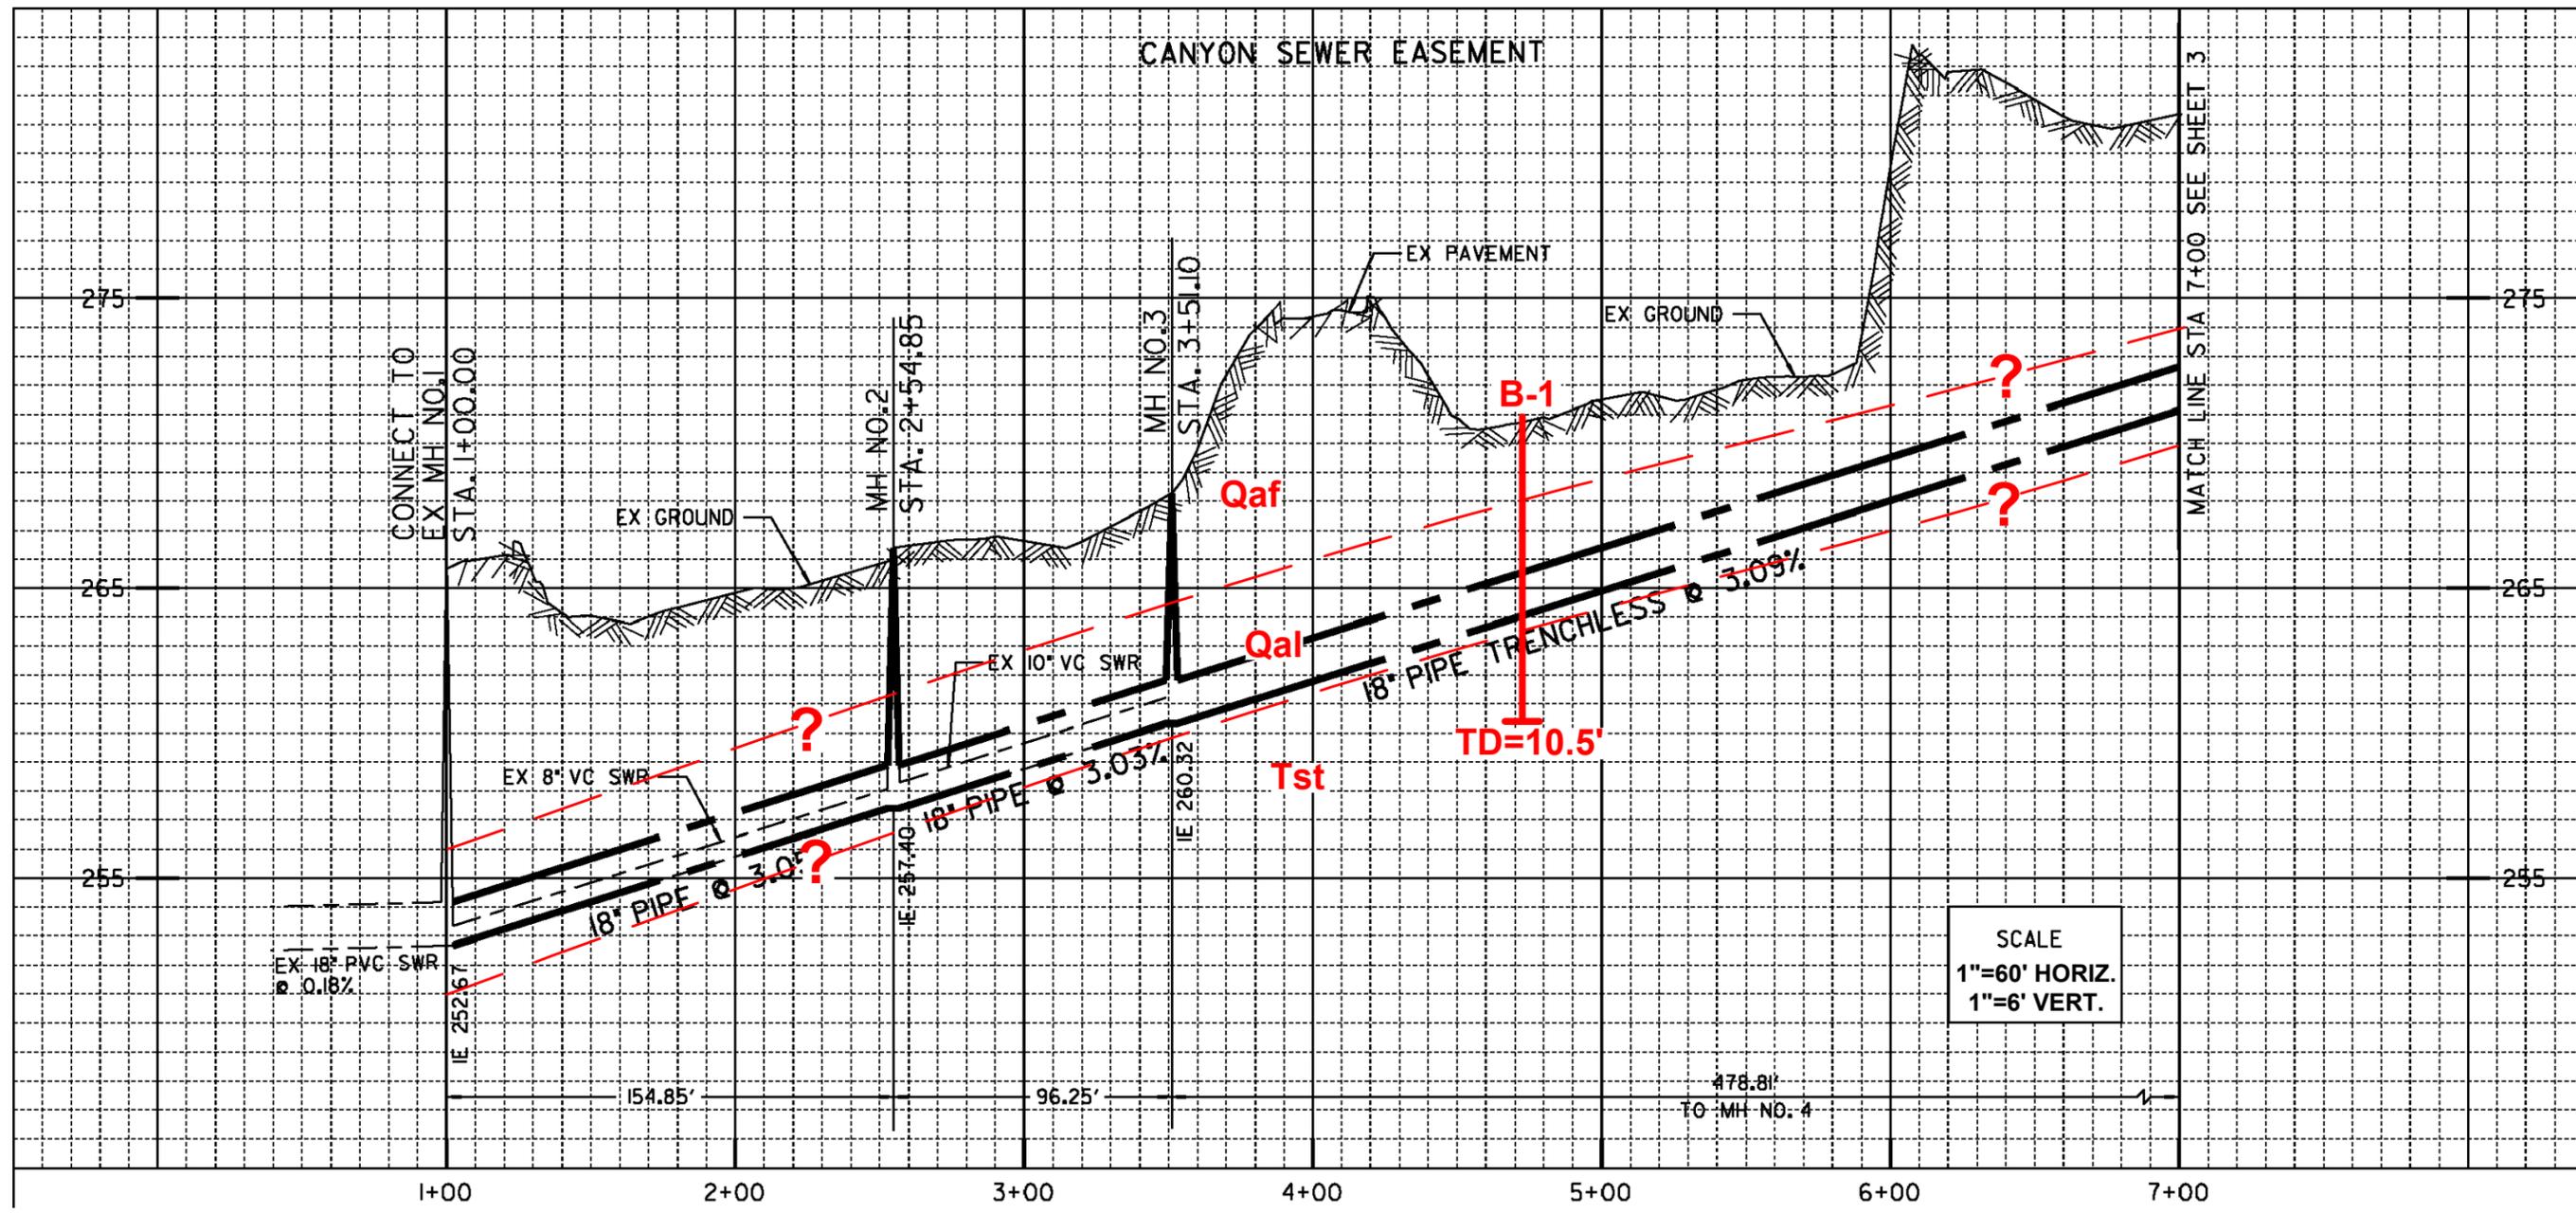
SCALE  
1"=60' HORIZ.  
1"=6' VERT.

- EXISTING GRADE
- APPROXIMATE LOCATION OF EXPLORATORY BORING  
TD = TERMINATION DEPTH IN FEET
- APPROXIMATE GEOLOGIC CONTACT LOCATION (QUERIED WHERE UNCERTAIN)
- ARTIFICIAL FILL
- ALLUVIUM
- STADIUM CONGOLOMERATE

GEOLOGIC CROSS SECTION		
15GT14 - College Area Sewer and Water Main Replacement 54th Street and Campanile Way San Diego, California		
PROJECT NO. 180004.2	REPORT DATE February 2018	FIGURE 6A

Field explorations were performed on January 17<sup>th</sup> and January 25<sup>th</sup>, 2018. The subsurface conditions were evaluated by drilling five borings to approximate depths ranging from 10.5 feet to 26.5 feet below existing ground surface (bgs). The borings were drilled using a UNIMOG truck-mounted drill rig equipped with 8-inch diameter hollow-stem augers. Twining also used track mounted drill rig (FRASTE) in two locations (B-4 and B-5) due to limited accessibility. The approximate locations of the exploratory borings are shown on Figure 2, Boring Location Map. The logs of borings are presented in Appendix A, Field Exploration. Cross sections of the anticipated geologic conditions are presented on Figures 6A through 6D. Note that due to terrain and property access issues, Borings B-2 through B-4 were drilled north of the proposed sewer alignment; anticipated geologic contacts were projected to the cross sections. Geologic contacts noted on the cross sections are considered approximate.

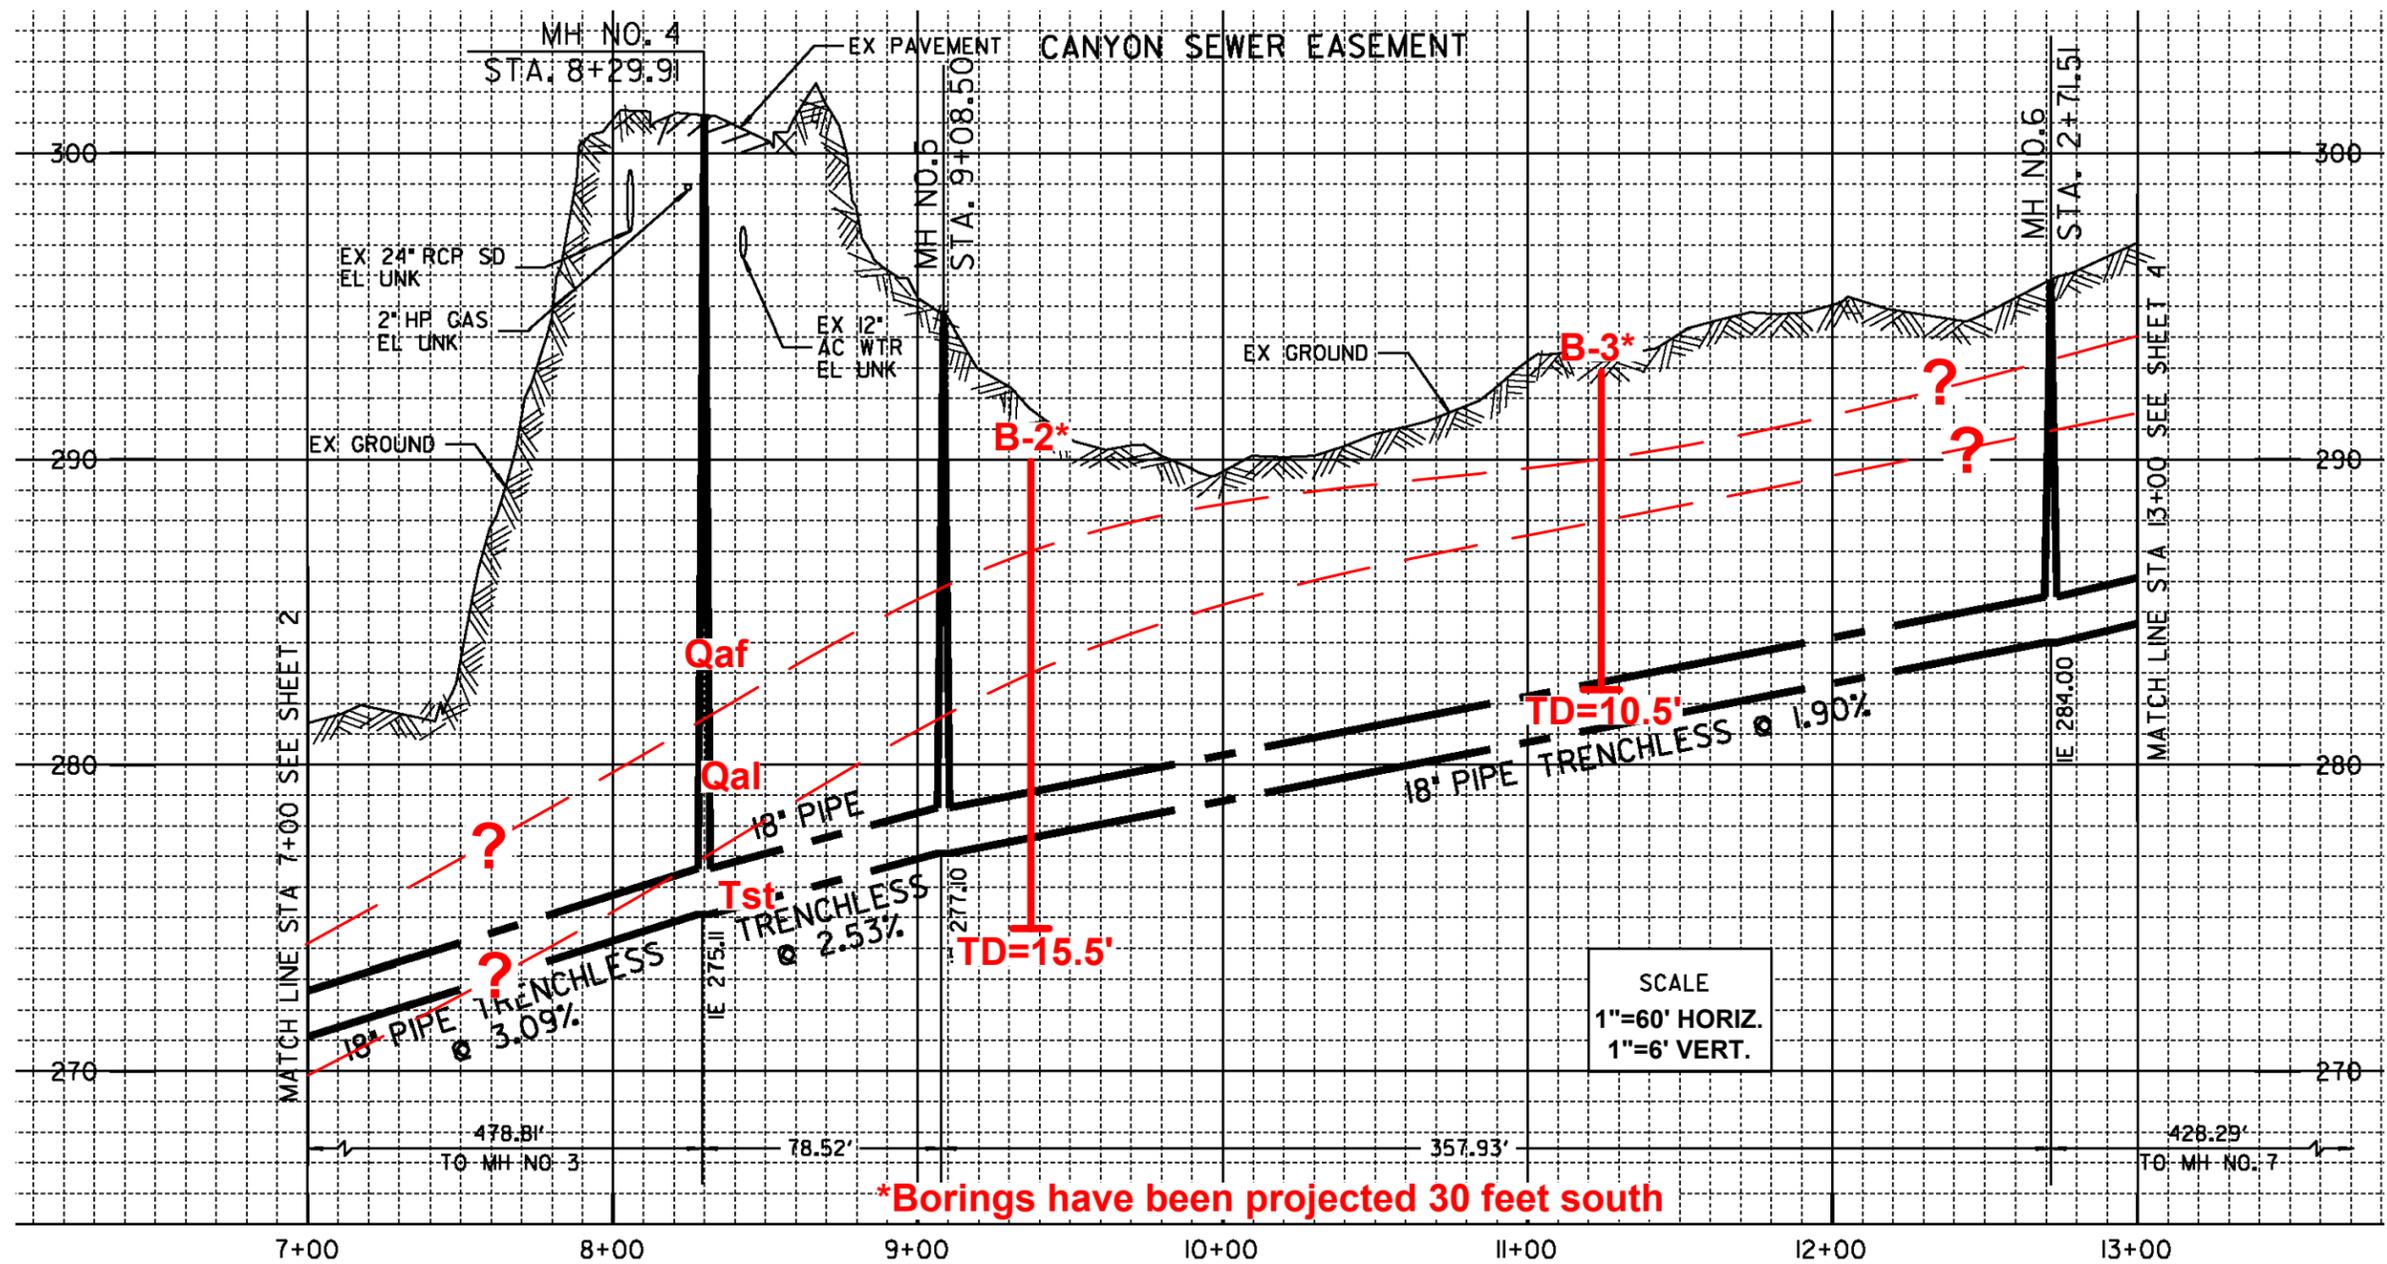
SCALE  
1"=60' HORIZ.  
1"=6' VERT.

EXISTING GRADE  
APPROXIMATE LOCATION OF EXPLORATORY BORING  
TD = TERMINATION DEPTH IN FEET  
APPROXIMATE GEOLOGIC CONTACT LOCATION (QUERIED WHERE UNCERTAIN)

PROJECT NO. 180004.2	REPORT DATE February 2018	FIGURE 6B
-------------------------	------------------------------	-----------

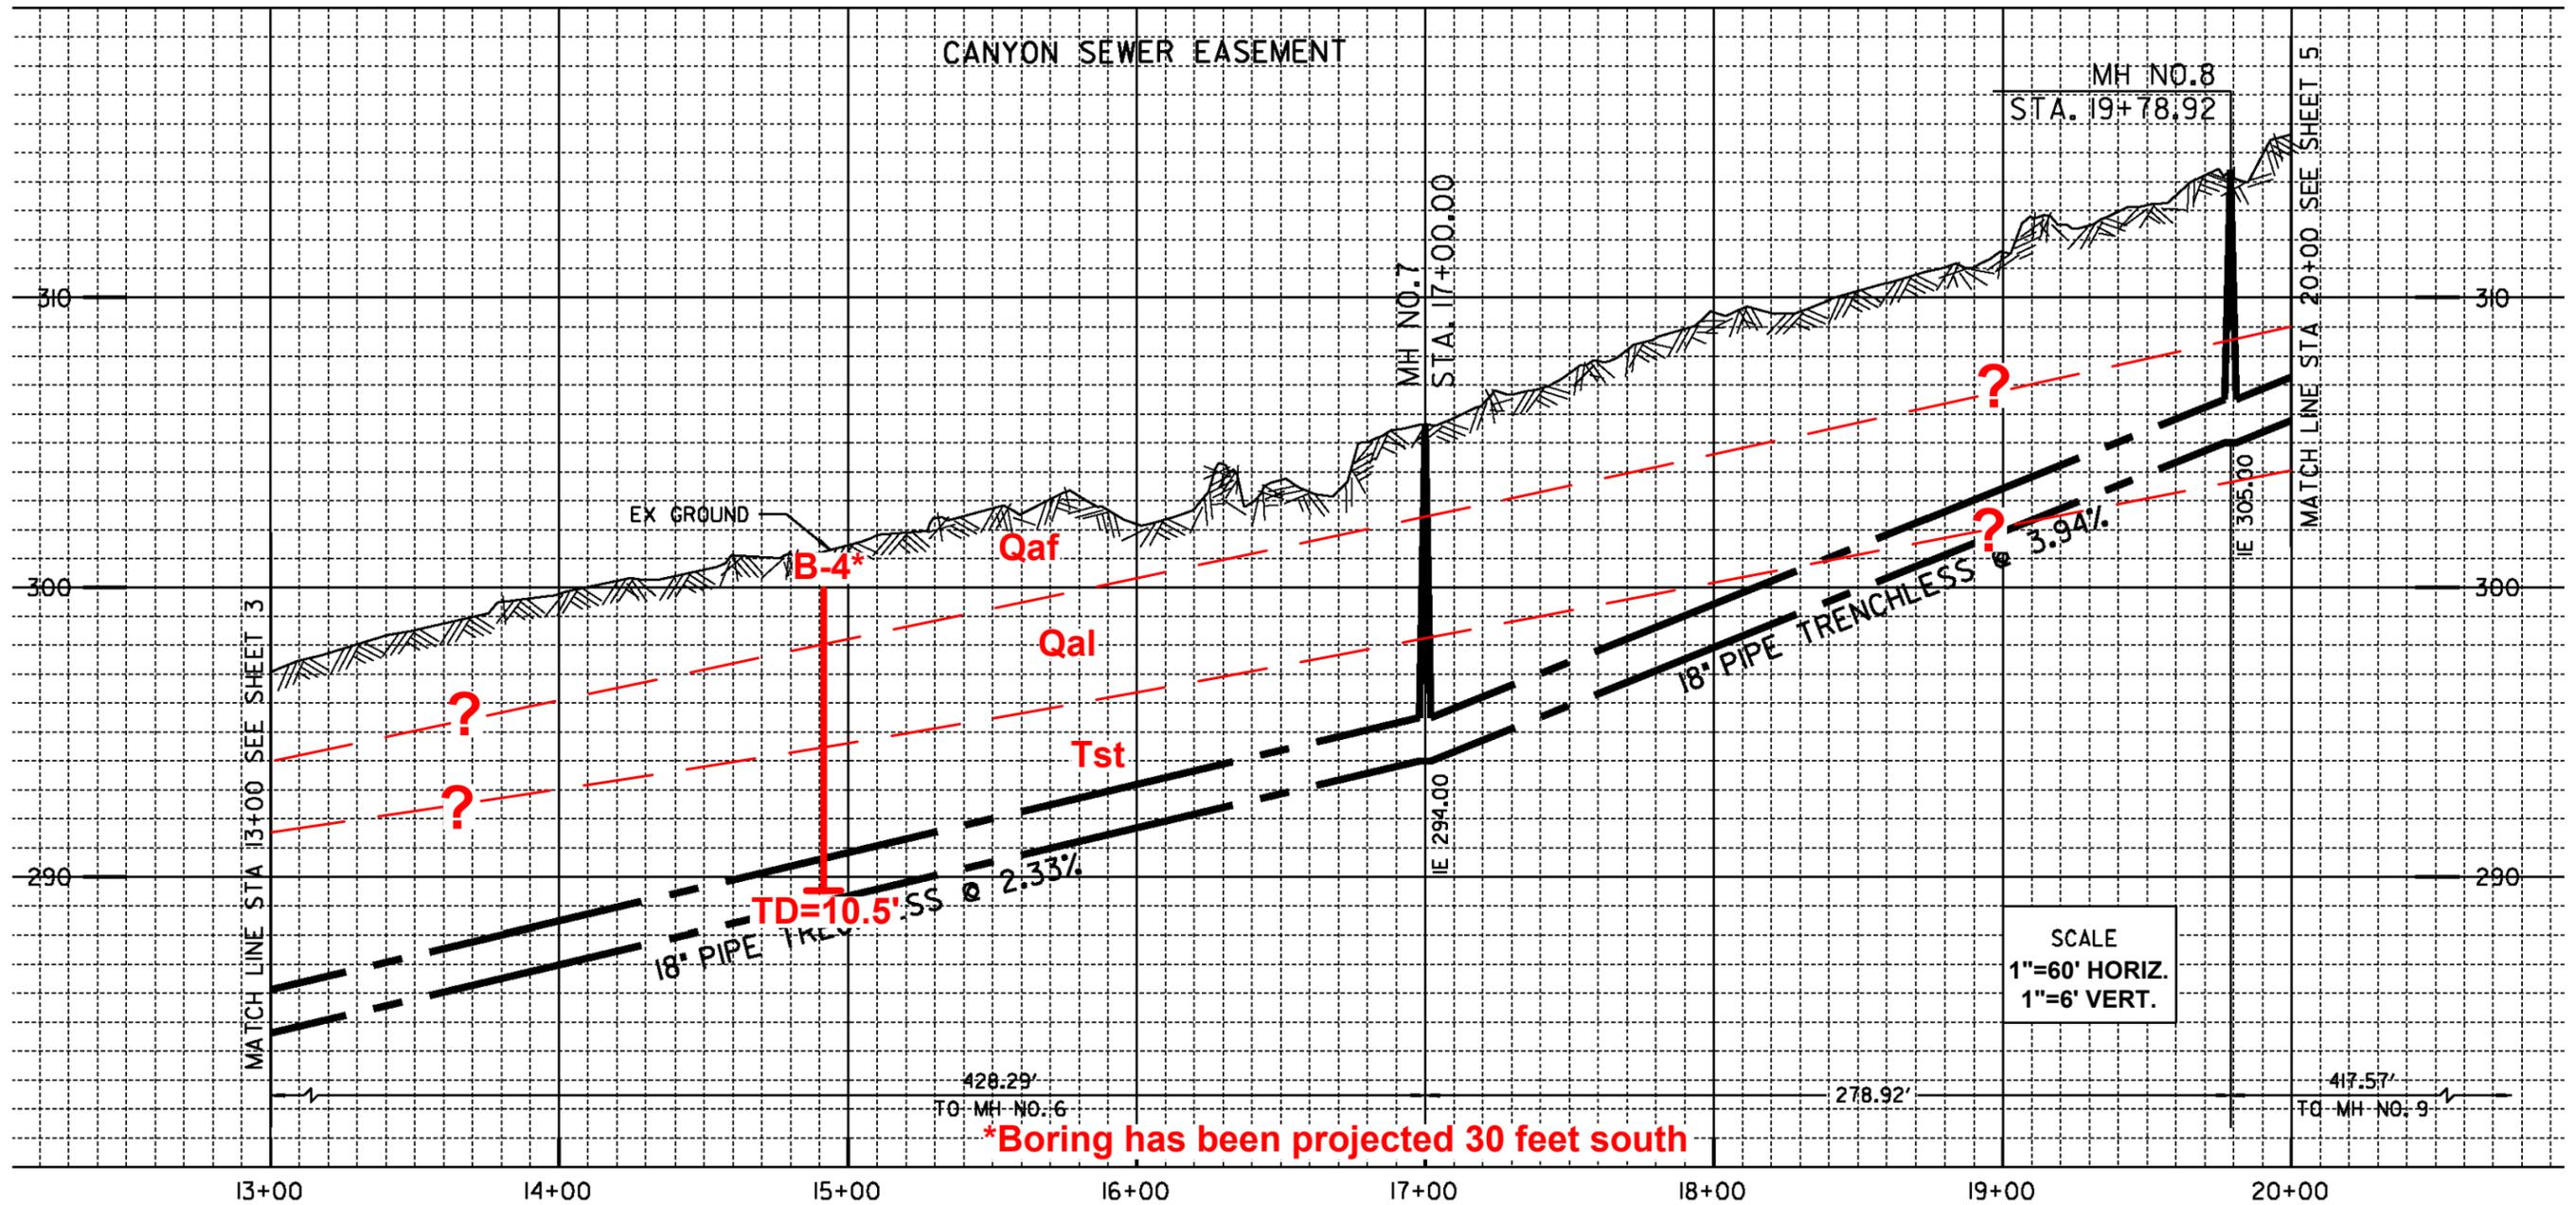
EXISTING GRADE  
 APPROXIMATE LOCATION OF EXPLORATORY BORING  
 TD = TERMINATION DEPTH IN FEET  
 APPROXIMATE GEOLOGIC CONTACT LOCATION (QUERIED WHERE UNCERTAIN)

PROJECT NO. 180004.2	REPORT DATE February 2018	FIGURE 6C
-------------------------	------------------------------	-----------

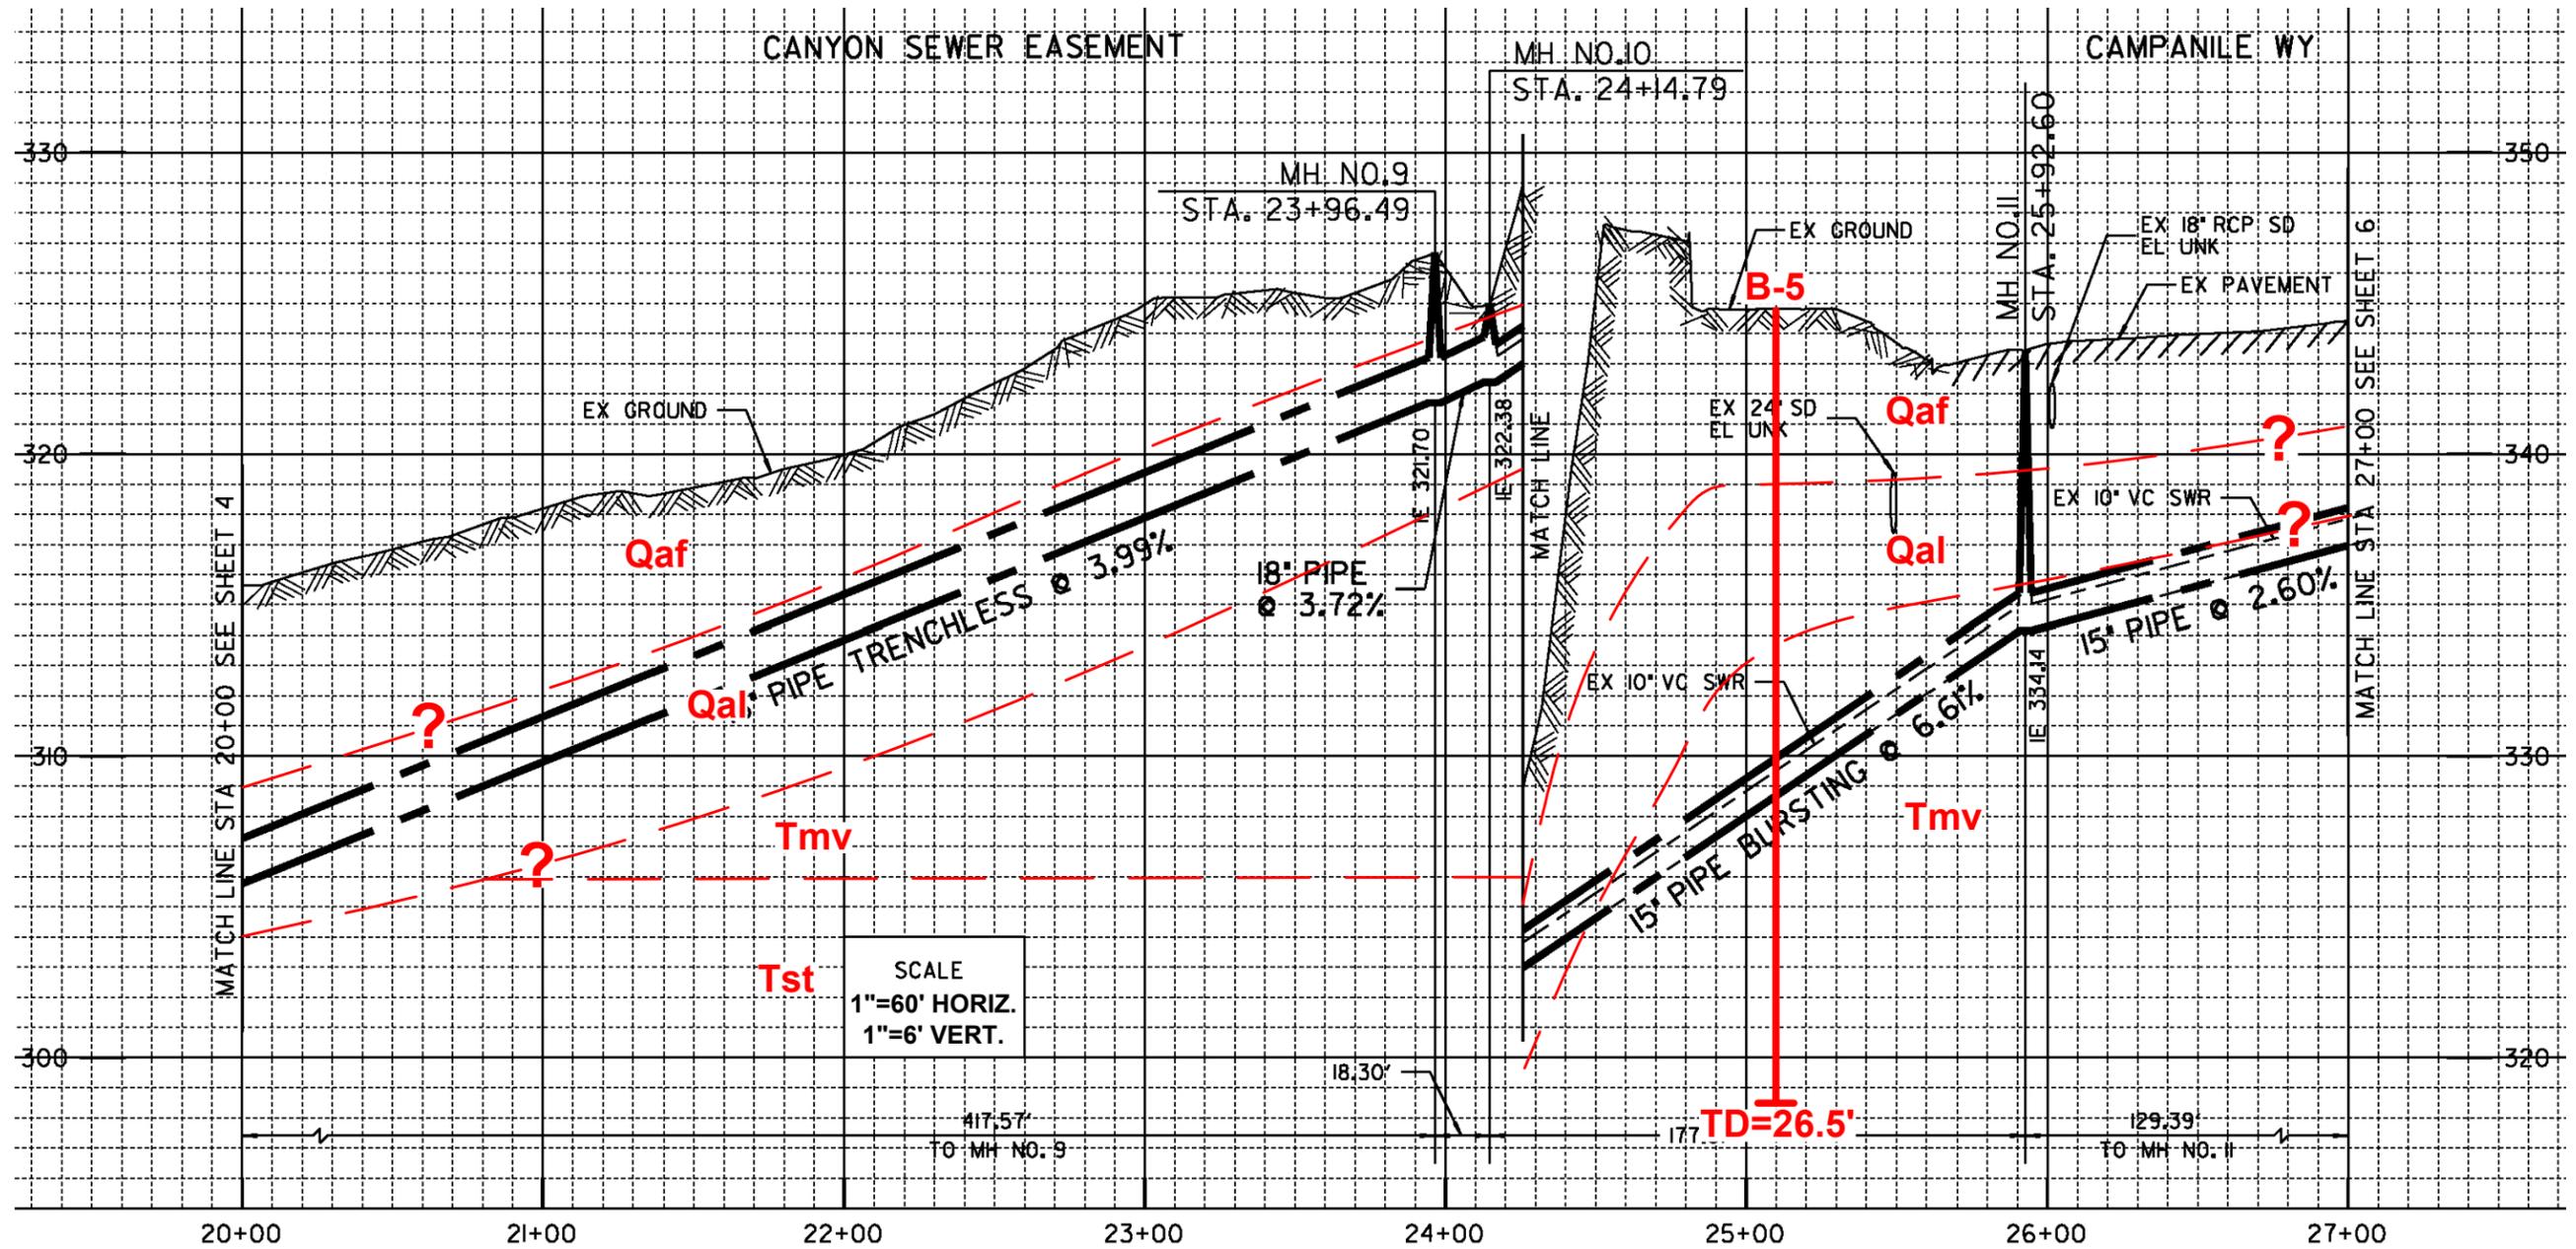
SCALE  
1"=60' HORIZ.  
1"=6' VERT.

GEOLOGIC CROSS SECTION		
15GT14 - College Area Sewer and Water Main Replacement 54th Street and Campanile Way San Diego, California		
PROJECT NO. 180004.2	REPORT DATE February 2018	FIGURE 6D

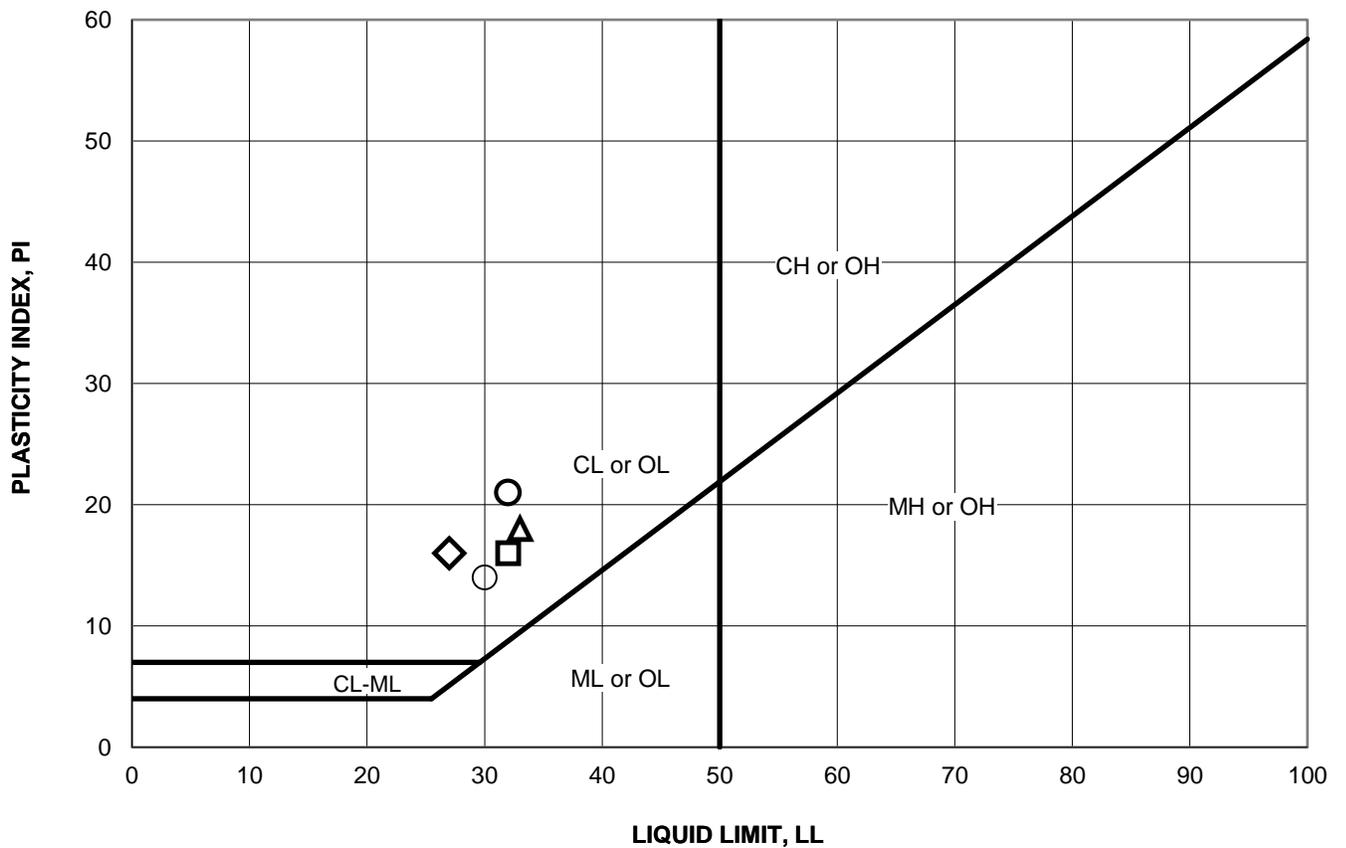
FIGURE B-1

SYMBOL	SAMPLE LOCATION	SAMPLE DEPTH (FT)	LIQUID LIMIT, LL	PLASTIC LIMIT, PL	PLASTICITY INDEX, PI	USCS (% Finer than No. 40)	USCS (Entire Sample)
▲	B-1	0-5'	33	15	18	CL	SC
□	B-2	0-5'	32	16	16	CL	SG
○	B-3	0-5'	32	11	21	CL	SC
◇	B-3	5'	27	11	16	CL	GM
⬡	B-5	0-5'	30	16	14	CL	SC

PERFORMED IN GENERAL ACCORDANCE WITH ASTM D 4318

Laboratory tests were performed on selected samples obtained from the borings in order to aid in the soil classification and to evaluate the engineering properties of the soils. The laboratory tests included: in-situ moisture and dry density, maximum density, Atterberg limits, sieve analyses, direct shear and corrosivity evaluation. In-situ moisture content and density data are presented on the boring logs in Appendix A. A description of the laboratory tests performed as well as the test results are shown in Appendix B.

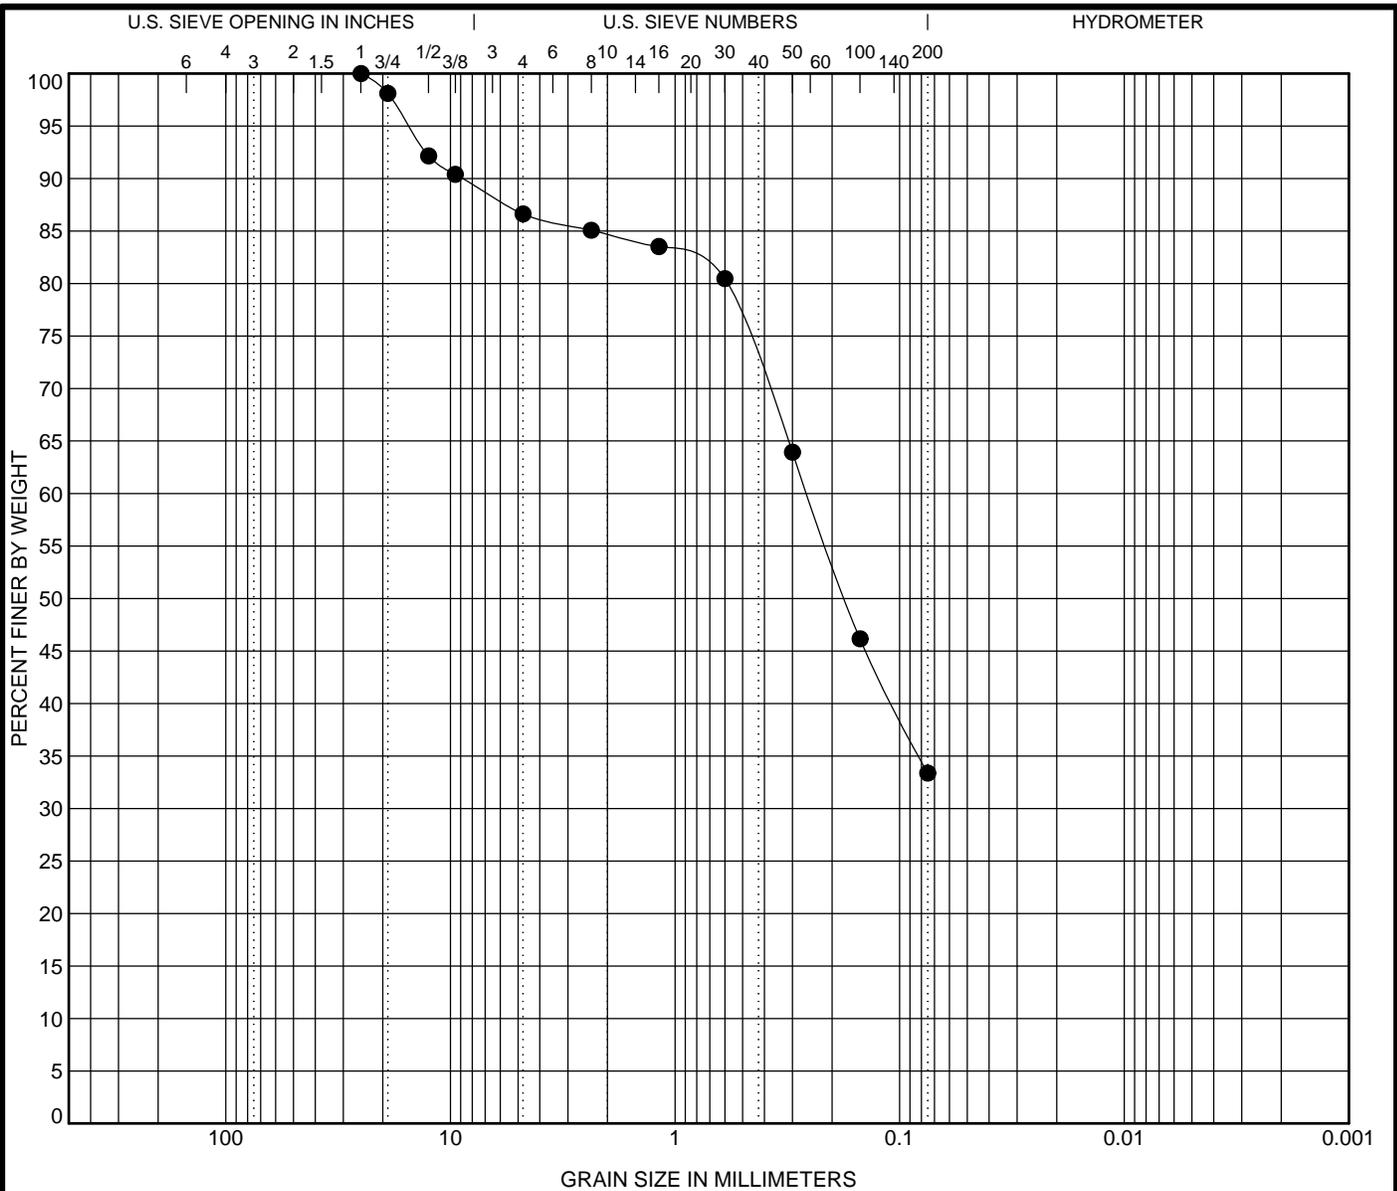
Sample Location	U.S.C.S. Classification						Cc	Cu
● B-1 at 0 - 5 ft	Clayey SAND							
D <sub>100</sub>	D <sub>60</sub>	D <sub>50</sub>	D <sub>30</sub>	D <sub>10</sub>	%Gravel	%Sand	%Silt	%Clay
25	0.257	0.174			13.4	53.3	33.4

GRAIN SIZE DISTRIBUTION		
15GT14-College Area Sewer and Water Main Replacement 54th Street & Campanile Way San Diego, California		
PROJECT NO. 180004.2	REPORT DATE February 2018	FIGURE B- 2
