## Preliminary Geotechnical Investigation

City of San Diego Task 15GT14 - College Area Sewer  
and AC Water Main Replacement  
54<sup>th</sup> Street & Campanile Way  
San Diego, California

February 26, 2018

Project No.: 180004.2

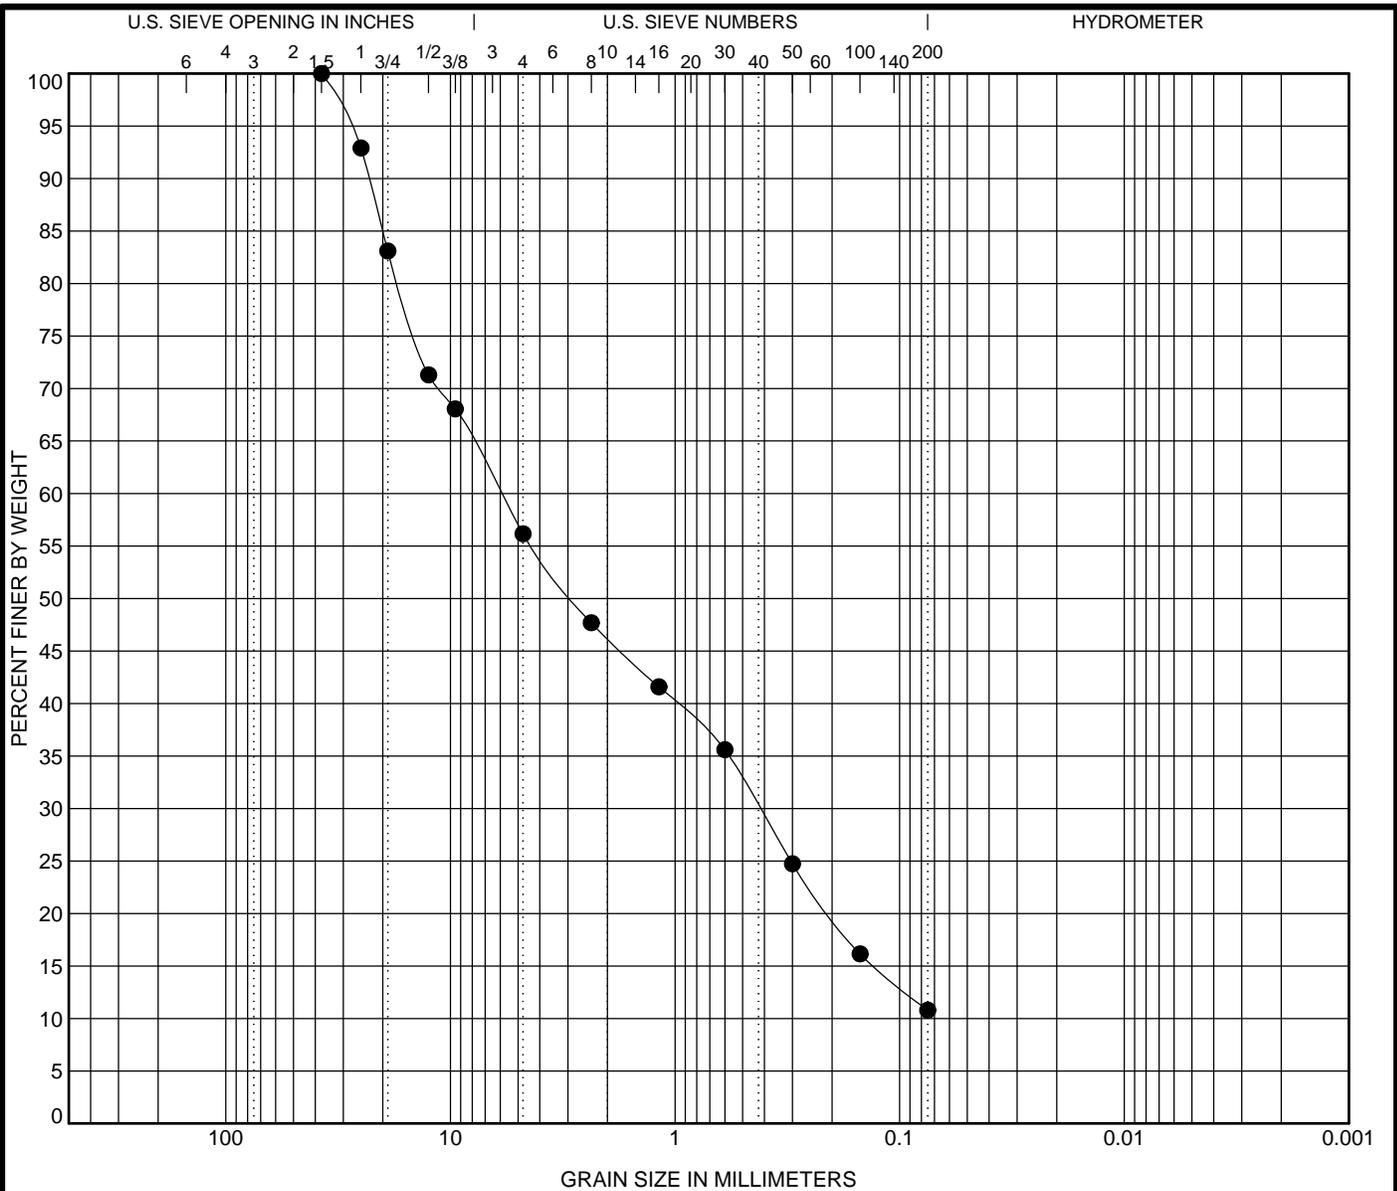
Sample Location		U.S.C.S. Classification					Cc	Cu
● B-1 at 5 ft		Sandy GRAVEL					0.44	87.75
D <sub>100</sub>	D <sub>60</sub>	D <sub>50</sub>	D <sub>30</sub>	D <sub>10</sub>	%Gravel	%Sand	%Silt	%Clay
37.5	5.939	2.854	0.42		43.8	45.4	10.8

GRAIN SIZE DISTRIBUTION		
15GT14-College Area Sewer and Water Main Replacement 54th Street & Campanile Way San Diego, California		
PROJECT NO. 180004.2	REPORT DATE February 2018	FIGURE B- 3

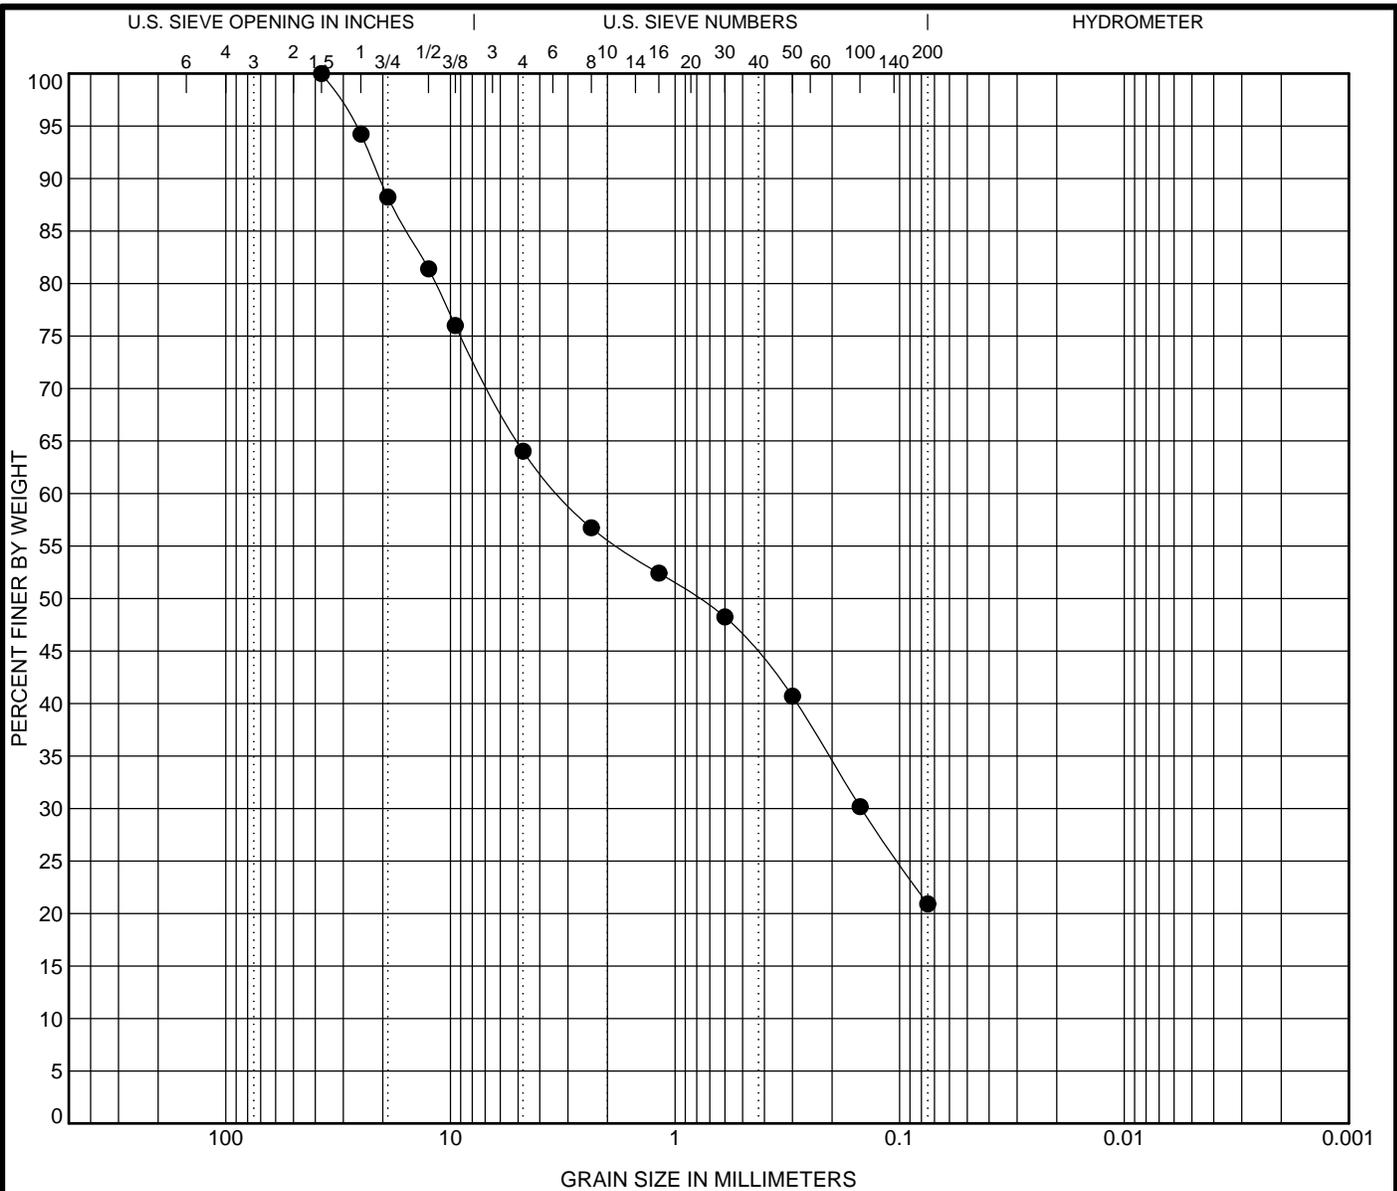
Sample Location		U.S.C.S. Classification						Cc	Cu
● B-2 at 0 - 5 ft		Gravelly SAND							
D <sub>100</sub>	D <sub>60</sub>	D <sub>50</sub>	D <sub>30</sub>	D <sub>10</sub>	%Gravel	%Sand	%Silt	%Clay	
37.5	3.226	0.797	0.148		36.0	43.1	20.9

GRAIN SIZE DISTRIBUTION		
15GT14-College Area Sewer and Water Main Replacement 54th Street & Campanile Way San Diego, California		
PROJECT NO. 180004.2	REPORT DATE February 2018	FIGURE B- 4

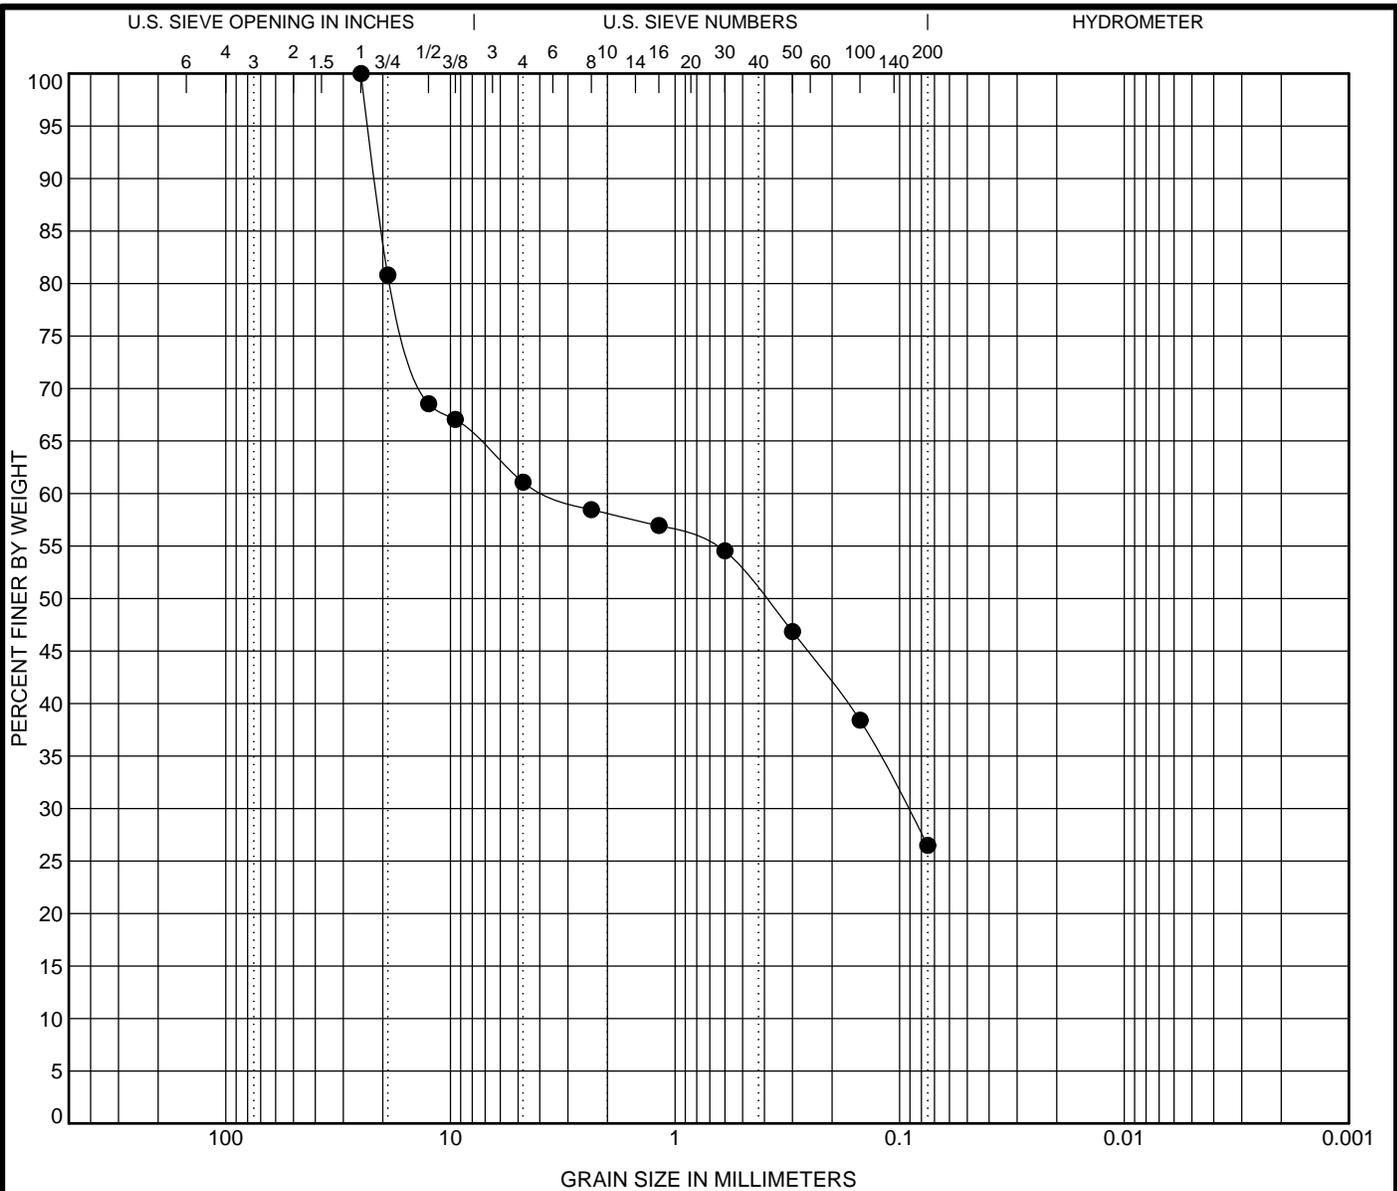
Sample Location	U.S.C.S. Classification						Cc	Cu
● B-2 at 5 ft	Sandy GRAVEL							
D <sub>100</sub>	D <sub>60</sub>	D <sub>50</sub>	D <sub>30</sub>	D <sub>10</sub>	%Gravel	%Sand	%Silt	%Clay
25	3.556	0.398	0.092		38.9	34.6	26.5

GRAIN SIZE DISTRIBUTION		
15GT14-College Area Sewer and Water Main Replacement 54th Street & Campanile Way San Diego, California		
PROJECT NO. 180004.2	REPORT DATE February 2018	FIGURE B- 5

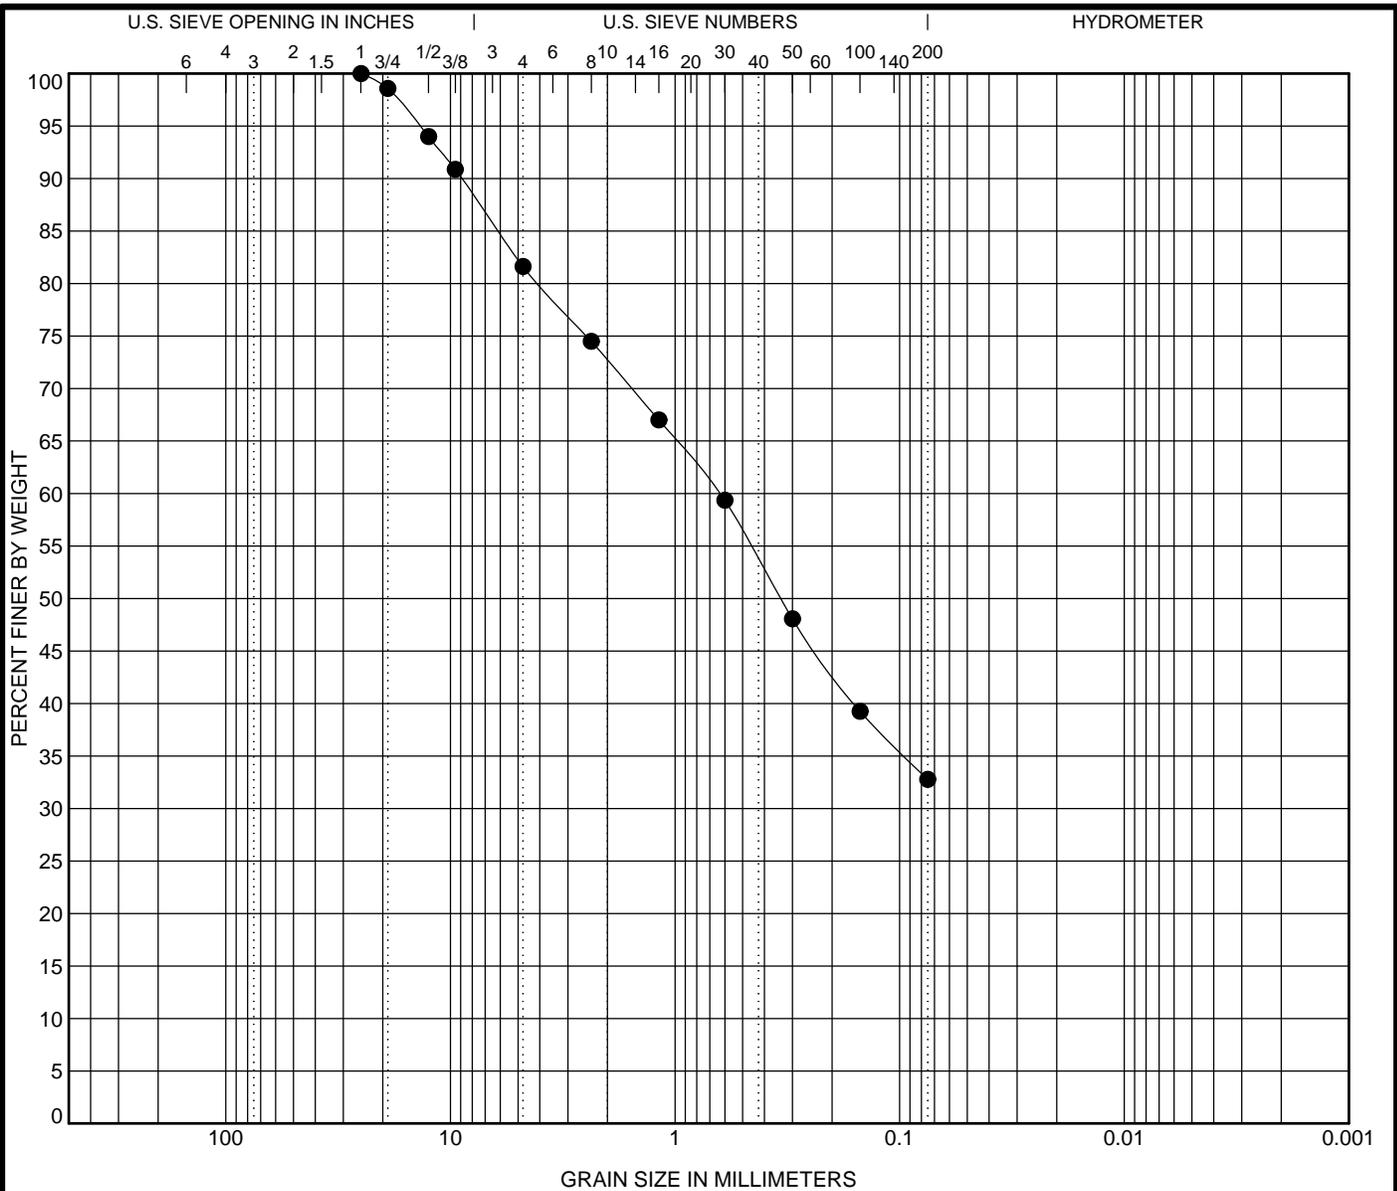
Sample Location		U.S.C.S. Classification						Cc	Cu
● B-3 at 0 - 5 ft		Clayey SAND							
D <sub>100</sub>	D <sub>60</sub>	D <sub>50</sub>	D <sub>30</sub>	D <sub>10</sub>	%Gravel	%Sand	%Silt	%Clay	
25	0.634	0.338			18.4	48.8	32.8

GRAIN SIZE DISTRIBUTION		
15GT14-College Area Sewer and Water Main Replacement 54th Street & Campanile Way San Diego, California		
PROJECT NO. 180004.2	REPORT DATE February 2018	FIGURE B- 6

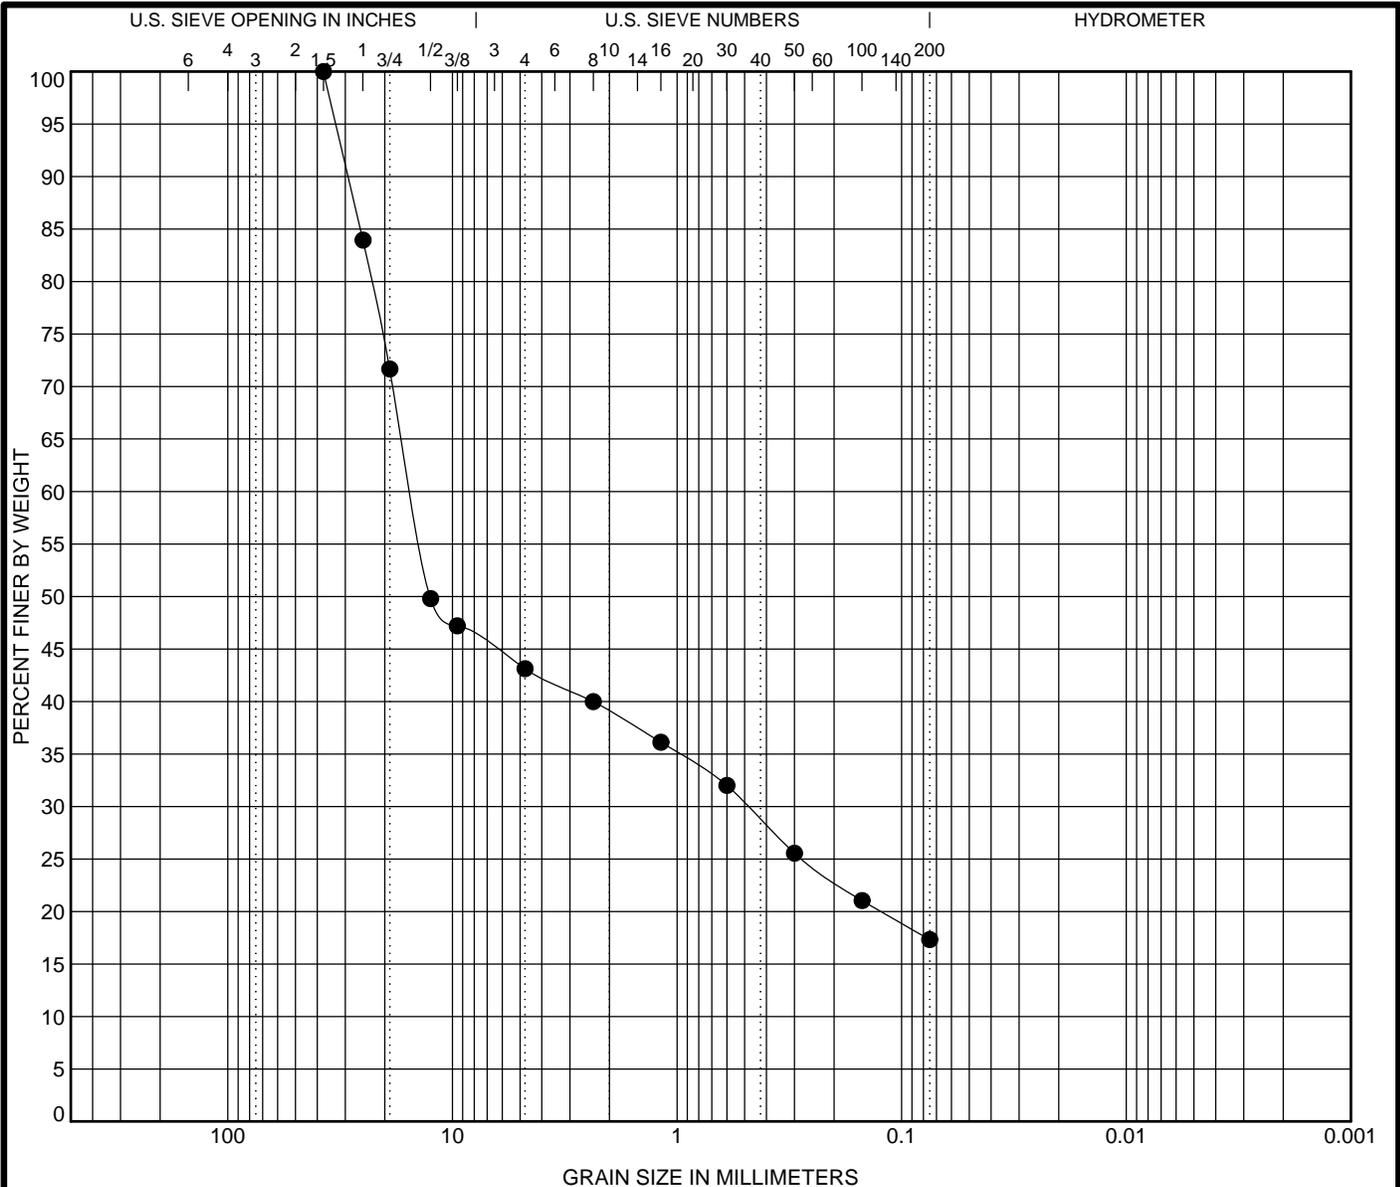
FIGURE B- 7

Sample Location	U.S.C.S. Classification						Cc	Cu
● B-3 at 10 ft	Sandy GRAVEL							
D <sub>100</sub>	D <sub>60</sub>	D <sub>50</sub>	D <sub>30</sub>	D <sub>10</sub>	%Gravel	%Sand	%Silt	%Clay
37.5	15.195	12.547	0.483		56.9	25.8	17.3

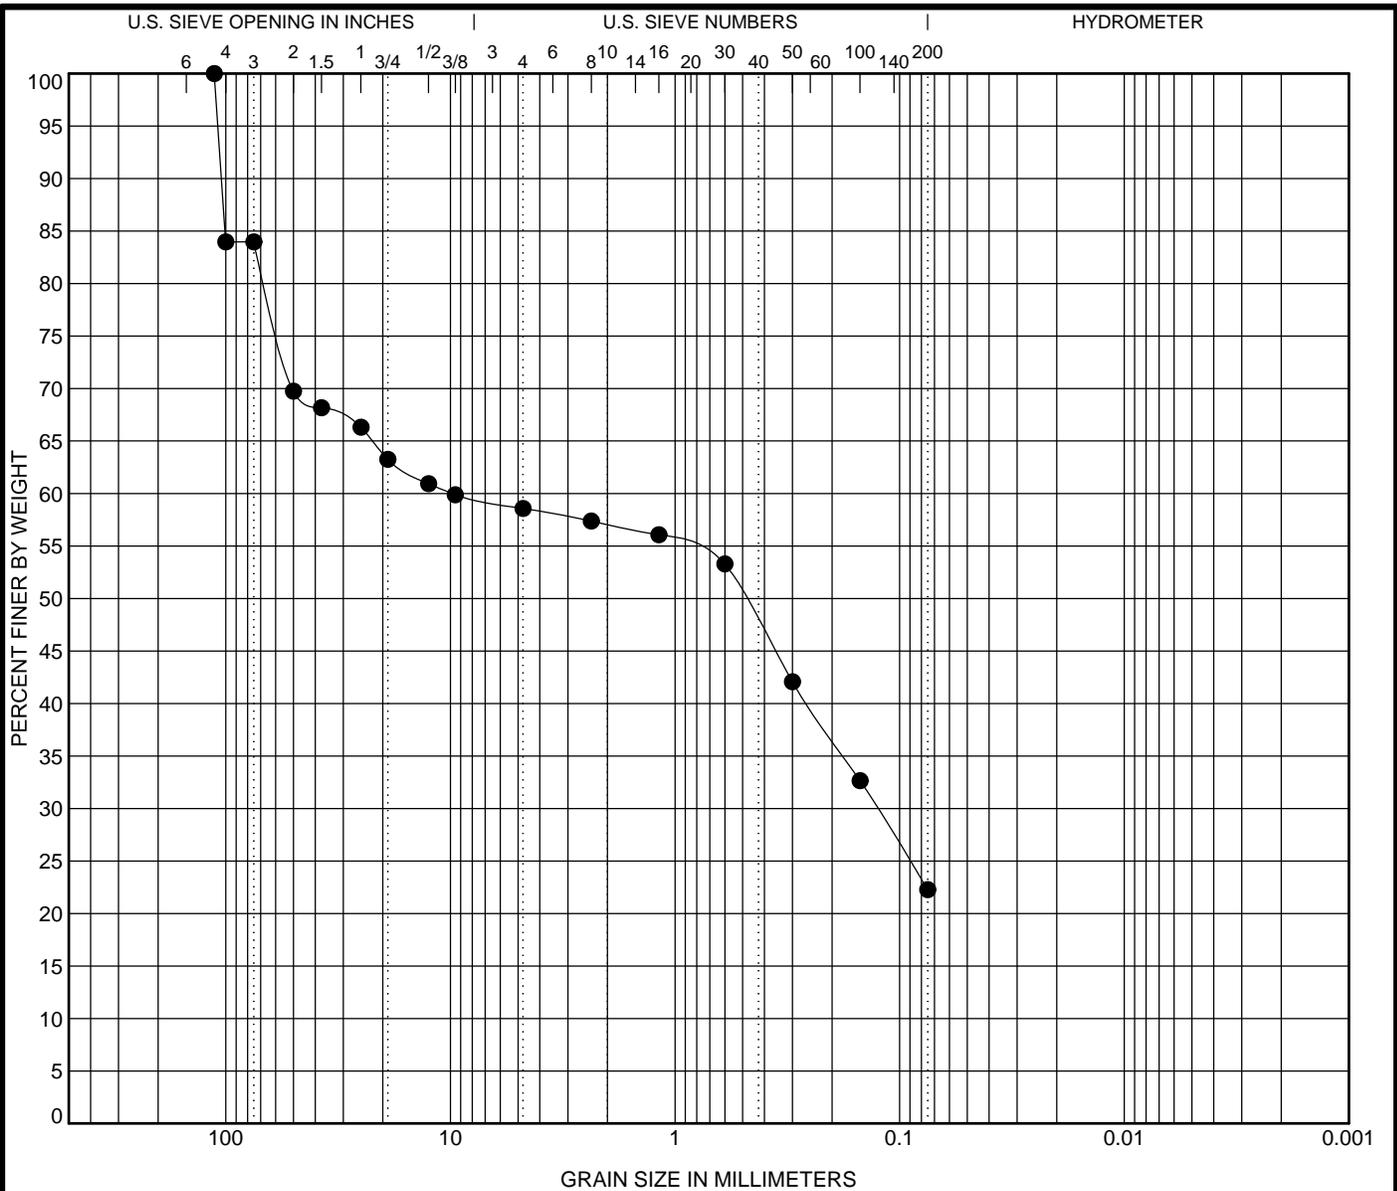
Sample Location		U.S.C.S. Classification						Cc	Cu
● B-4 at 0 - 5 ft		Sandy GRAVEL							
D <sub>100</sub>	D <sub>60</sub>	D <sub>50</sub>	D <sub>30</sub>	D <sub>10</sub>	%Gravel	%Sand	%Silt	%Clay	
112.5	9.79	0.49	0.126		25.4	36.3	22.3

GRAIN SIZE DISTRIBUTION		
15GT14-College Area Sewer and Water Main Replacement 54th Street & Campanile Way San Diego, California		
PROJECT NO. 180004.2	REPORT DATE February 2018	FIGURE B- 8

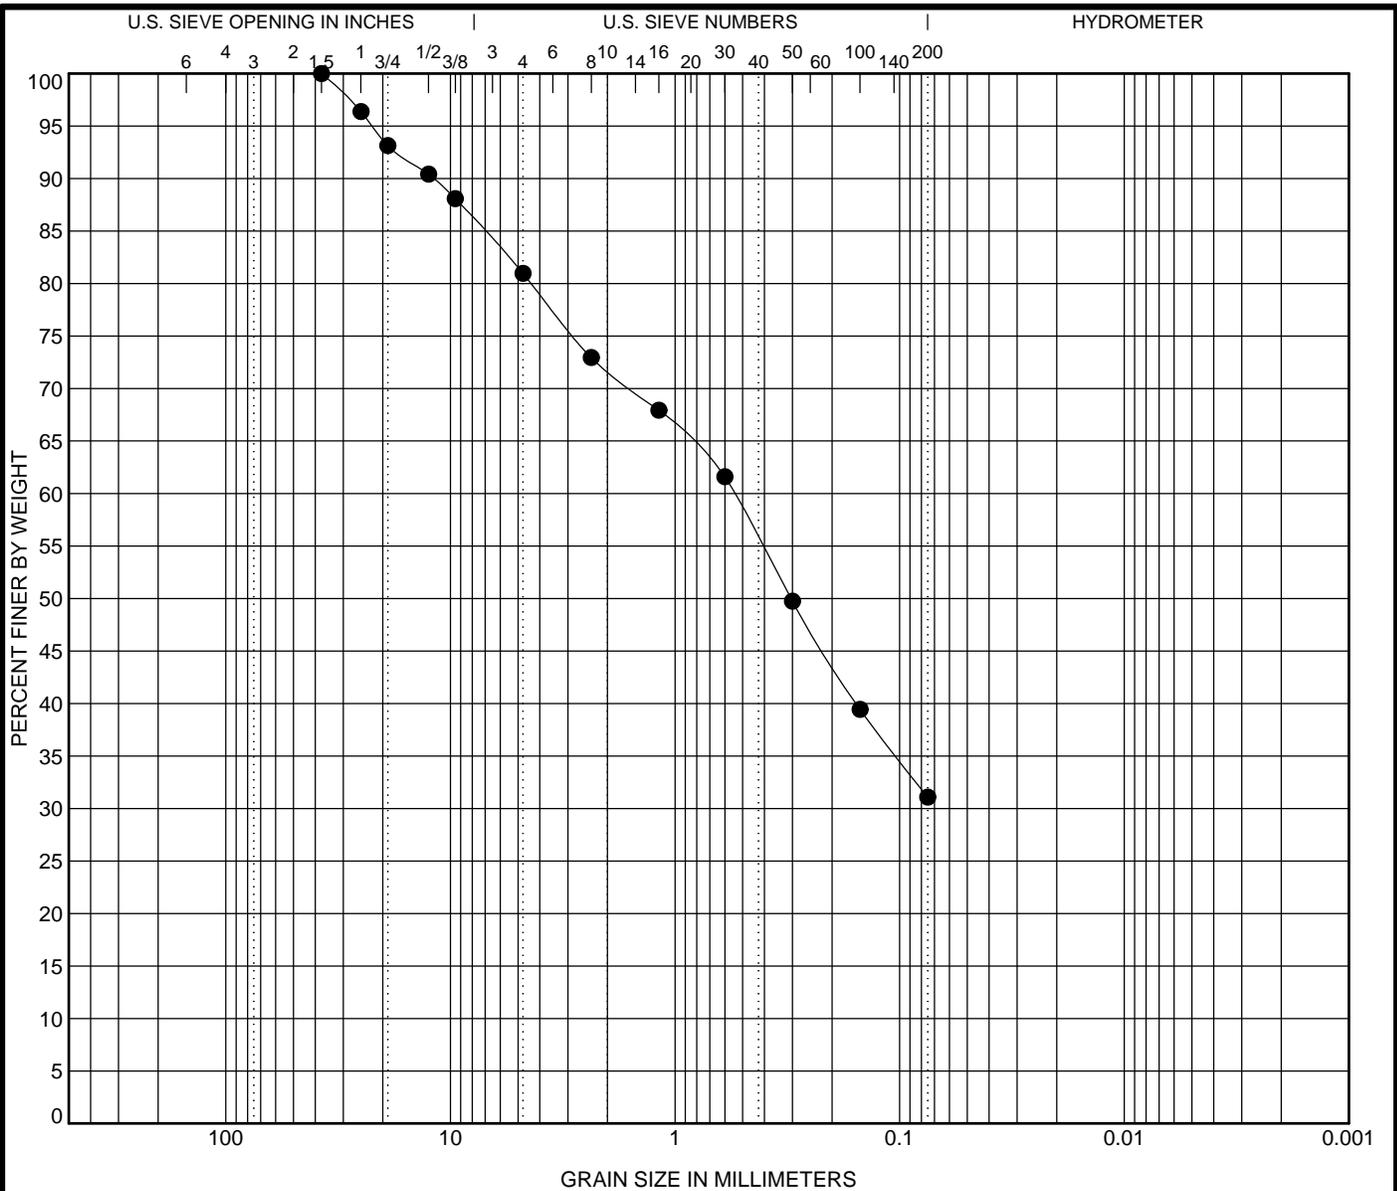
Sample Location		U.S.C.S. Classification						Cc	Cu
● B-5 at 0 - 5 ft		Clayey SAND							
D <sub>100</sub>	D <sub>60</sub>	D <sub>50</sub>	D <sub>30</sub>	D <sub>10</sub>	%Gravel	%Sand	%Silt	%Clay	
37.5	0.547	0.304			19.0	49.9	31.1

GRAIN SIZE DISTRIBUTION		
15GT14-College Area Sewer and Water Main Replacement 54th Street & Campanile Way San Diego, California		
PROJECT NO. 180004.2	REPORT DATE February 2018	FIGURE B- 9

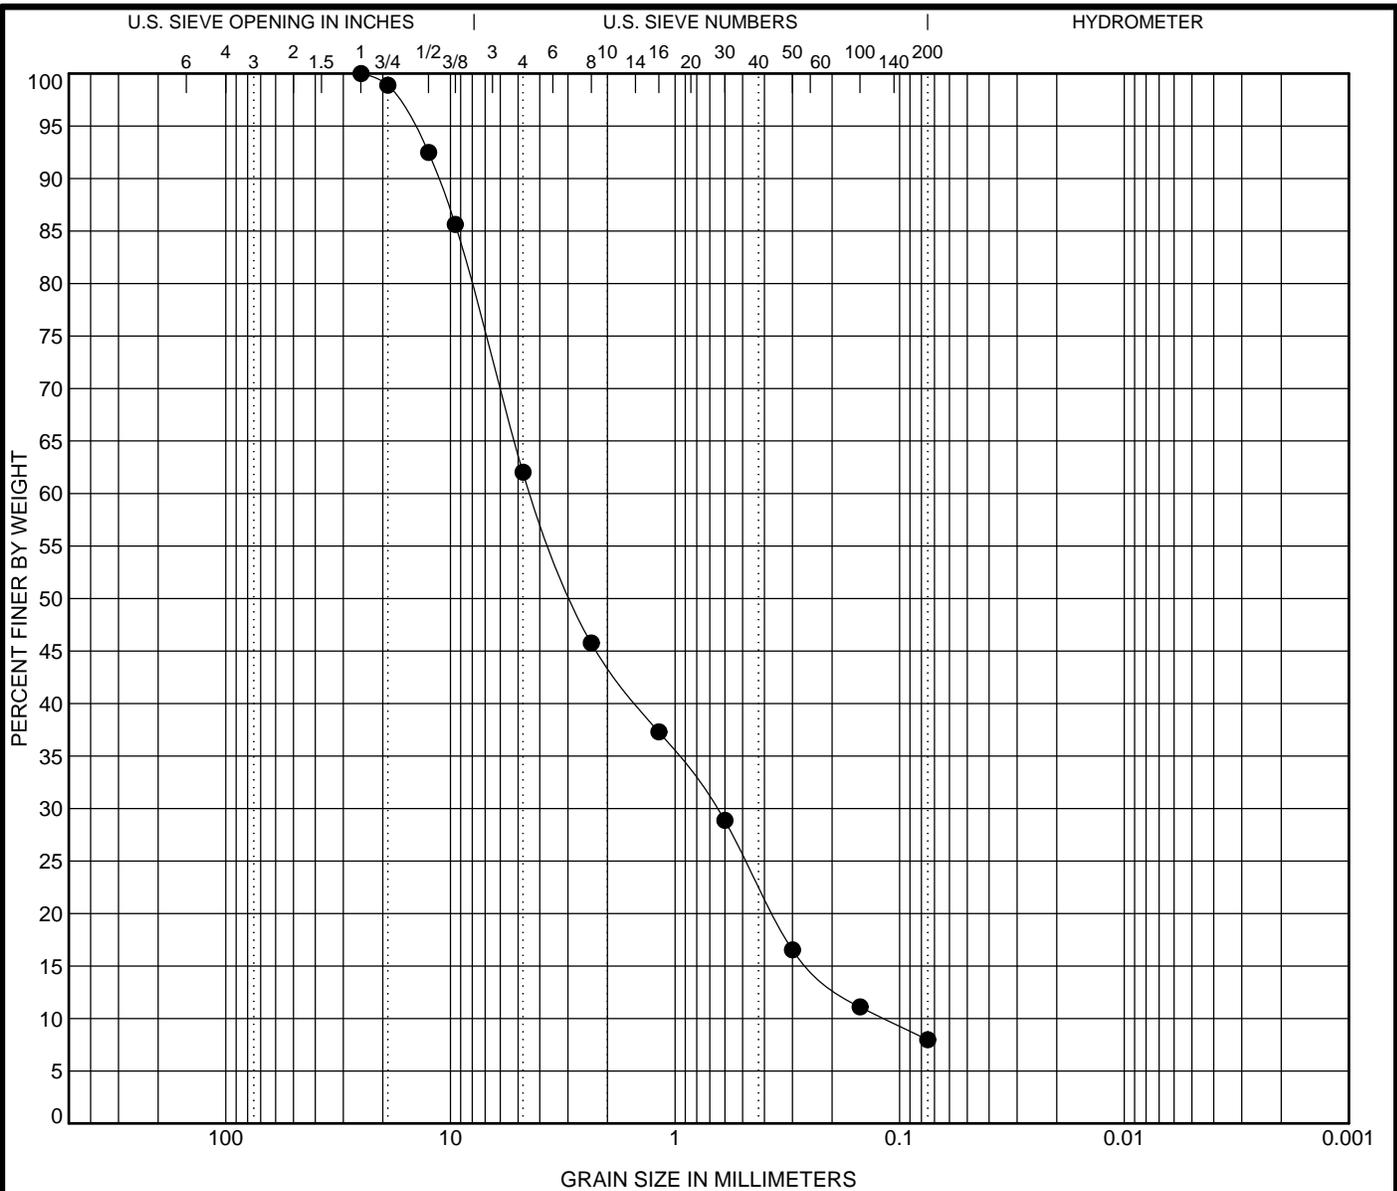
Sample Location		U.S.C.S. Classification						Cc	Cu
● B-5 at 15 - 20 ft		Gravelly SAND (Air Rotary Drilling - larger gravel fraction should be anticipated)						0.84	37.03
D <sub>100</sub>	D <sub>60</sub>	D <sub>50</sub>	D <sub>30</sub>	D <sub>10</sub>	%Gravel	%Sand	%Silt	%Clay	
25	4.352	2.831	0.657	0.118	38.0	54.1	8.0

<b>GRAIN SIZE DISTRIBUTION</b>		
15GT14-College Area Sewer and Water Main Replacement 54th Street & Campanile Way San Diego, California		
PROJECT NO. 180004.2	REPORT DATE February 2018	FIGURE B- 10

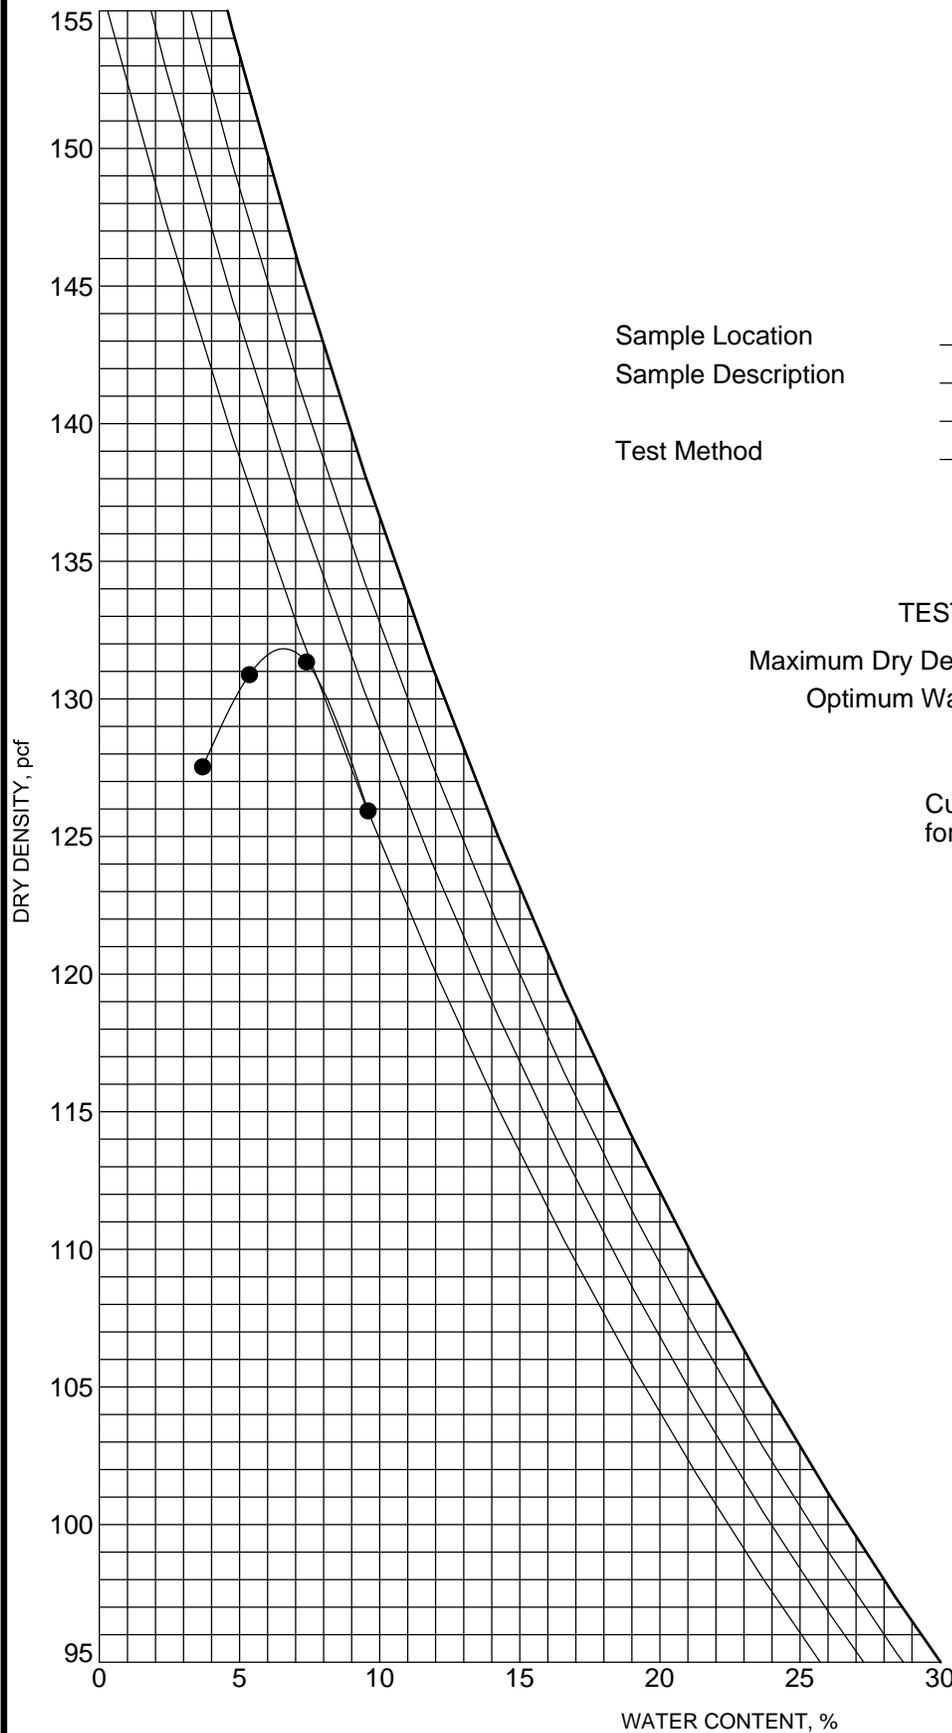
COMPACTION 15GT14 COLLEGE AREA SEWER AND AC WATER MAIN REPLACEMENT.GPJ TWINING LABS.GDT 2/24/18

Sample Location B-5 at 15' - 20'  
 Sample Description Tan Sandy Gravel  
 Test Method ASTM D1557 Method C
