Project No. G2432-52-01
August 23, 2019

Subject: STORM WATER MANAGEMENT INVESTIGATION
COLLEGE VIEW
5420-22 55TH STREET
SAN DIEGO, CALIFORNIA

STORM WATER MANAGEMENT INVESTIGATION

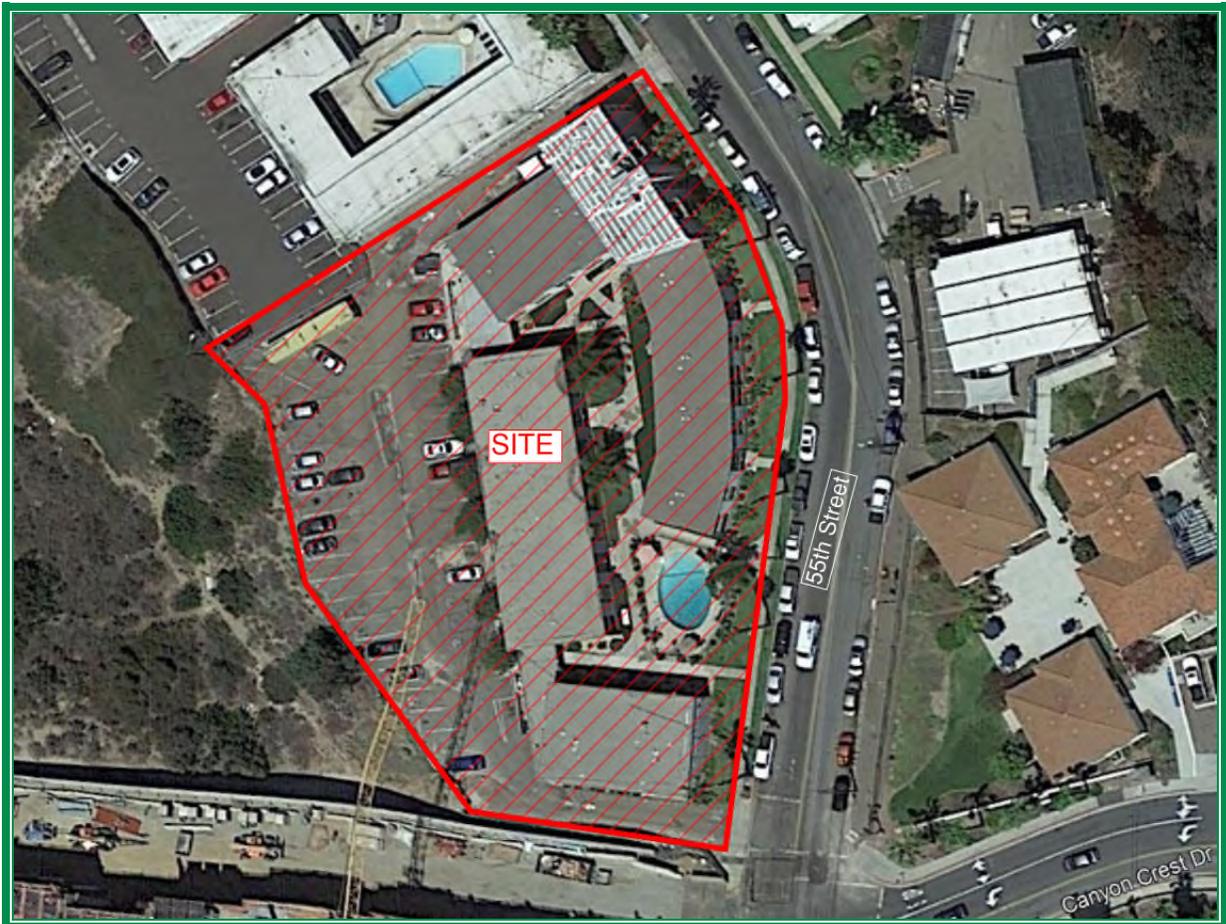
Existing Site Plan

The property is located at 5420-22 55th Street in the College area of the City of San Diego, California (see Vicinity Map, Figure 1). The existing property consists of 2- to 4-story apartment complex with accommodating pool area, utilities and landscaping. Surface parking is available on the west side of the buildings. The Existing Site Plans shows the existing conditions. A canyon slope descends to the west and drains to the northwest with a maximum slope height of about 50 feet.

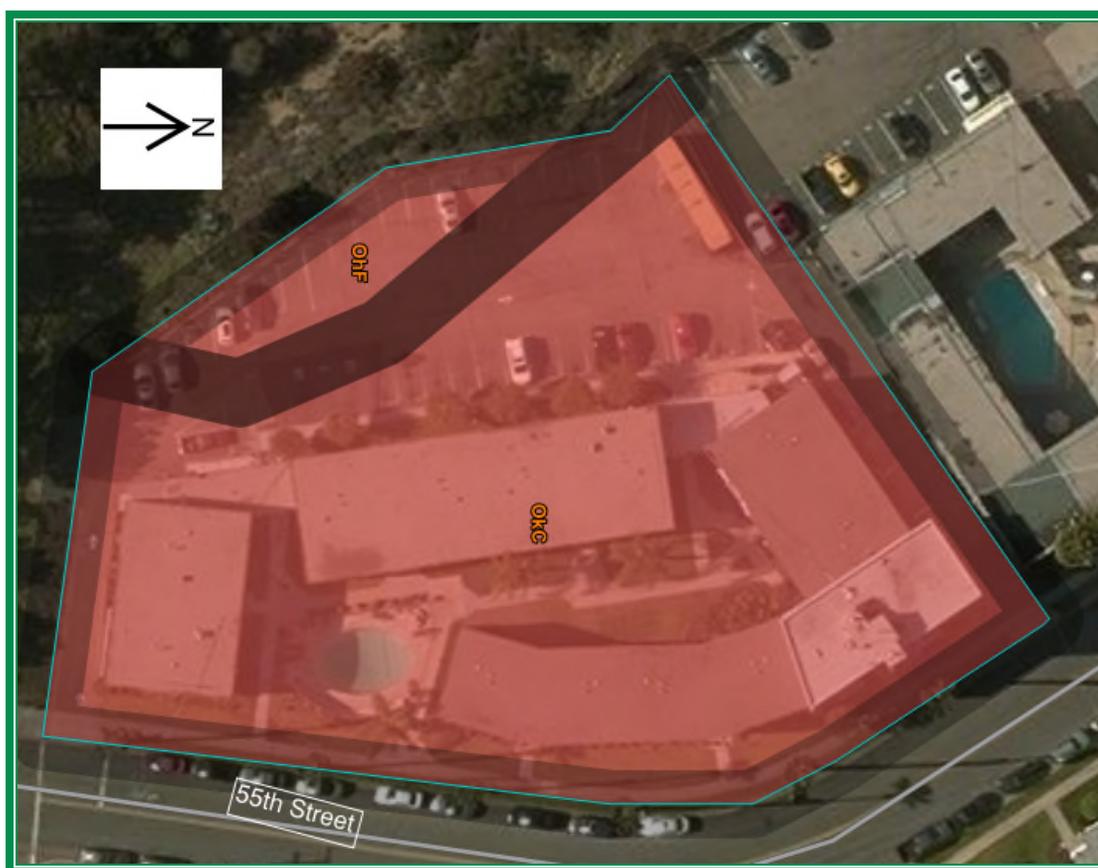
USDA Hydrologic Map

Map Unit Name	Map Unit Symbol	Approximate Percentage of Property	Hydrologic Soil Group	ks _{AT} of Most Limiting Layer (inches/hour)
Olivenhain cobbly loam, 30 to 50 percent slopes	OhF	10	D	0.00 – 0.06
Olivenhain-Urban land complex, 2 to 9 percent slopes	OkC	90	D	0.00 – 0.06

The United States Department of Agriculture (USDA), Natural Resources Conservation Services, possesses general information regarding the existing soil conditions for areas within the United States. The USDA website also provides the Hydrologic Soil Group. Table 1 presents the descriptions of the hydrologic soil groups. If a soil is assigned to a dual hydrologic group (A/D, B/D, or C/D), the first letter is for drained areas and the second is for undrained areas. In addition, the USDA website also provides an estimated saturated hydraulic conductivity for the existing soil.
