ARCHAEOLOGICAL SURVEY OF THE LIAGHAT PARCEL

LA JOLLA, CALIFORNIA

APN 352-13-003

City of San Diego Project No. 503701

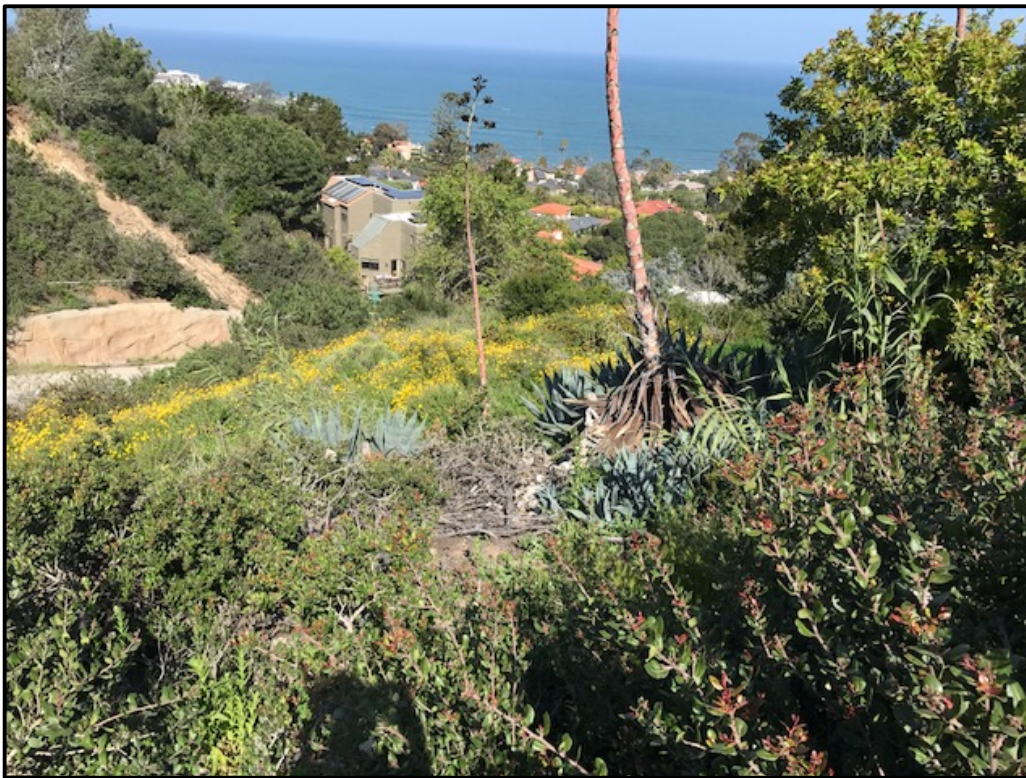
Plate 1: Overview of the Liaghat Parcel, facing northwest.

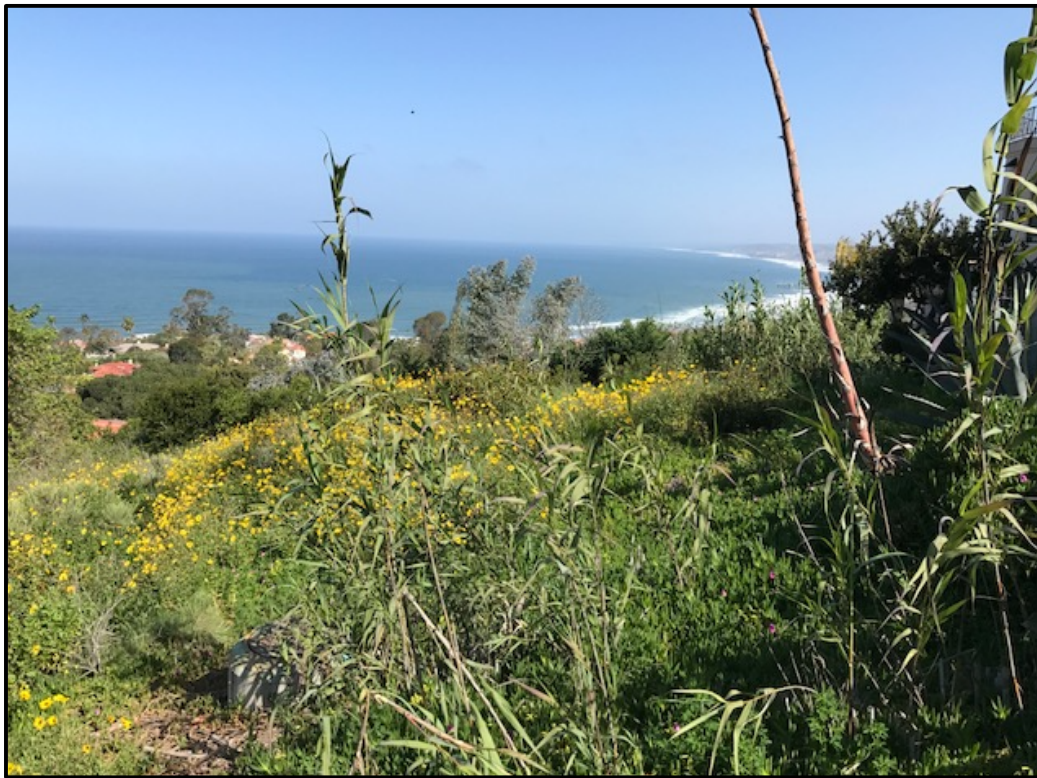
Plate 2: Overview of the Liaghat Parcel, facing north.

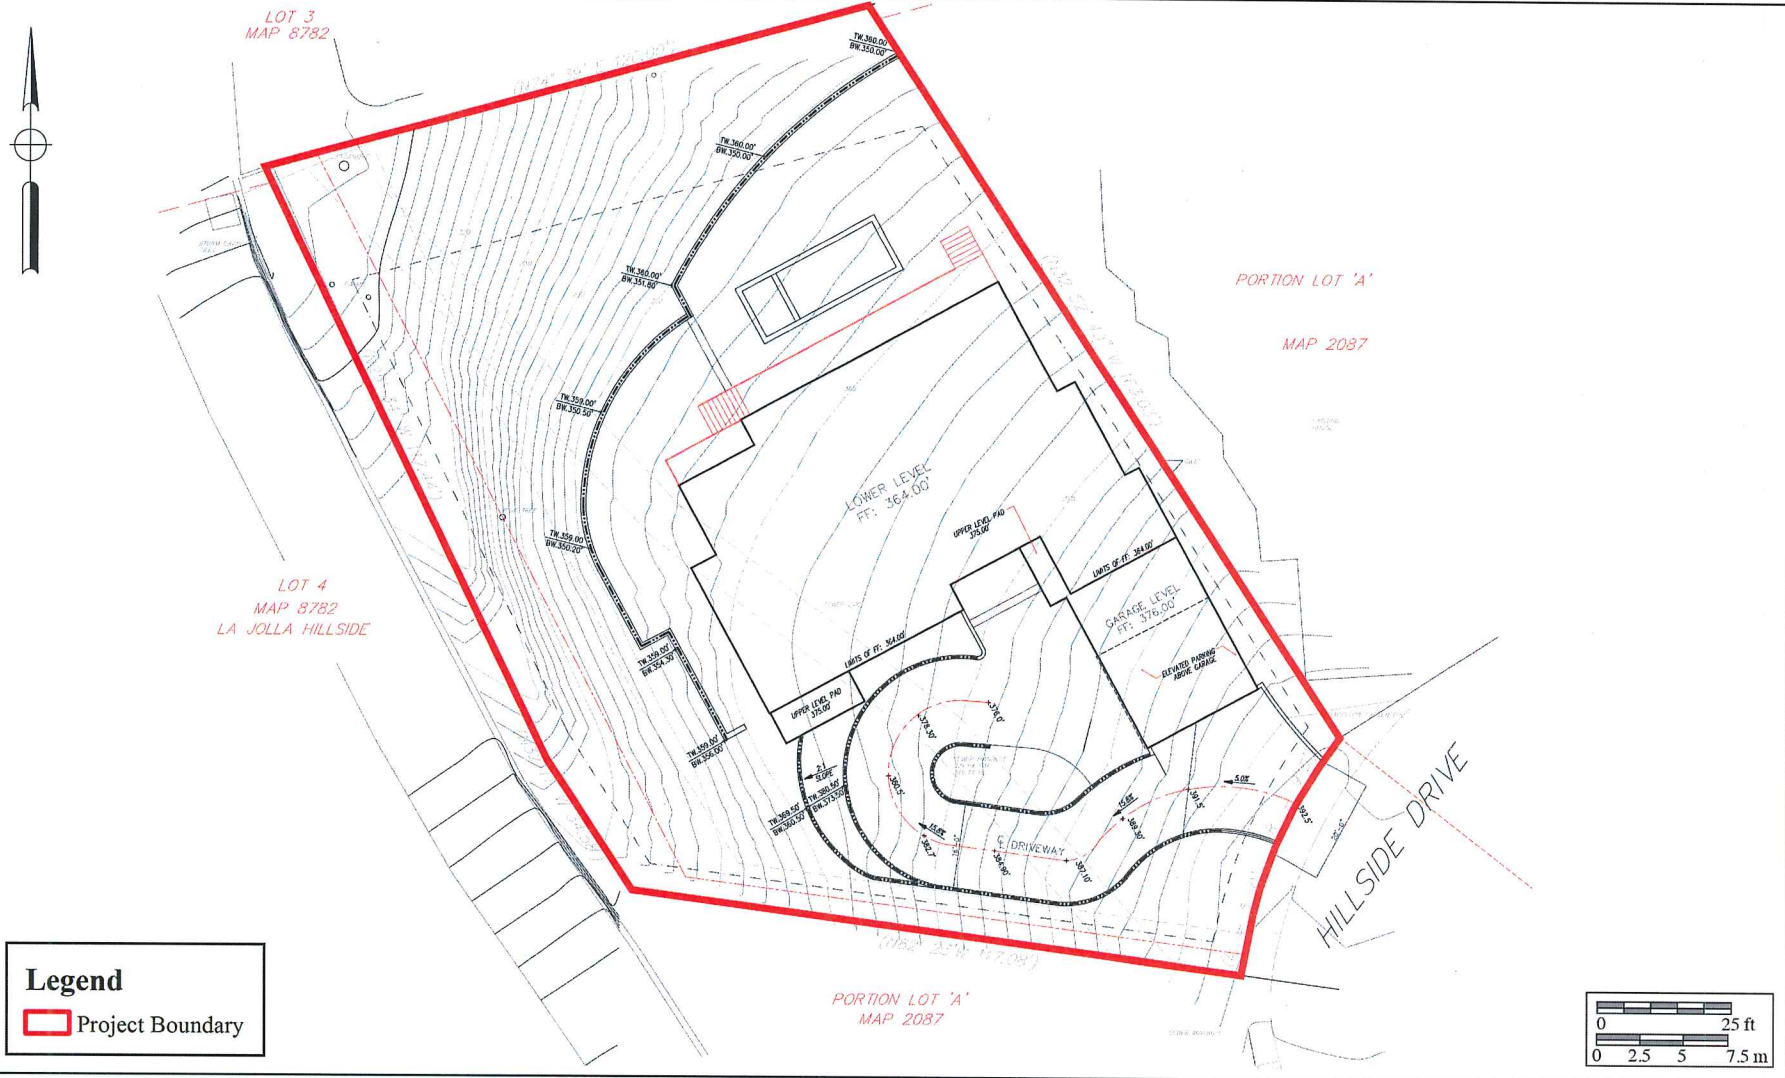
Figure 4
Site Plan
The Liaghat Parcel Project

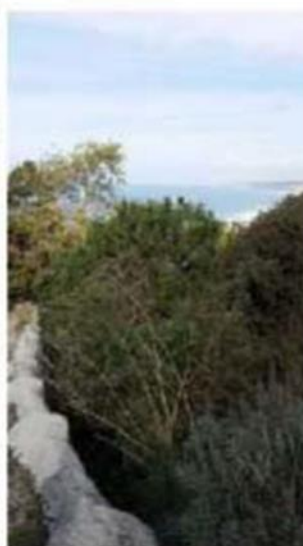
5 Western drain

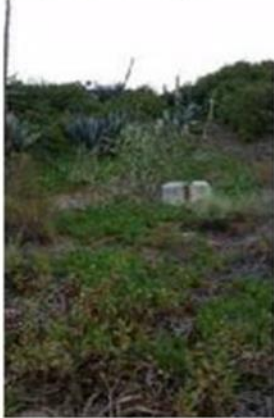
10 Sewer Access Port

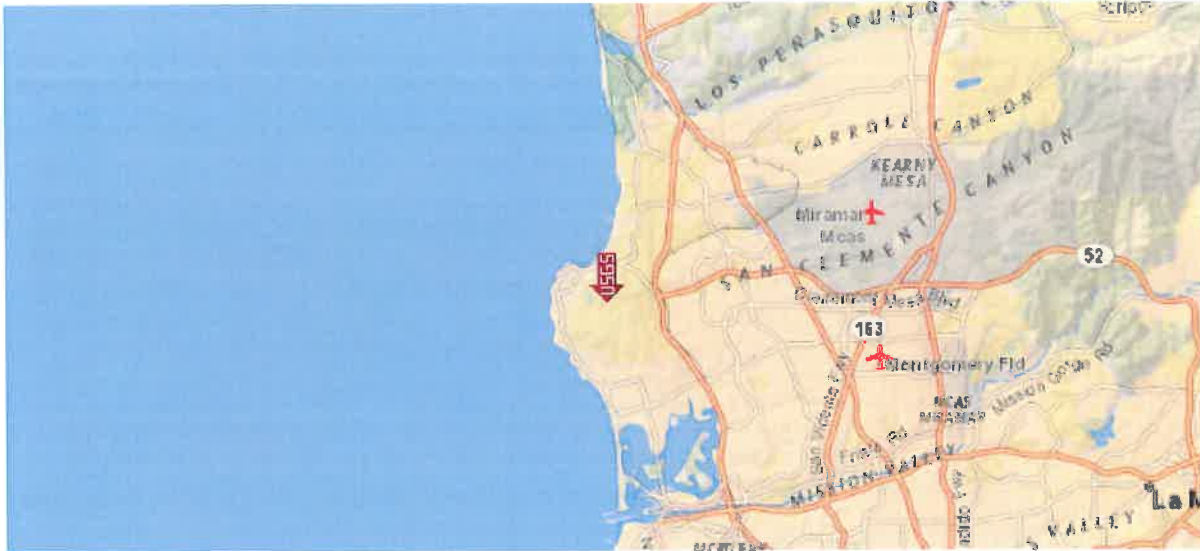
Site Soil Classification Site Class D – “Stiff Soil”

$S_s = 1.292 \text{ g}$	$S_{MS} = 1.292 \text{ g}$	$S_{DS} = 0.862 \text{ g}$
$S_1 = 0.500 \text{ g}$	$S_{M1} = 0.750 \text{ g}$	$S_{D1} = 0.500 \text{ g}$

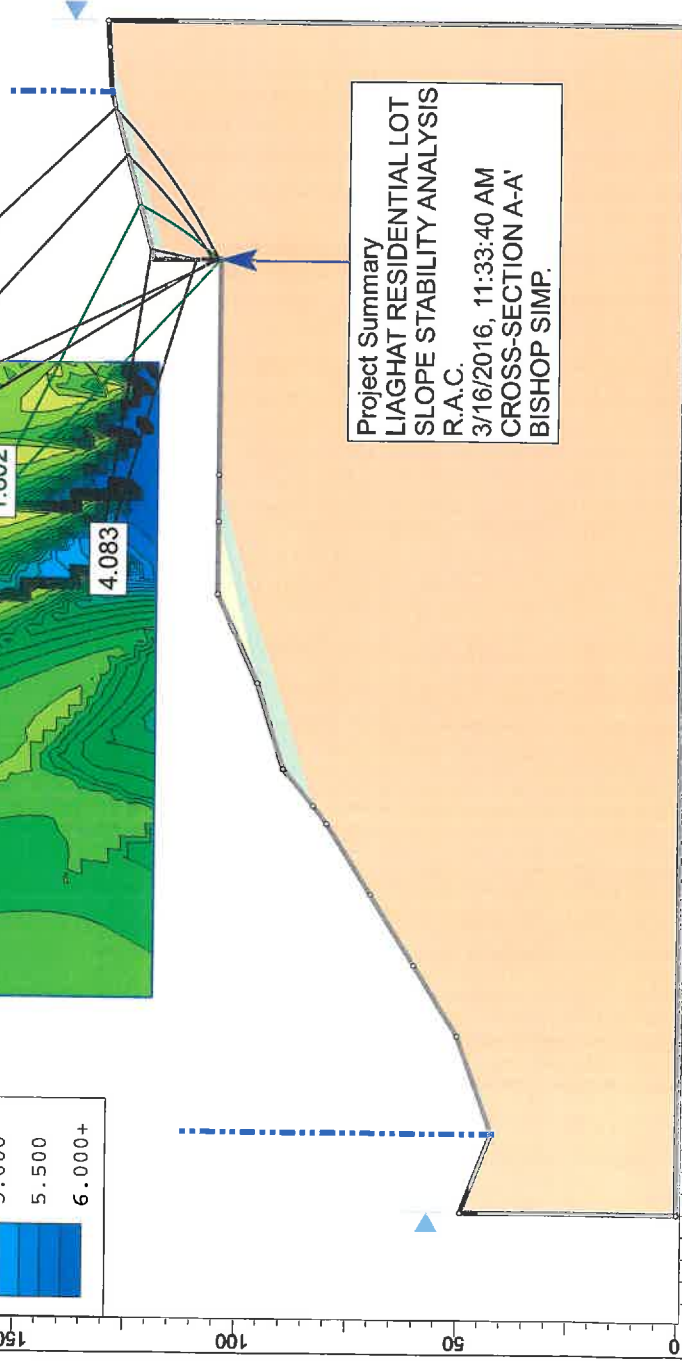
Analysis of the basement wall without
the effect of the wall under seismic
conditions.

Material Name	Color	Unit Weight (lbs/ft ³)	Strength Type	Cohesion (lb/ft ²)	Phi	Water Surface	Ru
FILL (Qaf)		120	Mohr-Coulomb	150	32	None	0
SLOPE WASH (Qsw)		120	Mohr-Coulomb	199	31	None	0
POINT LOMA FM. (Kp)		120	Mohr-Coulomb	691	45	None	0

Project		LIAGHAT RESIDENTIAL LOT	
Analysis Description		SLOPE STABILITY ANALYSIS	
Drawn By	R.A.C.	Scale	1:500
Date	3/16/2016, 11:33:40 AM	Company	
File Name		JOB NO. 16-11019A02w_0.15gSHAKE.slim

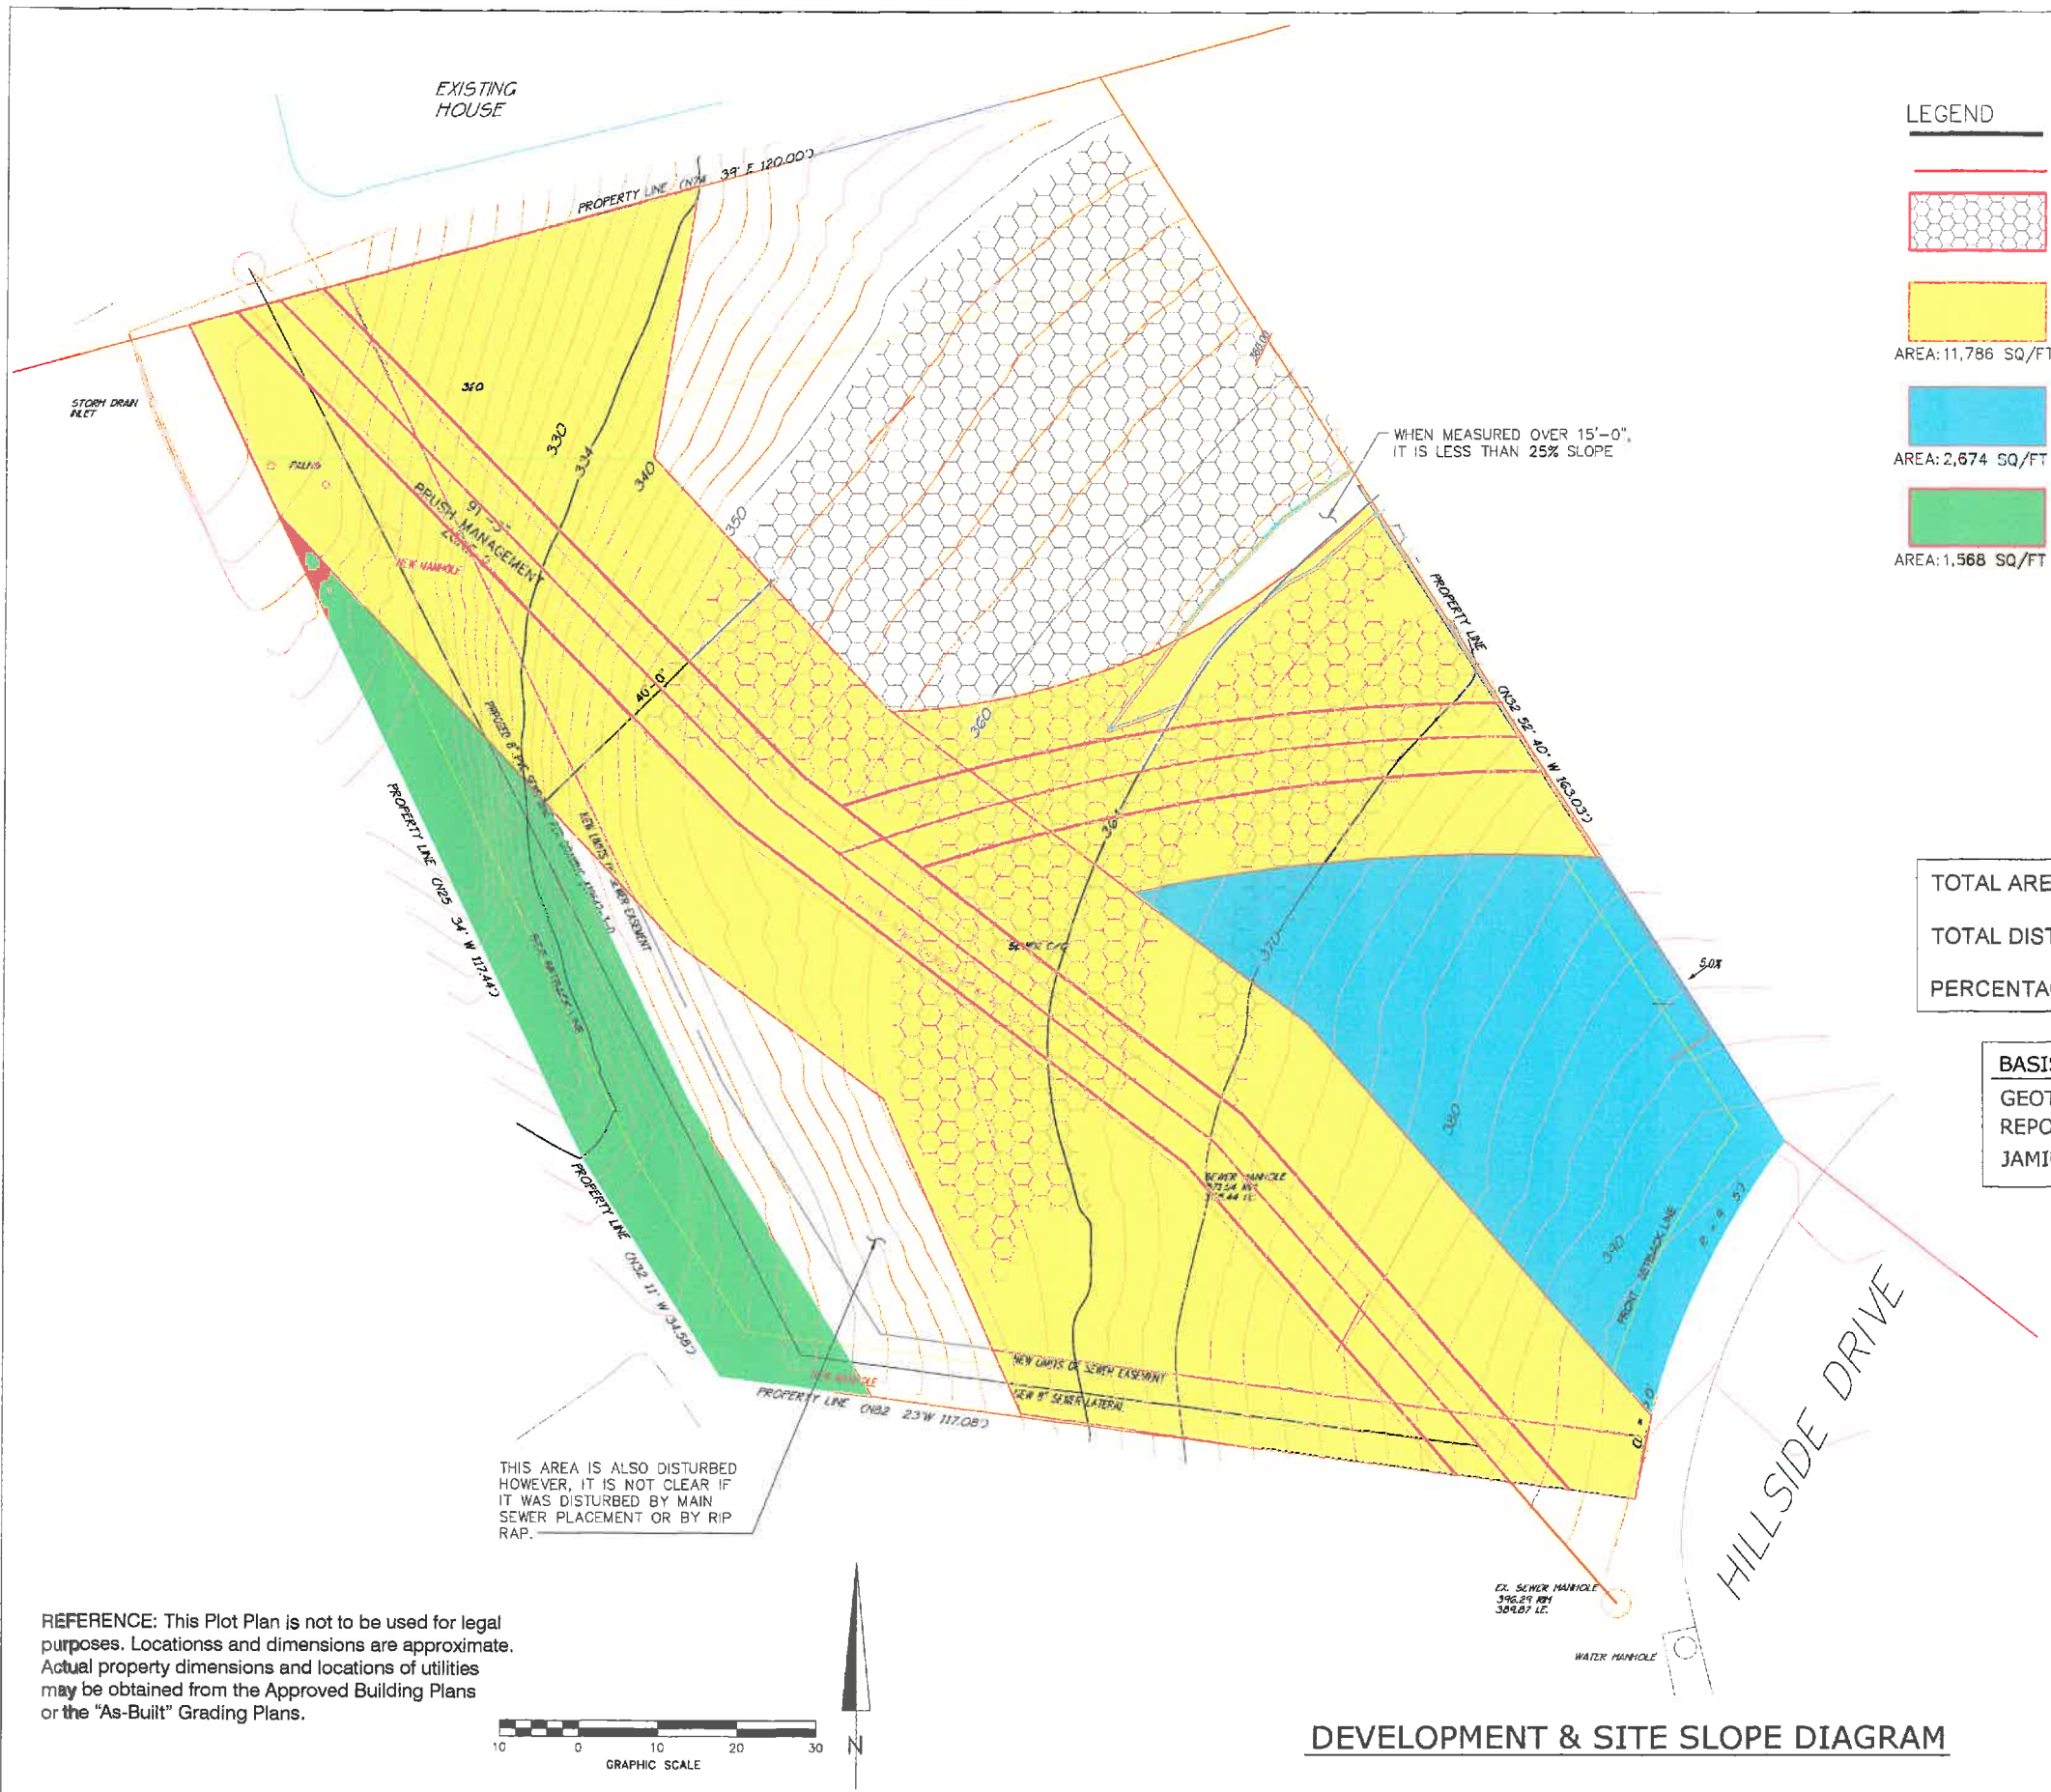
DEVELOPMENT & SITE SLOPE DIAGRAM

- LEGEND
- SEWER CENTERLINE
 - AREAS WITH LESS THAN 25% SLOPE
 - AREA IDENTIFIED TO BE DISTURBED BY SEWER MAIN AND SEWER LATERAL
AREA: 11,786 SQ/FT
 - AREA IDENTIFIED TO BE DISTURBED BY CONSTRUCTION OF HILLSIDE DRIVE
AREA: 2,674 SQ/FT
 - AREA IDENTIFIED TO BE DISTURBED BY PLACING OF RIP-RAP FOR NEIGHBORHOOD RUN-OFF DRAINAGE
AREA: 1,568 SQ/FT

TOTAL AREA OF PARCEL:	22,396 SQ/FT
TOTAL DISTURBED AREA:	16,028 SQ/FT
PERCENTAGE OF LOT DISTURBANCE:	0.715%

At the time of our recent site visits we observed potholes exposing disturbed soil in four specific areas, including, 1) at least a 40-foot-wide area over the existing sewer main that crosses the property from Hillside Drive to the northwest and 2) at least a 30-foot-wide area over the sewer lateral that crosses the middle of the property from east to west. 3) We also observed the physical conditions of

disturbance along the majority of the southern slope consisting of old concrete and broken brick walls and fill soils that were placed at the time Hillside Drive was constructed. The disturbed soil was observed from the edge of Hillside Drive to the north side of the sewer lateral at approximately contour elevation 360 feet MSL and 4) the lower slope adjacent to the west property line where rip rap has been placed for drainage runoff on the adjacent properties. In addition, we reviewed USDA stereo-pair aerial photographs, dated April 1953 and City of San Diego topographic and orthophotographic maps dated January 1963 and April 1979.
