**PRIORITY DEVELOPMENT PROJECT (PDP)
STORM WATER QUALITY MANAGEMENT
PLAN (SWQMP) FOR**

Project Name: Bodas Residence

PTS No. 551761

COFFEY ENGINEERING, INC.

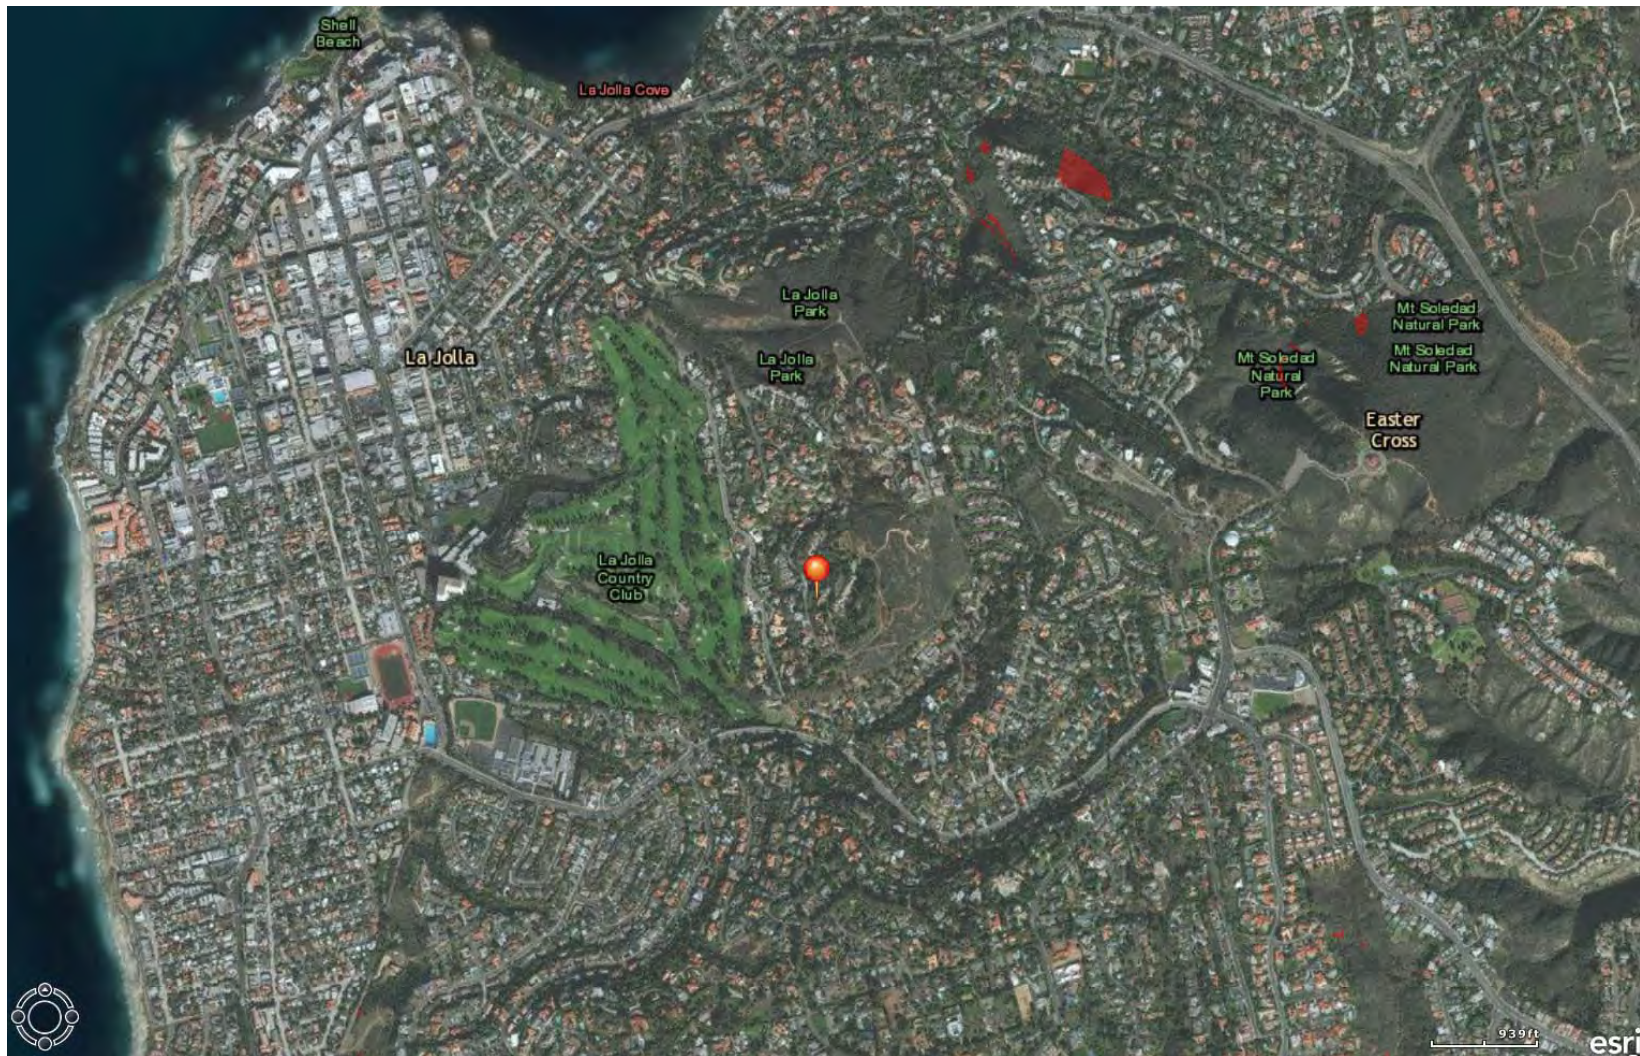
CRITICAL COURSE SEDIMENT YIELD AREAS – BODAS RESIDENCE

A (Drains to Biofiltration)
