Project No. G1815-11-01
June 6, 2016
Revised September 2, 2016

Subject: STORM WATER MANAGEMENT RECOMMENDATIONS
STRAUSS FIFTH AVENUE APARTMENTS
SAN DIEGO, CALIFORNIA

Reference: *Geotechnical Investigation, Strauss Fifth Avenue Apartments, San Diego, California,*
prepared by Geocon Incorporated, dated May 8, 2015 (Project No. G1815-11-01).

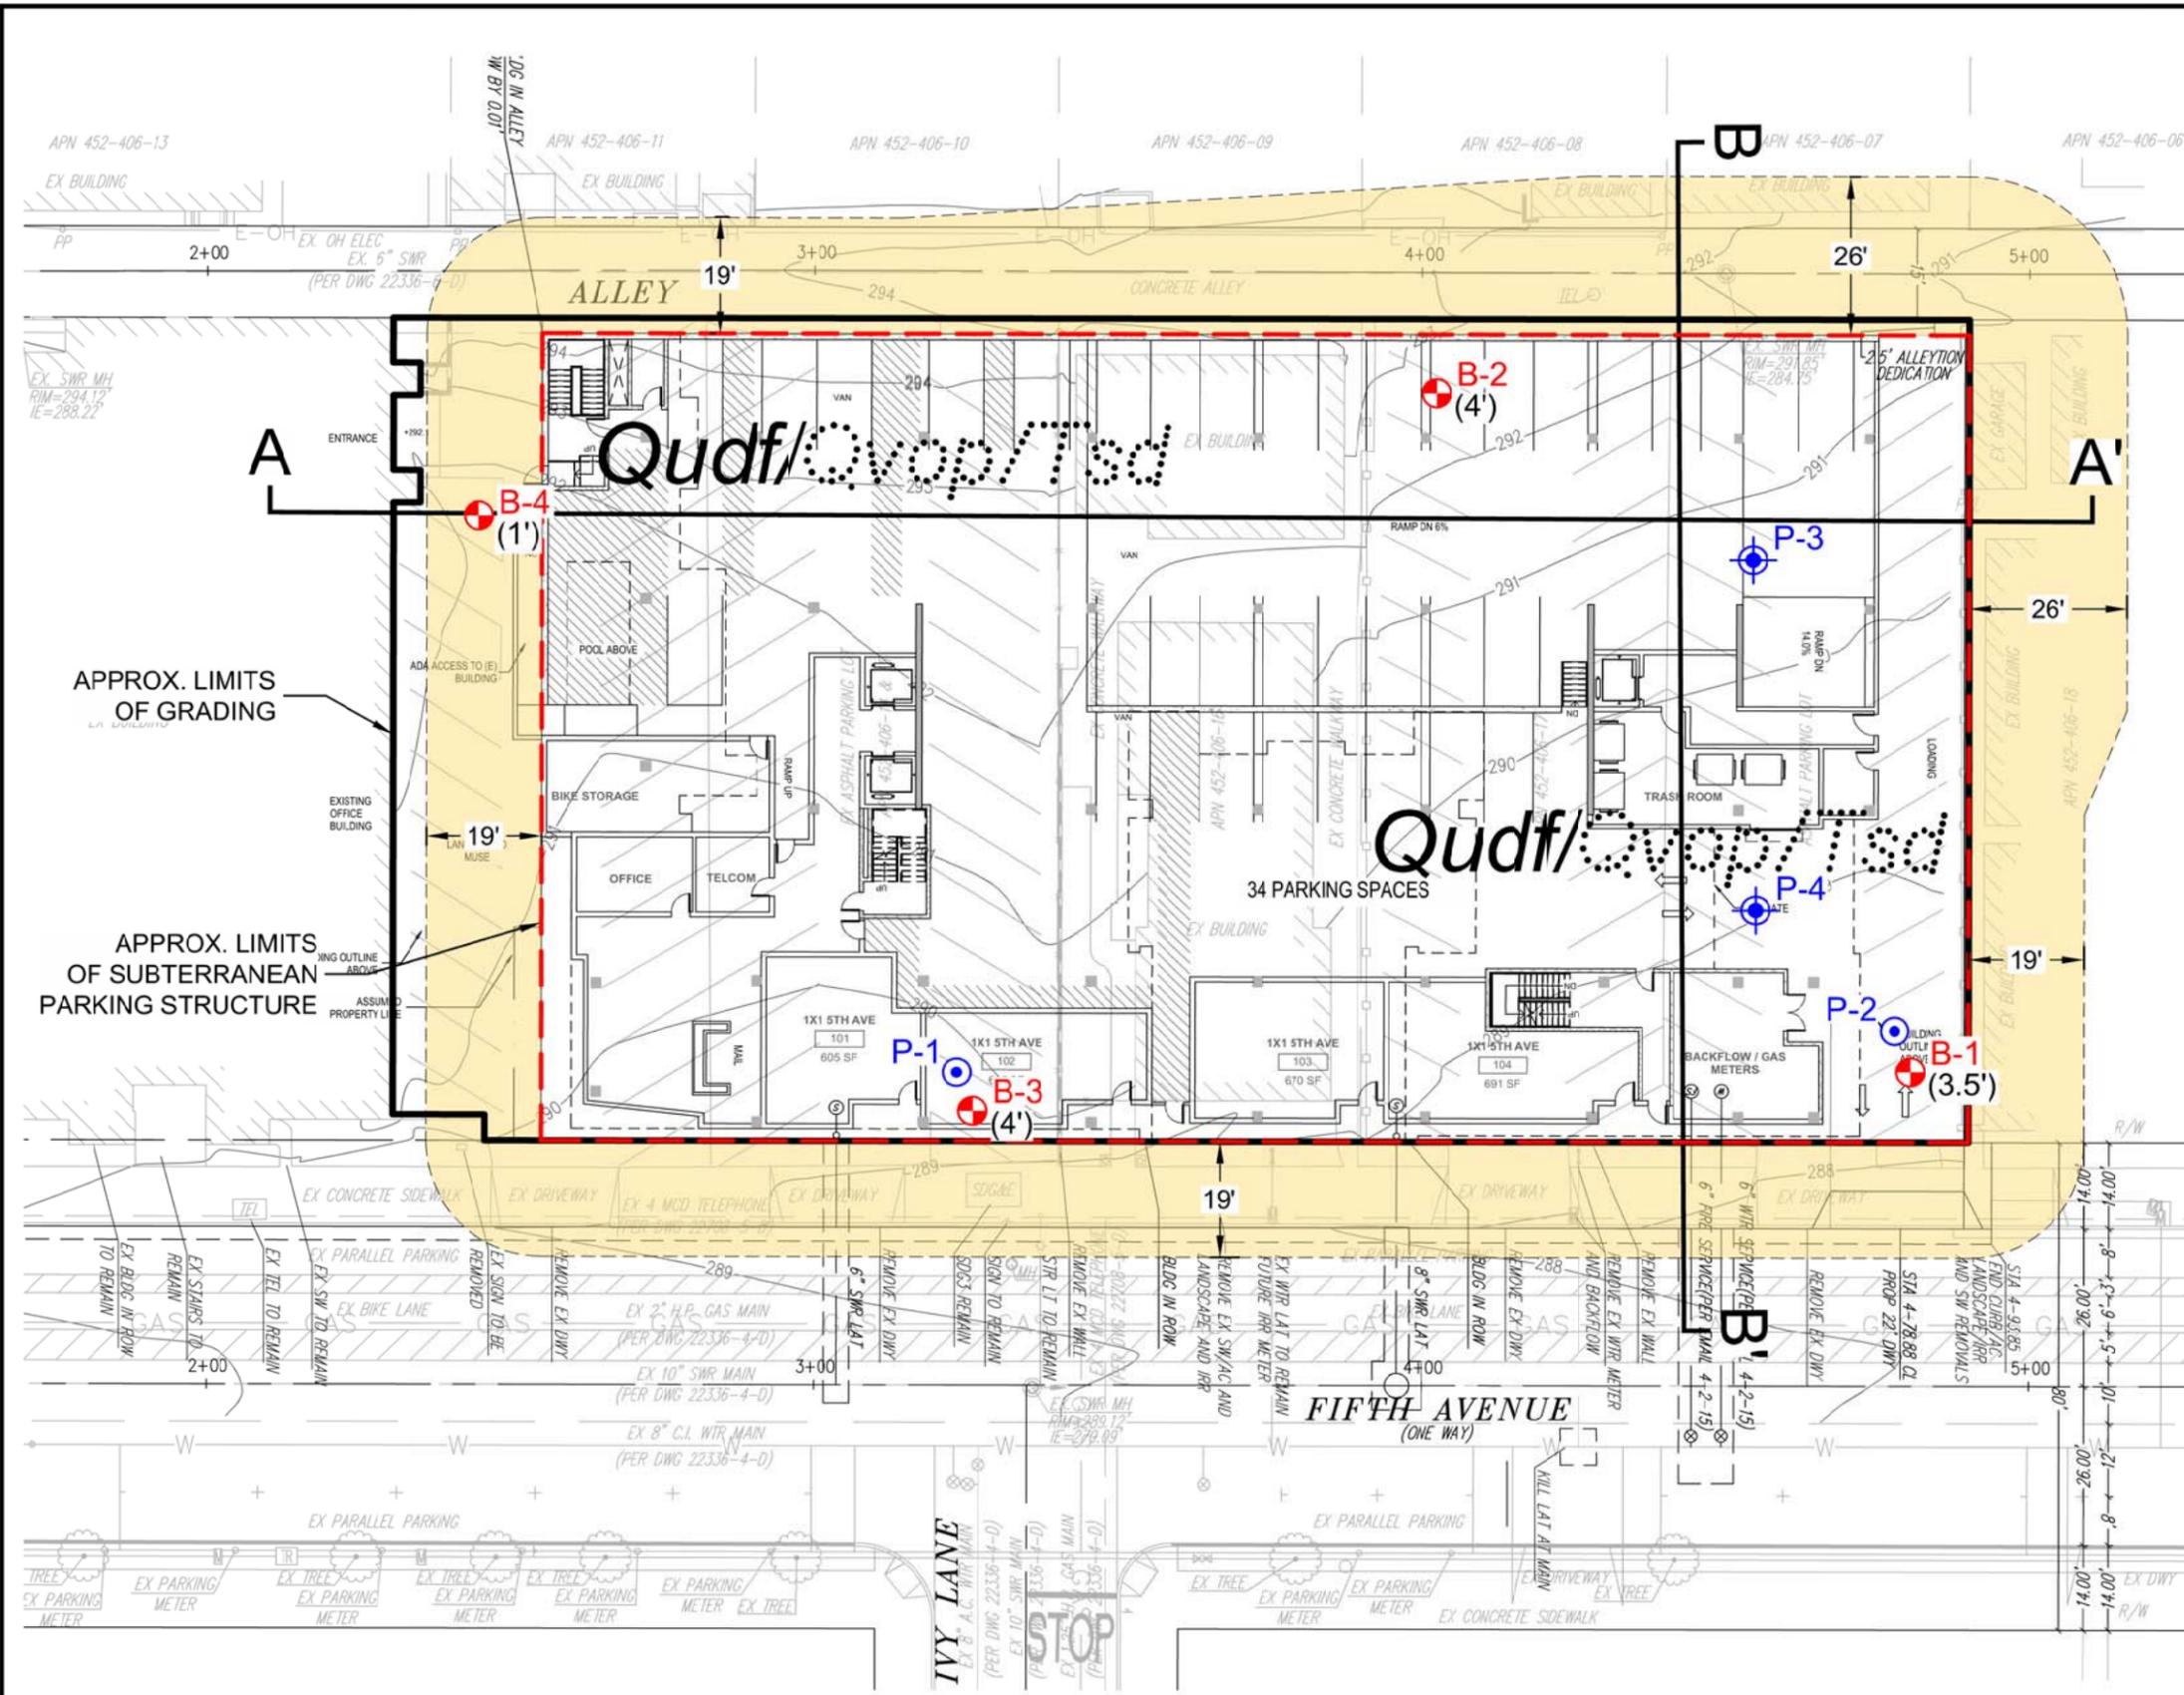
- Qudf** UNDOCUMENTED FILL
- Qvop** VERY OLD PARALIC DEPOSITS
(Dotted Where Buried)
- Tsd** SAN DIEGO FORMATION
(Dotted Where Buried)
- P-2** APPROX. LOCATION OF AARDVARKS PERMEATER TEST
- P-4** APPROX. LOCATION OF DEEP PERCOLATION TEST
- B-4** APPROX. LOCATION OF GEOTECHNICAL BORING
- (4')** APPROX. DEPTH TO BOTTOM OF UNDOCUMENTED FILL (Qudf) FROM EXISTING GRADE (In Feet)
- B-B'** APPROX. LOCATION OF GEOLOGIC CROSS SECTION
- [Yellow Shaded Area]** APPROX. AREA OF ACTIVE ZONE AT EXISTING GRADE ELEVATION

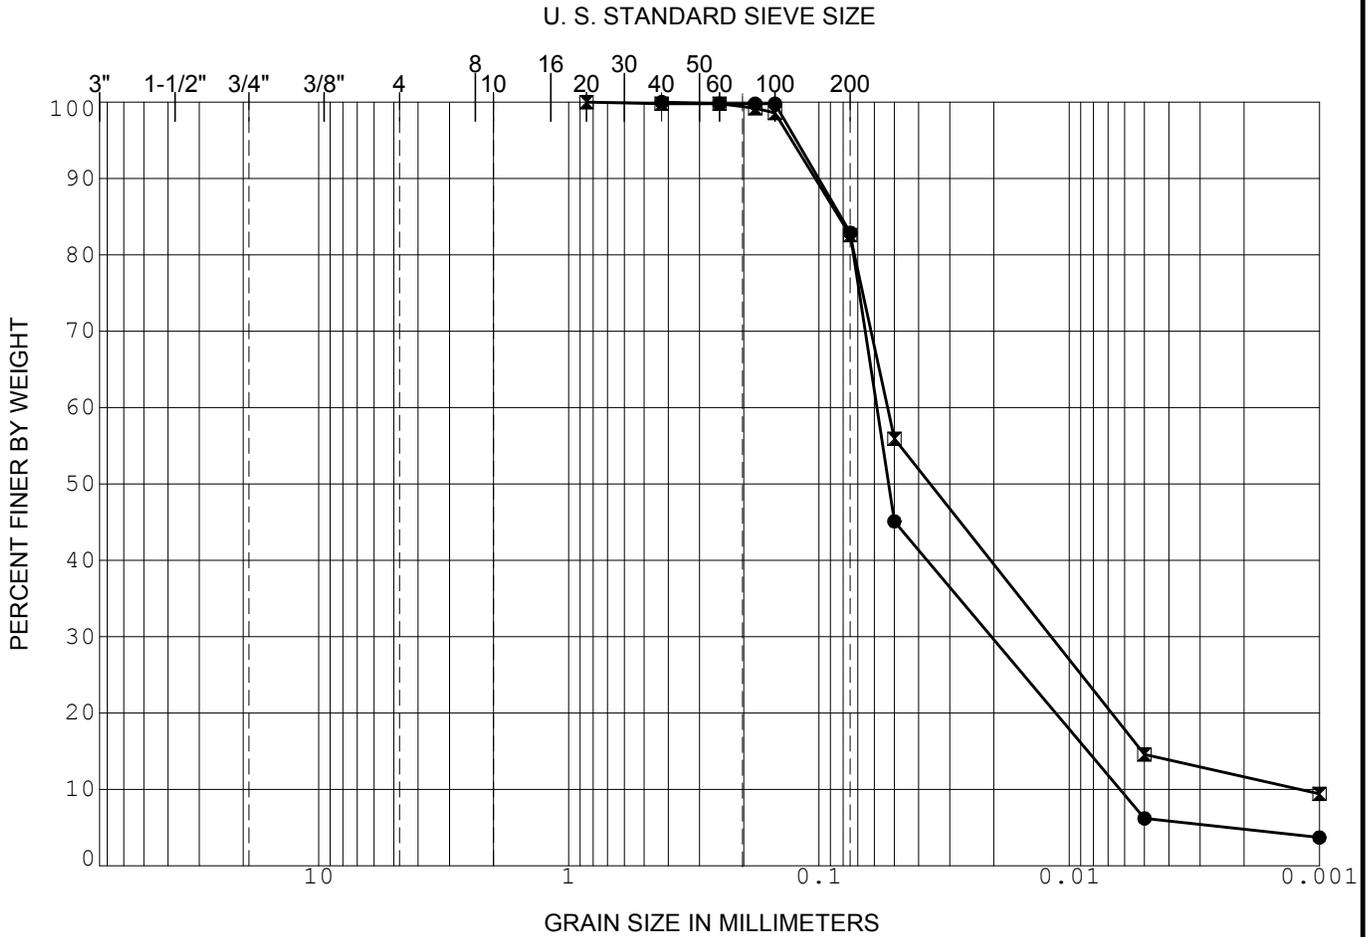
GRADATION CURVE

SAMPLE	DEPTH (ft)	CLASSIFICATION	NAT WC	LL	PL	PI
●	P3-2	55.0	(ML) Sandy SILT	12.6			
◻	P4-2	55.0	(ML) Sandy SILT	15.6			
▲

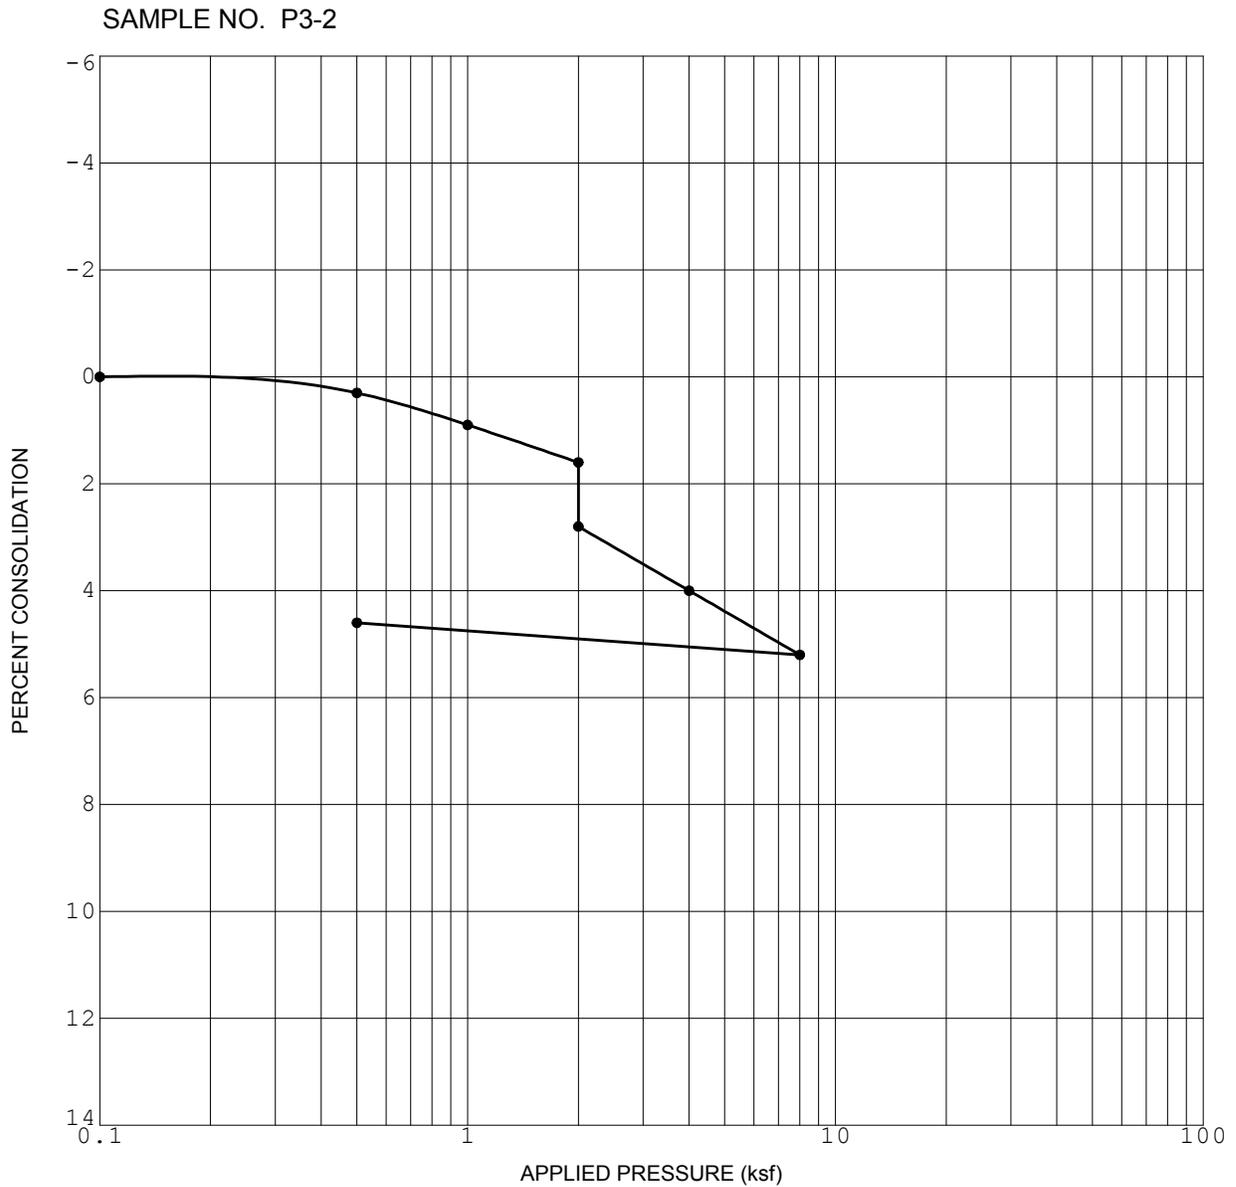
Initial Dry Density (pcf)	86.3
Initial Water Content (%)	12.6

Initial Saturation (%)	39.2
Sample Saturated at (ksf)	2.0

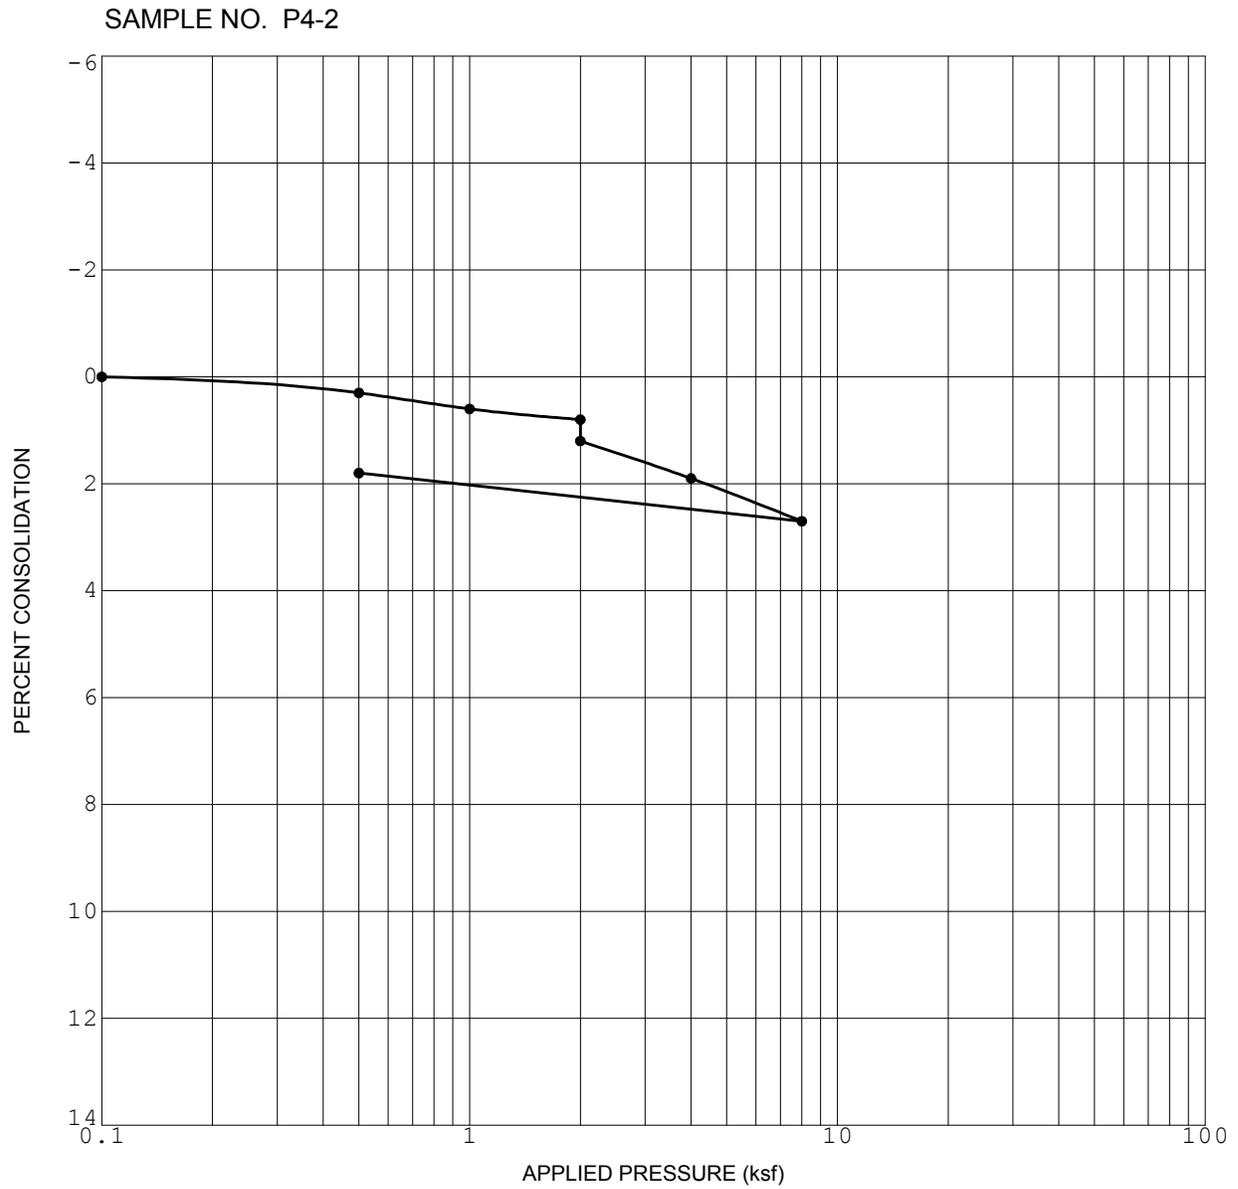
Initial Dry Density (pcf)	102.9
Initial Water Content (%)	15.6

Initial Saturation (%)	67.6
Sample Saturated at (ksf)	2.0

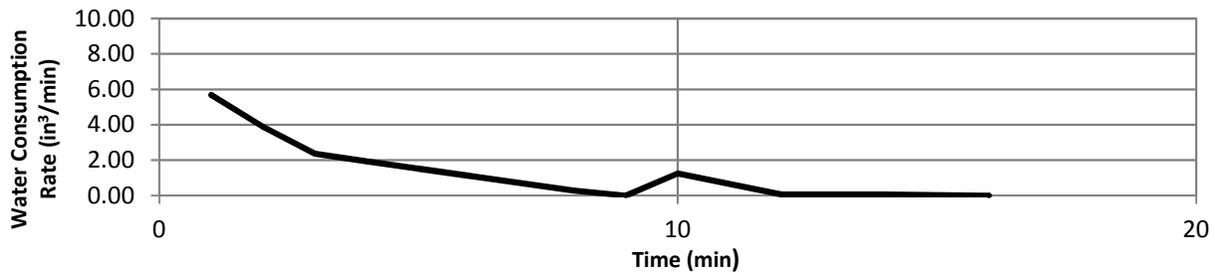
Borehole Diameter (inches): **8.00**
 Borehole Depth, H (feet): **6.92** Wetted Area, A (in²): **201.06**
 Distance Between Reservoir & Top of Borehole (feet): **2.50**
 Depth to Water Table, s (feet): **200**
 Height APM Raised from Bottom (inches): **2.00**
 Distance Between Reservoir and APM, D (feet): **8.65**
 Head Height, h (inches): **6.00**
 Distance Between Constant Head and Water Table, L (inches): **2323**

Reading	Time (min)	Time Elapsed (min)	Reservoir Water Weight (g)	Reservoir Water Weight (lbs)	Interval Water Consumption (lbs)	Total Water Consumption (lbs)	*Water Consumption Rate (in ³ /min)
1	0.00			13.350			
2	1.00	1.00		13.145	0.21	0.21	5.68
3	2.00	1.00		13.005	0.14	0.34	3.88
4	3.00	1.00		12.920	0.09	0.43	2.36
5	4.00	1.00		12.850	0.07	0.50	1.94
6	5.00	1.00		12.795	0.05	0.56	1.52
7	6.00	1.00		12.755	0.04	0.59	1.11
8	8.00	2.00		12.735	0.02	0.62	0.28
9	9.00	1.00		12.735	0.00	0.62	0.00
10	10.00	1.00		12.690	0.04	0.66	1.25
11	12.00	2.00		12.685	0.00	0.66	0.07
12	14.00	2.00		12.680	0.01	0.67	0.07
13	16.00	2.00		12.680	0.00	0.67	0.00
Steady Flow Rate, Q (in ³ /min):							0.07

Field-Saturated Hydraulic Conductivity

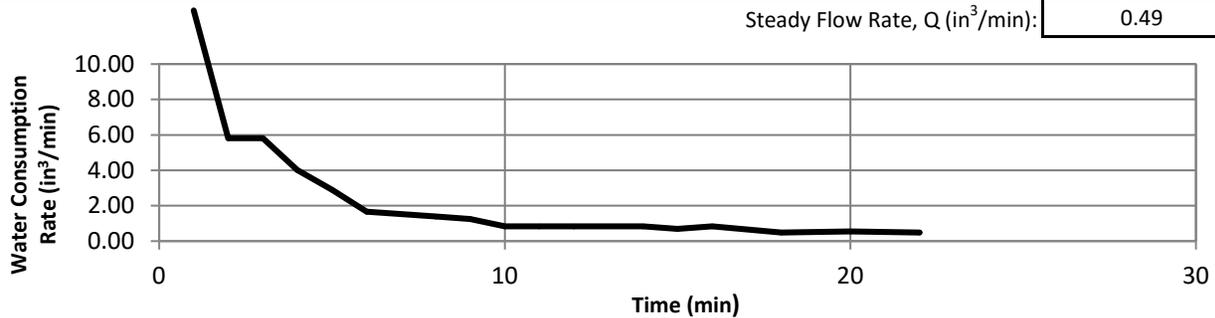
Project Name:	Strauss 5th Avenue	Date:	7/29/2016
Project Number:	G1815-11-1	By:	JML
Borehole Location:	P-2	Ref. EL (feet, MSL):	
		Bottom EL (feet, MSL):	
Borehole Diameter (inches):	8.00	Wetted Area, A (in ²):	201.06
Borehole Depth, H (feet):	5.00		
Distance Between Reservoir & Top of Borehole (feet):	2.50		
Depth to Water Table, s (feet):	200		
Height APM Raised from Bottom (inches):	2.00		
		Distance Between Reservoir and APM, D (feet):	6.73
		Head Height, h (inches):	6.00
		Distance Between Constant Head and Water Table, L (inches):	2346

Reading	Time (min)	Time Elapsed (min)	Reservoir Water Weight (g)	Reservoir Water Weight (lbs)	Interval Water Consumption (lbs)	Total Water Consumption (lbs)	*Water Consumption Rate (in ³ /min)
1	0.00			21.760			
2	1.00	1.00		21.290	0.47	0.47	13.03
3	2.00	1.00		21.080	0.21	0.68	5.82
4	3.00	1.00		20.870	0.21	0.89	5.82
5	4.00	1.00		20.725	0.15	1.04	4.02
6	5.00	1.00		20.620	0.11	1.14	2.91
7	6.00	1.00		20.560	0.06	1.20	1.66
8	8.00	2.00		20.460	0.10	1.30	1.39
9	9.00	1.00		20.415	0.05	1.35	1.25
10	10.00	1.00		20.385	0.03	1.38	0.83
11	11.00	1.00		20.355	0.03	1.41	0.83
12	12.00	1.00		20.325	0.03	1.44	0.83
13	14.00	2.00		20.265	0.06	1.50	0.83
14	15.00	1.00		20.240	0.03	1.52	0.69
15	16.00	1.00		20.210	0.03	1.55	0.83
16	18.00	2.00		20.175	0.04	1.59	0.49
17	20.00	2.00		20.135	0.04	1.63	0.55
18	22.00	2.00		20.100	0.04	1.66	0.49
19							
20							
21							
22							
23							
24							
25							
Steady Flow Rate, Q (in ³ /min):							0.49

Field-Saturated Hydraulic Conductivity

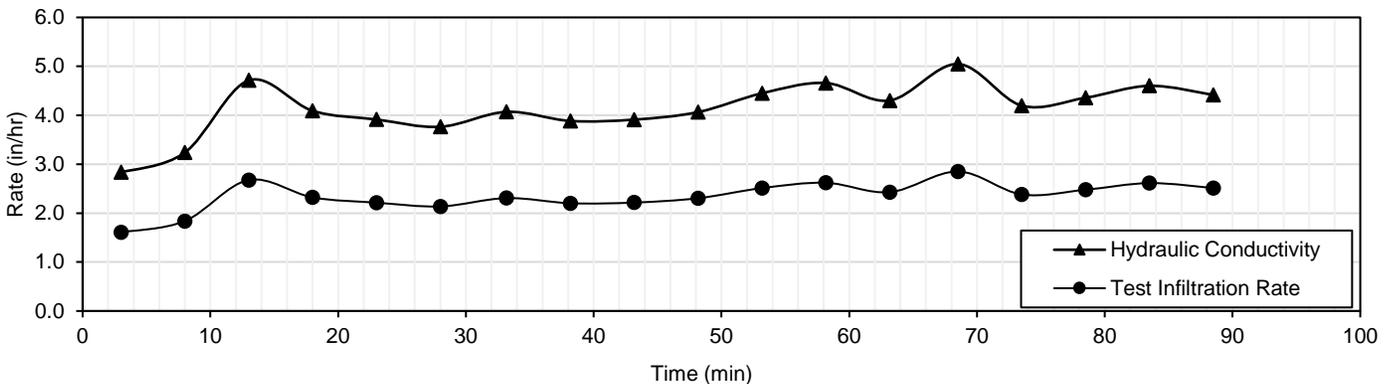
Set	Depth, D (ft)	Head, H (ft)	Dt (min)	Cumulative Time, t_{total} (min)	DH (ft)	Dvolume (ft ³)	Wetted Area, A_{wet} (ft ²)	Flow Rate, Q (ft ³ /hr)	Hydraulic Conductivity, K (in/hr)	Infiltration Rate, I_t (in/hr)
1	52.20 53.78	12.80 11.22	3.00	3.00	1.58	0.19	28.73	3.86	2.83	1.61
2	51.78 54.72	13.22 10.28	5.00	8.00	2.94	0.36	28.12	4.31	3.24	1.84
3	52.04 56.04	12.96 8.96	5.00	13.00	4.00	0.49	26.26	5.86	4.71	2.68
4	51.82 55.42	13.18 9.58	5.00	18.00	3.60	0.44	27.25	5.27	4.09	2.32
5	51.26 54.86	13.74 10.14	5.00	23.00	3.60	0.44	28.57	5.27	3.91	2.21
6	51.86 55.20	13.14 9.80	5.00	28.00	3.34	0.41	27.46	4.89	3.76	2.14
7	51.62 55.36	13.38 9.64	5.17	33.17	3.74	0.46	27.55	5.30	4.07	2.31
8	51.66 55.14	13.34 9.86	5.00	38.17	3.48	0.42	27.77	5.10	3.88	2.20
9	51.50 55.04	13.50 9.96	5.00	43.17	3.54	0.43	28.07	5.18	3.91	2.22
10	51.66 55.28	13.34 9.72	5.00	48.17	3.62	0.44	27.60	5.30	4.06	2.30
11	50.96 55.06	14.04 9.94	5.00	53.17	4.10	0.50	28.68	6.00	4.45	2.51

Hydraulic Conductivity, K (in/hr) = $1.15 * r_{eq} \frac{\log(h_0 + \frac{1}{2}r_{eq}) - \log(h_t + \frac{1}{2}r_{eq})}{t - t_0}$ = **4.42**

Test Infiltration Rate, I_t (in/hr) = $\frac{Q}{A_{wet}} = \frac{DH Pr_{eq}^2 60}{Dt (Pr_{eq}^2 + 2 Pr_{eq} H_{avg})}$ = **2.51**

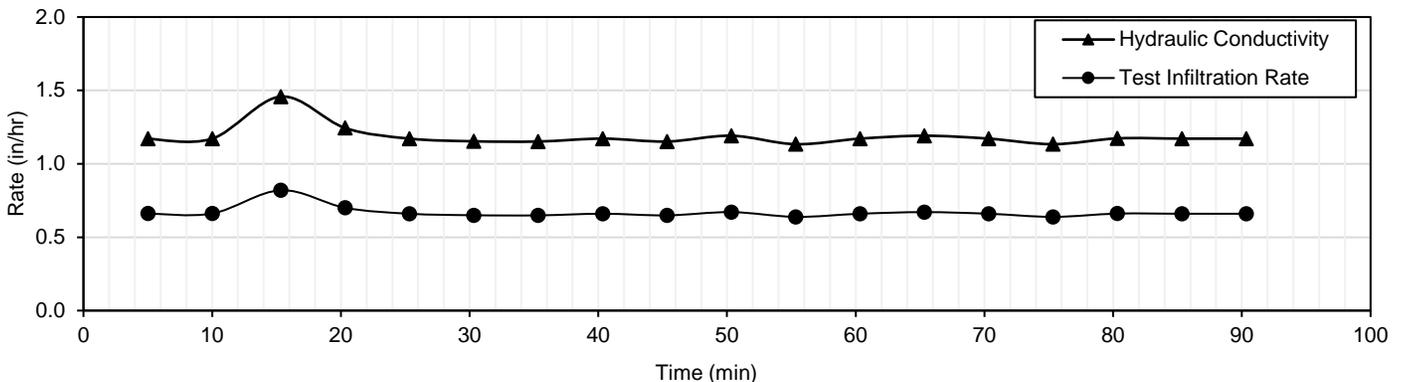
Set	Depth, D (ft)	Head, H (ft)	Dt (min)	Cumulative Time, t_{total} (min)	DH (ft)	Dvolume (ft ³)	Wetted Area, A_{wet} (ft ²)	Flow Rate, Q (ft ³ /hr)	Hydraulic Conductivity, K (in/hr)	Infiltration Rate, I_t (in/hr)
1	51.29	13.71	5.00	5.00	1.18	0.14	31.36	1.73	1.17	0.66

Hydraulic Conductivity, K (in/hr) = $1.15 * r_{eq} \frac{\log(h_o + \frac{1}{2}r_{eq}) - \log(h_t + \frac{1}{2}r_{eq})}{t - t_o}$ = 1.17

Test Infiltration Rate, I_t (in/hr) = $\frac{Q}{A_{wet}} = \frac{DH Pr_{eq}^2 60}{Dt(Pr_{eq}^2 + 2 Pr_{eq} H_{avg})}$ = 0.66
