**Subject: Geotechnical Investigation
Legacy International Center
Mission Valley Campus
875 Hotel Circle South
San Diego, California**

This report presents the results of our geotechnical engineering investigation and recommendations for design and construction of the proposed Legacy International Center, located at 875 Hotel Circle South, Mission Valley, San Diego, California.

**GEOTECHNICAL INVESTIGATION
LEGACY INTERNATIONAL CENTER
MISSION VALLEY CAMPUS
875 HOTEL CIRCLE SOUTH
SAN DIEGO, CALIFORNIA
KLF PROJECT NO. 20163965.001A**

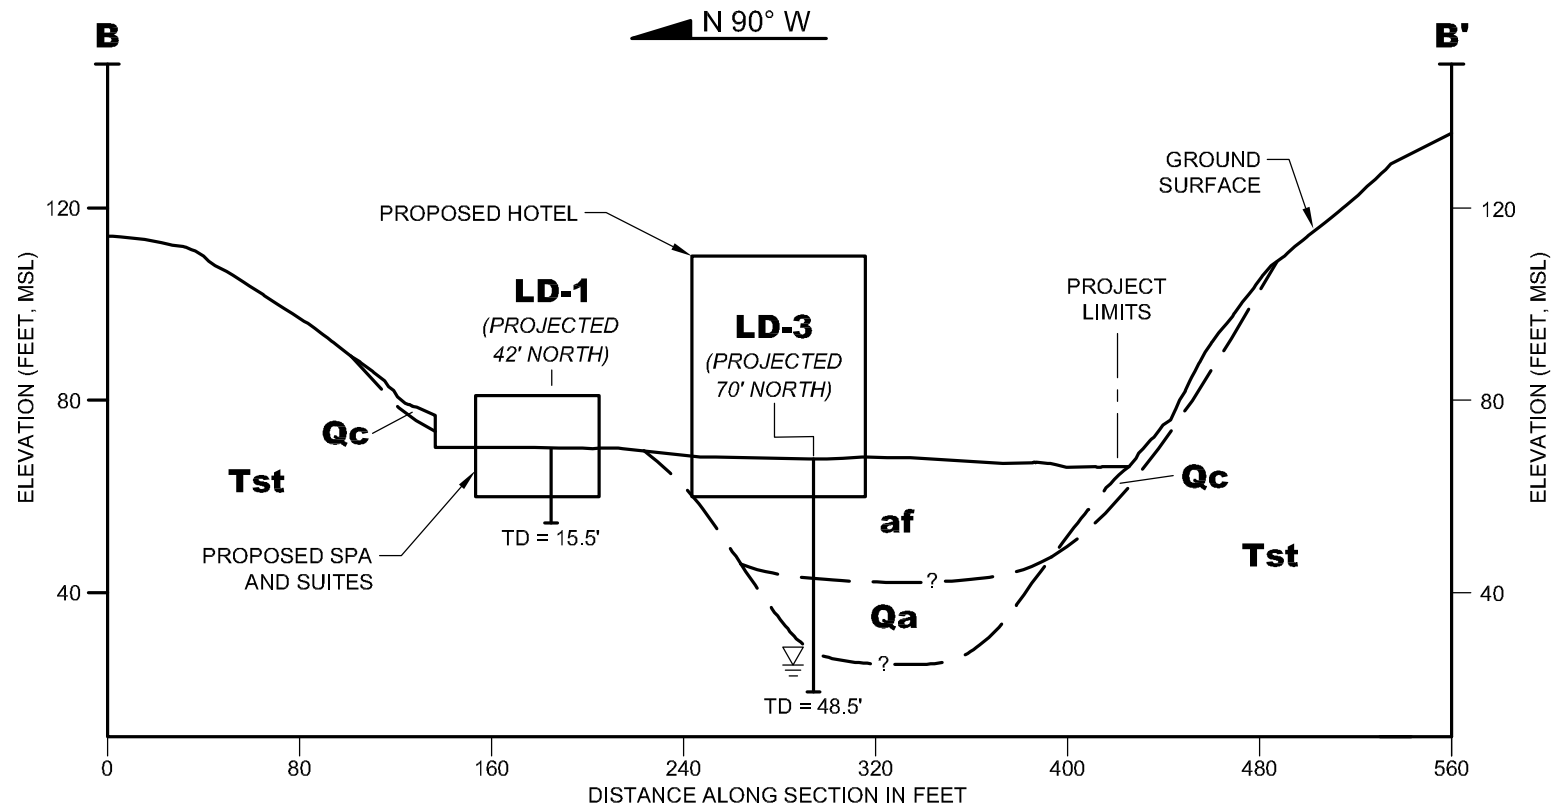
GEOLOGIC CROSS-SECTION B-B'

B-9
TD = 34' | APPROXIMATE LOCATION OF BORING, CPT, OR TEST PIT SHOWING PROJECTION AND TOTAL DEPTH IN FEET |

| | GROUNDWATER ENCOUNTERED AT TIME OF DRILLING |

The areal extent of these geologic units is depicted on Figure 3. Descriptions of these units are provided in the Borehole Logs (Appendix C), and generalized descriptions are provided in the subsequent sections below. The subsurface geologic conditions are depicted on the geologic cross-sections on Figures 6 through 10.

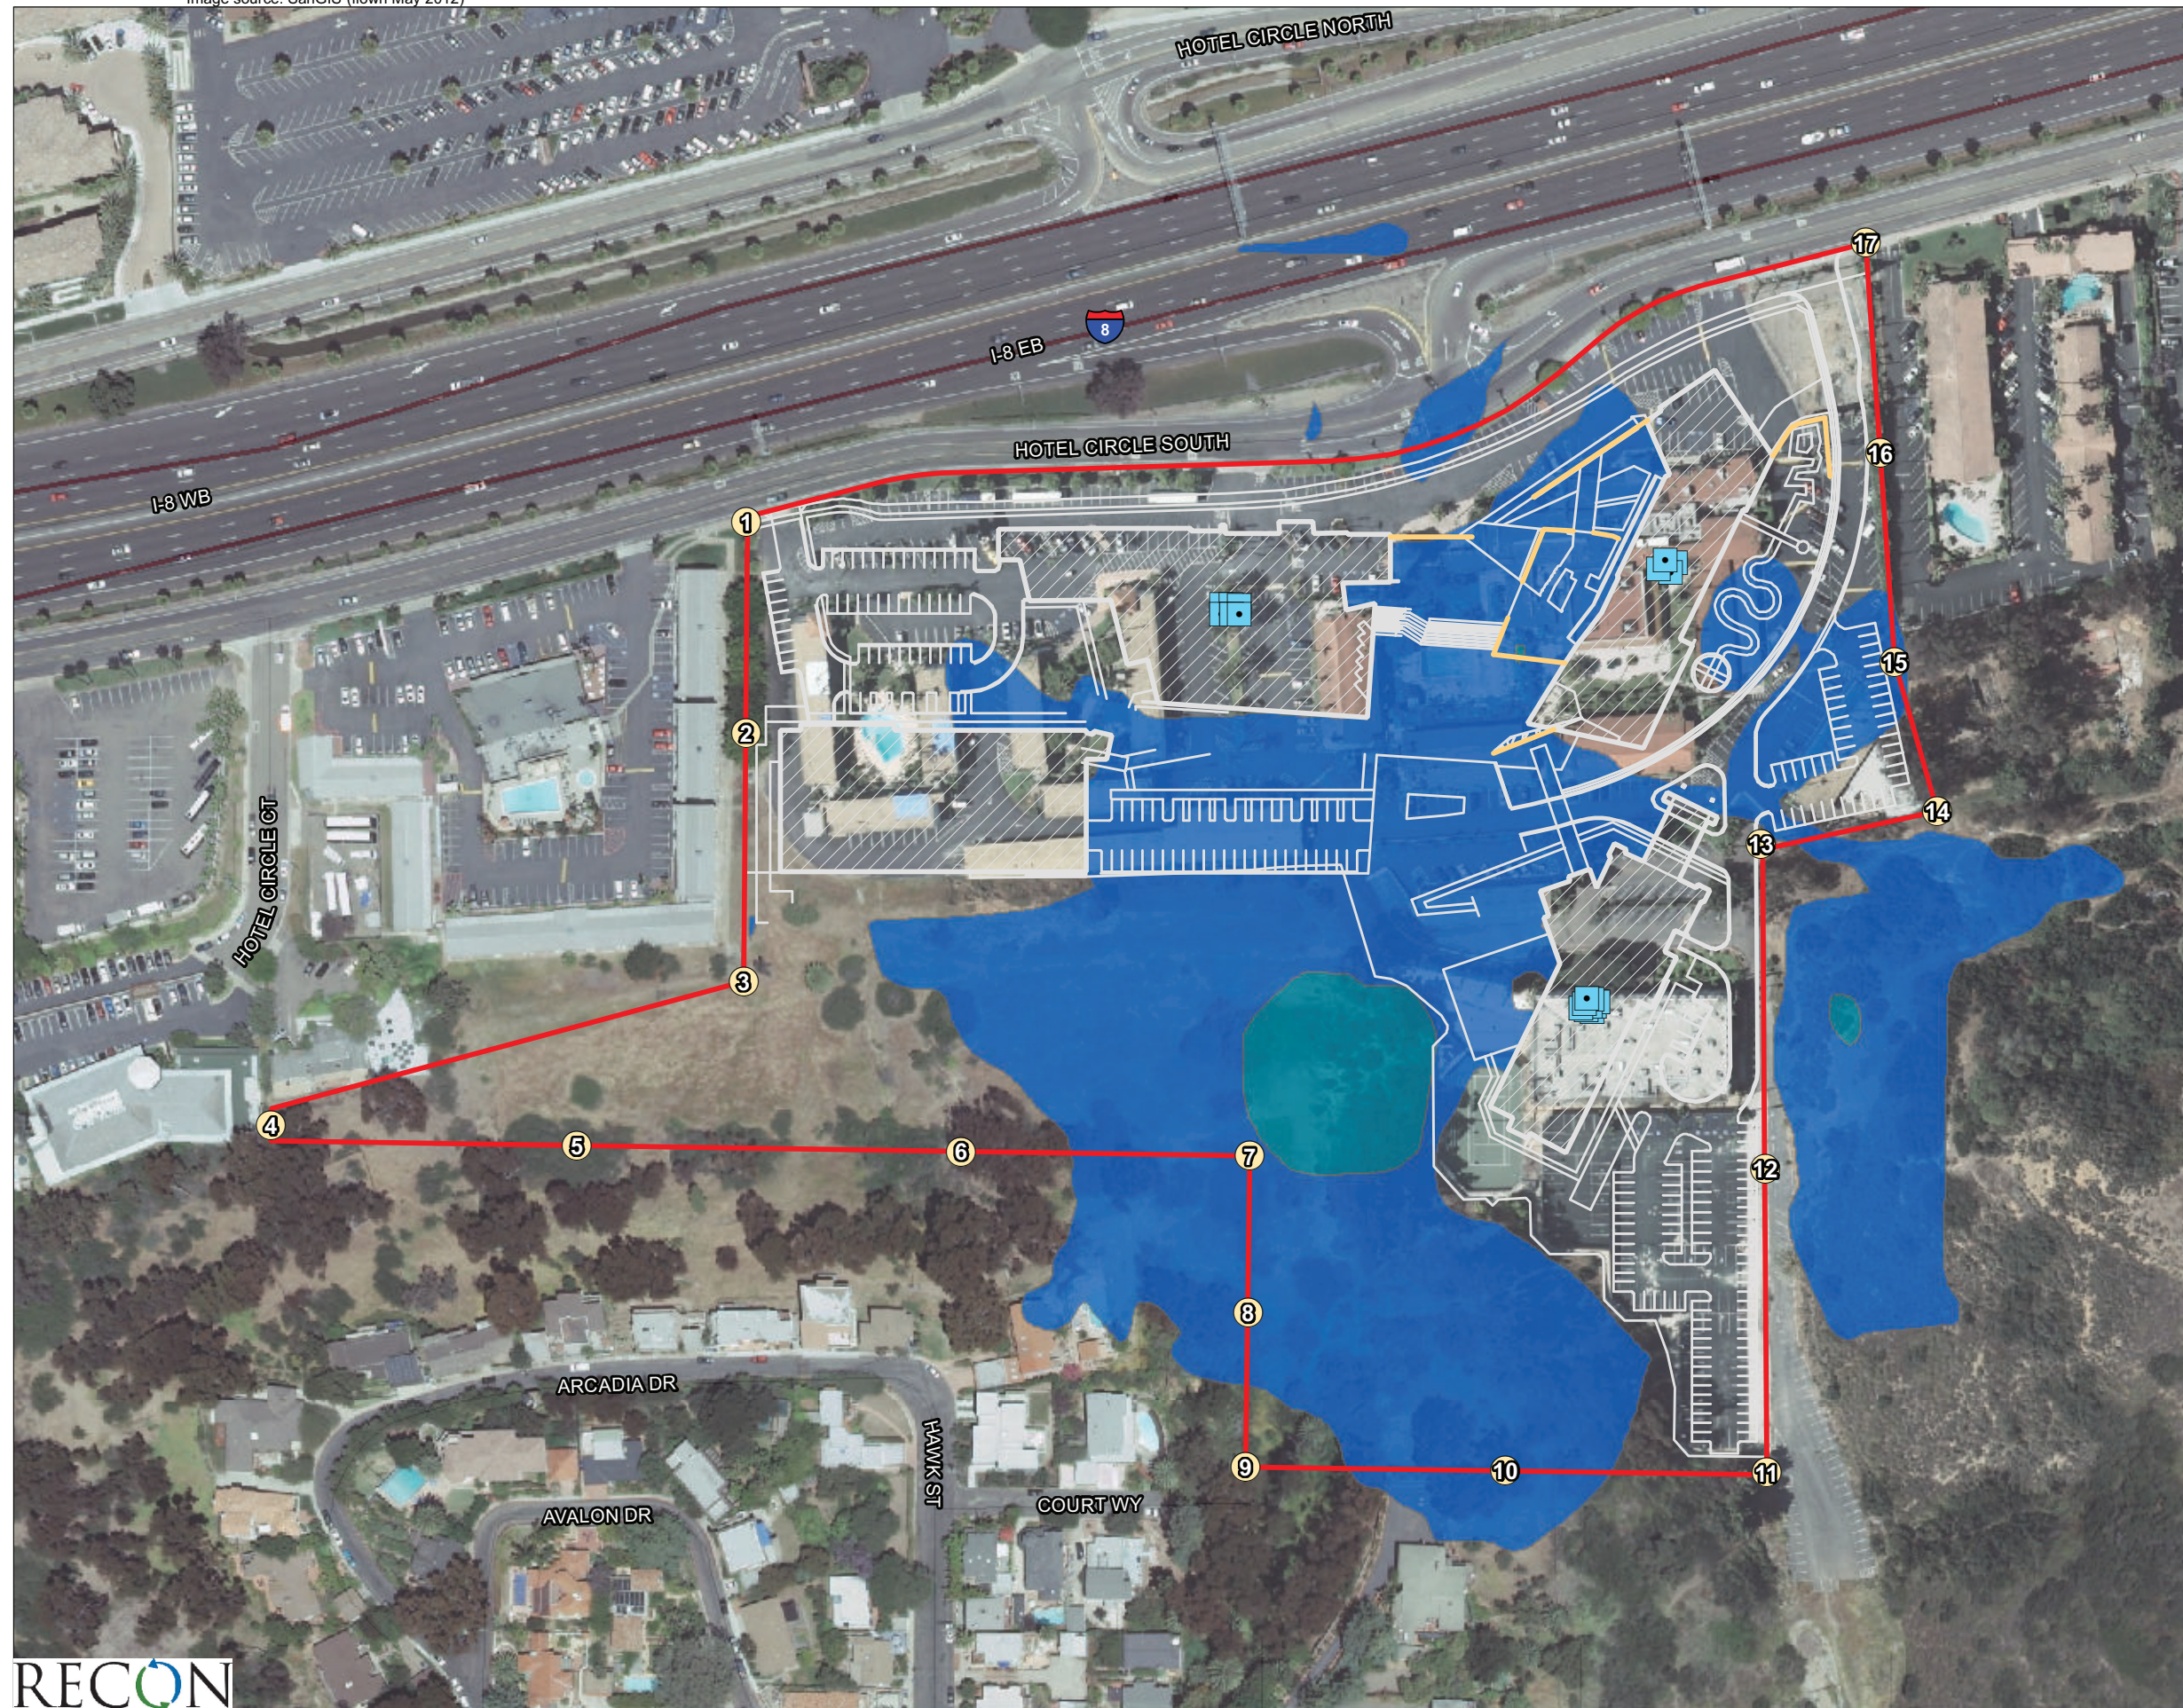
FIGURE 5
Daytime HVAC Noise Contours

- Project Boundary
- Property Line Receivers
- Planned HVAC
- Project Walls
- Plan Lines
- Noise Level dB(A)**
- 45-50
- 50-55

located along the project property line to determine noise levels at the property boundaries. Receiver and source locations are shown in Figure 5.

As shown in Table 7, maximum hourly noise levels at the property line due to the HVAC units are projected to be less than the property line noise limits. However, as the specific design has not been chosen at this stage, the project has been conditioned to provide specifications for the selection and placement of rooftop HVAC prior to issuance of building permits. Mitigation measure NM-1 establishes a requirement for further noise analysis.

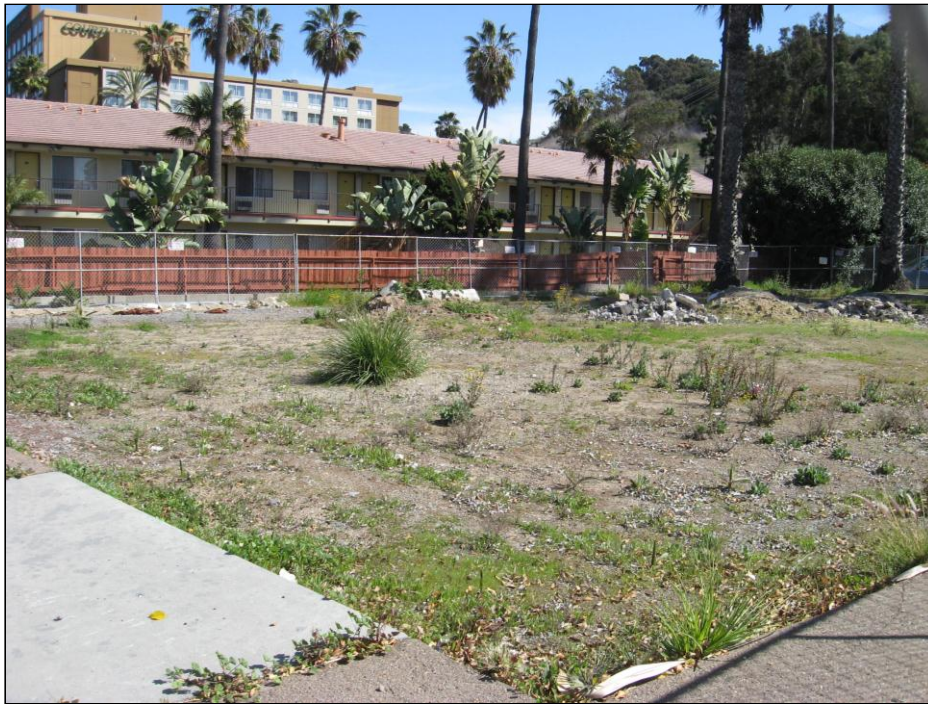
Photograph #5
Former fuel station on northeast corner of the Site. The Vagabond Inn is visible in background.

- **North** – The Site is bordered to the north by Hotel Circle South followed by Interstate 8 (Photograph Nos. 31 and 32).
- **West** – The Site is bordered to the west by the Travelodge hotel (Photograph No. 33).
- **South** – An undeveloped slope is adjacent to the south of the Site (Photograph Nos. 34 and 35) followed by single-family residences (Photograph No. 36).
- **East** – The Vagabond Inn is adjacent to the east of the Site (Photograph No. 5).

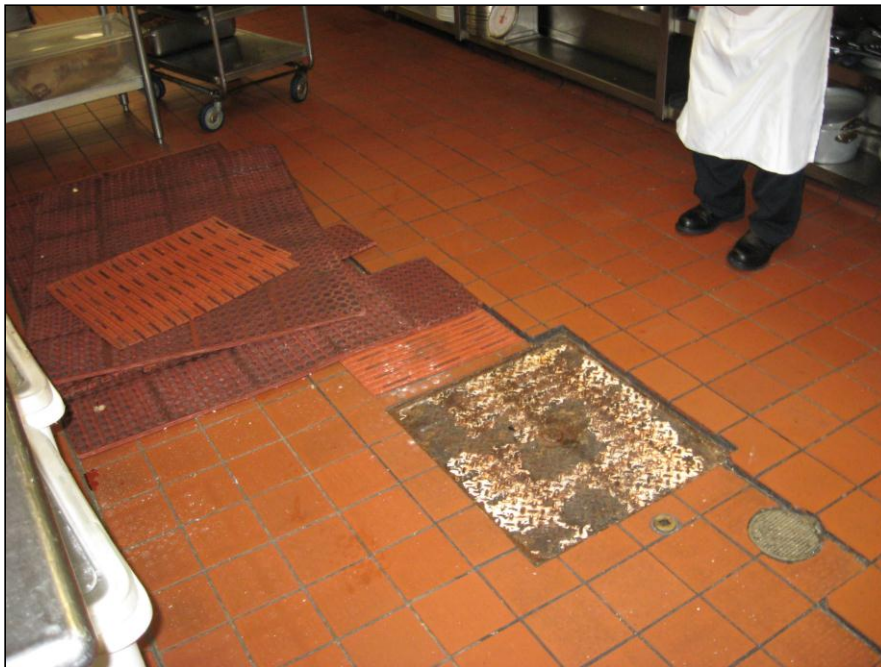
Photograph #8
Grease trap in restaurant kitchen.

Building 1 contains a check-in desk, office spaces, a family restaurant and bar, a convenience store, and guest rooms. Two 90-gallon grease traps related to the restaurant are located below the floor in the kitchen (Photograph No. 8). Mr. Biggs indicated the traps are emptied and cleaned monthly. Natural gas piping was observed entering the east side of Building 1 (Photograph No. 9). An electrical service panel was located south of Building 4 (Photograph No. 10). Storm drain inlets were observed on the southeast and northwest portions of the Site (Photograph No. 11).

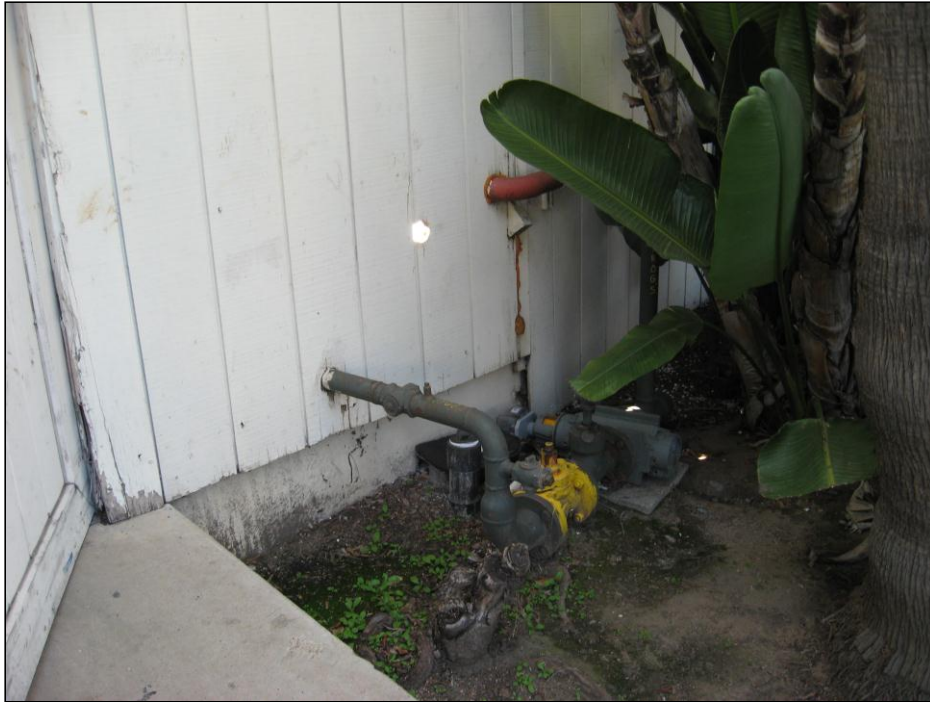
Photograph #9
Natural gas supply at Building 1.

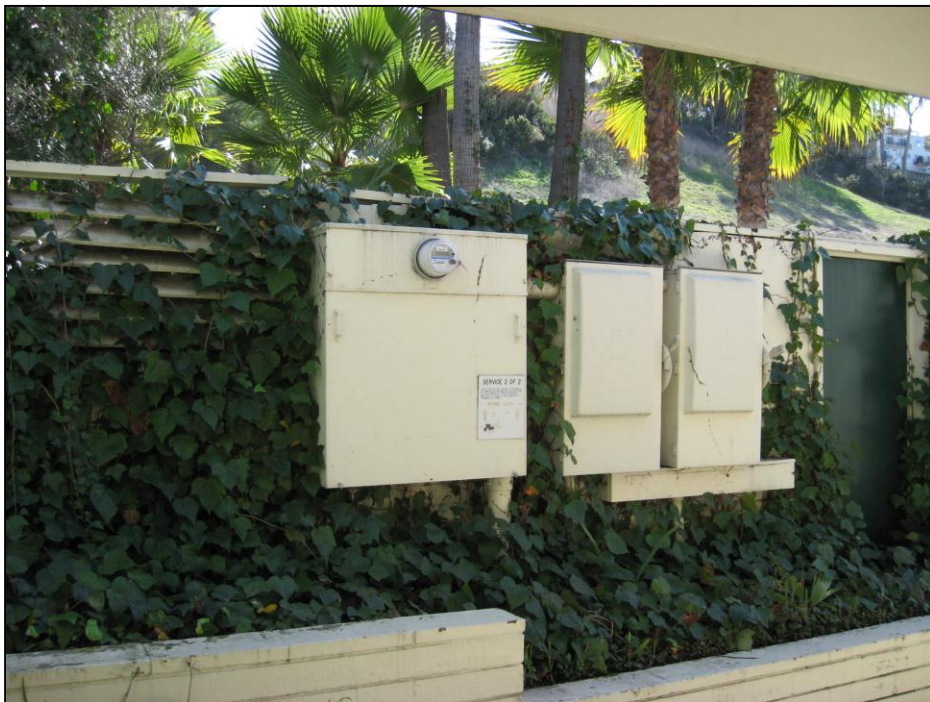
Photograph #10
Electrical Panel south of Building 4.

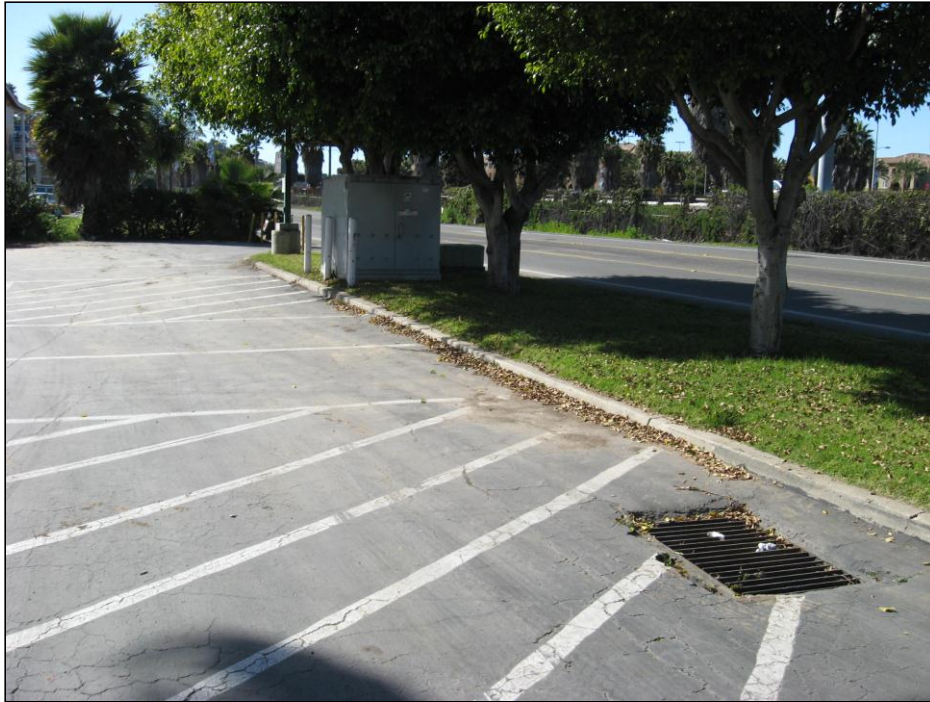
Photograph #11
Storm Drain inlet and pad mounted transformer on northwest corner of the Site.

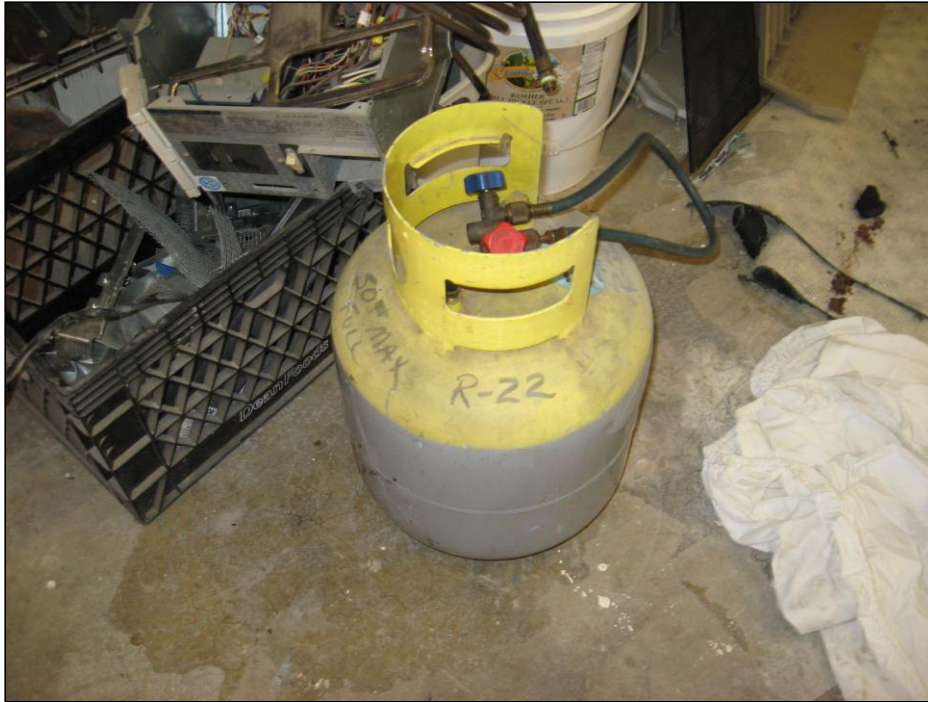
Photograph #17
50-pound bottle of R-22 refrigerant for air conditioner servicing.

Buildings 2 through 8 are used for guest accommodations (Photographs 12 and 13) and a storage building is located southeast of Building 5. Items observed in the area of the storage building include televisions, drywall, furniture, toilets, cans of paint, and a 50-pound tank of R-22 refrigerant used for servicing guest room air conditioning units (Photograph Nos. 14 through 17).

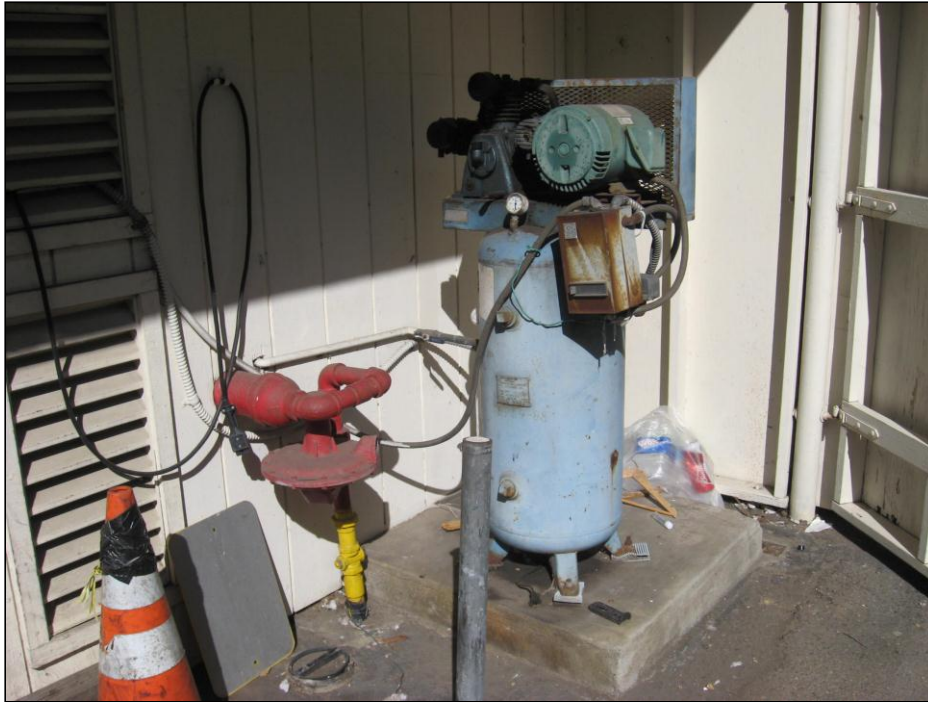
Photograph #23
Air compressor with de minimis staining behind maintenance building.

A storage area is located adjacent to the south of the laundry and maintenance building. We observed service vehicles, lawn mowers, a battery charging station, bags of water-softening salt and fertilizer in the storage area (Photograph Nos. 21 and 22). An air compressor with de minimis staining was located in the eastern portion of the storage area (Photograph No. 23). We observed a spool of cable and a corroding 5-gallon can labeled as paint thinner in a grassy area adjacent to the west of the storage area (Photograph Nos. 24 and 25).

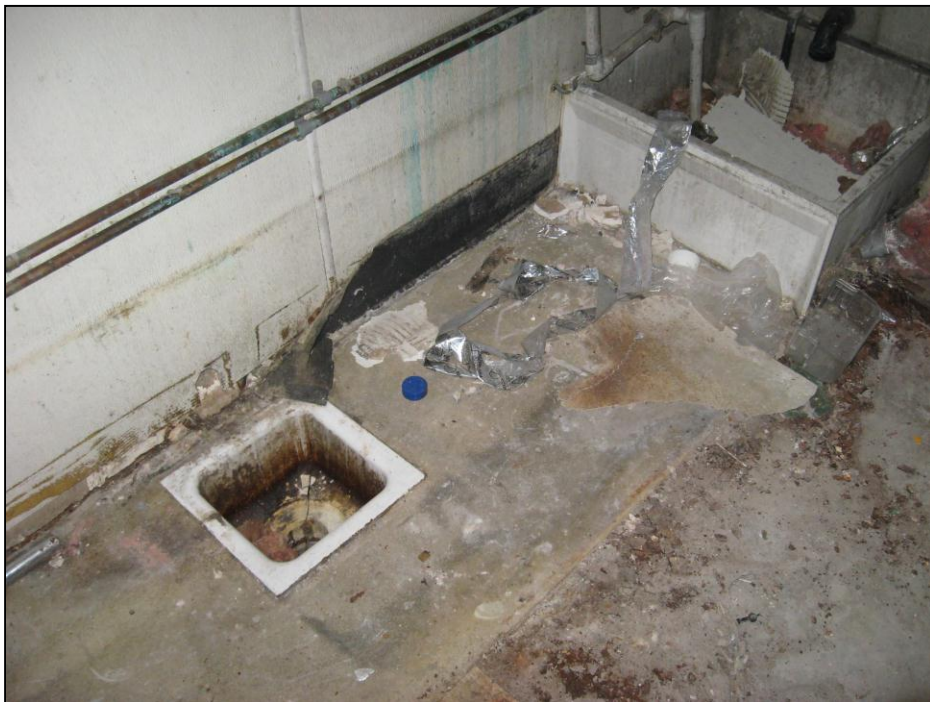
Photograph #28
Floor drains in cleaning room of vacant health club.

A vacant health club building is located on the southeastern portion of the Site. The two-story building contains racquetball courts, offices, saunas, showers and workout areas (Photograph Nos. 26 and 27). We observed two floor drains in a former wash room in the central portion of the building (Photograph No. 28). Significant staining was not observed in the area of the drains. The exterior areas of the health club included a swimming pool, parking areas, and basketball and tennis courts with cement bleachers.

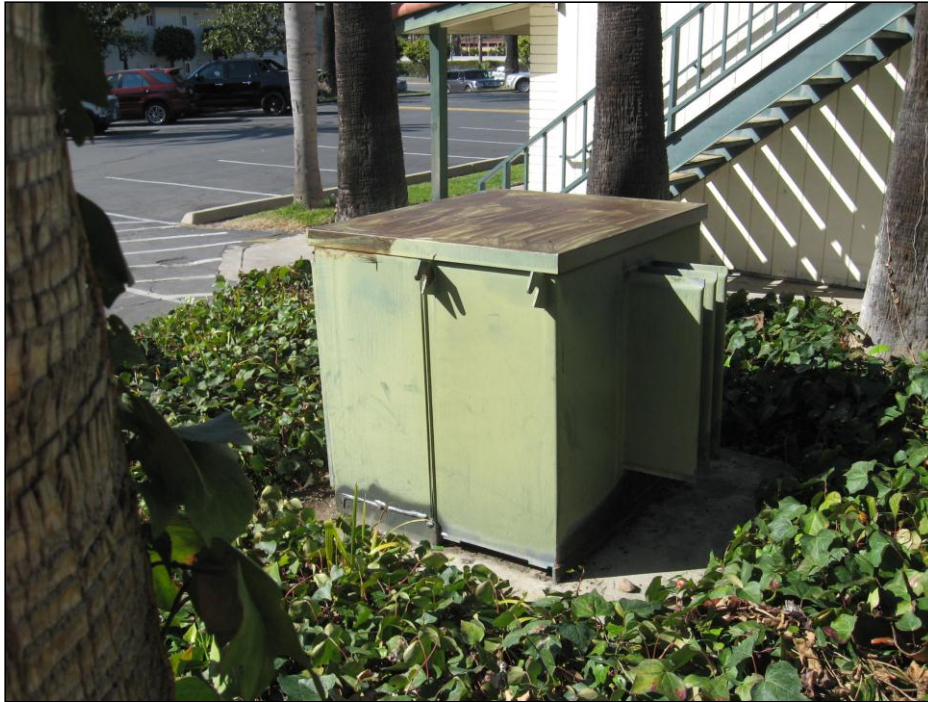
Photograph #29
Finned transformer south of Building 4.

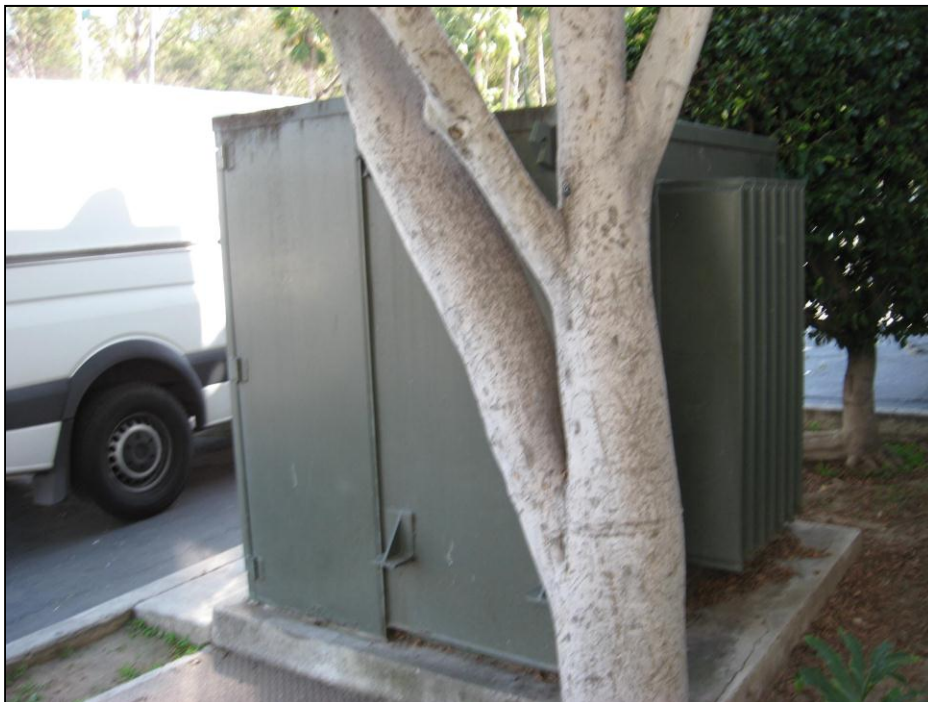
Photograph #30
Finned transformer east of building 1.
