THE CITY OF SAN DIEGO  
**Historical Resources Board**

DATE ISSUED: September 21, 2012 REPORT NO. HRB 12-046  
ATTENTION: Historical Resources Board  
Agenda of September 27, 2012  
SUBJECT: **ITEM #6 – 2235 Juan Street**  
APPLICANT: Mikhail Family Trust represented by Johnson and Johnson Architecture  
LOCATION: 2335 Juan Street; Uptown Community, Council District 2  
DESCRIPTION: Consider the designation of the 2335 Juan Street as a historical resource.

*Presentation of*  
2335 Juan Street Residence  
Rehabilitation Design Proposal

## Rehabilitation Design Proposal

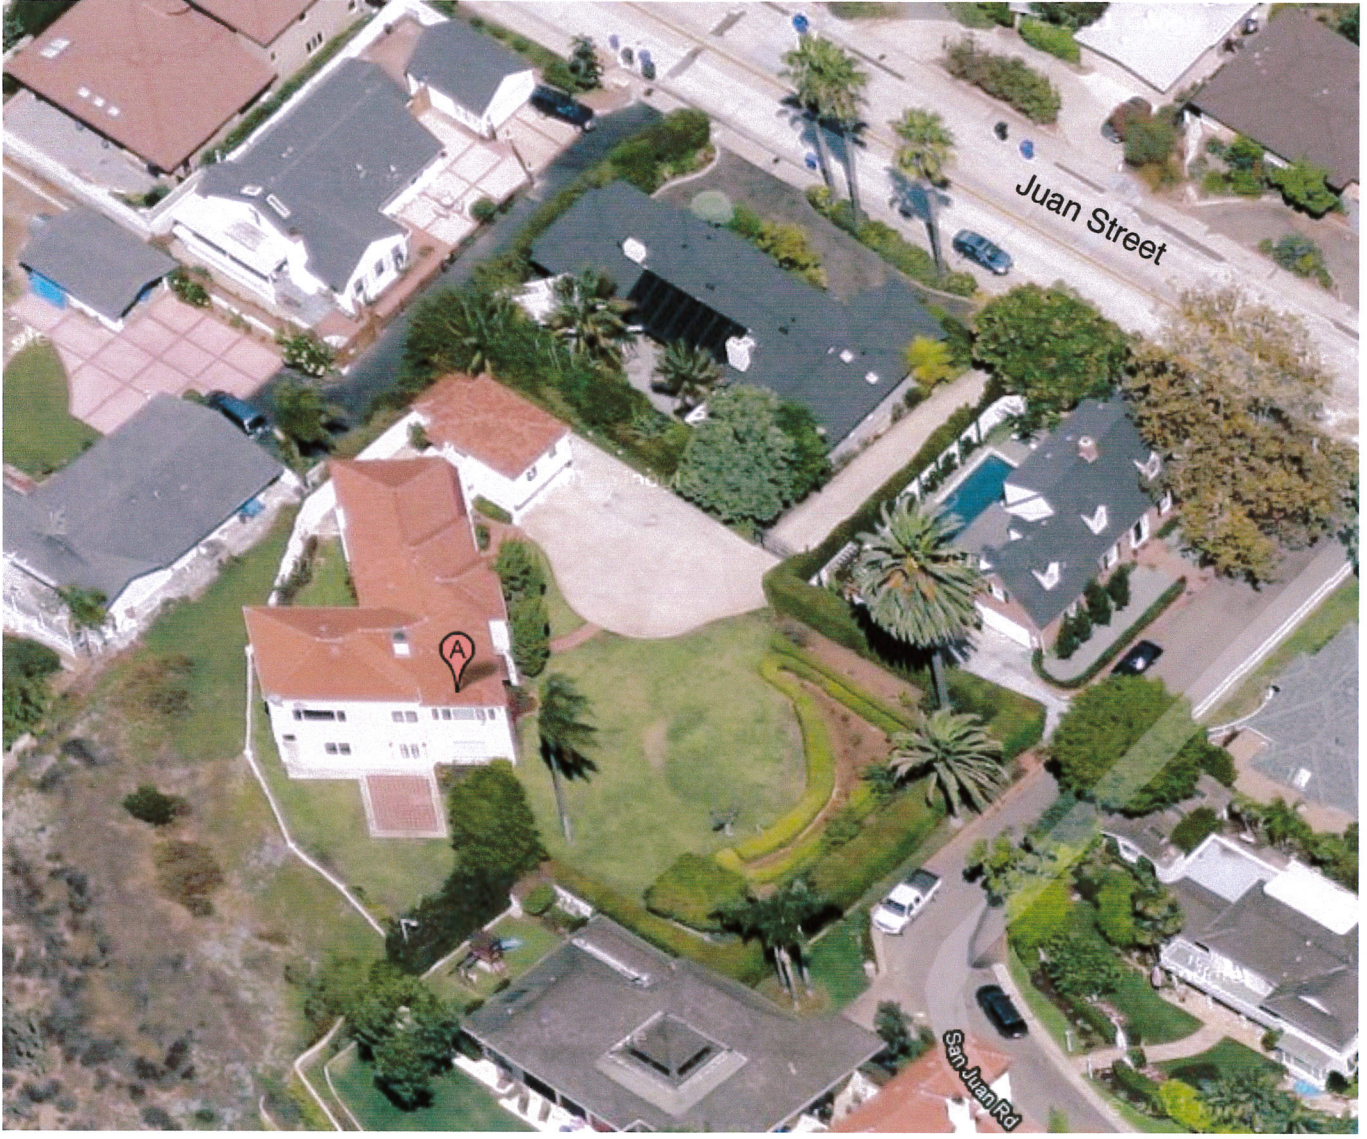
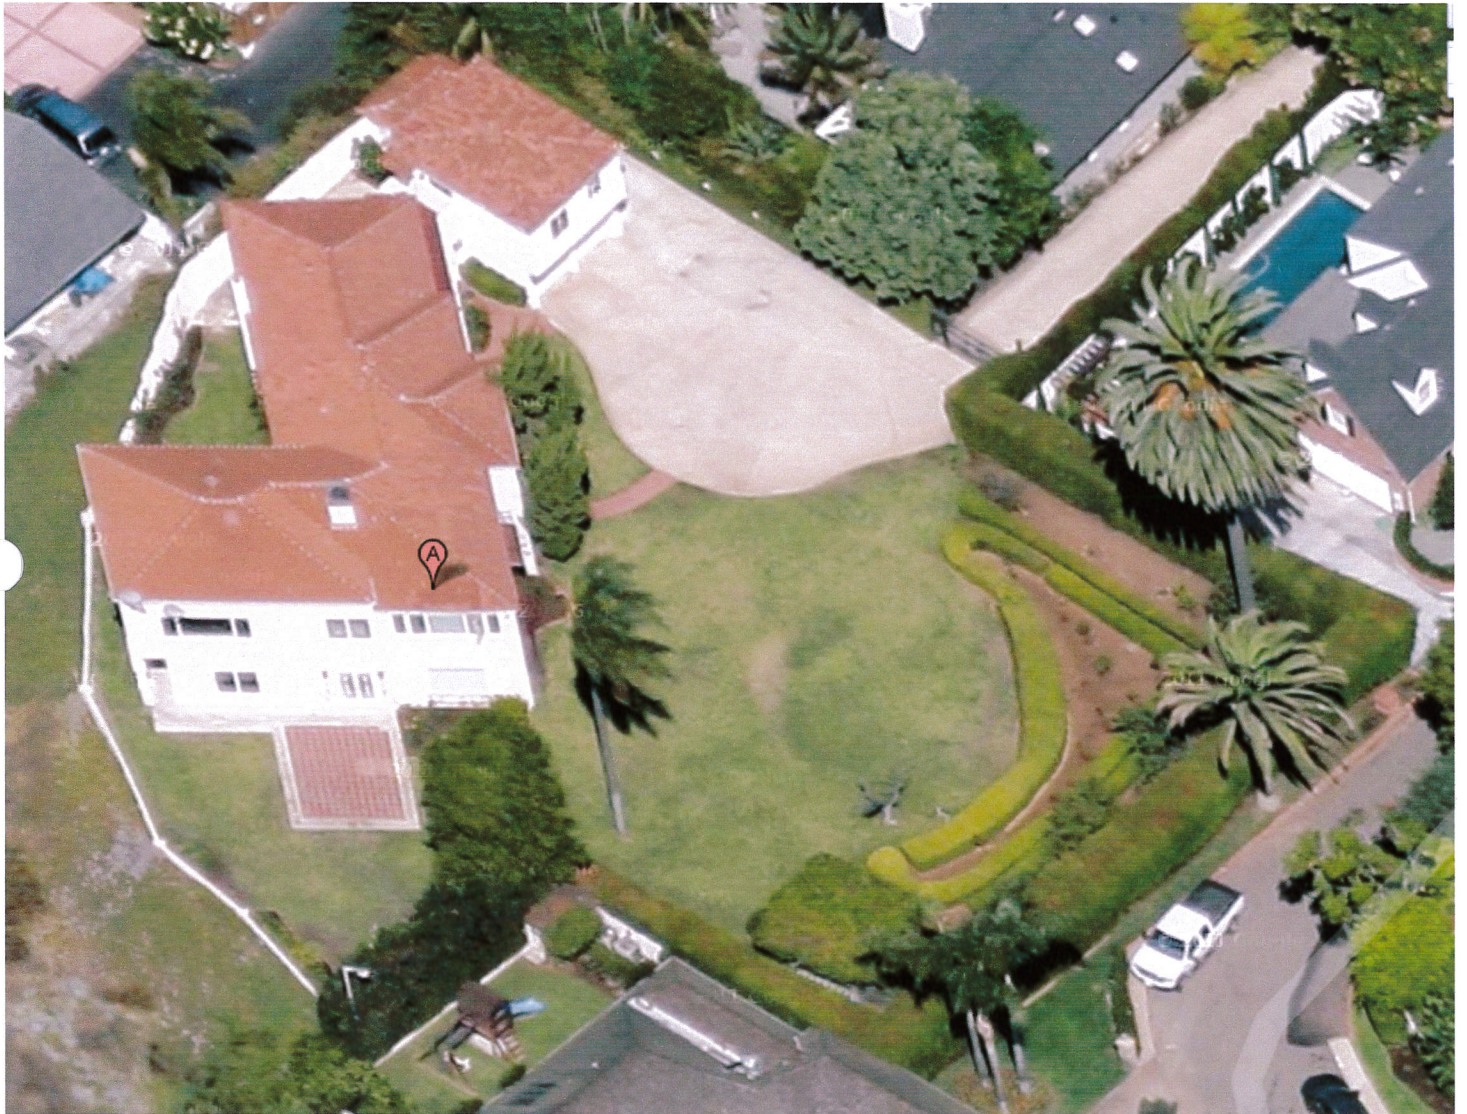
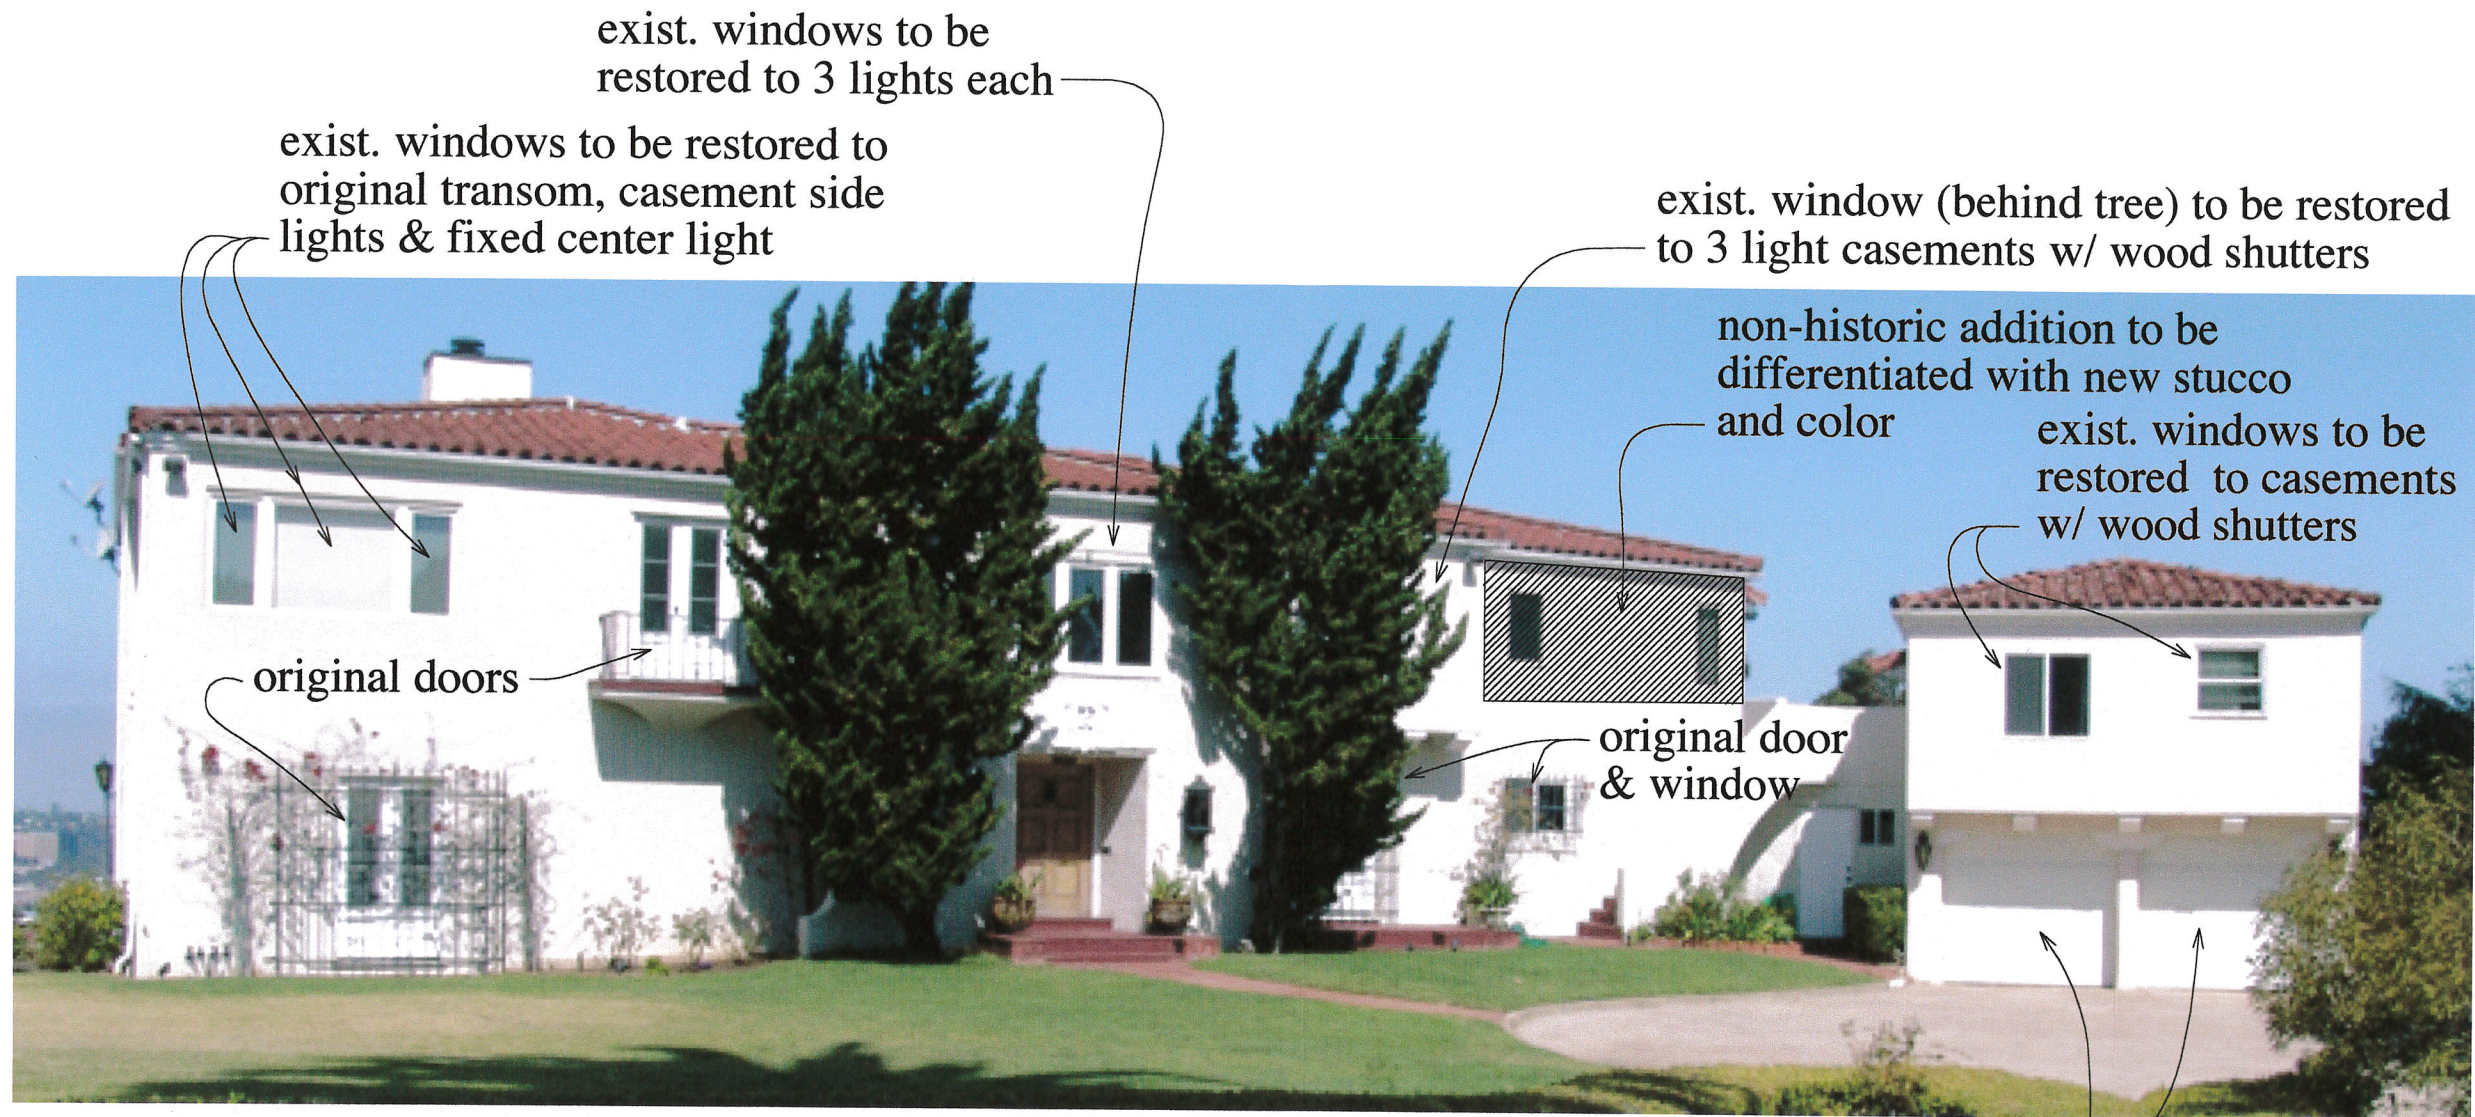
This design proposal presents certain modifications to the existing residence. First, a number of doors and windows are proposed to be restored to their original configuration. Second, a non-historic addition is to be differentiated, so not to be misconstrued as part of the true historic fabric. The goal is historic designation and the Mills Act.

- Notes: 1. Door & window sashes and frames, corbels and post which were shown to be painted a dark color in the historic photo, shall be painted to reproduce the original high contrast.
2. New windows and doors shall incorporate as much detail as possible, with close inspection of the historic photo.
