**TREATMENT PLAN
FOR THE RELOCATION OF:**

2544 COLLIER AVENUE & 2746 COPLEY AVENUE

IS Architecture
5649 La Jolla Blvd.
La Jolla, CA 92037

March 2014

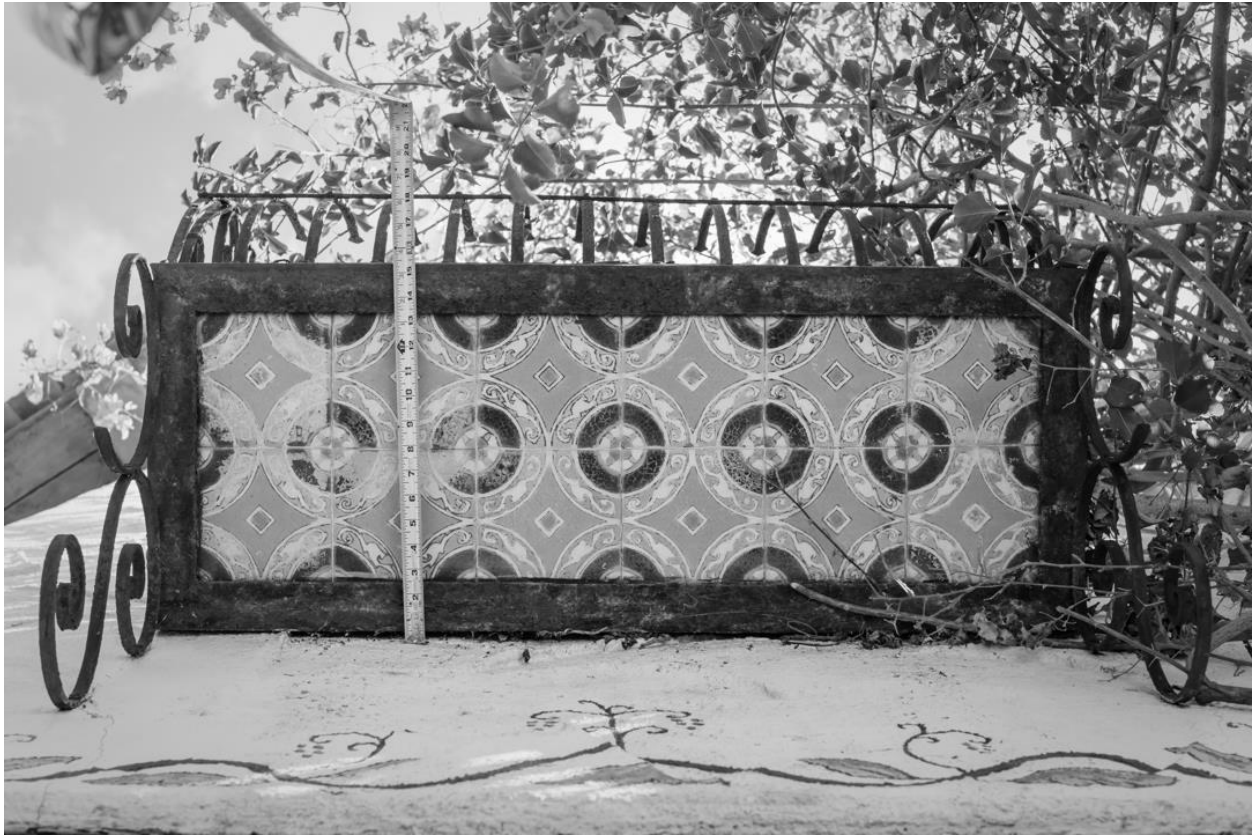
Figure 5: 2544 Collier, detail view of decorative scrolled iron balcony with tile base over front entry door.
Image Source: IS Architecture, December 2013.

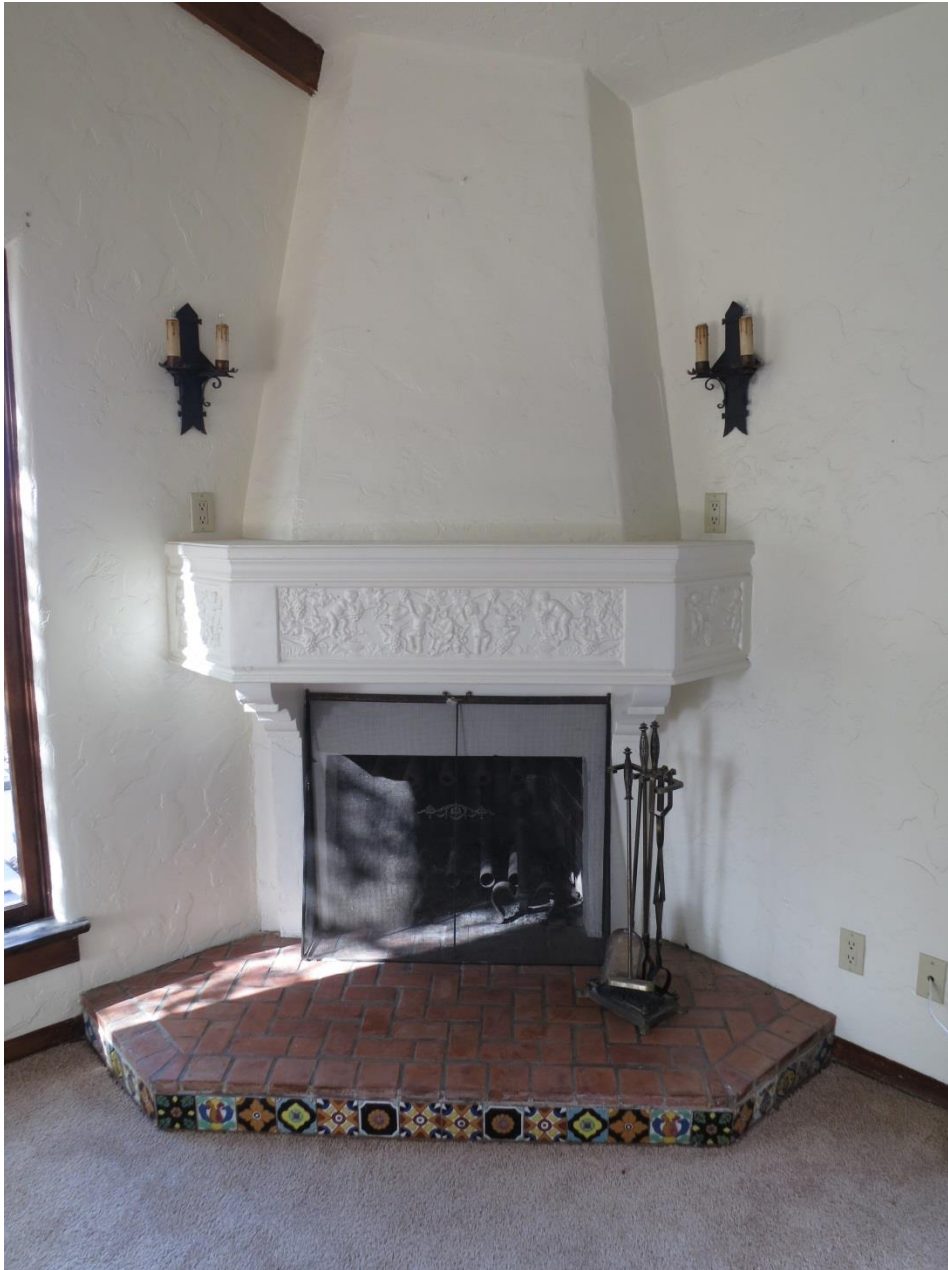
Figure 6: 2544 Collier, living room fireplace assembly. Image Source: IS Architecture, December 2013.

There are three chimneys. All three are character defining features. One includes a fireplace and services the living room, while the second and third do not include fireplaces and appear to be framed and stucco clad chimneys housing vent stacks. One appears to serve a furnace vent, the other a hot water heater vent. The living room chimney is situated in the northwest corner of the room and has an ornate asymmetrical gable cap with Spanish sand cast clay roof tile. Directly below the cap, on all four sides of the chimney, are vents constructed of a clay tile crisscross pattern. The lower portion of the chimney wraps the corner of the building with a stepped design on each side. The second chimney is not connected to a fireplace, but rather to the furnace in the basement. It is rectangular-shaped with rounded top. A lion-topped weather vane is mounted to this chimney. The third chimney is situated above the water heater located in the Servants bathroom. It is a low lying chimney with a gable cap.

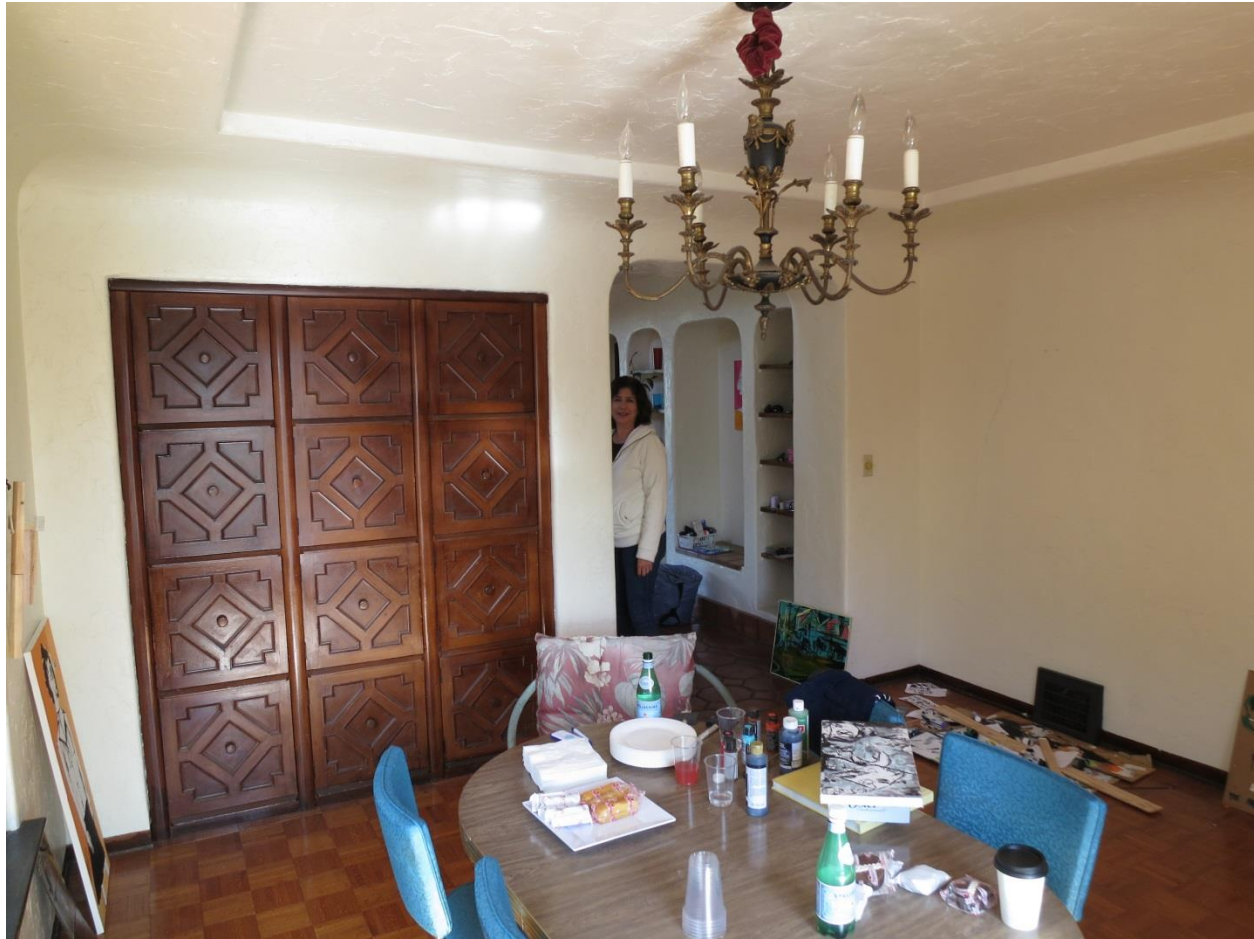
Figure 7: 2544 Collier, dining room light fixture. Image Source: IS Architecture, December 2013.

(Note: all fixtures are to be documented, crated, and saved for reinstallation)

All exterior light fixtures are character defining and shall be protected. Although protection of interior features is not required for local designation, it is recommended that all interior light fixtures also be protected. The existing electrical system, mechanical system, and plumbing are not character defining.

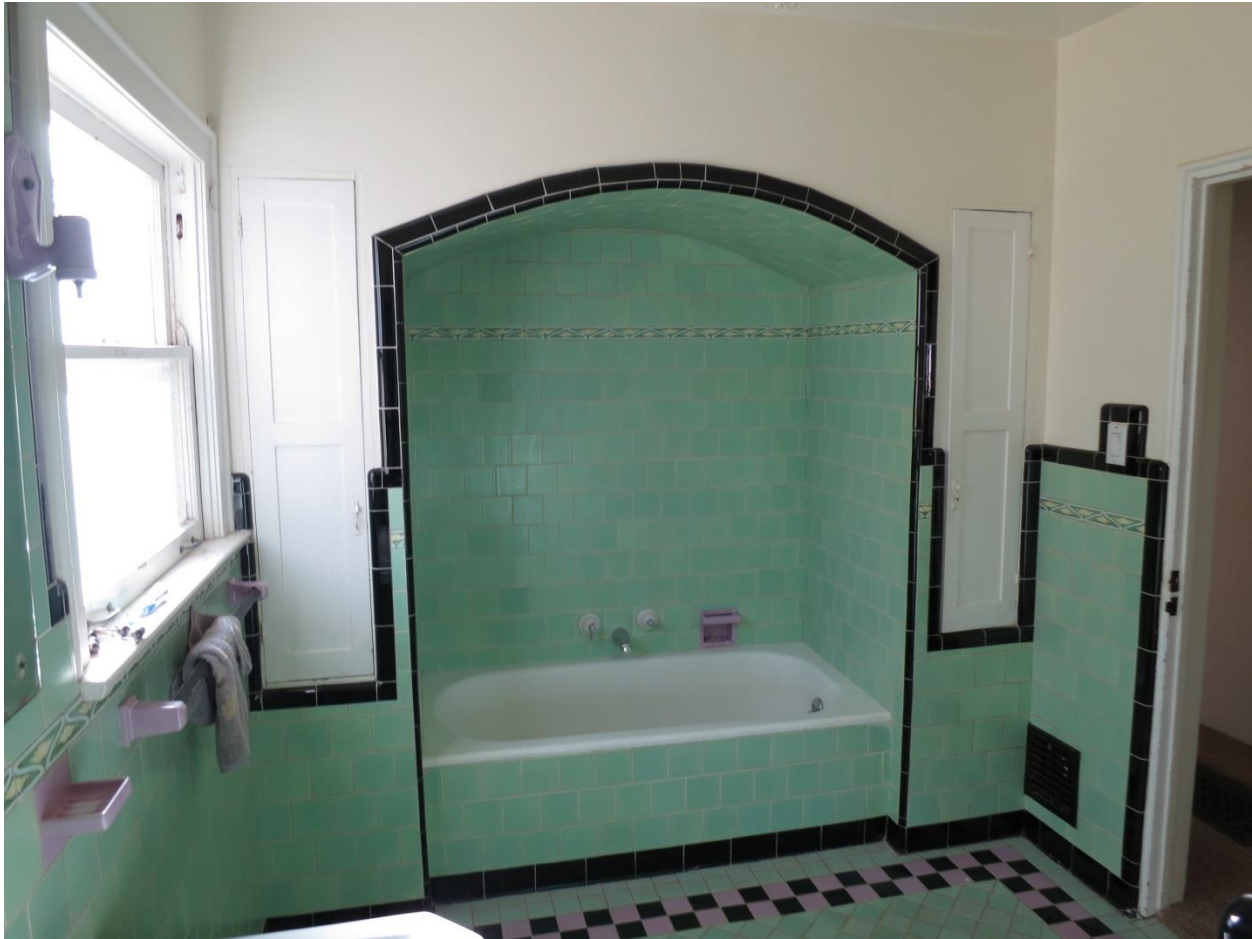
Figure 8: 2544 Collier, green, black, purple bathroom tile. Image Source: IS Architecture, December 2013.

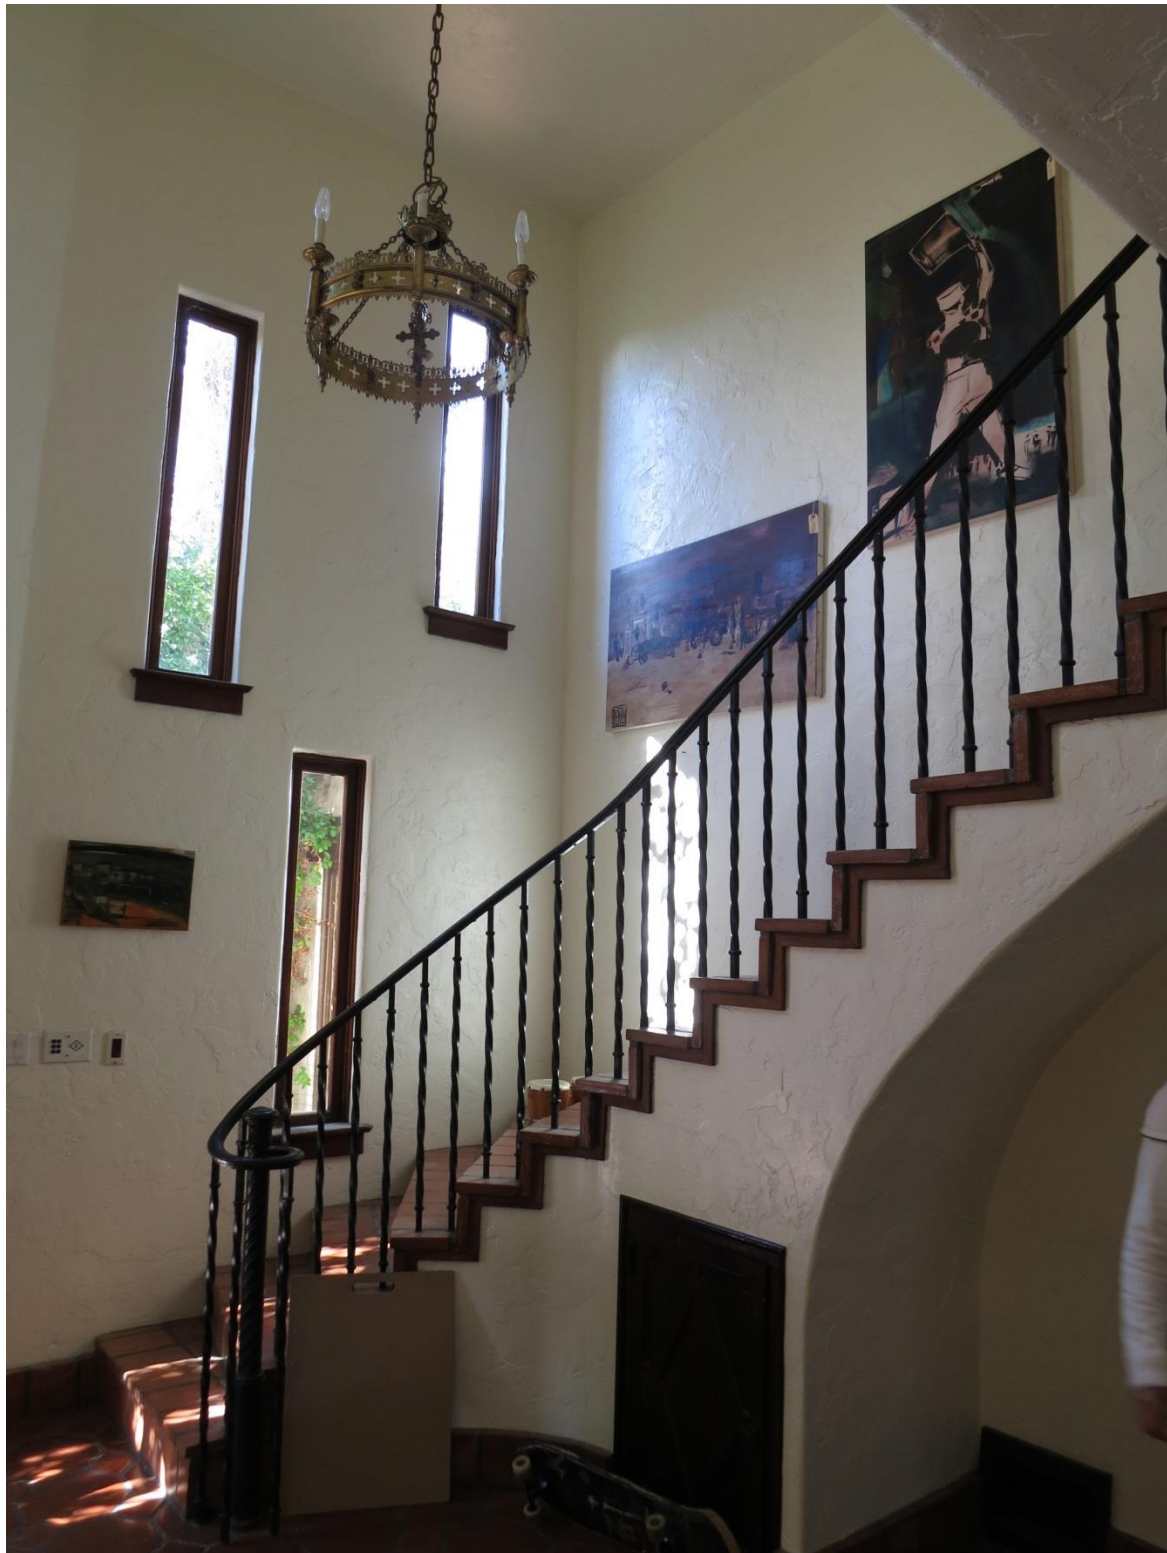
Figure 9: 2544 Collier, stair assembly. Image Source: IS Architecture, December 2013.

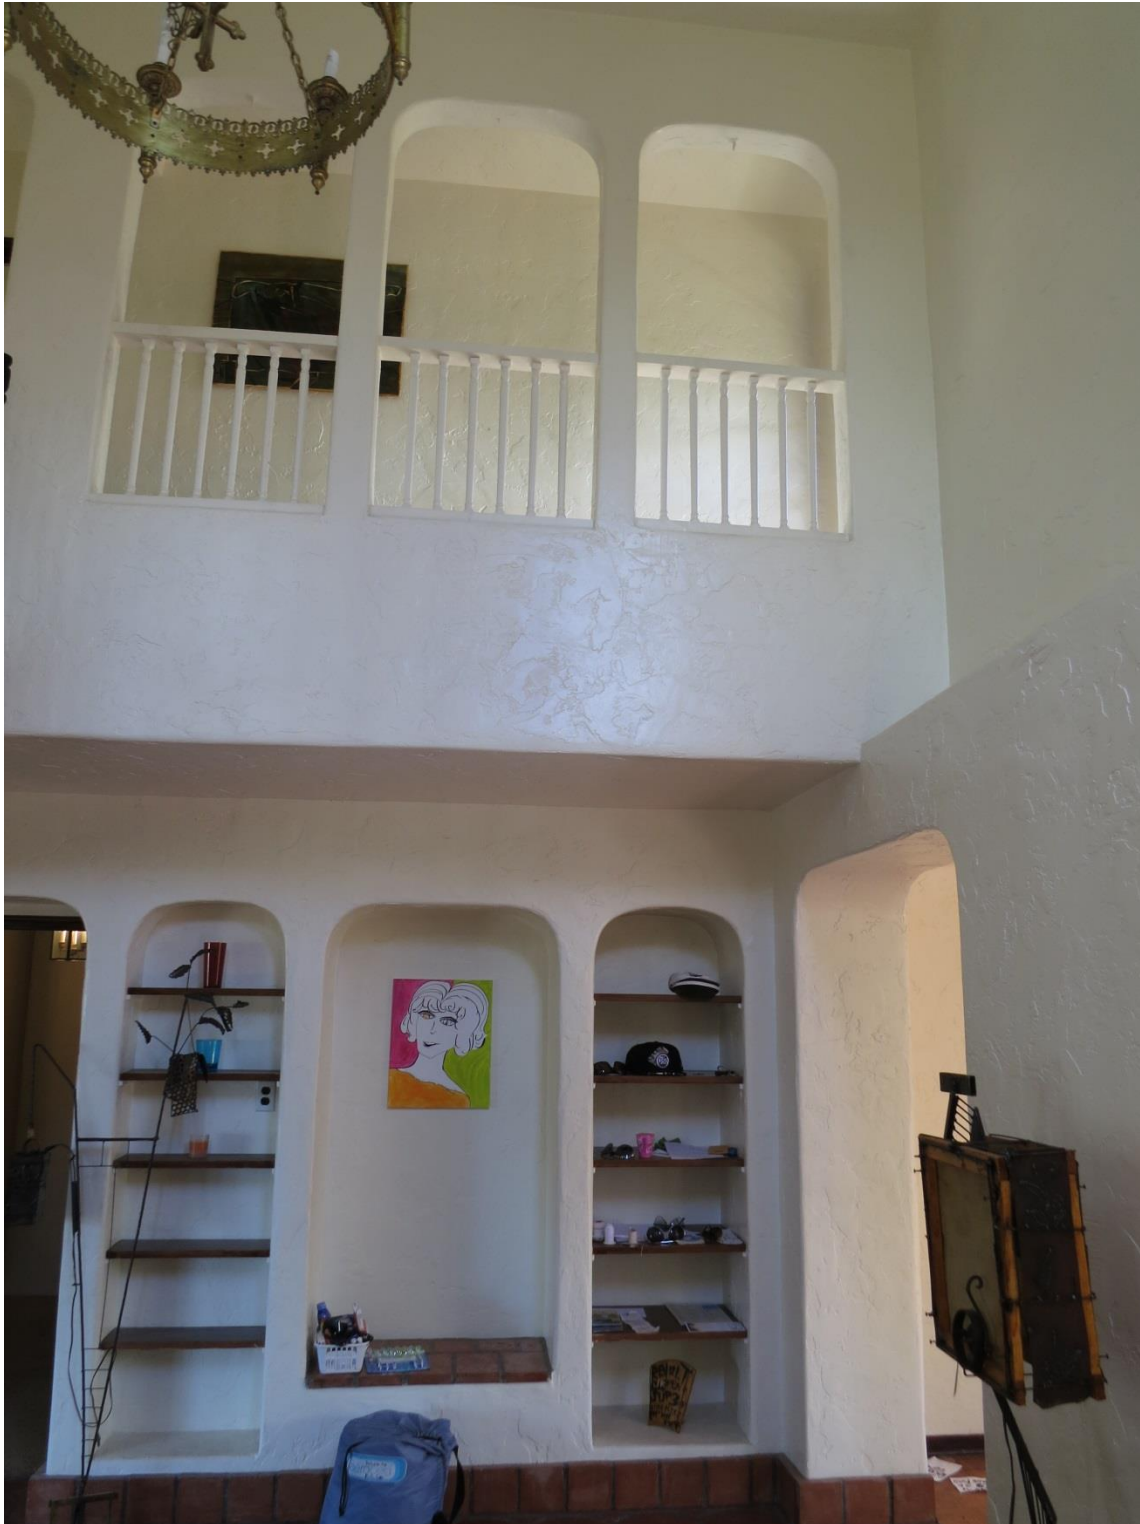
Figure 10: 2544 Collier, railing. Image Source: IS Architecture, December 2013.

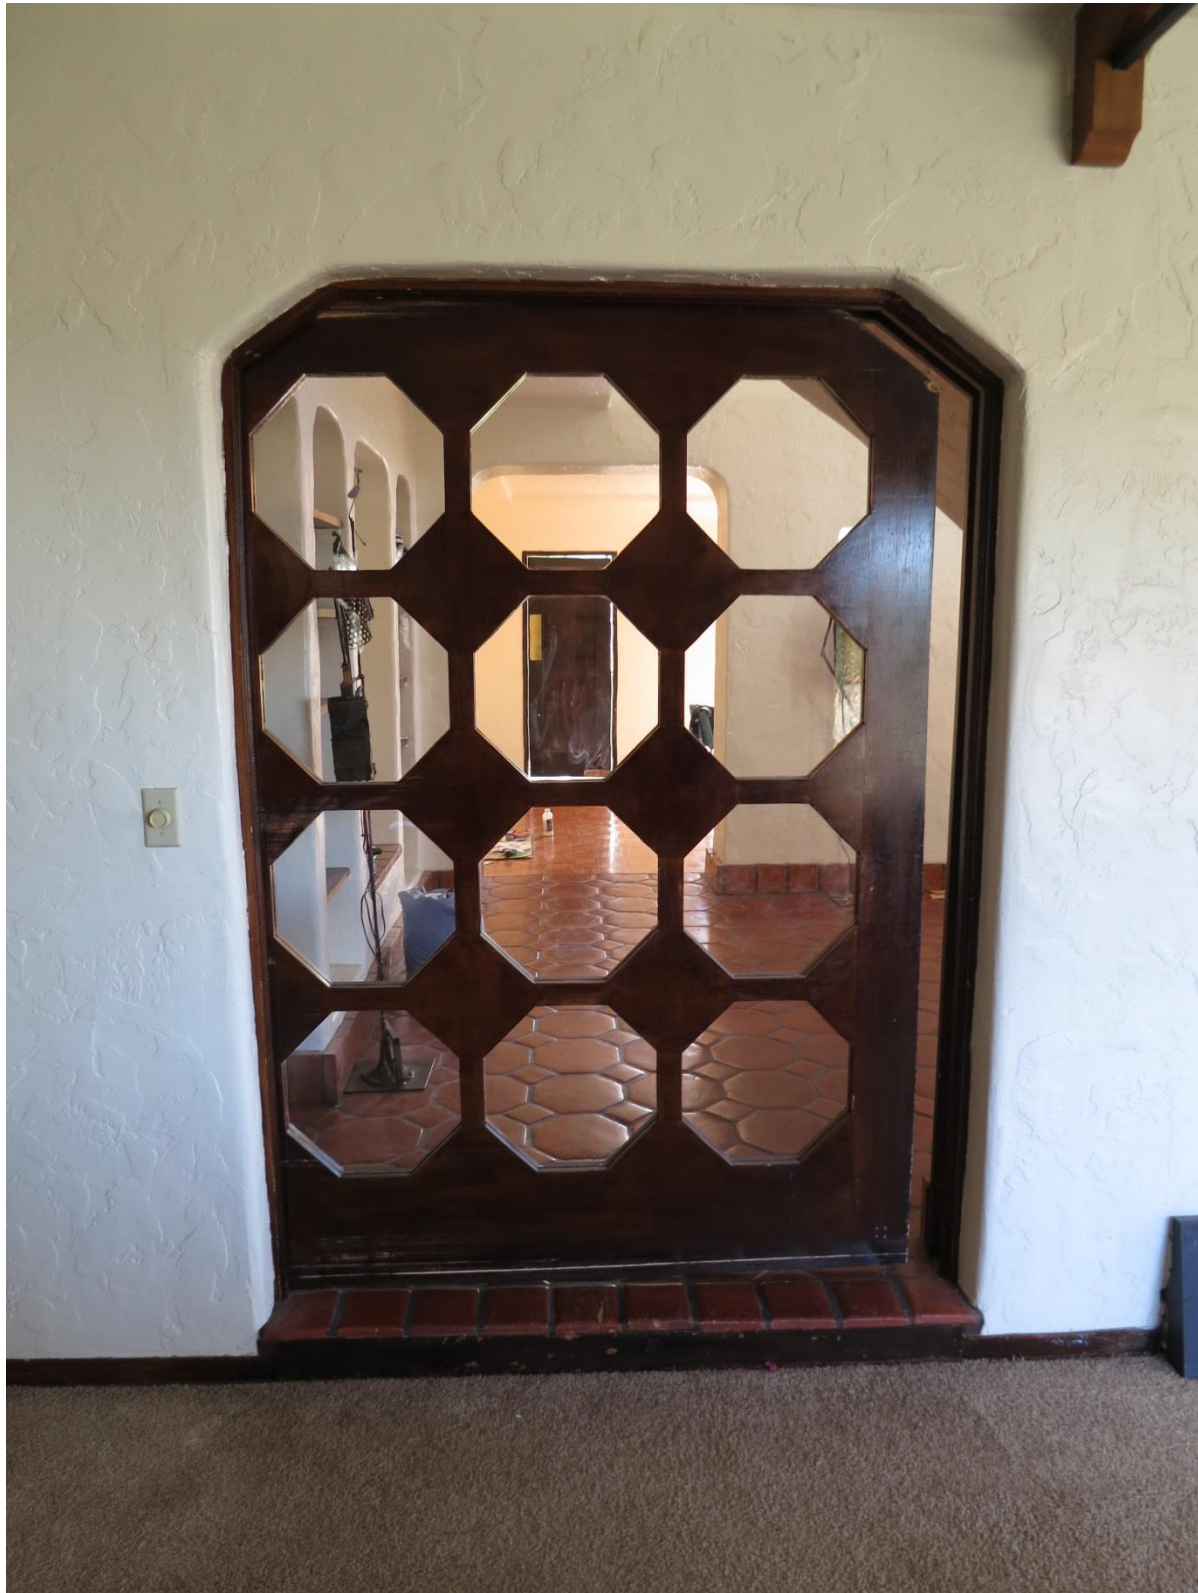
Figure 11: 2544 Collier, interior doors. Image Source: IS Architecture, December 2013.

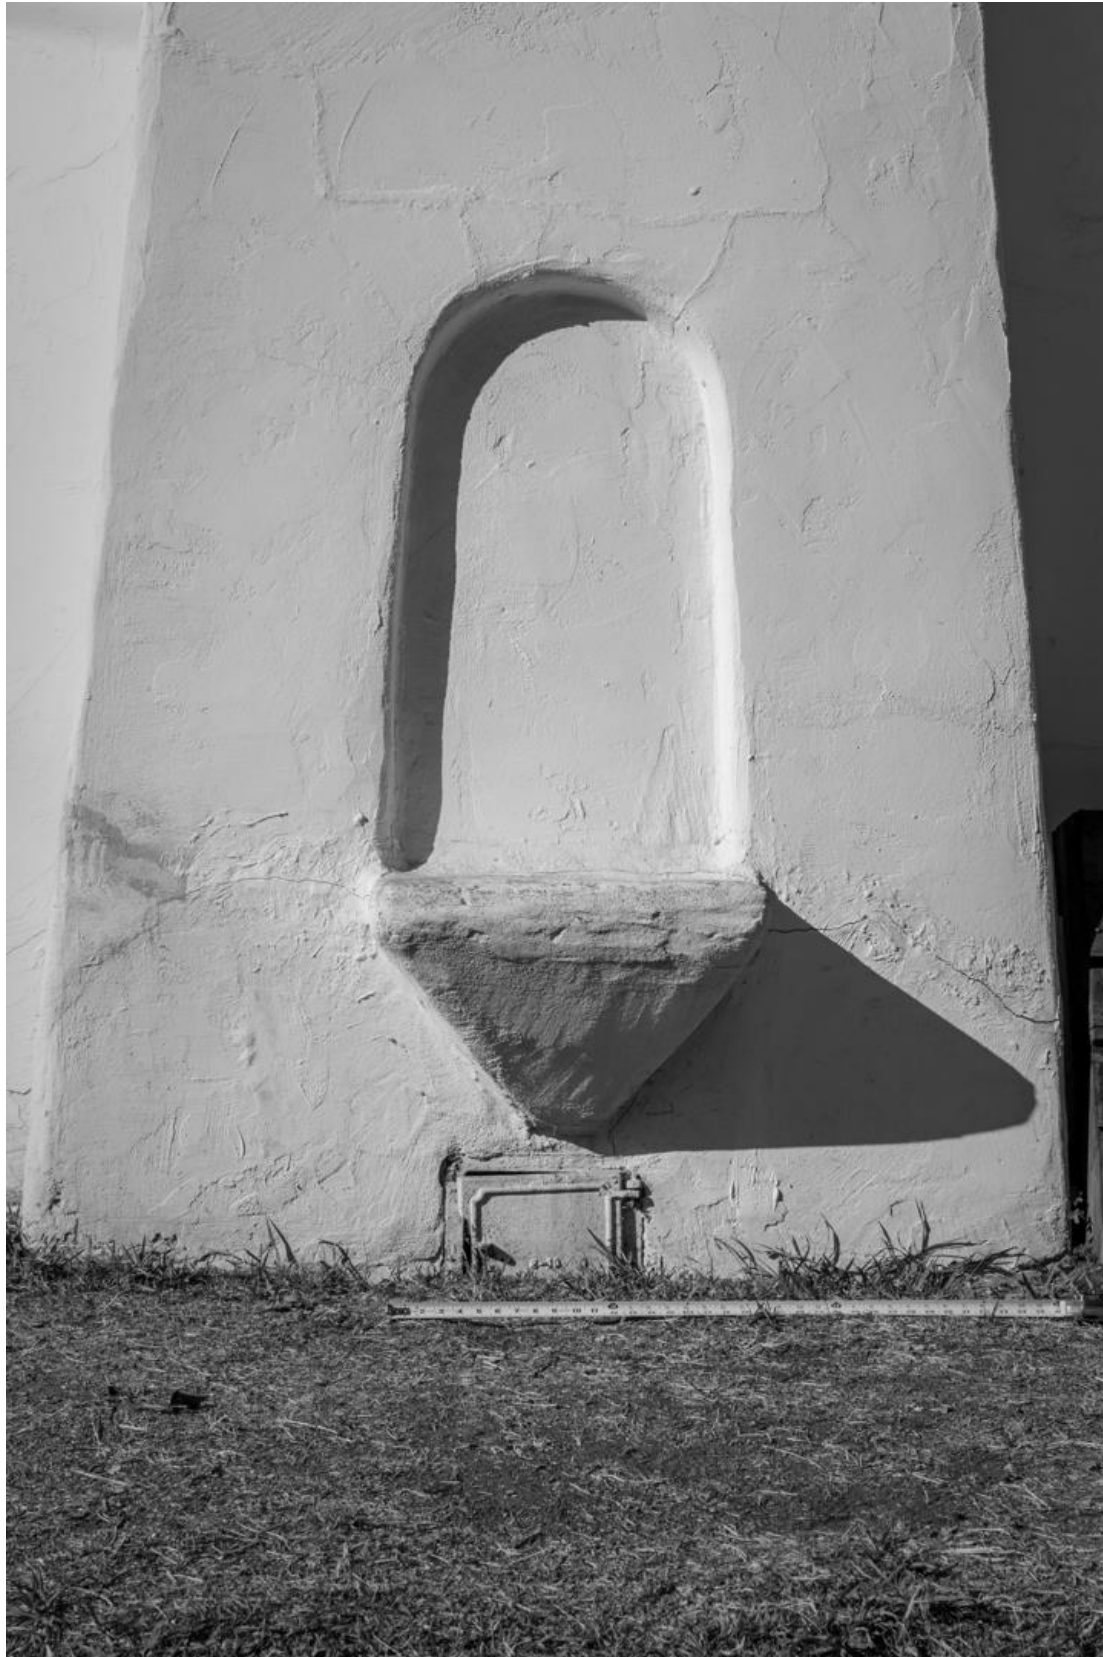
Figure 17: 2746 Copley, detail view of fireplace niche. Image Source: IS Architecture, December 2013.

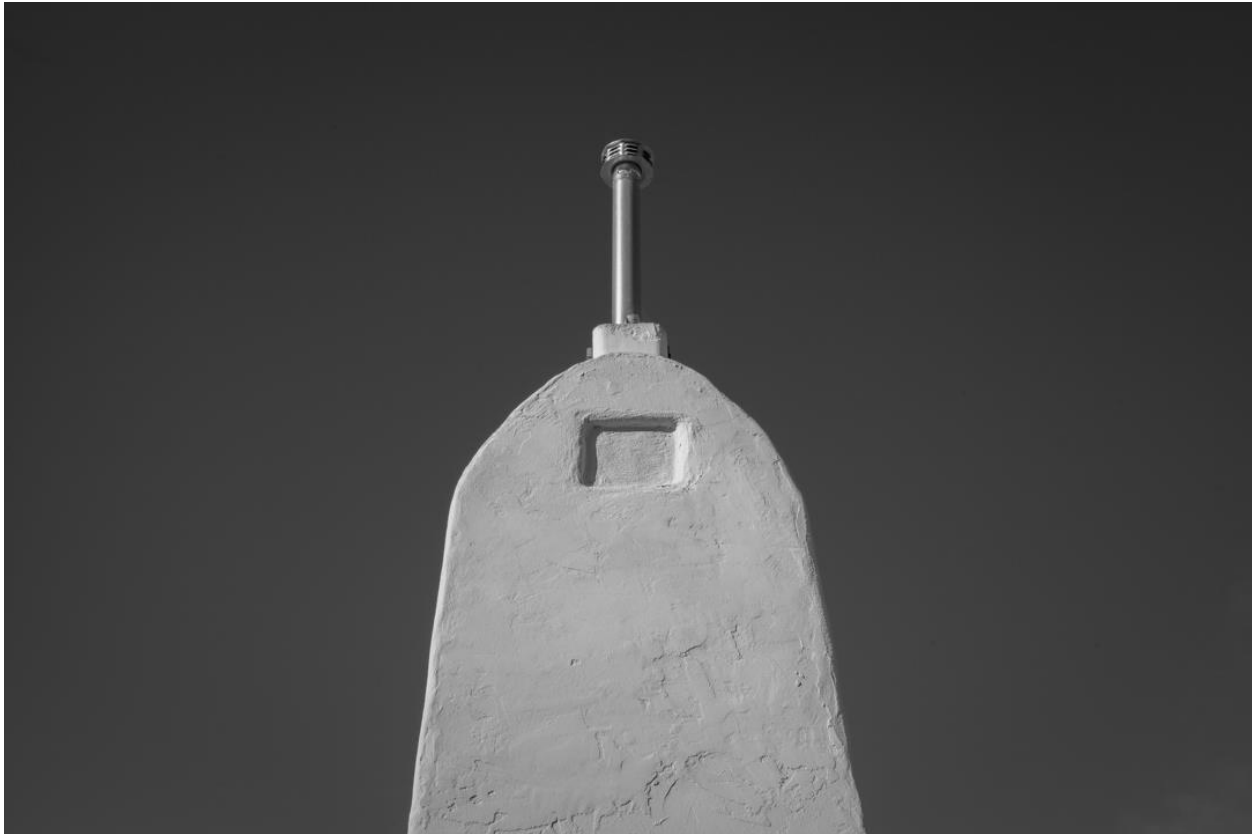
Figure 18: 2746 Copley, detail view of chimney. Image Source: IS Architecture, December 2013.

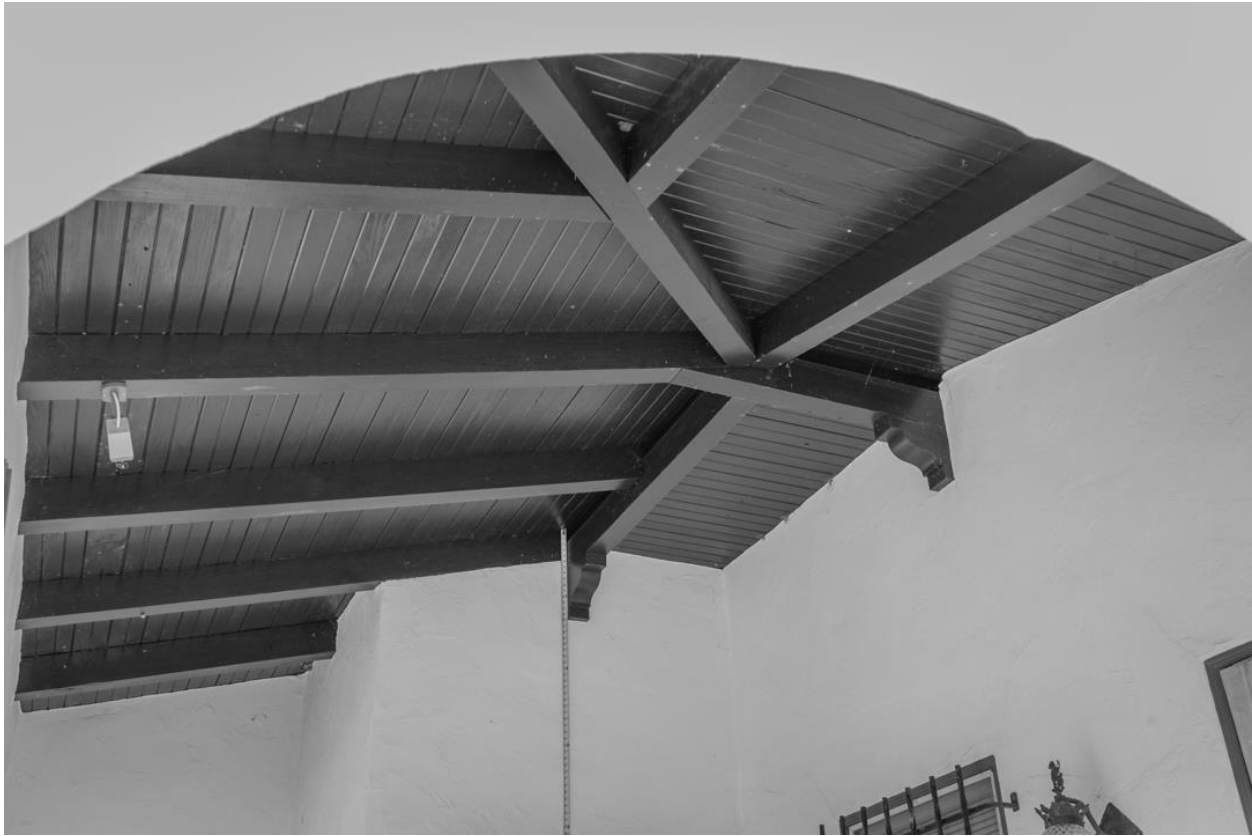
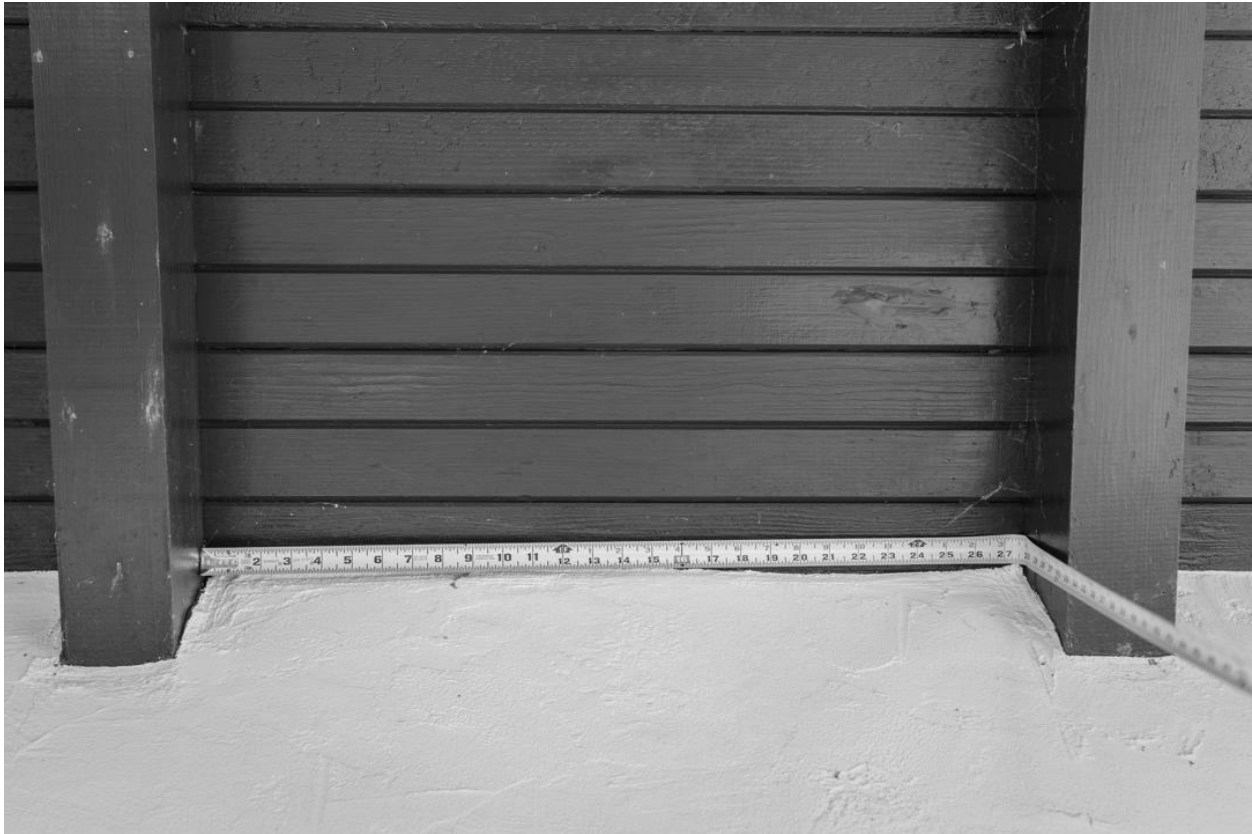
Figure 19: 2746 Copley, detail view of porch ceiling and roof framing. Image Source: IS Architecture, December 2013.

Figure 20: 2746 Copley, detail view of porch ceiling and roof framing. Image Source: IS Architecture, December 2013.

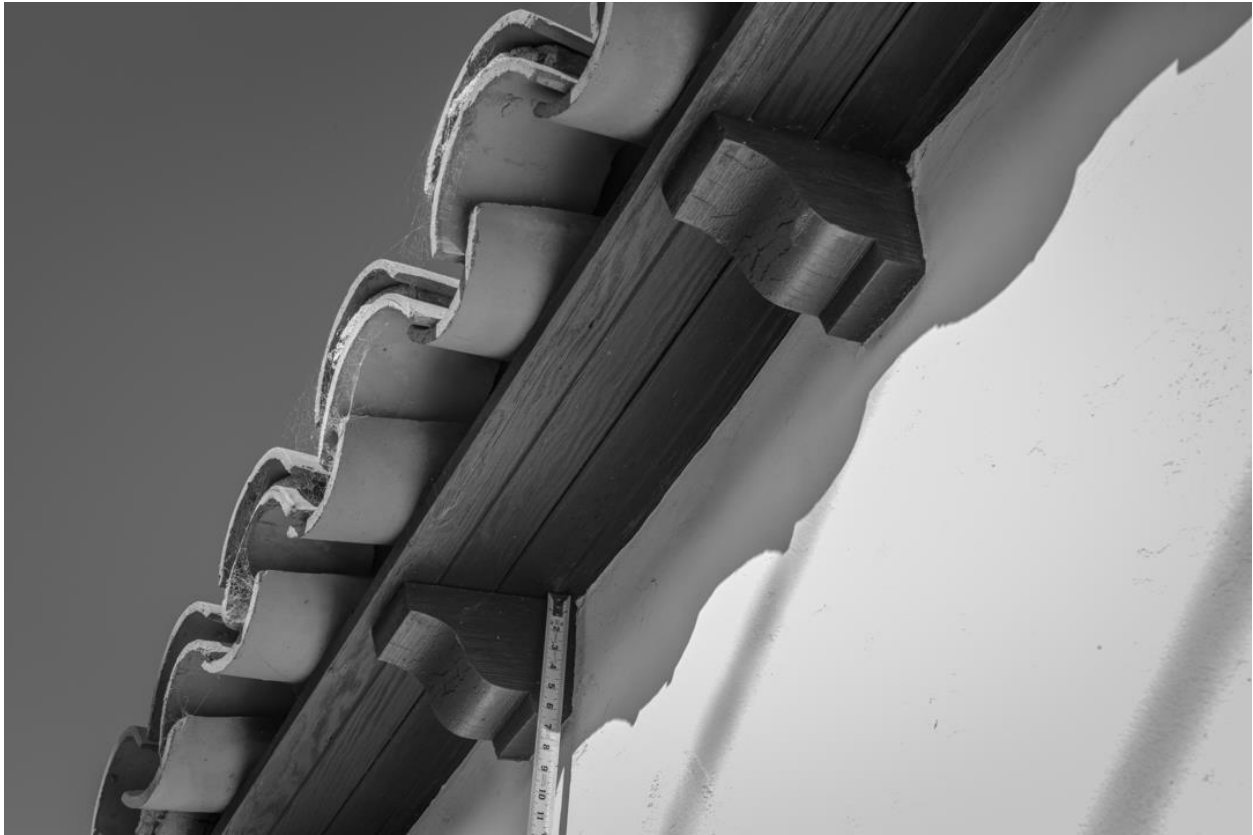
Figure 21: 2746 Copley, detail view of wood corbels showing vertical dimension. Image Source: IS Architecture, December 2013.

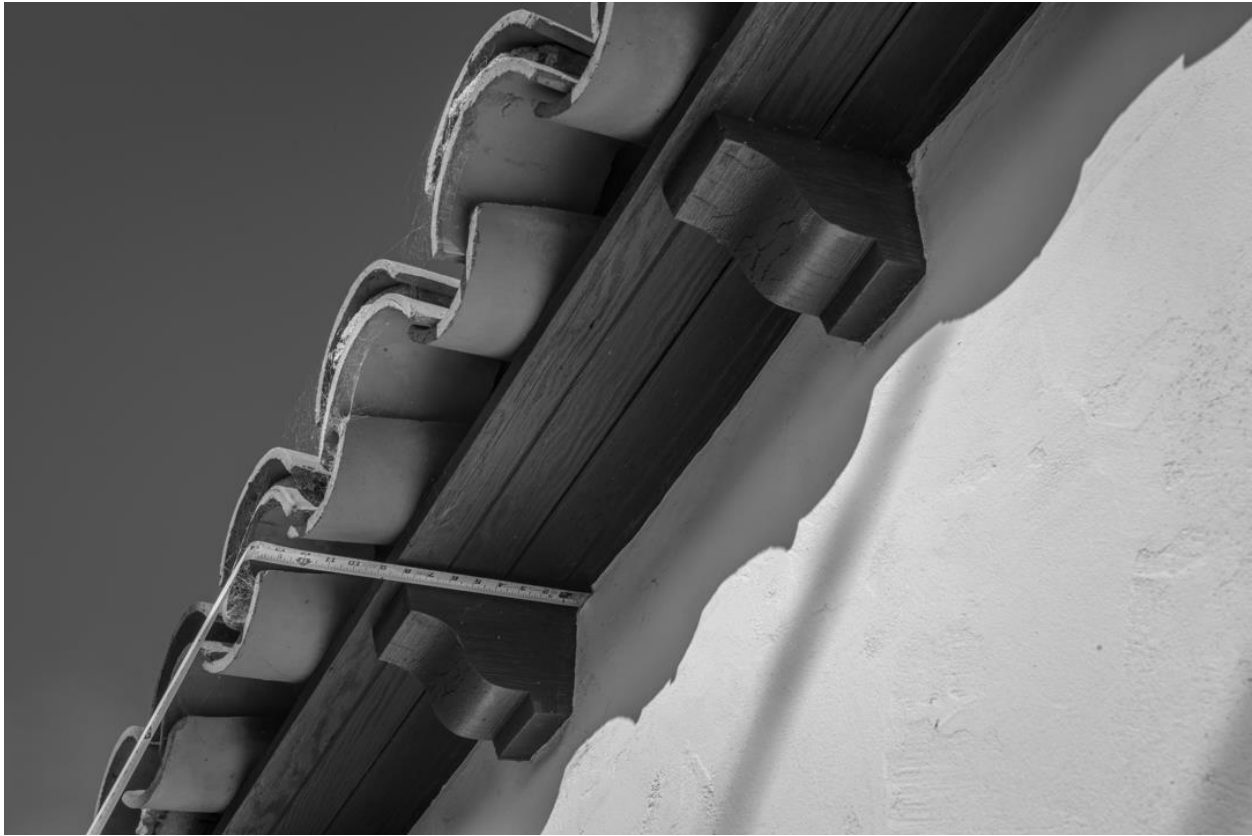
Figure 22: 2746 Copley, detail view of wood corbels showing horizontal dimension. Image Source: IS Architecture, December 2013.

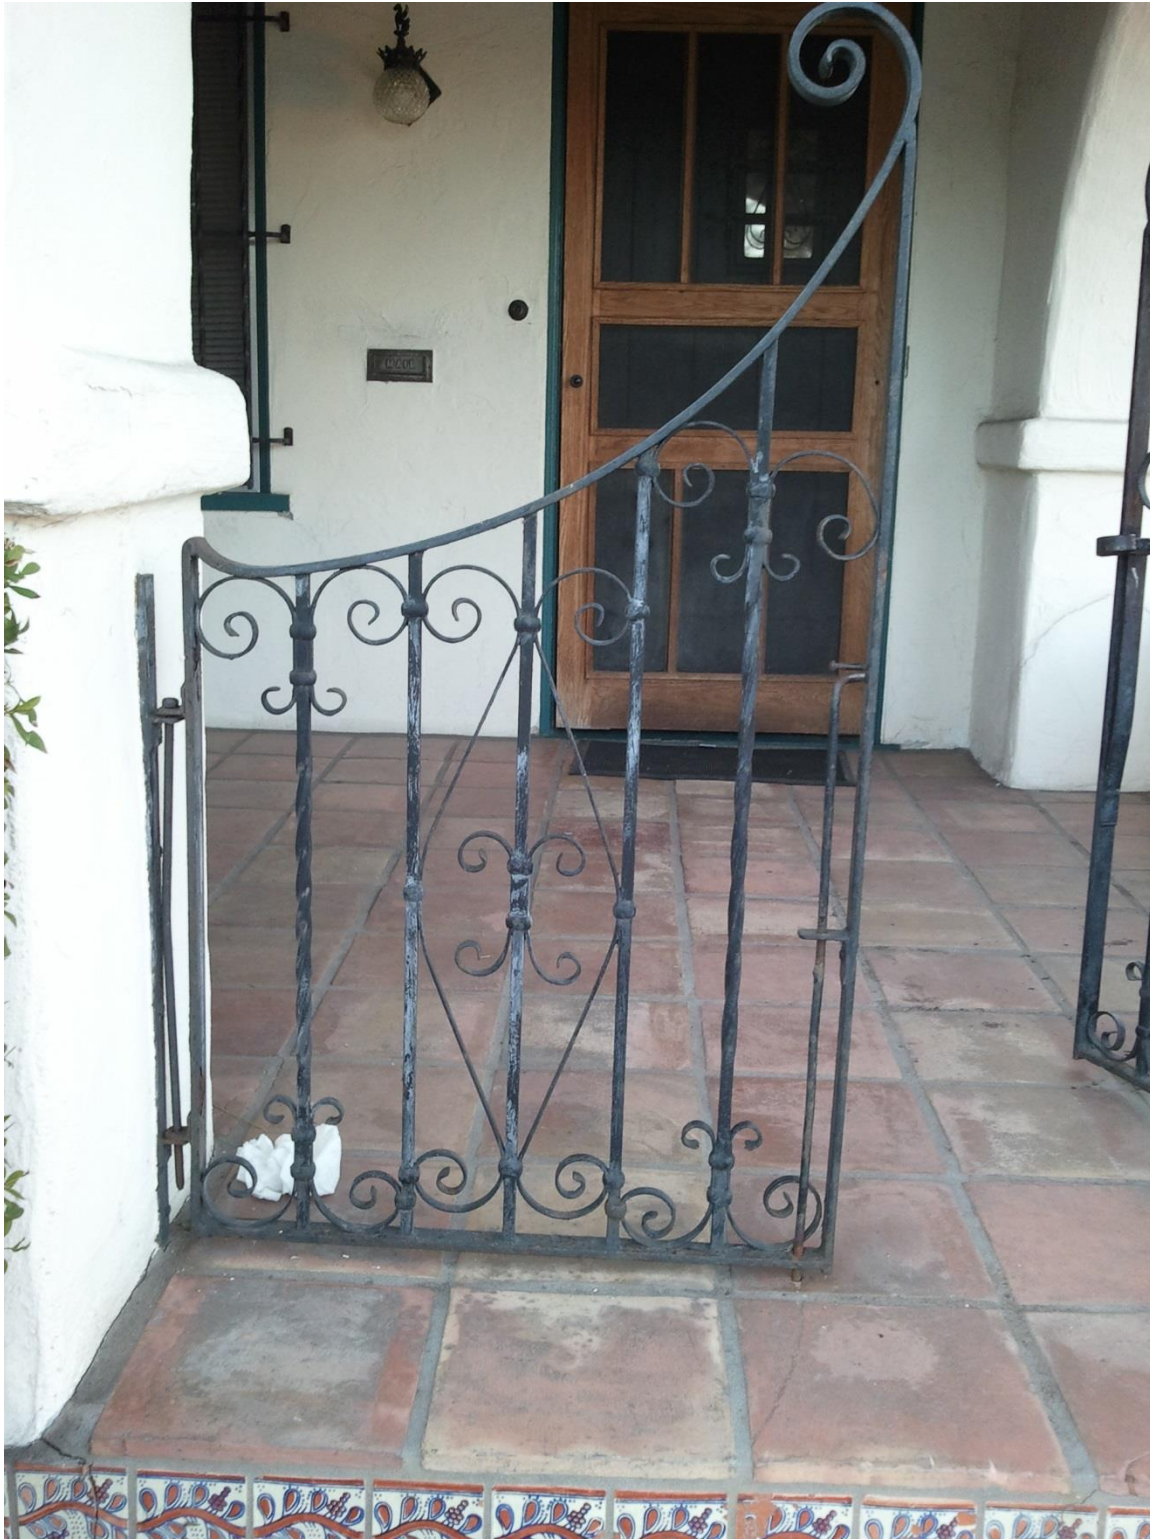
Figure 23: 2746 Copley, detail view of original Iron Gate. Image Source: IS Architecture, December 2013.

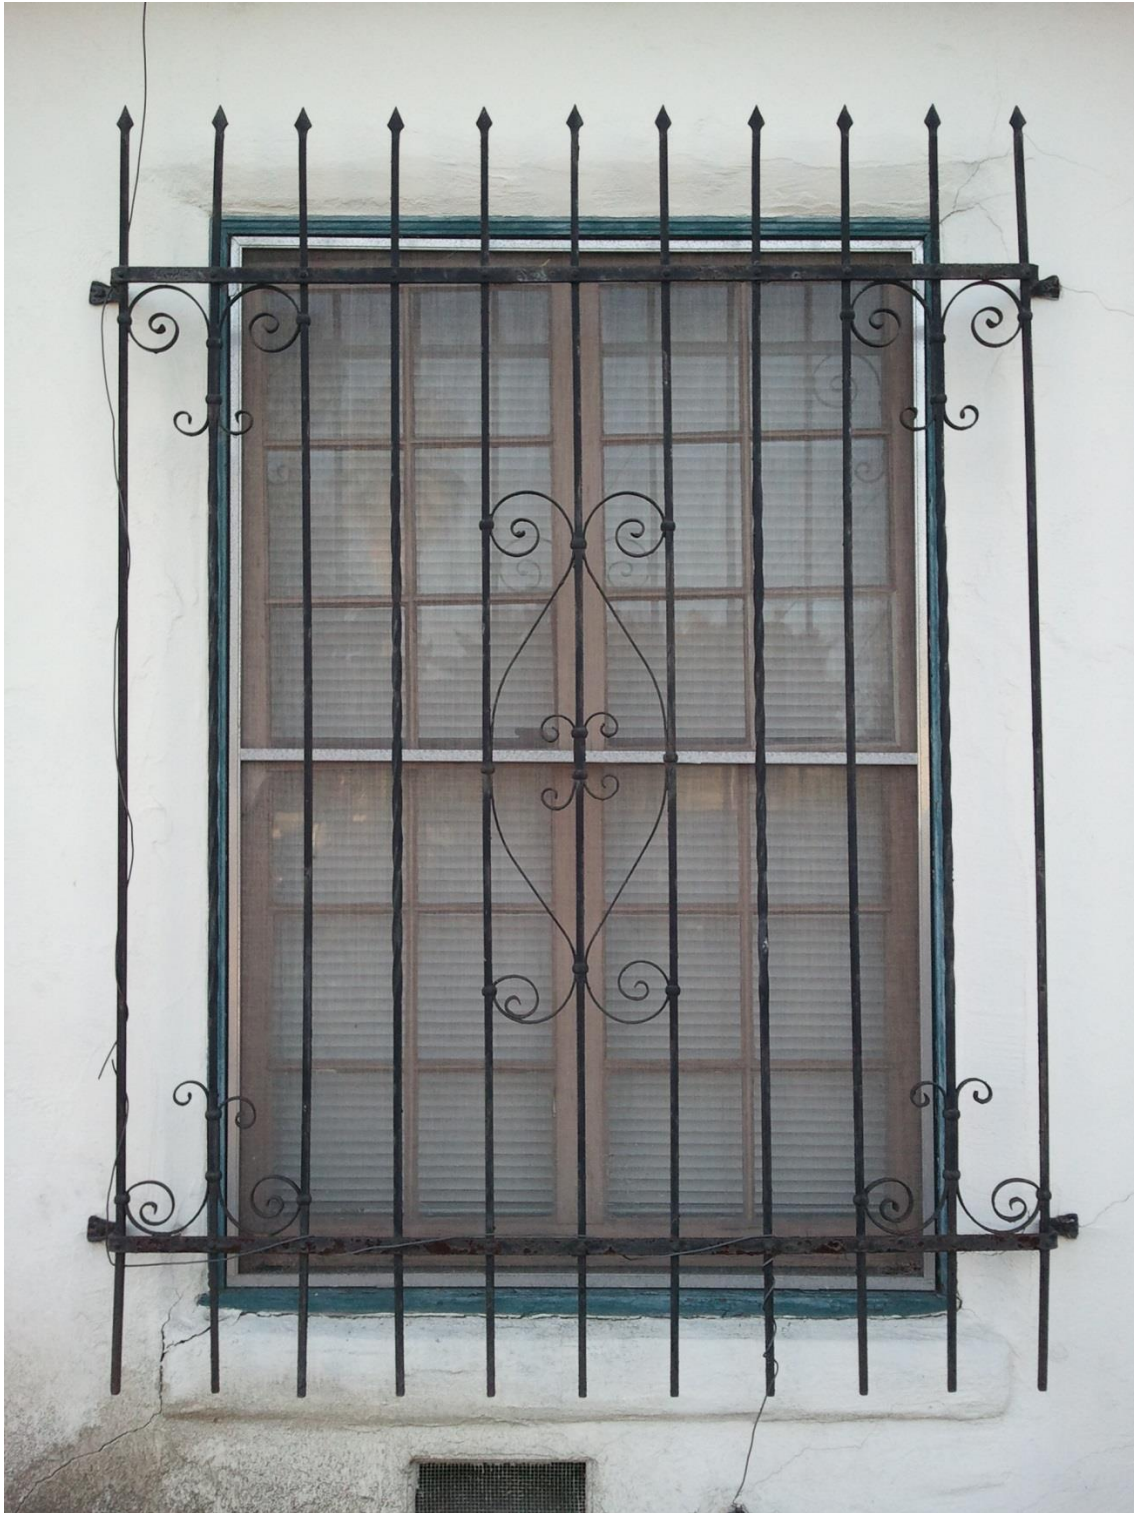
Figure 24: 2746 Copley, detail view of original Security Iron. Image Source: IS Architecture, December 2013

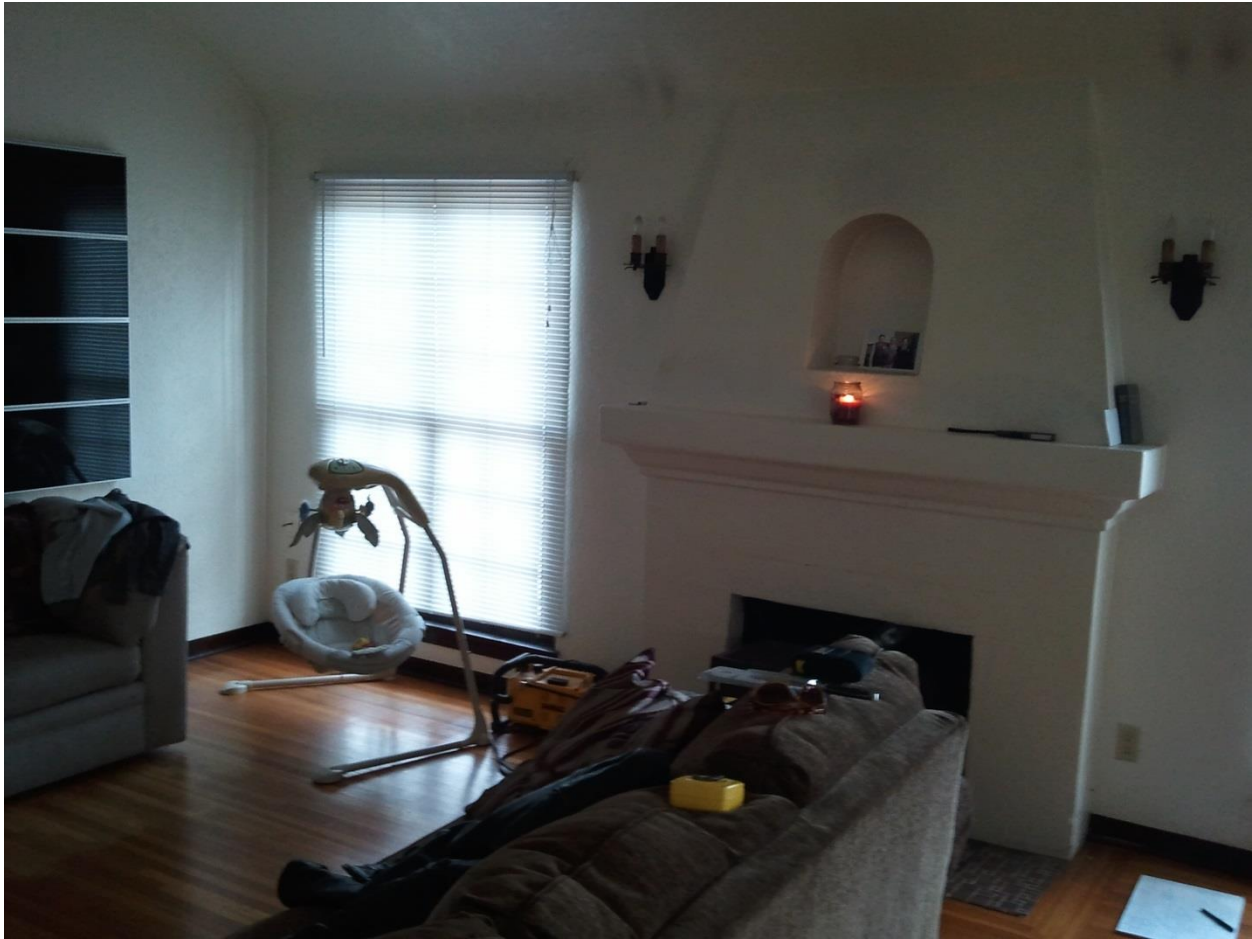
Figure 25: 2746 Copley, fireplace assembly. Image Source: IS Architecture, December 2013.
