**TREATMENT PLAN
FOR THE RELOCATION OF:**

2544 COLLIER AVENUE & 2746 COPLEY AVENUE

IS Architecture
5649 La Jolla Blvd.
La Jolla, CA 92037

March 2014

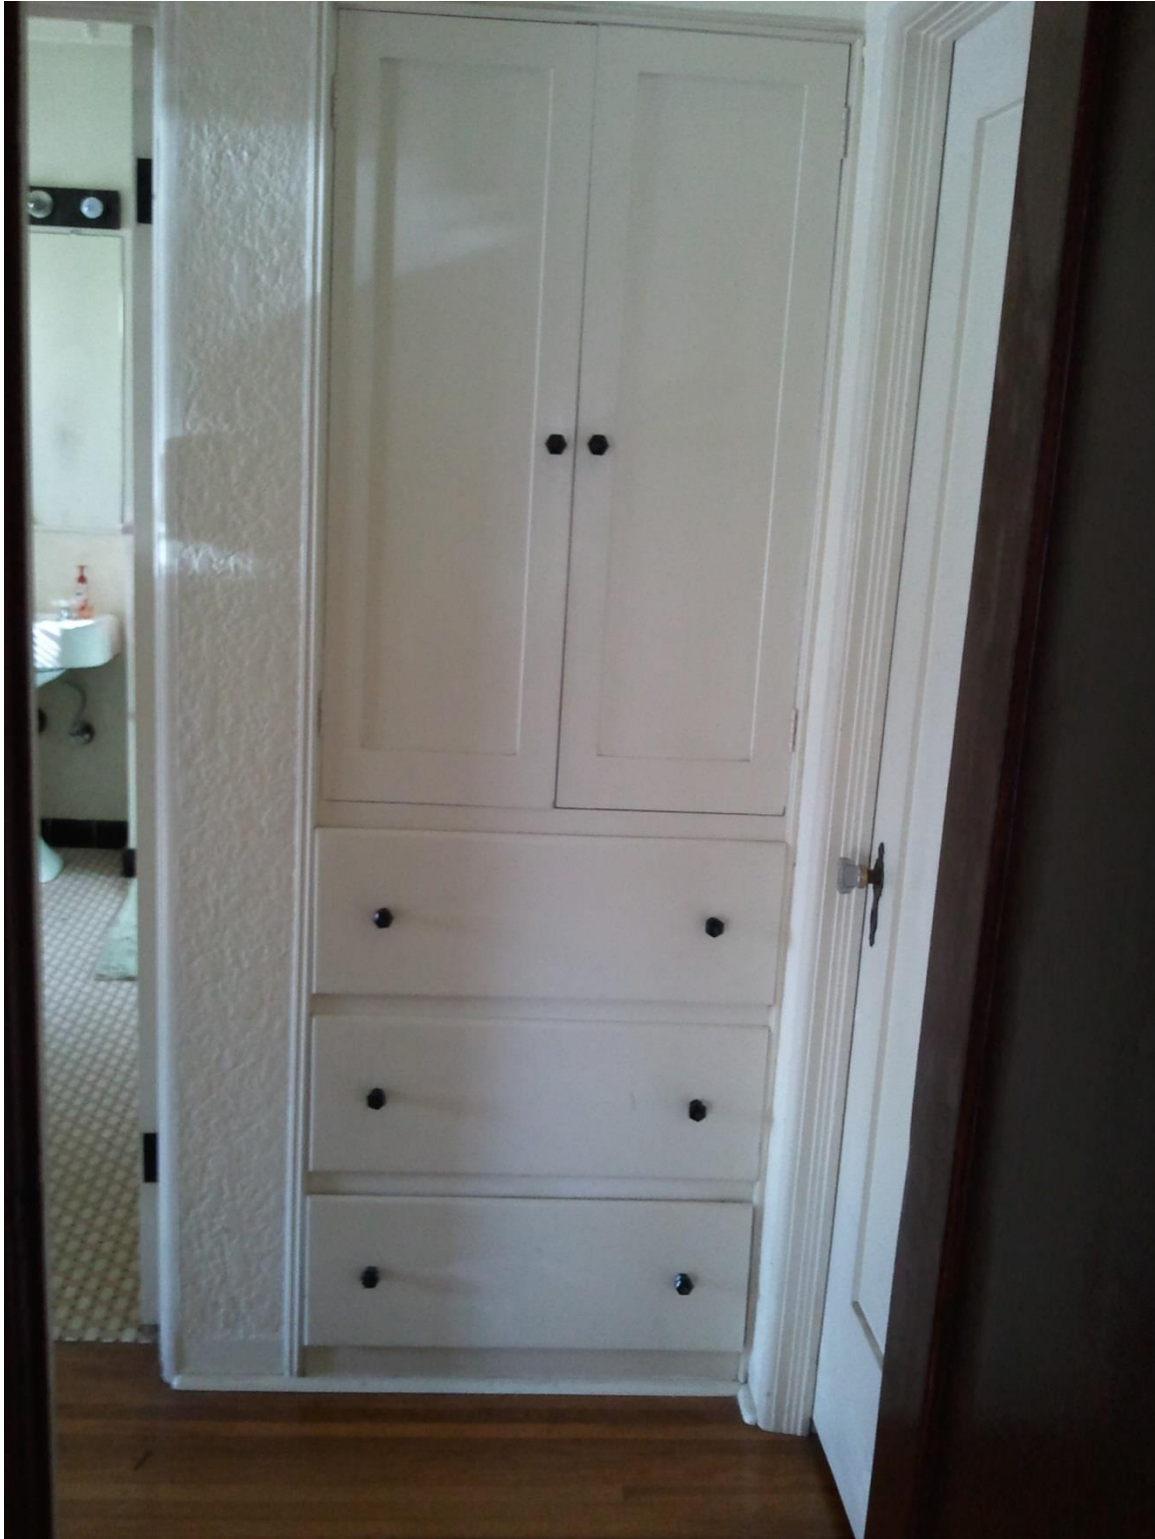
Figure 26: 2746 Copley, detail view of built-in storage & typical interior door. Image Source: IS Architecture, December 2013.
