THE CITY OF SAN DIEGO

MEMORANDUM

SUBJECT: City of San Diego Master Storm Water System Maintenance Program (MMP)
Substantial Conformance Review for Upper and Lower Alvarado Creek Channel
Maintenance Project; MMP Maps 59, 60 and 64

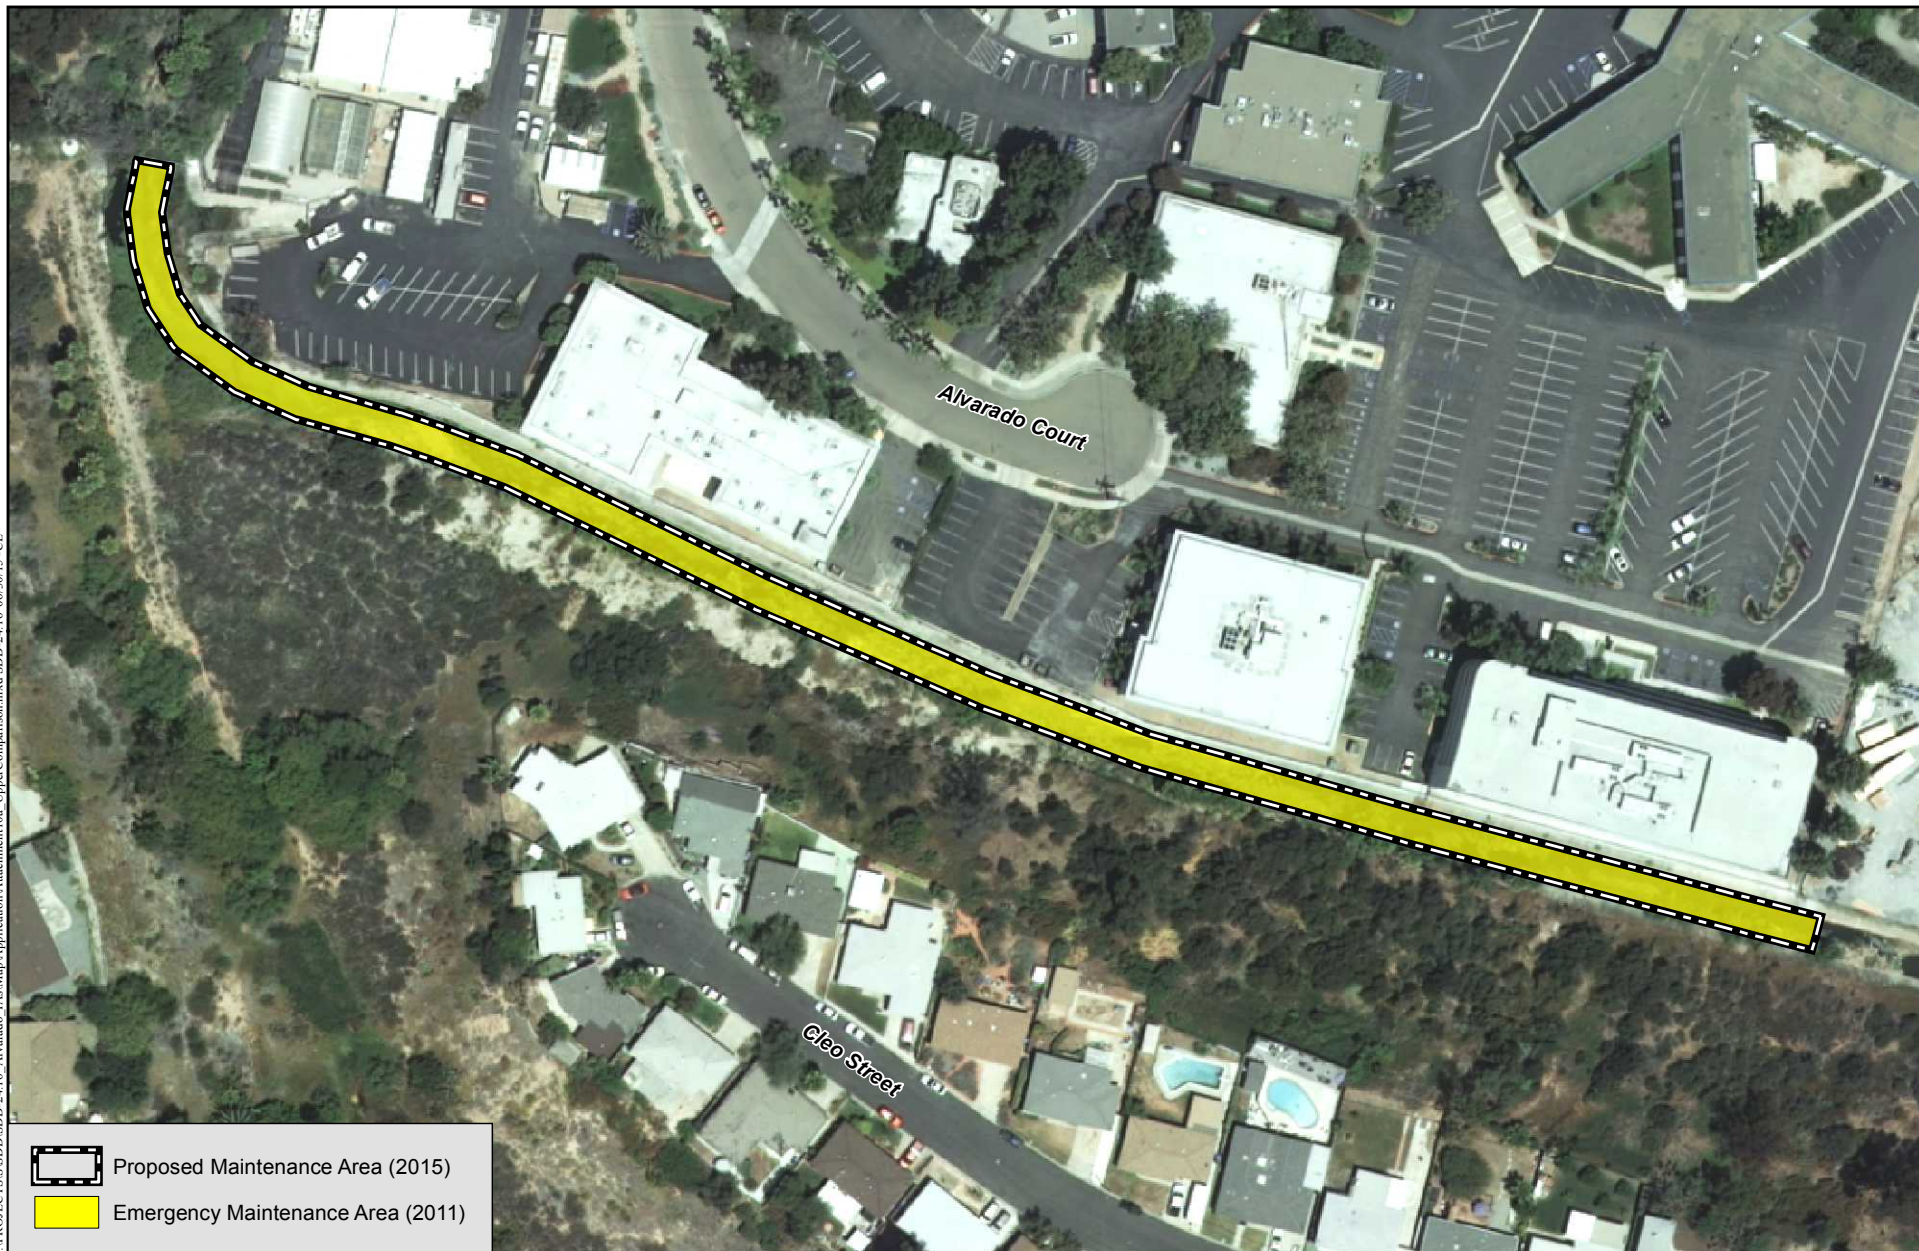
Attachment 10a

Comparison of Emergency and Proposed Maintenance Areas

UPPER ALVARADO CREEK (MAP 64)

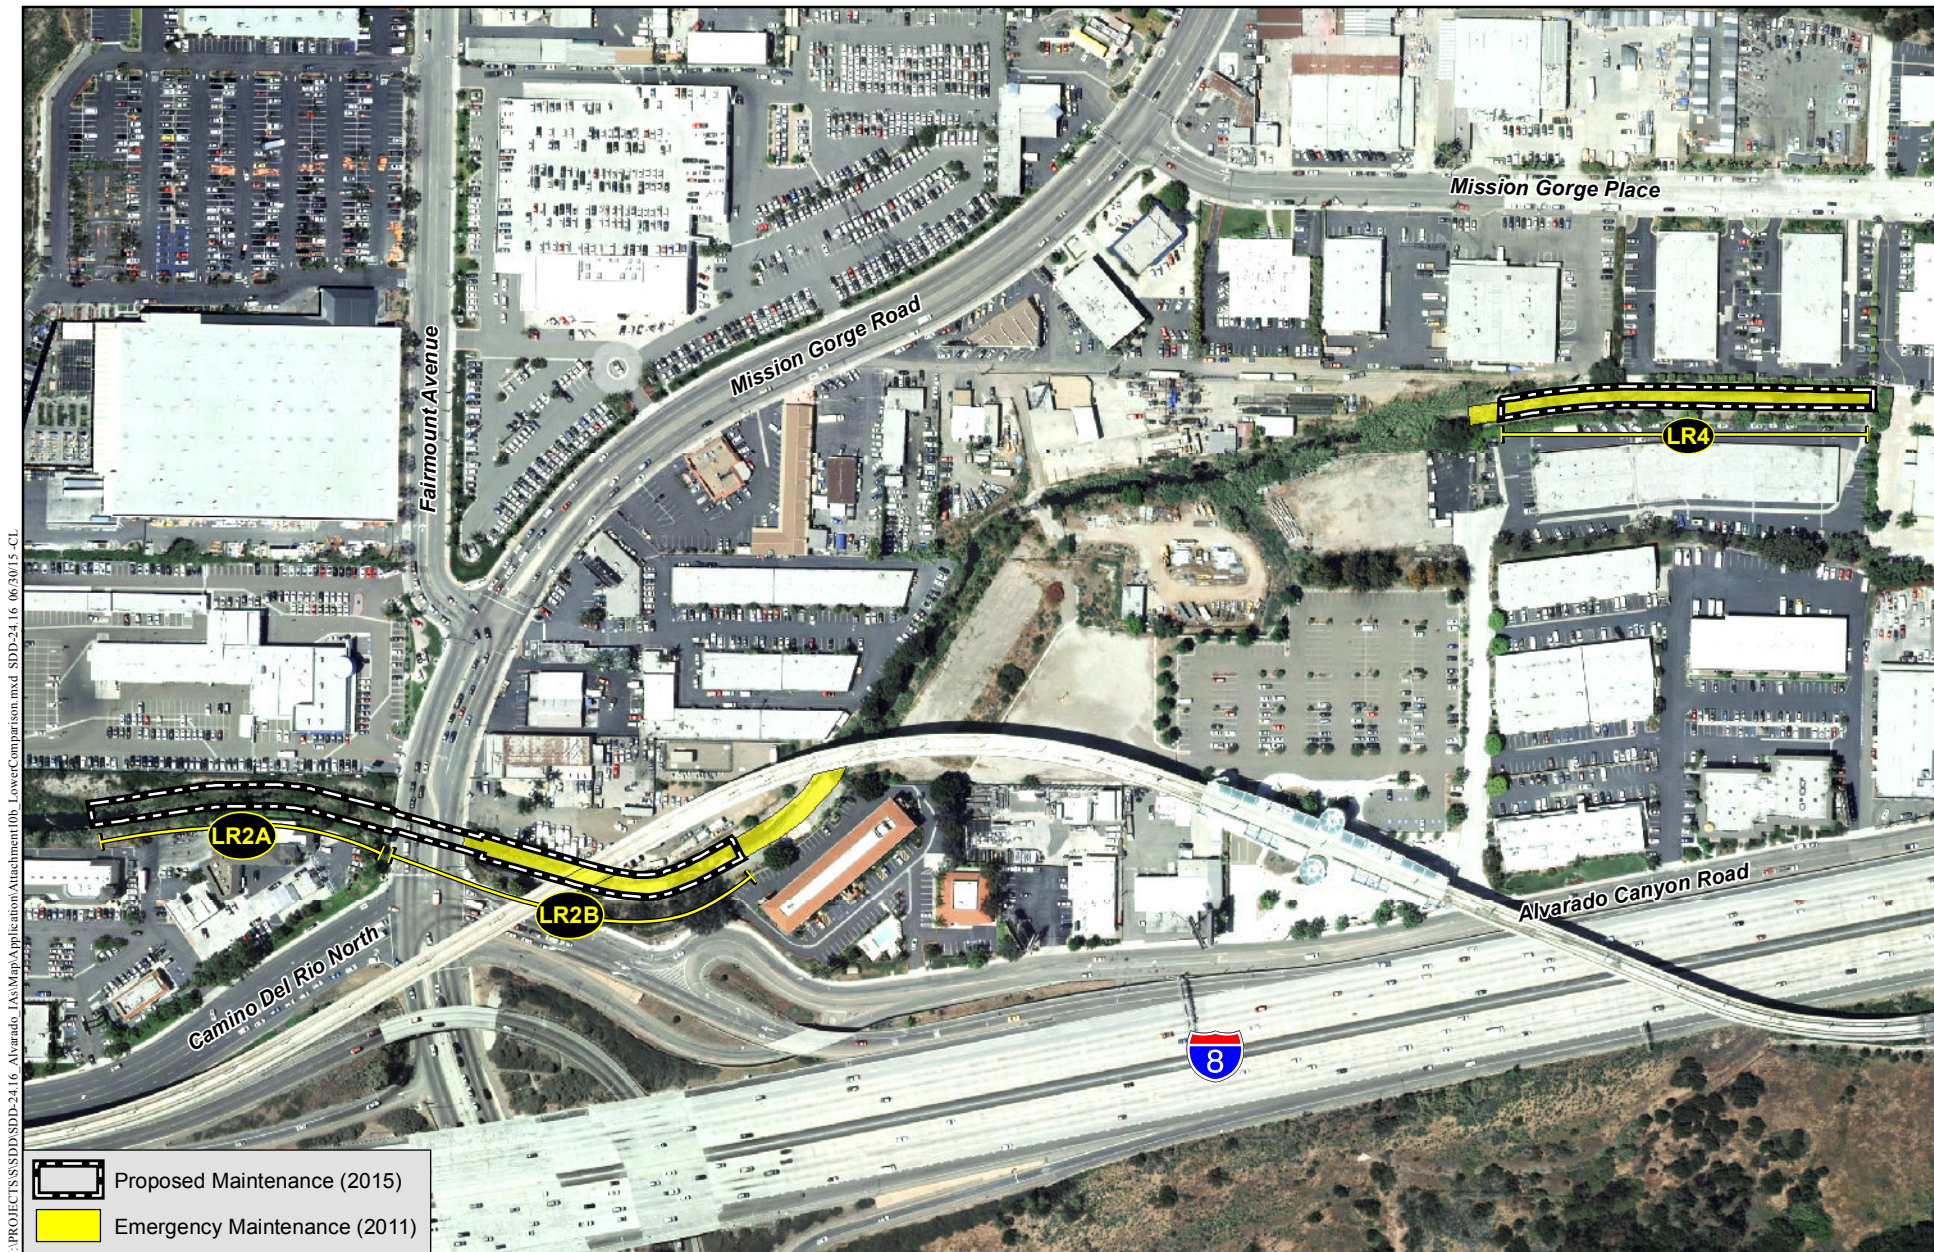
Attachment 10b

Comparison of Emergency and Proposed Maintenance Areas

LOWER ALVARADO CREEK (MAPS 59 AND 60)

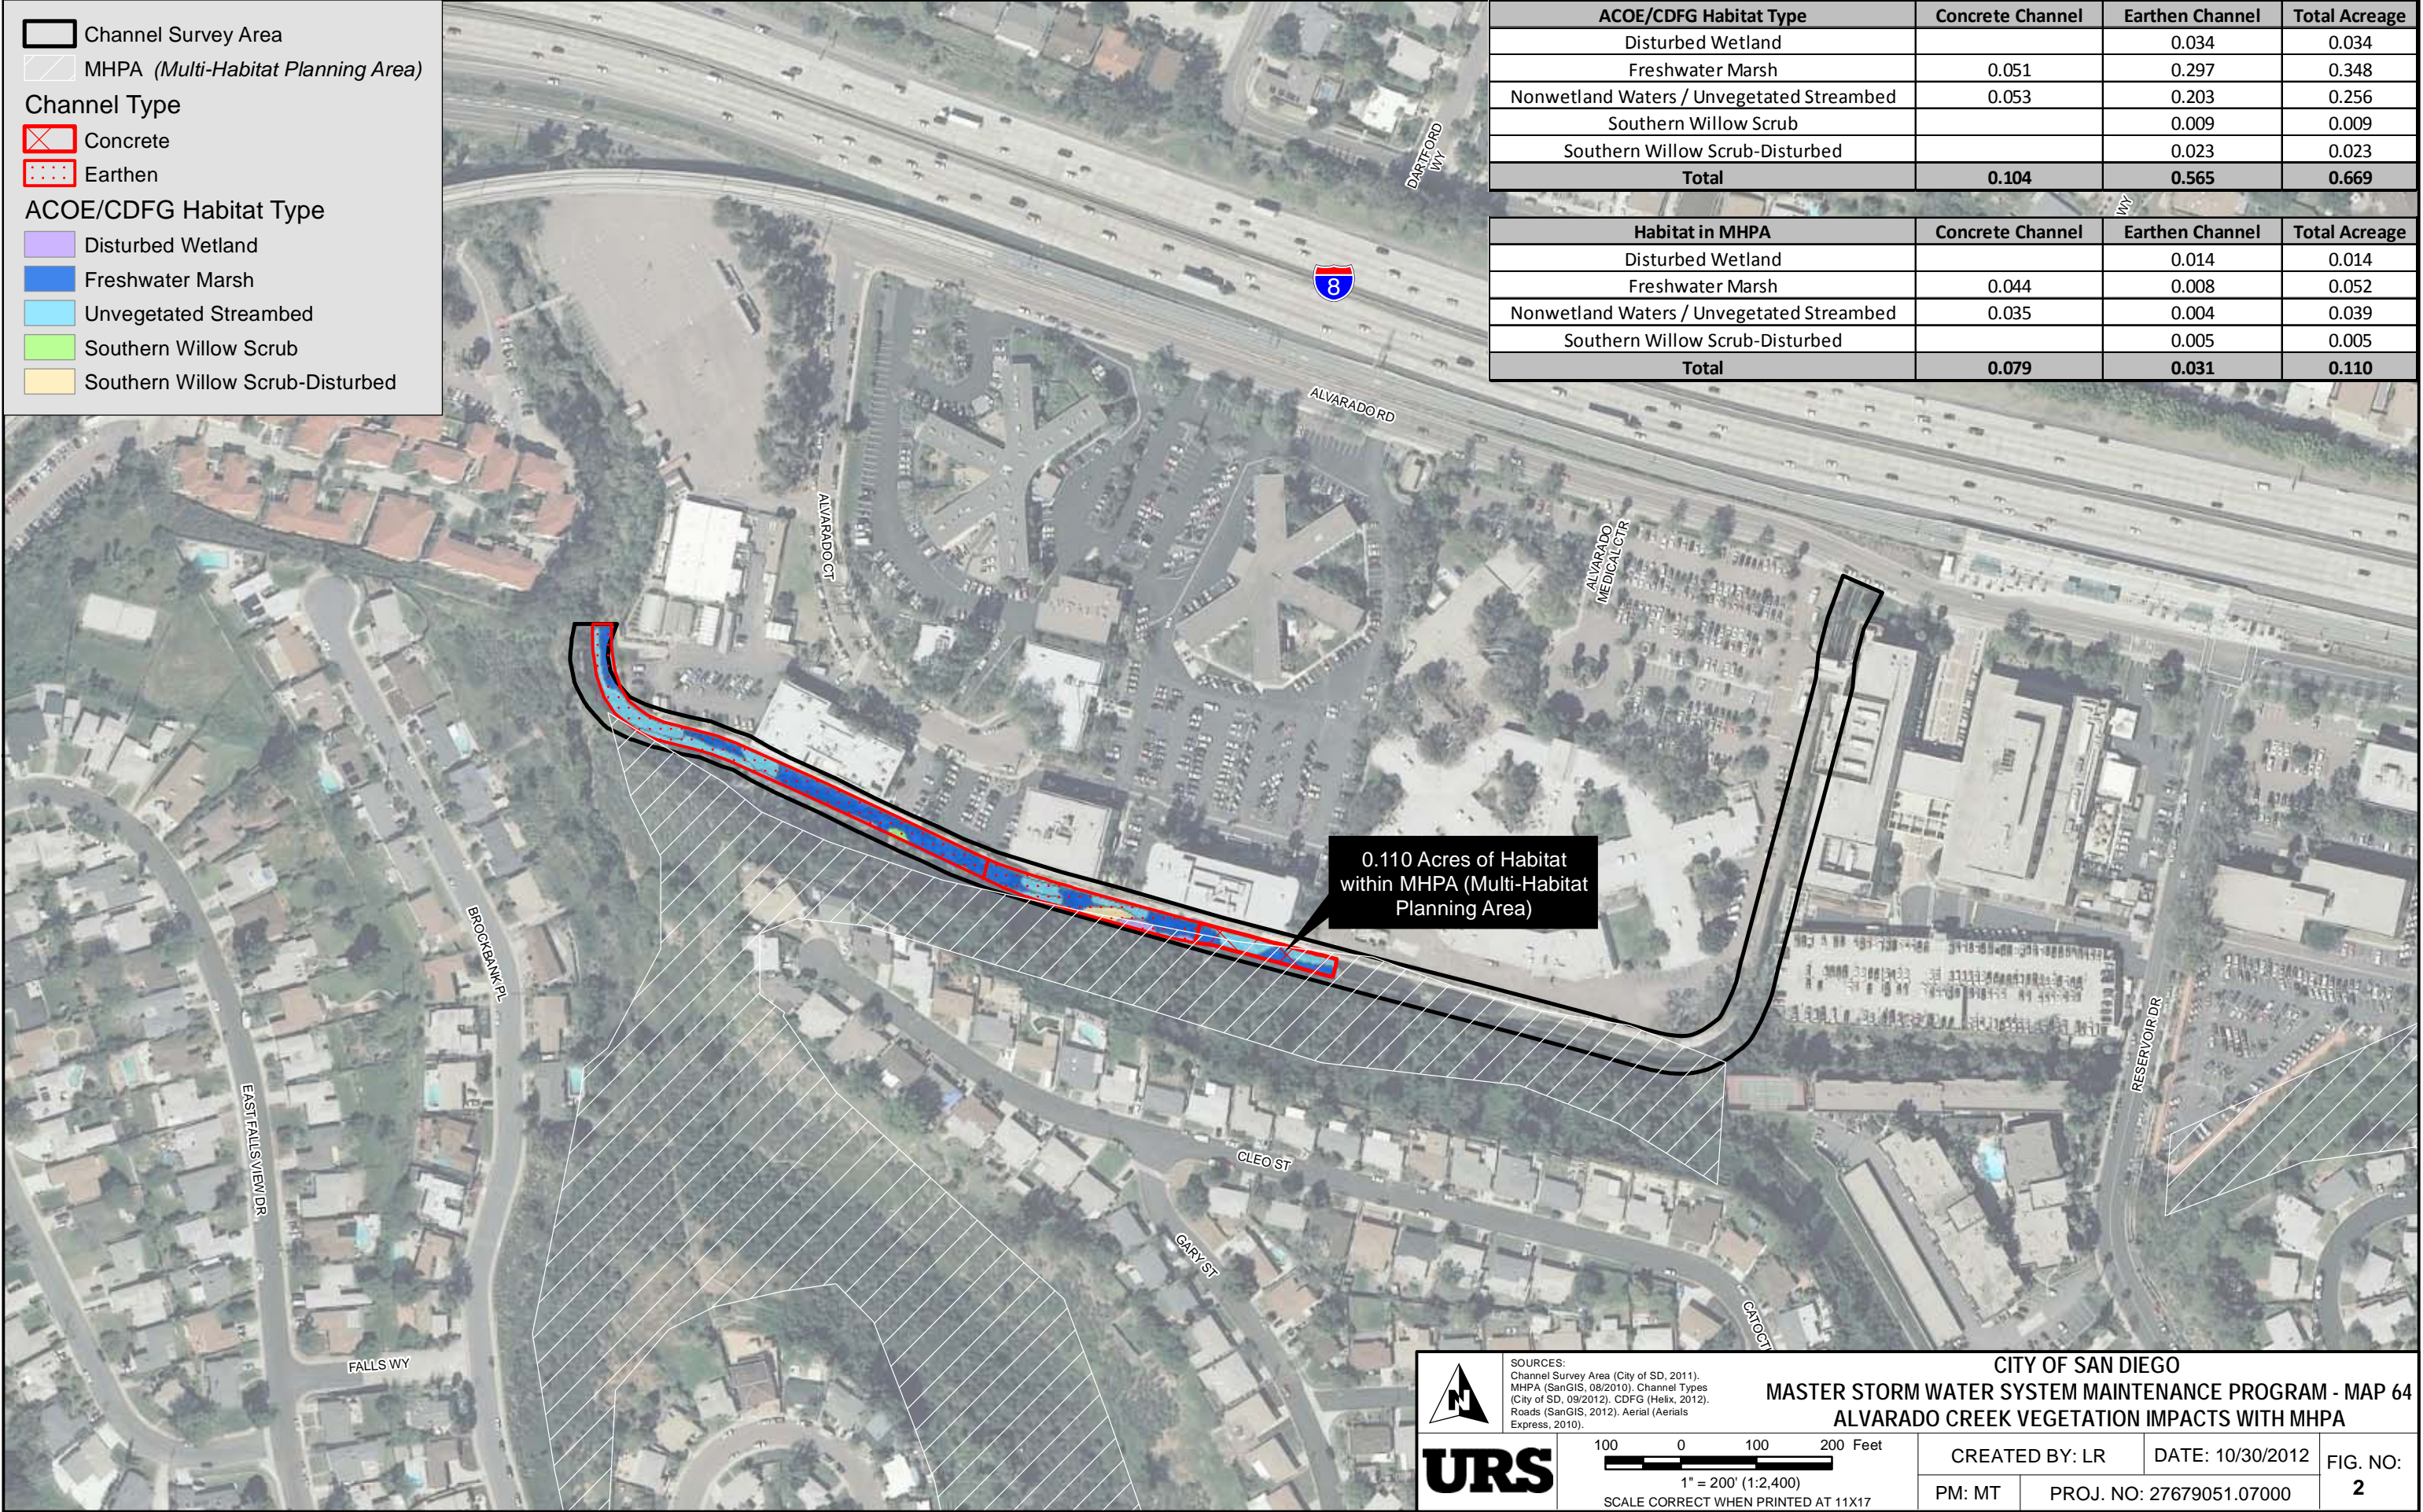
ACOE/CDFG Habitat Type	Concrete Channel	Earthen Channel	Total Acreage
Disturbed Wetland		0.034	0.034
Freshwater Marsh	0.051	0.297	0.348
Nonwetland Waters / Unvegetated Streambed	0.053	0.203	0.256
Southern Willow Scrub		0.009	0.009
Southern Willow Scrub-Disturbed		0.023	0.023
Total	0.104	0.565	0.669

Habitat in MHPA	Concrete Channel	Earthen Channel	Total Acreage
Disturbed Wetland		0.014	0.014
Freshwater Marsh	0.044	0.008	0.052
Nonwetland Waters / Unvegetated Streambed	0.035	0.004	0.039
Southern Willow Scrub-Disturbed		0.005	0.005
Total	0.079	0.031	0.110

On Map 64 (Figure 2), the MHPA boundary intersects the maintenance area at its eastern end along approximately 200 feet of the channel. Most of this section of the channel is concrete bottomed but did contain small areas of freshwater marsh and other wetland habitats. The extent and vegetation types impacted are shown on Figure 2. The total area of wetland impacts within the MHPA boundary is 0.11 acres.

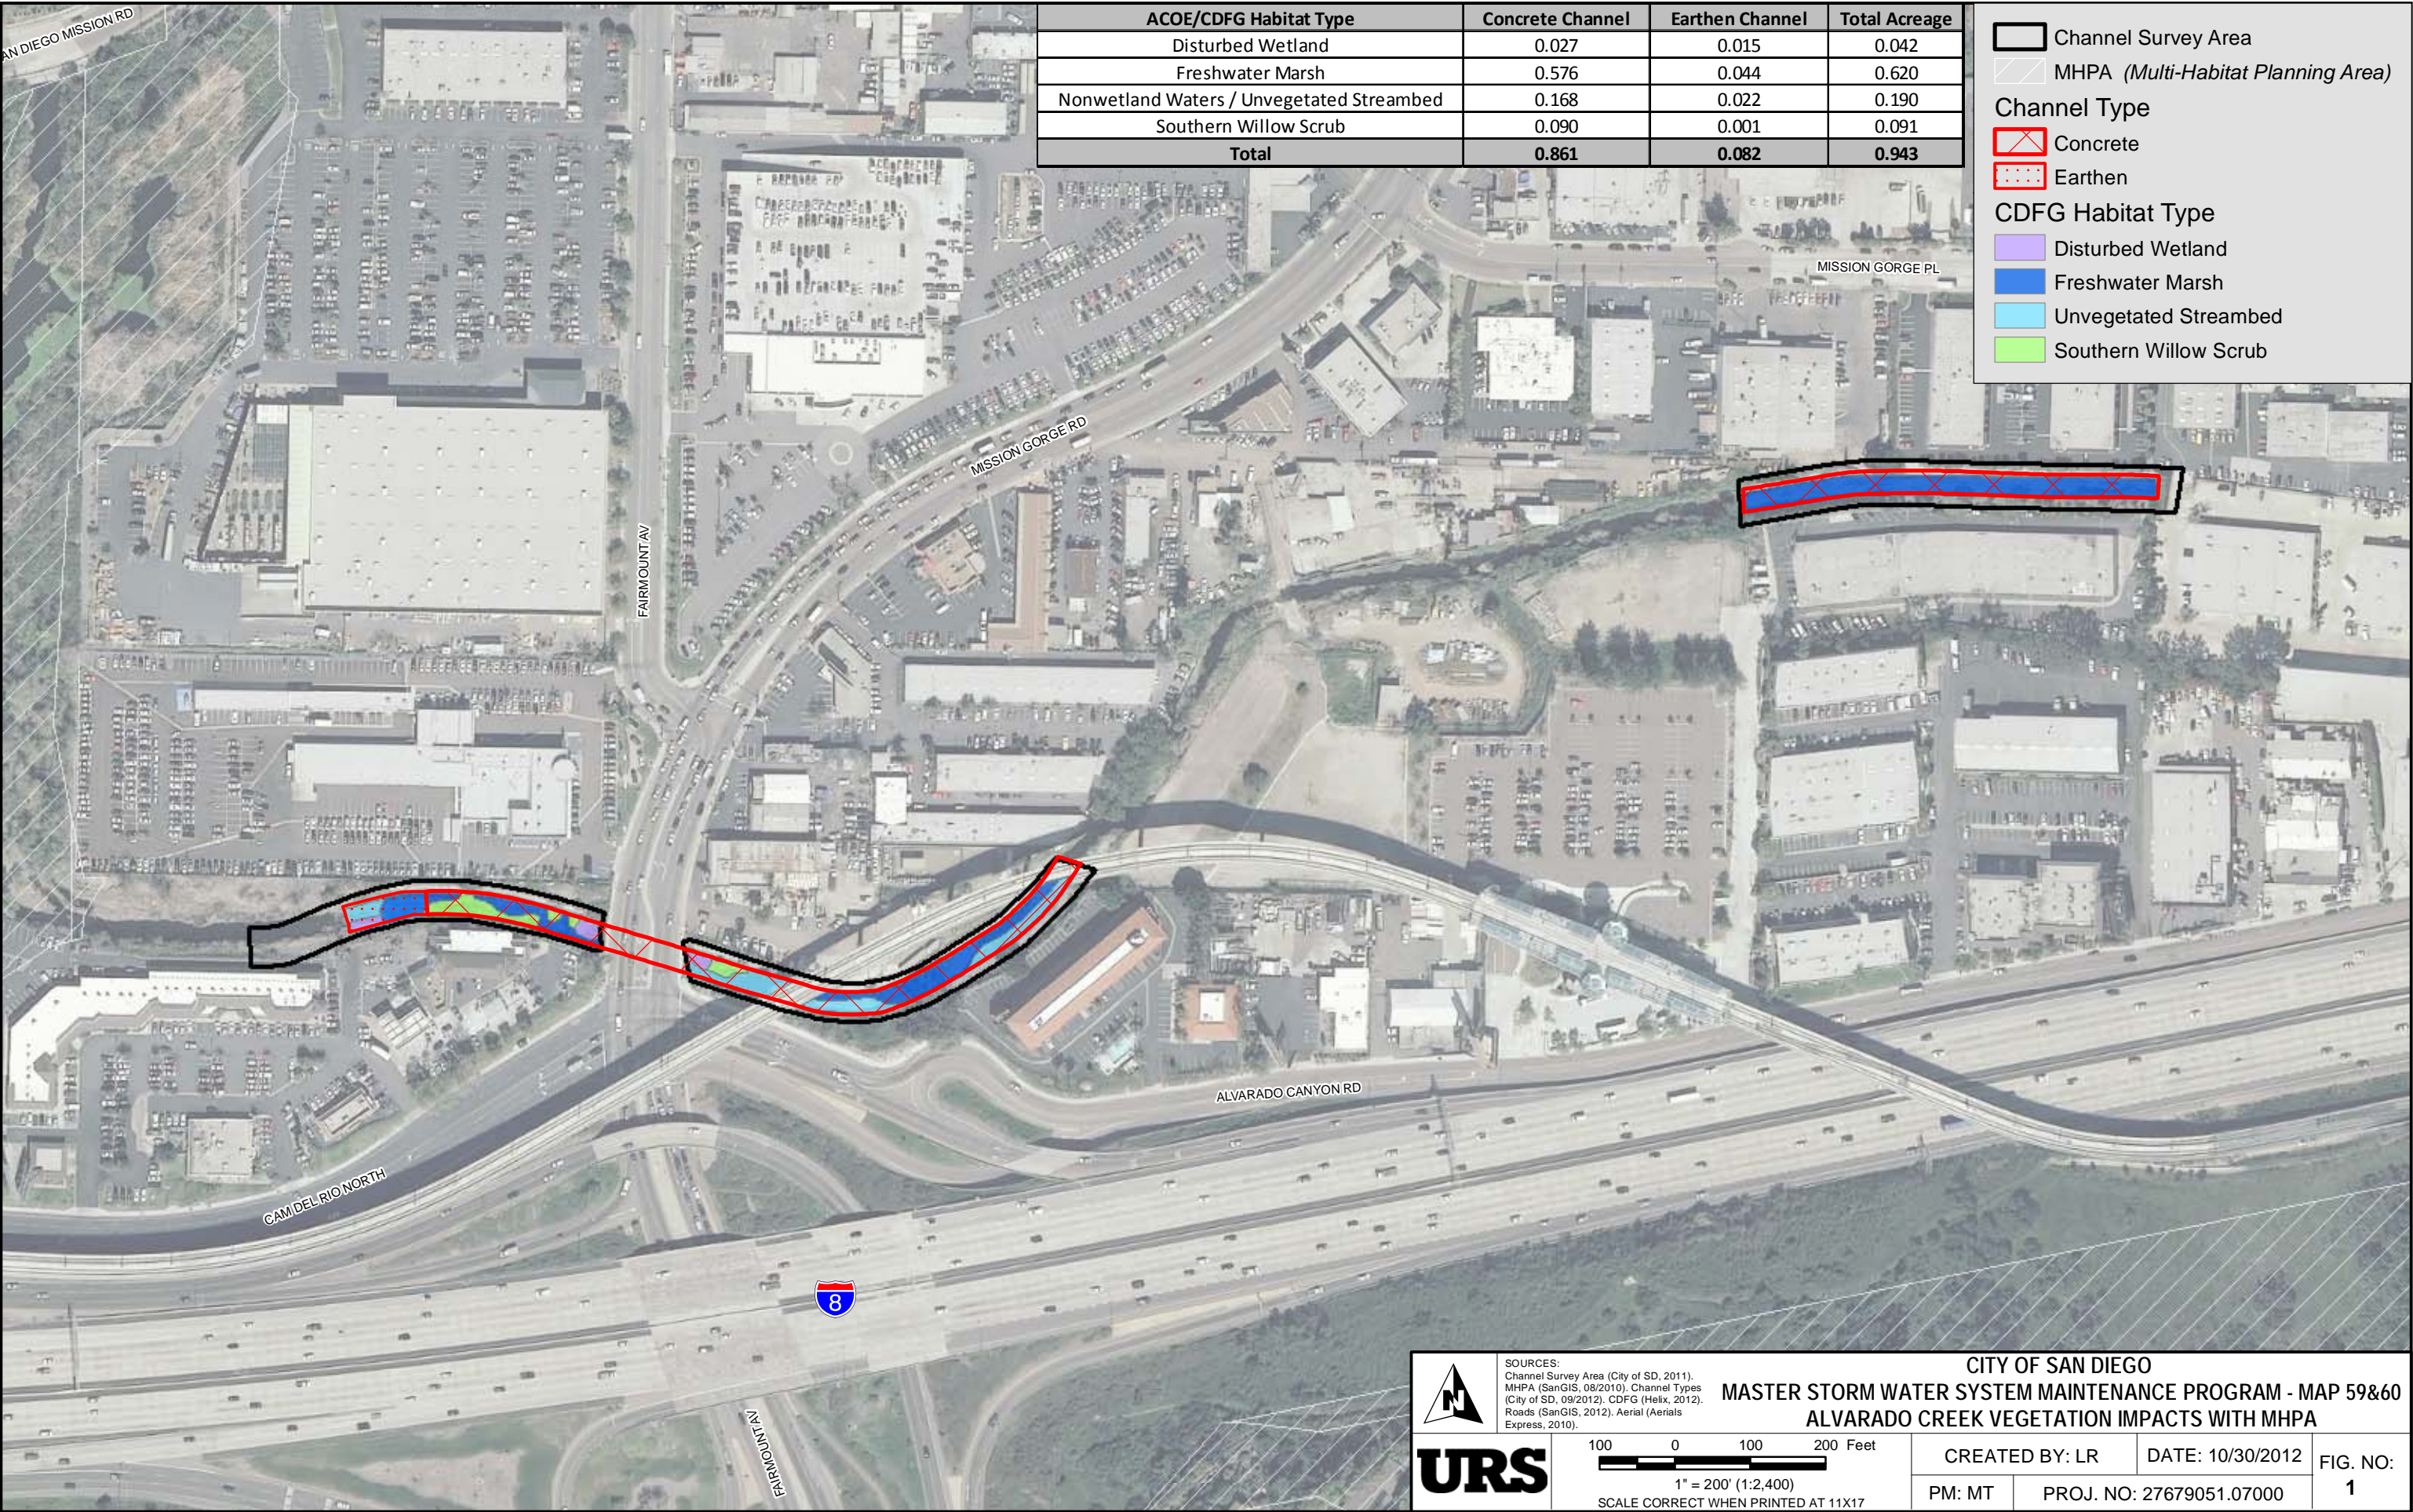
Puh: G:\gis\projects\1577\2767905\map_docs\msd\Alvarado\Alvarado_West_MHPA.mxd, paul_moreno, 10/30/2012, 12:20:34 PM

SOURCES:
Channel Survey Area (City of SD, 2011).
MHPA (SanGIS, 08/2010), Channel Types
(City of SD, 09/2012), CDFG (Helix, 2012).
Roads (SanGIS, 2012), Aerial (Aerials
Express, 2010).

MHPA boundaries near Alvarado Channel are presented on Figures 1 and 2 (attached). Maintenance work in the westernmost channel segments (Map 59, Figure 1) did not encroach into the MHPA. The MHPA boundary is located approximately 380 feet to the west of the end of the maintenance area.

The MHPA boundary is approximately 380 feet to the west of the maintenance area (Figure 1). Numerous factors make the area unsuitable for Least Bell’s Vireo (LBV) including, (1) the general lack or sparse density of trees that might provide habitat (2) the extensive patches of non-native species that do not provide habitat, (3) the upper banks of the channel are immediately adjacent to parking lots and other commercial development, and (4) Fairmont/Mission Gorge is a very busy roadway and is immediately adjacent to the maintenance area. These conditions are not conducive to LBV occupation or breeding and resulted in the conclusion of the IBA authors that the area has limited wildlife habitat value. URS biologists concur with this conclusion. The area may have some potential to serve as a wildlife corridor however this is also limited due to habitat discontinuities in the upstream direction (to the east).

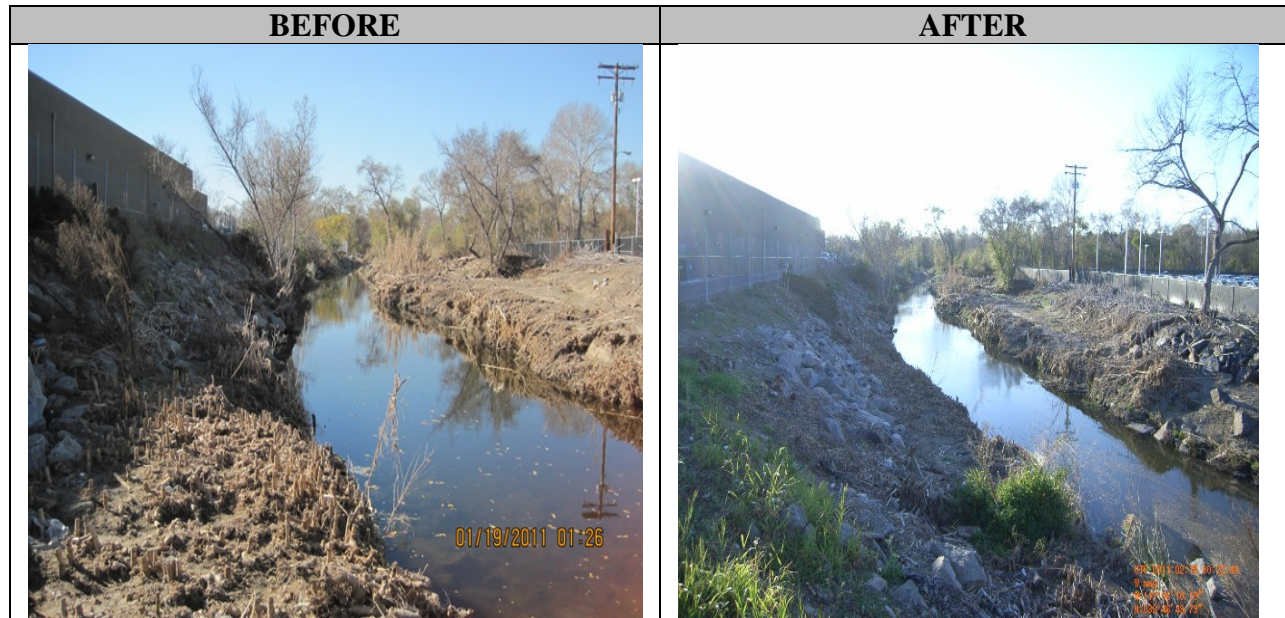
PHOTO NOTES: View from midpoint of west boundary of Map 59 & Mission Gorge Road Bridge (MGRB).
Looking downstream in western direction. (No maintenance conducted in this segment)

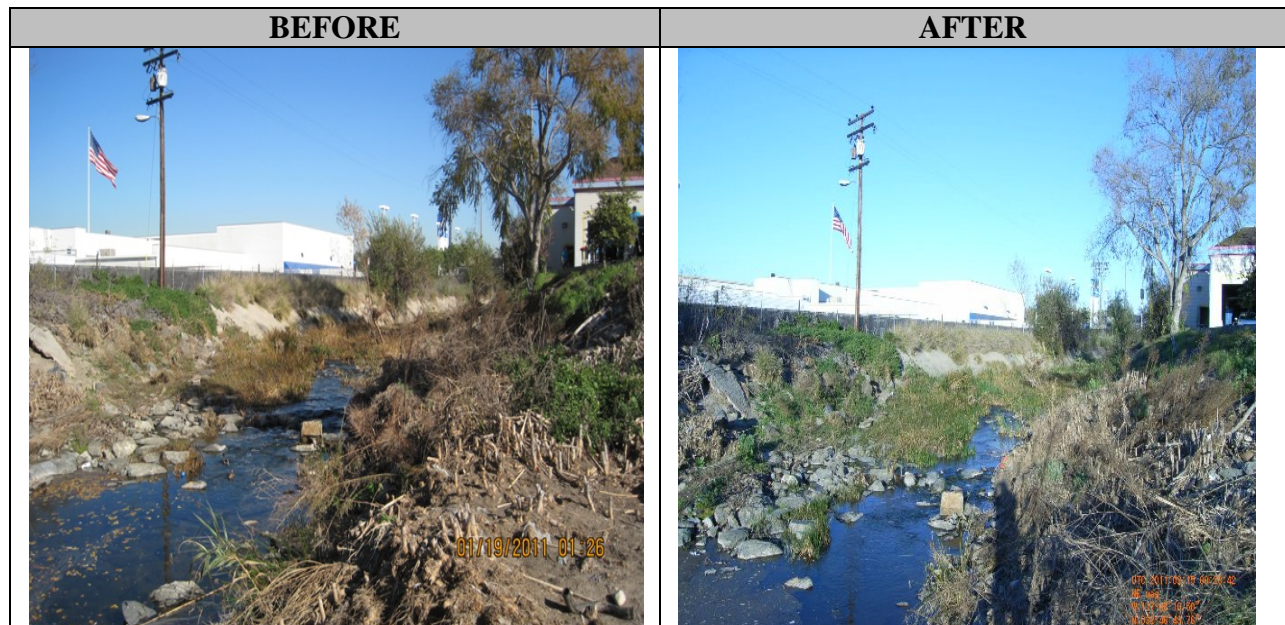
PHOTO NOTES: View from midpoint of west end of Map 59 and MGRB. Looking upstream in eastern direction.
(No maintenance conducted in this segment.)

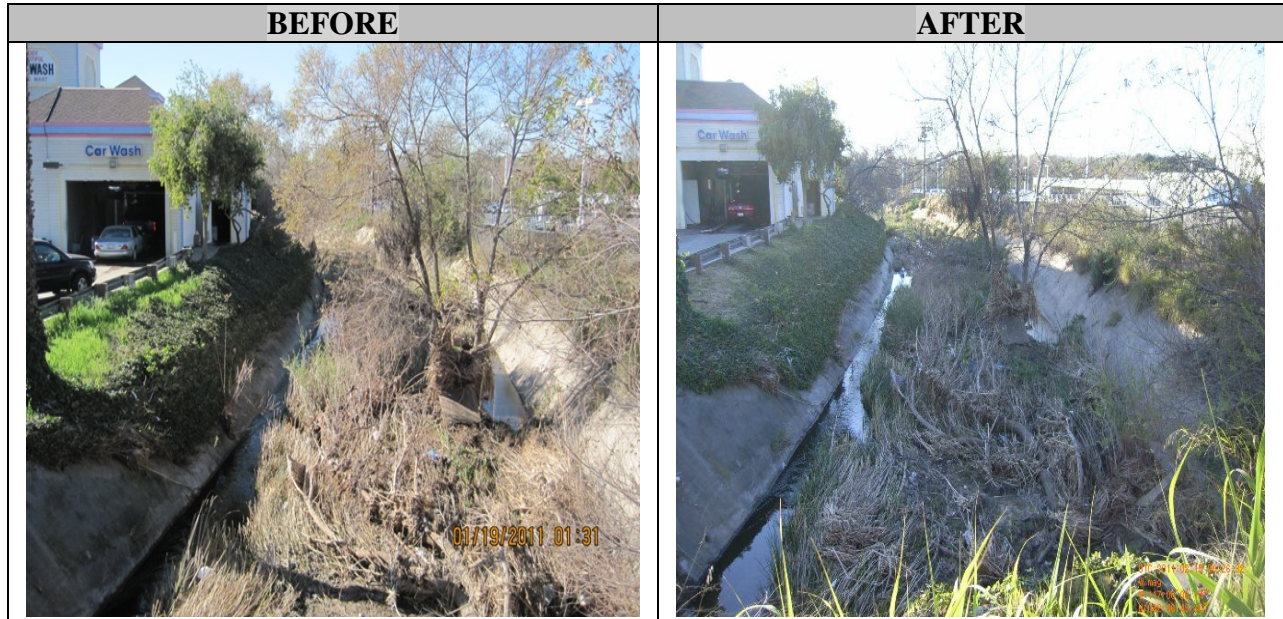
PHOTO NOTES: View looking downstream in western direction from MGRB. (No maintenance conducted in this segment).

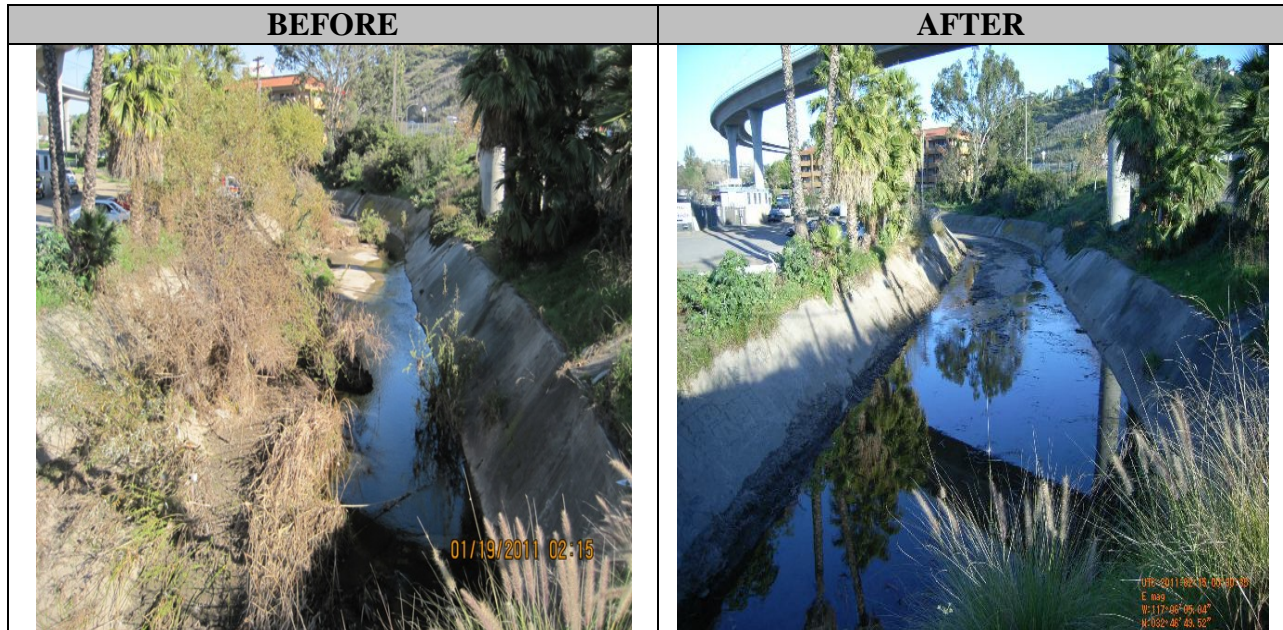
PHOTO NOTES: View looking upstream in eastern direction from MGRB.

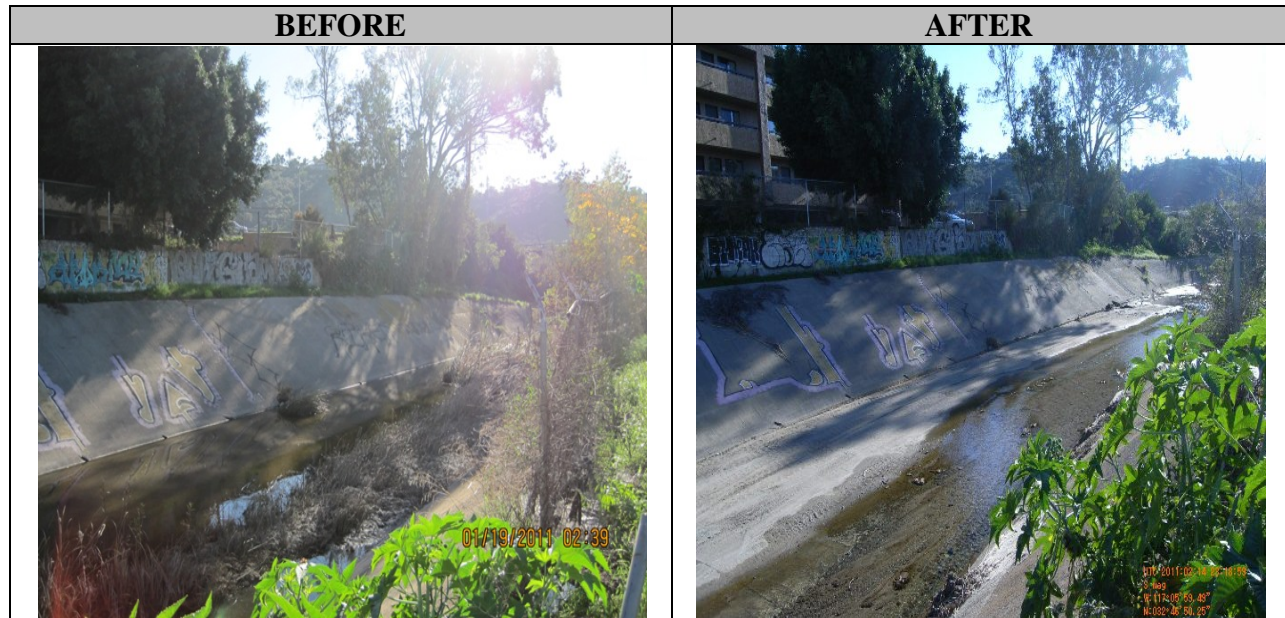
PHOTO NOTES: View from about twenty feet from end of concrete lined channel and start of earthen channel at a segment between auto repair shop and hotel near MGRB. Looking downstream towards east side of MGRB.

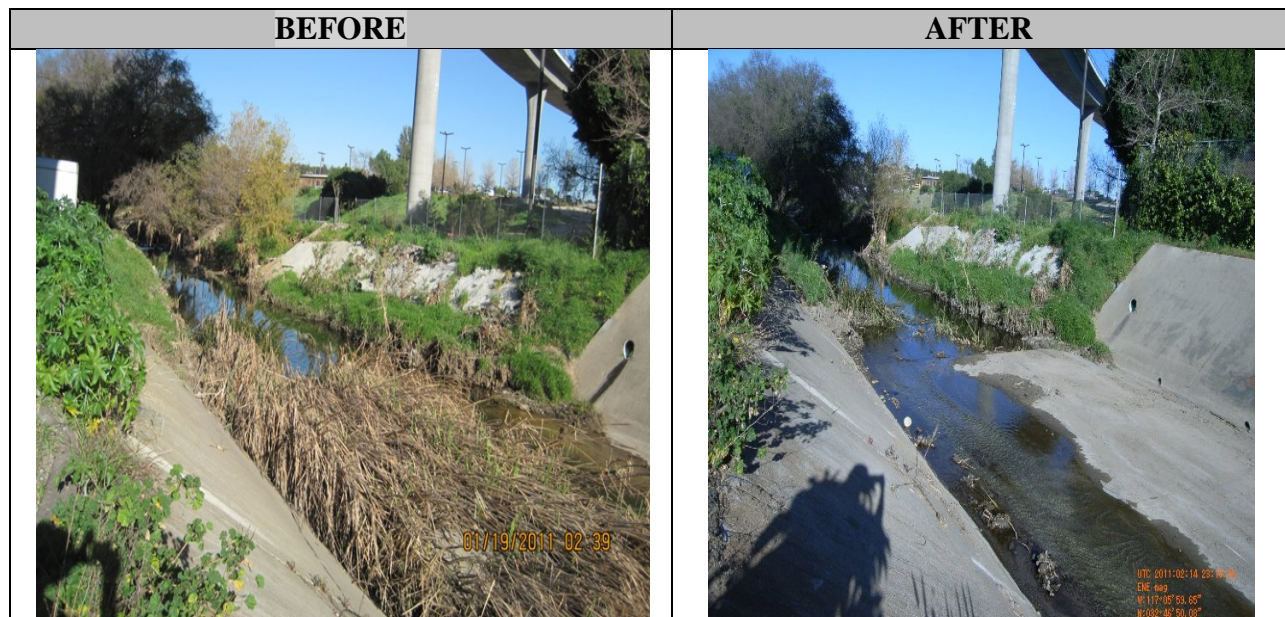
PHOTO NOTES: View from about twenty feet from end of concrete lined channel & start of earthen channel. This segment is between auto repair shop and hotel near MGRB (east side). Looking upstream in eastern direction.

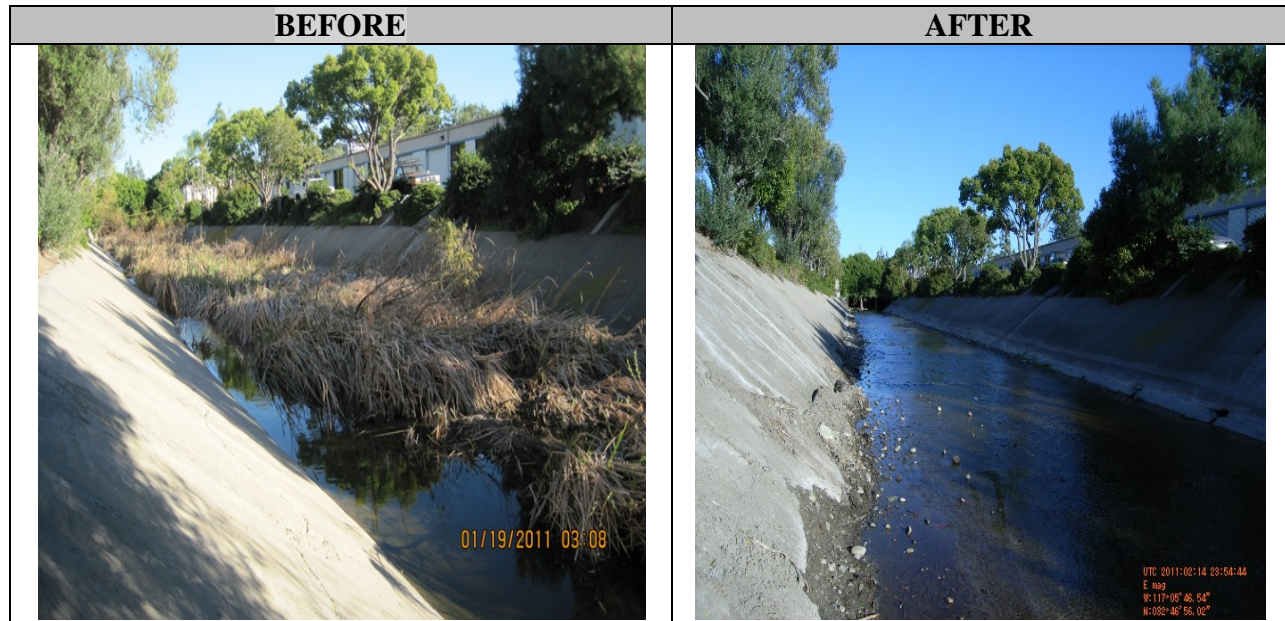
PHOTO NOTES: View from access point to box drain culvert at east end of map 60. Looking in eastern direction towards box drain culvert.

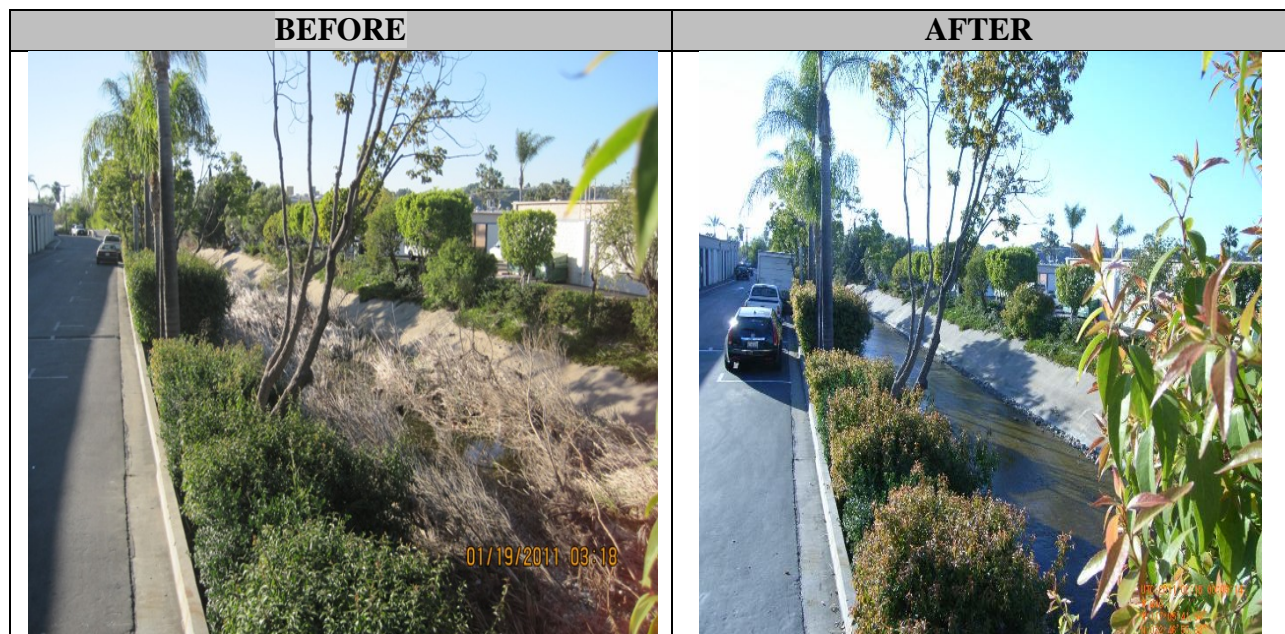
PHOTO NOTES: View from south side of channel next to box drain culvert at east end of Map 60 Looking downstream in western direction.

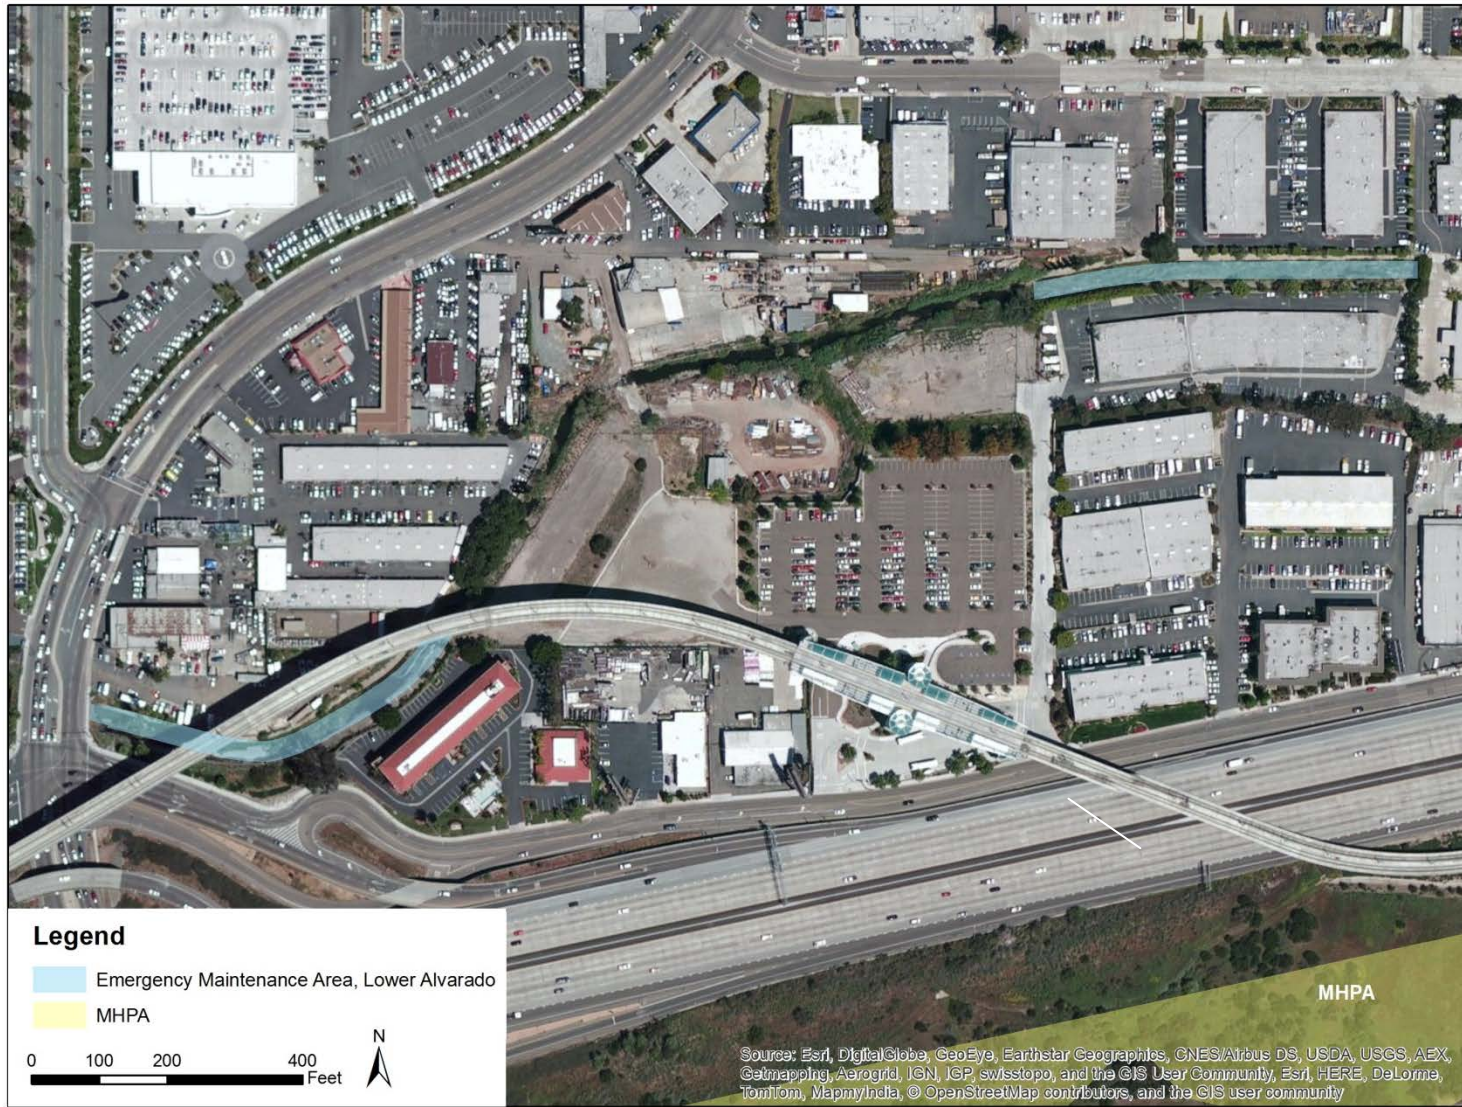
Figure 1: Map of Emergency Maintenance, Lower Alvarado. Though satellite imagery was obtained 07-13-15, it is substantially representative of surrounding landmarks as of the dates of maintenance.

- Using photos from the original Feb 2011 IMAR;
- Confirming work areas with Equipment Operator Ed Rodriguez on July 13 and 14, 2015, to reflect that maintenance was limited to the impact area depicted in Figure 1;
- Confirming channel substrate in the field
- Editing sections of the IMAR for clarity and consistency; and
- Correcting impact length and acreages using the GIS shapefiles from Figure 1 of this IMAR.

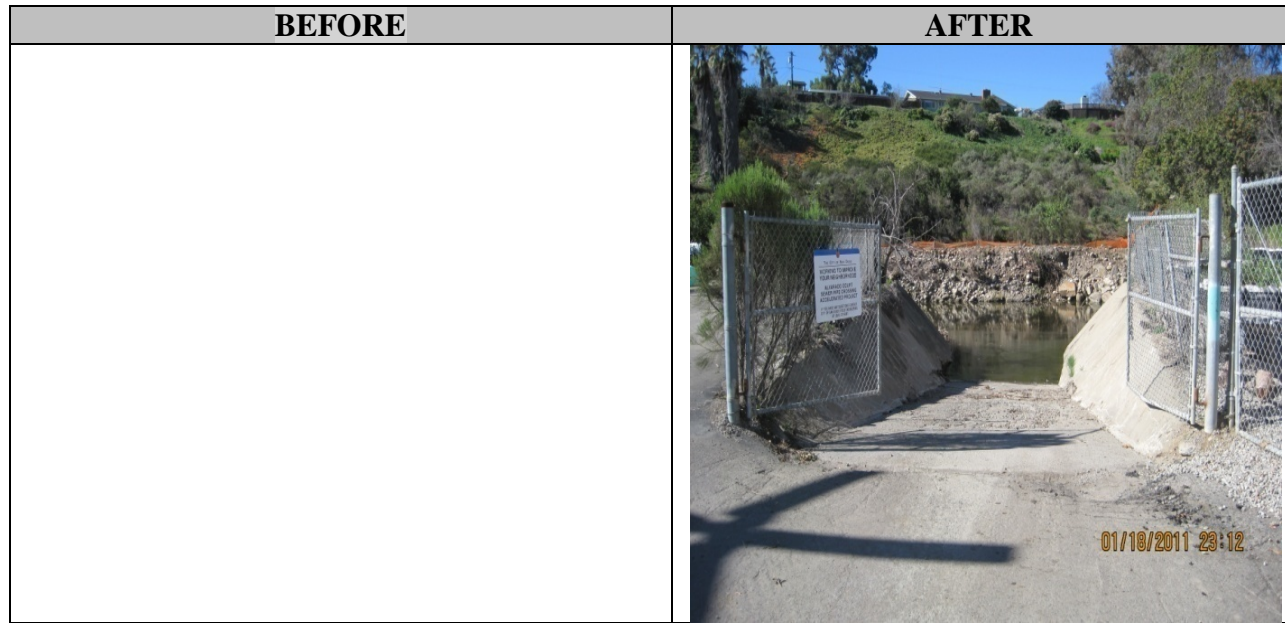
PHOTO NOTES: View of concrete access ramp about 280 feet from west end of Map 64. Concrete-lined & earthen channel. Looking at side profile of channel from north side.
