THE CITY OF SAN DIEGO

MEMORANDUM

SUBJECT: City of San Diego Master Storm Water System Maintenance Program (MMP)
Substantial Conformance Review for Upper and Lower Alvarado Creek Channel
Maintenance Project; MMP Maps 59, 60 and 64

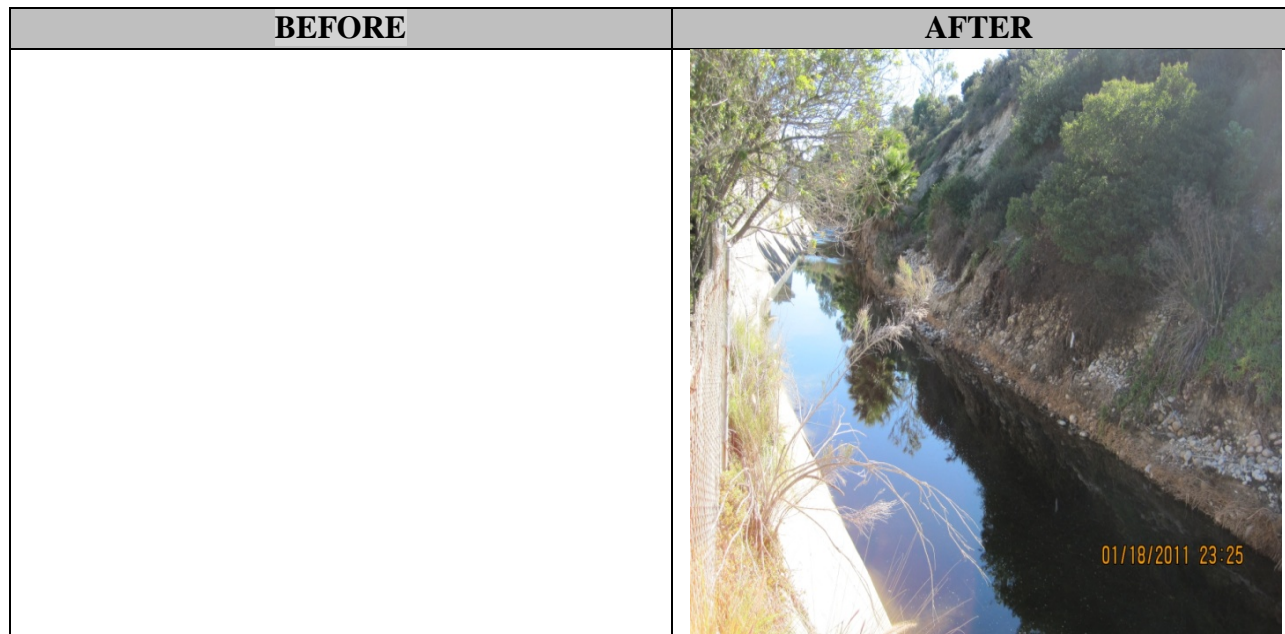
PHOTO NOTES: View from east side of access ramp. Looking upstream in eastern direction.

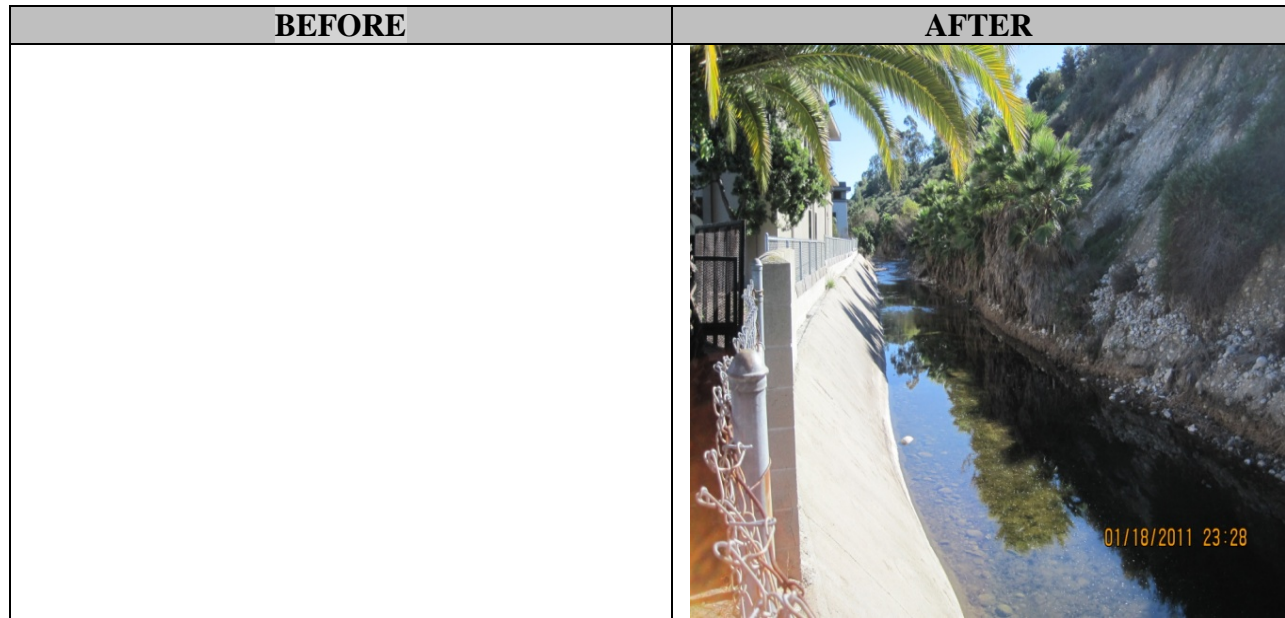
PHOTO NOTES: View from midpoint of parking area at 6363 Alvarado Court. Looking upstream in eastern direction.

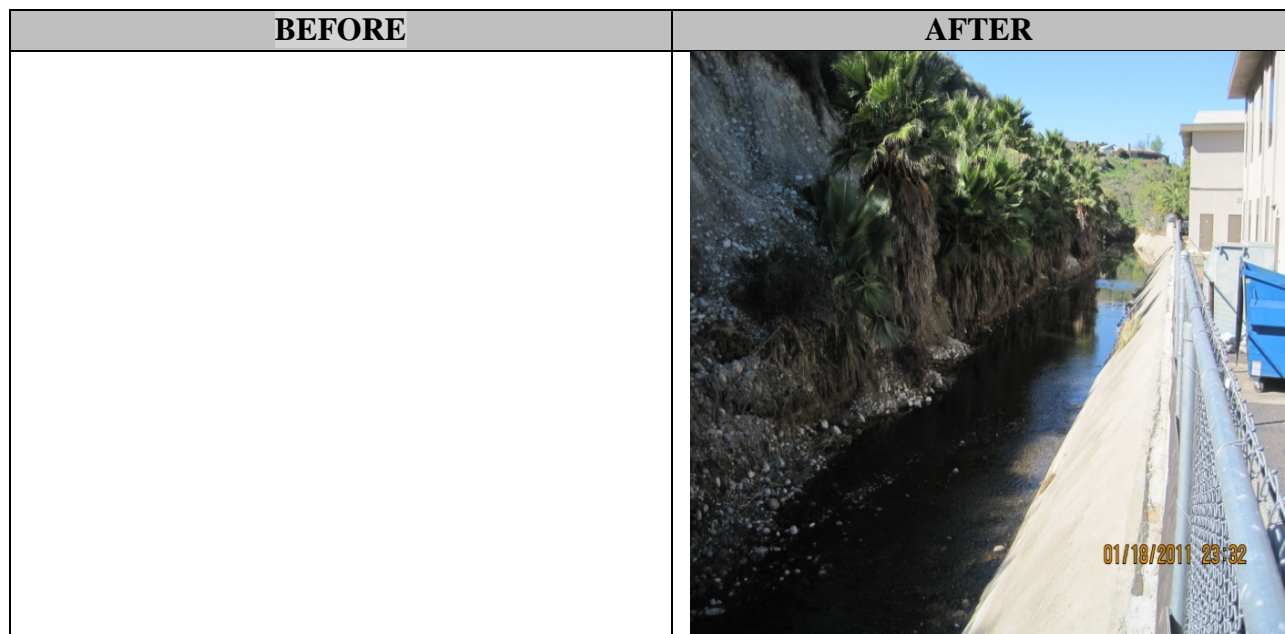
PHOTO NOTES: View from midpoint between 6363 and 6367 Alvarado Court. Looking downstream towards west end of Map 64.

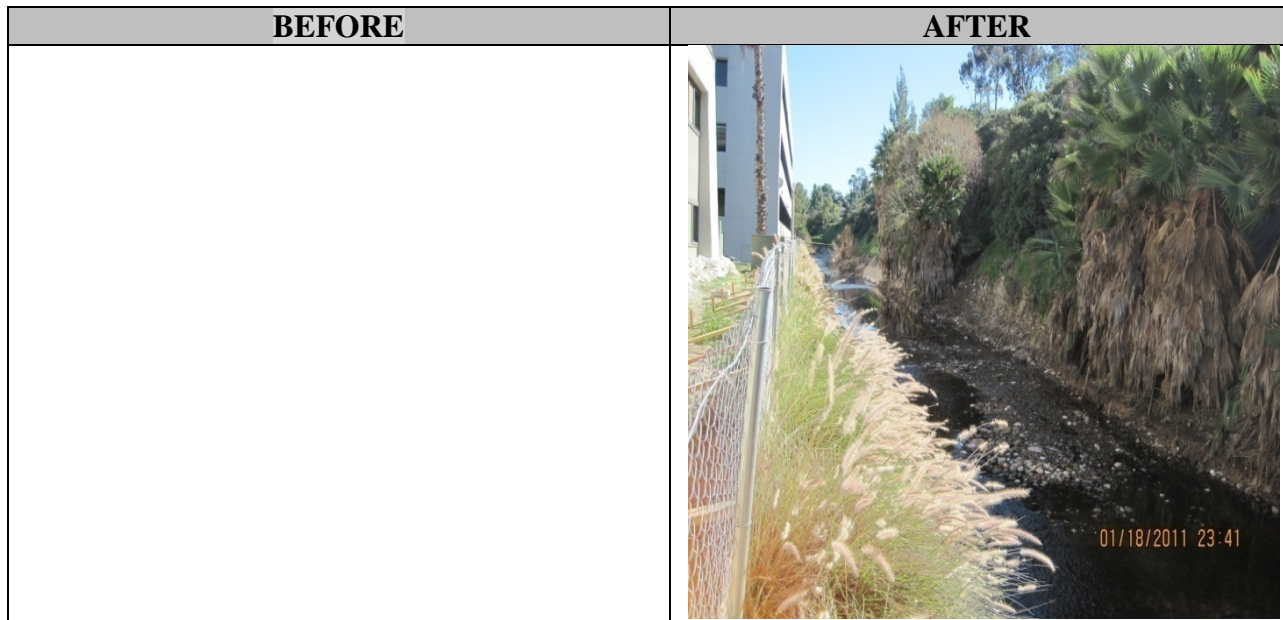
PHOTO NOTES: View from midpoint of 6367 Alvarado Court. Looking upstream in eastern direction.

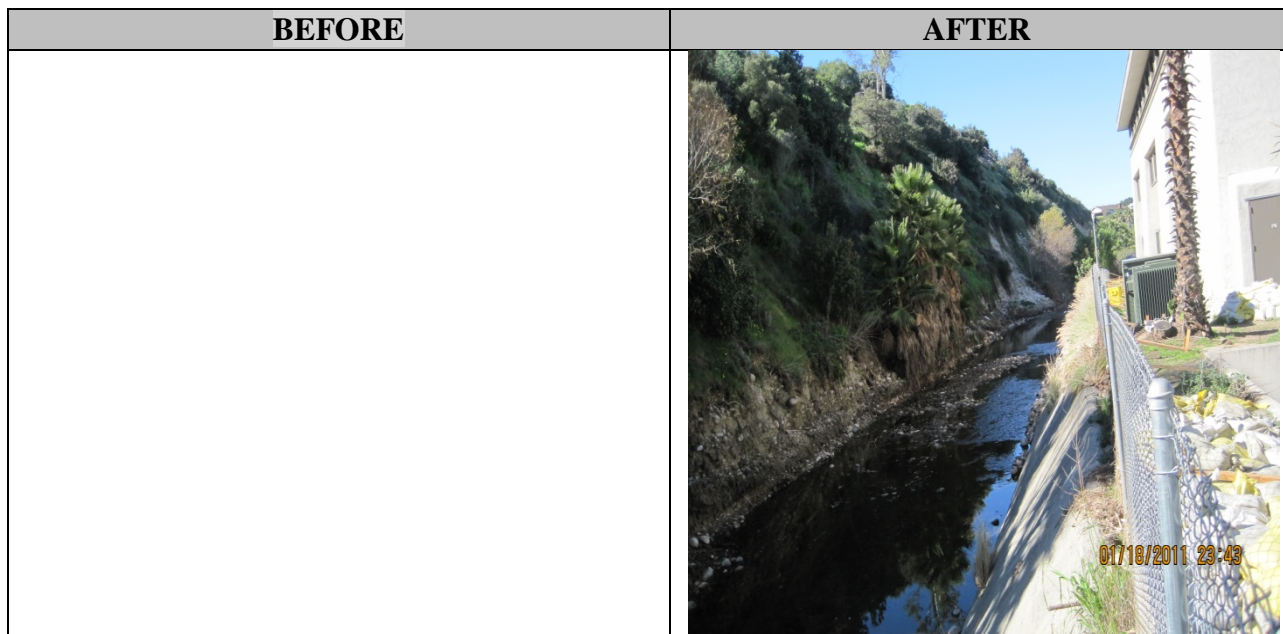
PHOTO NOTES: View from midpoint between 6367 and 6386 Alvarado Court. Looking downstream in western direction.

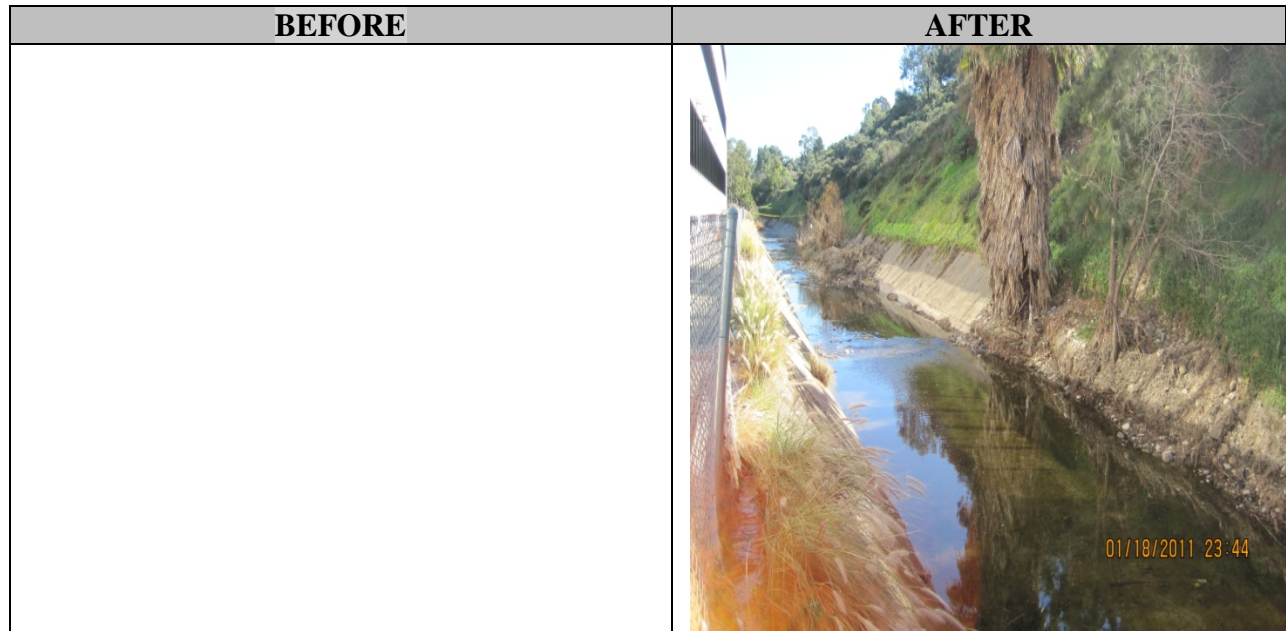
PHOTO NOTES: View from midpoint between 6367 and 6386 Alvarado Court. Looking upstream towards east end of Map 64.

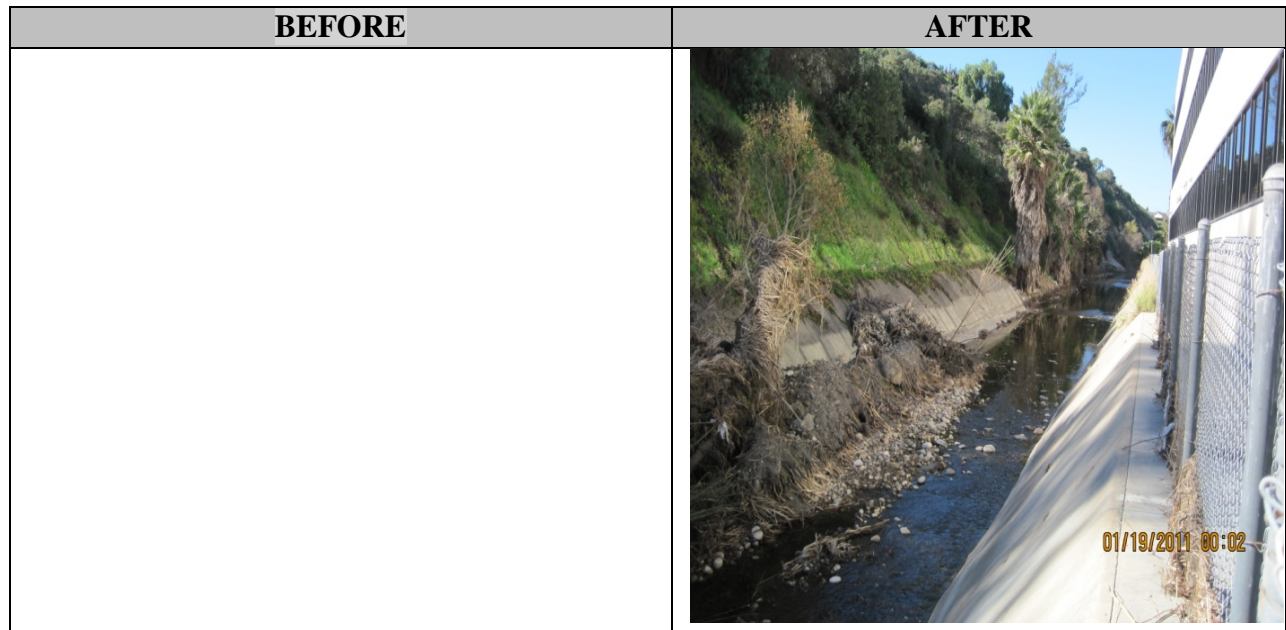
PHOTO NOTES: View from north side of channel at east end of bldg at 6386 Alvarado Court. Looking downstream in western direction.

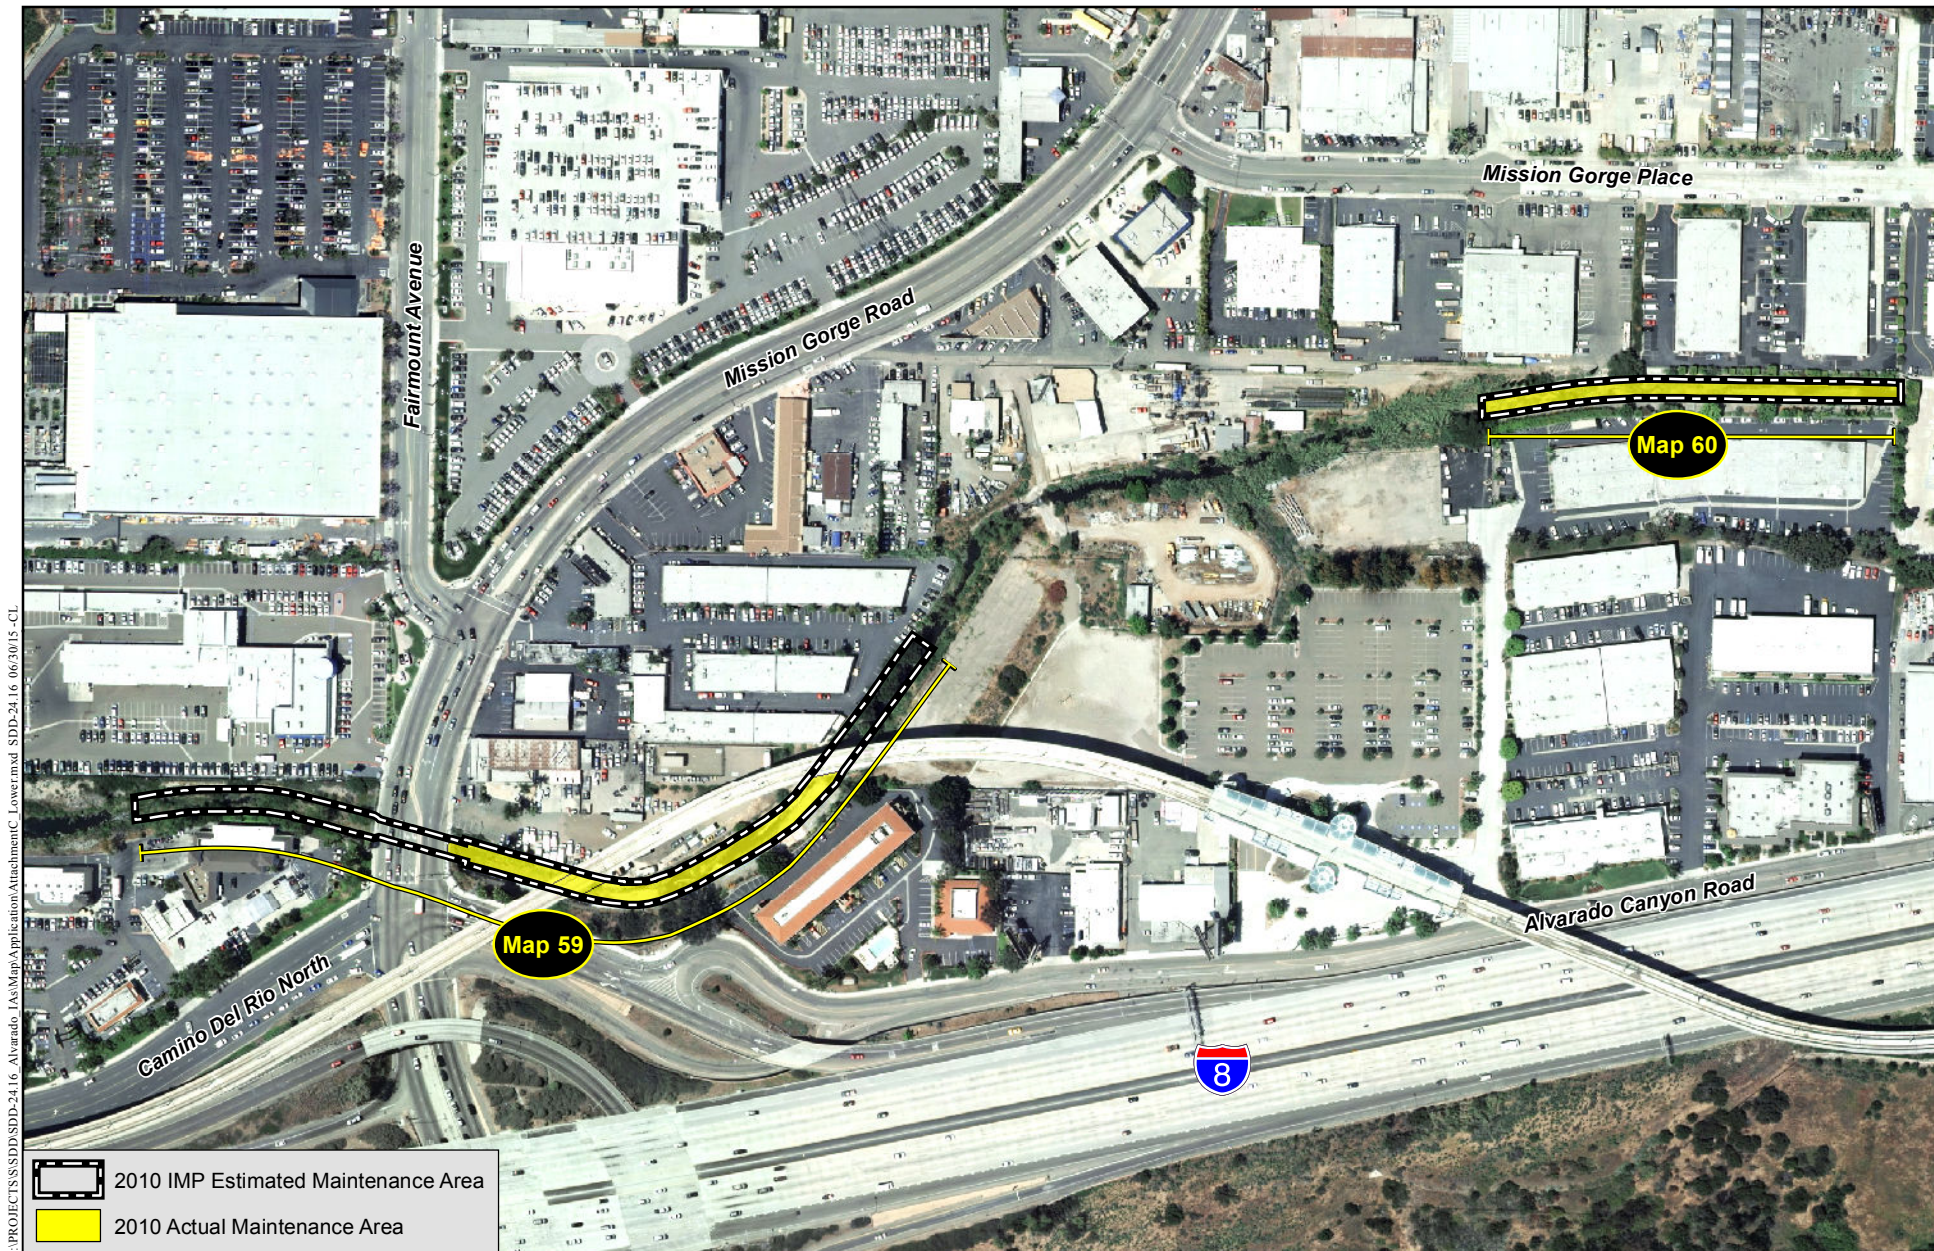
Comparison of IMP - Estimated and Actual Emergency Maintenance Areas

LOWER ALVARADO CREEK (MAPS 59 AND 60)

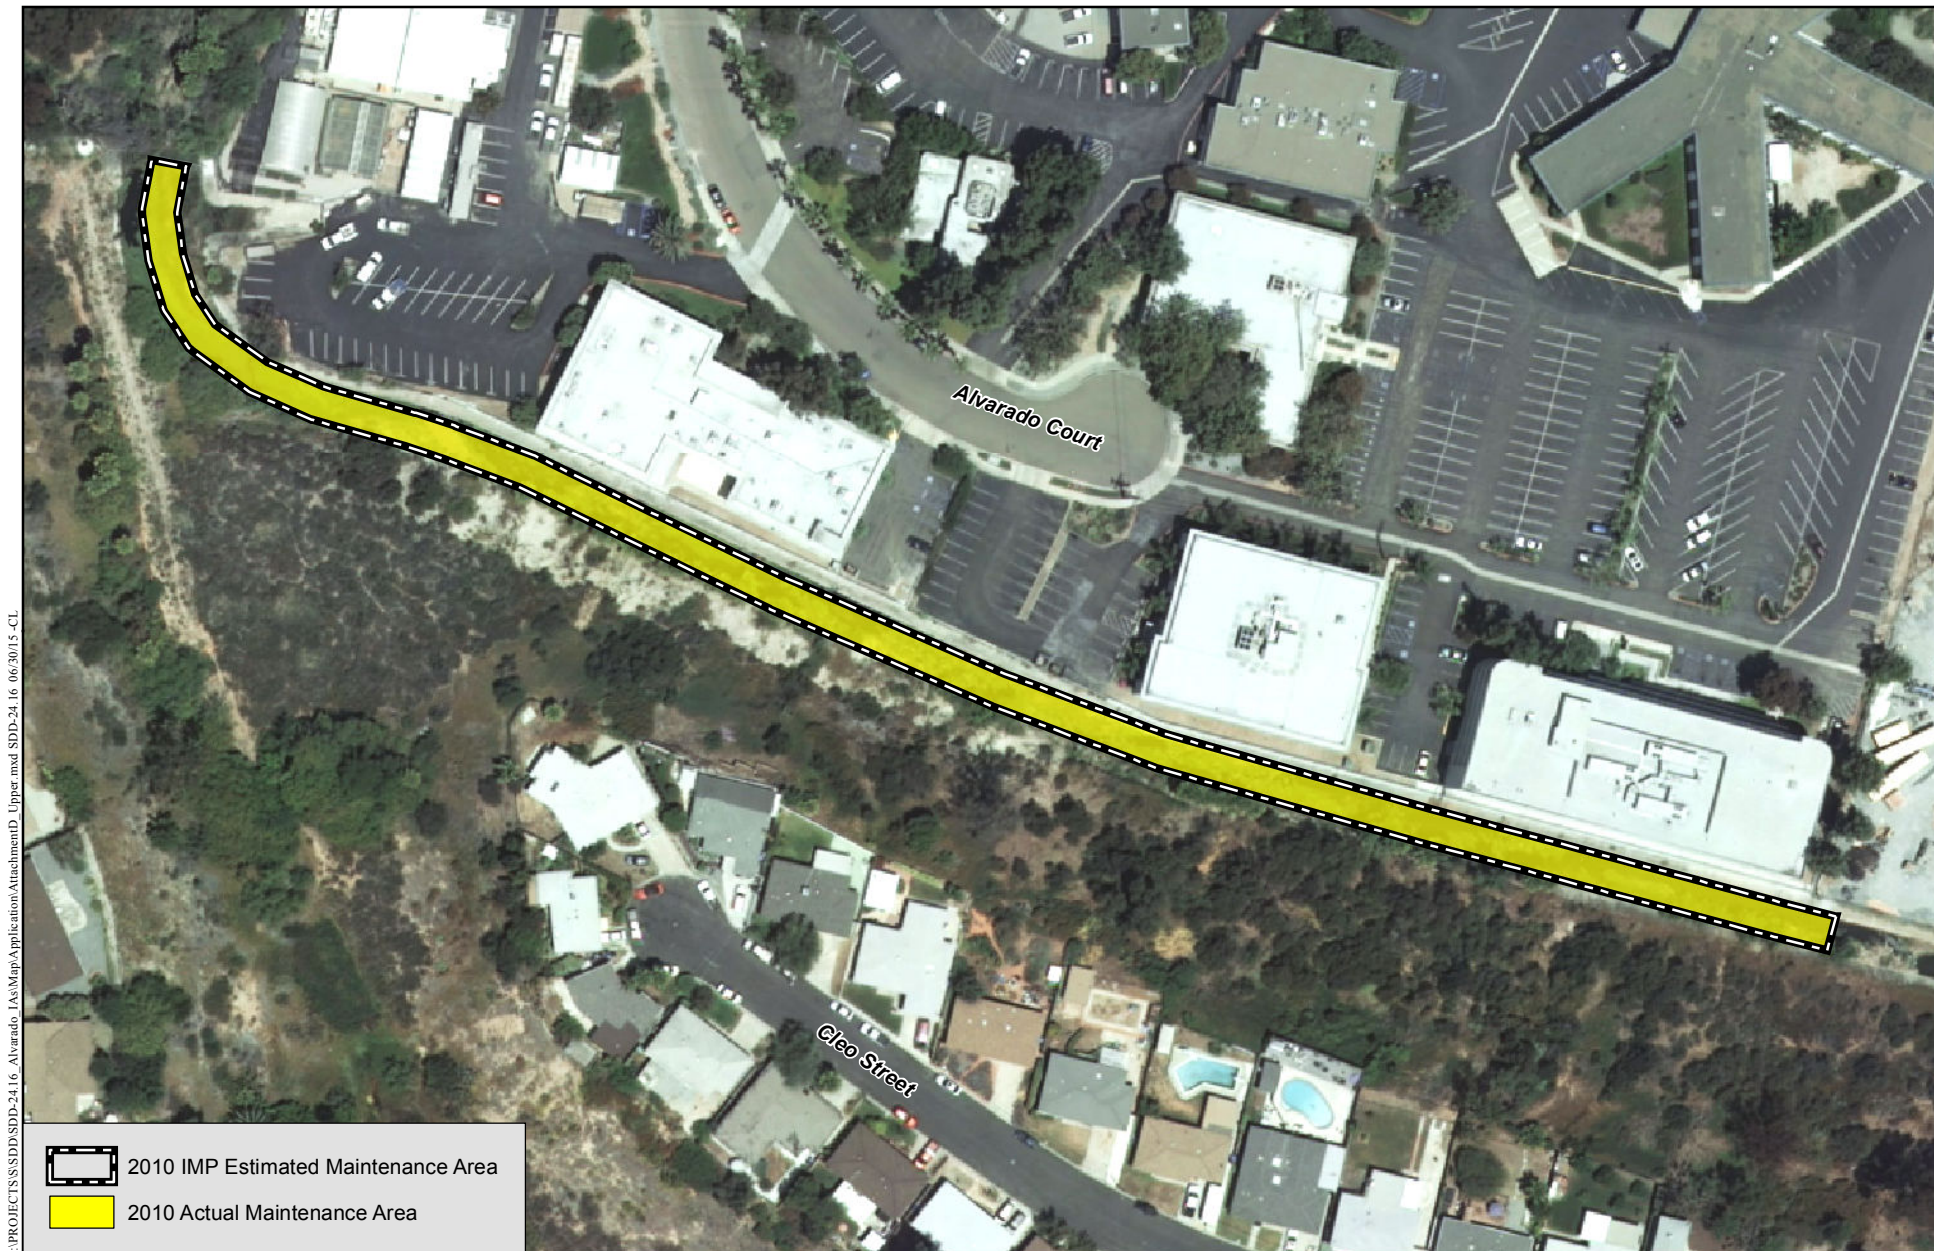
Comparison of IMP - Estimated and Actual Emergency Maintenance Areas

UPPER ALVARADO CREEK (MAP 64)
