SOUTH BAY OCEAN OUTFALL ANNUAL INSPECTION REPORT 2017

DATE: June 08, 2018
TO: Peter Vroom, Deputy Director Public Utilities
FROM: Richard Snow, Senior Civil Engineer
SUBJECT: South Bay Ocean Outfall 2017 Annual Inspection Report

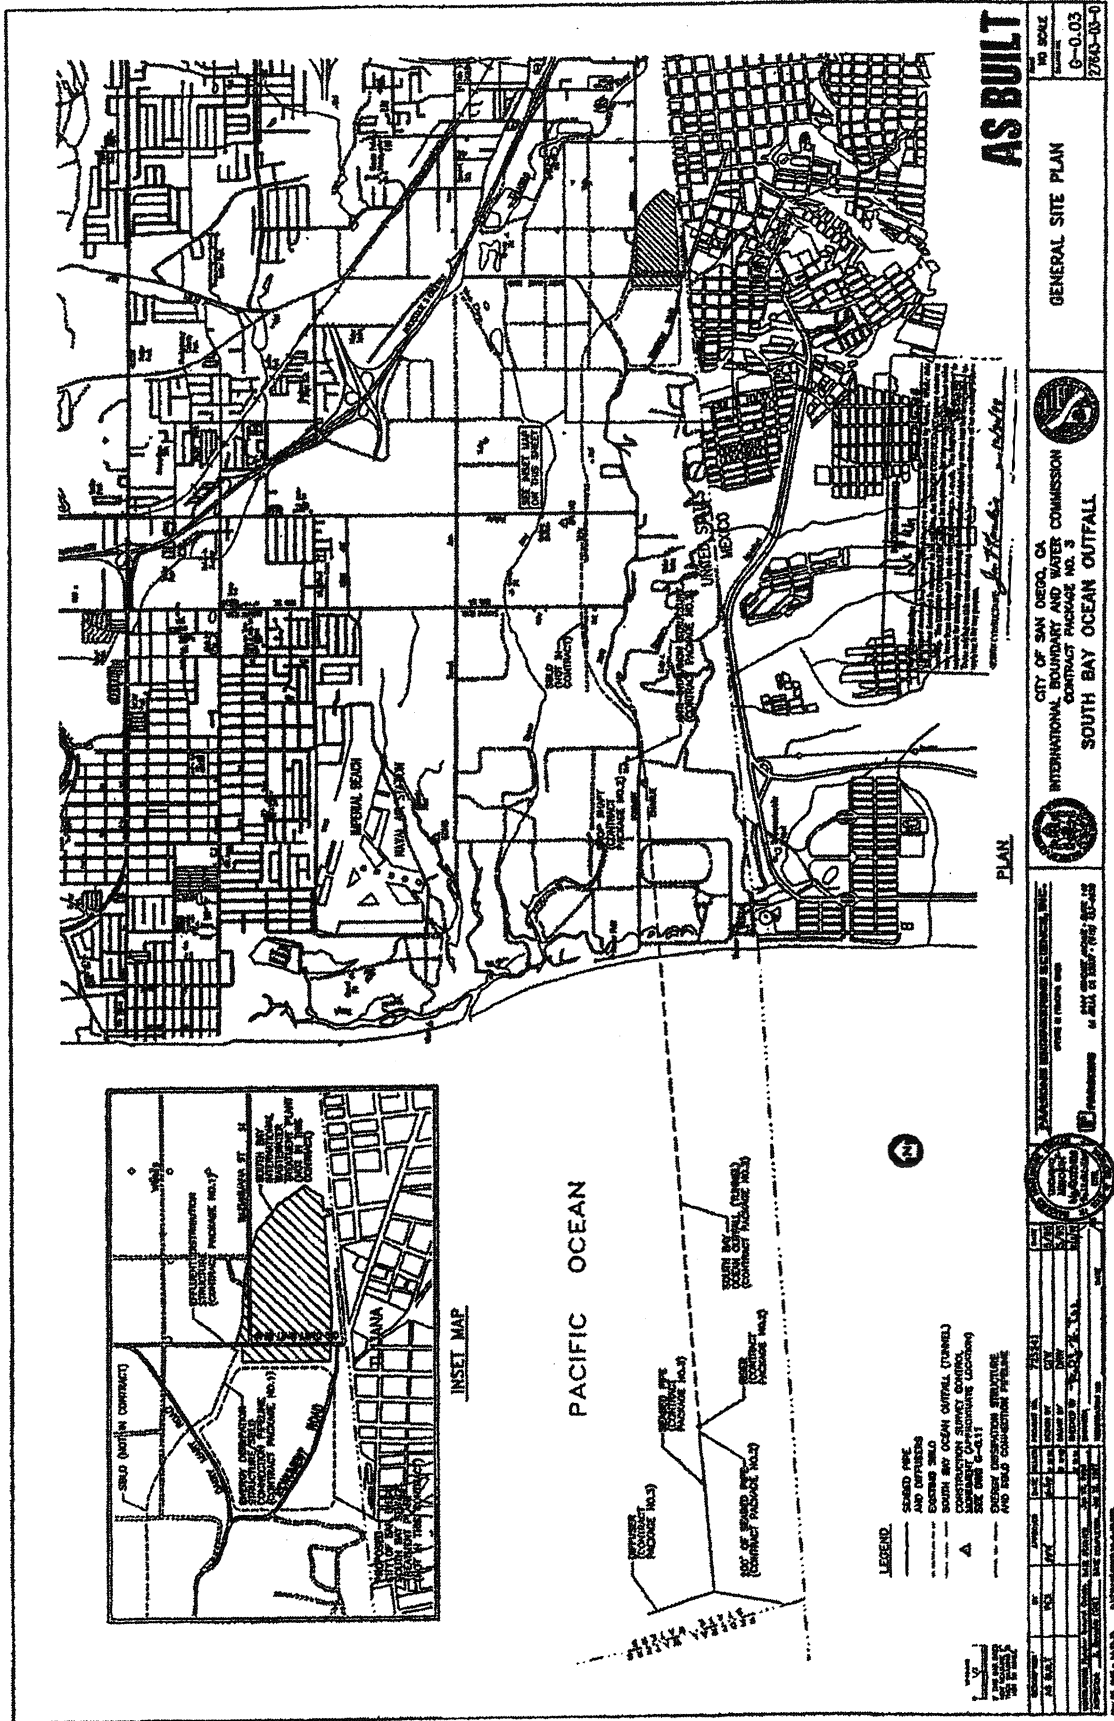
Figure 1. Map of the land and ocean based portions of the South Bay Outfall

Inspection involved surveying the visible and buried underwater, exterior portions of the outfall, the South Diffuser Leg termination structure (terminus), the South Diffuser Leg, the Wye, the North Diffuser Leg and termination, the Main Barrel and the manhole covers and maintenance access hatches (numbered 6 to 1 proceeding inshore), and the riser assembly shield (see Figure 1 in Appendix A).

The SBOO discharges the combined effluent at a location of approximately 3.5 statute miles off the coast of Imperial Beach, CA, at an approximate depth of 90 feet below mean sea level and at a minimum initial dilution of 100:1 (see Figure 1 in Appendix A). The partial tunnel/partial conventional seafloor configuration was chosen because overall construction and environmental mitigation costs were lower than other available options. It is important to note that the tunnel does not extend all the way to the diffusers due to the westerly drop off of the San Diego Formation (SDF), a favorable tunneling geology. Lowering the tunnel to remain within the SDF would have exceeded the realm of tunneling technology at the time of construction. Therefore, the decision was made to construct a riser assembly conduit at one of the offshore boring locations and to also build a conventional seafloor configuration in order to achieve the desired depth and location for effluent discharge.

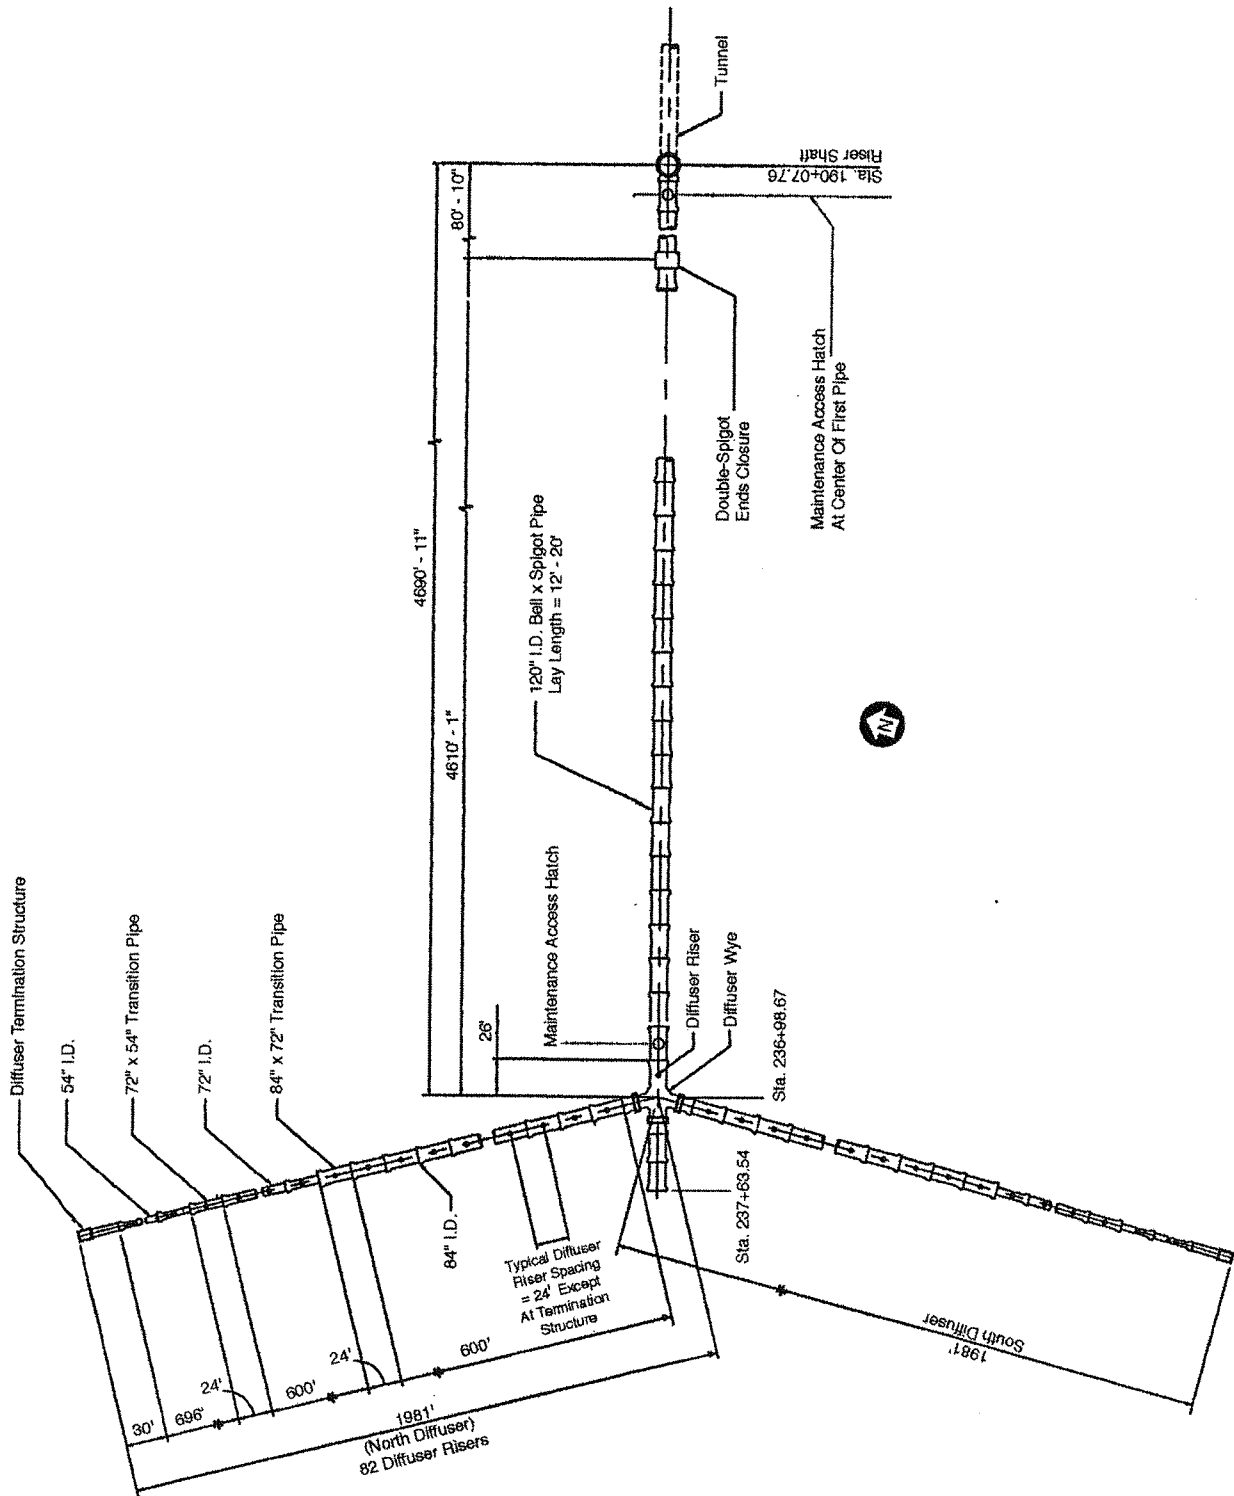
Figure 2. The South Bay Ocean Outfall seabed pipe and diffusers.

The outfall is approximately 4,691 feet long from the center of the riser shaft to the center of the diffuser wye (see Figure 2 in Appendix A). The 120-inch inside diameter (I.D.) seabed pipe was constructed by excavating a trench, then simultaneously placing the bedding stone and the pipe sections. The pipe sections are constructed of reinforced concrete, bell and spigot pipe of the raised bell type, with two gaskets at each joint. The bells of the pipe face offshore. The pipe sits on a bedding of class 3 stone which is covered with a minimum of 1 foot of class 2 ballast/filter stone, followed by a 3.5 foot armor layer of class 1 stone (see Figure 3 in Appendix A). The alignment of the main barrel of the outfall is approximately 210° - 215°, starts at a depth of 71 feet (MLLW) and ends in approximately 90 feet (MLLW).

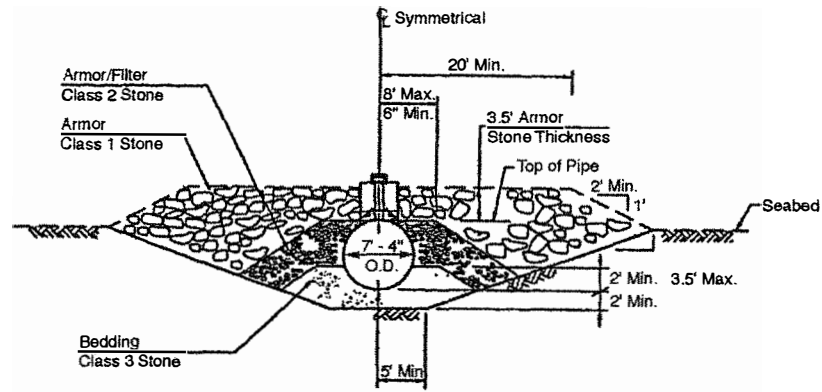
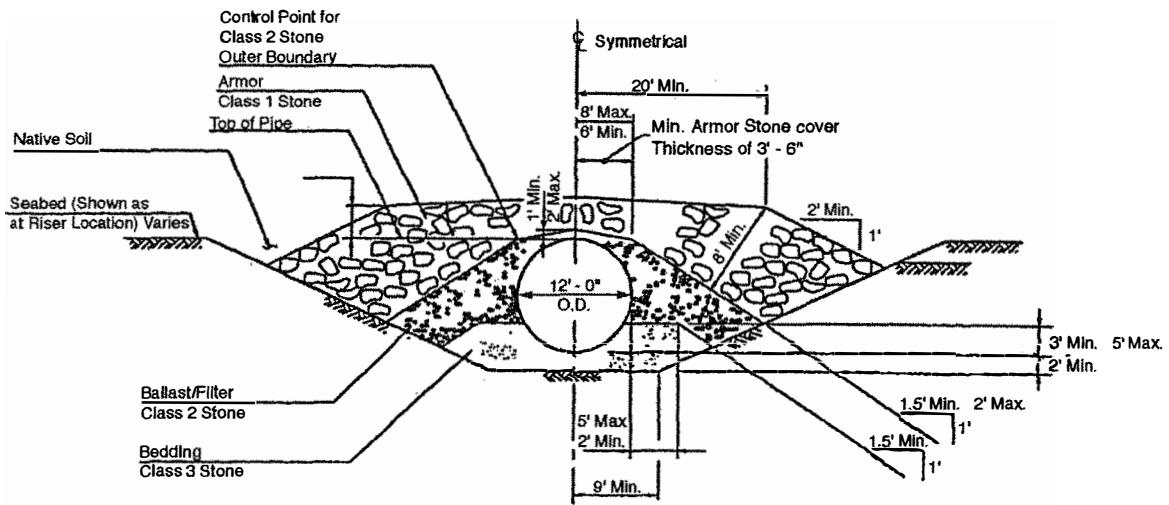
72 - Inch I.D. Diffuser
Not to Scale

120 - Inch I.D. Seabed Pipe
Not to Scale

Figure 3. Cross-section of the South Bay Ocean Outfall and ballast rock.

The main barrel is completely covered in ballast rock, with the exception of the Inshore Riser Cover, the six maintenance access hatches (manholes), the diffuser risers, and the diffuser termination structures. The first manhole (Station 190 + 30) is located in the center of the first pipe section next to the riser shaft (see Figure 4 in Appendix A). There is a 2-foot diameter opening with a lid in the center of the riser. Armor stone is piled over the outfall pipe to just below the riser cover. Inside the riser is an air relief assembly that bleeds off excess air from the outfall pipe. There is a maintenance access hatch inside the riser that opens to the seabed pipe. The rest of the manholes are built the same and accessed through risers (see Figure 5 in Appendix A). A 10-inch thick reinforced concrete cover seals the 7 foot 6 inch outside diameter (O.D.) riser. Three lifting hooks are used to open the cover. The maintenance access hatch is located inside the riser. Approximately 5 feet of stone covers the seabed pipe around the riser cover.

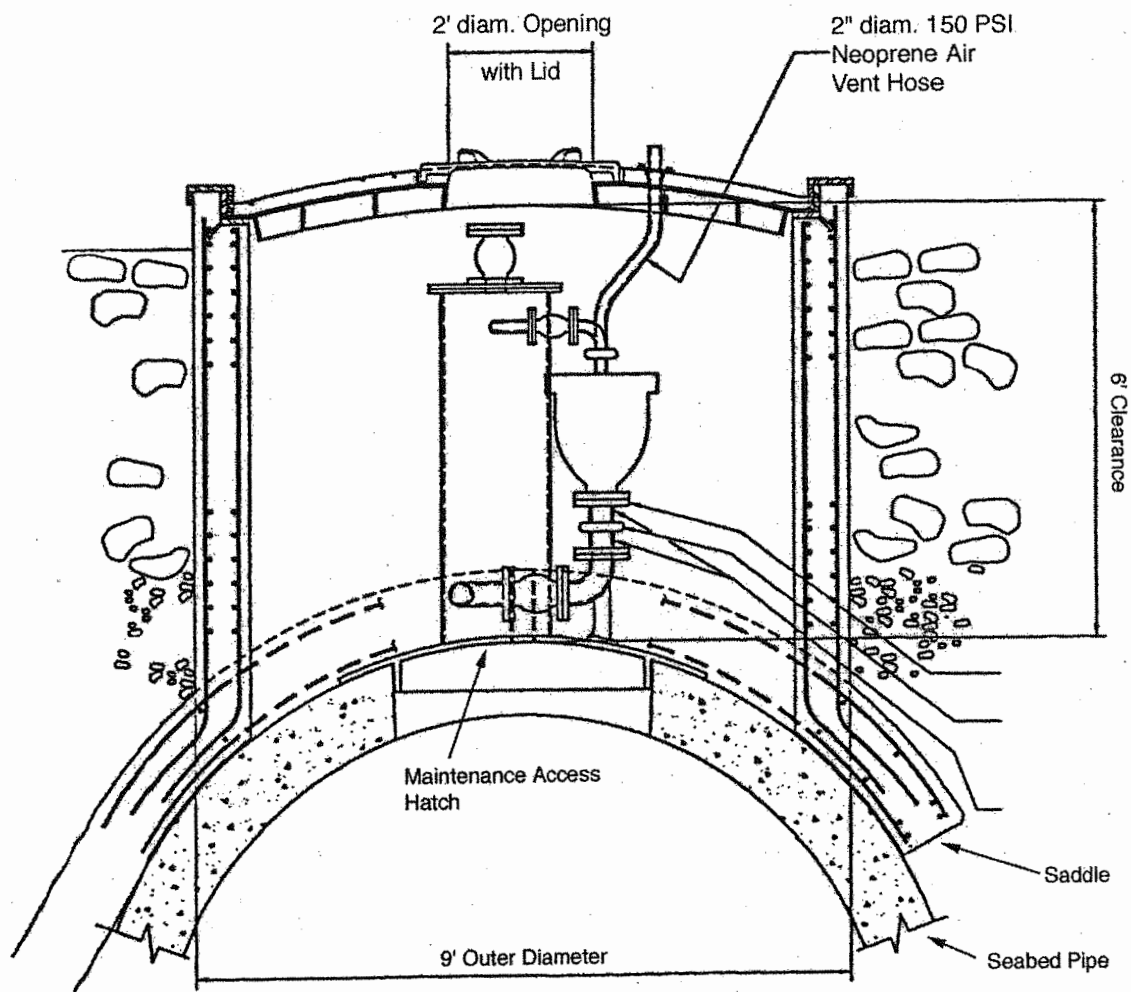
Figure 4. Air relief assembly and maintenance hatch.

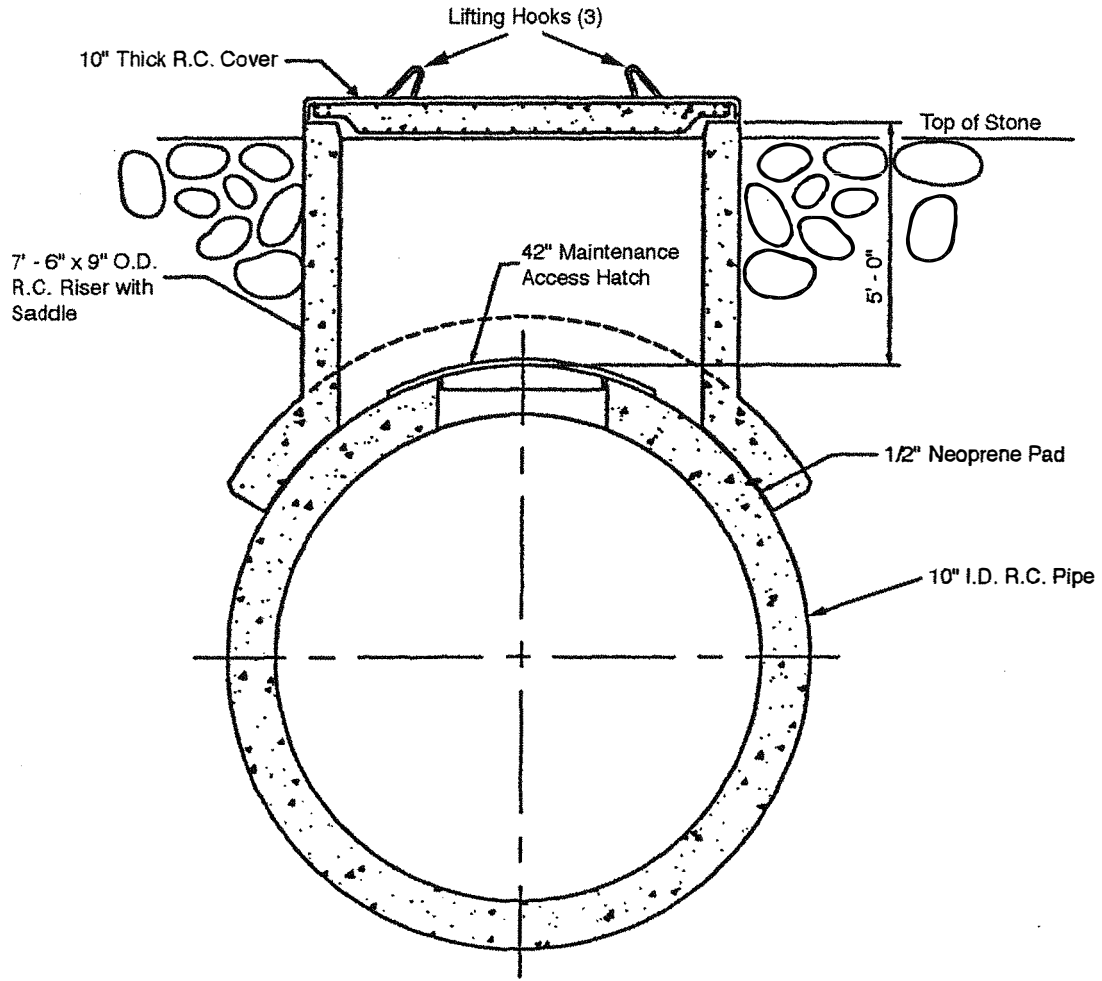
Figure 5. Maintenance access hatch and riser.

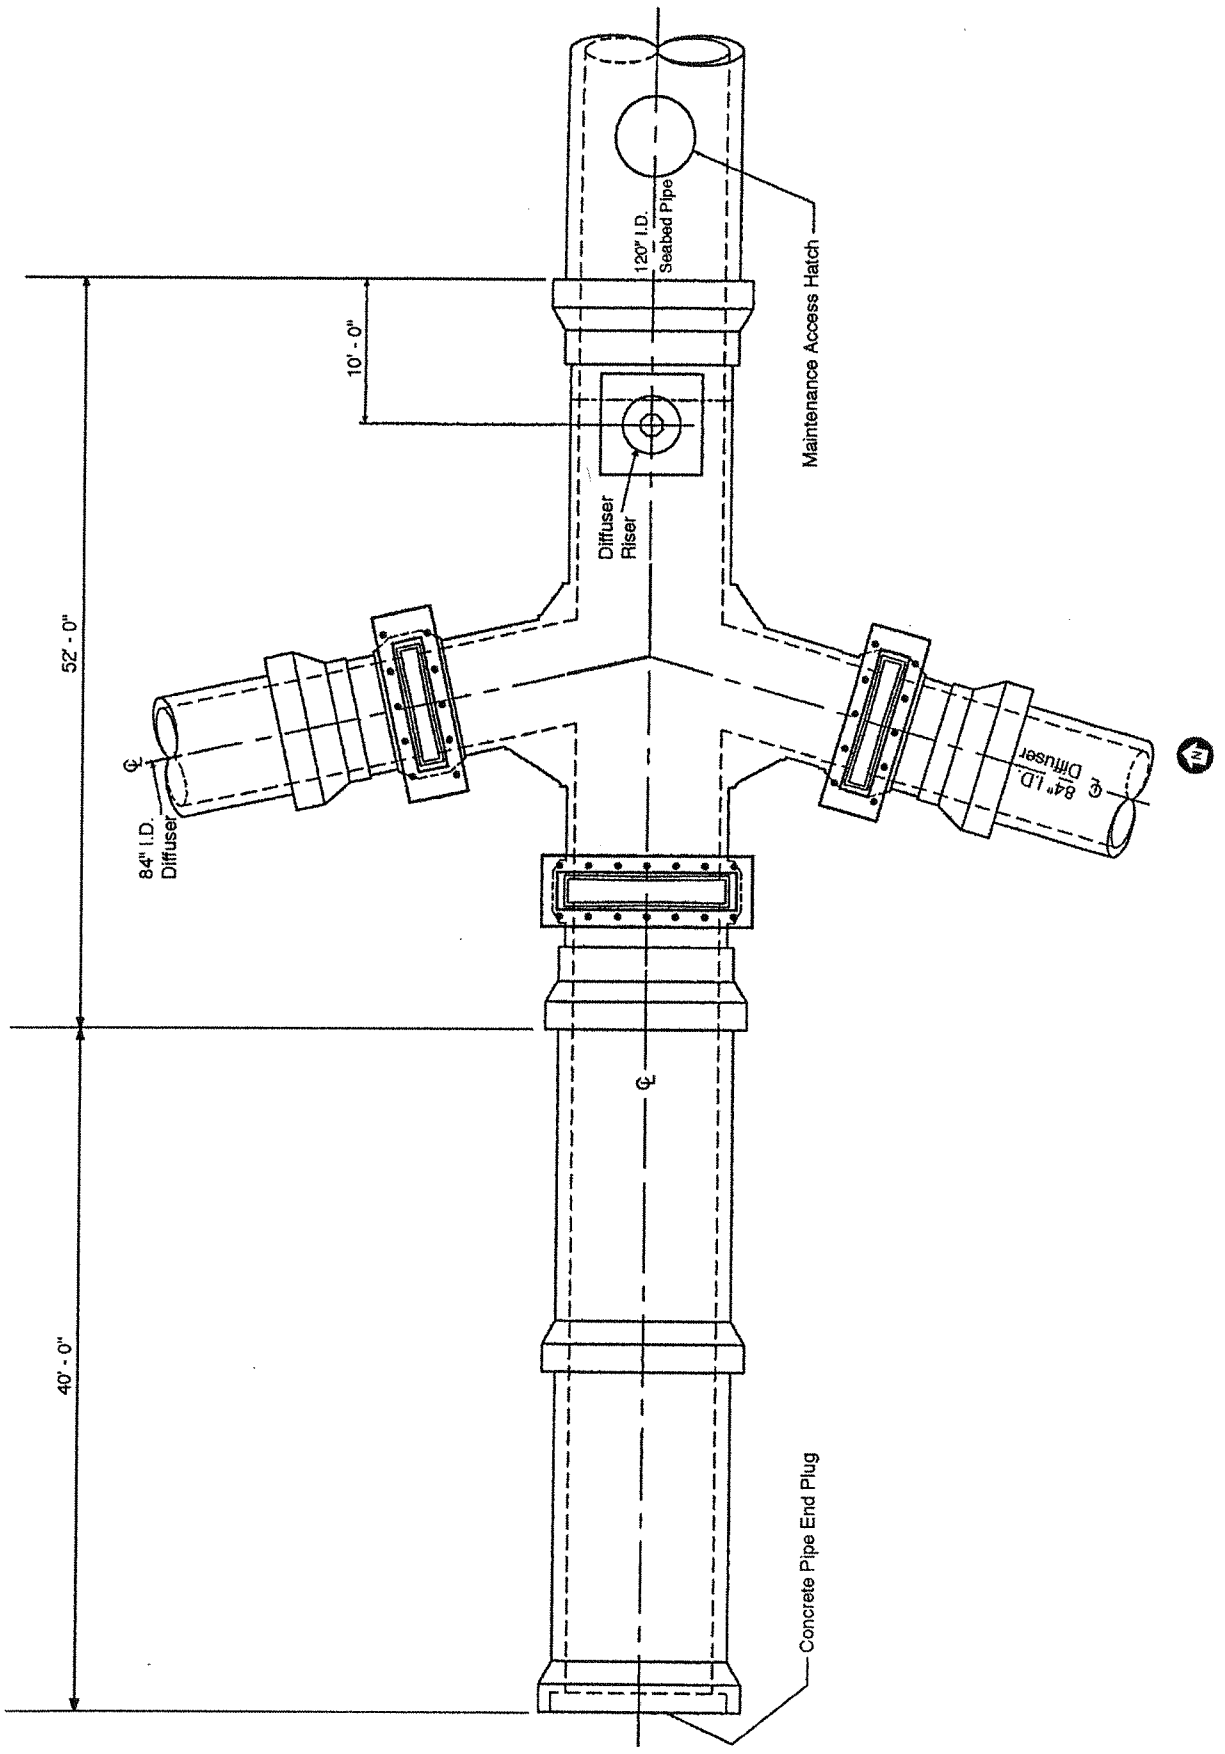
Figure 6. The diffuser wye structure for the South Bay Ocean Outfall.

The diffuser legs branch off from the main seabed pipe at the diffuser wye (Station 236 + 98.67) (see Figure 6 in Appendix A). The length of the diffuser wye section from bell end to bell end is 52 feet along the main axis of the seabed pipe. The angles between the north and south diffuser leg centerlines on the offshore ends and the wye structure centerline is 77° and 74° respectively. The approximate alignments of the north and south diffuser legs are 340° and 185° respectively.

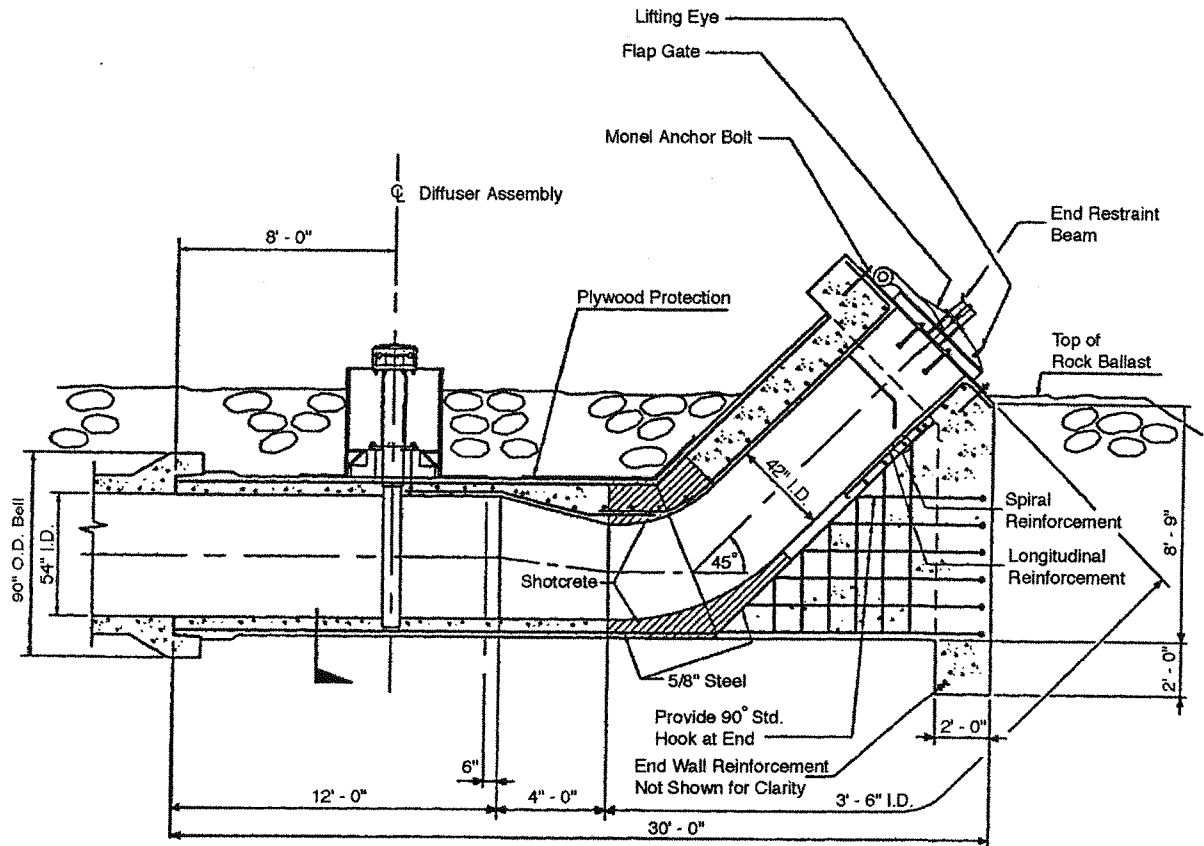
Figure 7. Termination structure found at the end of the South Bay Ocean Outfall diffuser legs.

The length of each diffuser leg is 1,981 feet from the end of the termination structure to the Wye centerline. The diffuser sections are 84 inch I.D. where they connect to the diffuser wye (Station 0 + 00). At Station 6 + 00 a 24 foot transition section reduces the pipe diameter to 72 inches I.D. Another 24 foot transition section at Station 12 + 24 further reduces the pipe diameter to 52 inch I.D. The north and south diffuser legs end at Station 19 + 81.00 and Station 19 + 80.98, respectively. A 30-foot termination structure seals the end of each diffuser leg (see Figure 7 in Appendix A) and a flap gate seals the 42-inch I.D. pipe section of the termination structure. Rock ballast covers all of the termination structure, except for the flap gate and concrete support for the termination pipe.

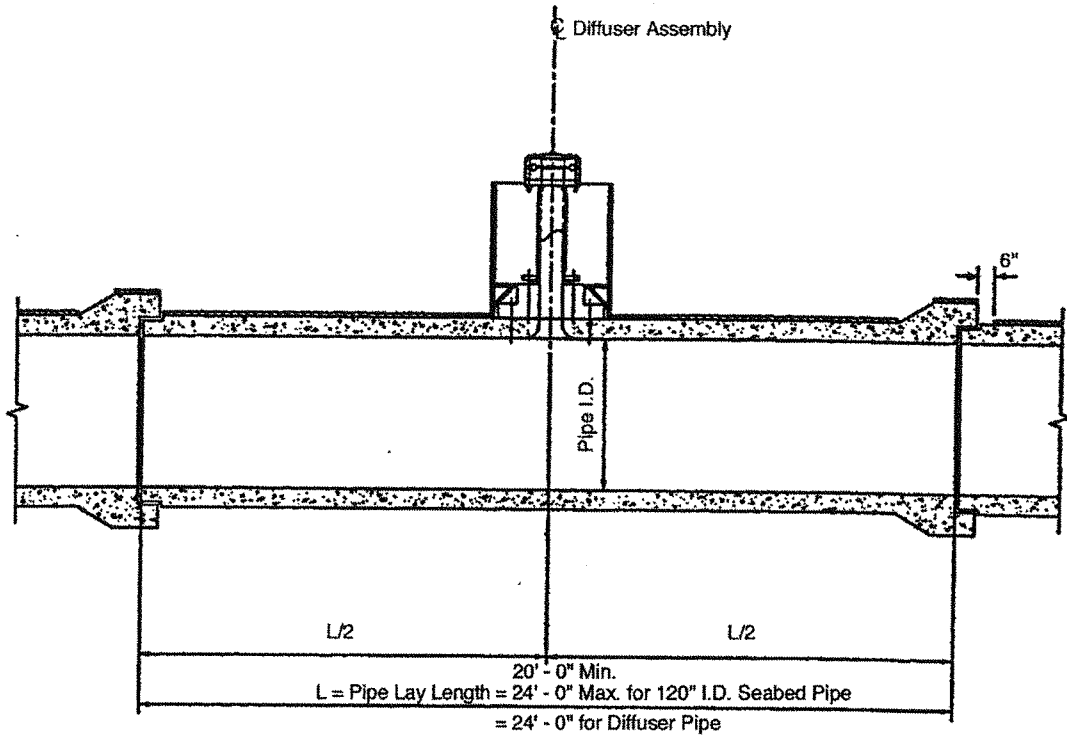
Figure 8. Diffuser assembly on the South Bay Ocean Outfall diffuser legs.

Since the diffuser legs are buried, effluent from the outfall enters the ocean through diffuser riser assemblies which are bolted to the top of the diffuser leg conduits and to the wye structure. The effluent rises vertically through the high-density polyethylene diffuser risers and transitions to horizontal discharge from a 1 foot 7.5 inch diffuser head with four ports. Each diffuser riser assembly is provided with a surrounding canister which protects it from the adjacent rock, and vessel anchors (see Figure 8 in Appendix A).
