Draft Preliminary Report

January 19, 2005

City of San Diego Redevelopment Agency 600 B Street, Fourth Floor, MS904 San Diego, California 92101-4506 (619) 533-4233 www.sandiego.gov/redevelopment-agency

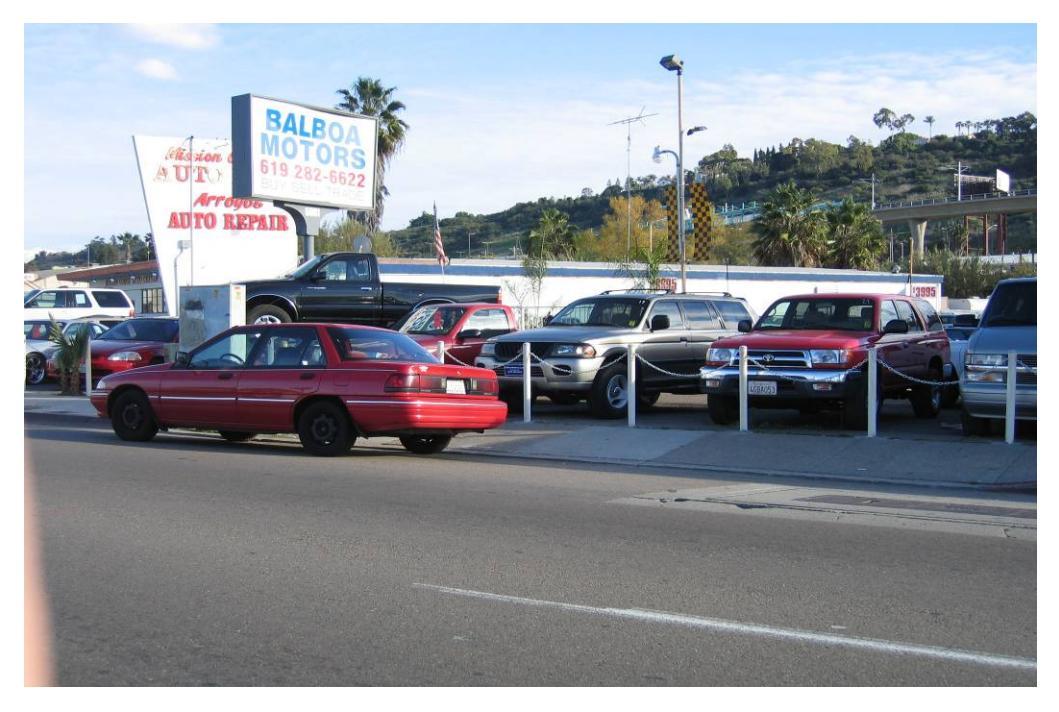
Parcel Number - 461 320 06

Used car lots and repair shops are a common use along Mission Gorge Road. These uses are an inefficient use of the narrow commercial properties and cause circulation congestion.

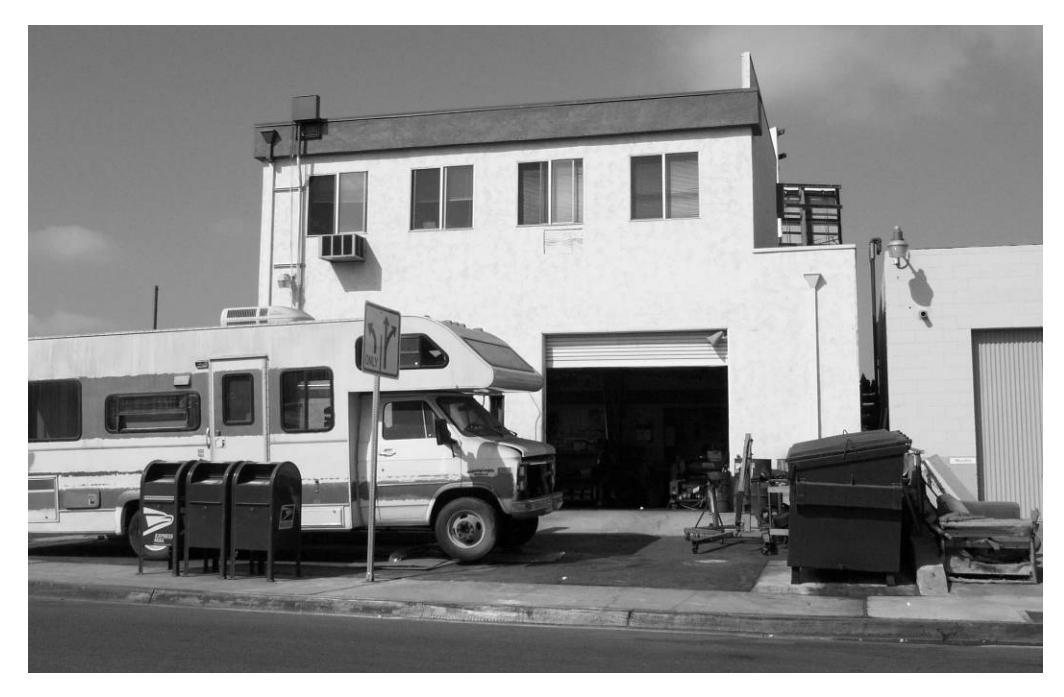
Parcel Number – 461 210 12

Outdoor vehicle repair shop with outdoor hydraulic lift along Mission Gorge Road does not reflect modern development standards and detracts from surrounding commercial uses.

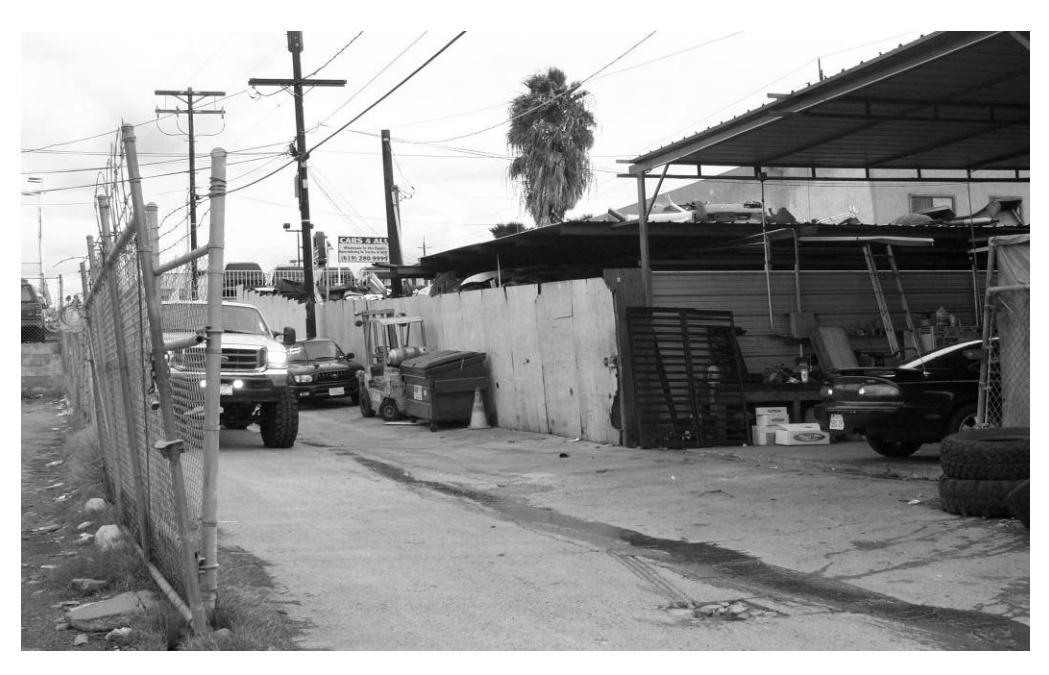
Parcel Number - 458 522 09

Vehicle repair area for used car dealership on Mission Gorge Road. Vehicles regularly use alley for parking, limiting access through the area. The repair operation has also created a small salvage area to store damage parts that is less than 100 feet from the Mission Gorge Road. All vehicles are serviced in outdoor bays with commercial trash container and debris encroaching on the alley.

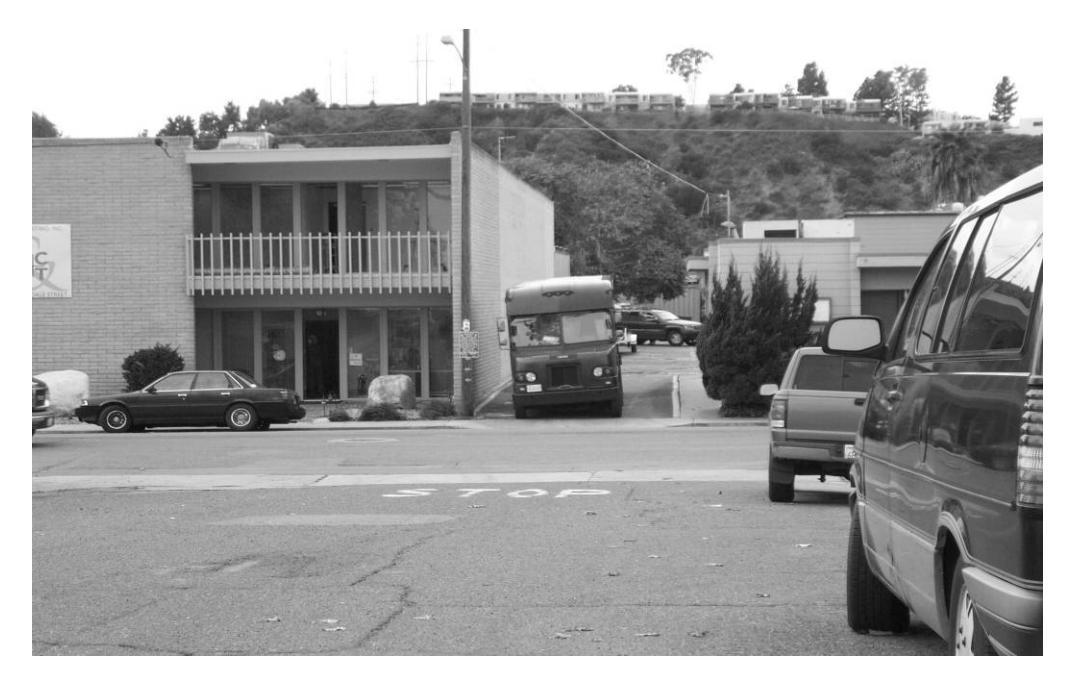
Parcel Number – 458 510 32

Delivery vehicle stopped in driveway to make delivery to neighboring property, thereby restricting access to the property.

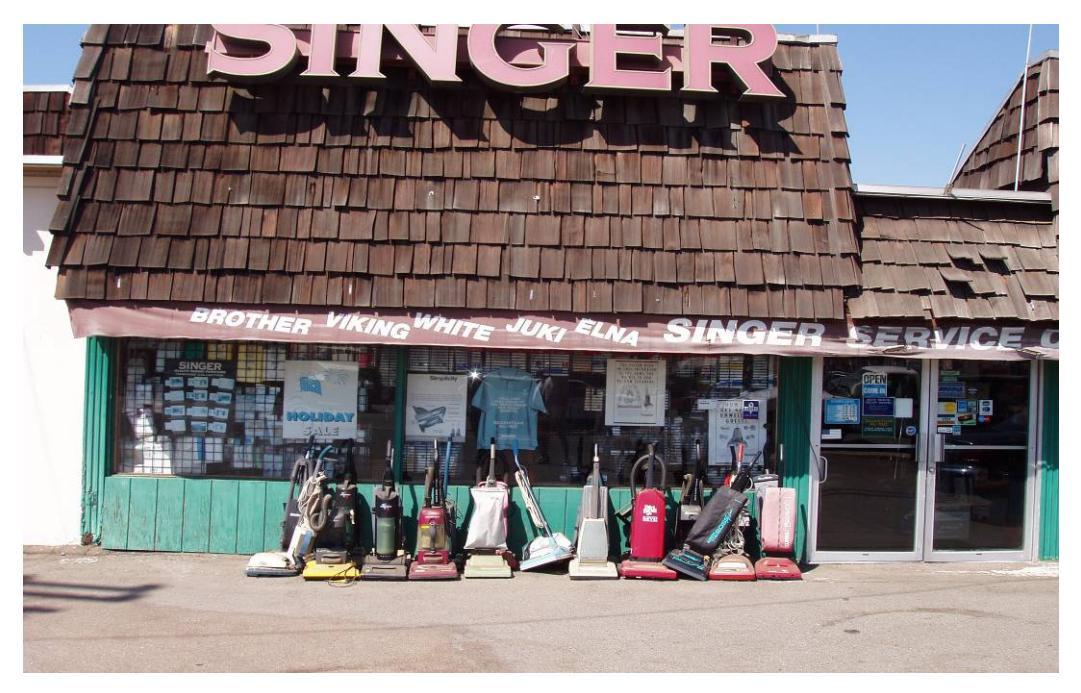
Parcel Number - 461 220 11

Outdoor display area in the parking area. Also excessive window signage in violation of city code, which is unattractive to passers by.

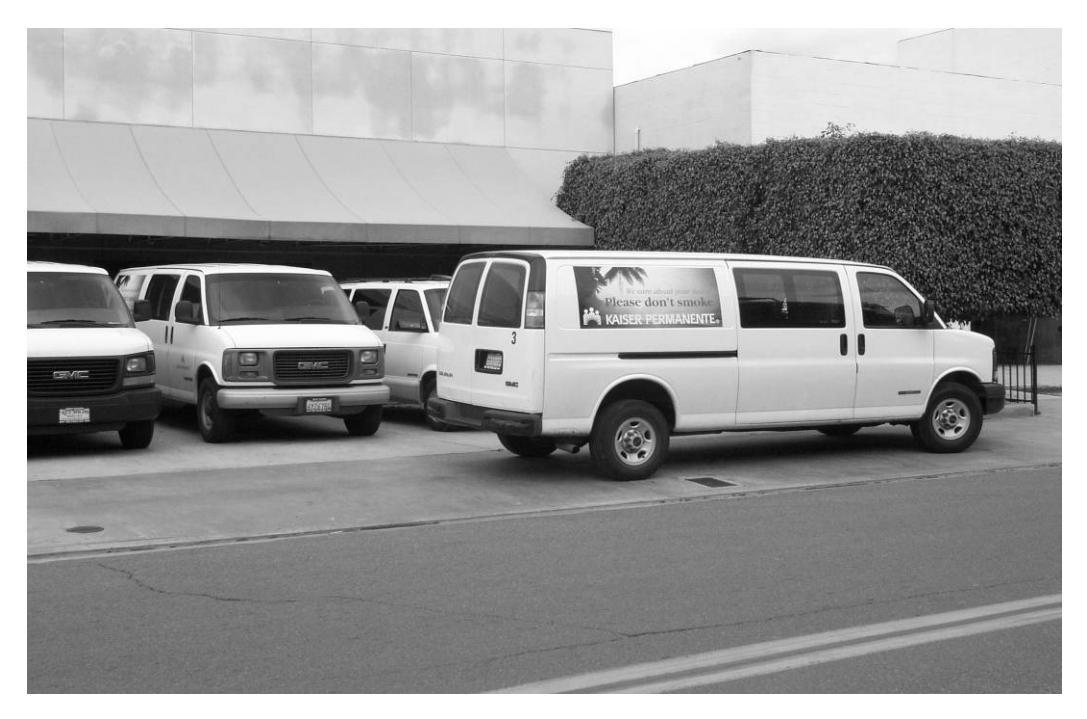
Parcel Number – 458 522 19

Inadequate parking for delivery vehicles results in blocking of ingress and egress for other vehicles and discourages pedestrian access because delivery vans must use sidewalk for parking.

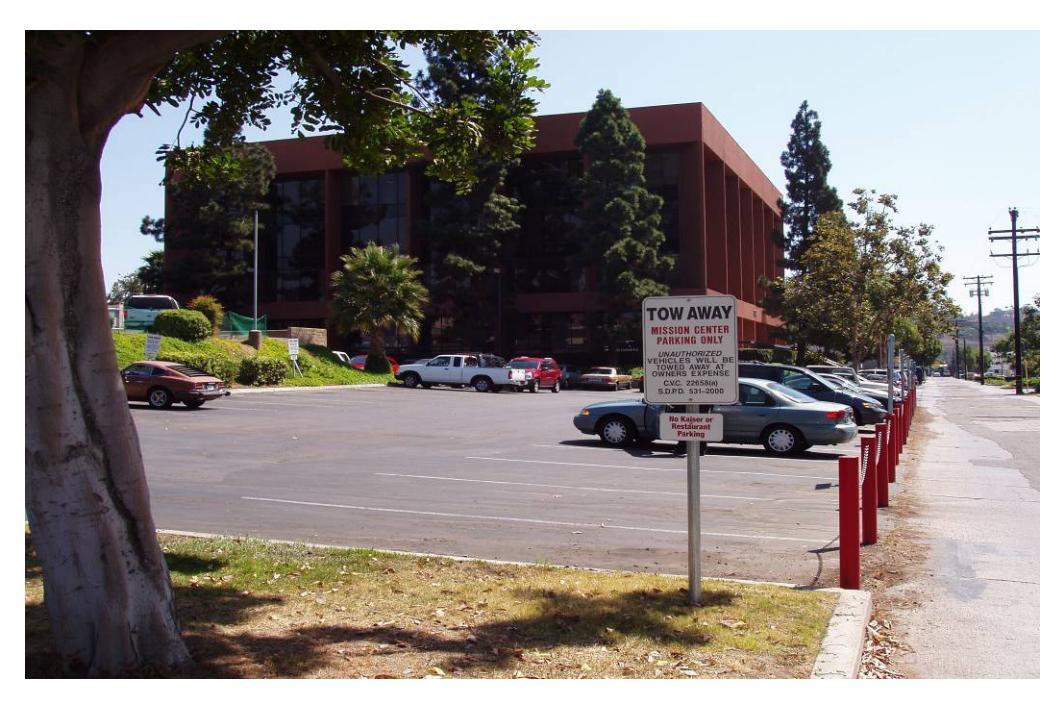
Parcel Number - 461 220 45

Due to parking shortages in many portions of the Project Area, property owners have installed signage restricting parking.

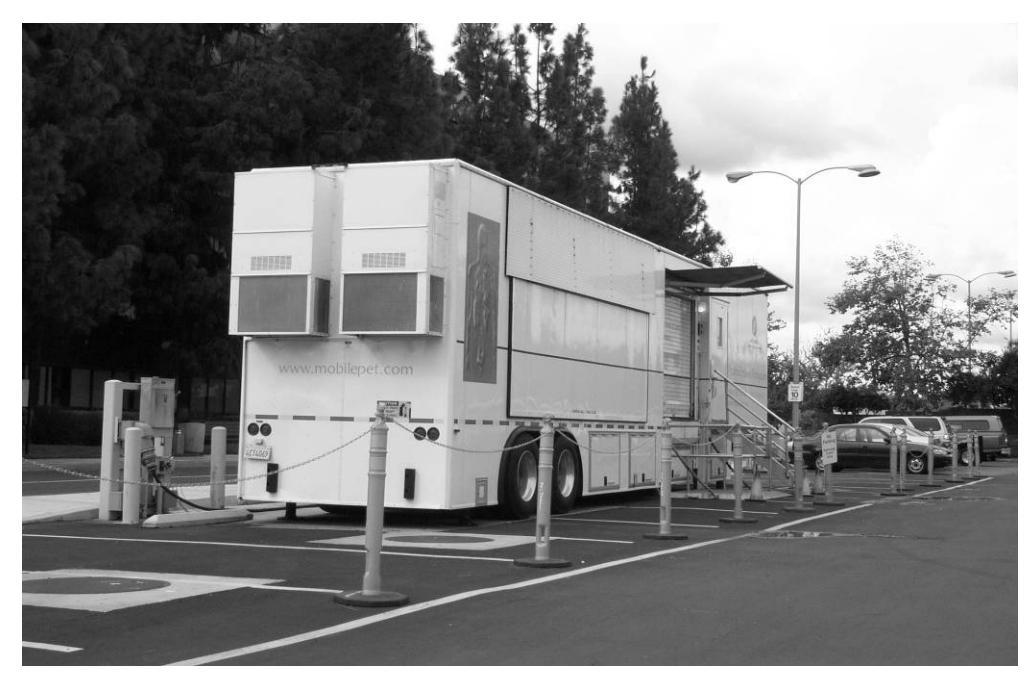
Parcel Number - 458 343 27

Inadequate storage and staging area causes shifting uses in parking lots and reduces that amount of parking available to patrons.

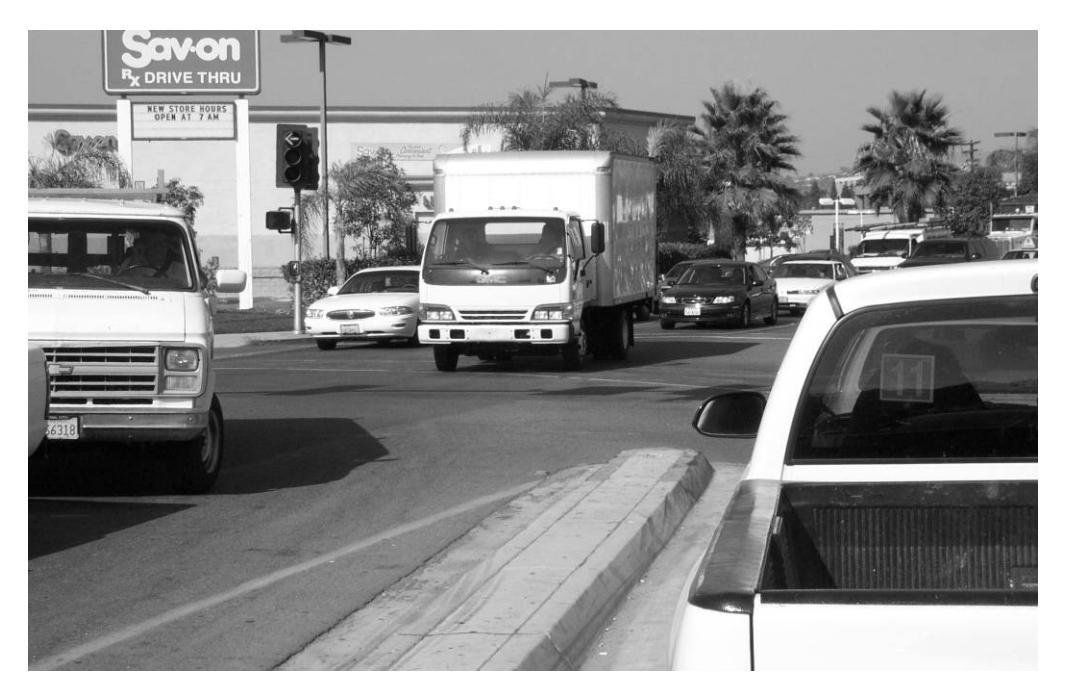
Parcel Number - 461 320 25

Poor traffic circulation causes drivers to make unsafe manures such as making turns before there is adequate lane capacity to accommodate the vehicle. This leads to both lanes being blocked.

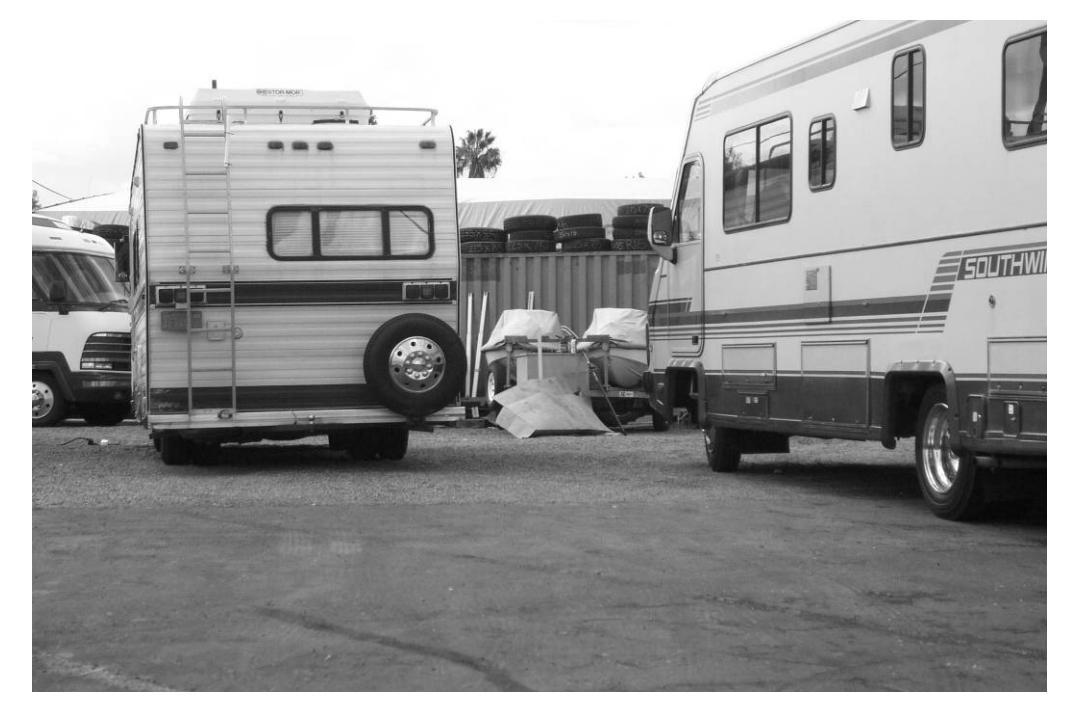
Parcel Number - 458 290 13

Survey data showed no less than ten recreational vehicles in the commercial center parking at any one time awaiting repairs. Outdoor repair activities such as this are incompatible with surrounding commercial and residential uses.

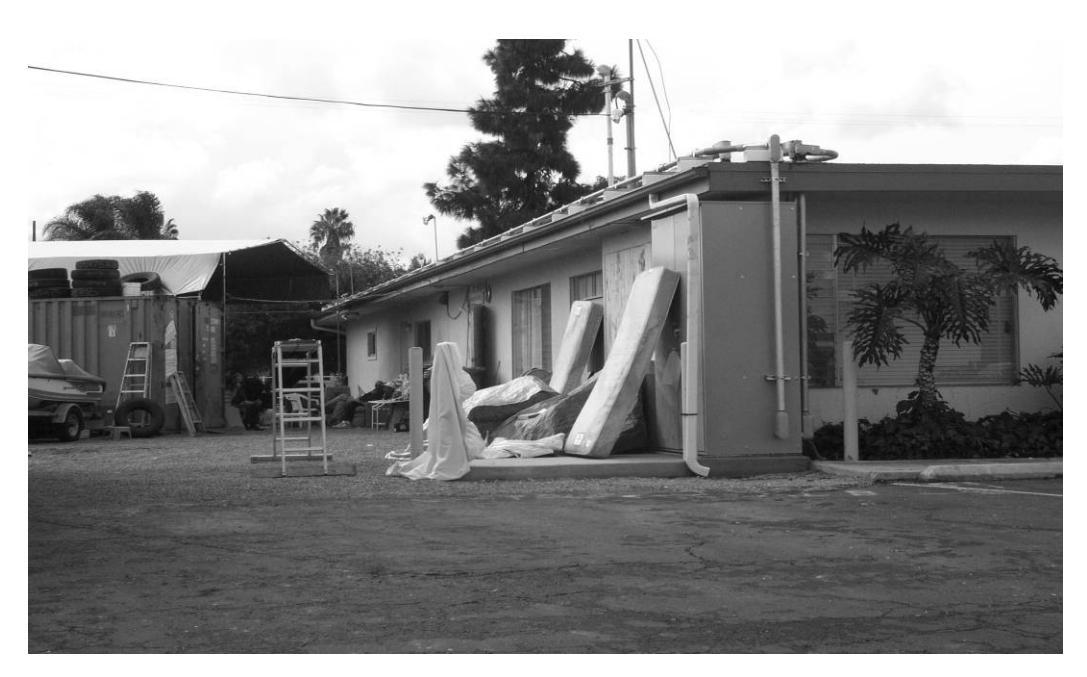
Parcel Number - 458 290 13

The recreational vehicle repair facility includes a metal storage container and tarp covered area as permanent fixtures, which is illegal per the zoning code.

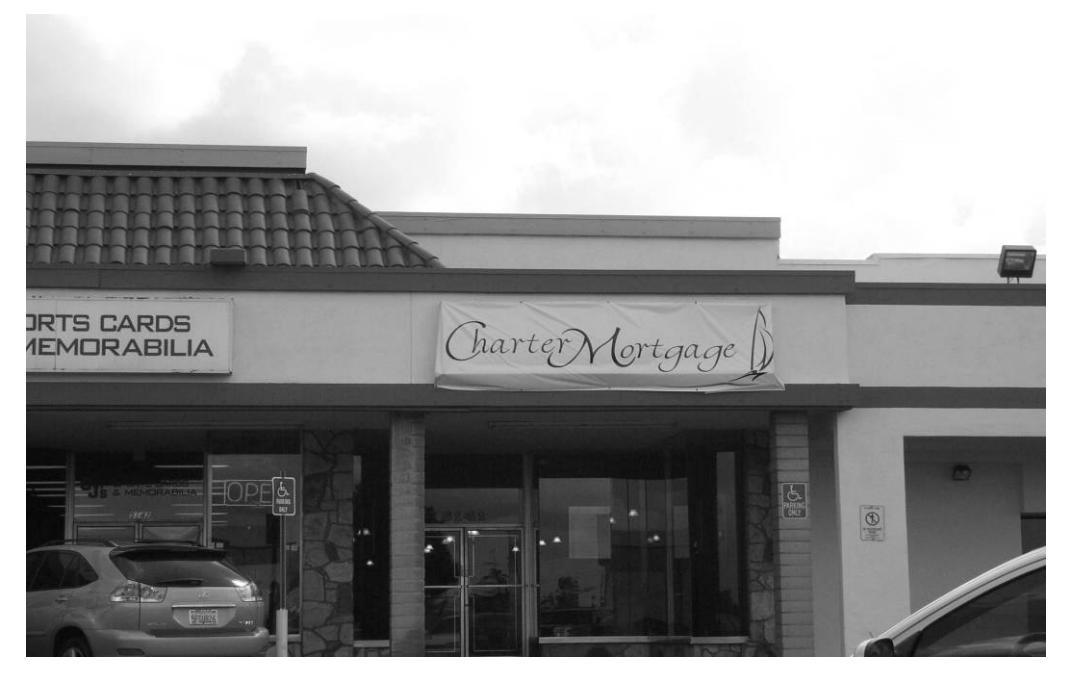
Parcel Number - 458 290 07

Several businesses were using banner signage as permanent signage, which detracts from the visual appearance of the area and is in violation of zoning regulations.

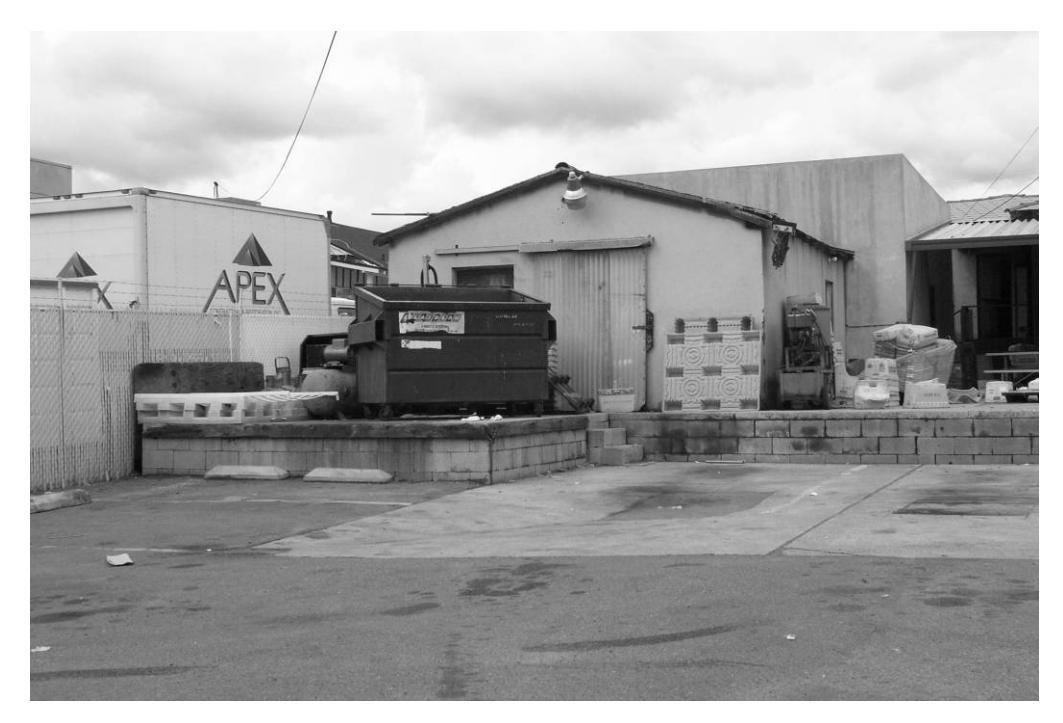
Parcel Number - 458 522 04

This property is suffering from physical deterioration due to lack of maintenance and excessive use. The single-family has been converted to a distributions center for a courier service through a series of substandard and poorly maintained additions.

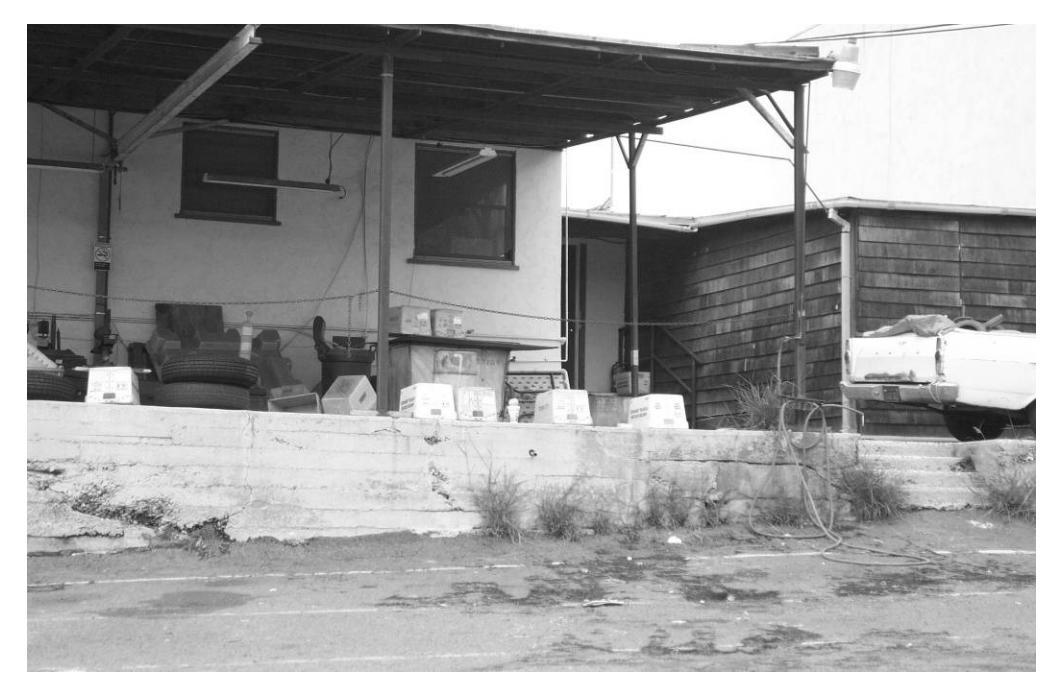
Parcel Number - 458 522 06

This single-family residential structure also suffers from incompatible industrial uses, substandard and deteriorating additions as well as a lack of storage area for trash and debris.

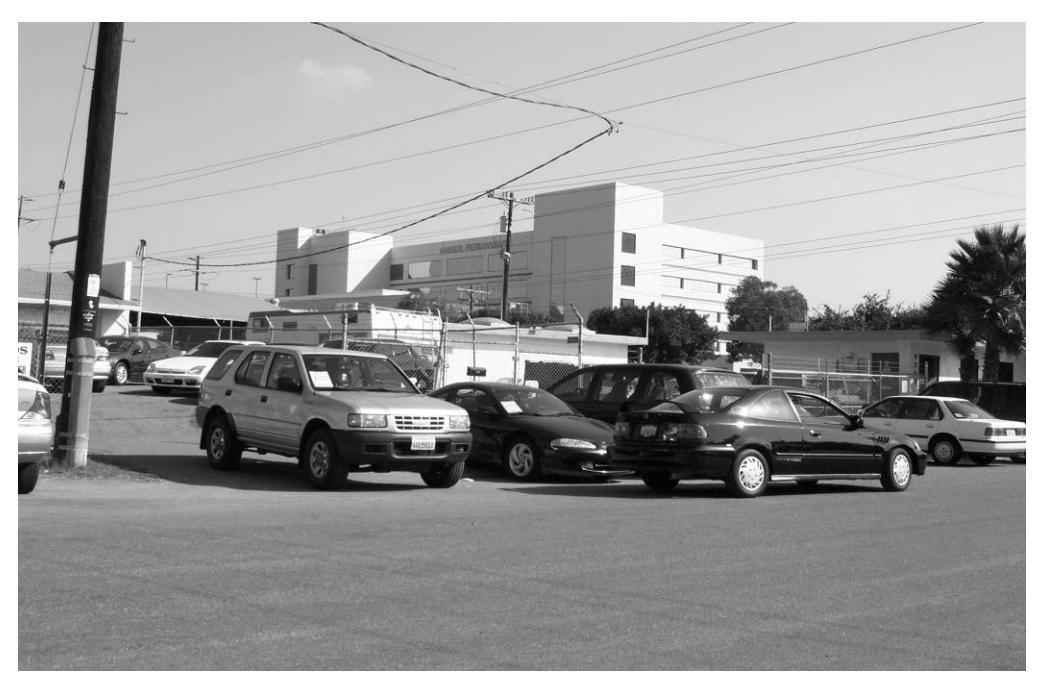
Parcel Number – 458 510 14

Lack of off-street parking, caused vehicles to be double parked in the public right-of-way creating an unsafe access and egress to the properties for cars and pedestrians.

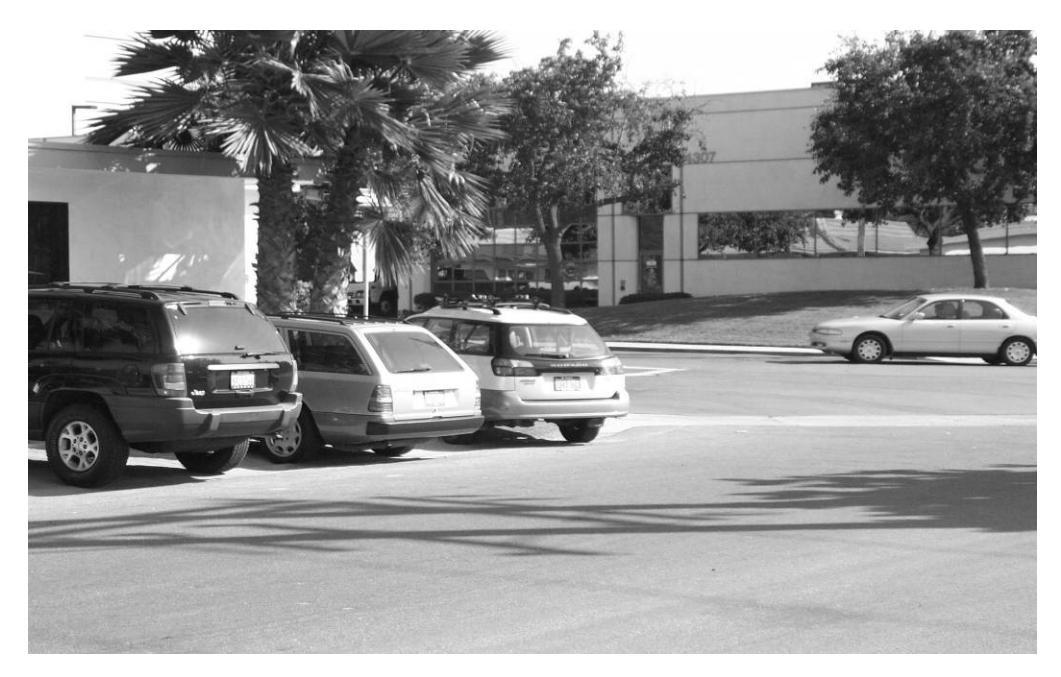
Parcel Number - 458 510 30

Lack of on-site parking, causing vehicles to park in the public right-of-way creating an unsafe traffic condition by restricting traffic view sight lines for vehicles and pedestrians.

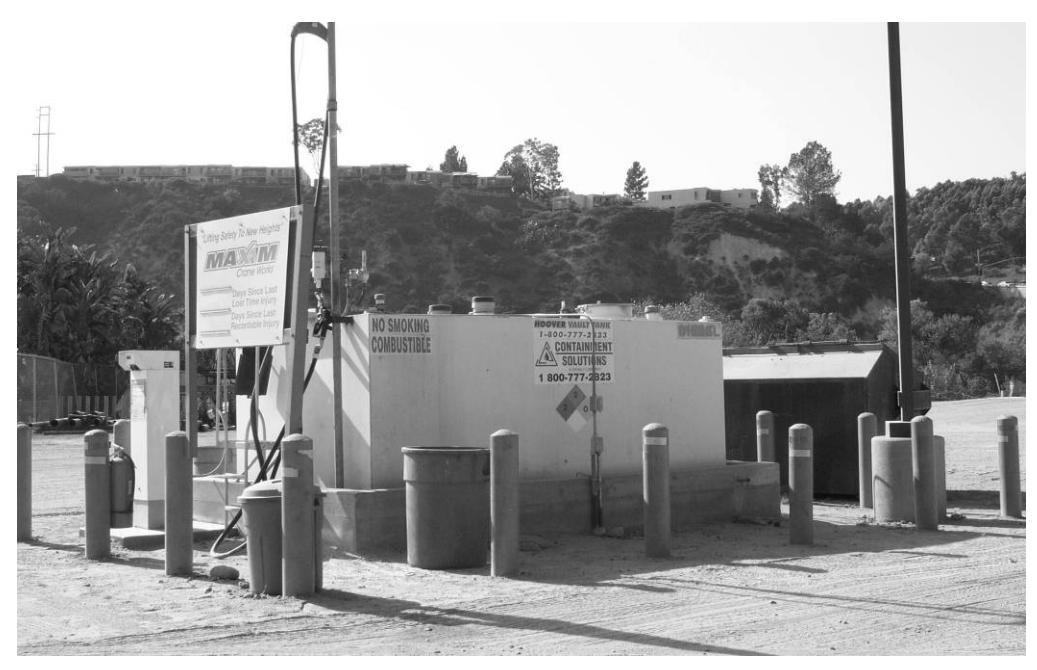
Parcel Number - 458 300 03

Outdoor refueling area on dirt lot next to San Diego River. Outdoor welding and storage of heavy equipment takes place at this site with runoff from welding debris, rusting equipment and refueling operations draining directly into the San Diego River or leaching into the soil and groundwater.

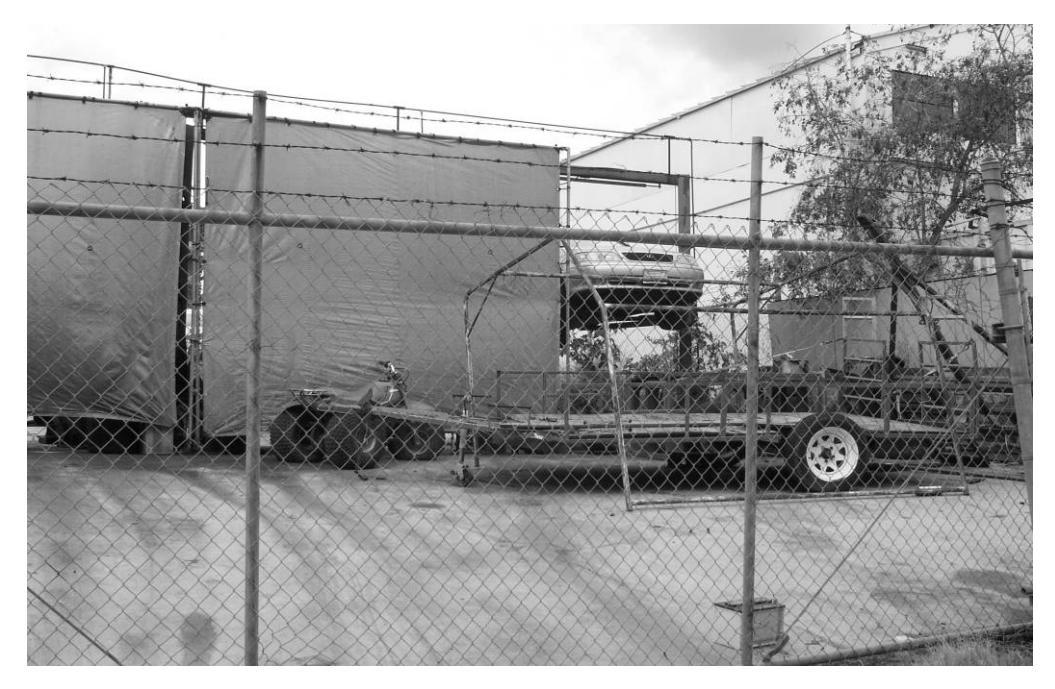
Parcel Number – 458 521 25

Outdoor vehicle repair area with industrial runoff including motor oil, transmission fluid and battery acid. Left-over parts from repairs (batteries engines blocks) are a significant source of contamination in the Project Area.

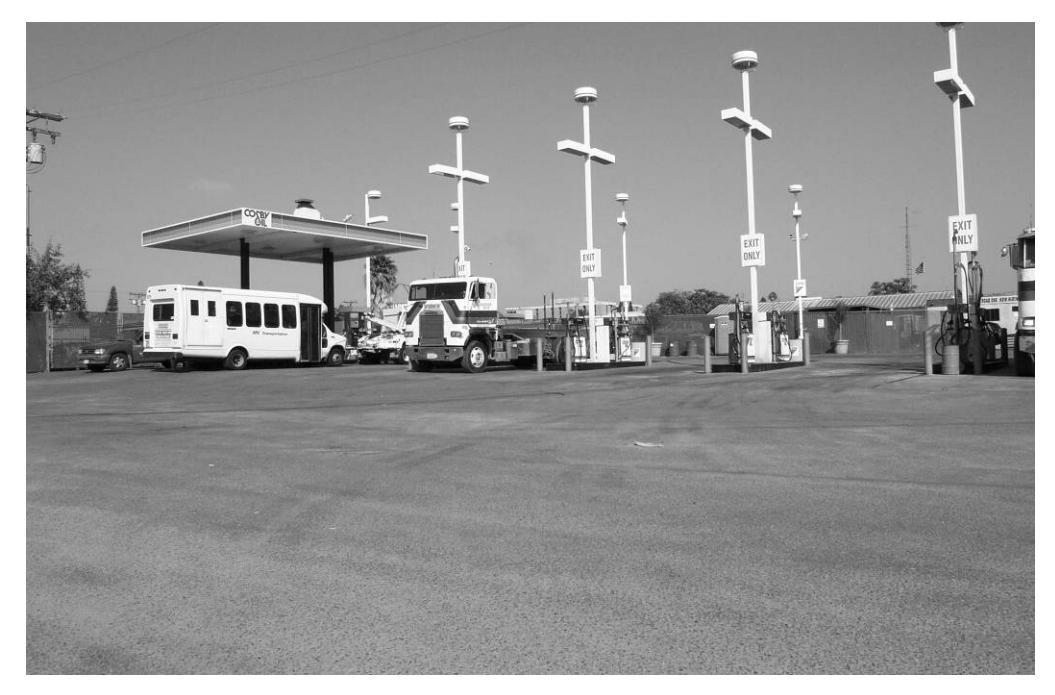
Parcel Number – 458-510-03

Gas station for commercial vehicles, which drains runoff directly into the San Diego River and takes access off side streets and alleys, negatively affecting surrounding traffic circulation as large vehicles travel these smaller streets.

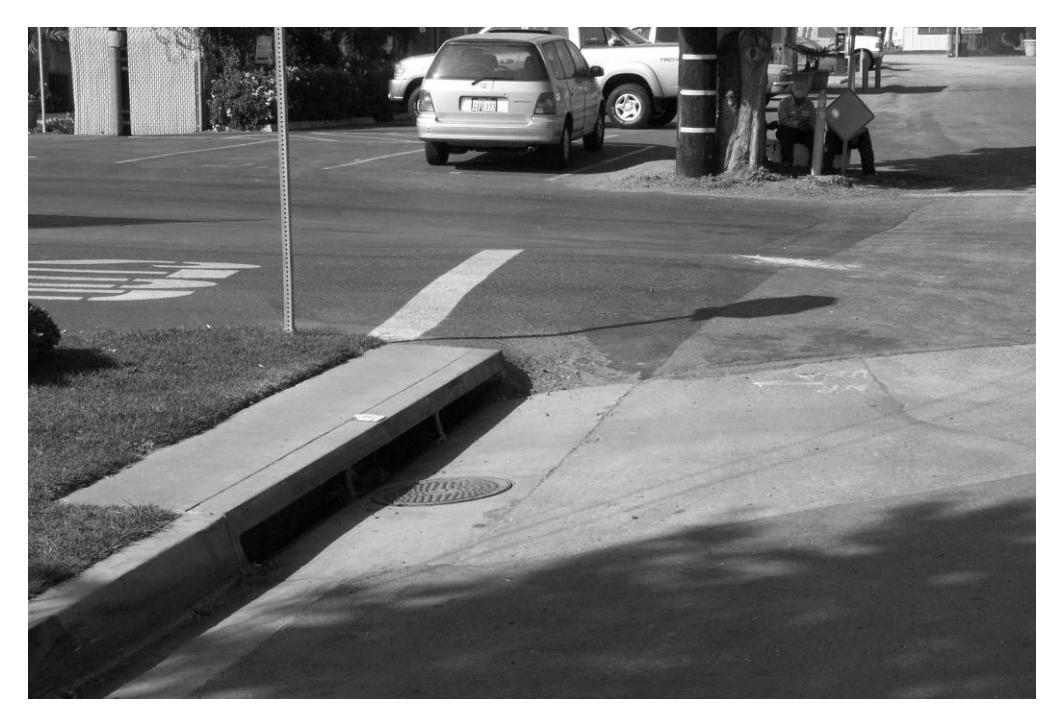
Parcel Number – 458 150 10

Storm drains serving most of the Fairmont industrial area capture runoff and send it directly (untreated) into the San Diego River.

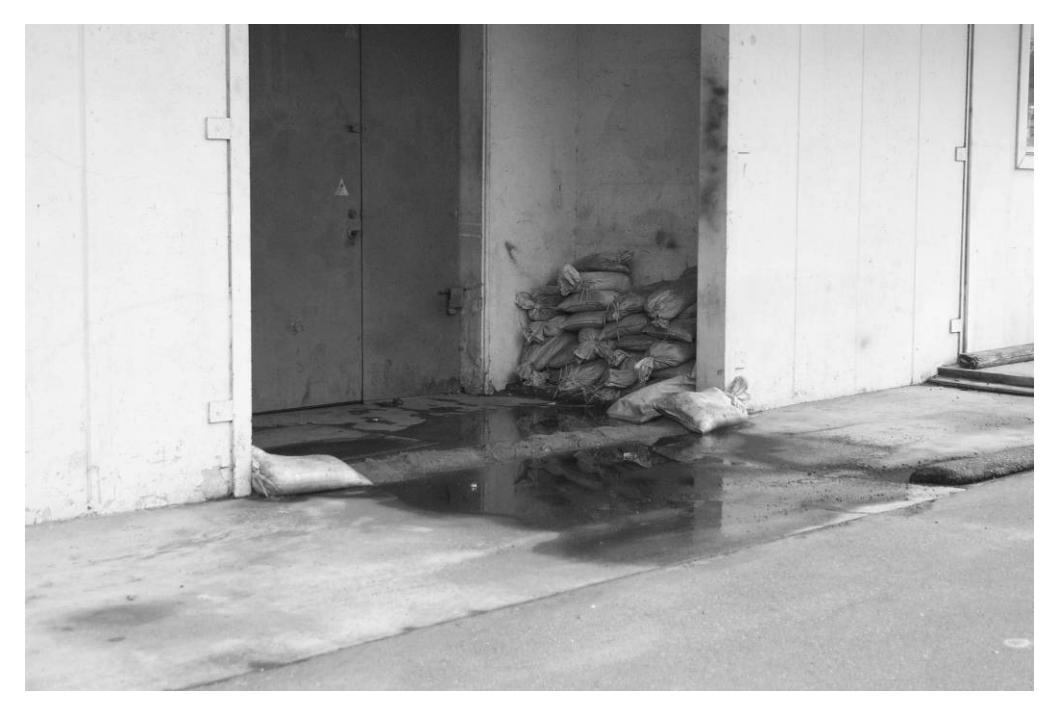
Parcel Number – 461-220-12 Area is prone to flooding and suffer from stagnant water after a storm.

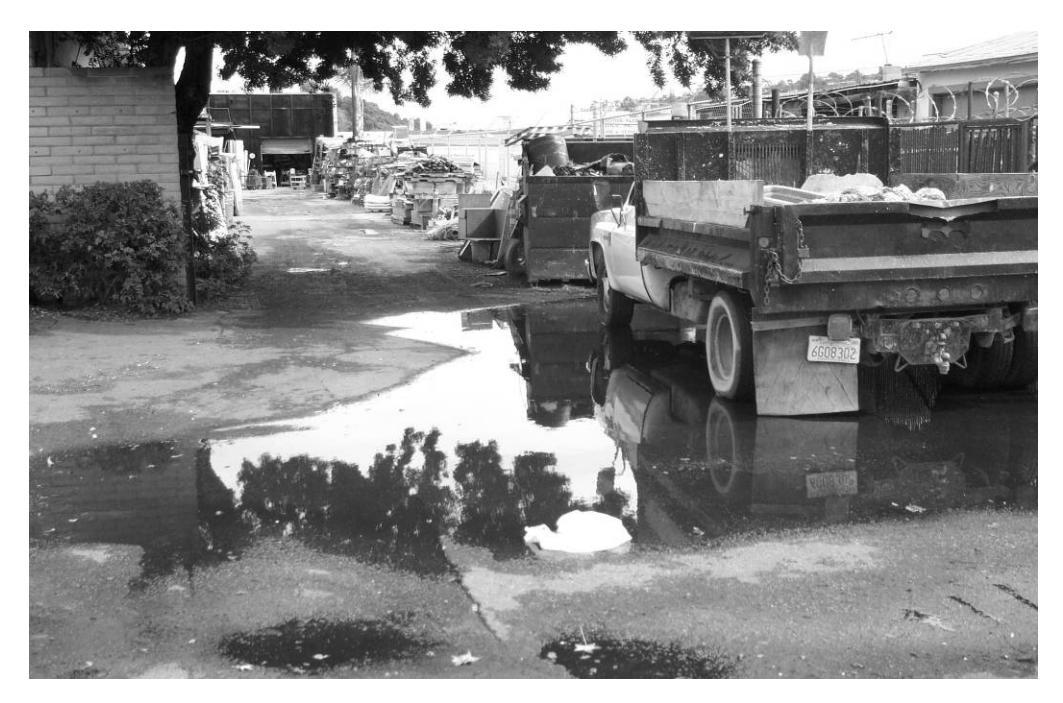
Parcel Number – 461 160 01 Excessive lot coverage and unsafe storage of flammable materials in crowded conditions.

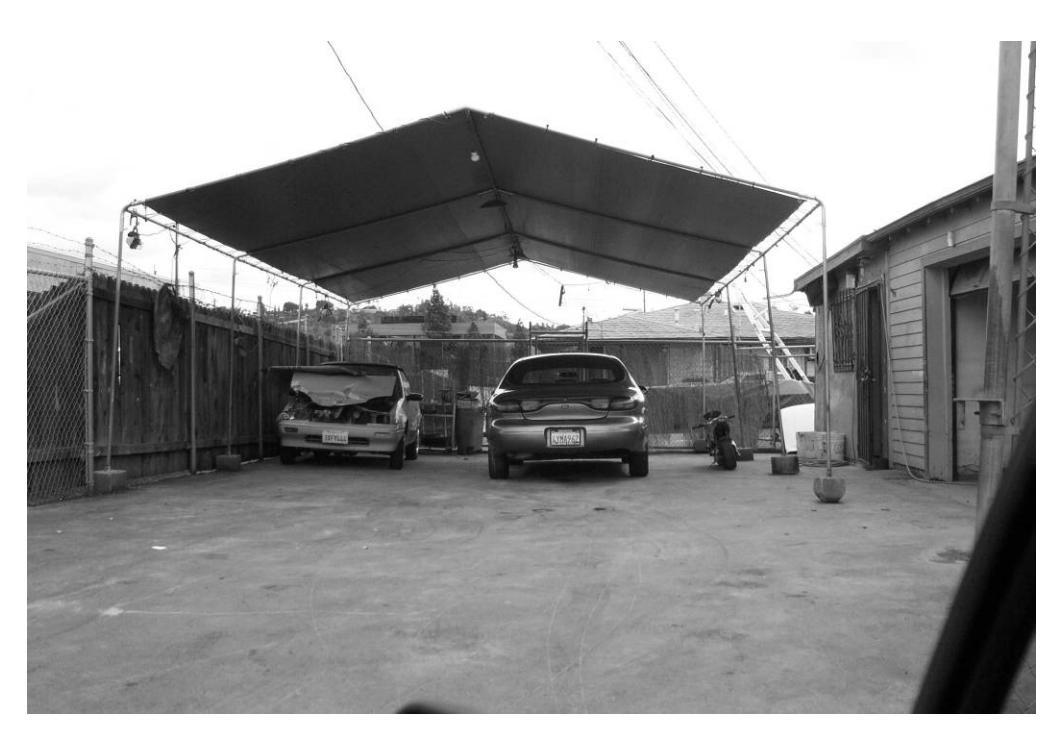
Parcel Number – 458 521 11

Outdoor auto body repair using canvas canopies without proper air ventilation equipment for painting in a residential structure converted to industrial use.

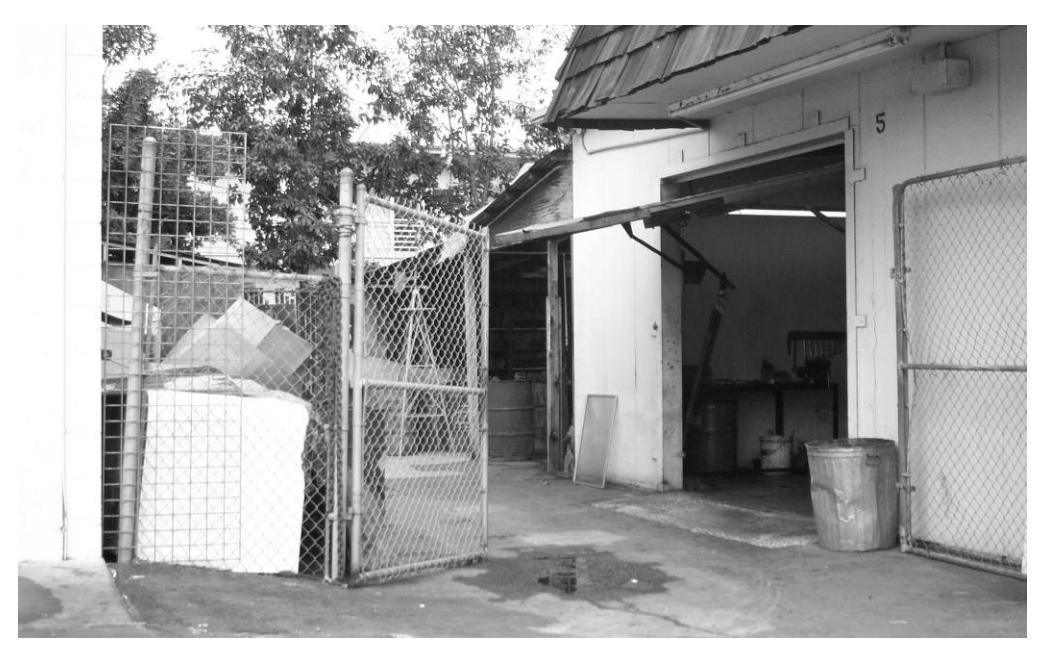
Parcel Number – 461 220 12 Poorly constructed addition with use of flammable materials in a confined working area.

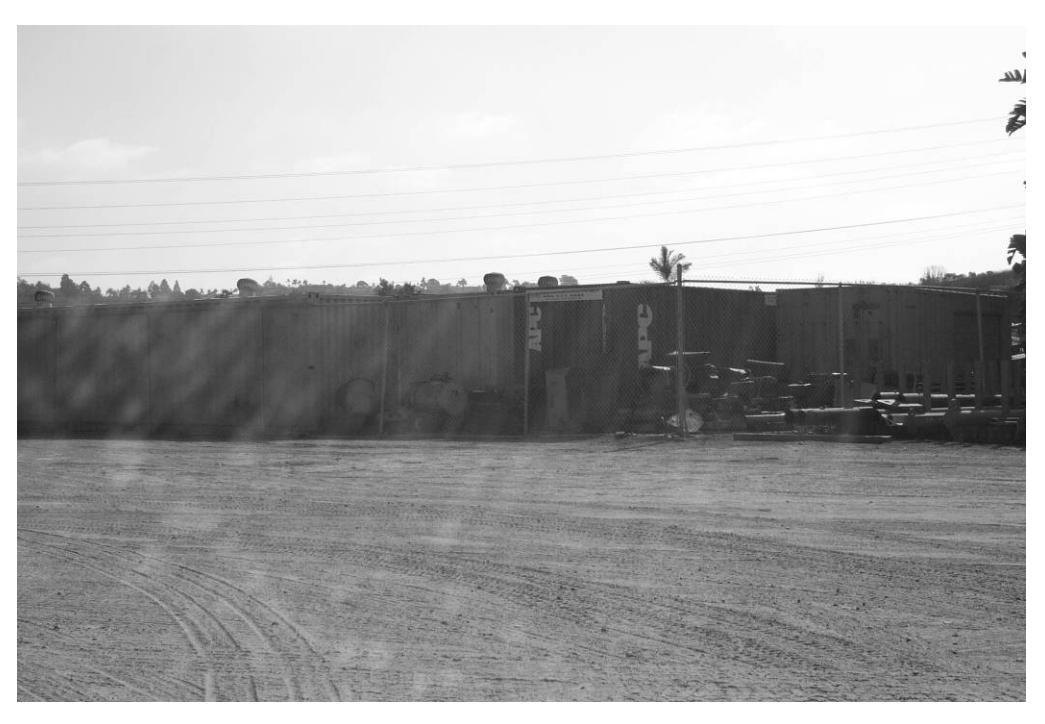
Parcel Number – 458 300 04

Container storage units with ventilation fans and unpermitted electrical service have been converted to substandard work areas.

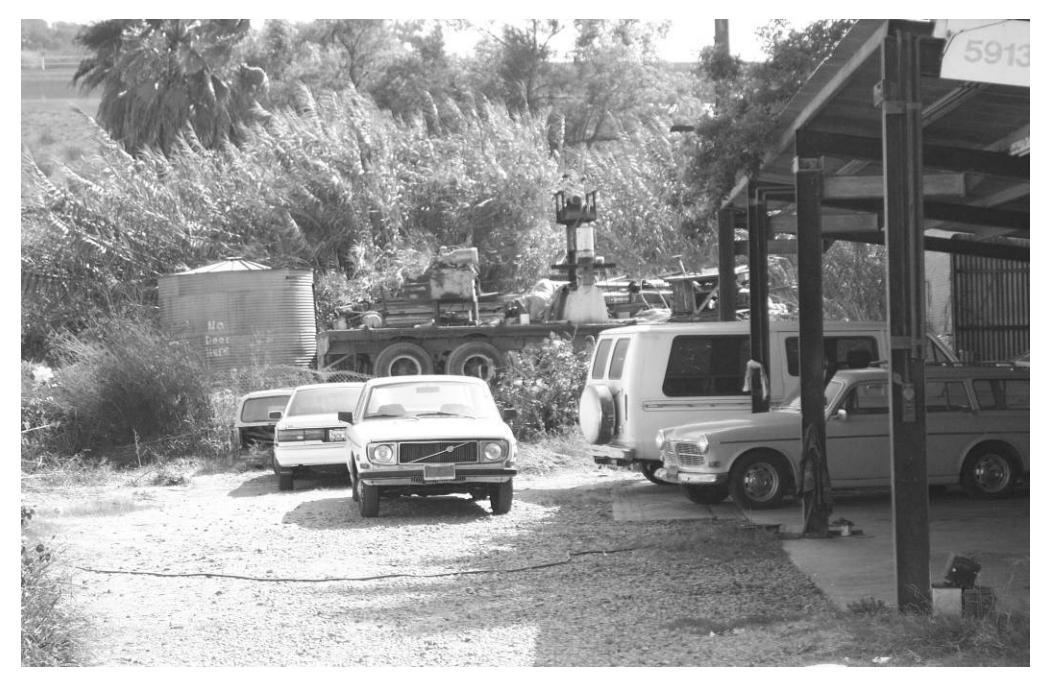
Parcel Number – 461 320 11

Outdoor vehicle repair with storage of salvaged vehicles and machinery on a dirt lot next to Alvarado Creek where site runoff drains to.

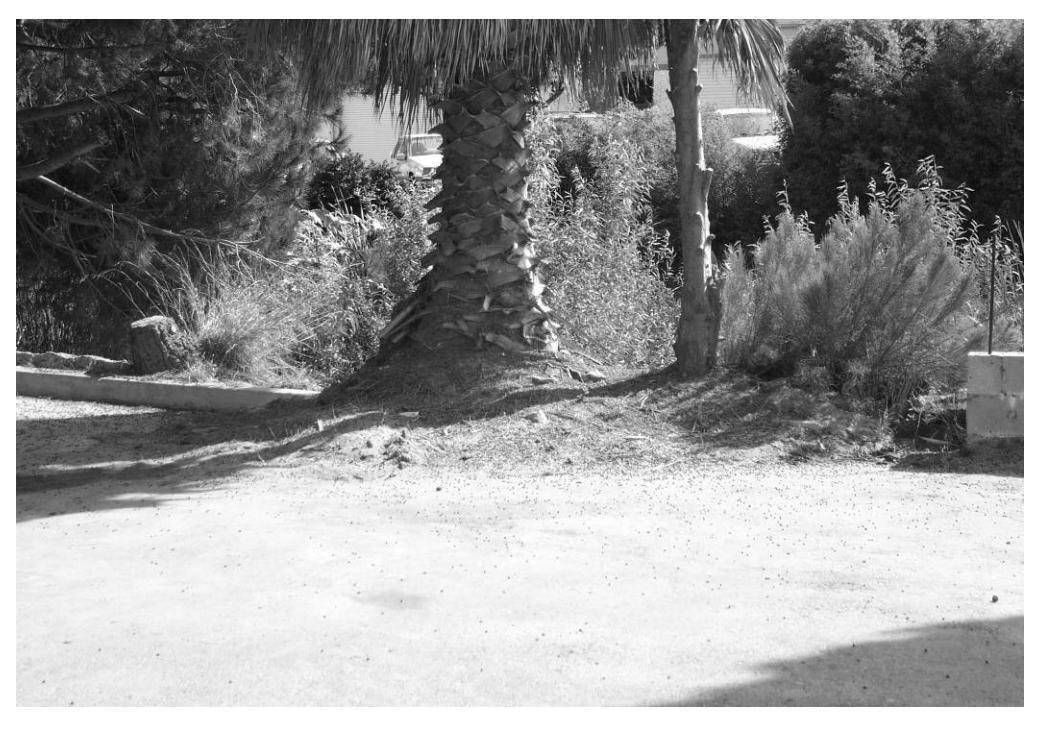
Parcel Number – 461 210 05

Most of Mission Gorge Place is subject to flooding conditions. This property shows where Alvarado Creek has overflowed its bank and left soil deposits on the property.

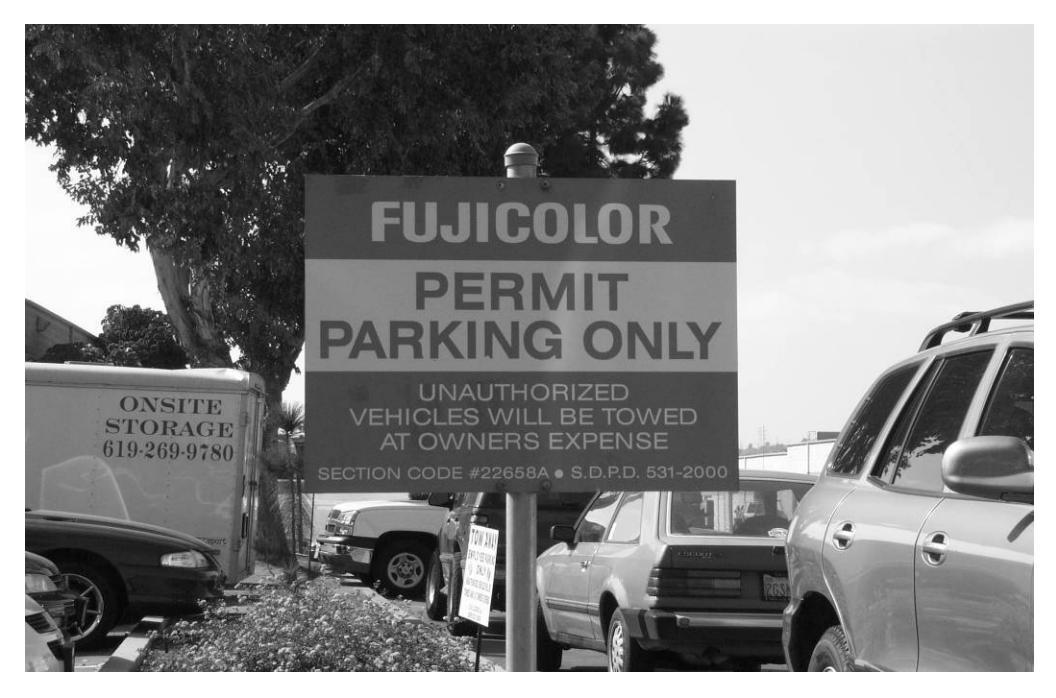
Parcel Number - 461 330 21

Inadequate on-site parking for neighboring properties requires permit parking to be instituted.

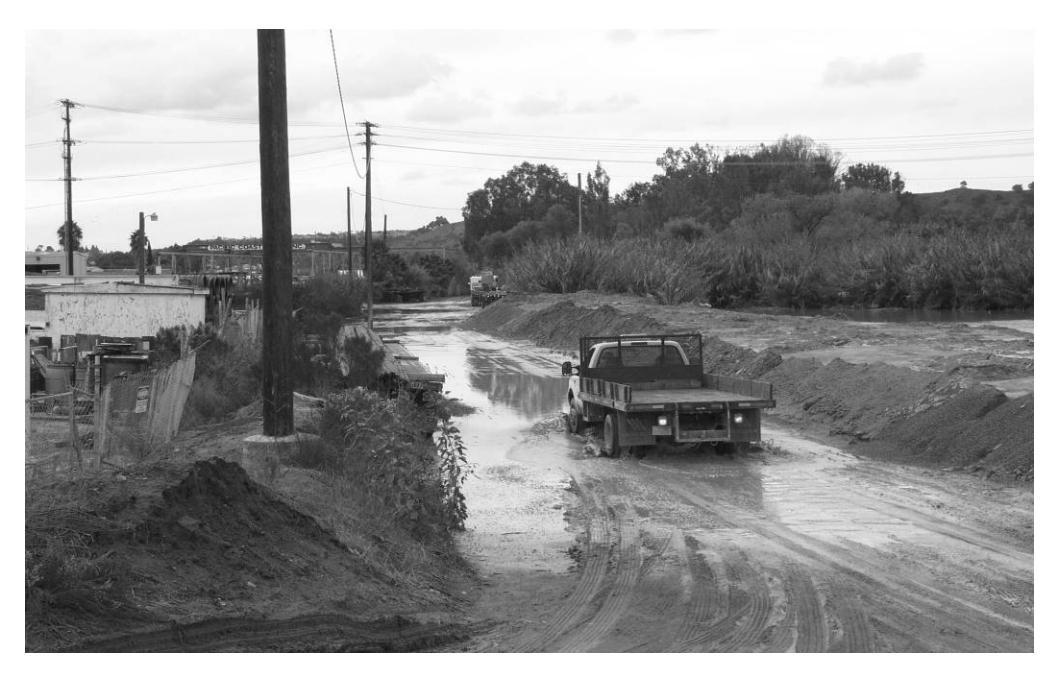
Parcel Number - 455 030 26

Flooding conditions are prevalent in this portion of the Project Area due to its proximity to the San Diego River. Properties to the right are primarily dirt lots for industrial storage that either drain or leach runoff directly into the river.
