Draft Preliminary Report

January 19, 2005

City of San Diego Redevelopment Agency 600 B Street, Fourth Floor, MS904 San Diego, California 92101-4506 (619) 533-4233 www.sandiego.gov/redevelopment-agency

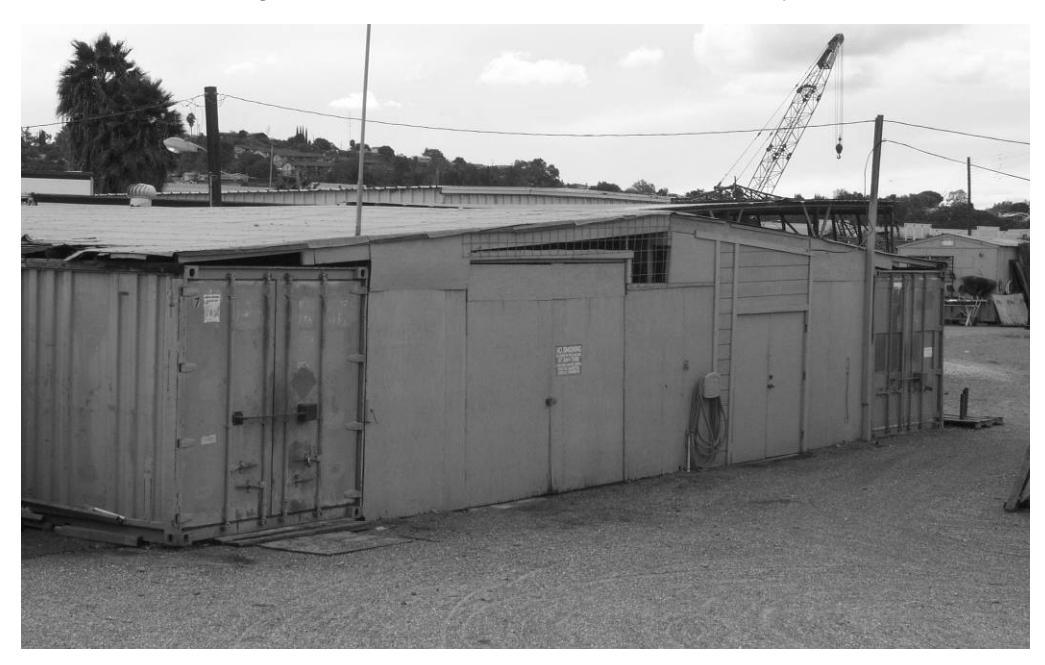
Parcel Number - 455 030 26

Substandard additions with metal storage containers attached to buildings, a violating of the building code. These additions have substandard electrical and ventilation, which present fire and health hazards to workers.

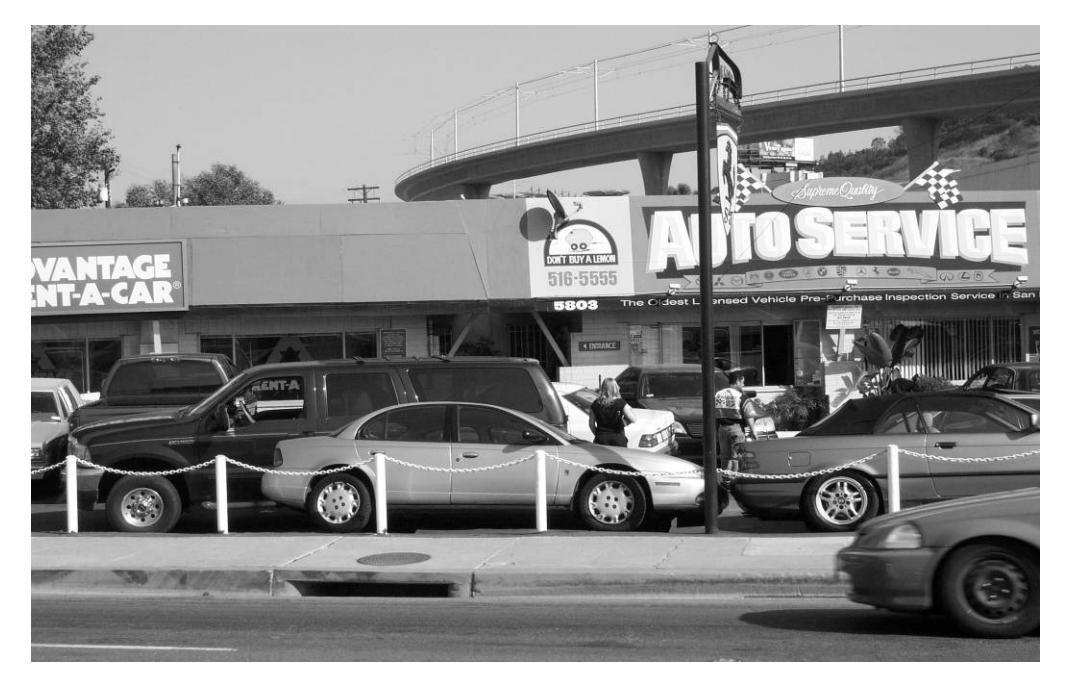
Parcel Number – 461 320 02

Lack of adequate on street parking creates crowded on site conditions for this rental car operation, which shares the property with an auto repair facility.

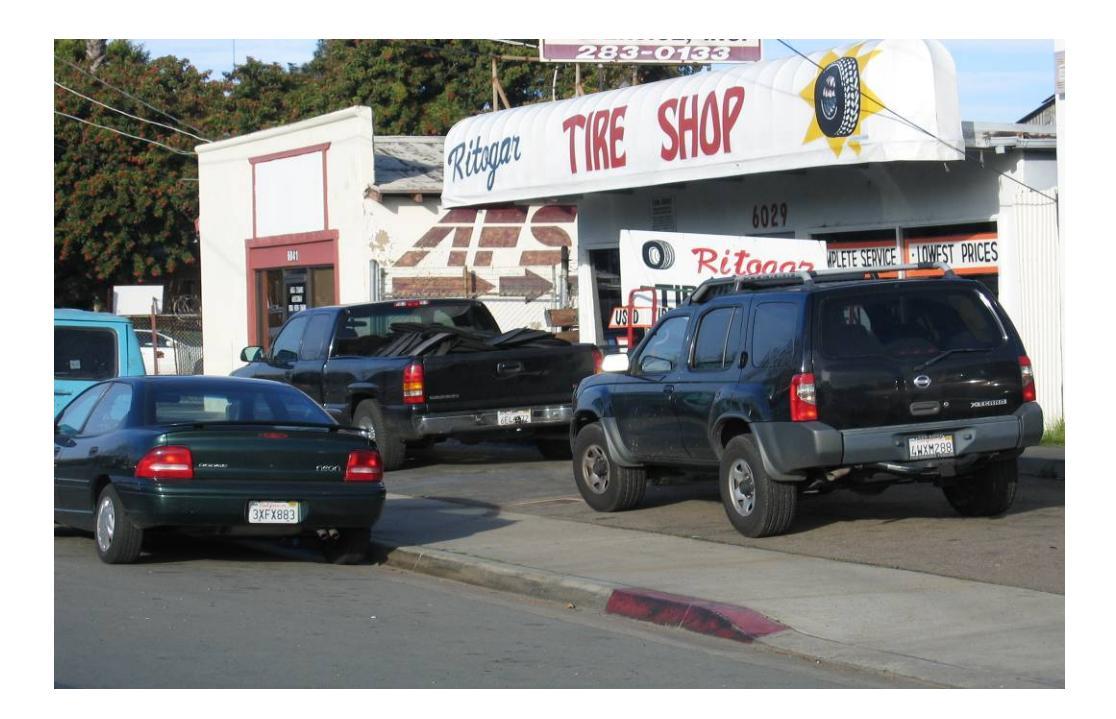
Parcel Number – 461 160 04

Inadequate parking is also caused by small parcel sizes. Here vehicles and outdoor tire displays congest the front of this building making it an unsafe area for pedestrians to walk and vehicles to access the property.

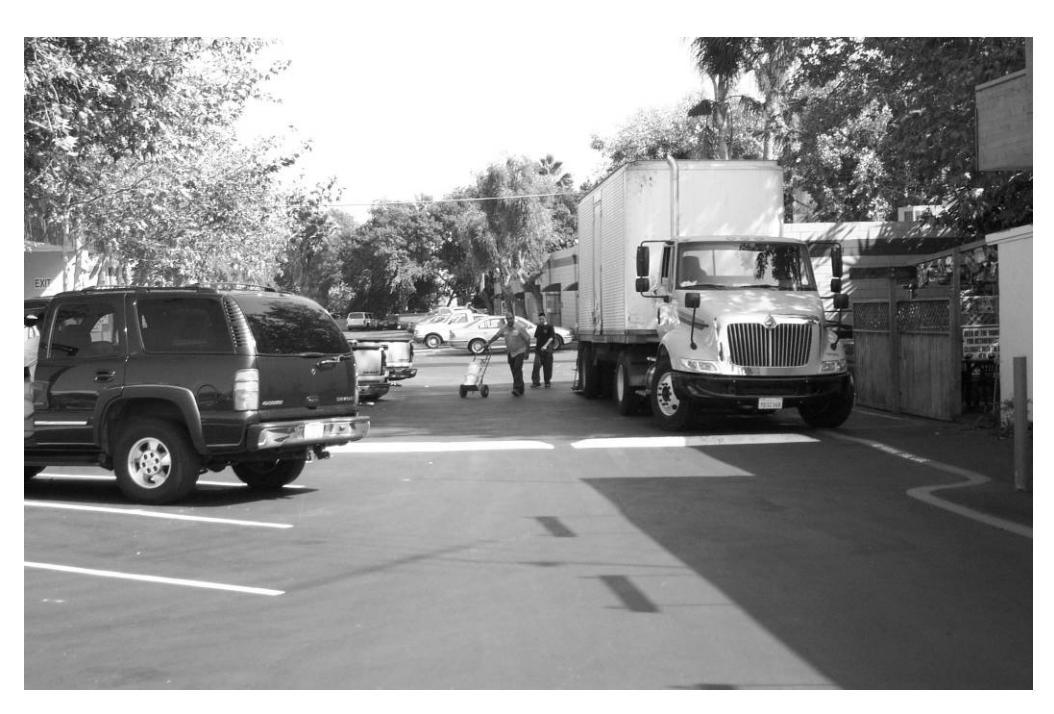
Parcel Number – 461 320 03

Narrow entry ways, which restrict property access are further impaired by delivery vehicles which often block traffic and fire lanes to make deliveries.

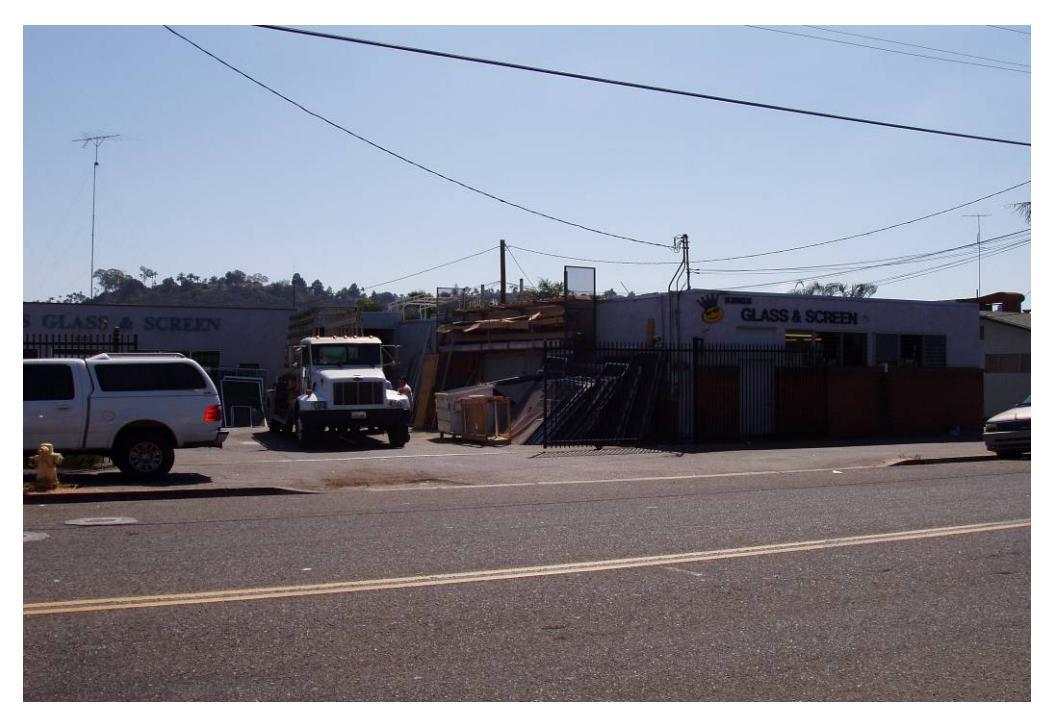
Parcel Number – 461 160 08

This glass and screen installation company has outdoor storage of its materials, where broken glass can also create a hazardous condition Further, this activity detracts from the overall appearance of the area and reduces on-site parking for employees and customers.

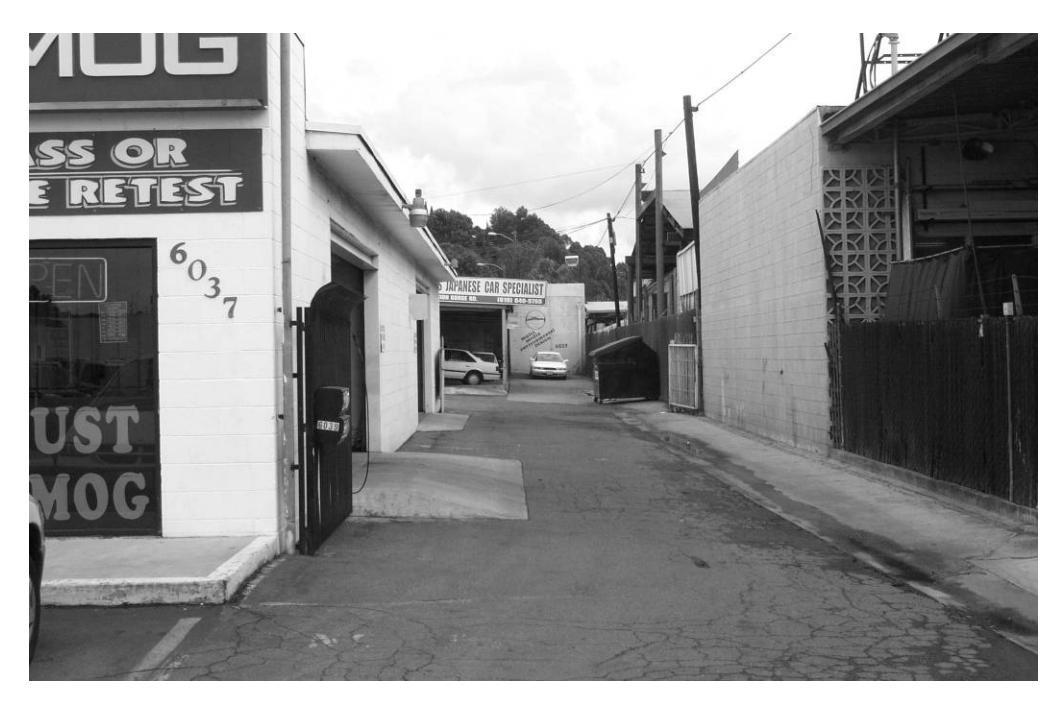
Parcel Number – 461 200 02

Narrow access between multiple businesses is an obsolete and unsafe design that would not meet current development standards.

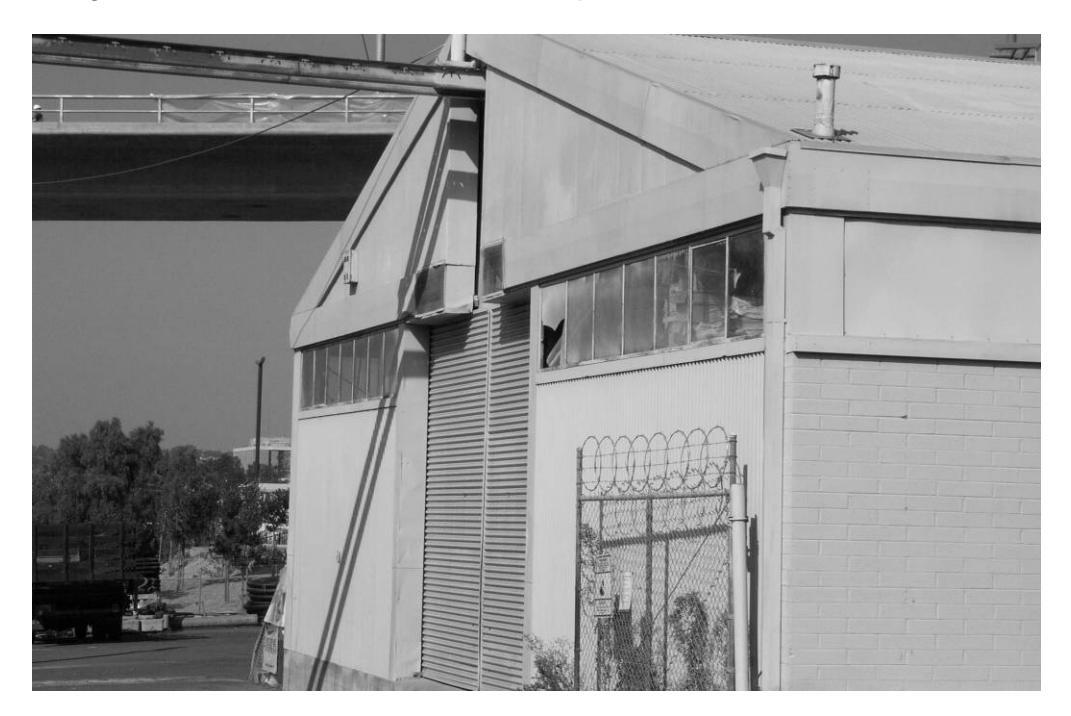
Parcel Number - 461 320 23

Obsolete industrial building with substandard corrugated metal building material.
