GEOTECHNICAL AND GEOLOGIC EVALUATION REPORT FOR STADIUM RECONSTRUCTION PROJECT SAN DIEGO, CALIFORNIA

AECOM Project No. 60431885

July 29, 2015

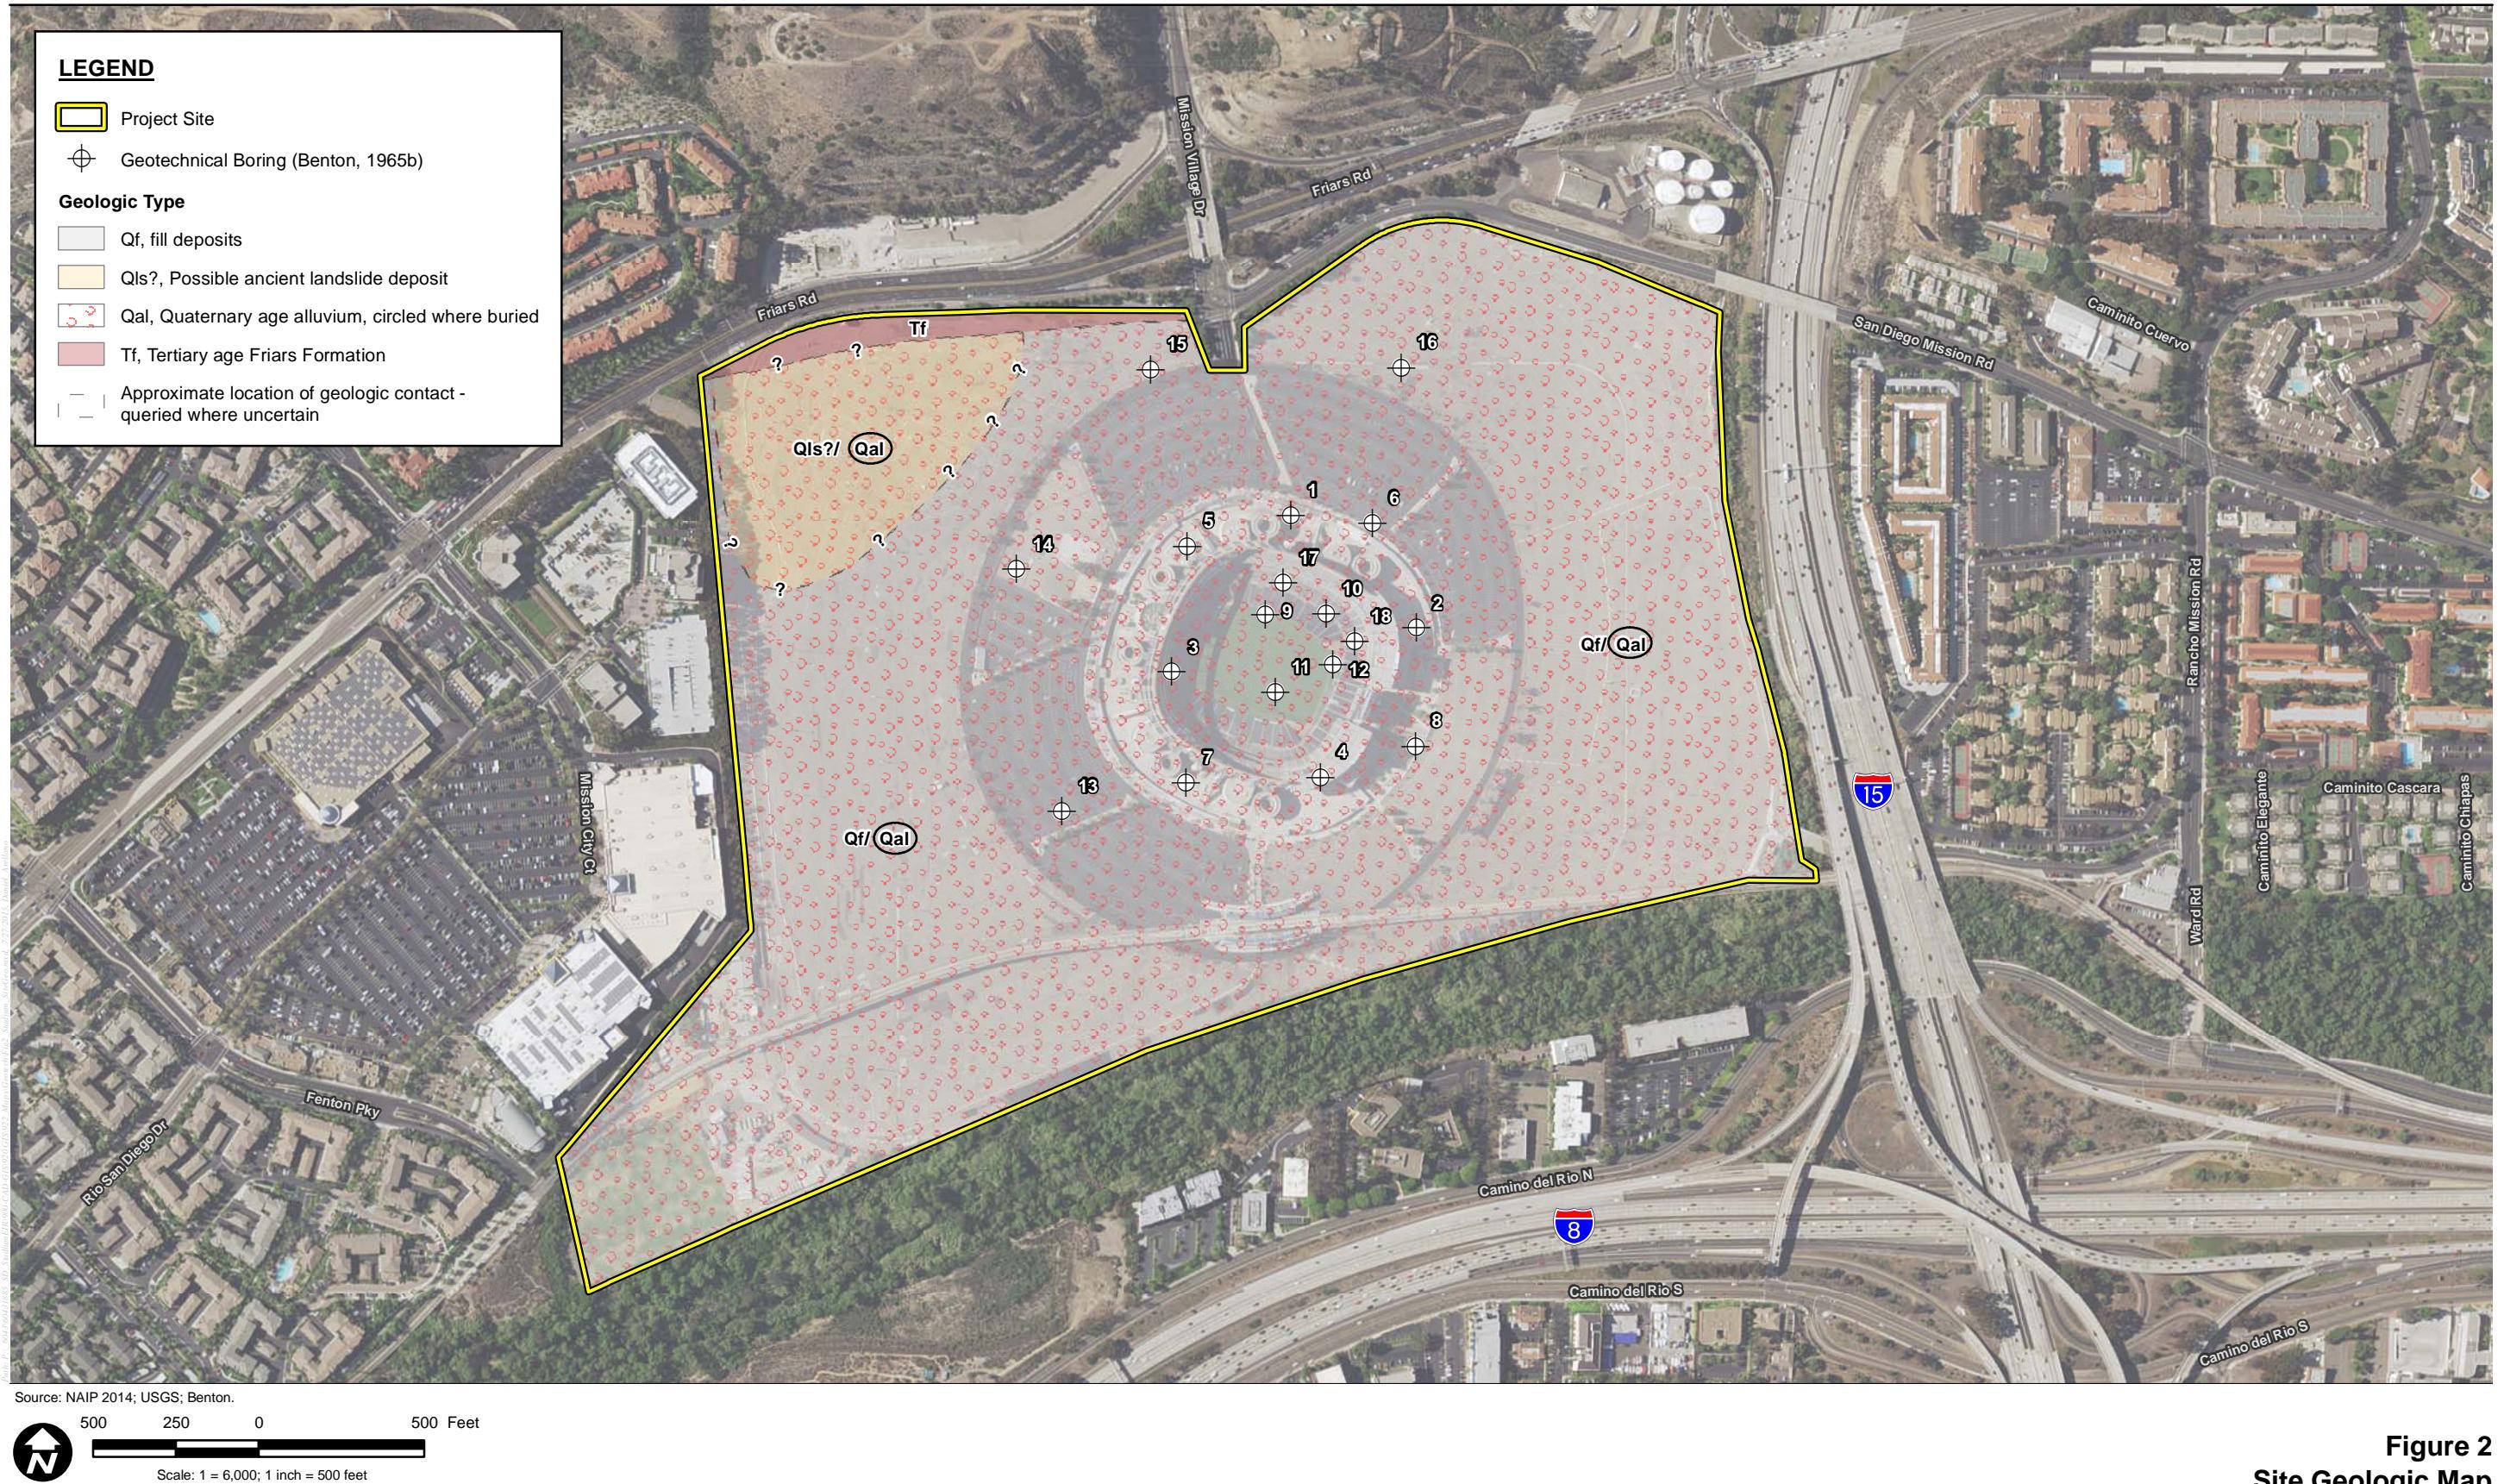
Qualcomm Stadium is located in Mission Valley along the northern margins of the former floodplain of the San Diego River and near the outlet of Murphy Canyon, a south-trending subsidiary drainage. A regional geologic map of the area is shown in Figure 3 and is based on published regional geologic mapping (Kennedy and Tan 2008). The immediate site area is mapped as older alluvial deposits (Qoa). These older alluvial deposits are overlain locally by younger alluvial and colluvial deposits associated with the Murphy Canyon drainage and the adjacent hillslopes. The alluvial and colluvial deposits are overlain by fill soils placed during development of Qualcomm Stadium. Site-specific mapping of the floodplain was performed for the Qualcomm Stadium design (Benton 1965a). This mapping provides some geomorphic detail with a delineation of three terrace levels within the floodplain alluvial deposits. It also maps a small landslide to the northwest of the Project site along the slopes of the canyon approximately 1,000 feet to the west of Mission Village Drive. A Site Geologic Map is presented as Figure 2.

The proposed Project would be constructed near the northeast corner of the Qualcomm Stadium property, as shown in Figure 2 Site Geologic Map. Alternative projects are being considered and are discussed in Section 6 of this report. The proposed Project would cover an area of approximately 750,000 square feet (approximately 17 acres). It would be a steel-framed structure with a maximum height of 250 feet above the ground surface (including lighting and architectural features). Qualcomm Stadium would likely be demolished after completed construction of the new stadium.

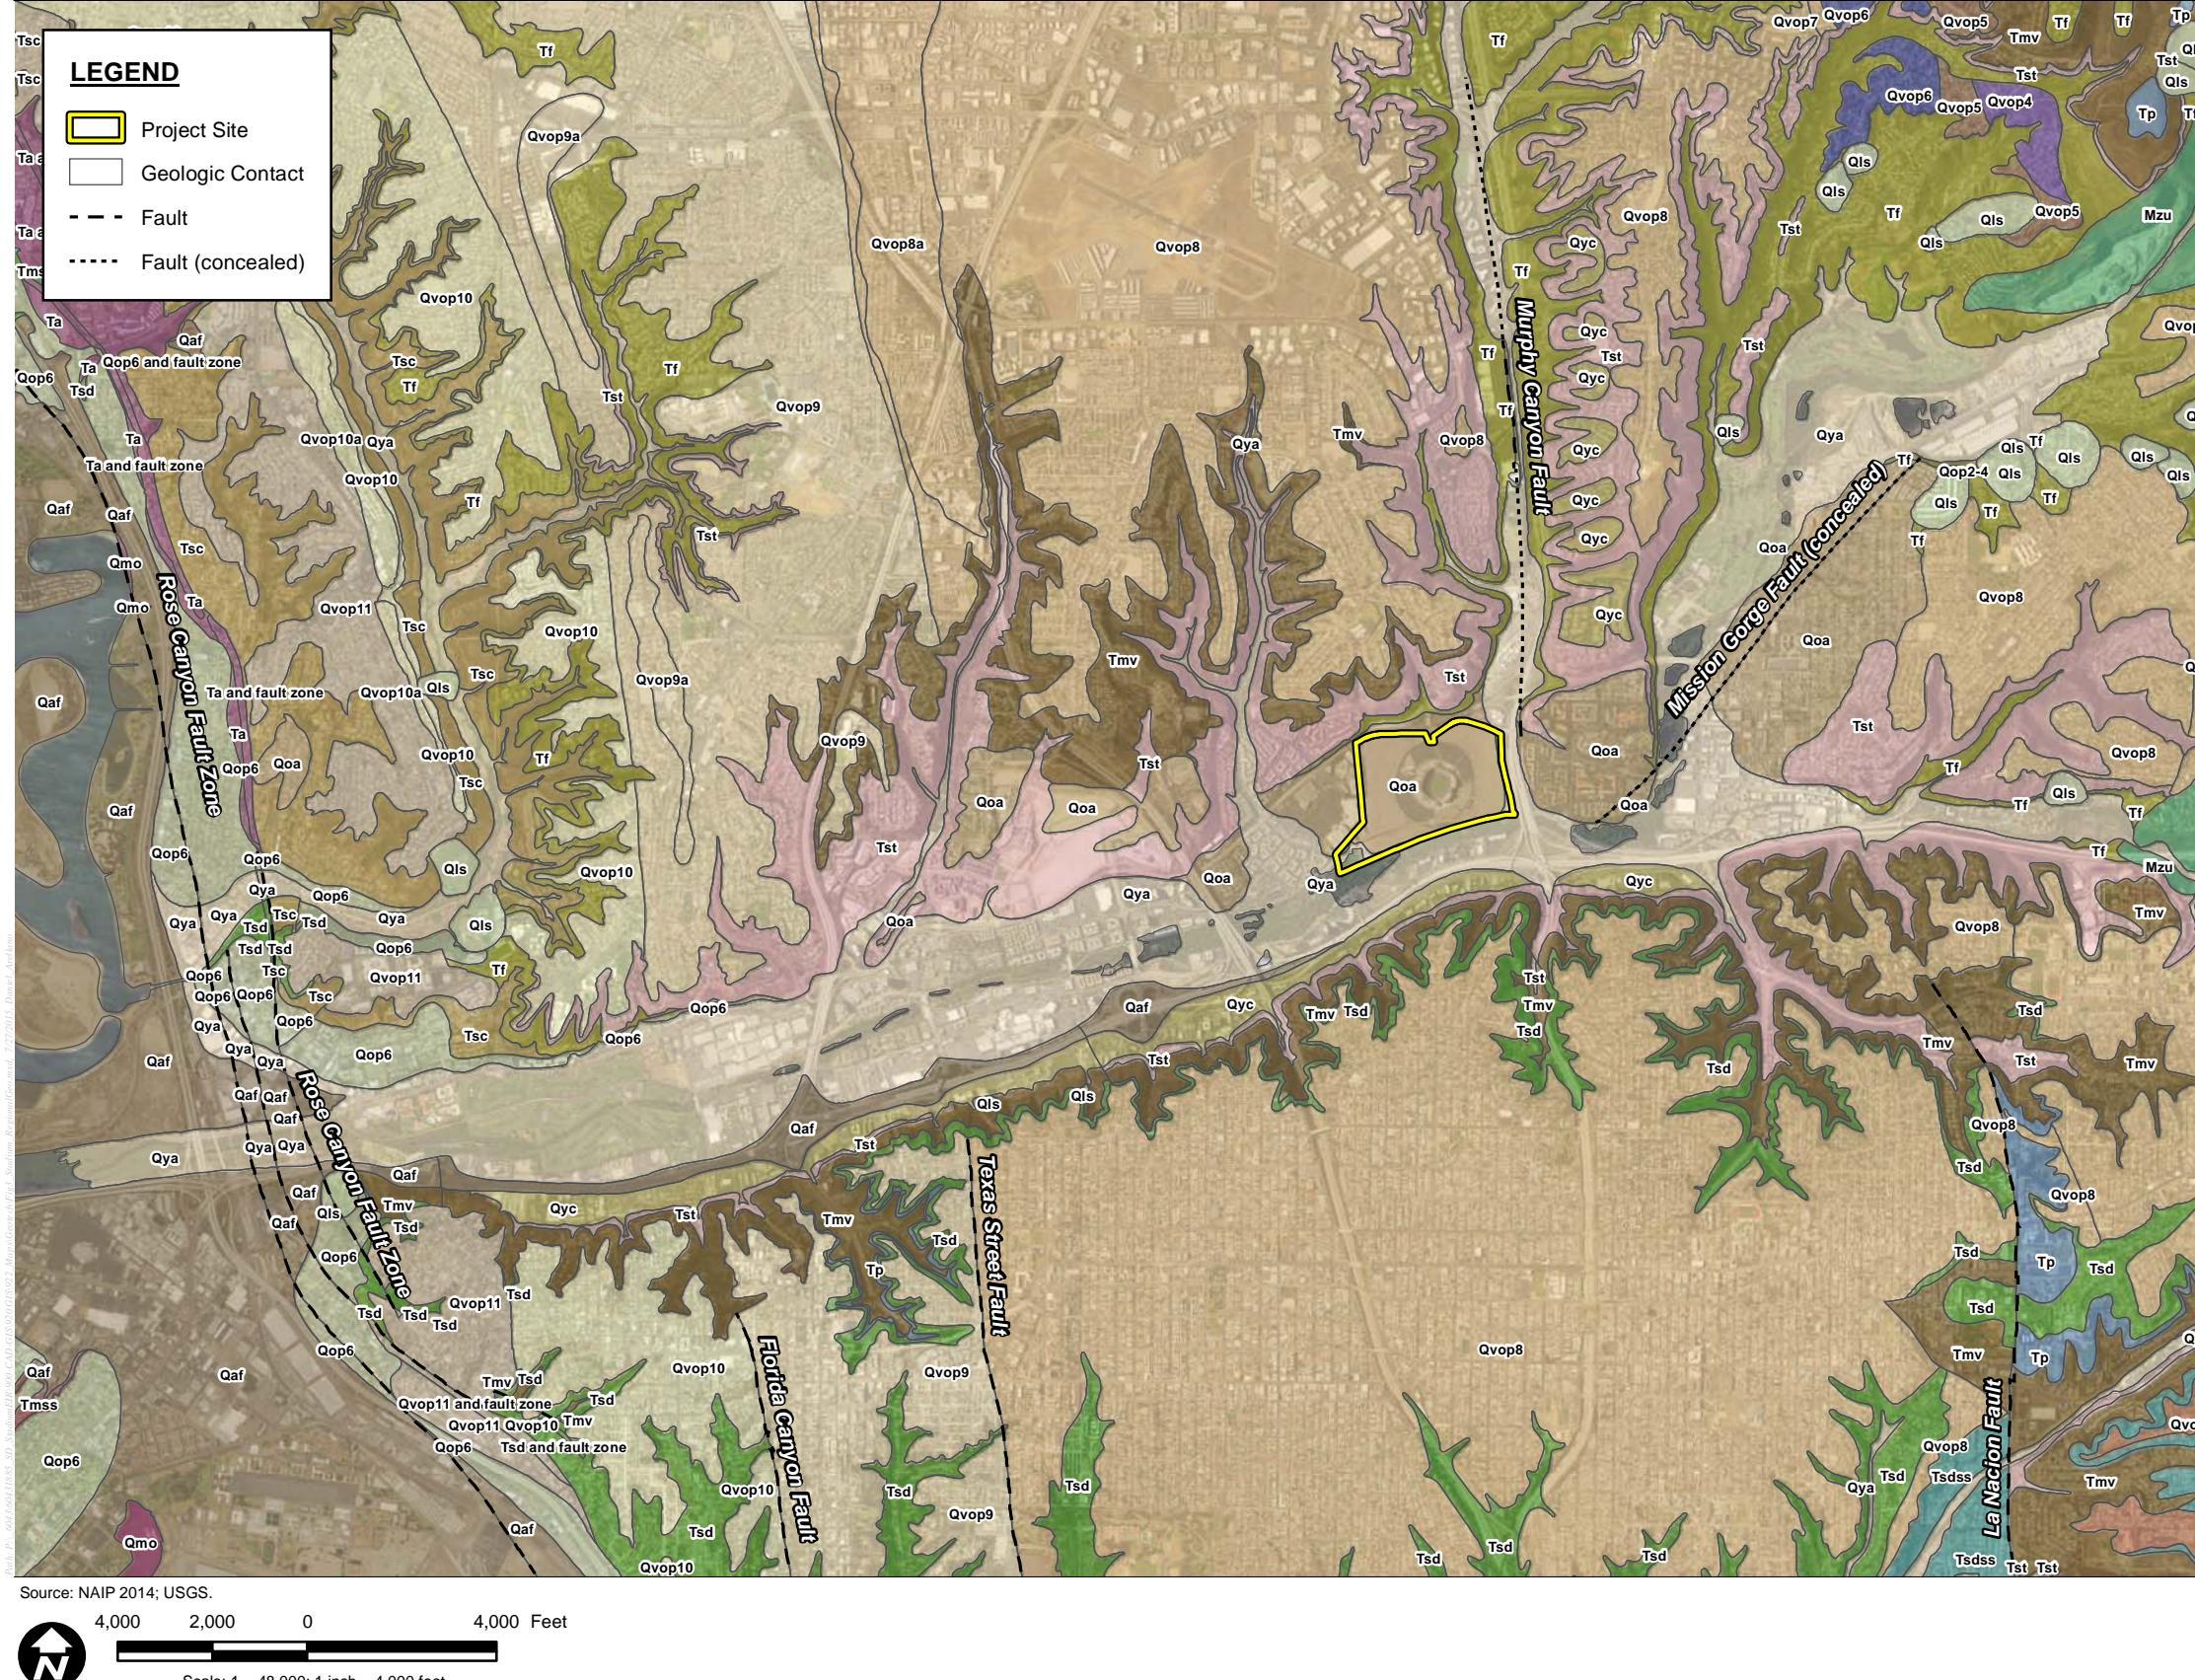
Figure 3 Regional Geologic Map

Scale: 1 = 48,000; 1 inch = 4,000 feet

Ta, Ardath Shale	5. 17 -
Tmss, Mount Soledad Formation, sandstone	
Tmsc, Mount Soledad Formation, cobble conglomerate	1
Kgu, Granodiorite and tonalite undivided	
Mzu, Metasedimentary and metavolcanic rocks undivide	ed
Qvop	~
Tsdss	
Tadas Tau	Tmv
Qya
