INDIVIDUAL BIOLOGICAL ASSESSMENT REPORT

Site Name/Facility:	Sorrento Valley Channel Emergency Maintenance (Reaches 3 & 7)
Master Program	
Map No.:	9, 11, & 12
Date:	July 18, 2016
Biologist Name/Cell	
Phone No.:	Scott Gressard (858-997-6874)

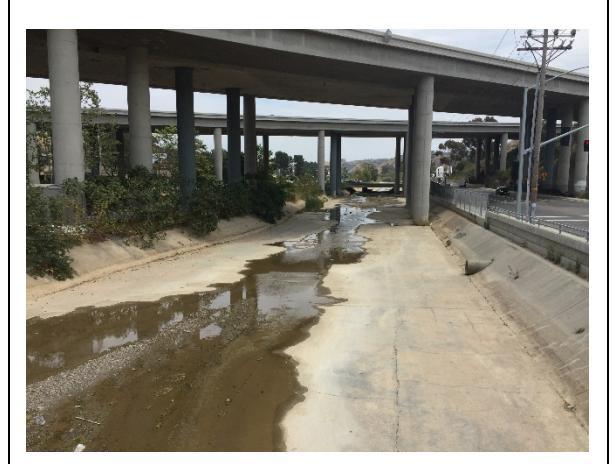
Photograph 4: Looking northwest from the pedestrian bridge located in the downstream end of Reach 3 toward the downstream limit of the channel where Reach 3 (concrete-lined) transitions to Reach 2 (earthen bottom; Figure 3A).

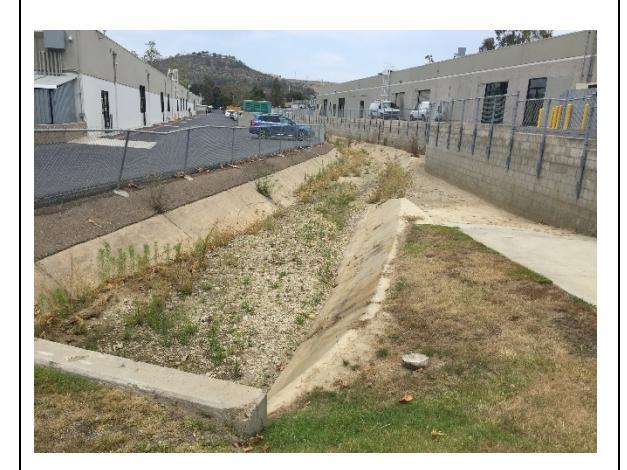
Photograph 1: Looking east from the upstream end of the Reach 7 channel on Flintkote Avenue (Figure 3C).

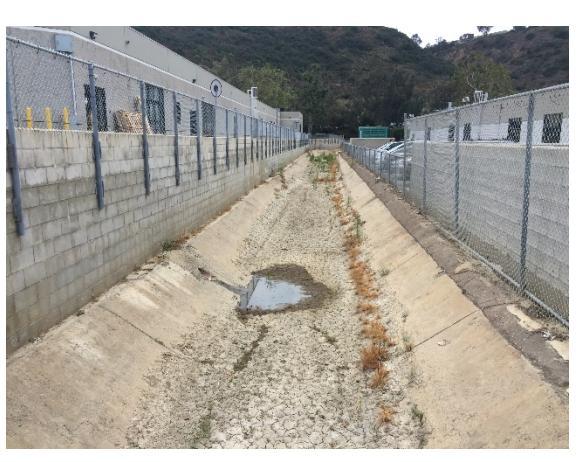
Photograph 2: Looking west from the pedestrian bridge at the upstream section of Reach 7; Figure 3C.

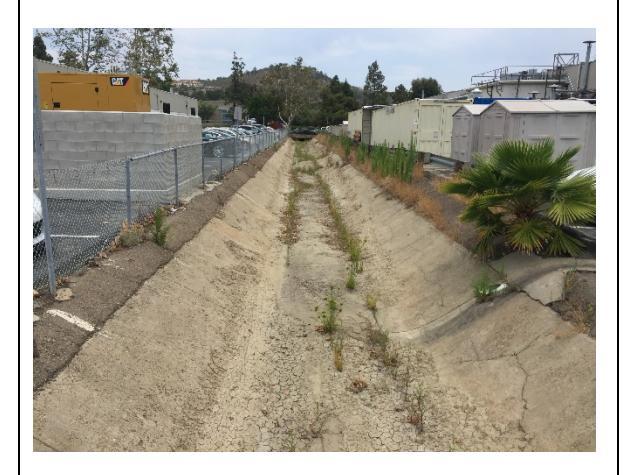
Photograph 3: Looking east from the pedestrian bridge at the center section of Reach 7; Figure 3C located west of Roselle Street.

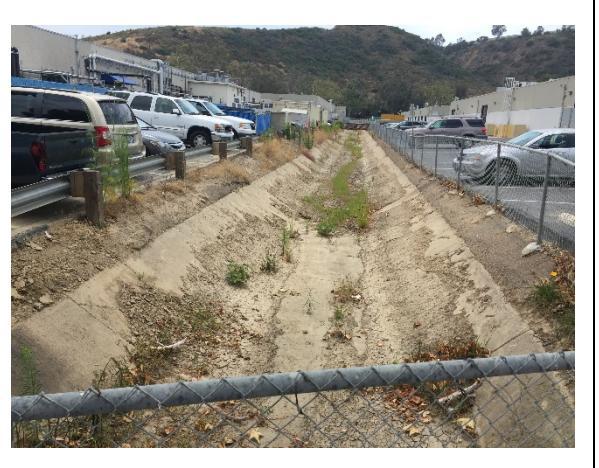
Photograph 4: Looking west toward the pedestrian bridge at the center section of Reach 7; Figure 3C from Roselle Street.

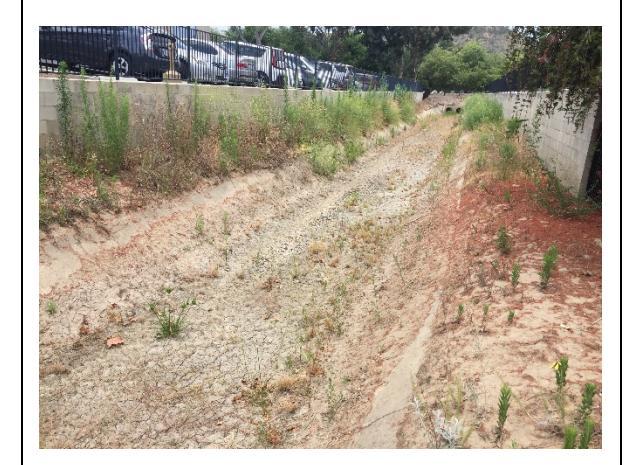
Photograph 3: Looking east at the downstream end of Reach 7; Figure 3C toward the Reach 2 earthen channel from Roselle Street.
