# Pergola Redesign

**Inez Grant Parker Memorial Rose Garden**

April 11, 2024

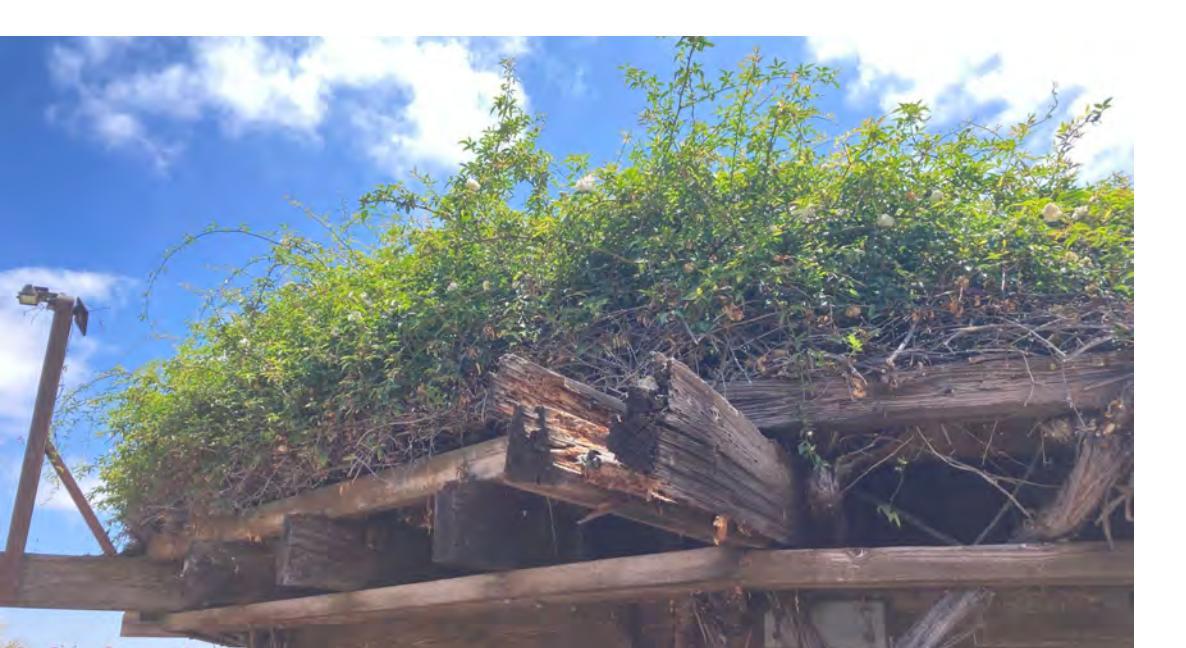
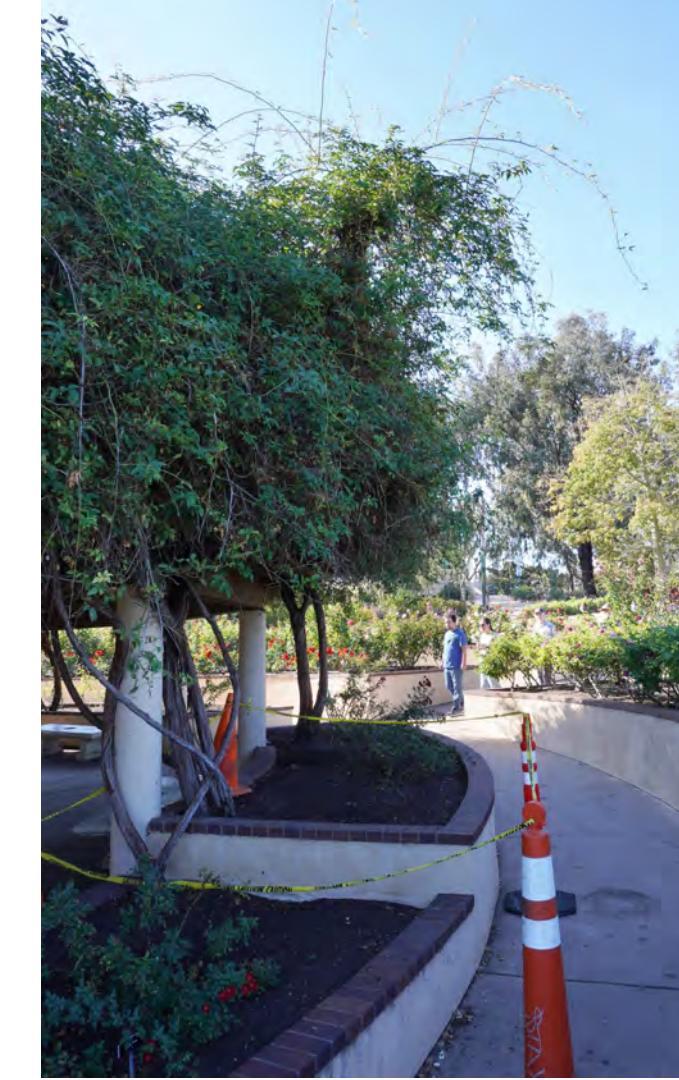
#### Previous Pergola Removal

- Structure was over 30 years old
- Wood beams had rotted
- Rose vines had become overgrown and unmanageable
- FBP and Parks & Rec. collaborated for removal in early 2023

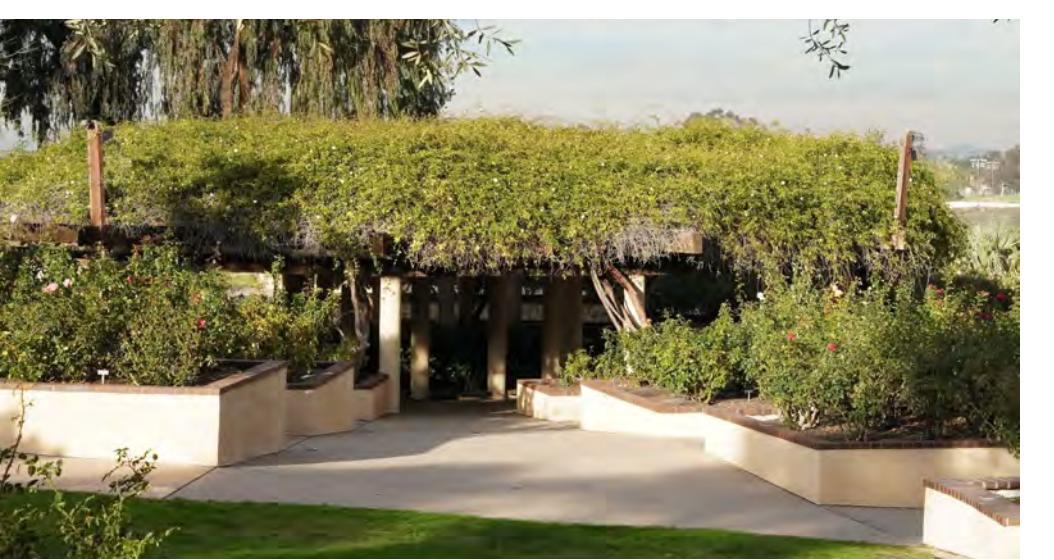
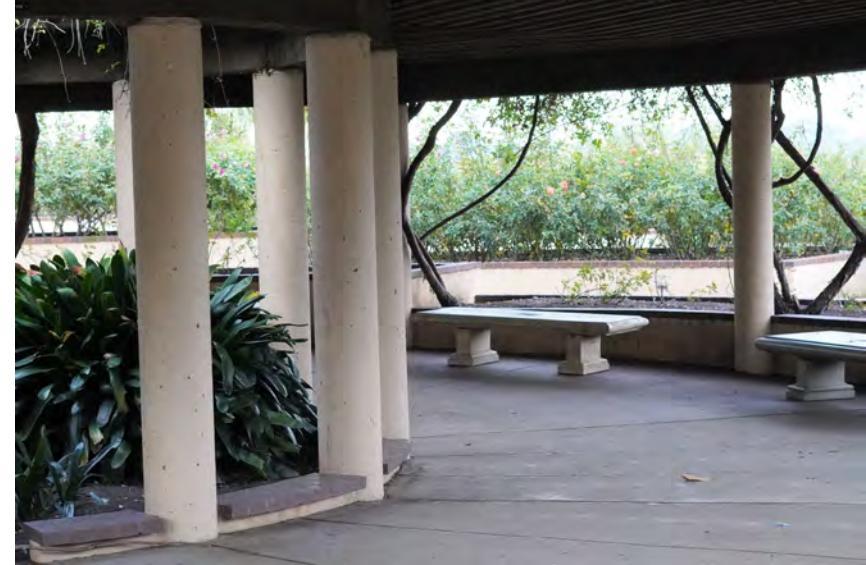
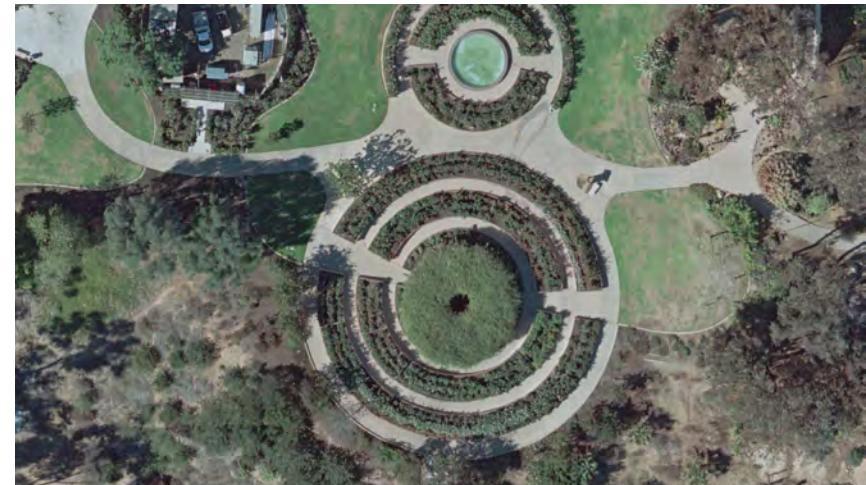
#### Previous Pergola Design

- Not considered a historic element
- Simple design
- Deep shade
- Low roof (6.5'-8' high)
- Central Planter
- Thick concrete pillars

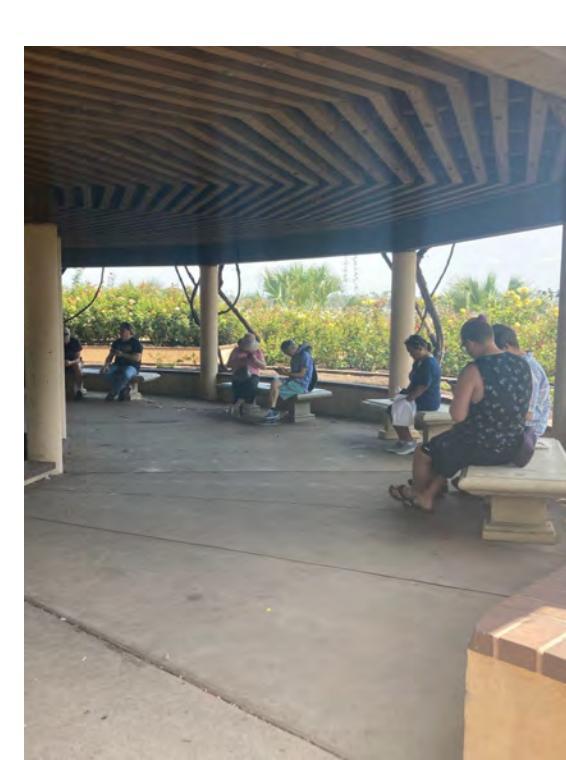
### **Existing Conditions**

- Limited capacity for maintenance
- Minimal lighting and security
- Vandalism and anti-social behaviors in the area
- Existing Conditions
  - Columns and paving require replacement

Paving

Columns

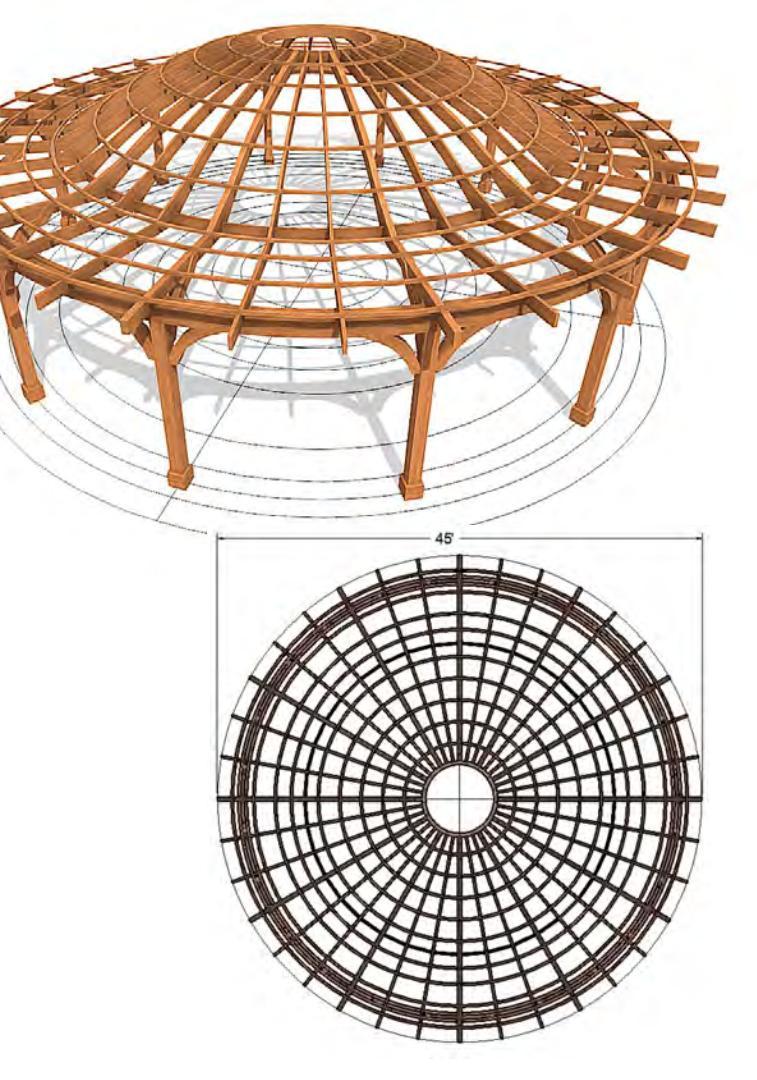
#### **Preferred Design**

- Domed shape with no central supports
  - Echoes arches of El Prado area and form of the Botanical Building
  - Open central area expands use for rose garden volunteer meetings and permitted ceremonies/events
- Douglas Fir
  - Maintains simplicity and aesthetic of former pergola
  - Preferred material for Parks and Rec team

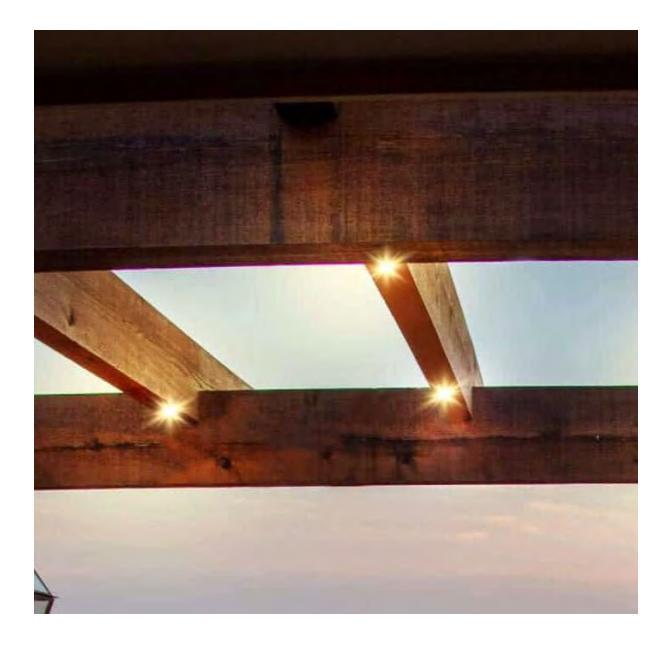
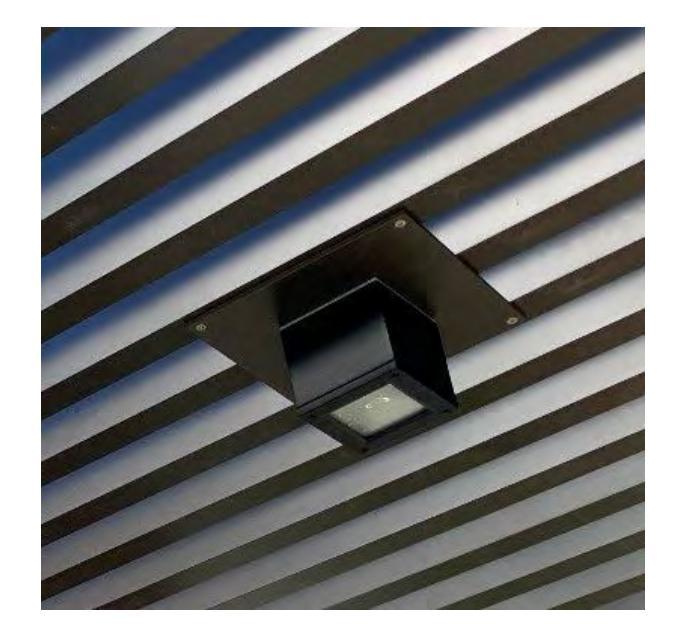
#### Pergola Lighting

• Integrated lighting in structure to enhance experience for evening visitors as well as safety and security
