Toyon Road Private Residence Project

General Biological Survey Report Project no. 599273

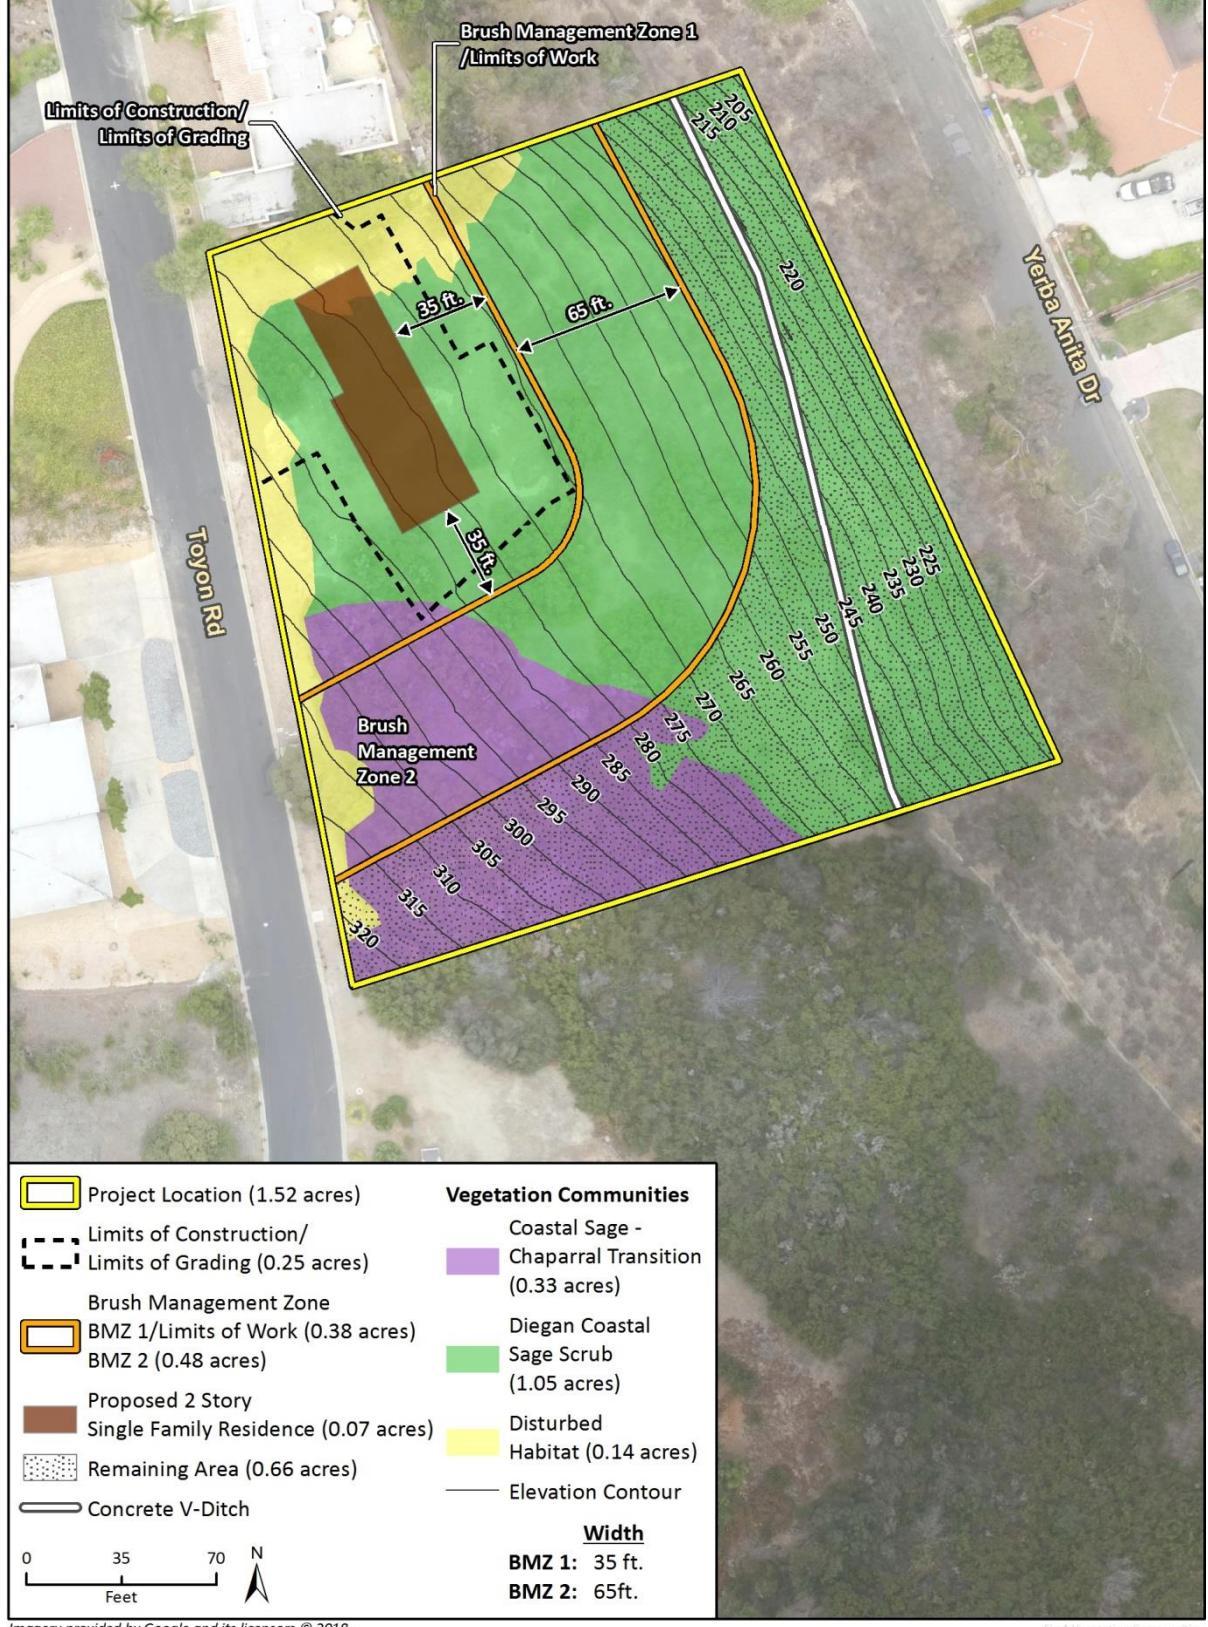
Figure 4 Vegetation Communities

Three vegetation communities or land cover types were mapped during the field survey and are presented in this report; DCSS (Tier II), Coastal Sage-Chaparral Transition (CSS/Chaparral, Tier II), and disturbed habitat (Tier IV) (Figure 4). Table 2 lists total acreage of each vegetation community/land cover types on-site.

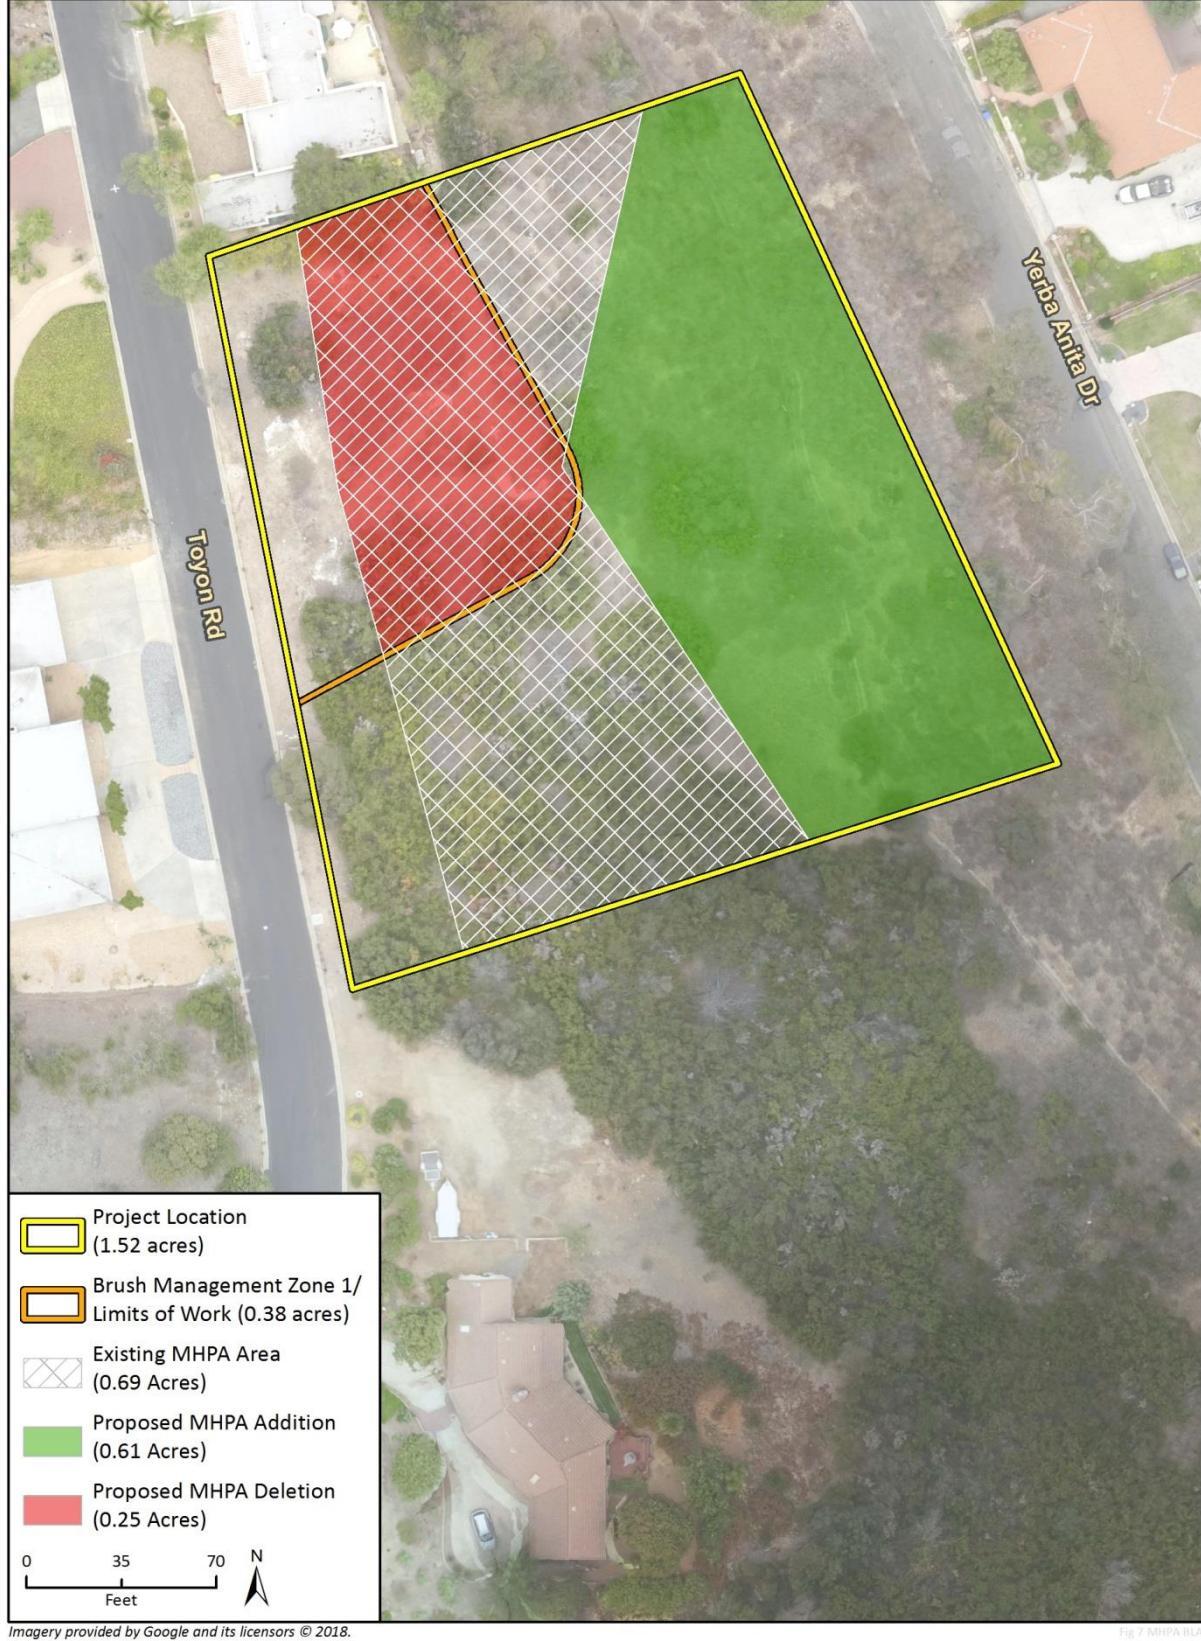
Figure 7 MHPA BLA Addition and Deletion

As described above, development of the proposed project is not possible without some encroachment into the existing MHPA. Therefore, a BLA is proposed to reconfigure the MHPA preserve on-site to obtain a reasonable, contiguous development area. The property includes both native vegetation communities within and adjacent to existing MHPA lands. Overall, the proposed BLA would delete 0.20 acre of DCSS and 0.01 acre of CSS/Chaparral from the MHPA and add 0.61 acre of DCSS (Figures 7 and 8).

The habitats that would be added to the MHPA through the BLA have the same species composition, but the DCSS in this area is less disturbed and contains steep slopes (0.58 acre); this habitat is considered more sensitive and of higher biological value for covered species. The BLA will delete 0.20 acre of lower quality DCSS and add 0.61 acre of steeper and less disturbed DCSS, which would improve the quality and quantity of conserved habitats on-site. Therefore the BLA will exchange habitat of lower quality (disturbed) for habitat of higher quality.

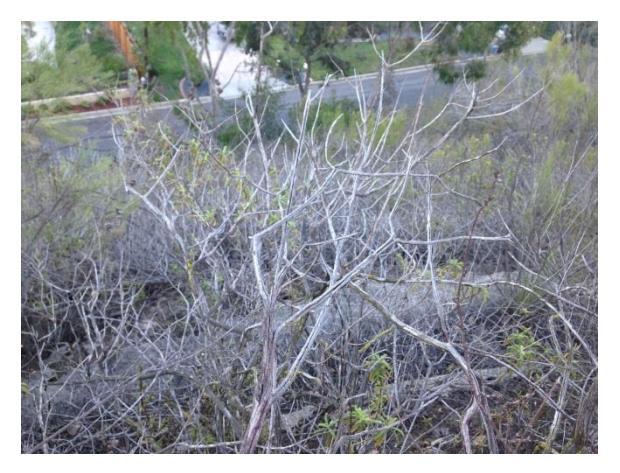
Photo 9. View east and down over east fenceline. Concrete runoff conveyance visible behind vegetation.

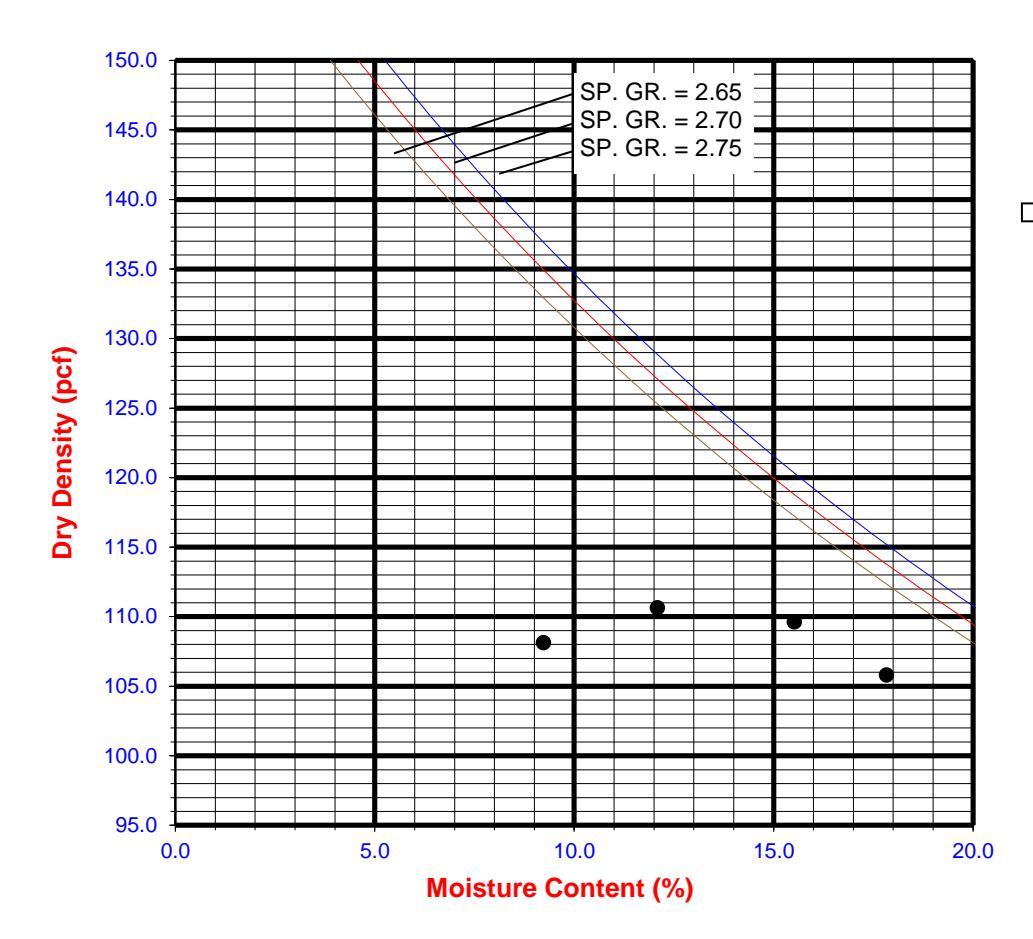
COMPACTION TEST

Maximum Dry Density (pcf) 112.0

Optimum Moisture Content (%) 14.0

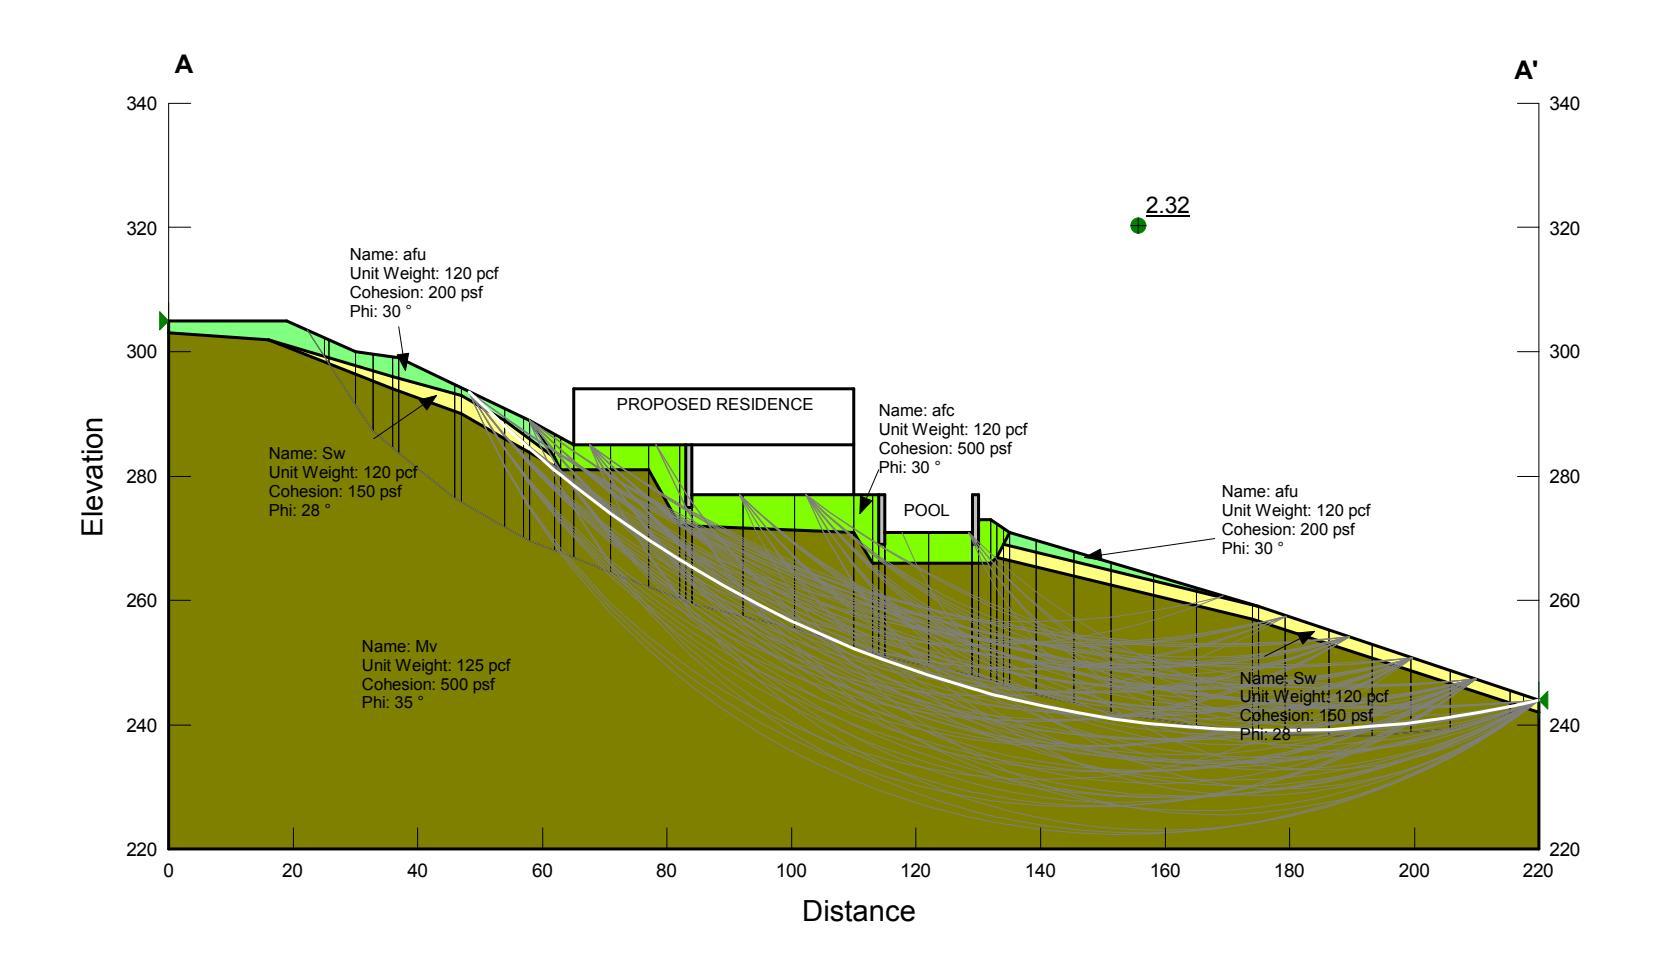
Project Name: Munch Residence File No. 17188 Method: Spencer Horz Seismic Load: 0.15

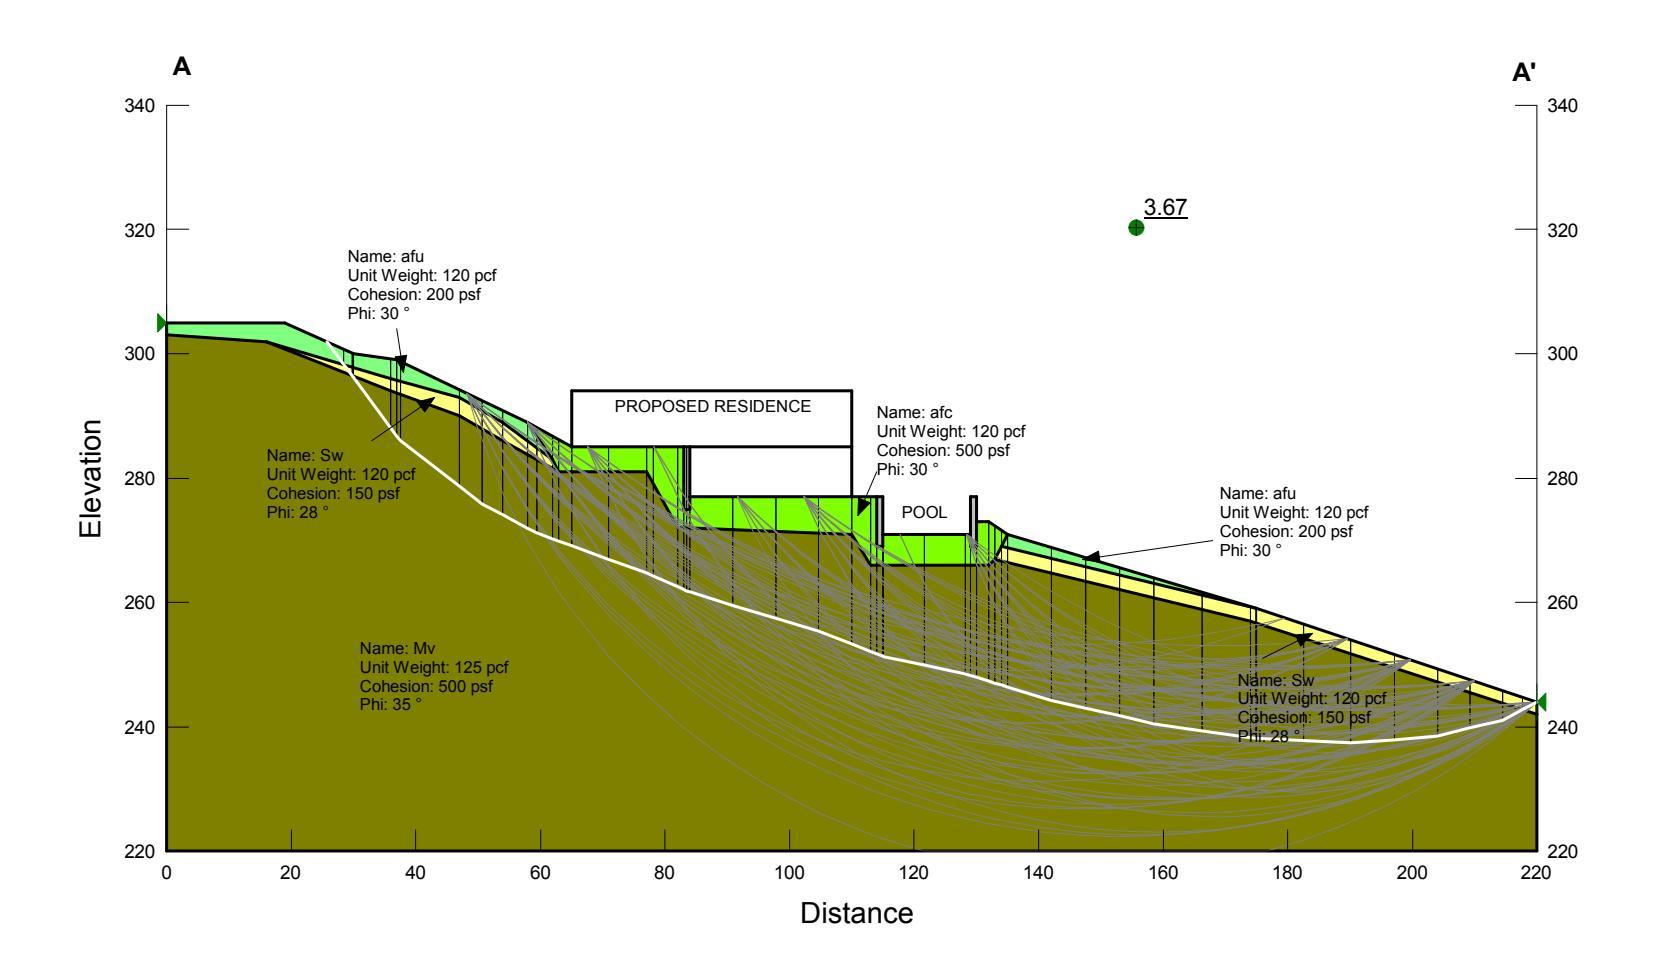
Project Name: Munch Residence File No. 17188 Method: Spencer Horz Seismic Load: 0

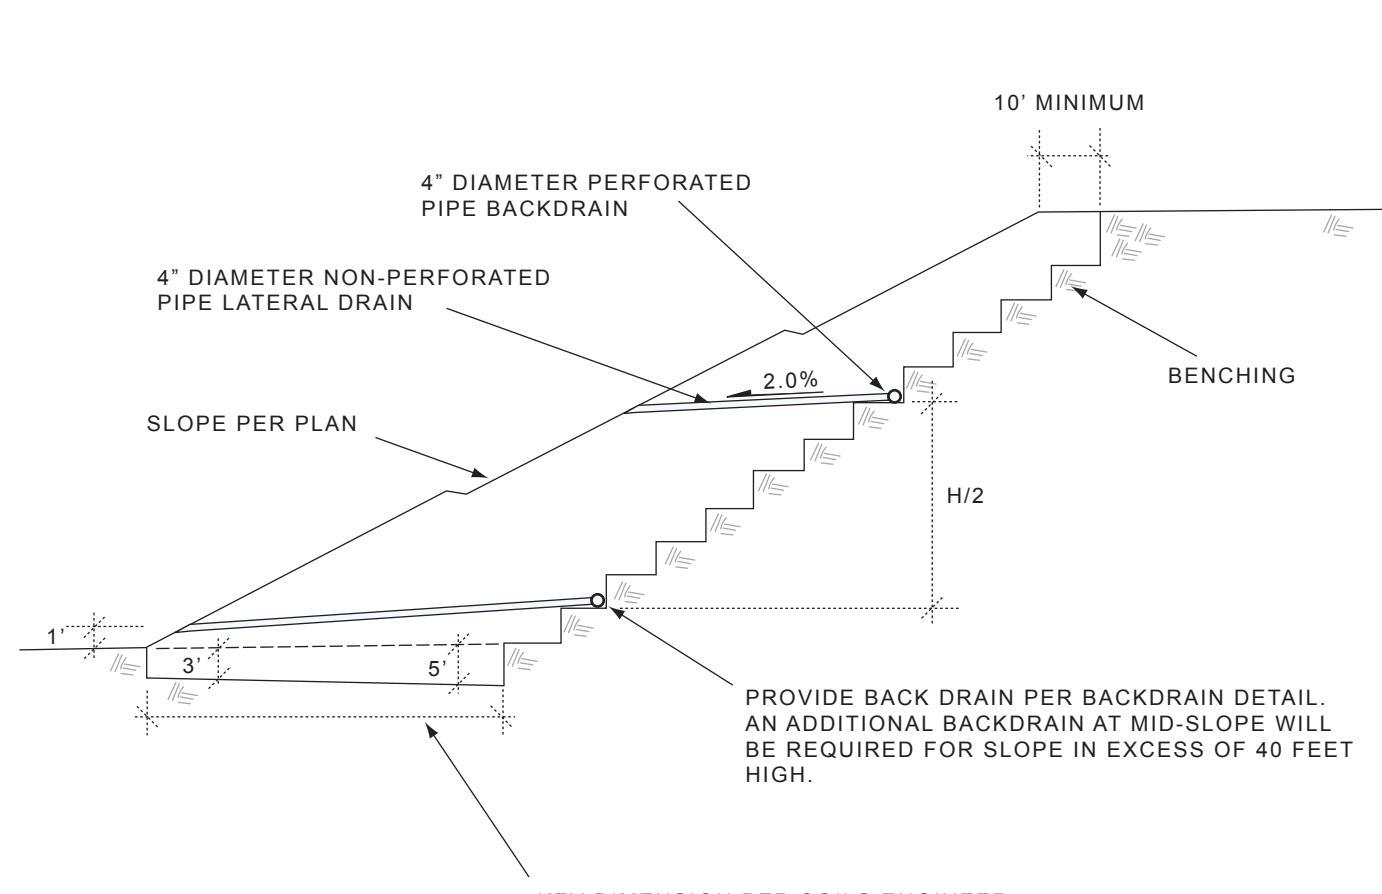
TYPICAL BUTTRESS FILL DETAIL

KEY-DIMENSION PER SOILS ENGINEER

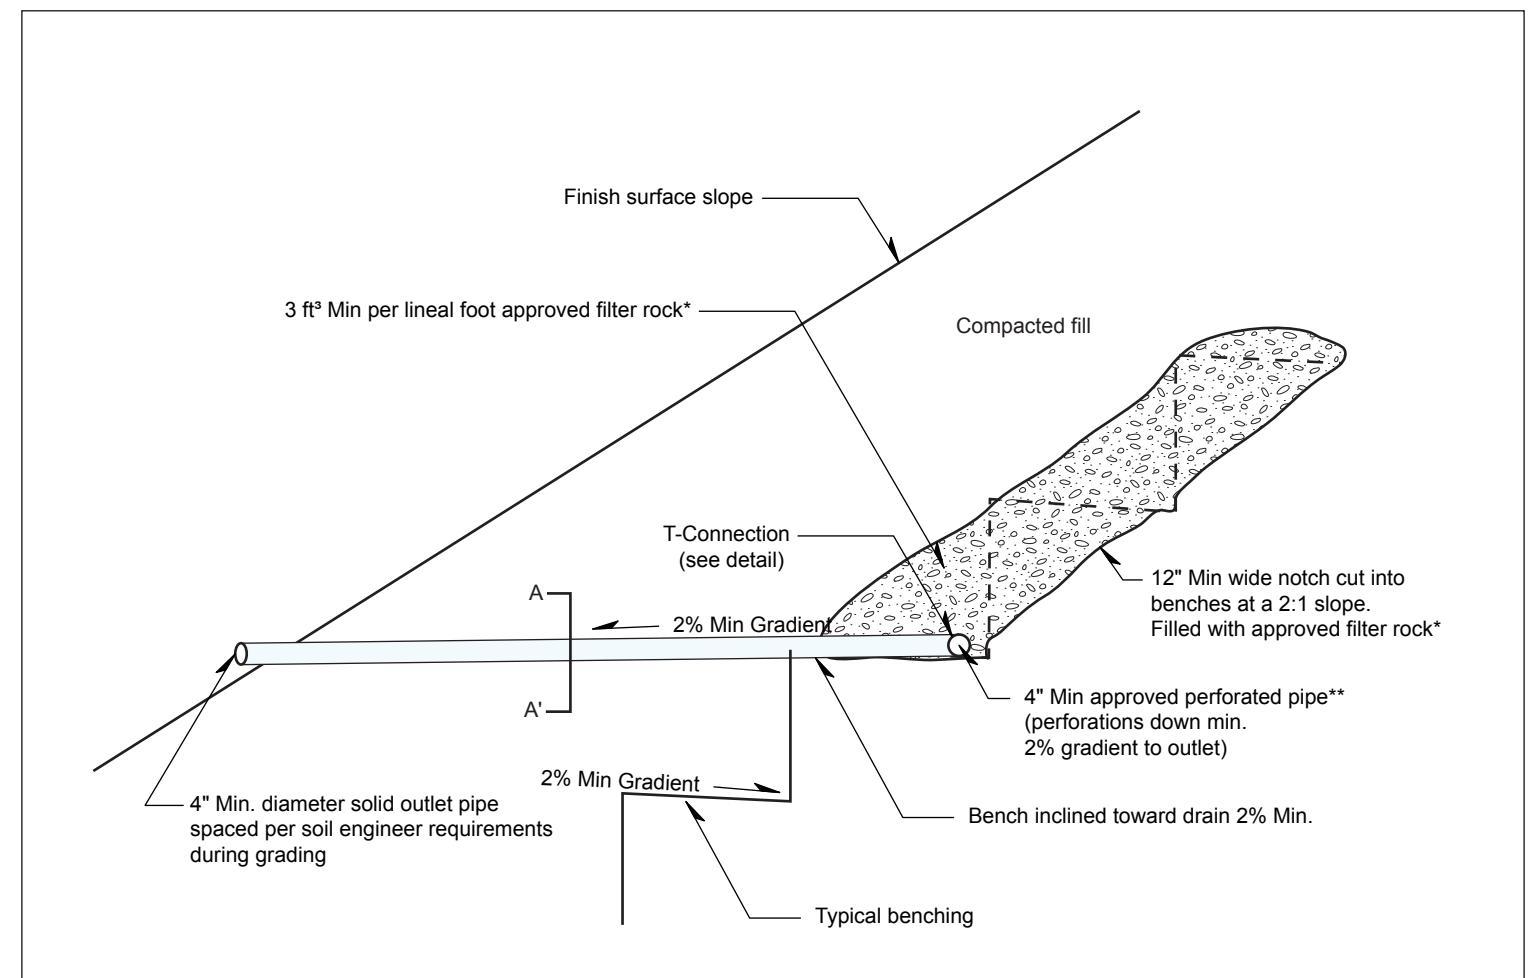
BACKDRAIN DETAIL (GEOFABRIC)

* Filter rock to meet following specifications or approved equal.

Sieve	% Passing
1"	100
3/4"	90-100
3/8"	40-100
No.4	25-40
No.30	5-15
No.50	0-7
No.200	0-3

** Approved pipe type: Schedule 40 polyvinyl chloride (P.V.C.) or approved equal. Min. crush strength 1000 PSI.

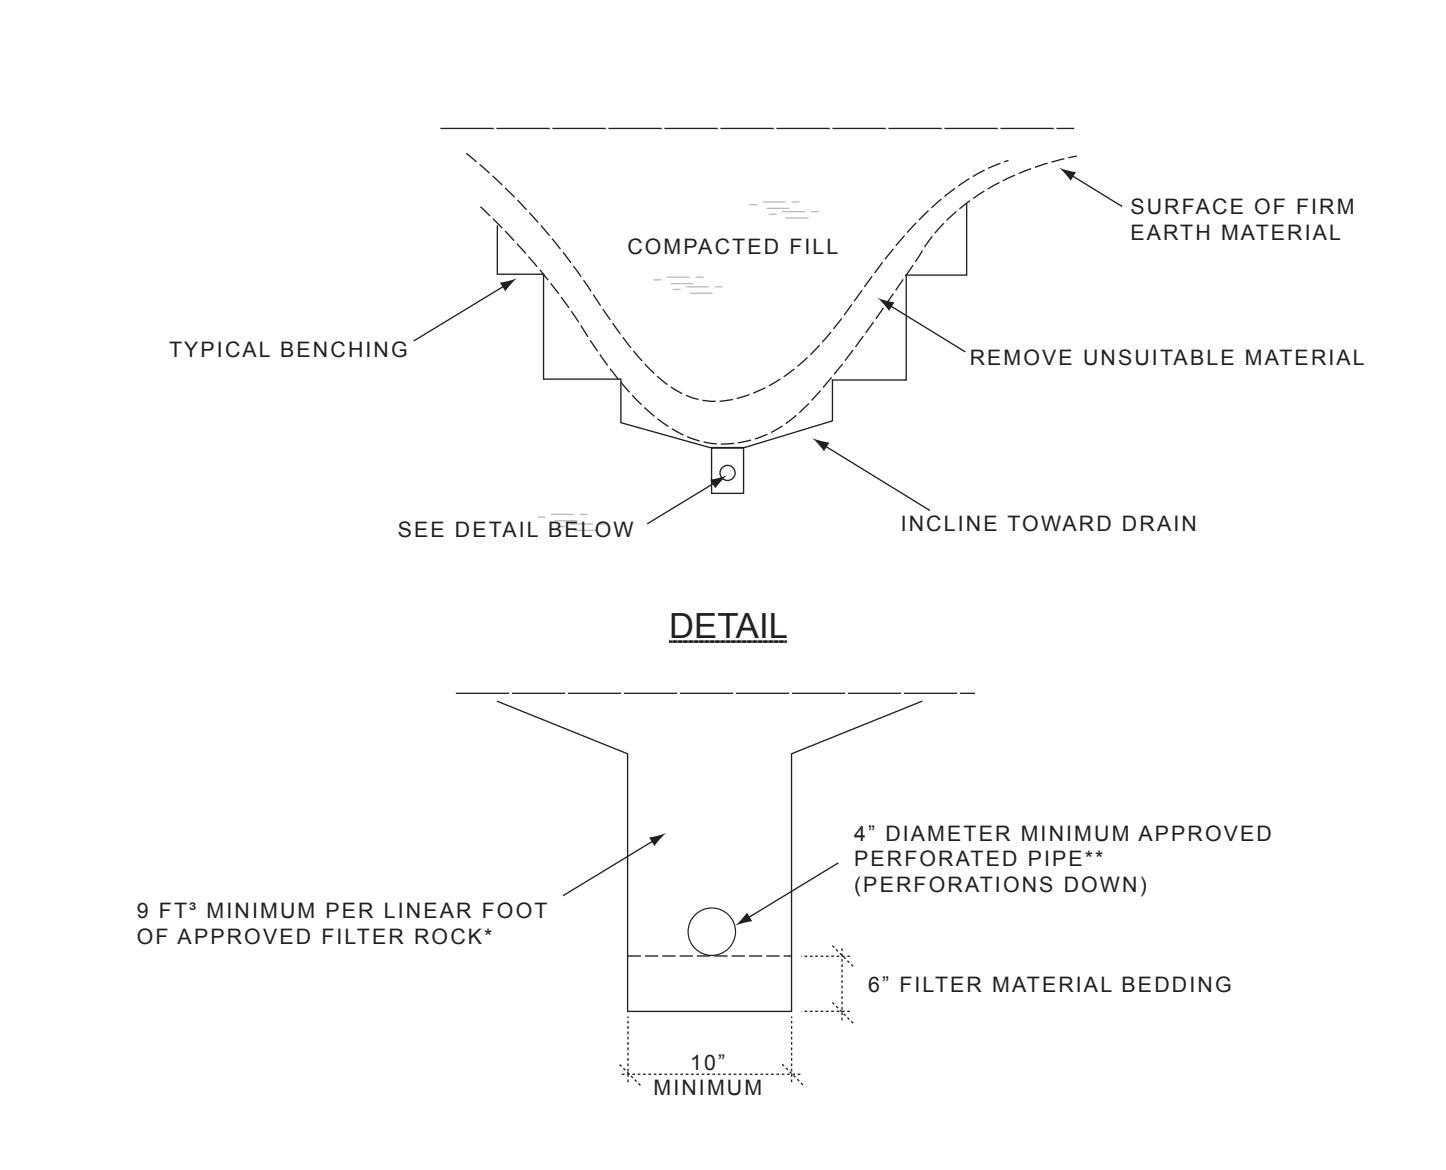
TYPICAL CANYON SUBDRAIN DETAIL

* Filter rock to meet following specifications or approved equal.

P		
<u>Sieve</u> 1"	<u>% Passing</u> _ 100	Schedule 40 polyvinyl chlori (P.V.C.) or approved equal.	de
3/4"	90-100	Min. crush strength 1000 PSI. Pipe diameter to meet hte following criteria. Subject to field review based on actual geotechnical conditions	
3/8"	40-100		
No.4	25-40		
No.30	5-15		
No.50	0-7		
No.200	0-3	encountered during grading.	
		Longth of Run	Dine

** APPROVED PIPE TYPE

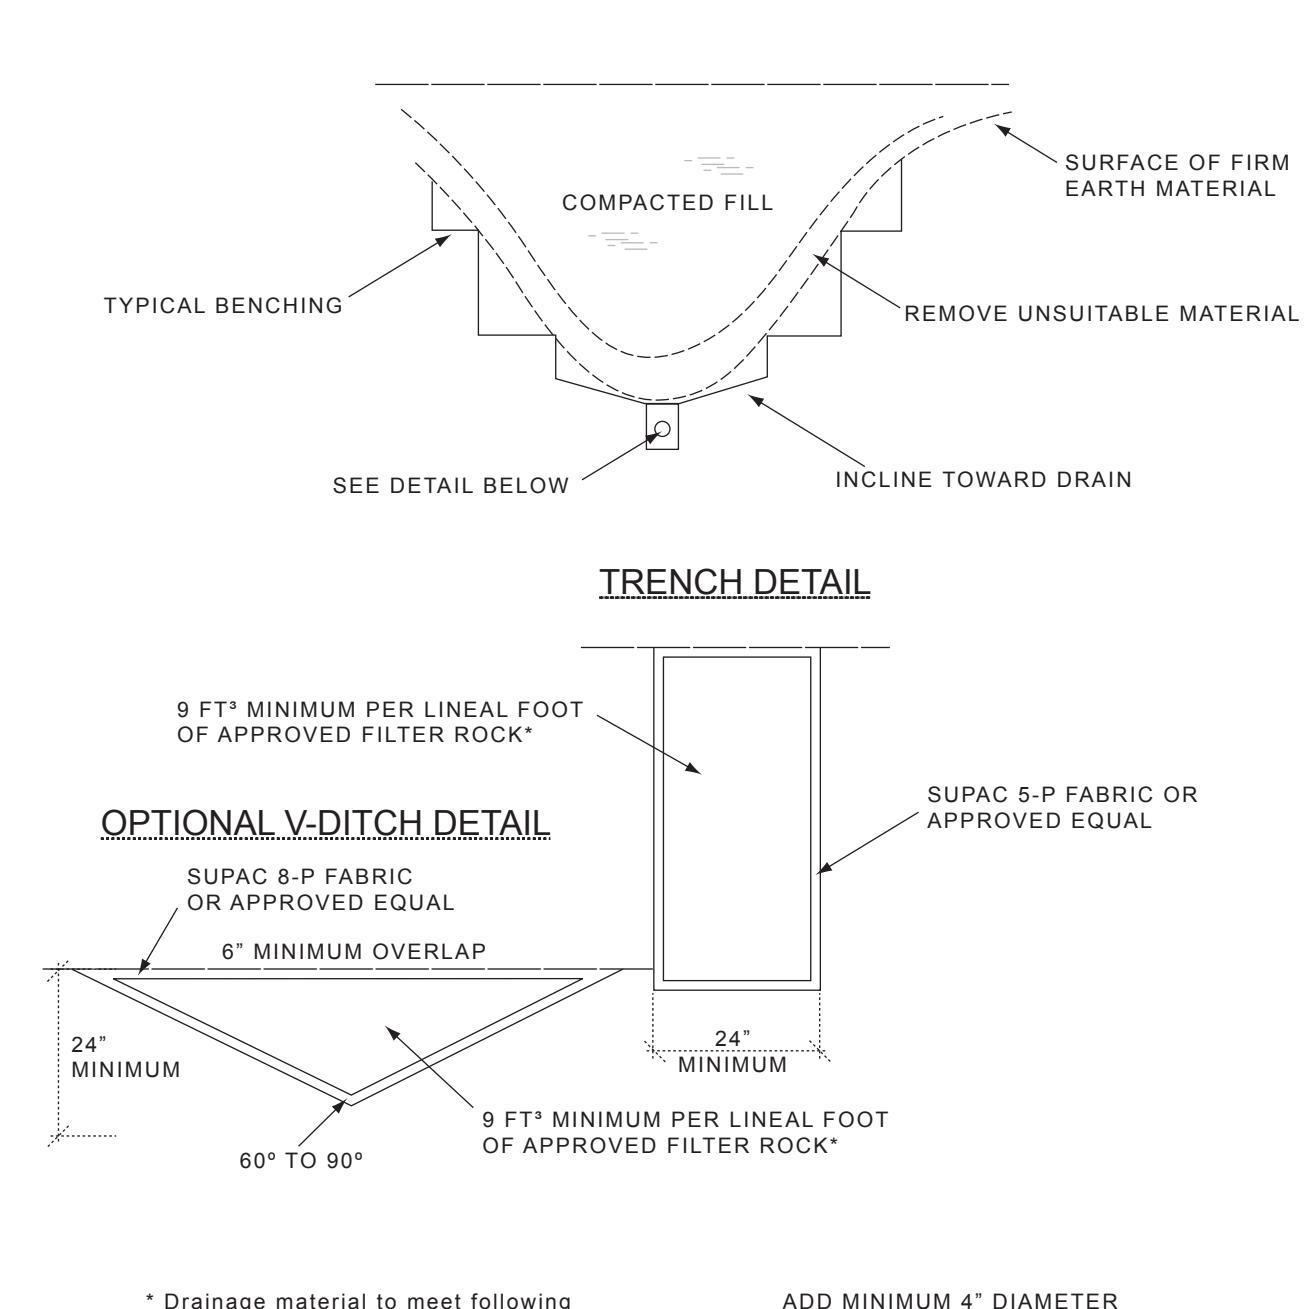
GEOFABRIC SUBDRAIN

* Drainage material to meet following specifications or approved equal.

Sieve	<u>% Passing</u>	PIPE WHEN GRADIENT IS
1 1⁄2"	88-100	LESS THAN 2%
1"	5-40	
3/4" 3/8" No.200	0-17 0-7 0-3	APPROVED PIPE TO BE SCHEDULE 40 POLY-VINYL-CHLORIDE (P.V.C.) OR APPROVED EQUAL. MINIMUM CRUSH STRENGTH 1000 psi.

APPROVED PERFORATED
