GEOTECHNICAL INVESTIGATION

CARMEL MOUNTAIN RANCH GOLF COURSE SAN DIEGO, CALIFORNIA

NEW URBAN WEST, INCORPORATED SAN DIEGO, CALIFORNIA

> OCTOBER 25, 2019 PROJECT NO. 03071-32-45A

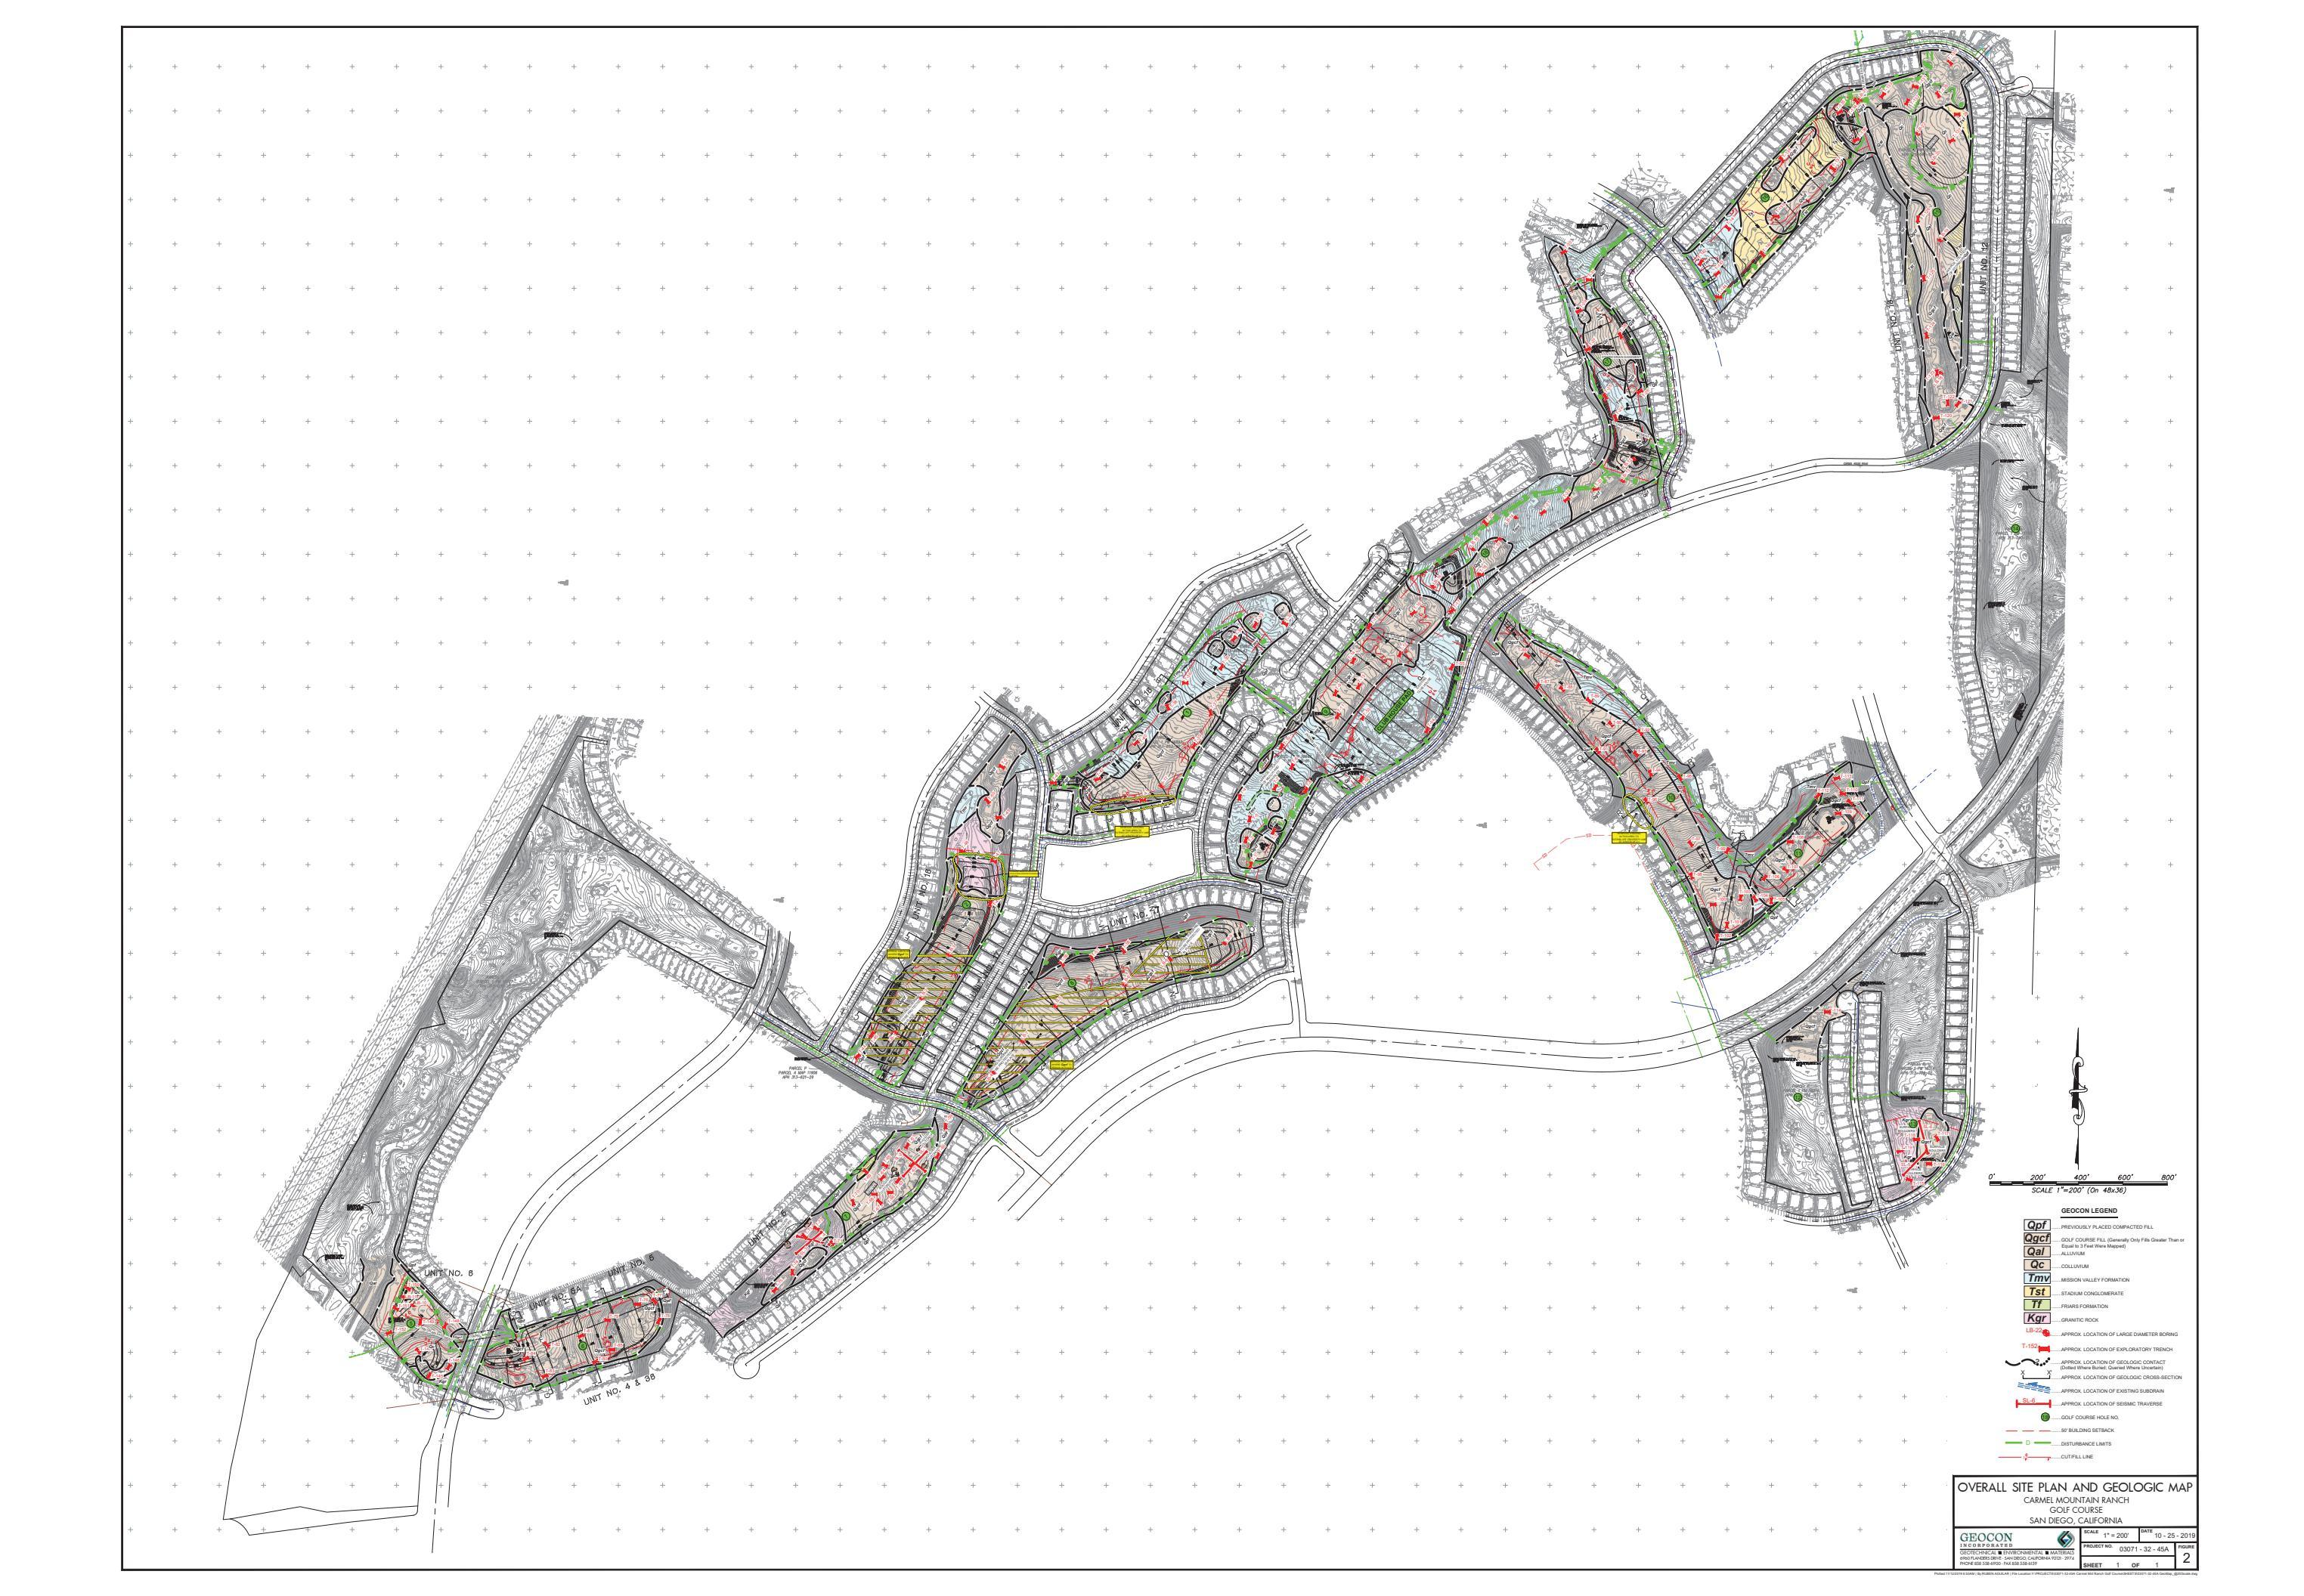
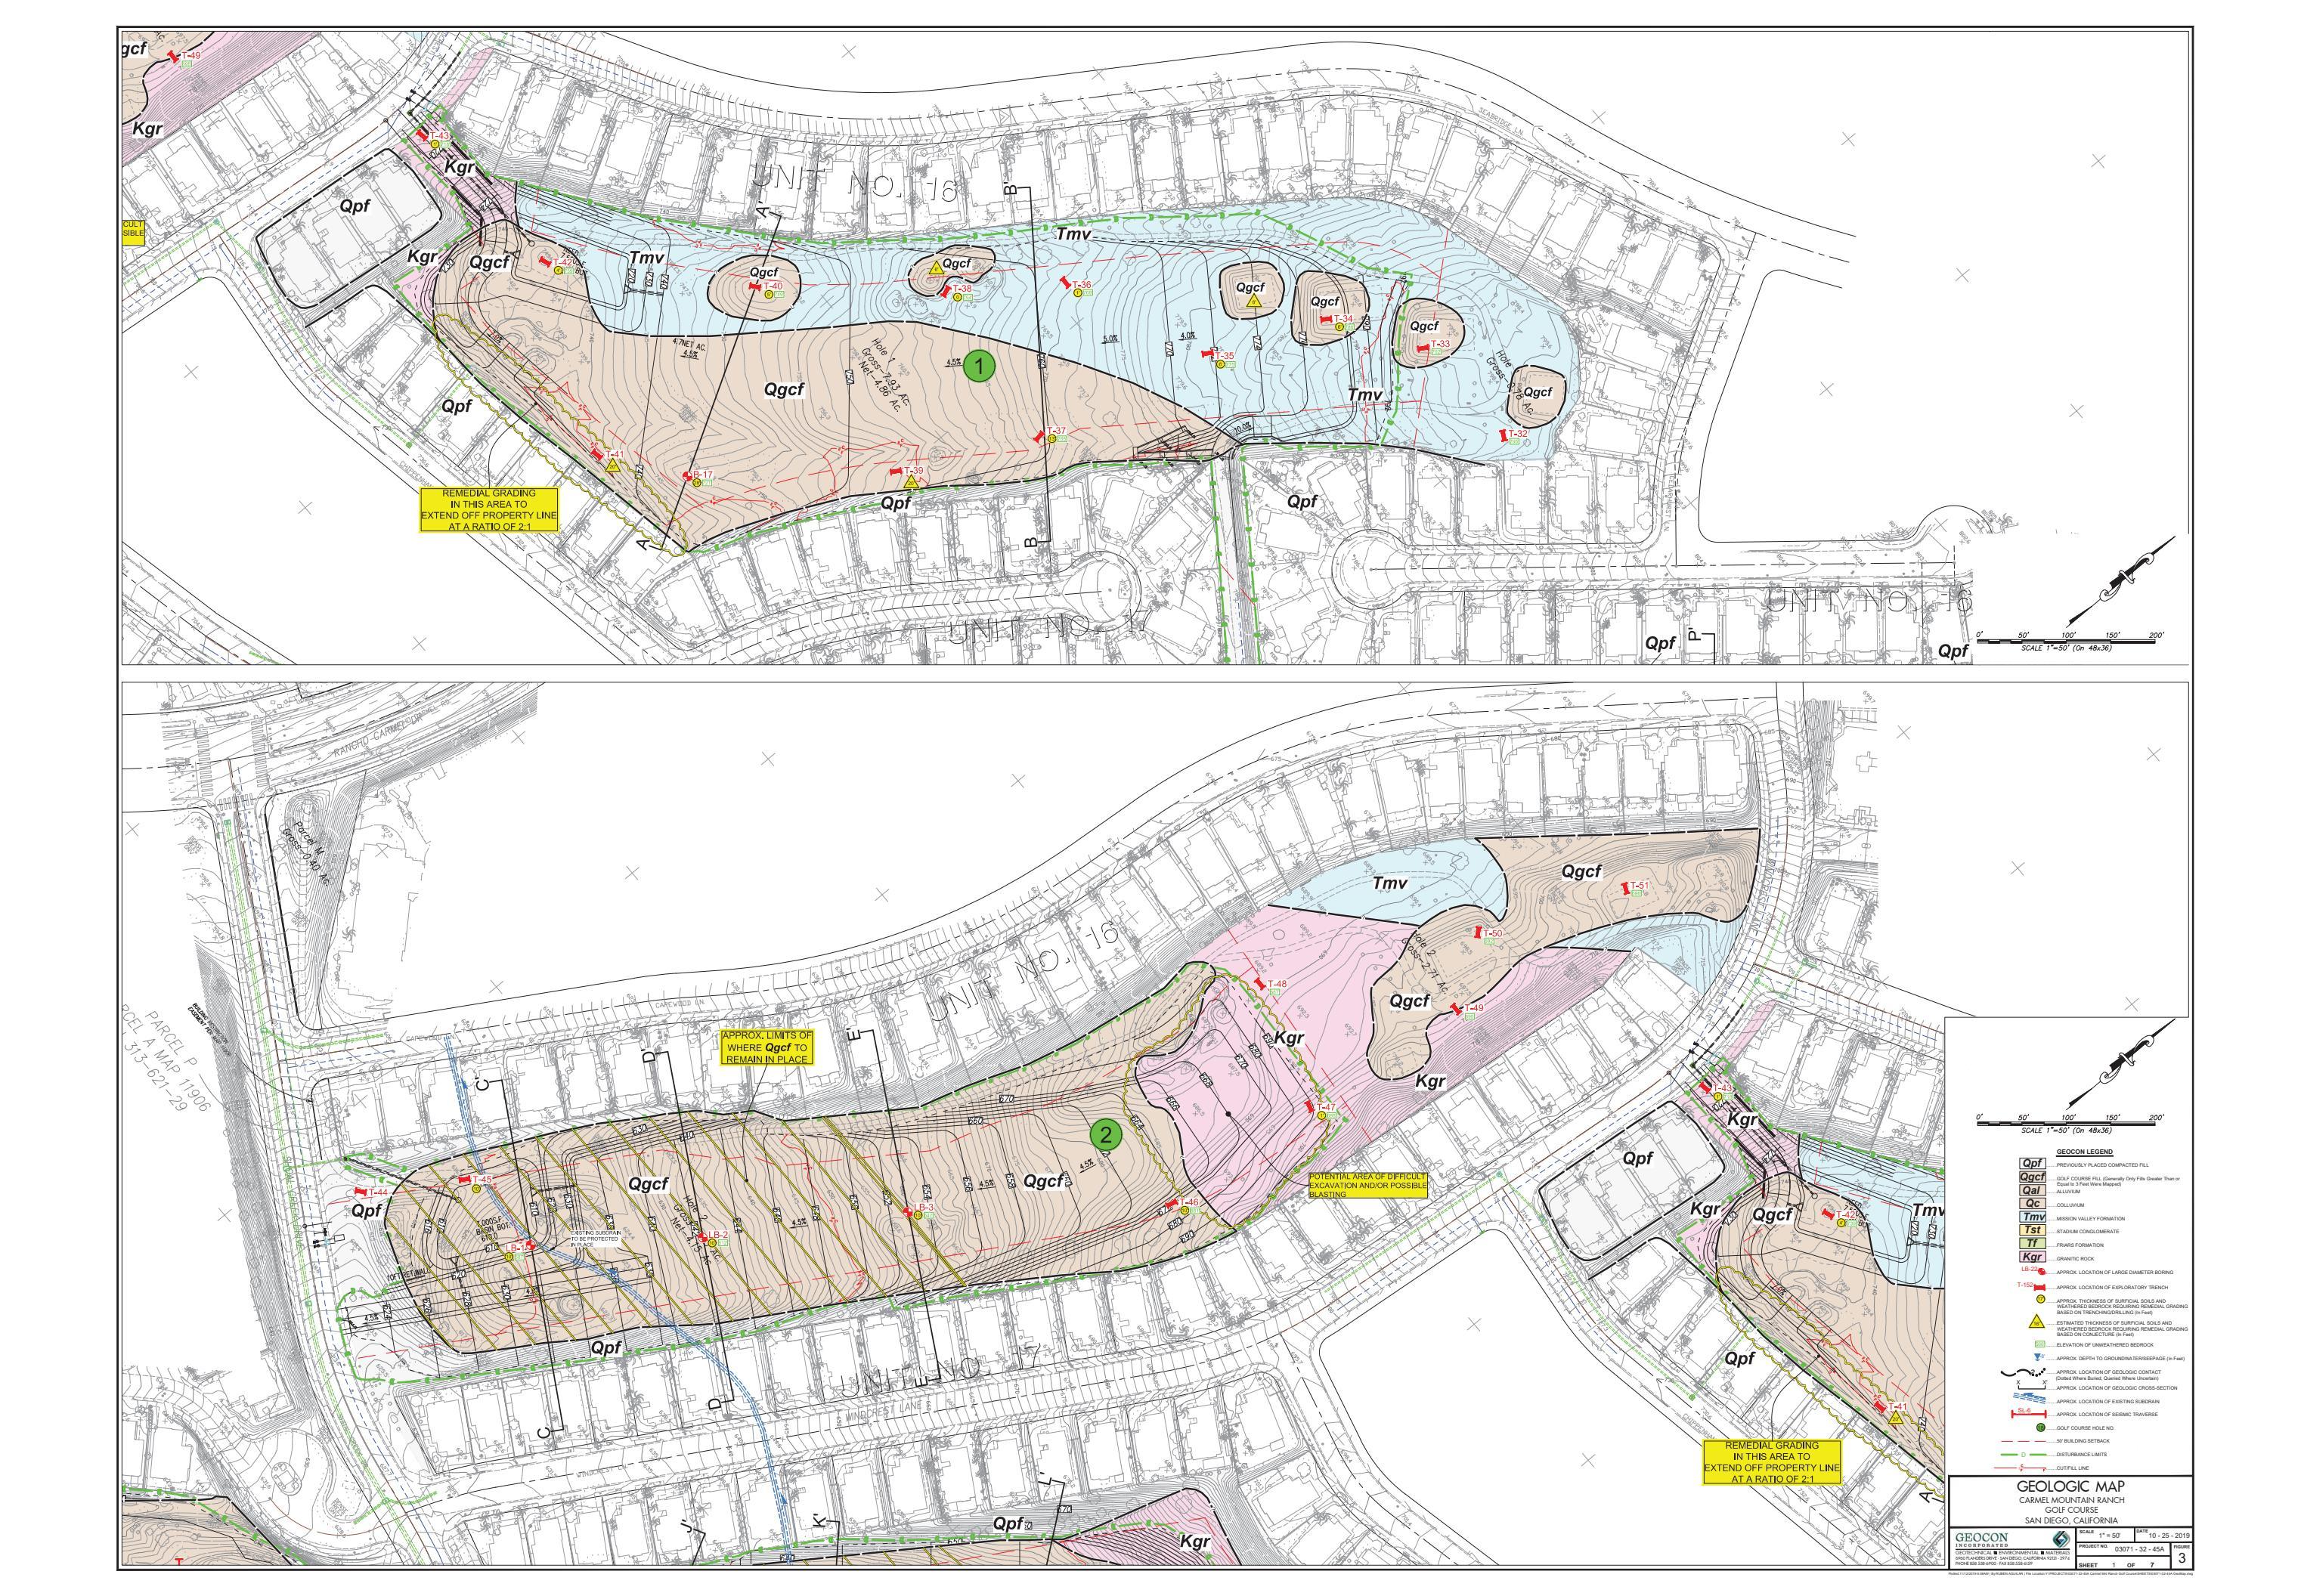
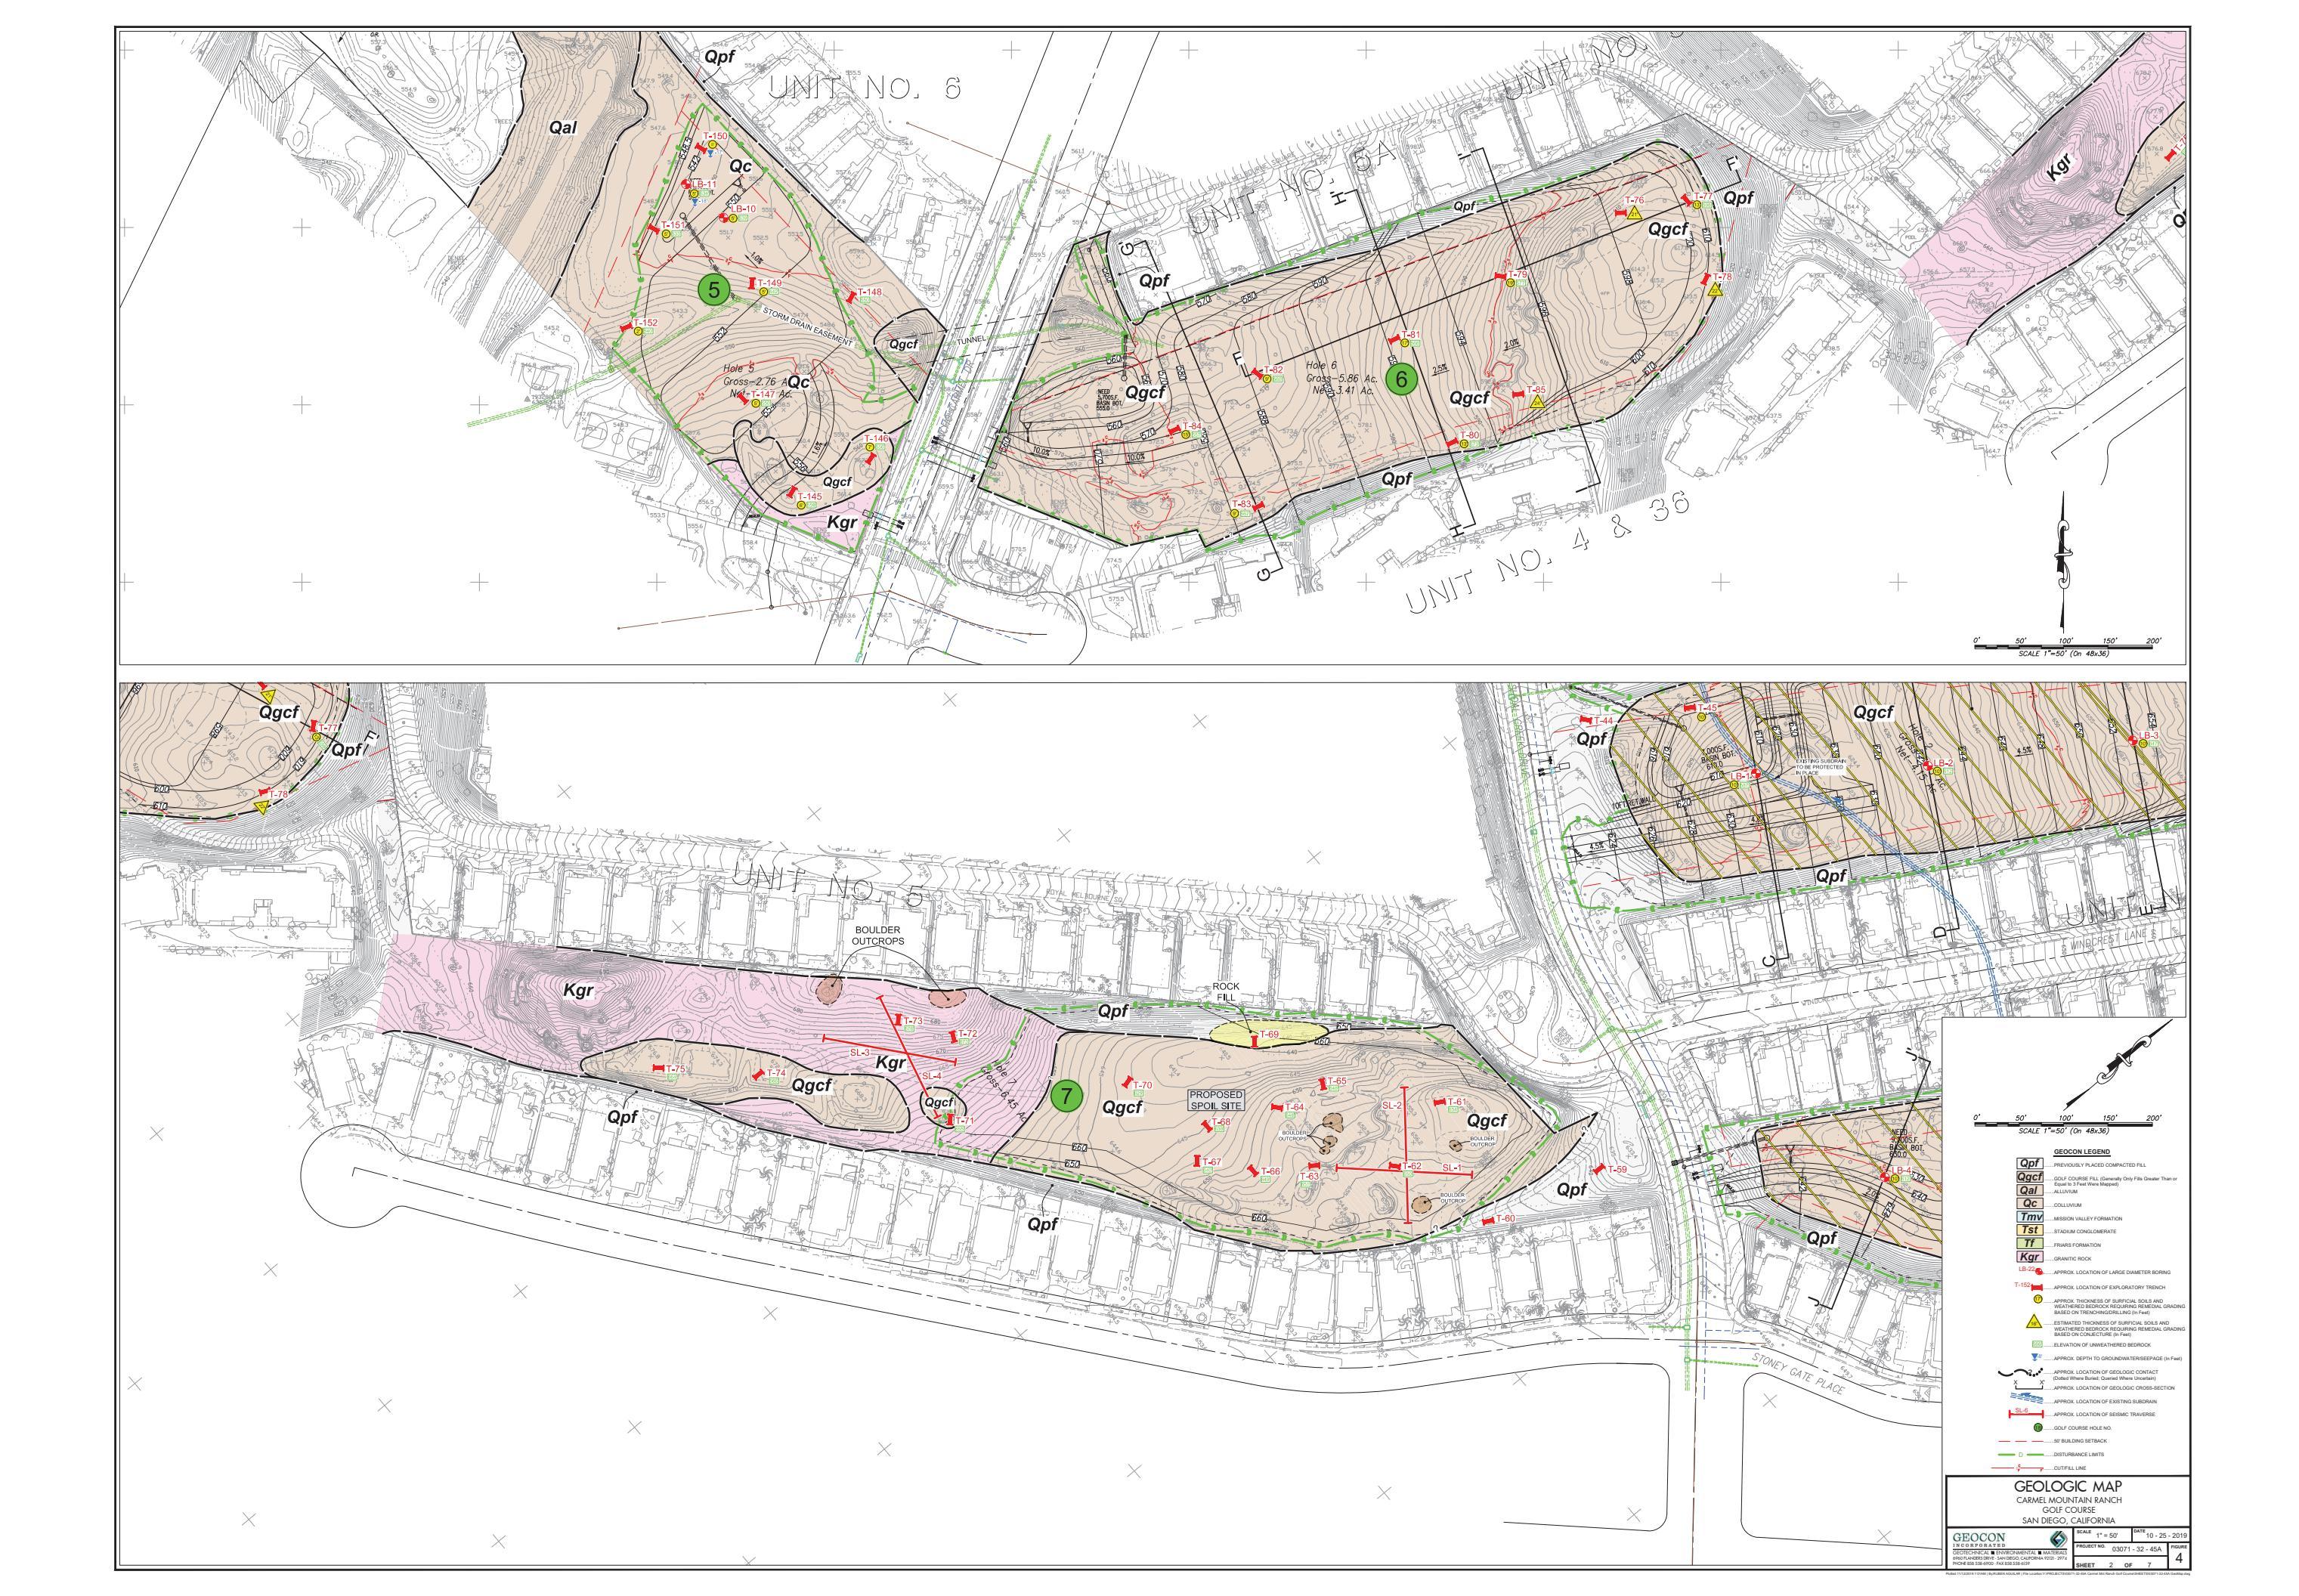
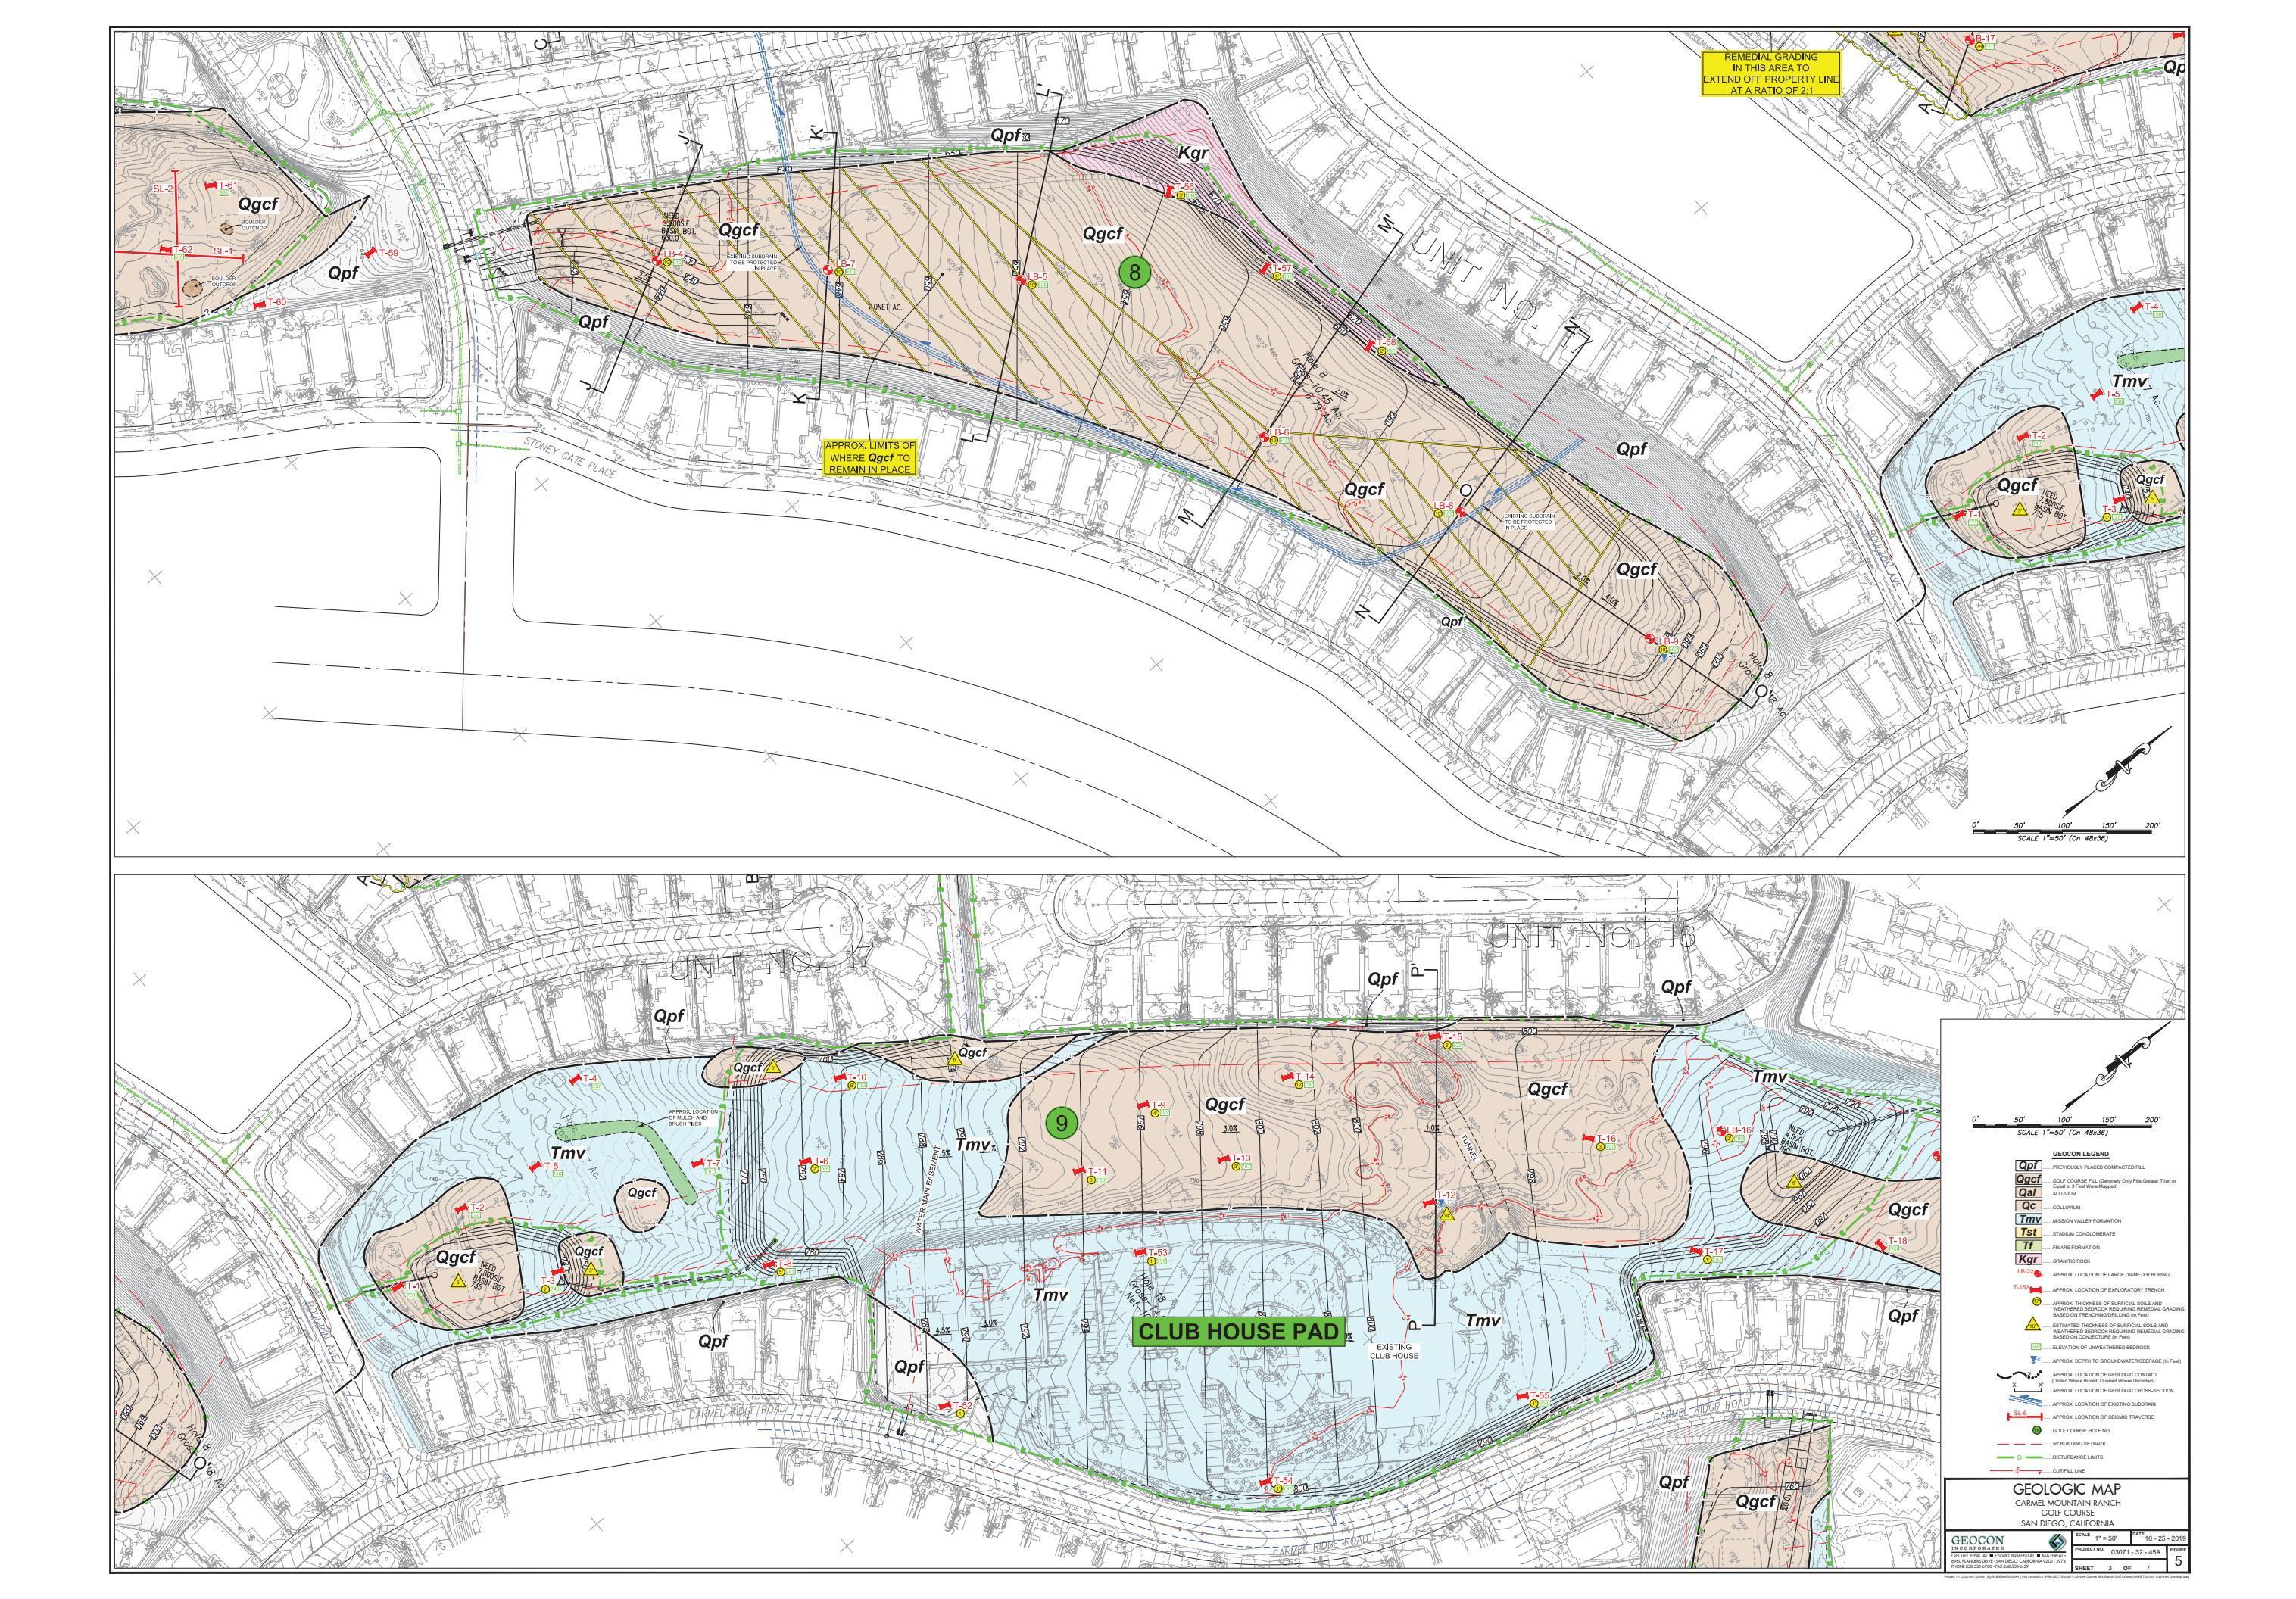
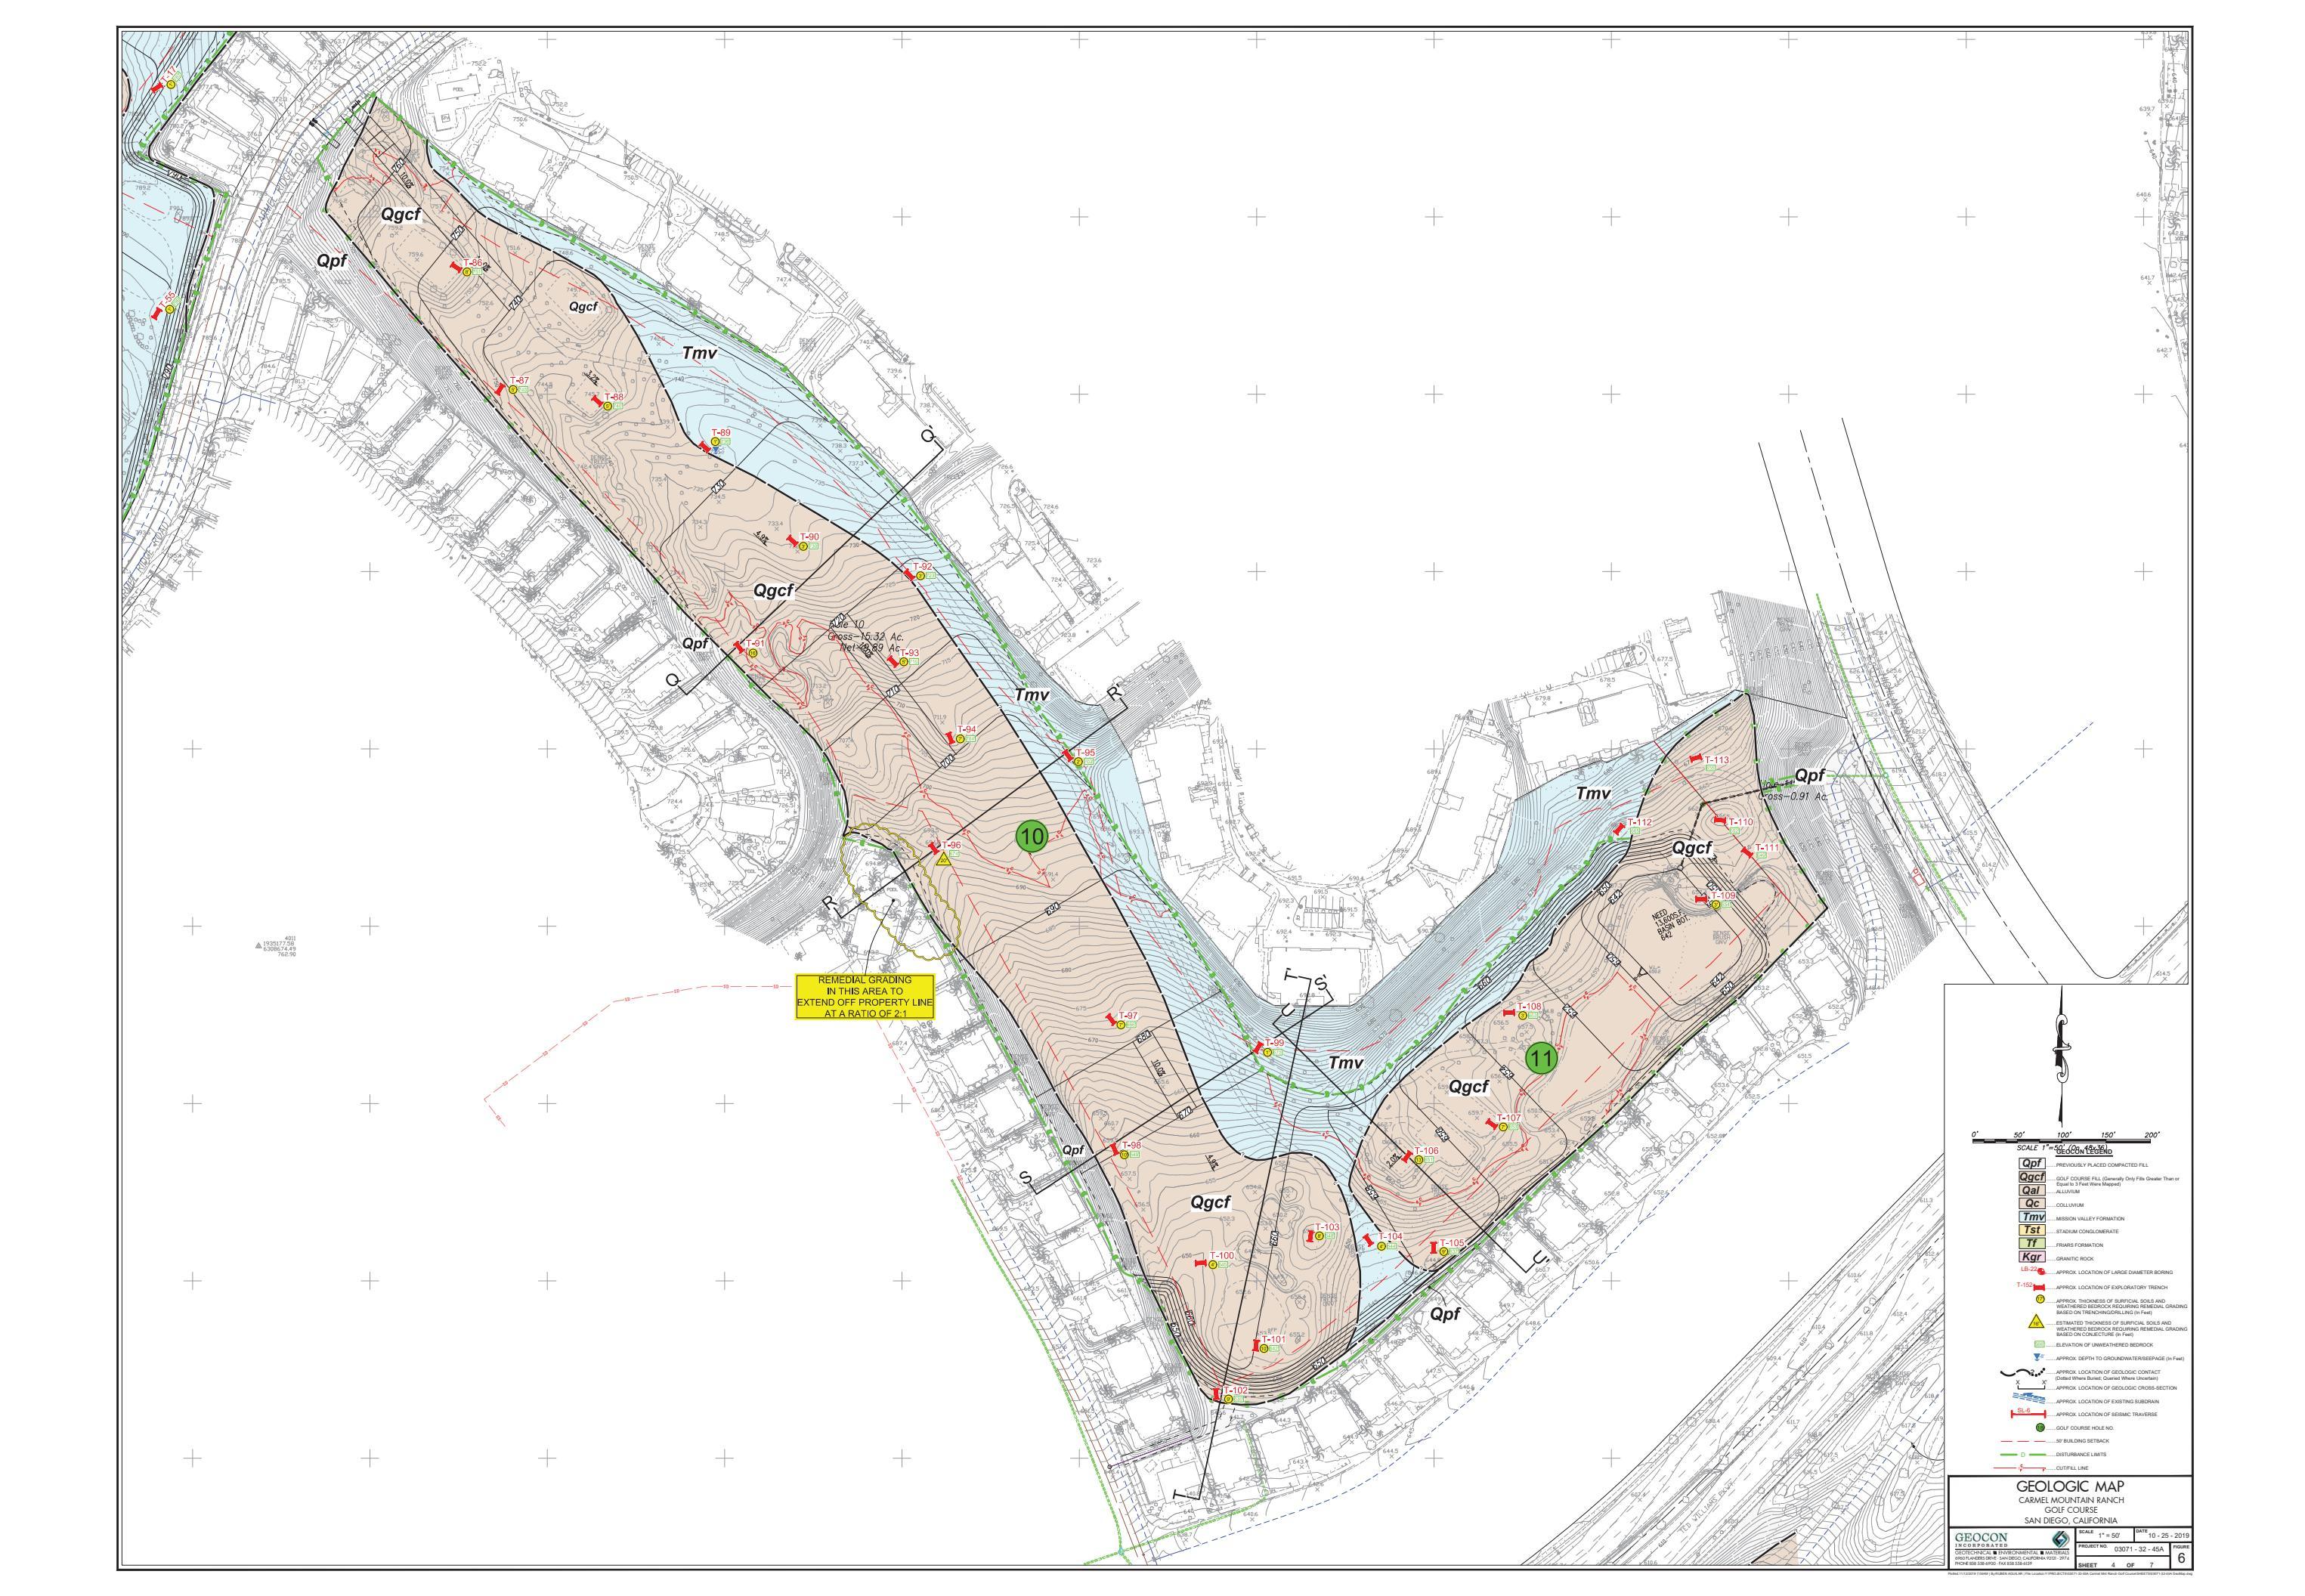
Figures 3 – 9, Geologic Map (Map Pocket)

The approximate locations of the subsurface information are shown on the *Geologic Maps*, Figures 3 through 9. *Geologic Cross-Sections* A-A' through X-X' (Figures 10 through 13) represent our interpretation of the geologic conditions across the areas of proposed development.
