GEOTECHNICAL INVESTIGATION

CARMEL MOUNTAIN RANCH GOLF COURSE SAN DIEGO, CALIFORNIA

NEW URBAN WEST, INCORPORATED SAN DIEGO, CALIFORNIA

> OCTOBER 25, 2019 PROJECT NO. 03071-32-45A

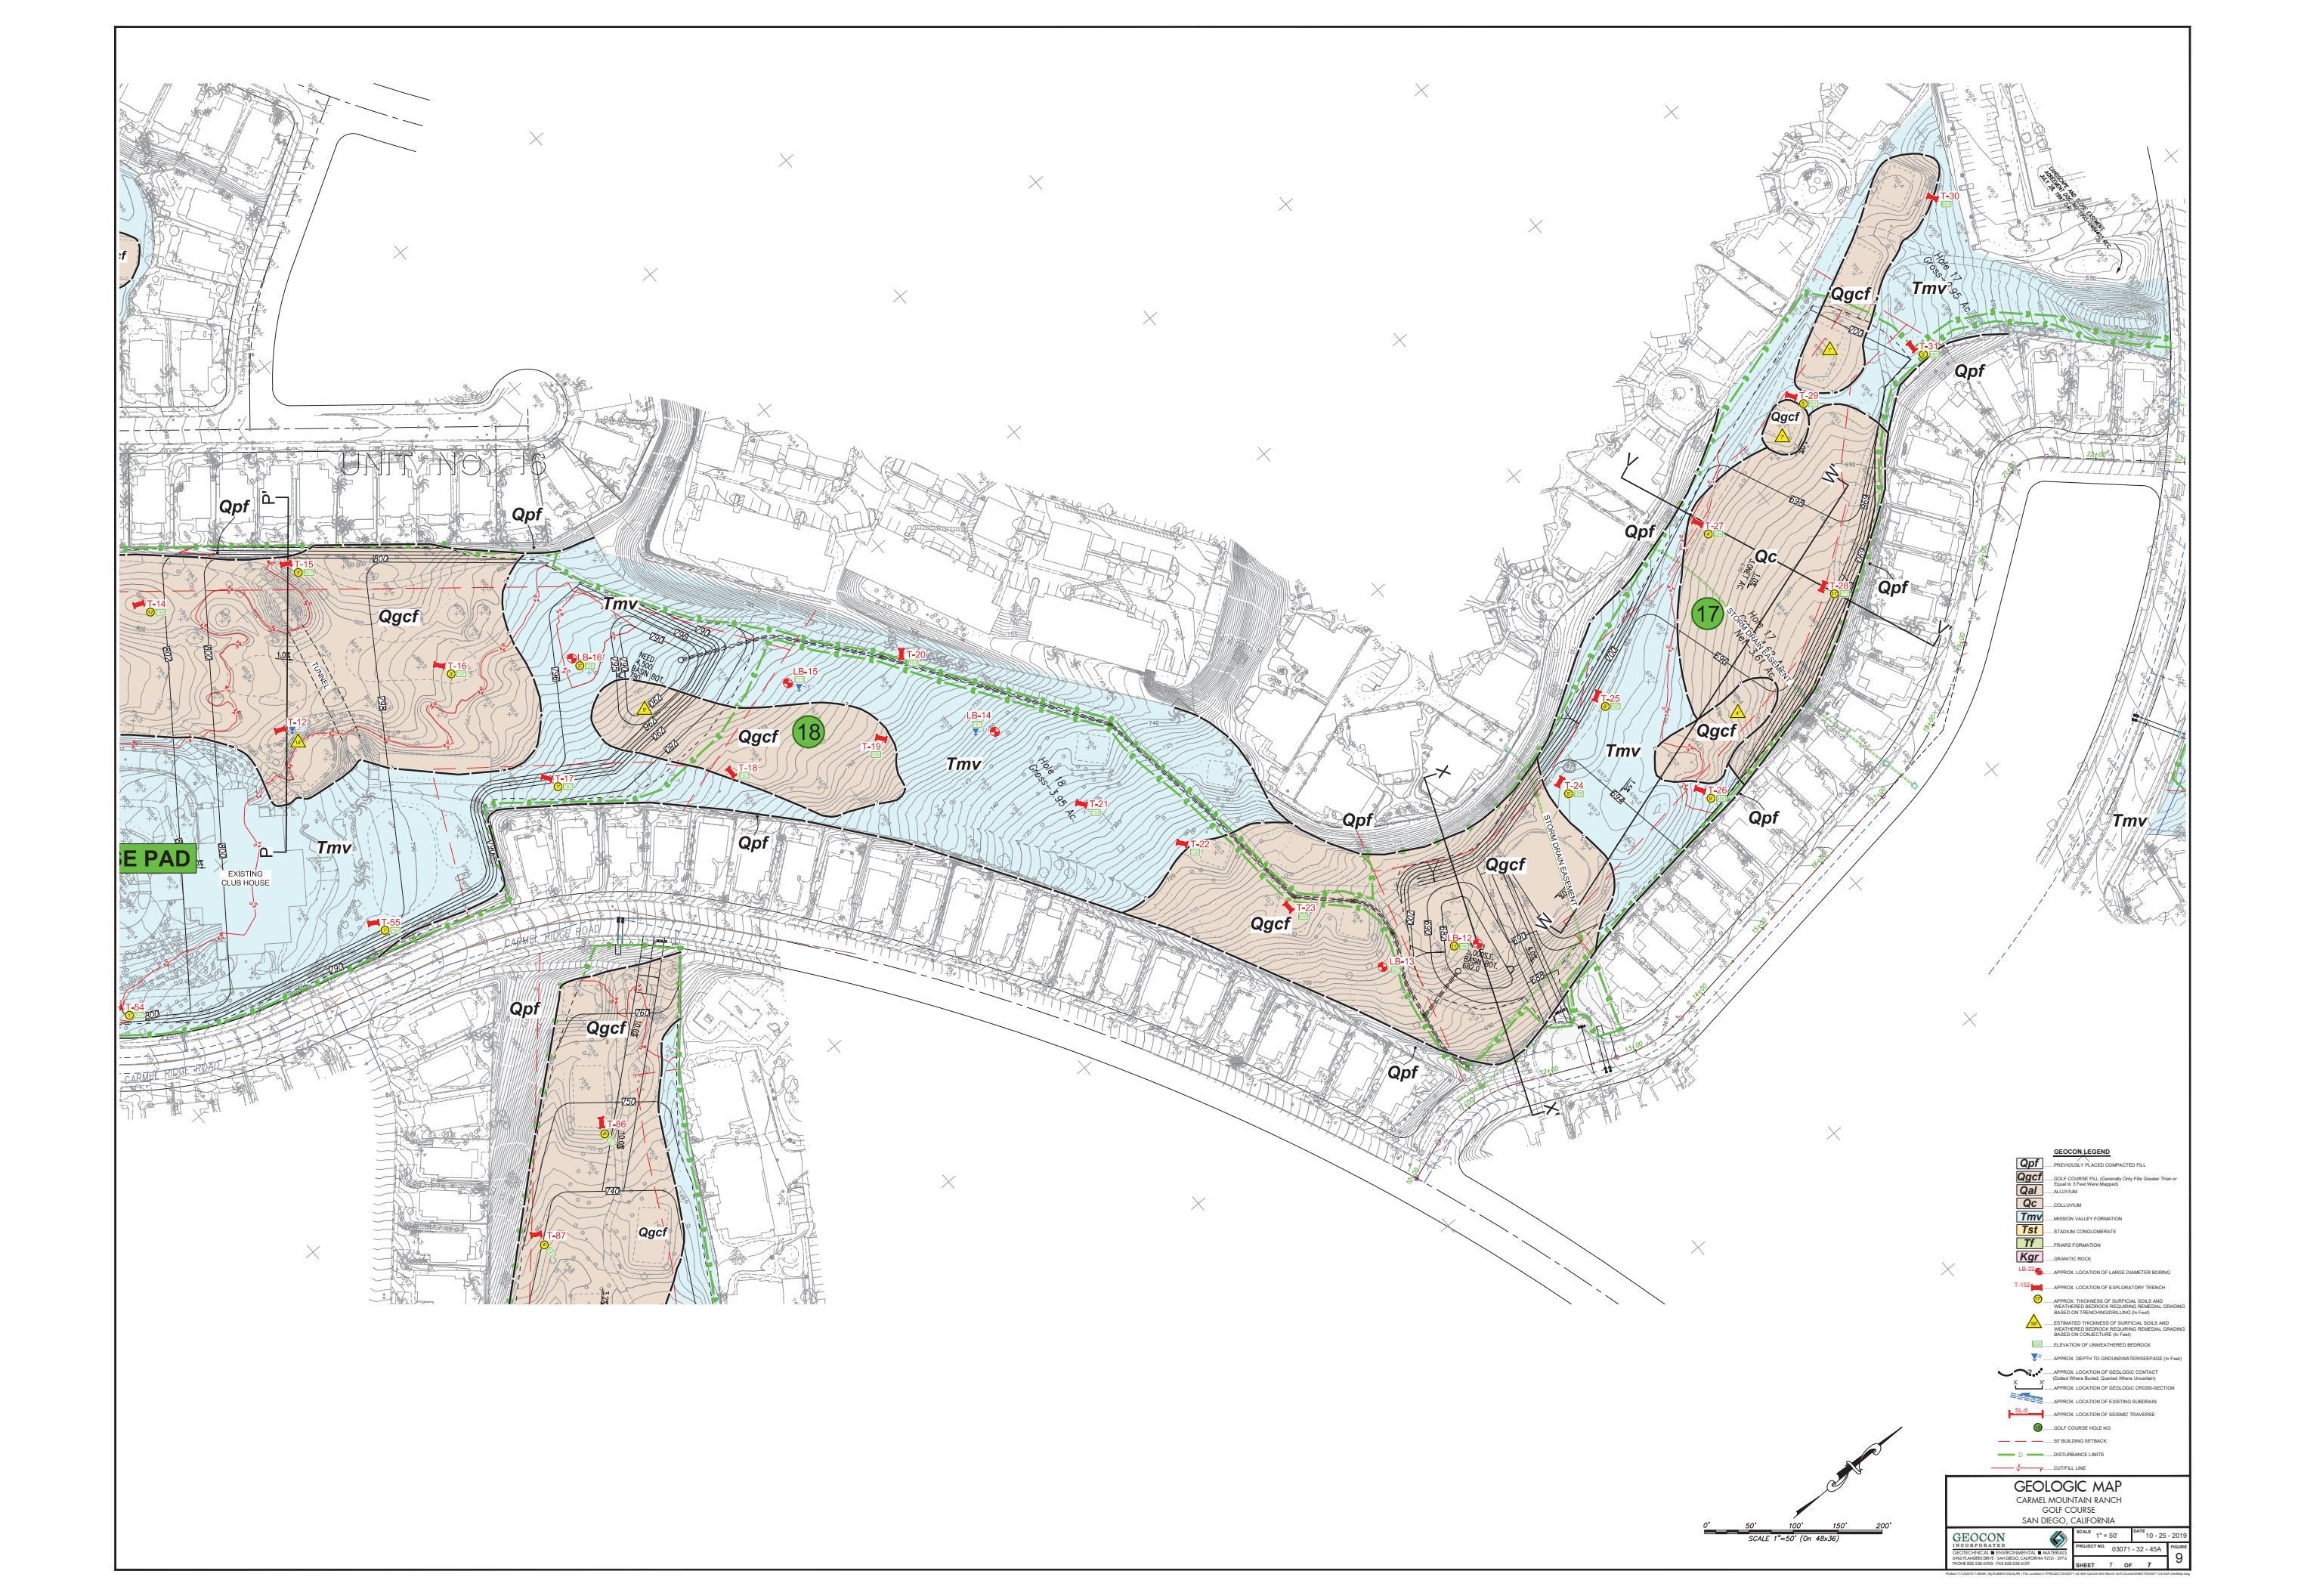
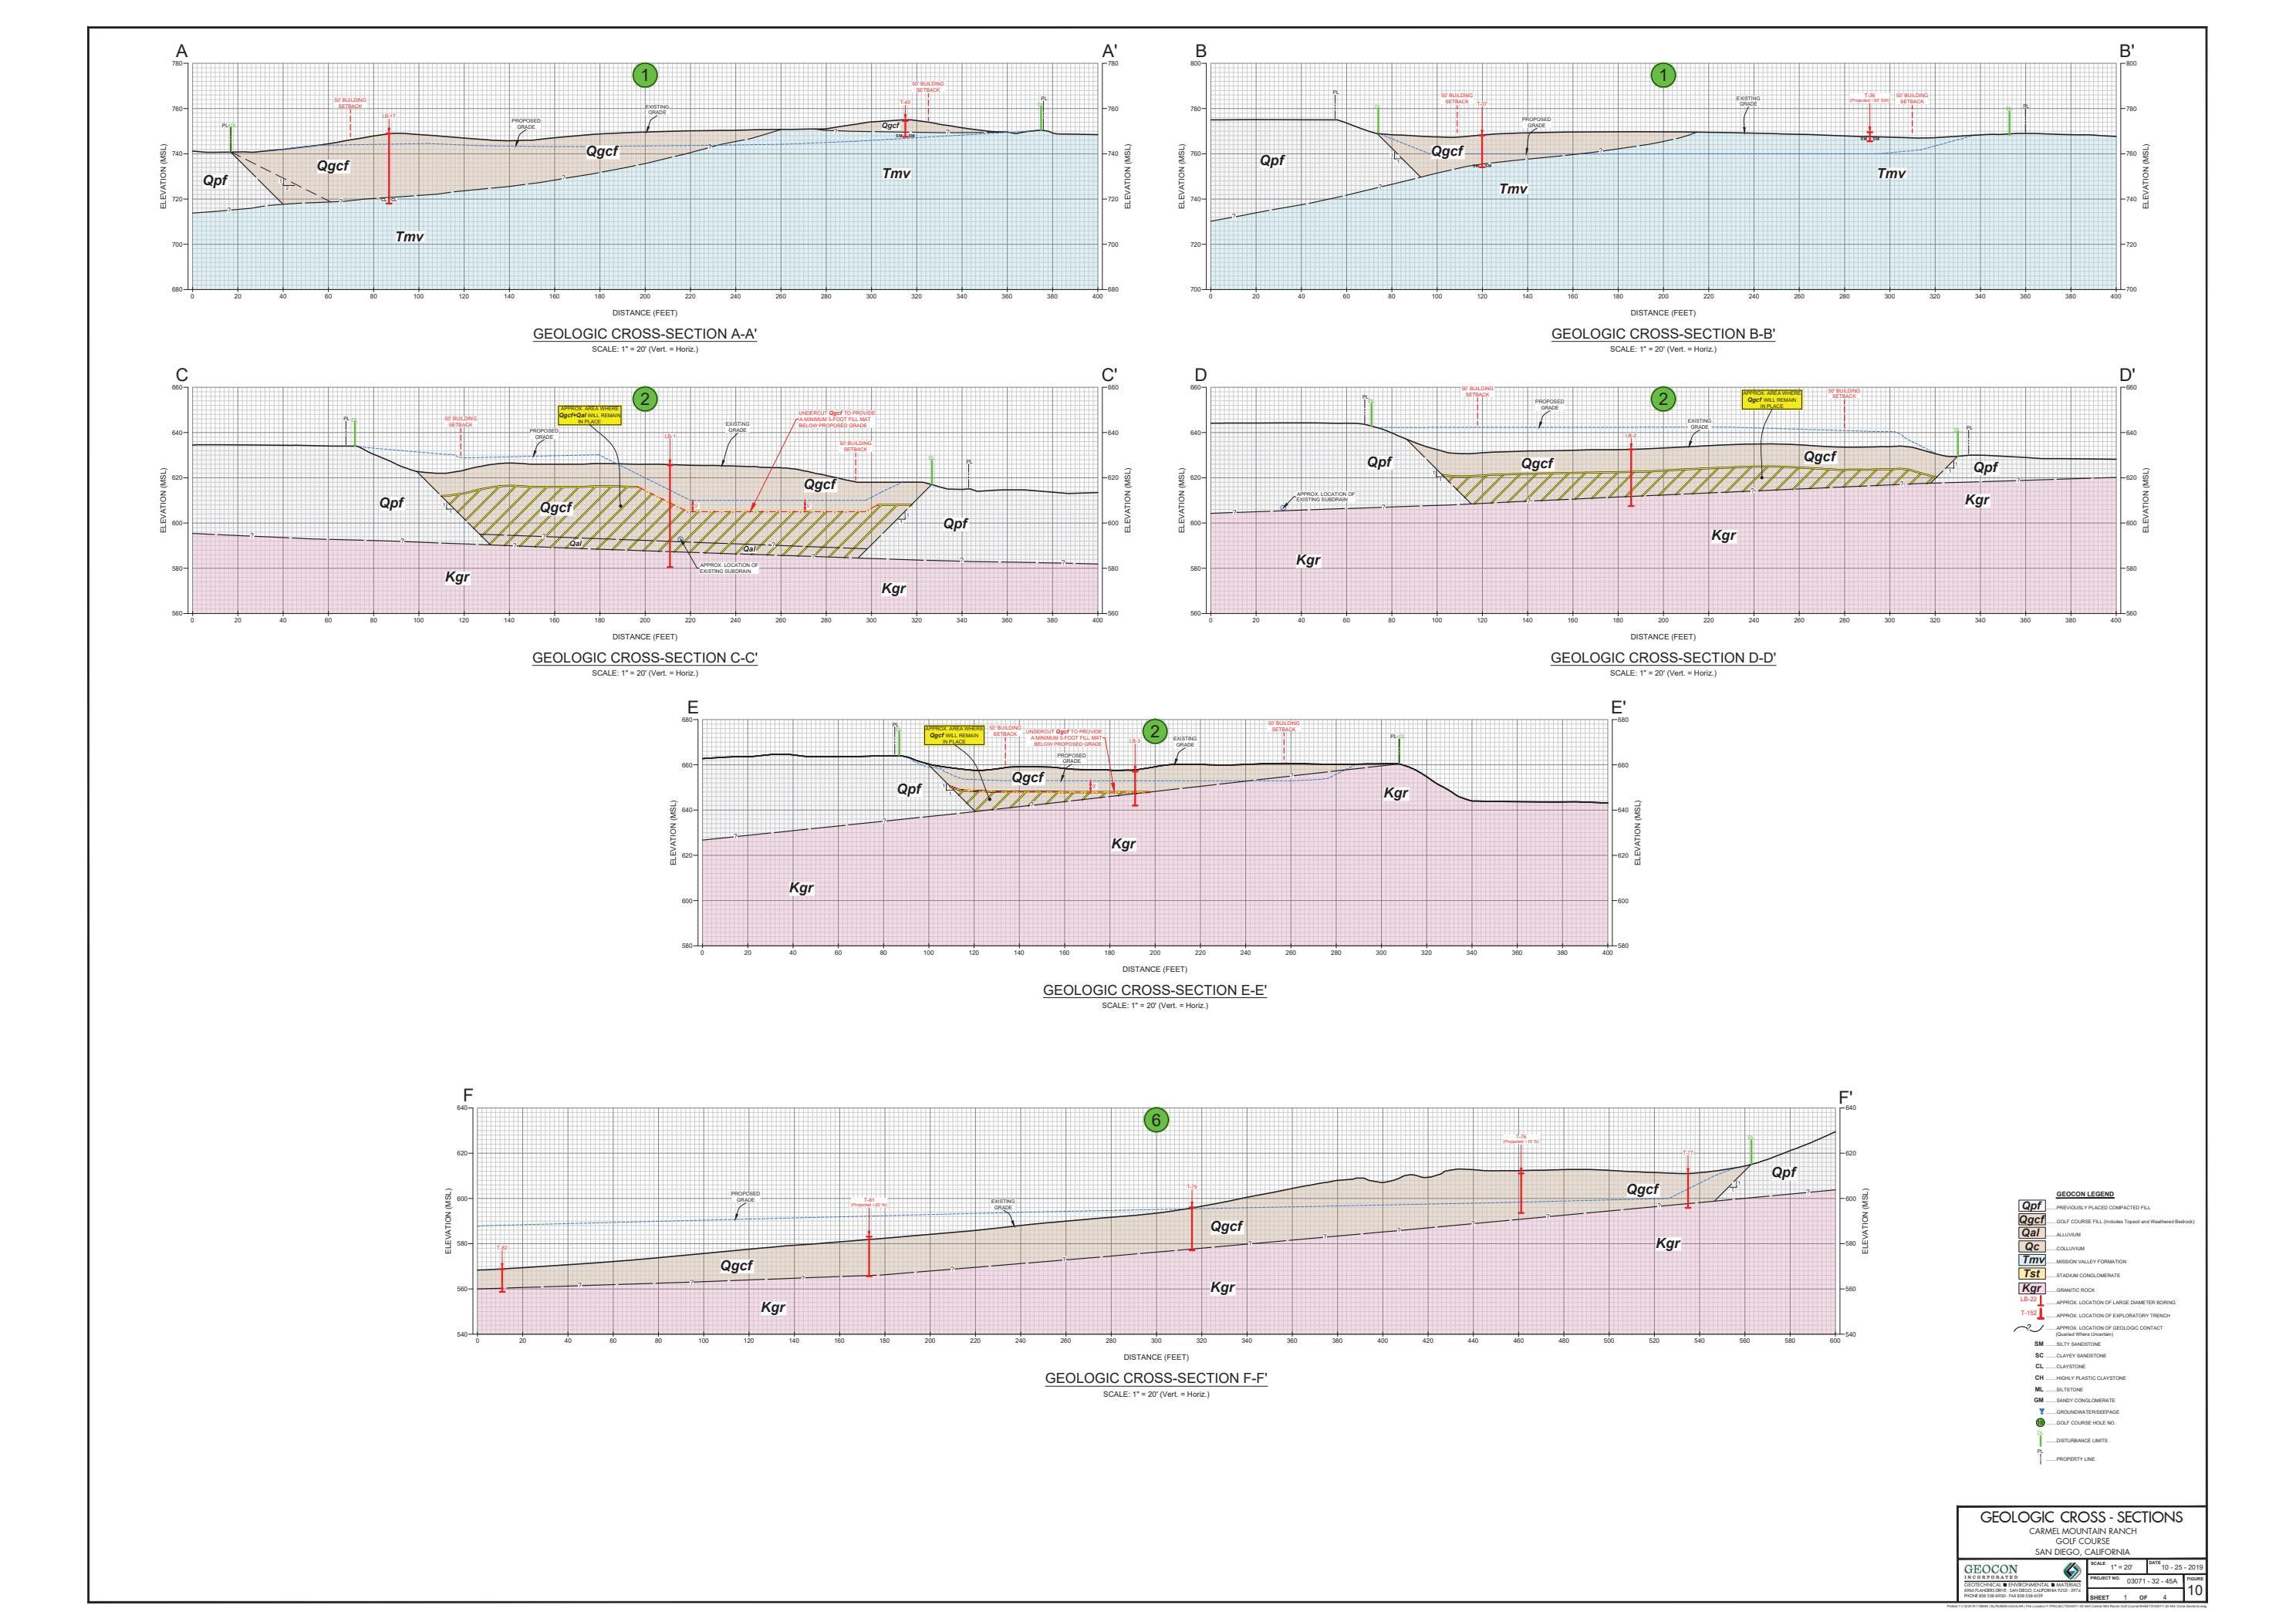
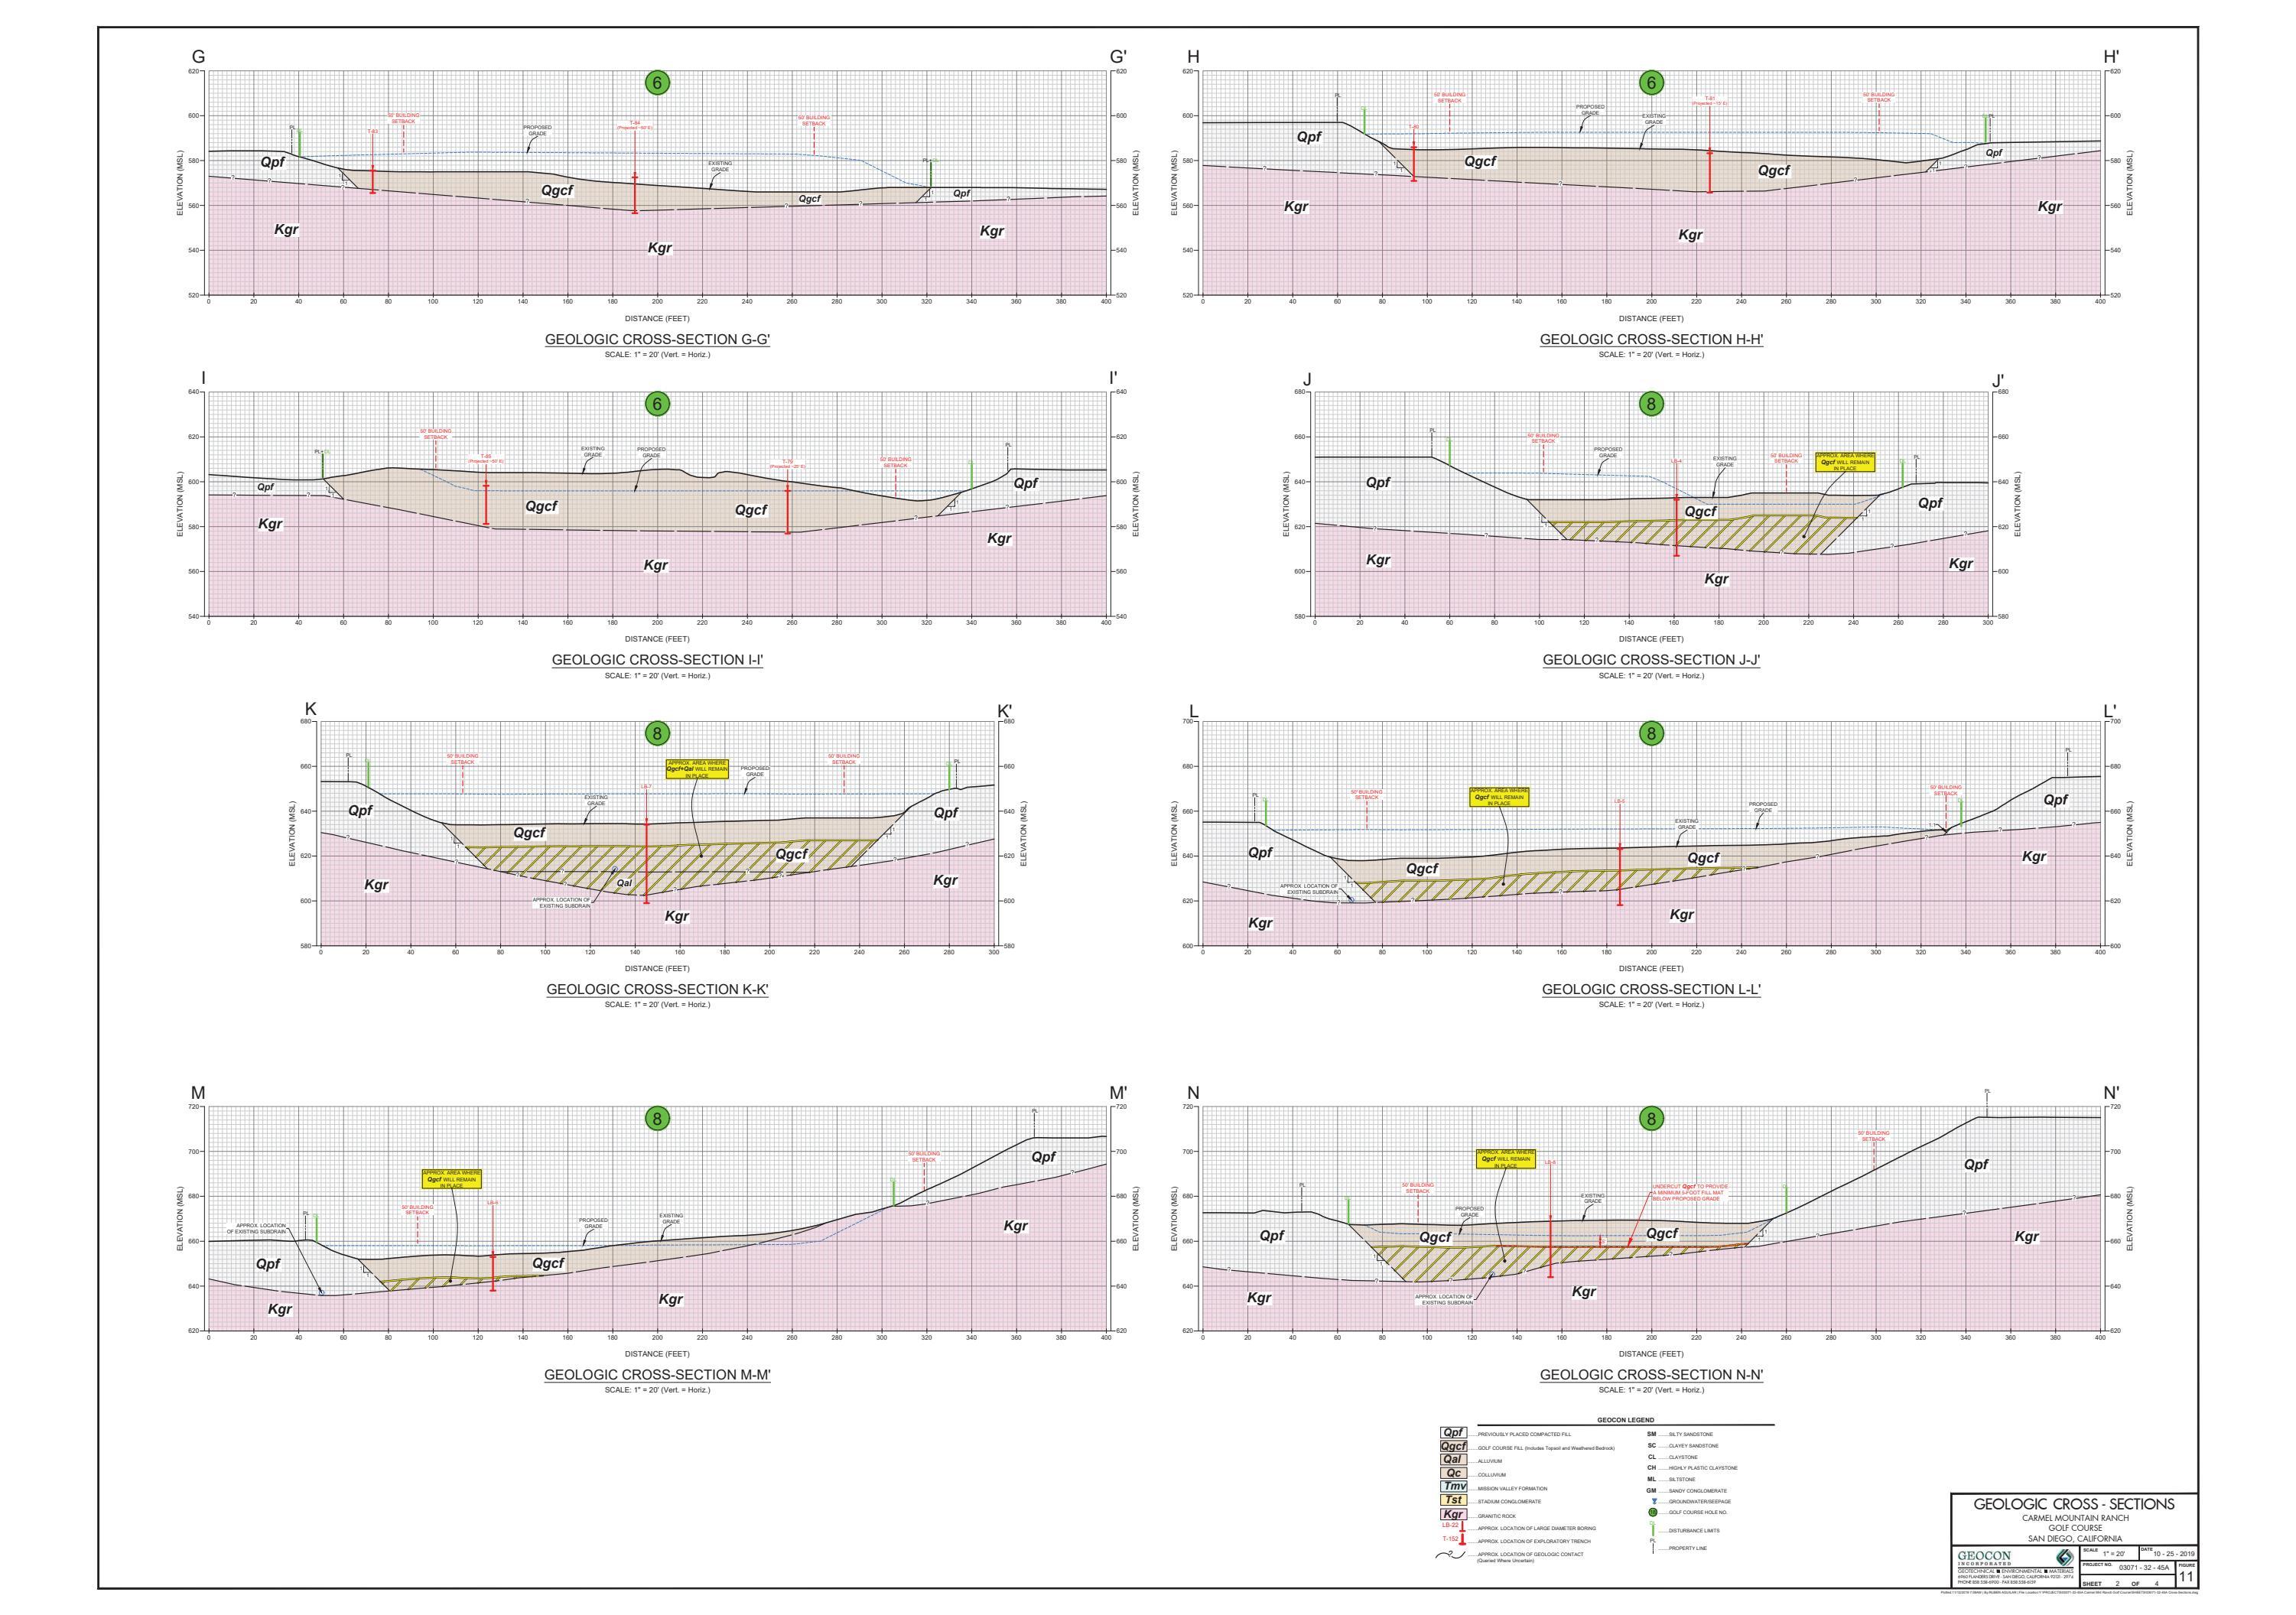
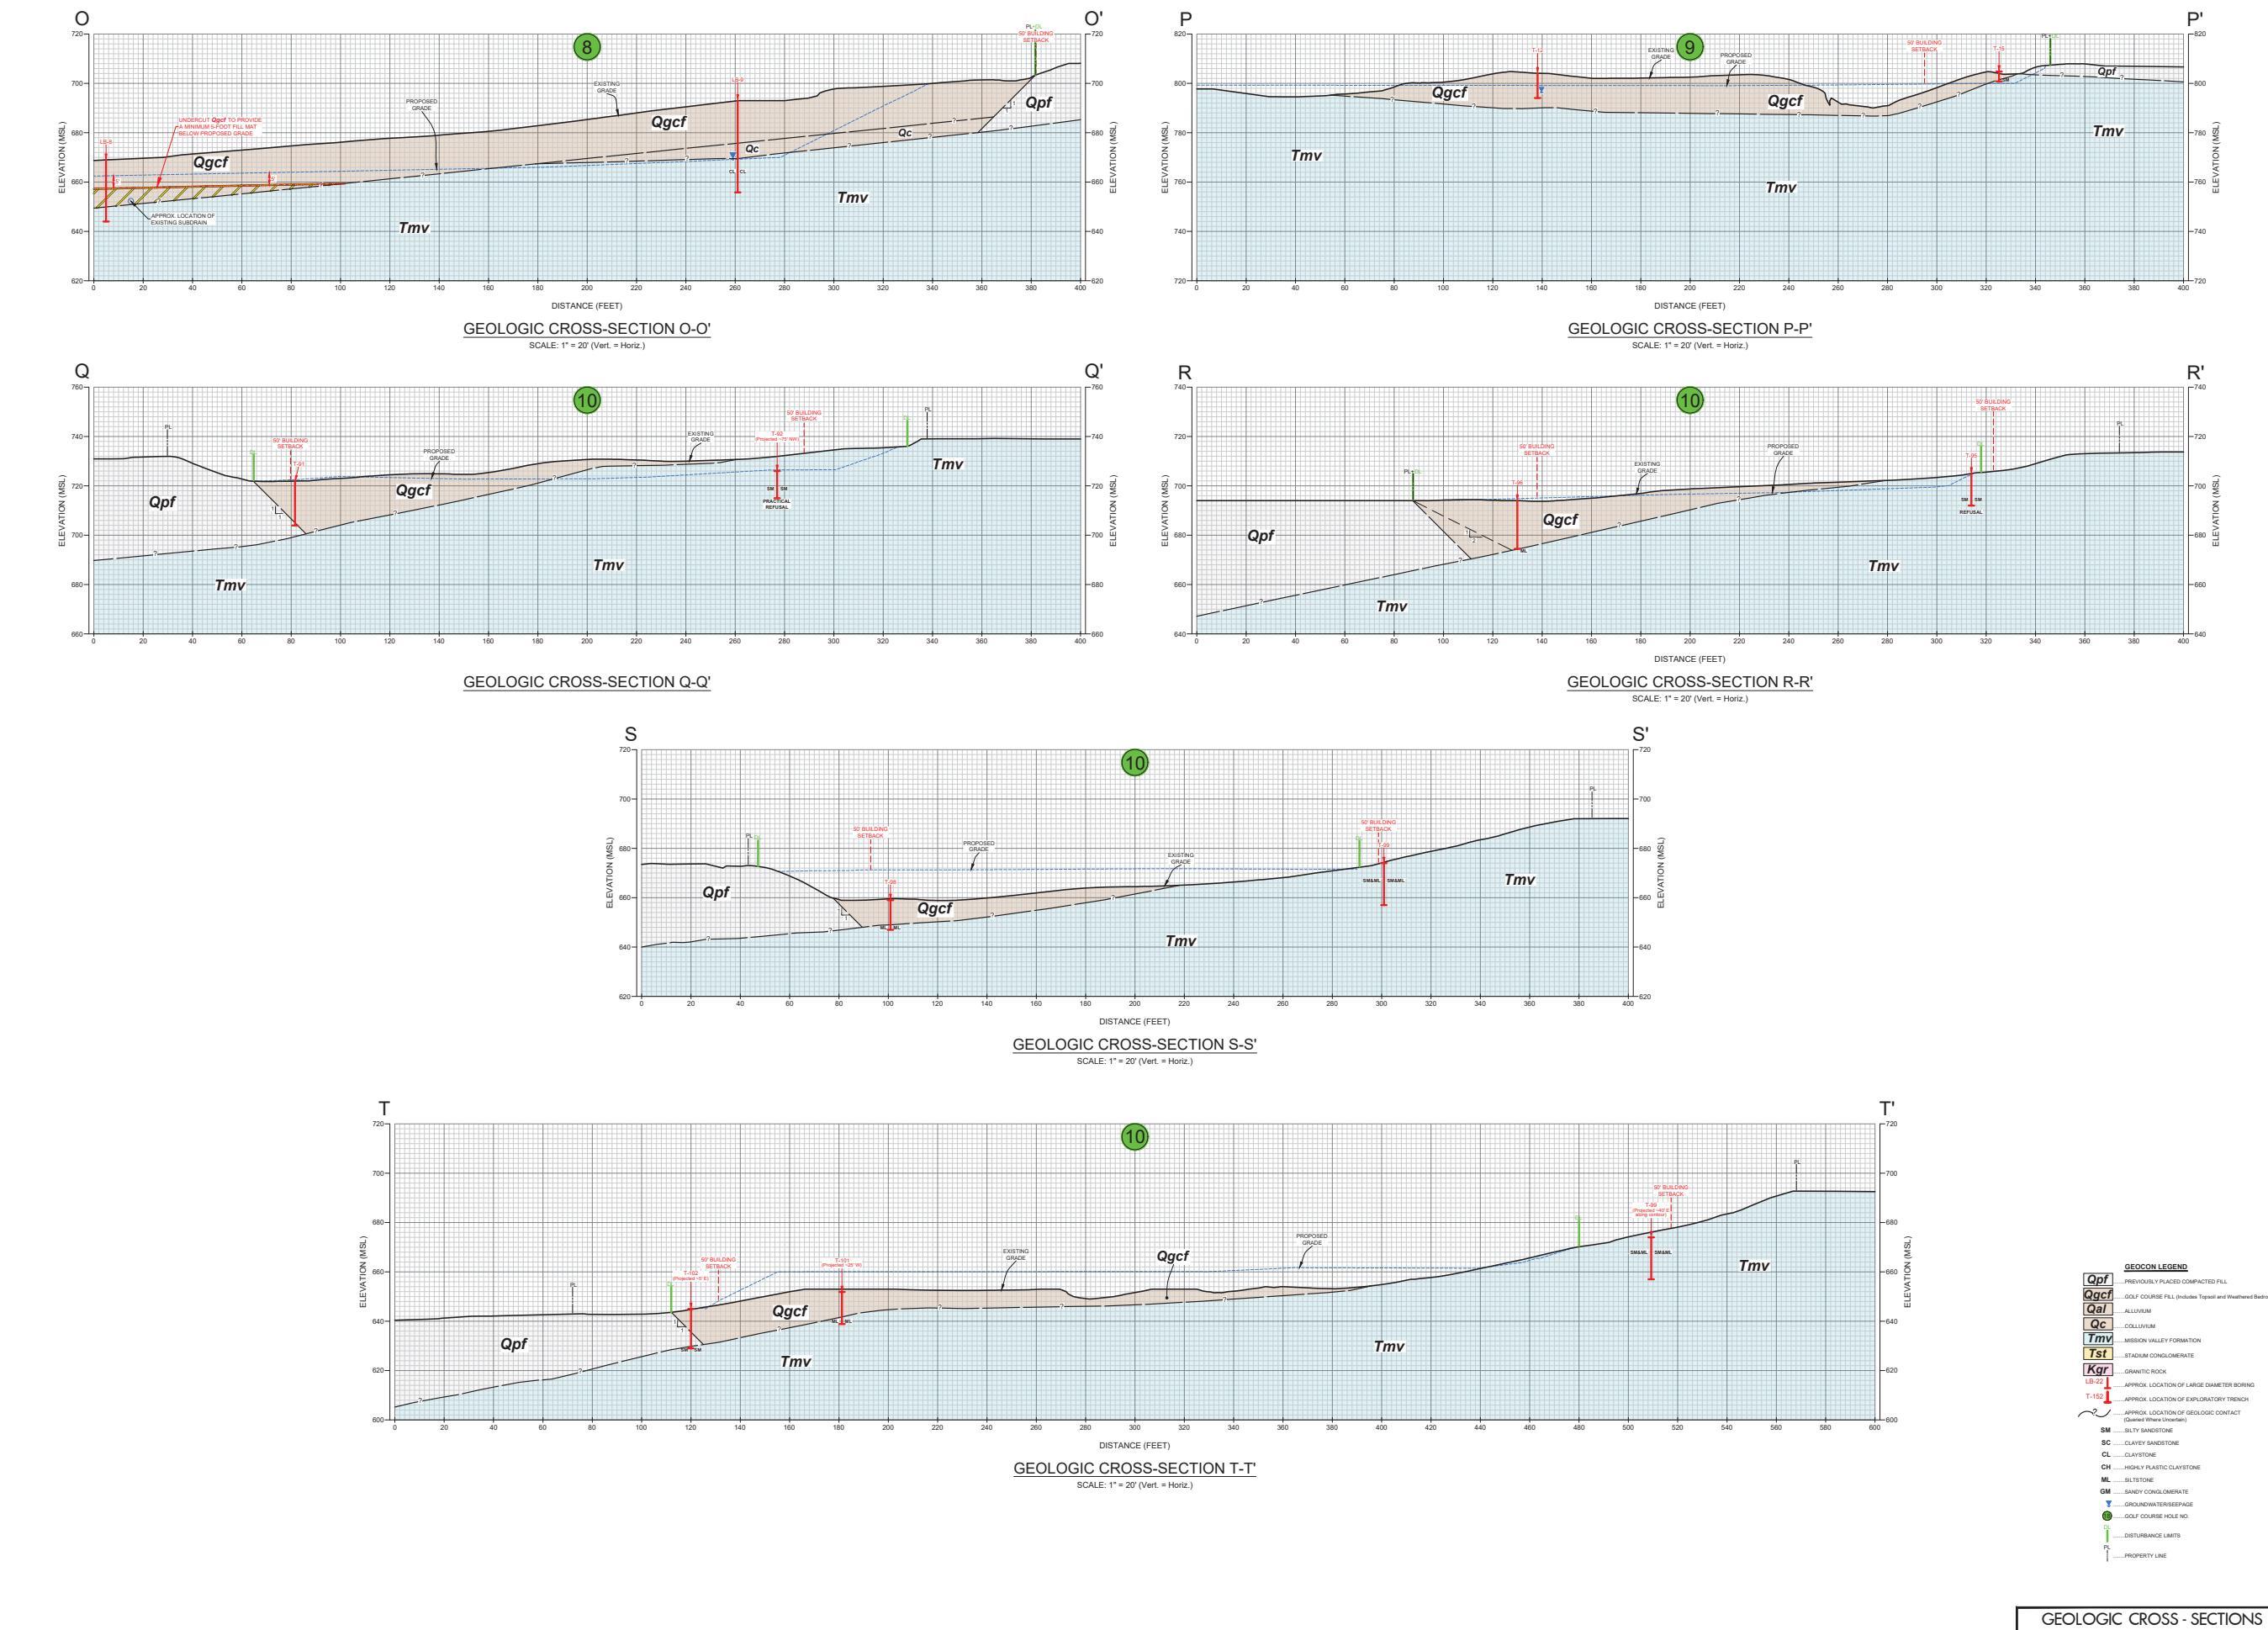
The approximate locations of the subsurface information are shown on the *Geologic Maps*, Figures 3 through 9. *Geologic Cross-Sections* A-A' through X-X' (Figures 10 through 13) represent our interpretation of the geologic conditions across the areas of proposed development.

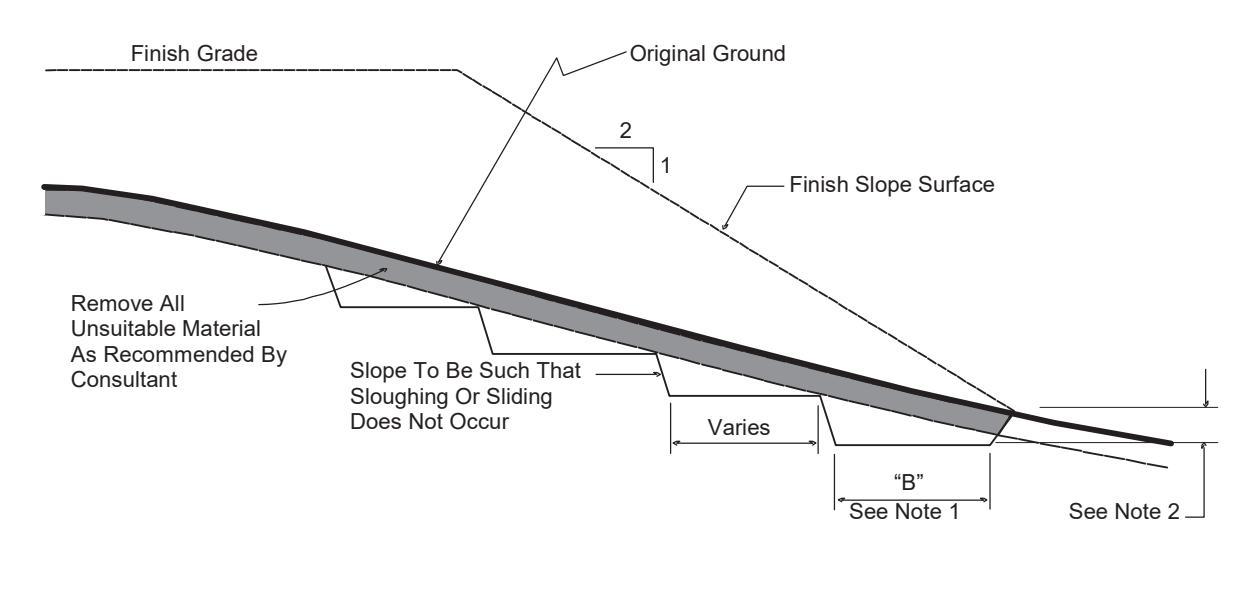
TYPICAL BENCHING DETAIL

- 4.3 After clearing and grubbing of organic matter and other unsuitable material, loose or porous soils shall be removed to the depth recommended in the Geotechnical Report. The depth of removal and compaction should be observed and approved by a representative of the Consultant. The exposed surface shall then be plowed or scarified to a minimum depth of 6 inches and until the surface is free from uneven features that would tend to prevent uniform compaction by the equipment to be used.
- 4.4 Where the slope ratio of the original ground is steeper than 5:1 (horizontal:vertical), or where recommended by the Consultant, the original ground should be benched in accordance with the following illustration.

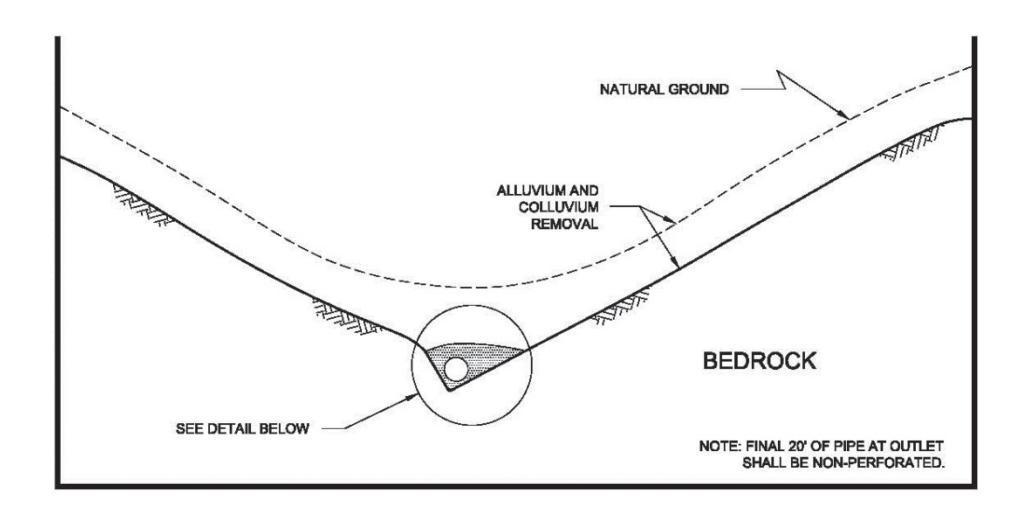
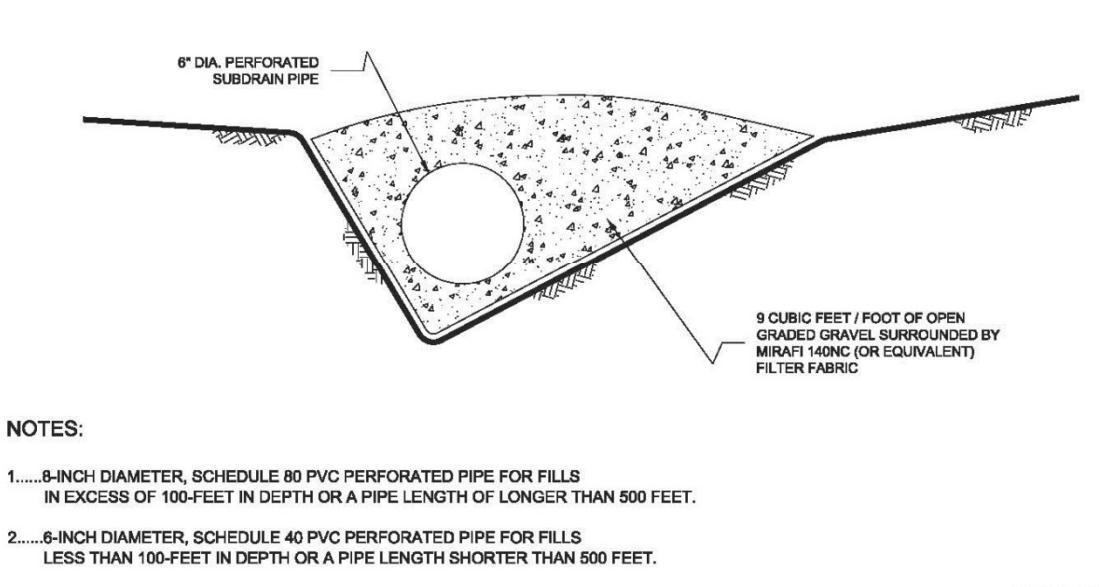
7.1 The geologic units on the site may have permeability characteristics and/or fracture systems that could be susceptible under certain conditions to seepage. The use of canyon subdrains may be necessary to mitigate the potential for adverse impacts associated with seepage conditions. Canyon subdrains with lengths in excess of 500 feet or extensions of existing offsite subdrains should use 8-inch-diameter pipes. Canyon subdrains less than 500 feet in length should use 6-inch-diameter pipes.

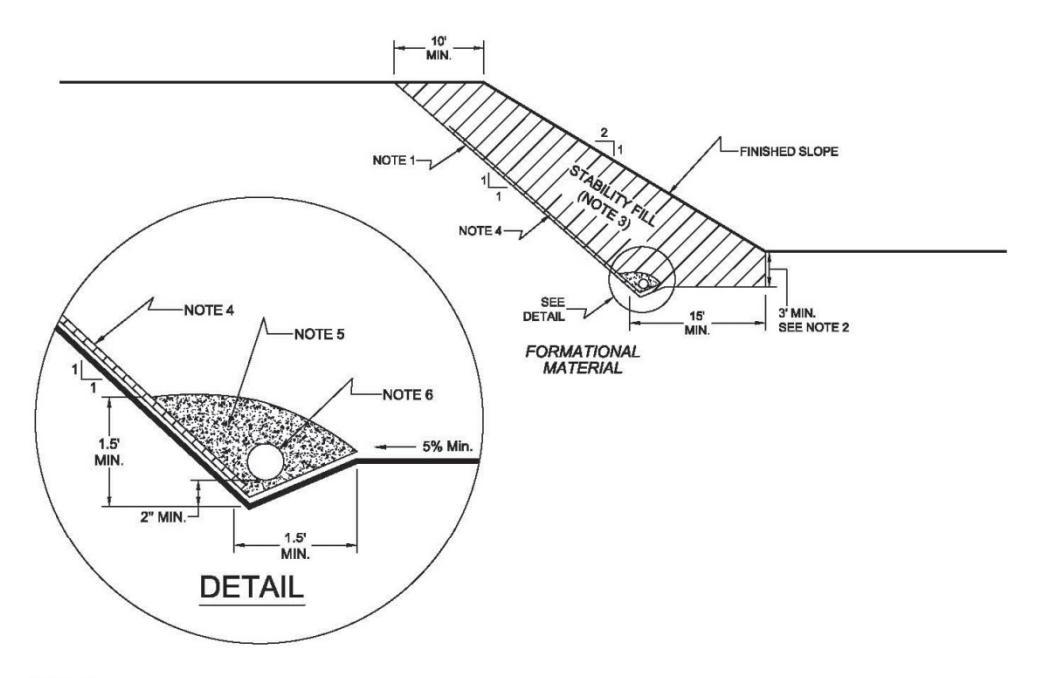
7.2 Slope drains within stability fill keyways should use 4-inch-diameter (or lager) pipes.

1.....EXCAVATE BACKCUT AT 1:1 INCLINATION (UNLESS OTHERWISE NOTED).

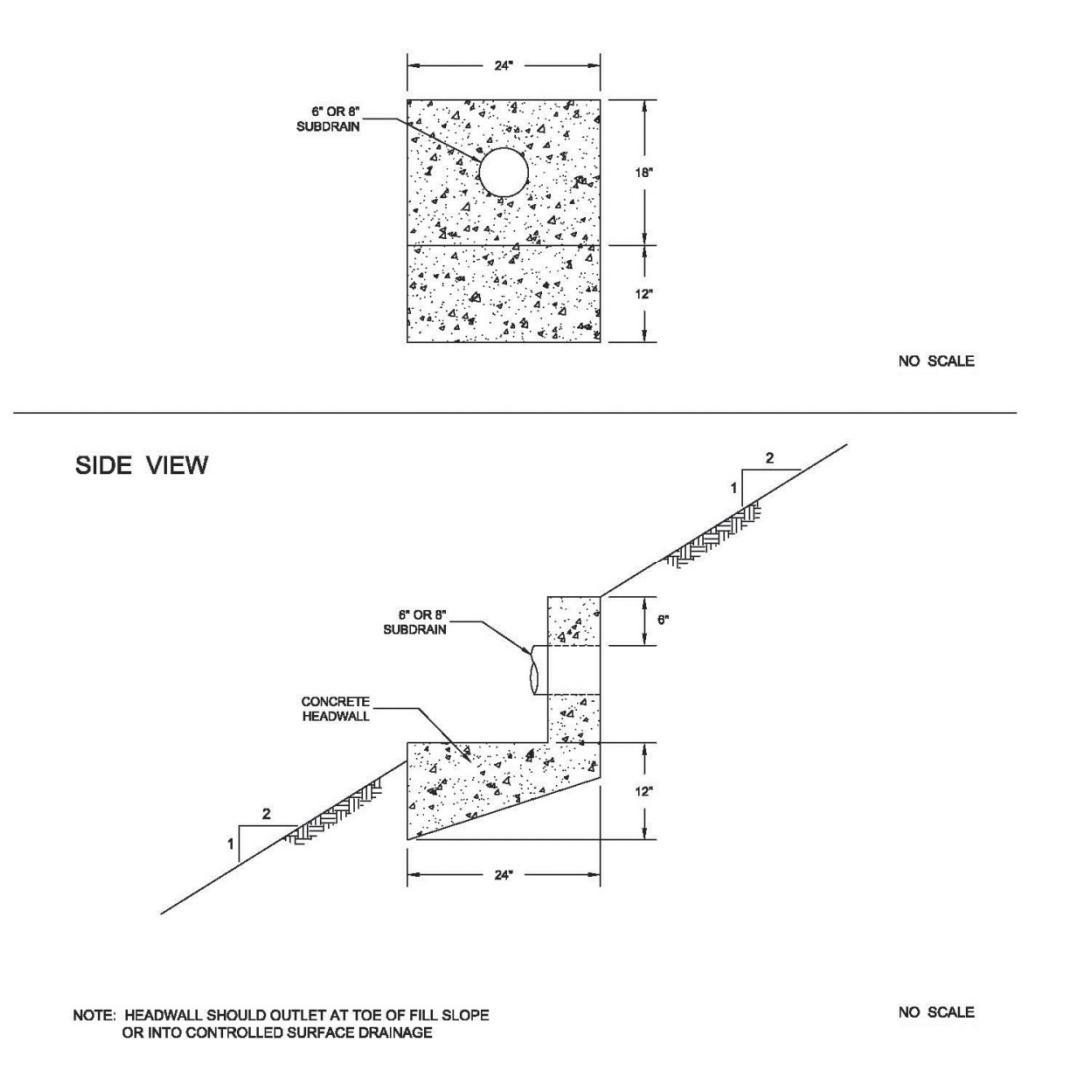
FRONT VIEW

7.6 Subdrains that discharge into a natural drainage course or open space area should be provided with a permanent headwall structure.
