INDIVIDUAL BIOLOGICAL ASSESSMENT REPORT

Parkside Emergency Maintenance		
122		
February 8, 2016		
Scott Gressard (858-997-6874), Erin Bergman (760-274-3927) and Paul Lemons (760-479-4238)

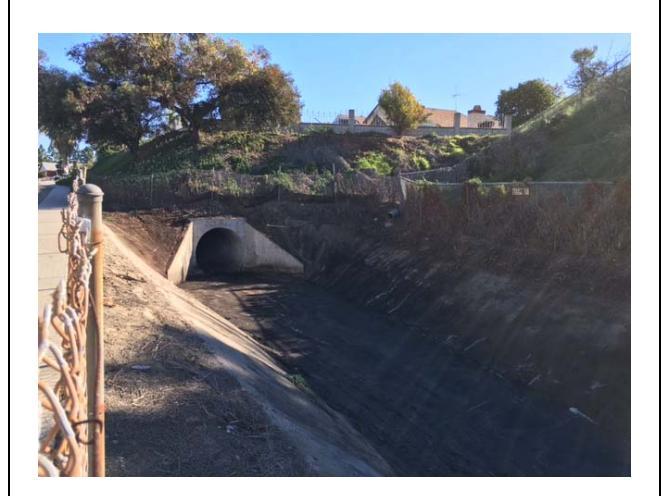
Photograph 5: Looking east upstream at the upstream culvert following the completion of maintenance in MMP Map 122; Figure 3.

(December 26, 2015)

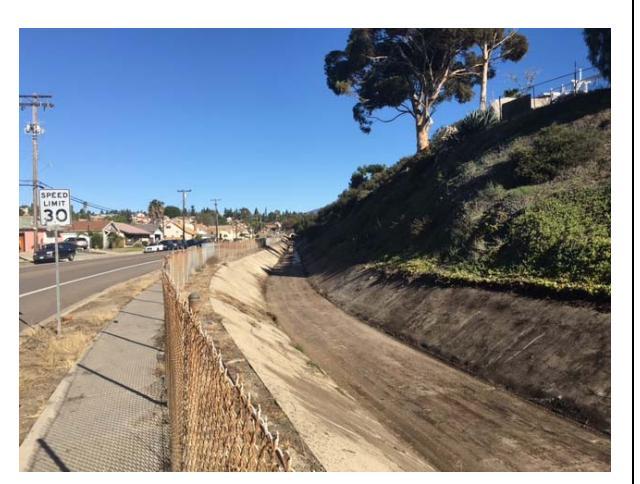
Photograph 6: Looking east upstream from the west end of MMP Map 122; Figure 3 following the completion of maintenance.

(December 26, 2015)
