Miramar Road Subsystem Extension
San Diego, California

**ALIGNMENT MAP
NORTH CITY TO SAN VICENTE RESERVOIR PIPELINE**

PROPOSED NORTH CITY ADVANCED WATER PURIFICATION FACILITY SAN DIEGO, CALIFORNIA

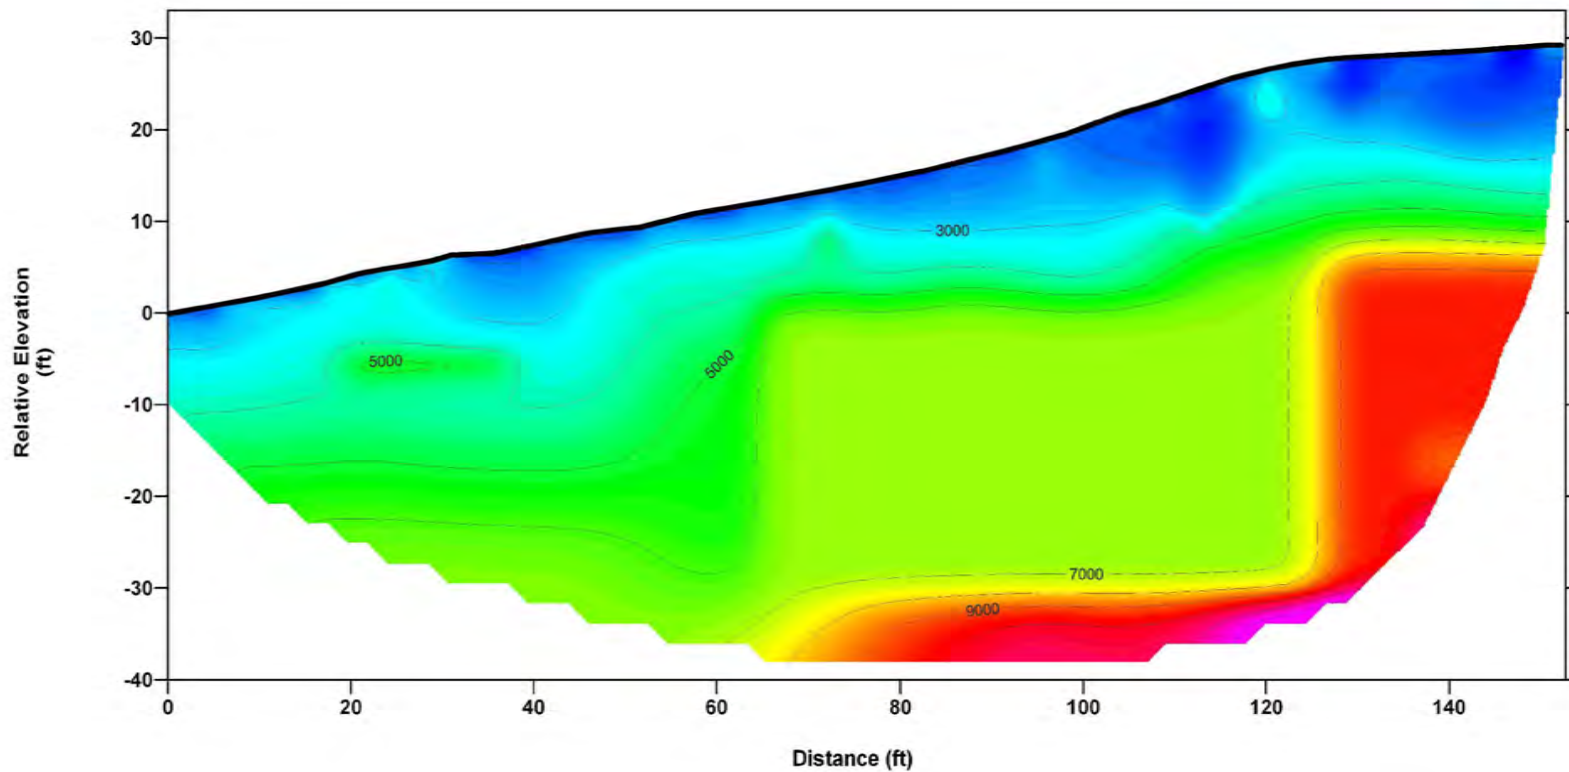
**SEISMIC PROFILE
SL-4**

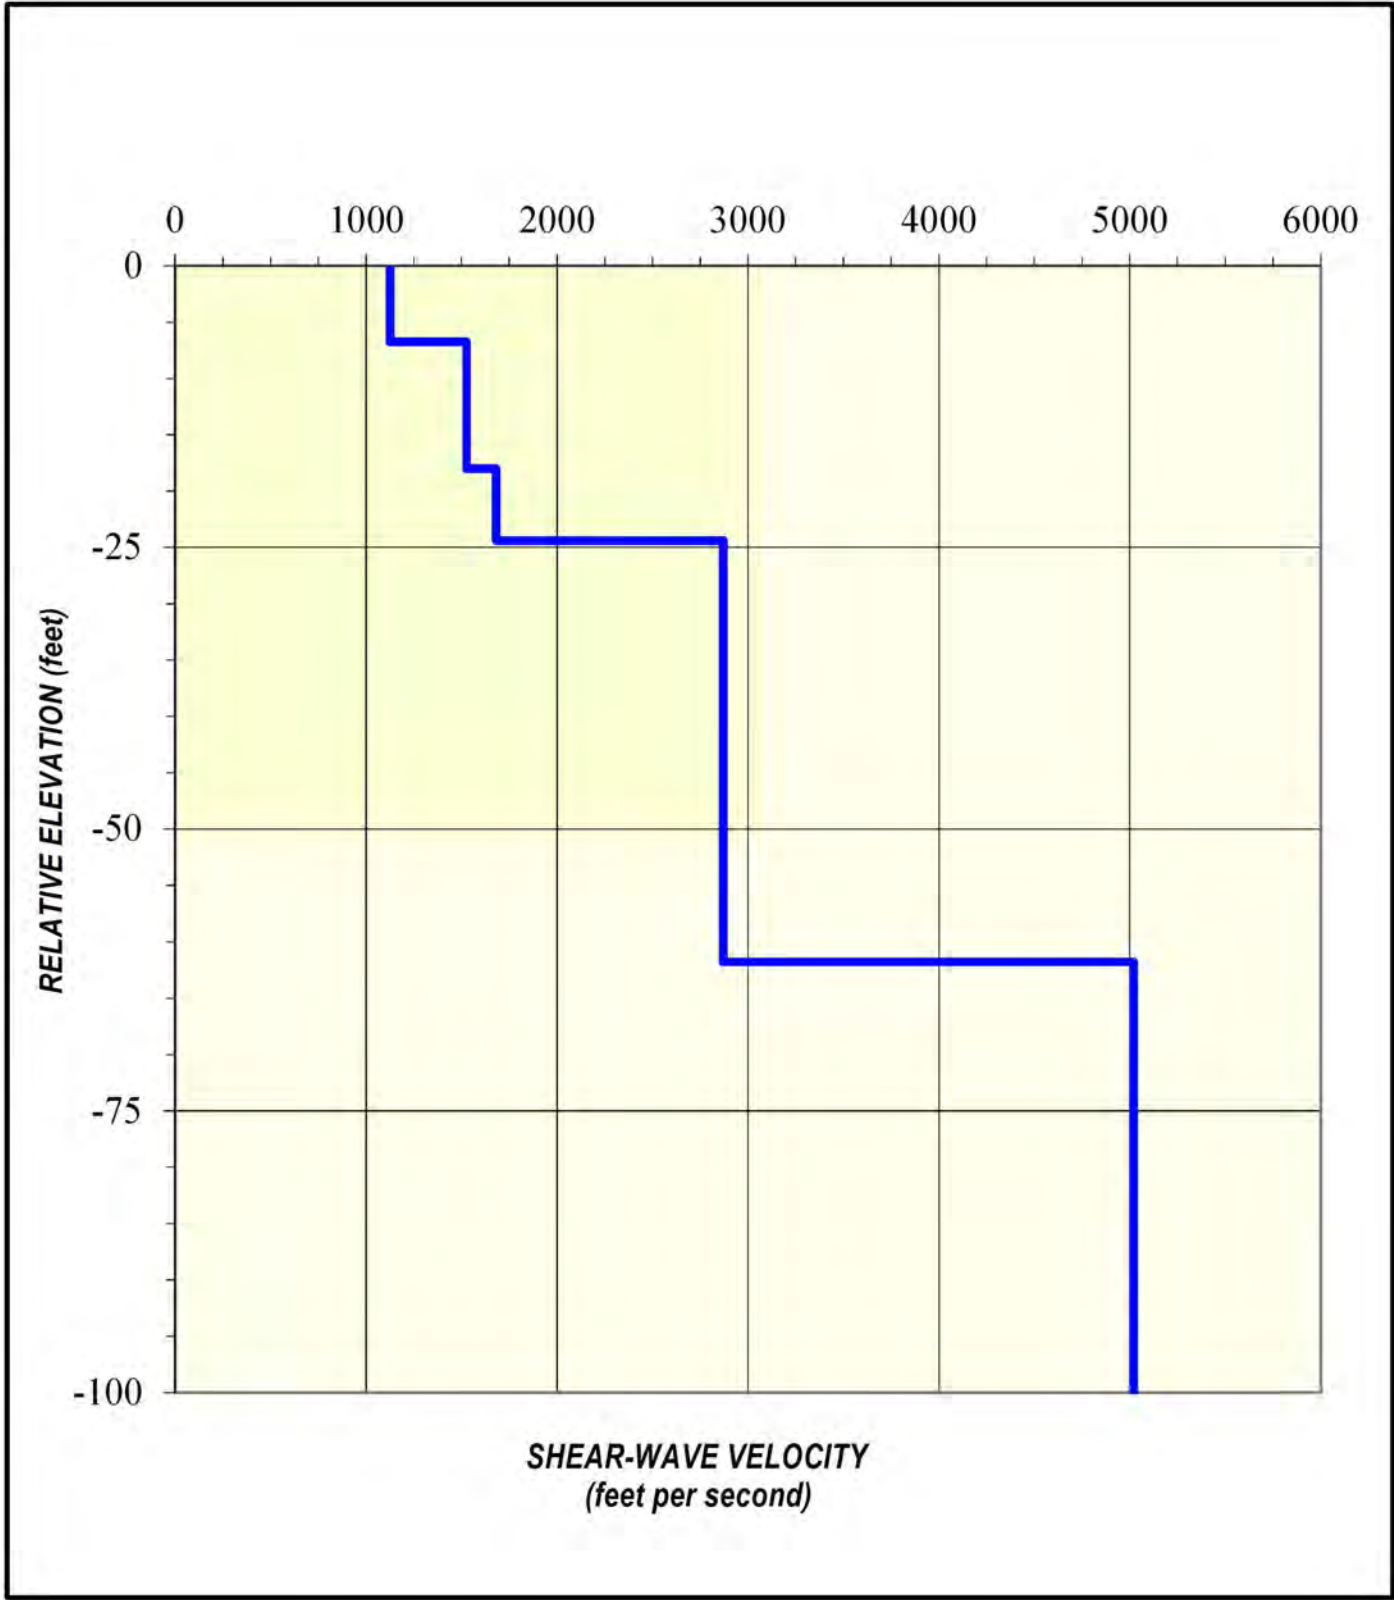
**ReMi RESULTS
RL-1**

NCCS Miramar Pipeline
San Diego, California

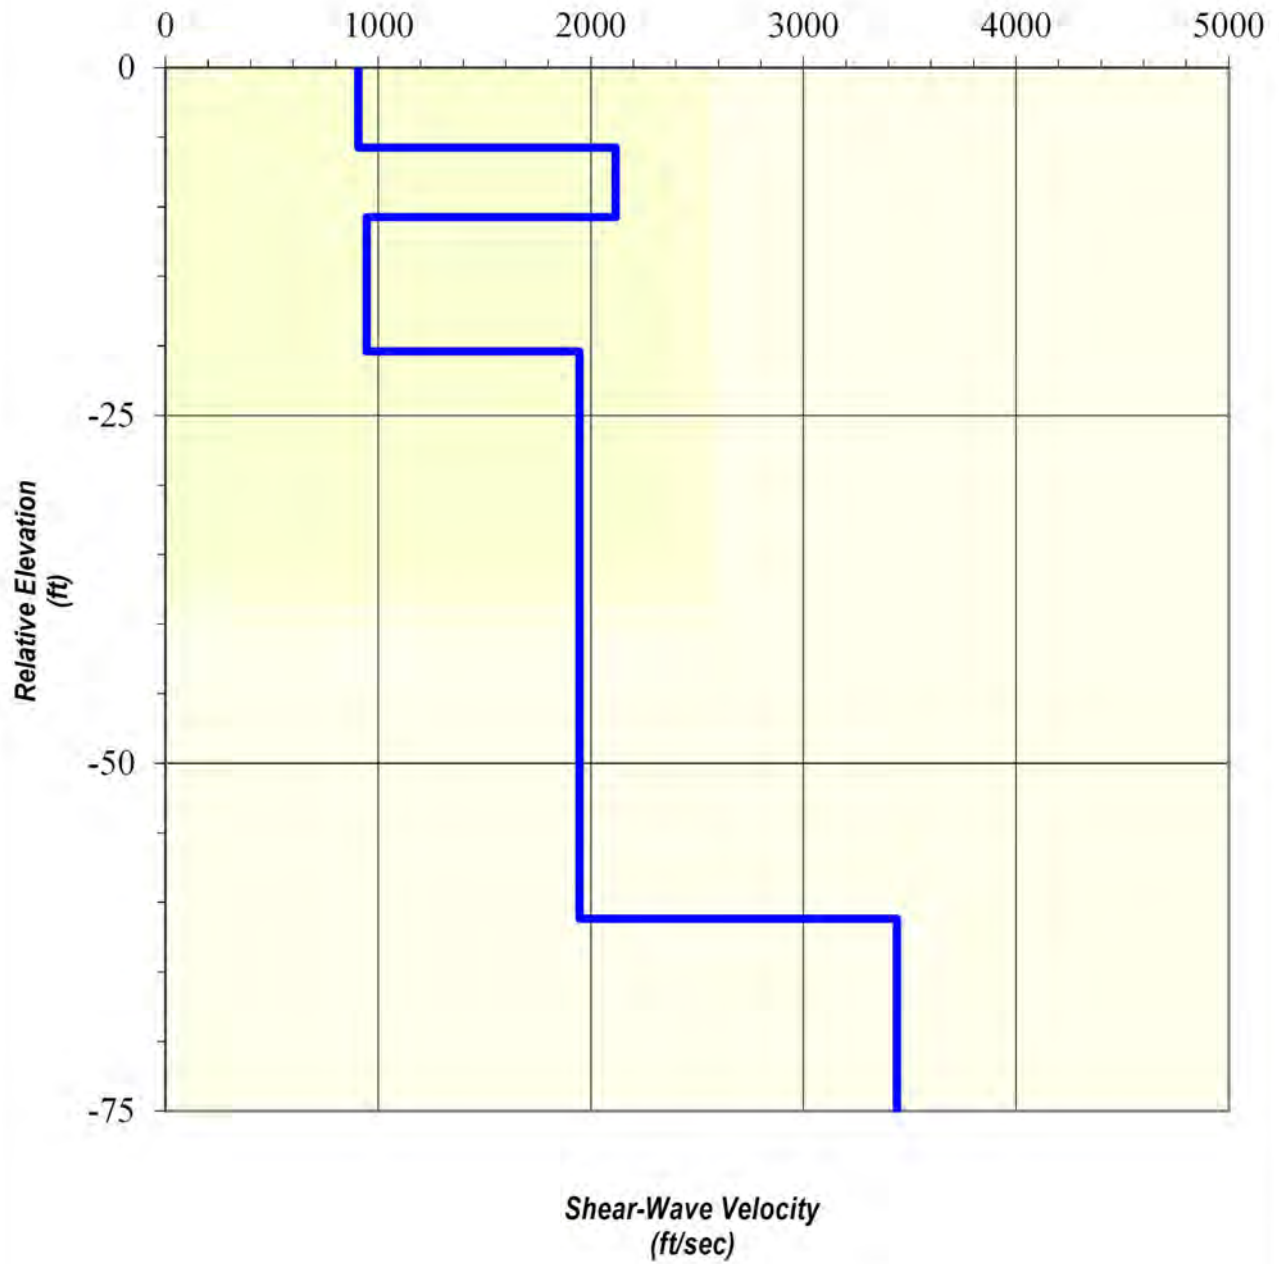
Figure 5a

**ReMi RESULTS
SL-7**

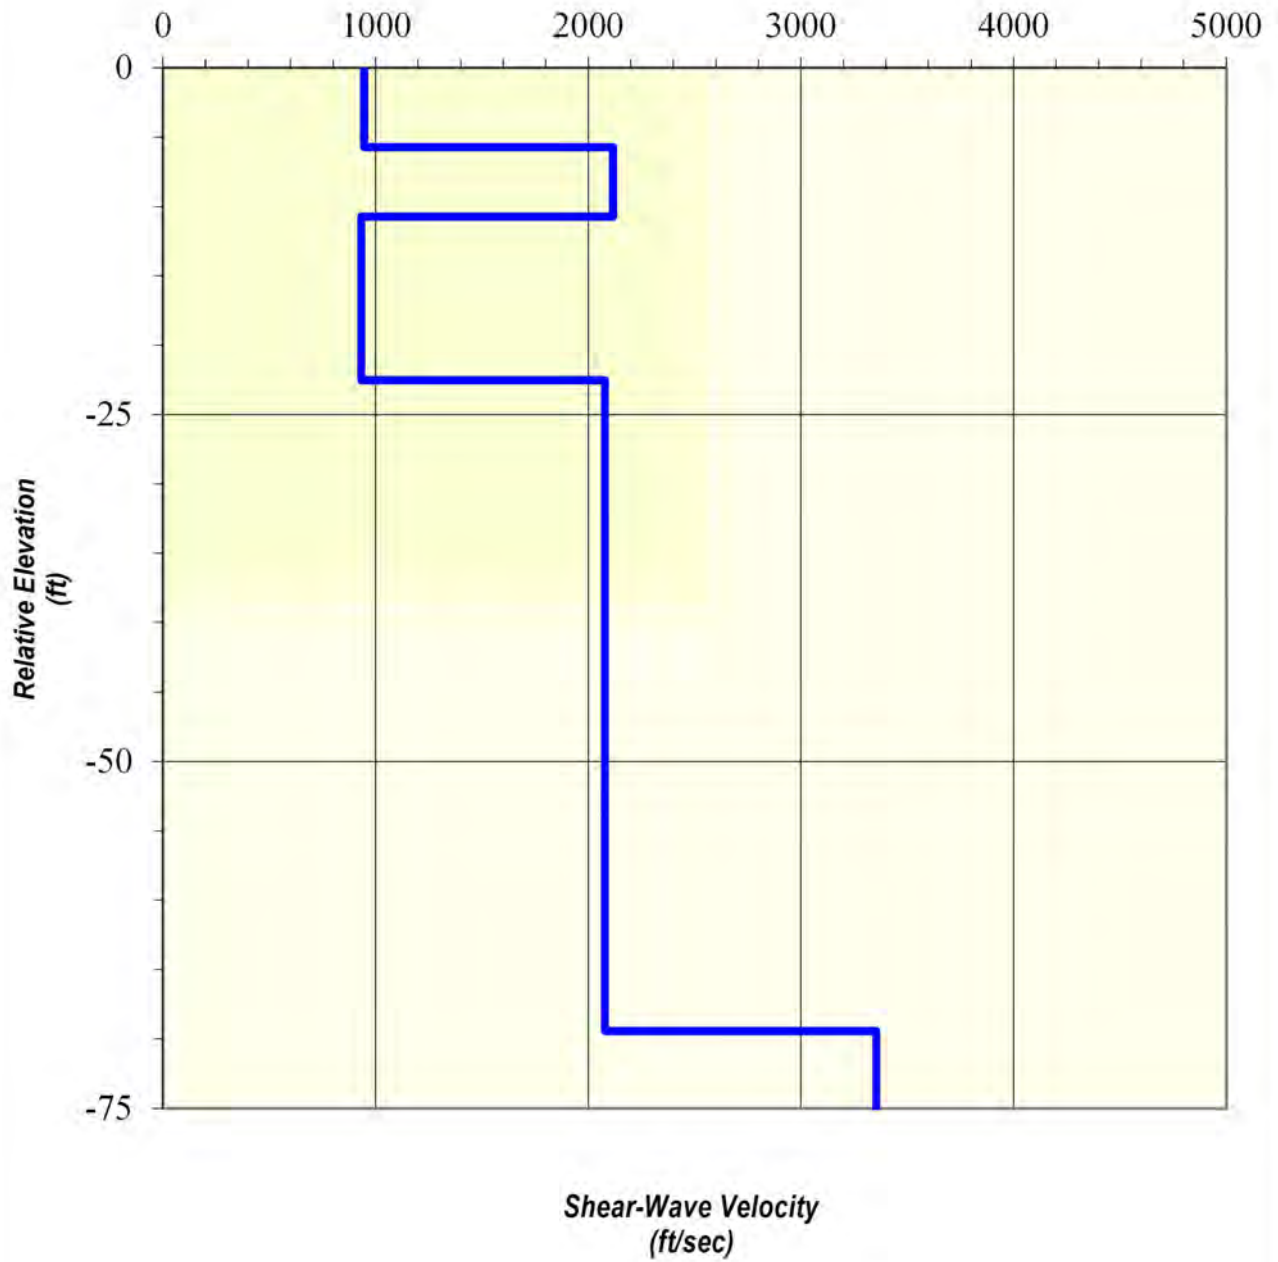
Figure 5b

**ReMi RESULTS
SL-8**

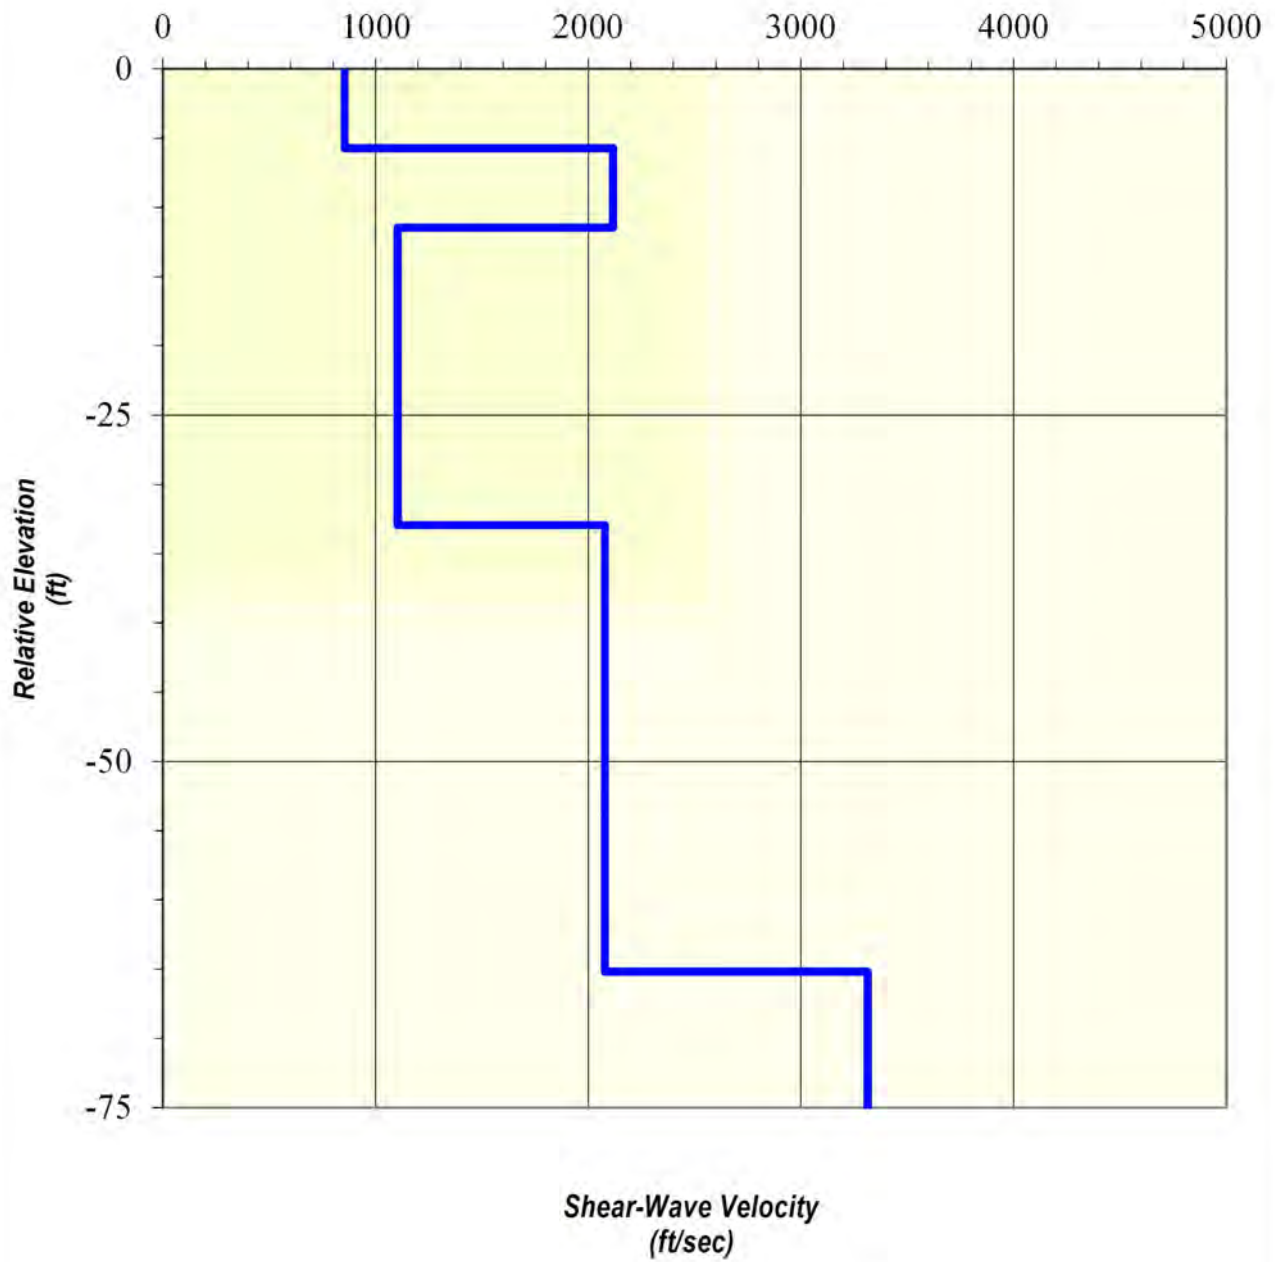
**ReMi RESULTS
SL-9**

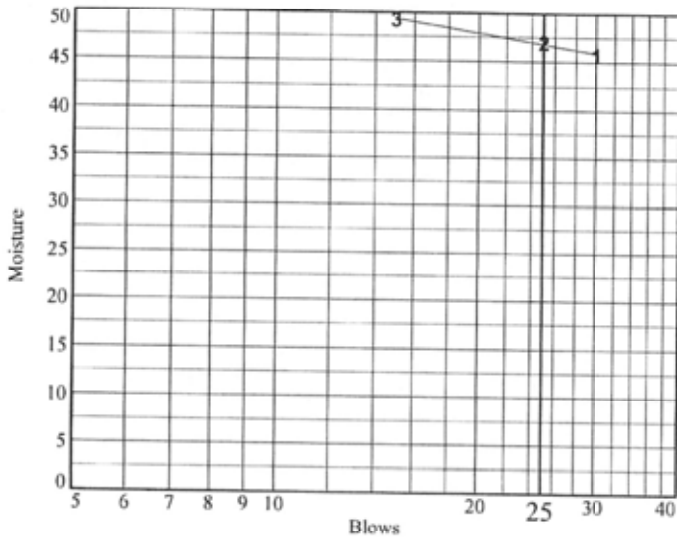
Liquid Limit= 46.8
 Plastic Limit= 21.0
 Plasticity Index= 25.8

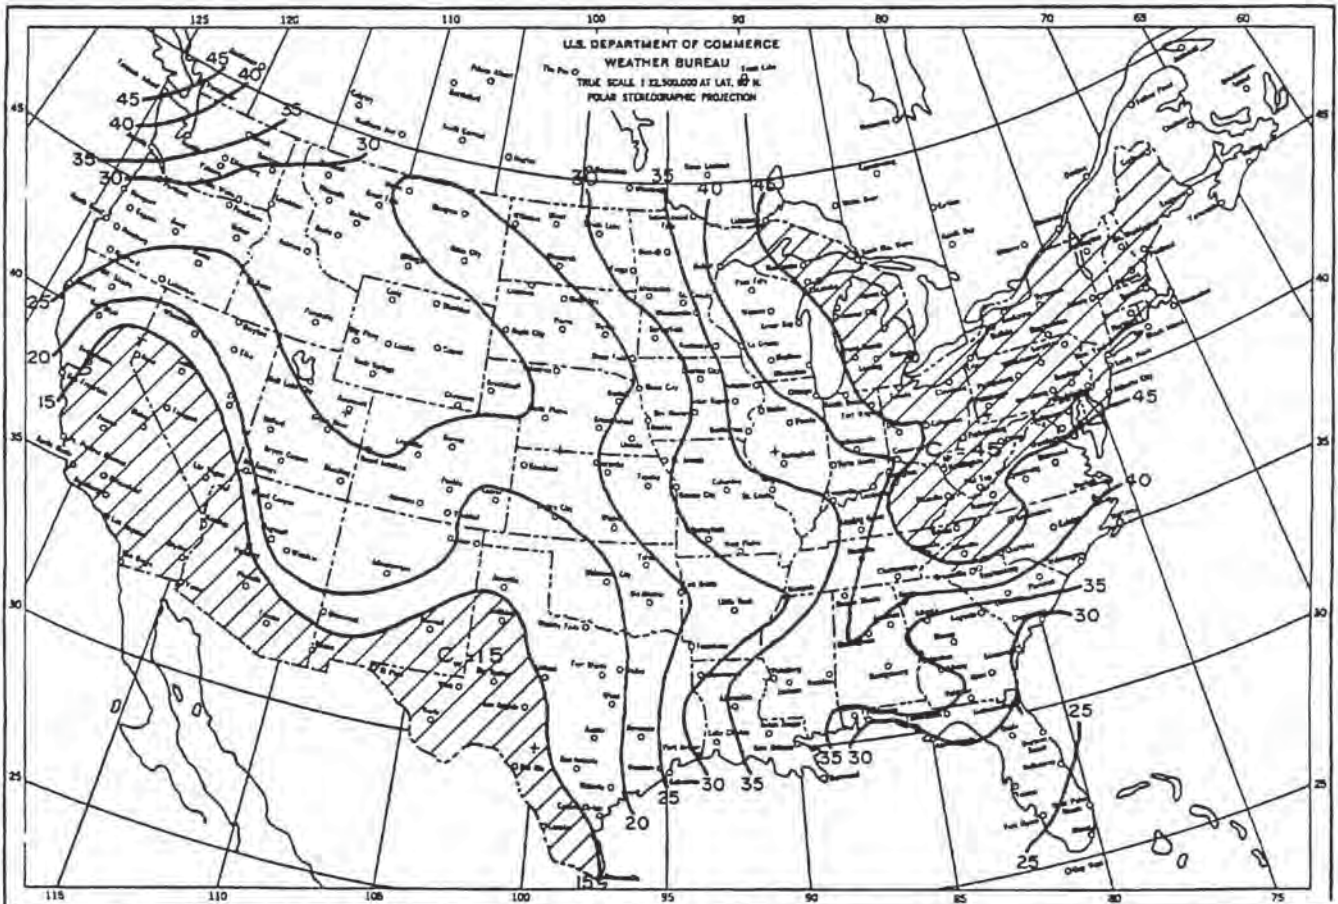
BRAB utilized the Climatic rating (see Figure 4) of the locality to reflect the stability of the moisture content in an expansive soil. While there are other methods of accounting for the seasonal moisture change potential, this system has seemed to work well.

Climatic Ratings (C_w) for Continental United States

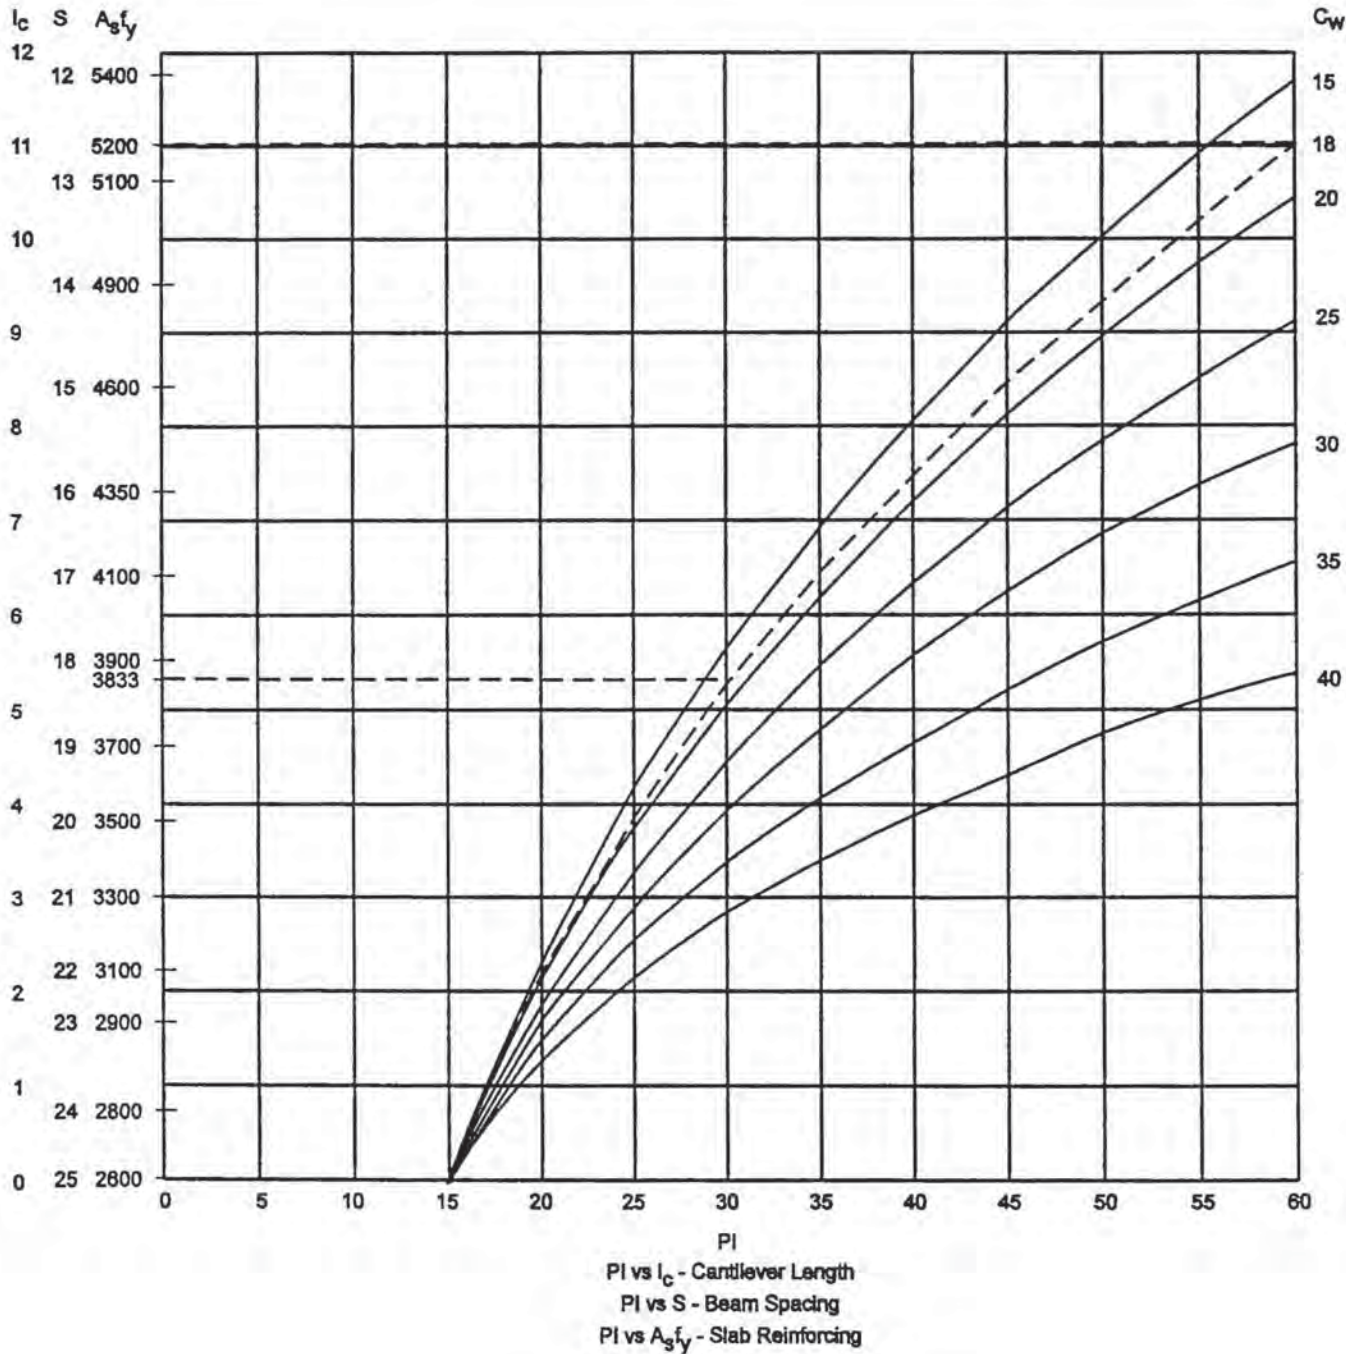
Looking at the various loading conditions above and slabs in the field, it became apparent that the foundations were very sensitive to the changes at the edges. It was decided that a cantilever distance, (l_c) would be used as a basis for this design procedure to replace the $L(1-C)$ utilized by BRAB. Figure 5 gives a cantilever design length for a given soil condition (PI) in a given climatic rating (C_w).

It seems apparent that the size of the foundation must also be considered. The values given in Figure 5 for the cantilever length are for large slabs. Figure 6 gives a modification coefficient which will adjust the cantilever length for smaller slabs depending on the slab size.

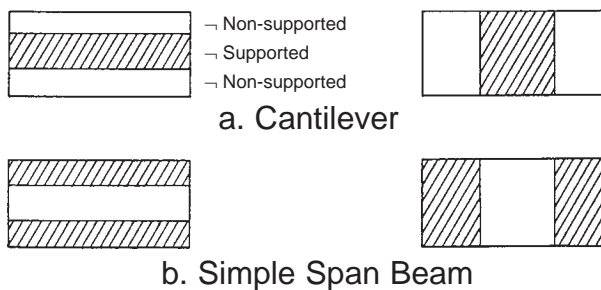
This procedure designed only one or two beams at a time. The BRAB report showed support conditions (see Fig.9) which allowed all beams in a given direction to be considered at one time. This simplified the design procedure, and, when the two design procedures were compared, they were found to give similar results. The BRAB procedure produced heavier-designs, but, with minor modifications, they could be adjusted

Assumed Support Conditions
Figure 9

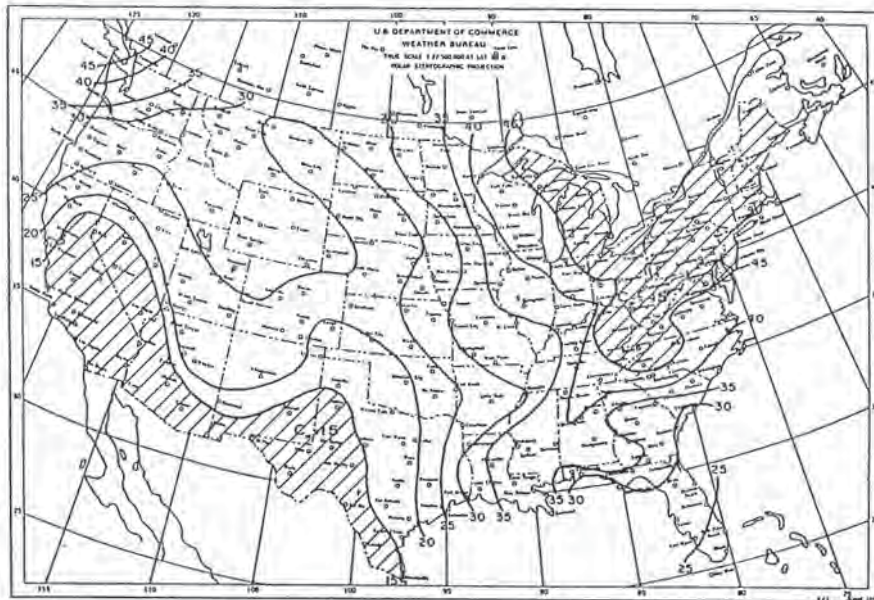
With the weight of the house known, refer to Fig. 14 which is extracted directly from BRAB report to select the climatic rating for the city in which the house is to built. The values for Texas range

Climatic Rating (C_w) Chart
Figure 14

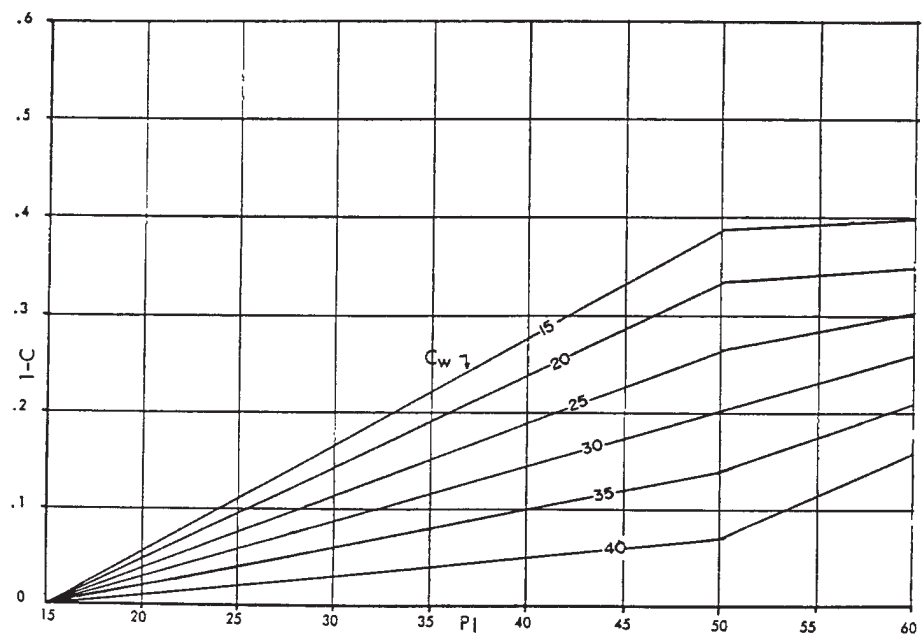
PI vs. (1-C)
Figure 15

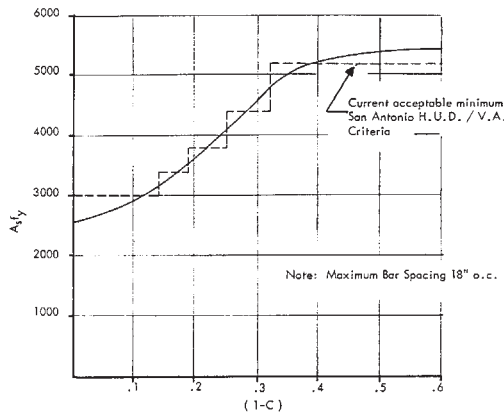
1-C vs. $A_s f_y$
Figure 18

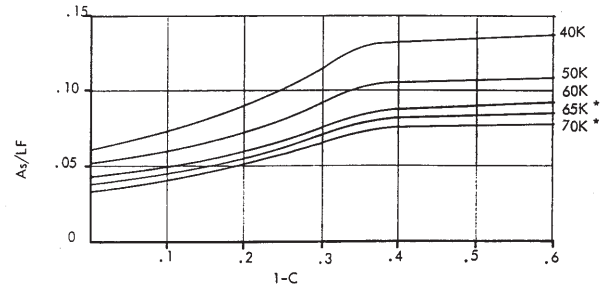
(1-C) vs. A_s/LF
Figure 19

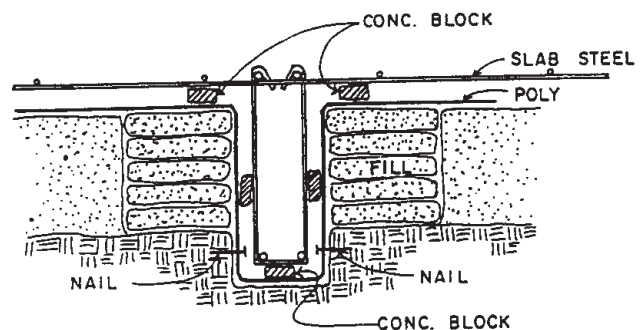
Blocking Steel Interior Beam
Figure 30

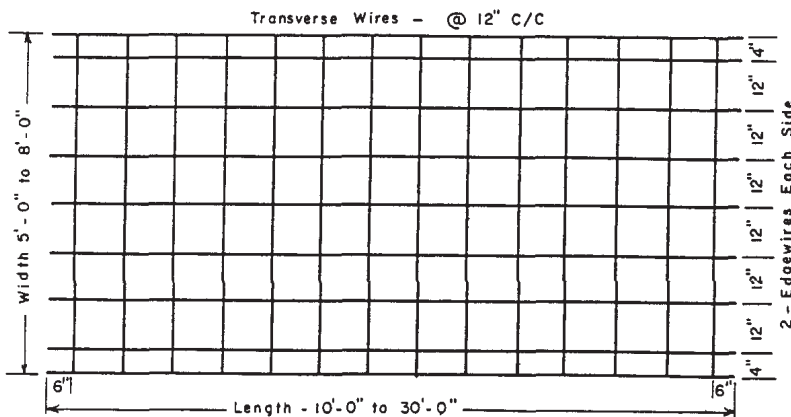
The length of splice for deformed welded wire reinforcement is determined by the size and spacing of the spliced wires, and only the outside cross wire is lapped. While the lap length cannot be changed, the size of the outside cross wire can be reduced without changing the strength of the lap. ASTM Specification A497 stipulates that the weld shear strength shall not be less than 35,000 times the area of the larger wire. These engineered welded wire reinforcement styles are not generally available for small foundation slabs, but, when numerous small buildings or large slabs are being considered, it is prudent to check with welded wire reinforcement suppliers because substantial savings in cost can often be accomplished. As with rebar reinforcing, welded wire reinforcement must be chaired or supported on brick or blocks to insure proper placement in the slab.

Engineered Welded Wire Reinforcement Sheet with Special Side Laps
Welded Smooth Welded Wire Reinforcement

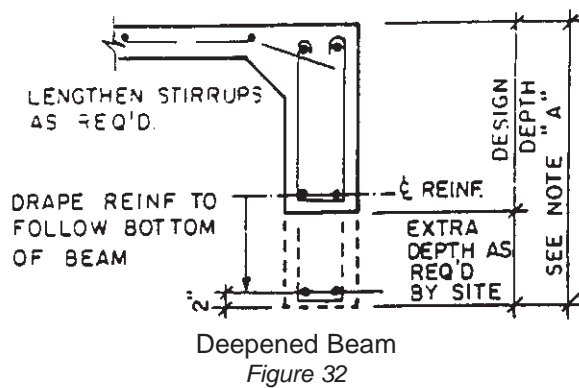
Deepened Beam
Figure 32

beam, the Contractor needs instructions in the typical details telling how to handle the situation. In the case of the deep beam, deepen the beam by the required amount and relocate steel (Fig. 32). Refer to "Note A" to see if additional steel is required. Obviously, if the beam exceeds 72", the engineer must be contacted for additional information.

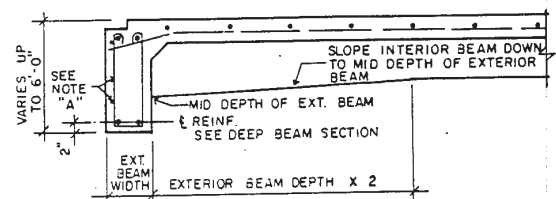
Interior to Exterior Beam
Figure 33

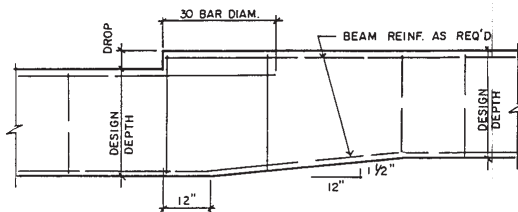
Side View of Typical Beam at Drop
Figure 35

4. Beams that continue through drops must be deepened by the amount of the drop, and the transition sloped (Fig. 35). If the drop is framed as a sharp corner on the bottom of the beam, stress concentrations can occur which may cause difficulties.

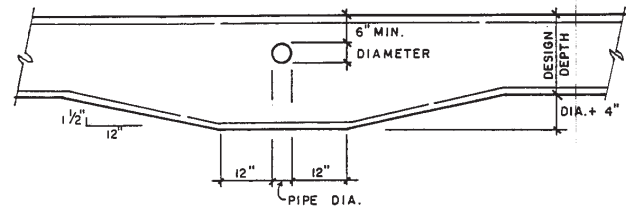
Drop under Sleeve through Beam

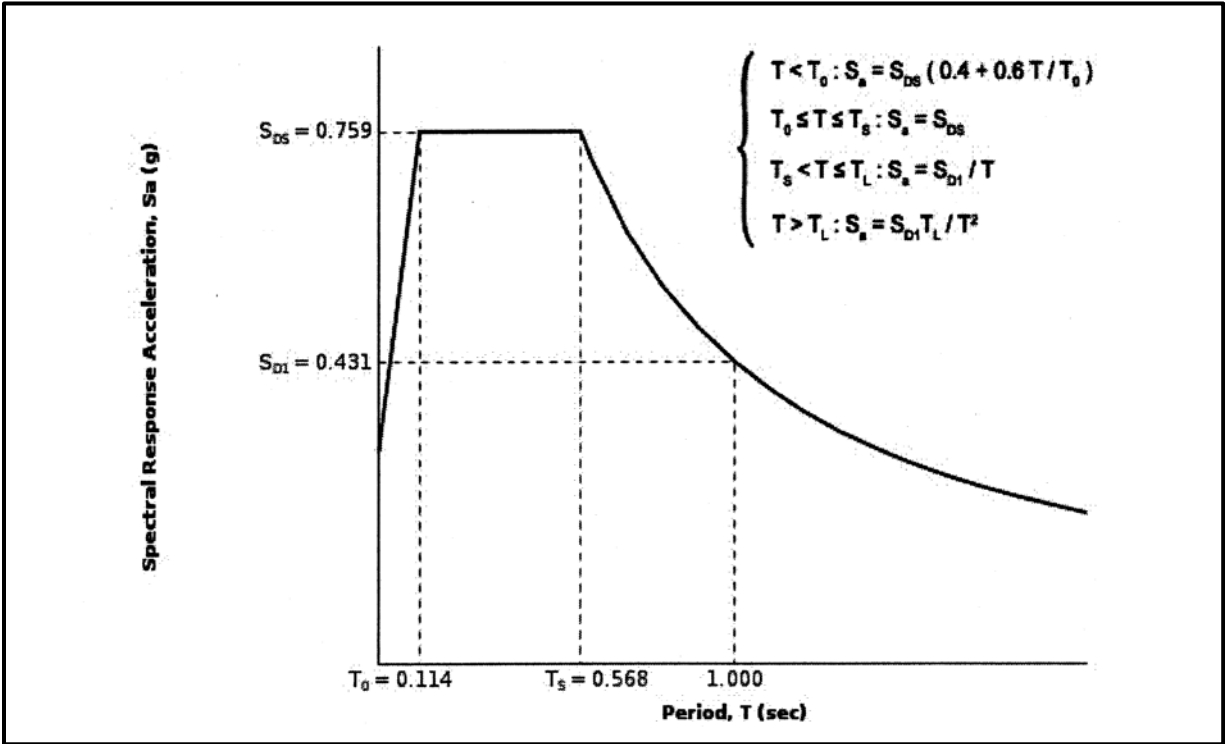
**DESIGN RESPONSE SPECTRUM
CAMPO ROAD SEWER REPLACEMENT PROJECT**

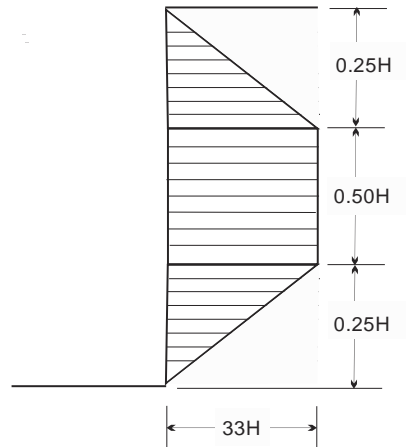
For design of tied-back retaining walls, we recommend that a trapezoidal pressure distribution such as that presented below be used. The recommended maximum pressure may be taken as 33H in pounds per square foot, where H is the height of the retaining wall in feet. The recommended pressure is for a level backfill. If the at-rest pressure is used then the maximum pressure should be 47H for the restrained walls. Similar values are presented for the non-expansive imported fills meeting the specifications outlined in Section 6.6. Recommendations for tie-back shoring including the use of soldier piles and anchors may be provided at if required.

Lateral Pressure Distribution

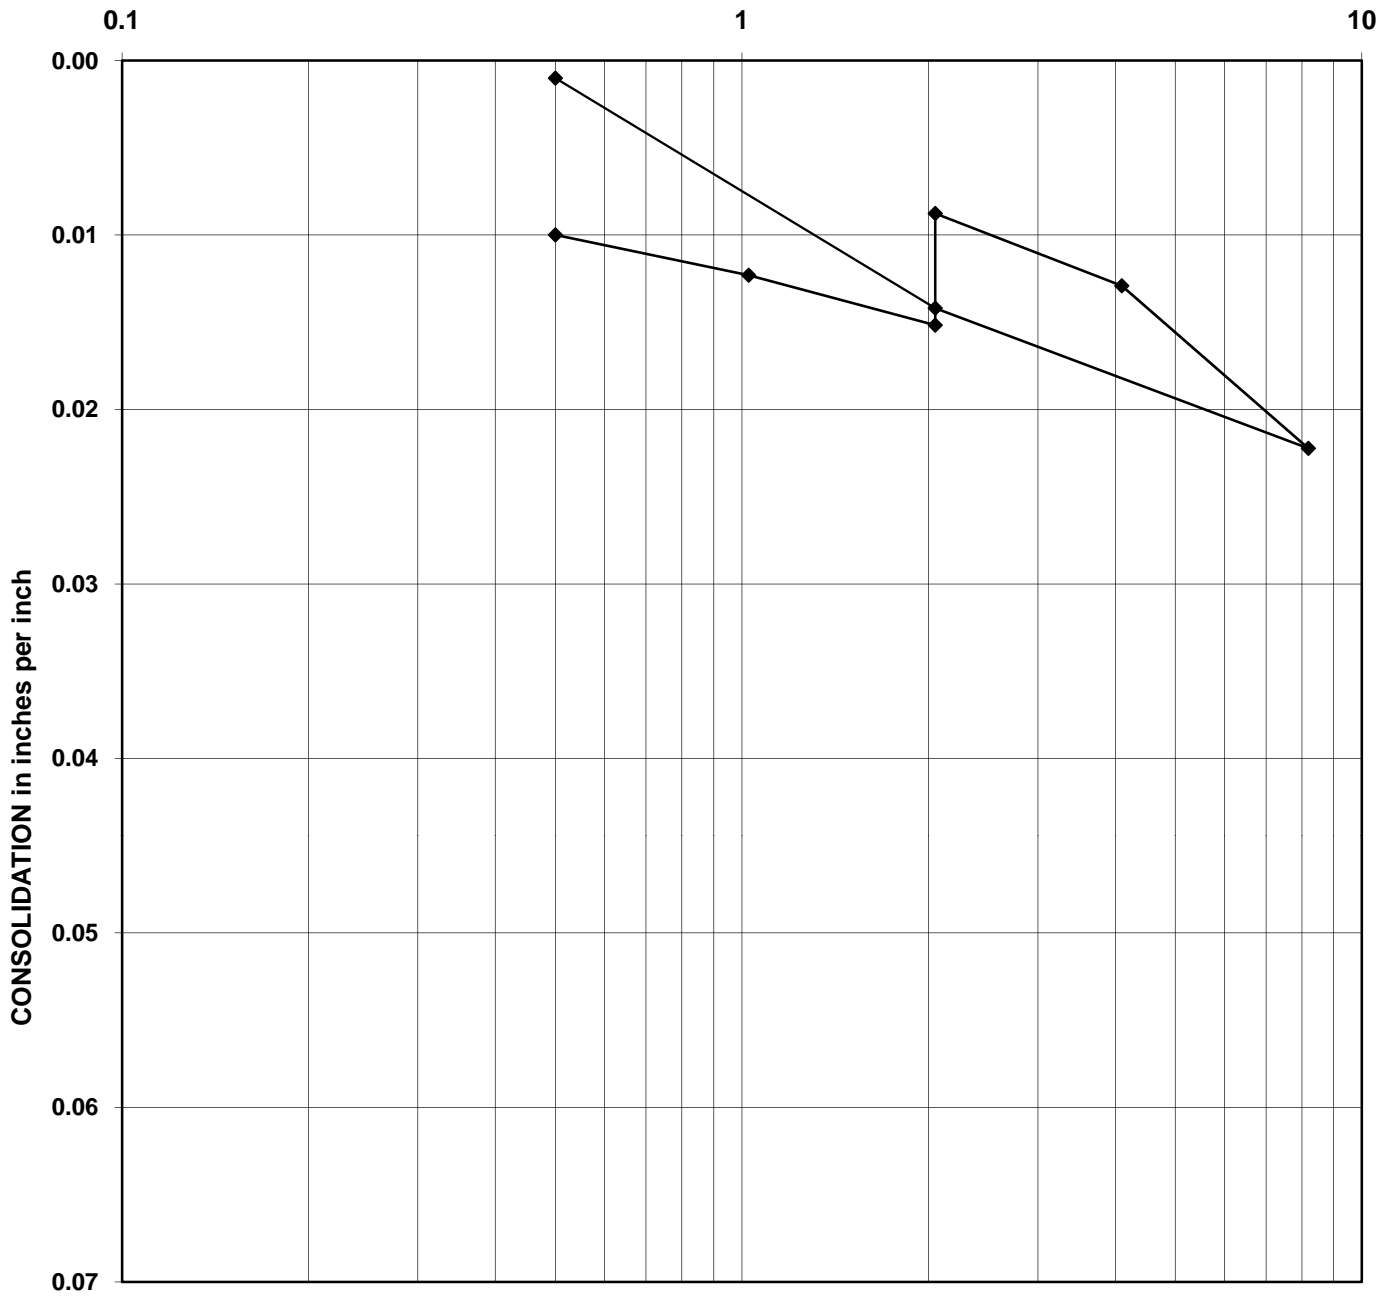
Note: Water added to the sample after consolidation under a load of 2.0 kips per square foot.

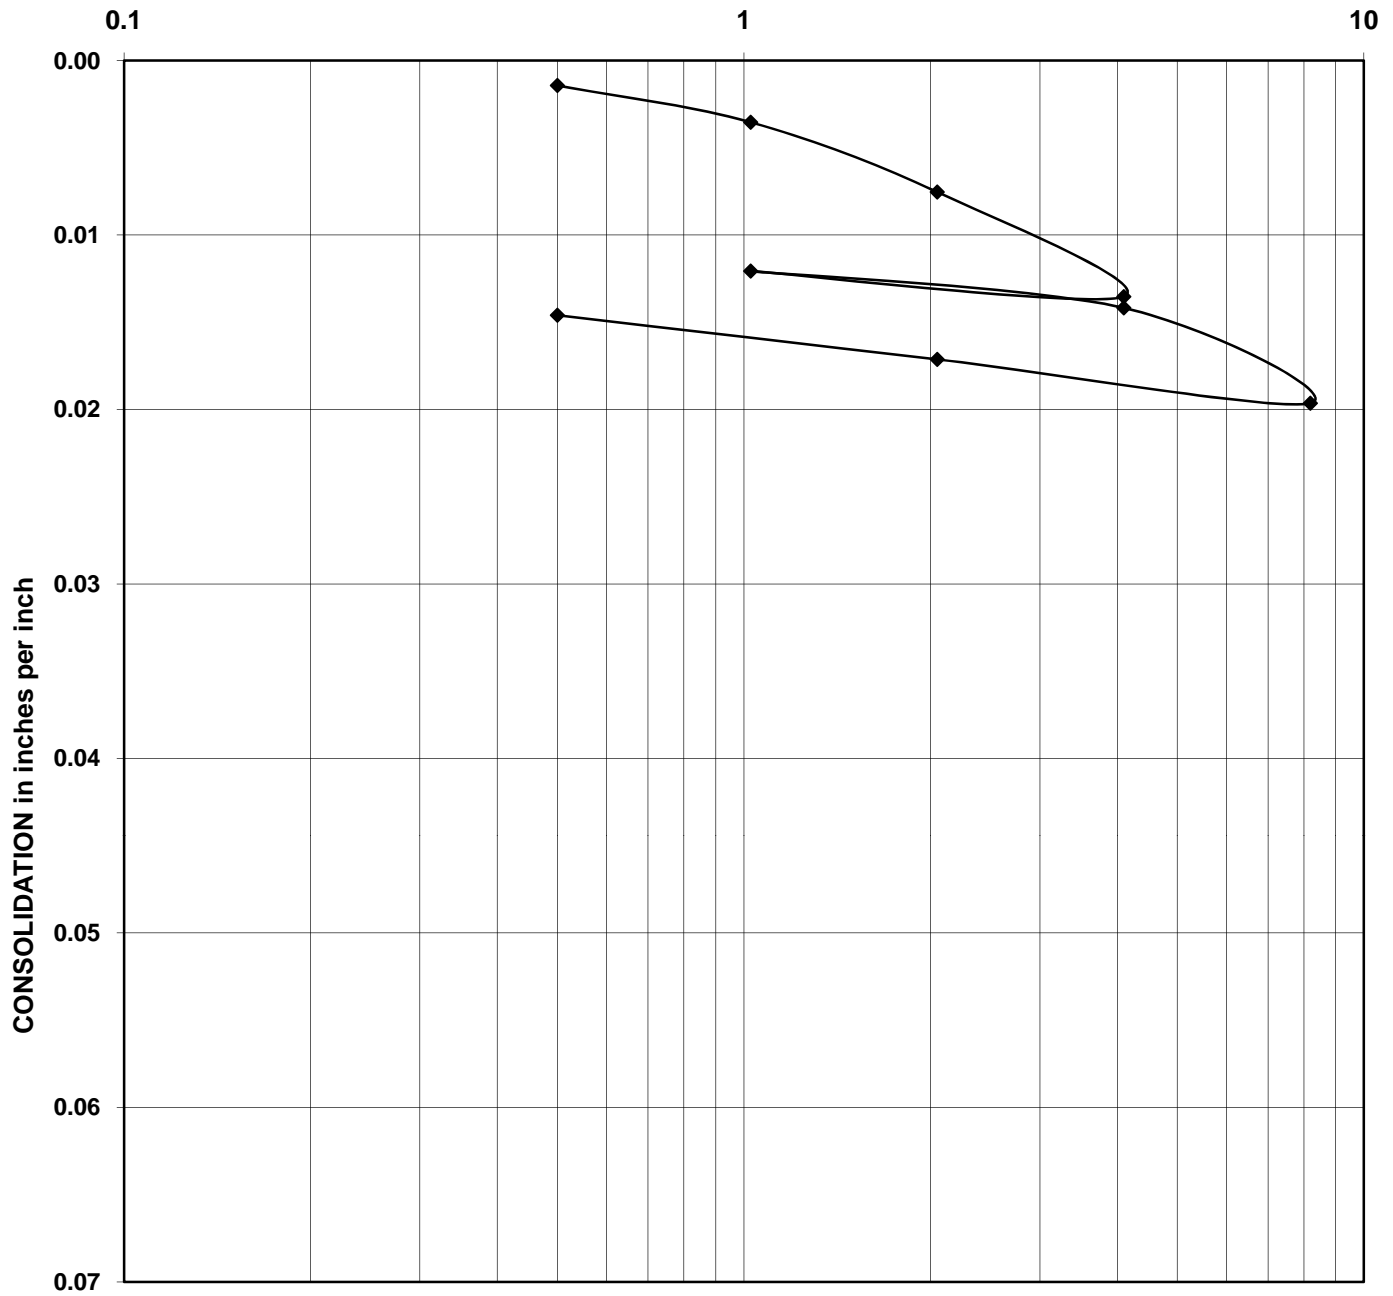
Note: Sample tested at field moisture content.
