**Historical Resources Technical Report  
for the  
North City Project  
San Diego County, California  
City Project No. 386038  
PTS #499621**

**Type of Study:** Historical Resources Inventory

**Historical Resources Technical Report  
for the North City Project, San Diego County, California**

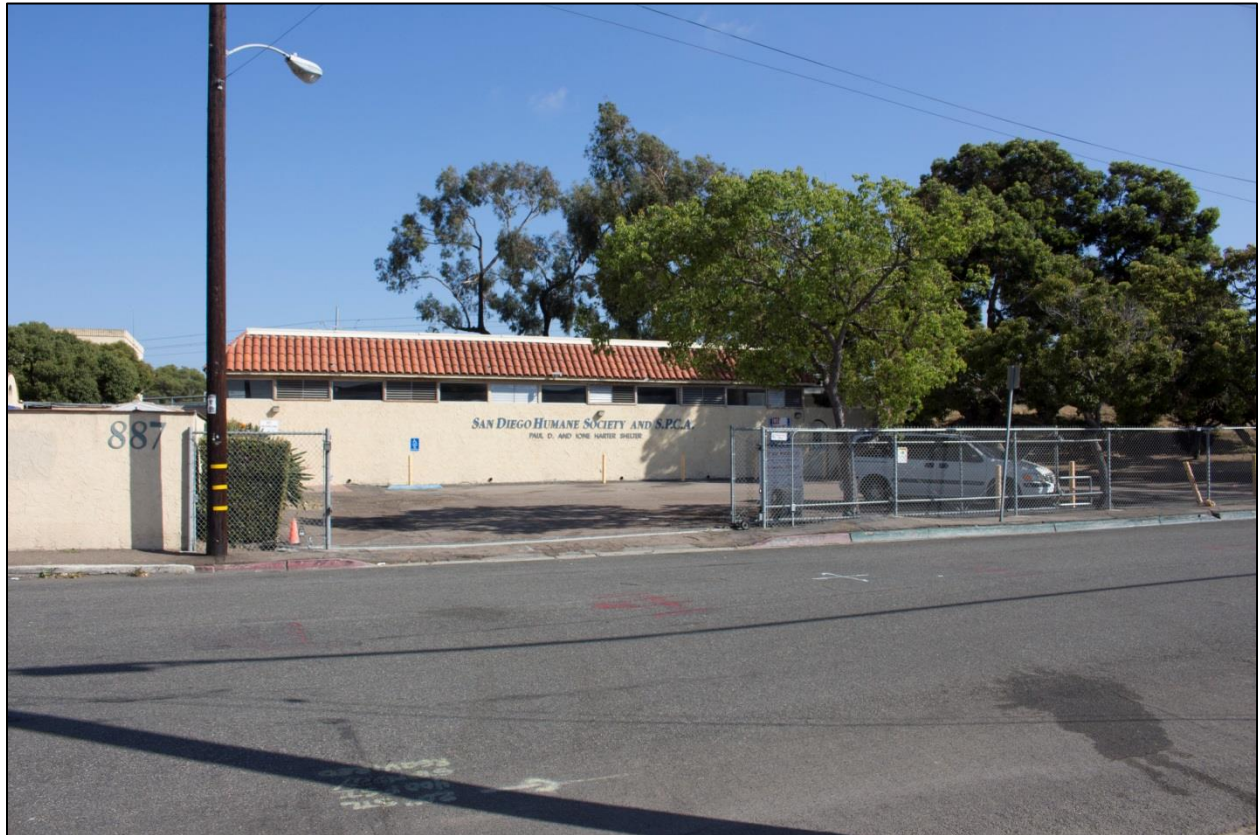
**Figure 5. Public entrance to the Humane Society, main elevation;  
view south from Sherman Street  
(Photo credit: Dudek).**

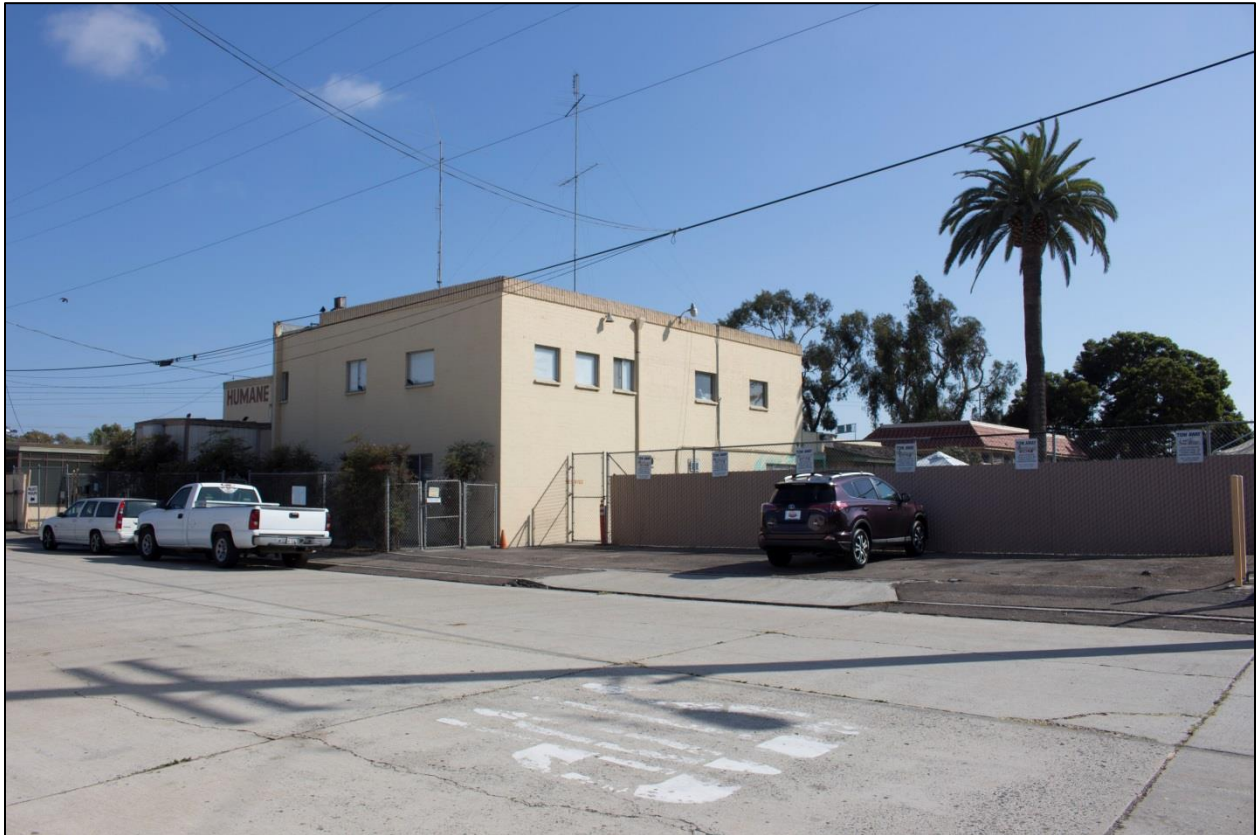
**Figure 7. View of the main and east elevations; looking southwest from the intersection of Custer Street with Sherman Street (Photo credit: Dudek).**

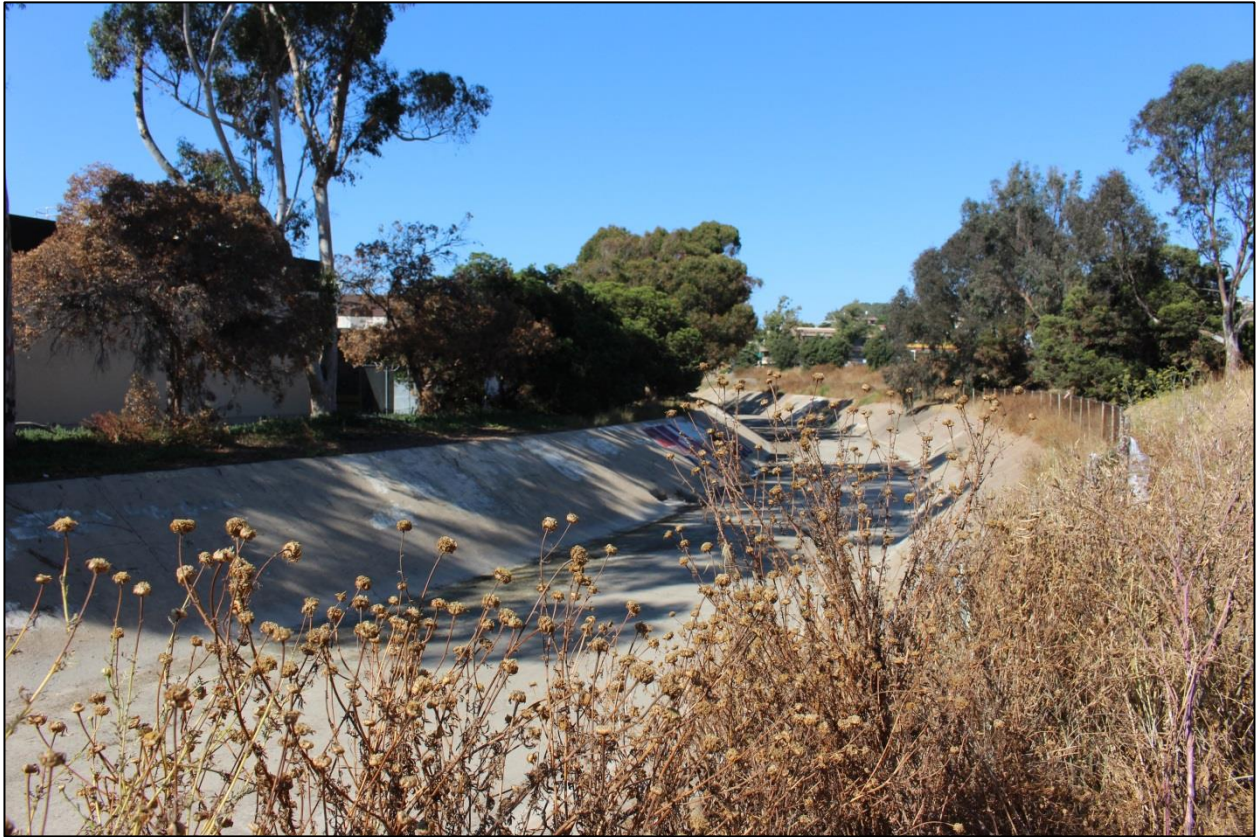
**Figure 11. View of the Tecolote Creek concrete channel, looking east-northeast from W. Morena Boulevard at a point just north of Tecolote Road (Photo credit: Dudek).**

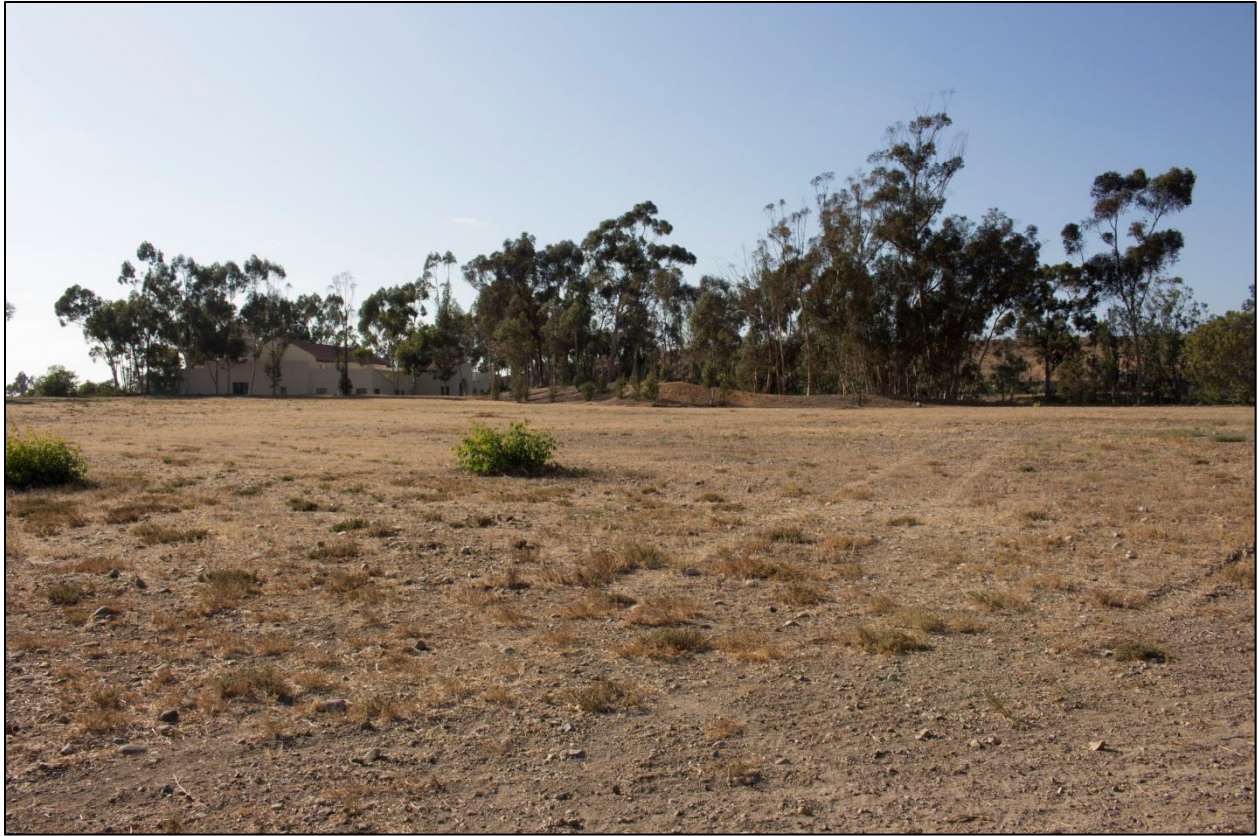
**Figure 13. View of the Scripps Meanley stables and house property, looking north-northeast; from left to right: Scripps Miramar Ranch Library, dirt road embankment (supported by the stone wall to the north), and former location of the stables and attendant outbuildings; Evan's Pond lies beyond (Photo credit: Dudek).**

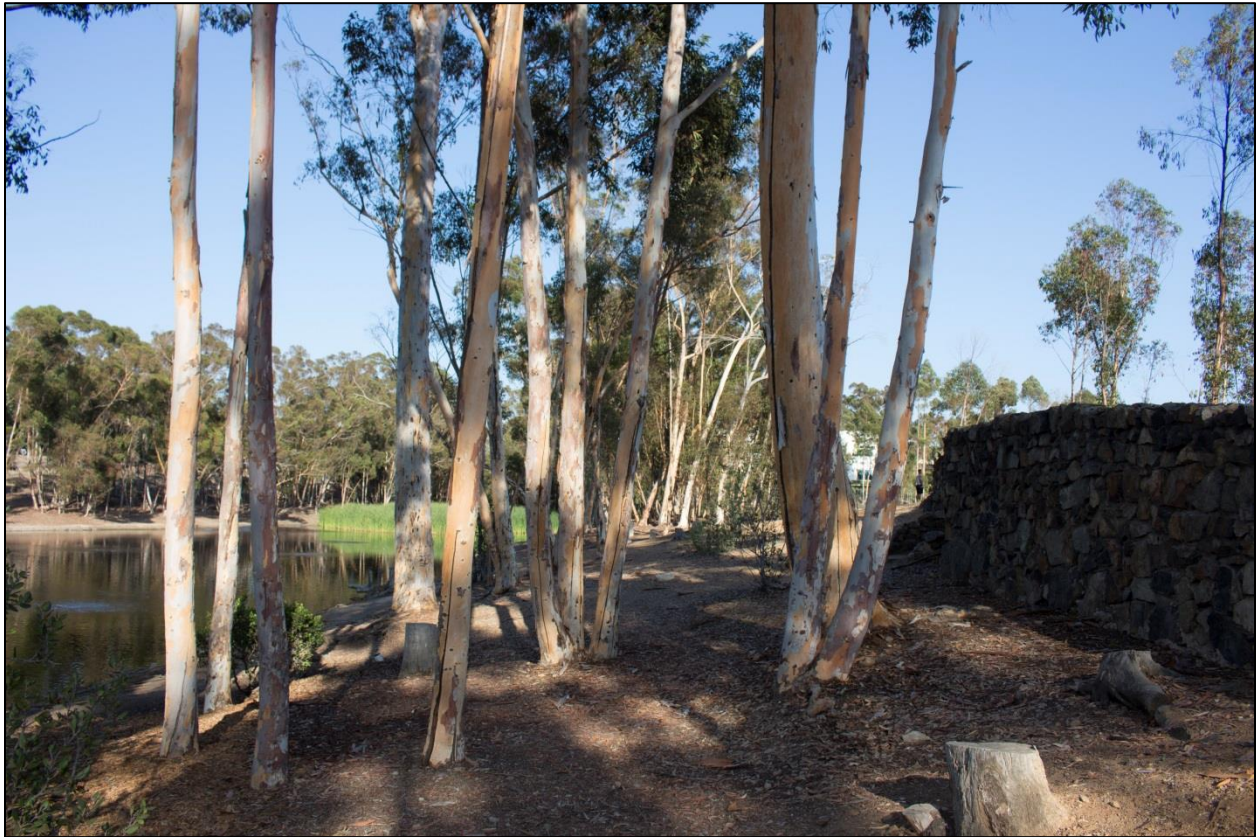
**Figure 14. View of the stone wall and Evan's Pond, looking east-southeast  
(Photo credit: Dudek).**

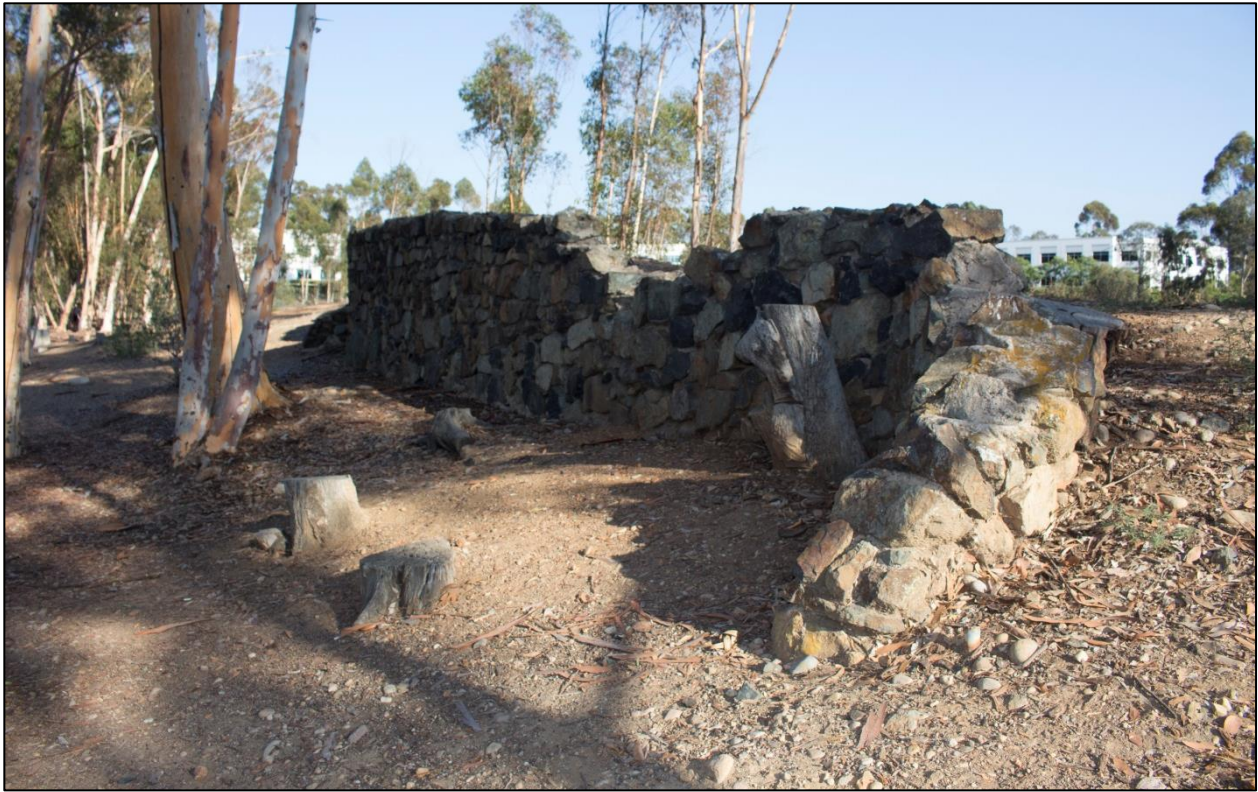
**Figure 15. View of the stone wall showing missing portions, looking east-southeast  
(Photo credit: Dudek).**

The current survey revisited the site and found it to be in relatively the same condition as recorded in 2000. A site survey conducted on August 27, 2016, documented the existing conditions of the three remaining built historical resources. The tree-lined dirt drive and Evan’s Pond are intact and in good condition. However, the stone wall is in fair to poor condition. Sections along the top edge and sporadic cobbles are missing, and, despite evidence of previous mortar repair campaigns, numerous cracks (some quite large) are evident (Figures 15 through 19).

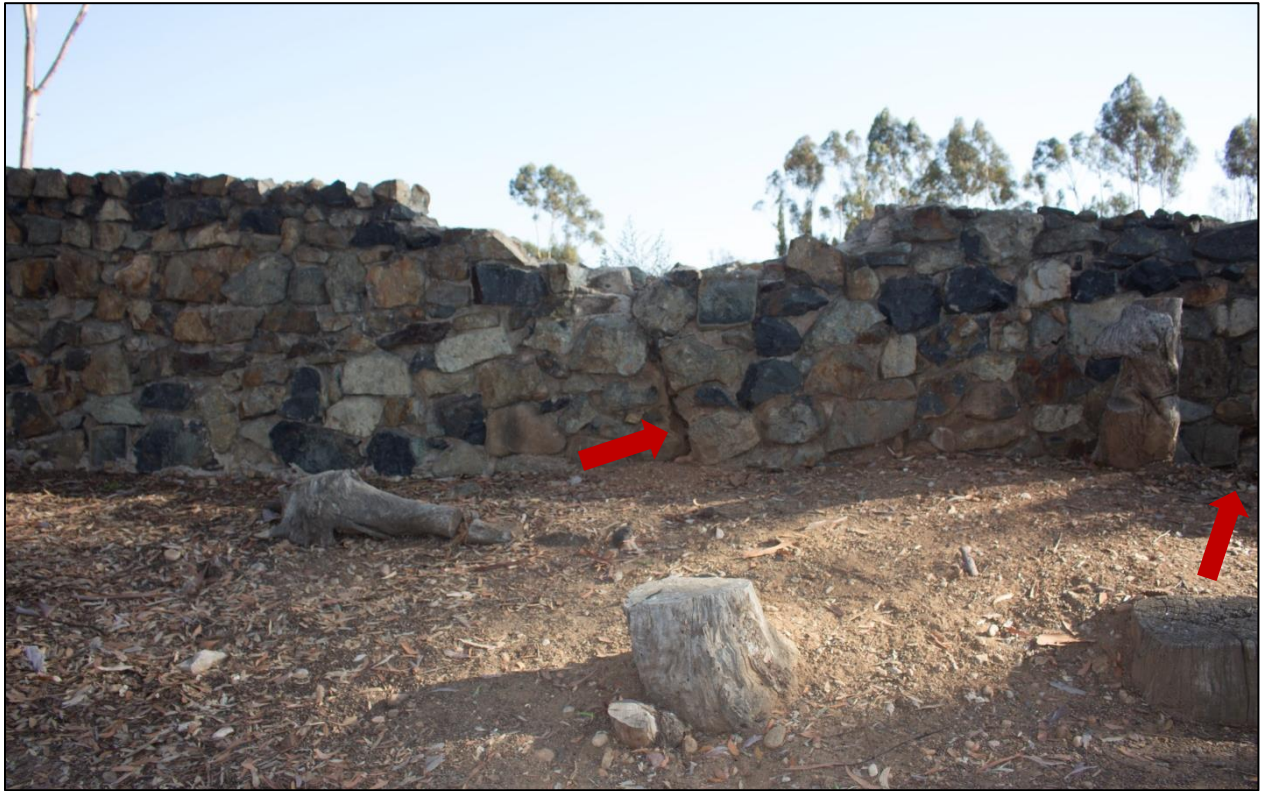
**Figure 16. View of wall section showing missing portions and cracks (red arrows)  
(Photo credit: Dudek).**

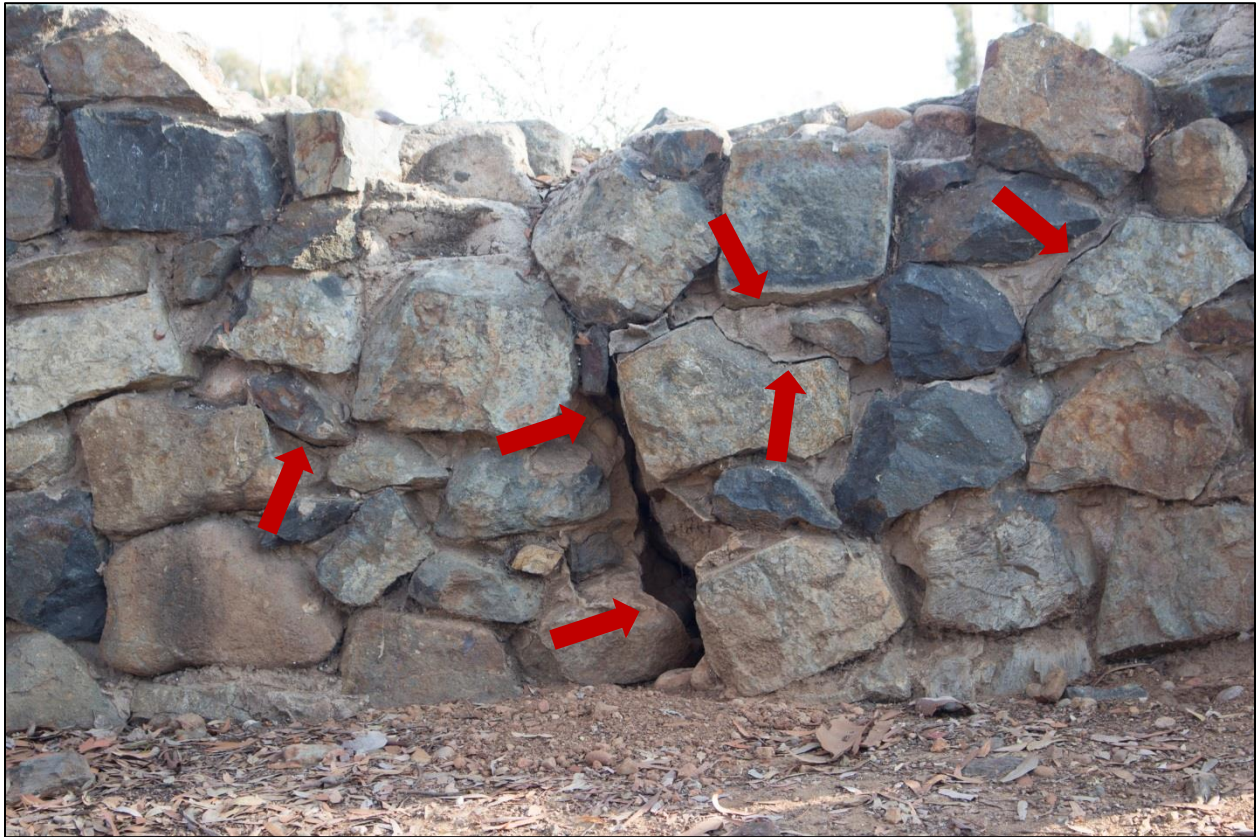
**Figure 17. Detail view of above wall section showing missing portions and cracks (red arrows)  
(Photo credit: Dudek).**

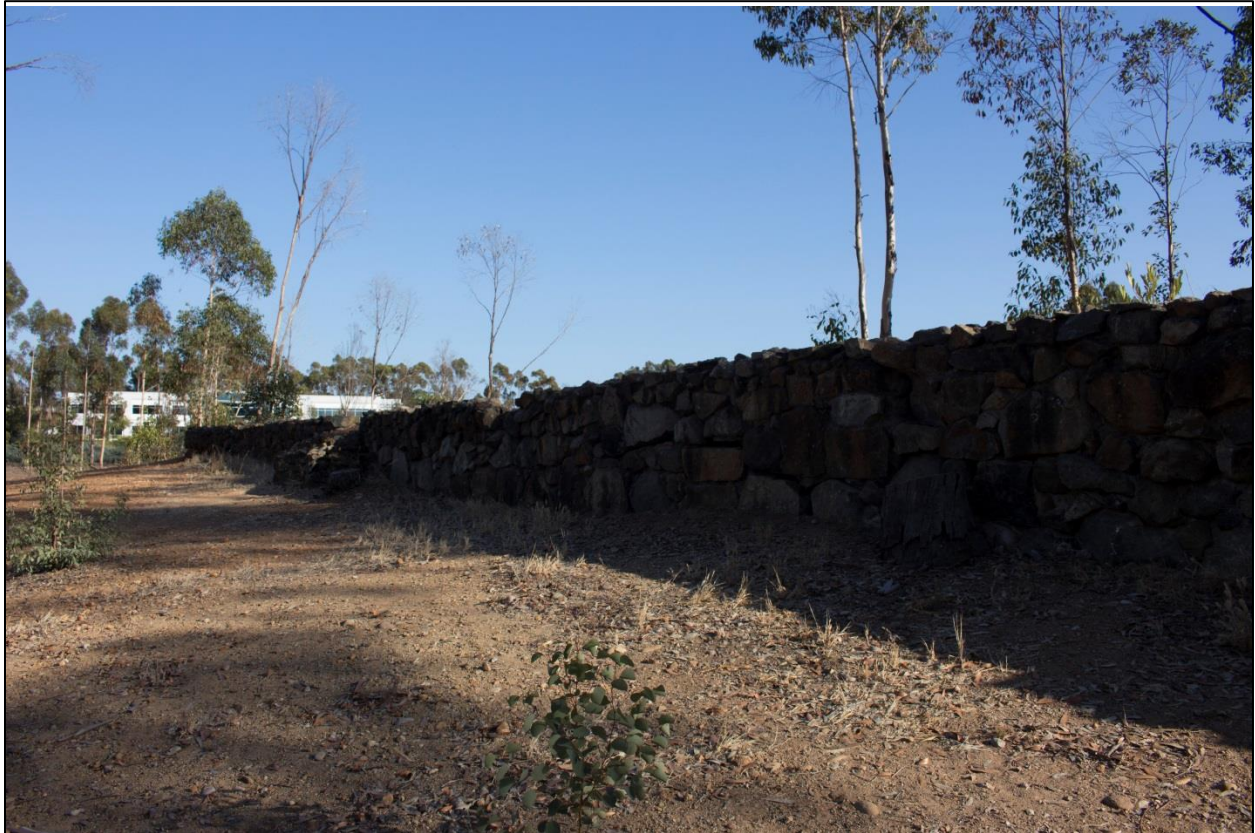
**Figure 18. Length of wall; notice the large crack near center-right of the picture  
(Photo credit: Dudek).**

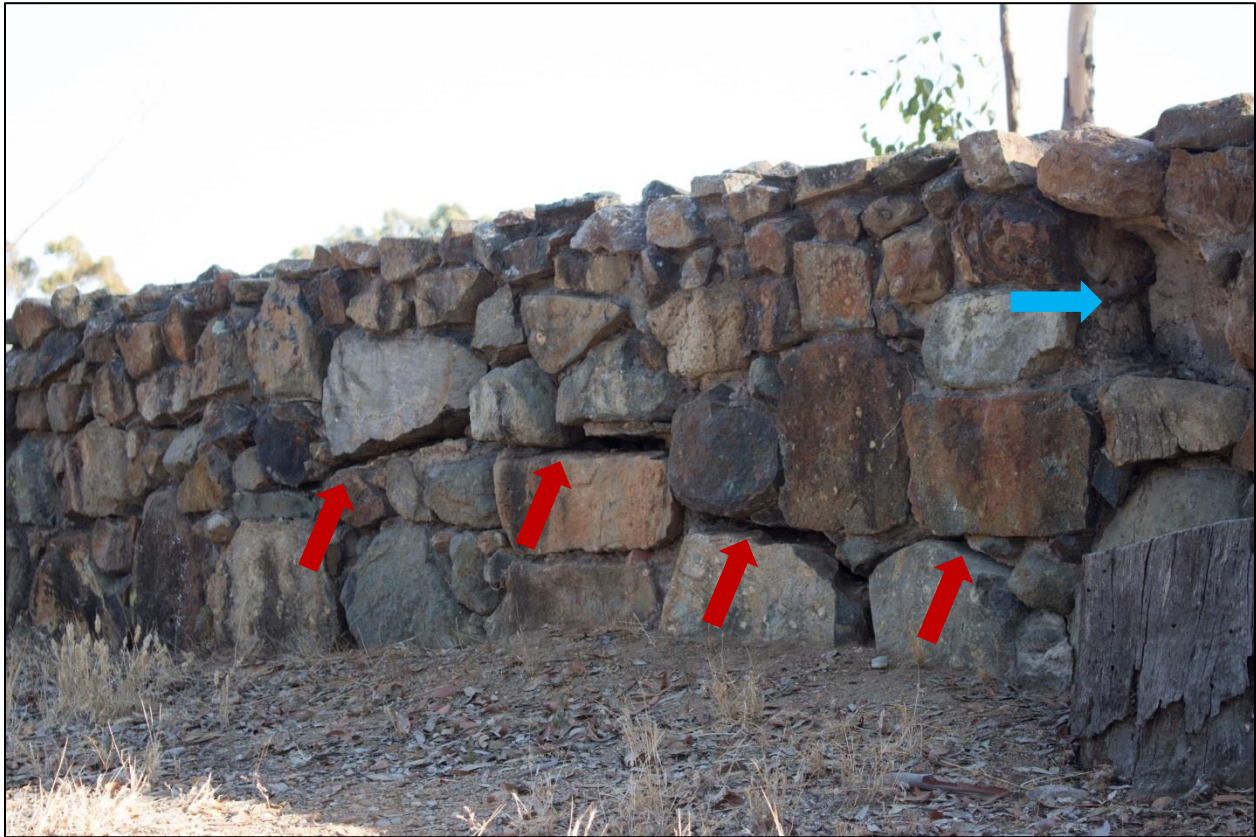
**Figure 19. Detail view of above wall section showing large crack (red arrows) and a missing cobblestone (blue arrow) (Photo credit: Dudek).**

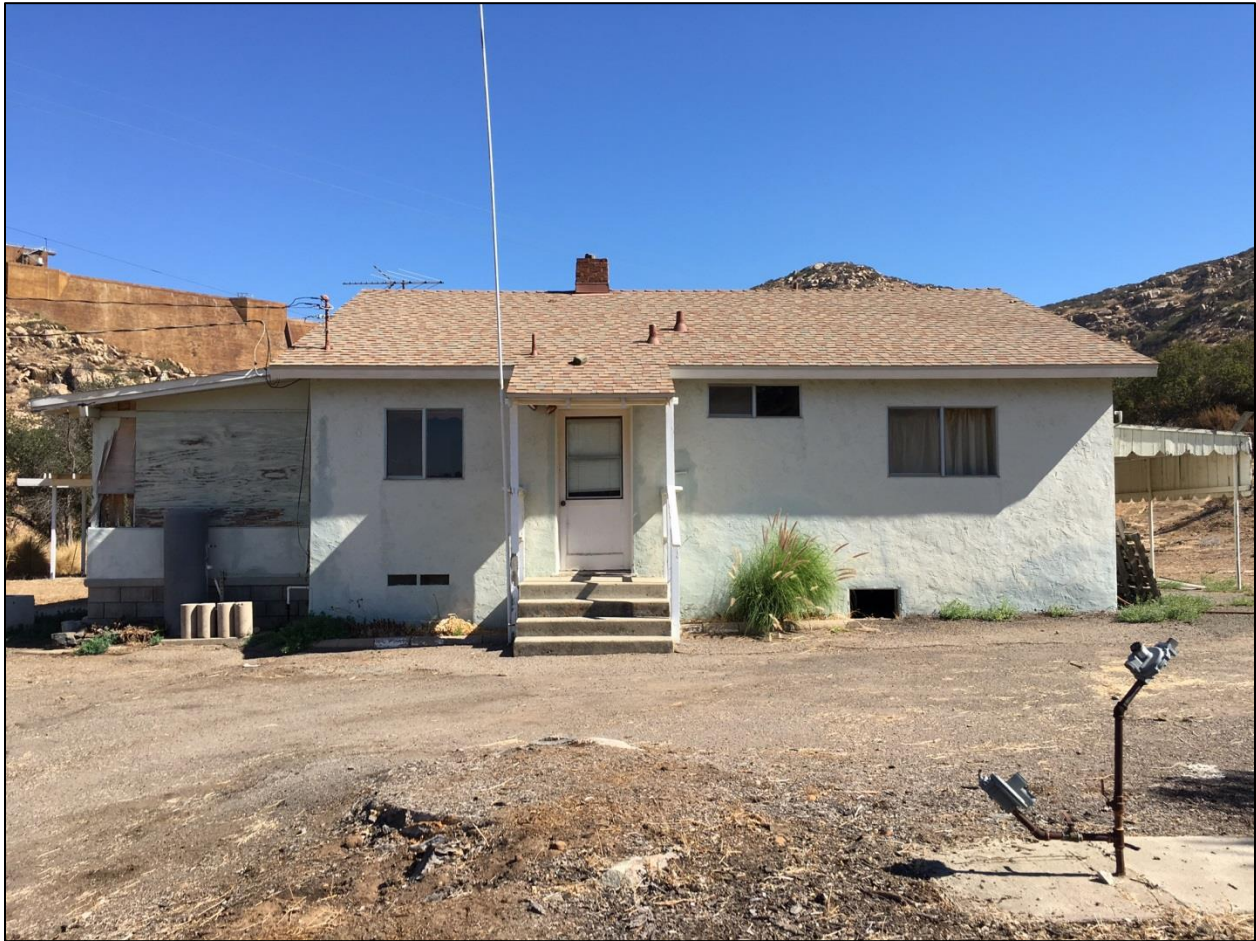
**Figure 20. View of the southwest (main) elevation; note the two additions and the proximity to the San Vicente Reservoir dam (Photo credit: Dudek).**

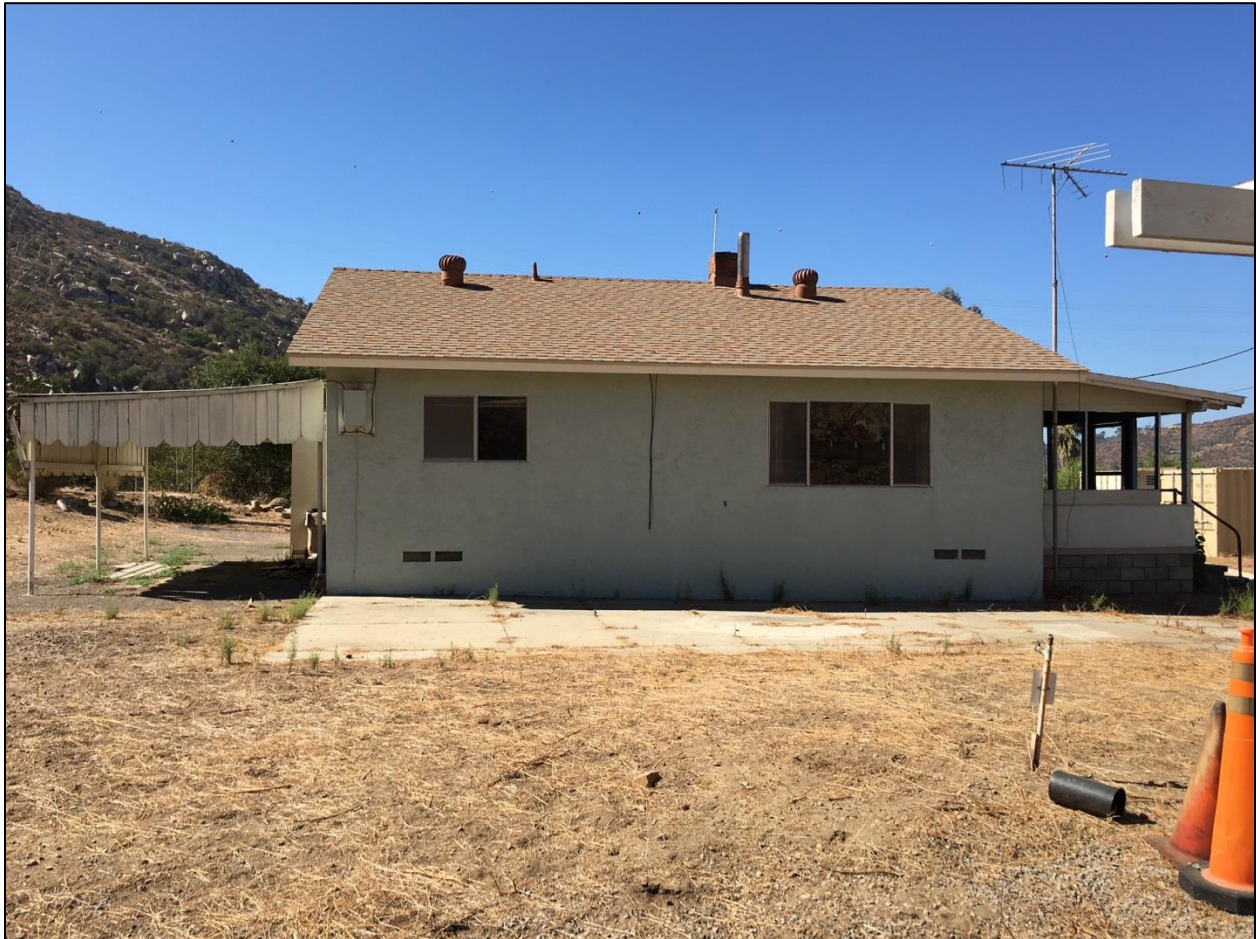
**Figure 22. View of the northeast elevation; note the carport addition on the left (south) and the enclosed patio addition on the right (north)  
(Photo credit: Dudek).**

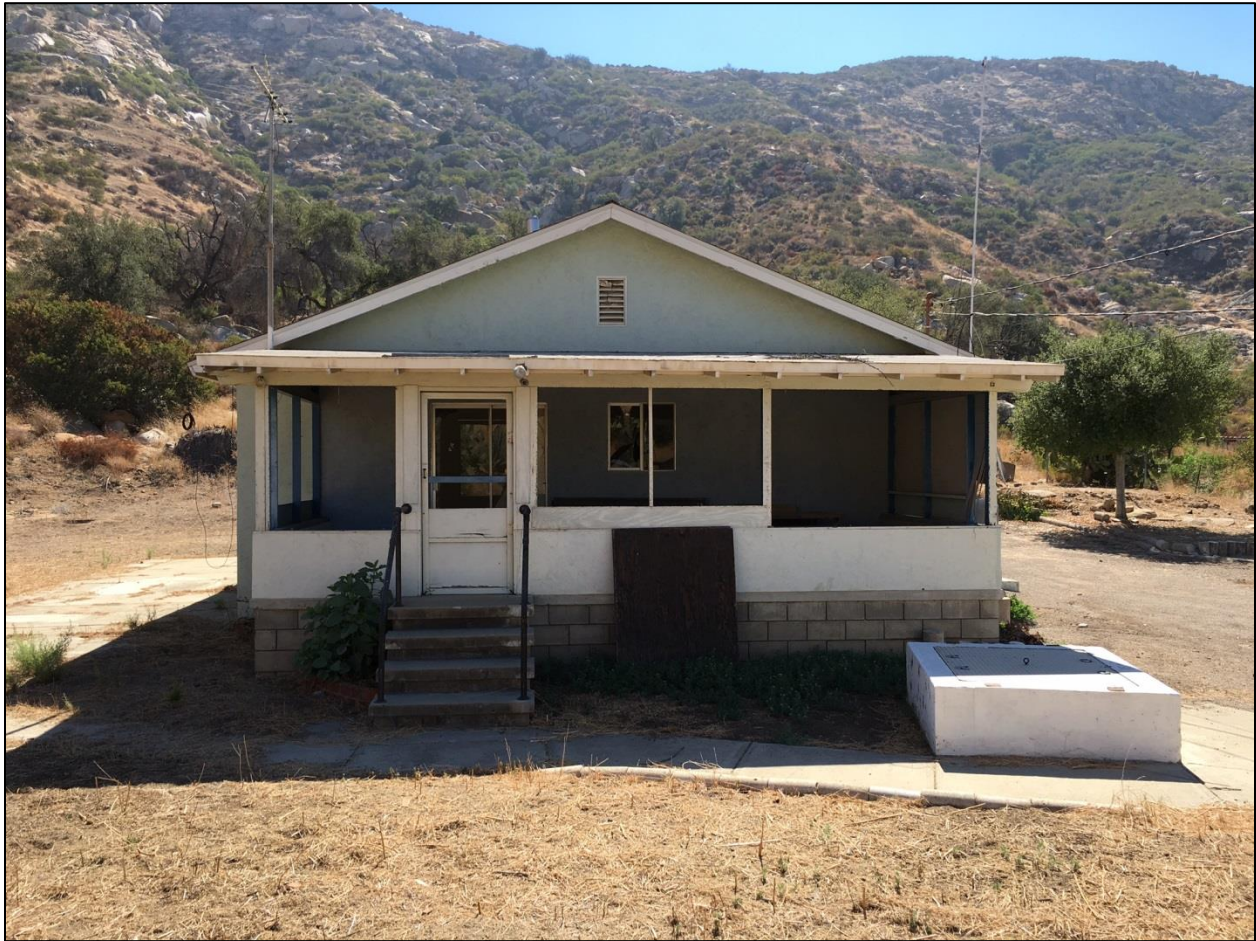
**Figure 23. View of the northwest elevation, with the full-width enclosed patio addition  
(Photo credit: Dudek).**

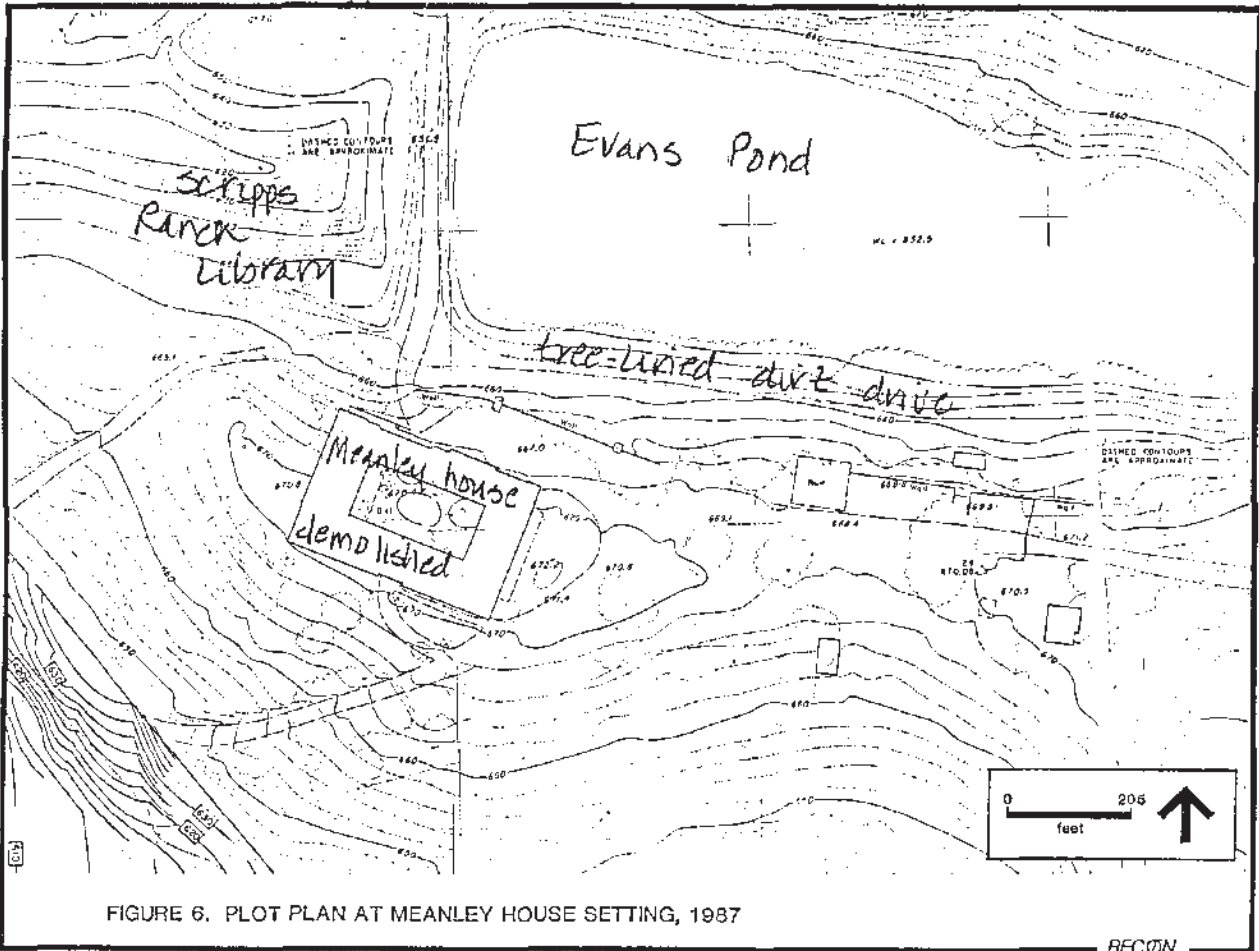
FIGURE 6. PLOT PLAN AT MEANLEY HOUSE SETTING, 1987

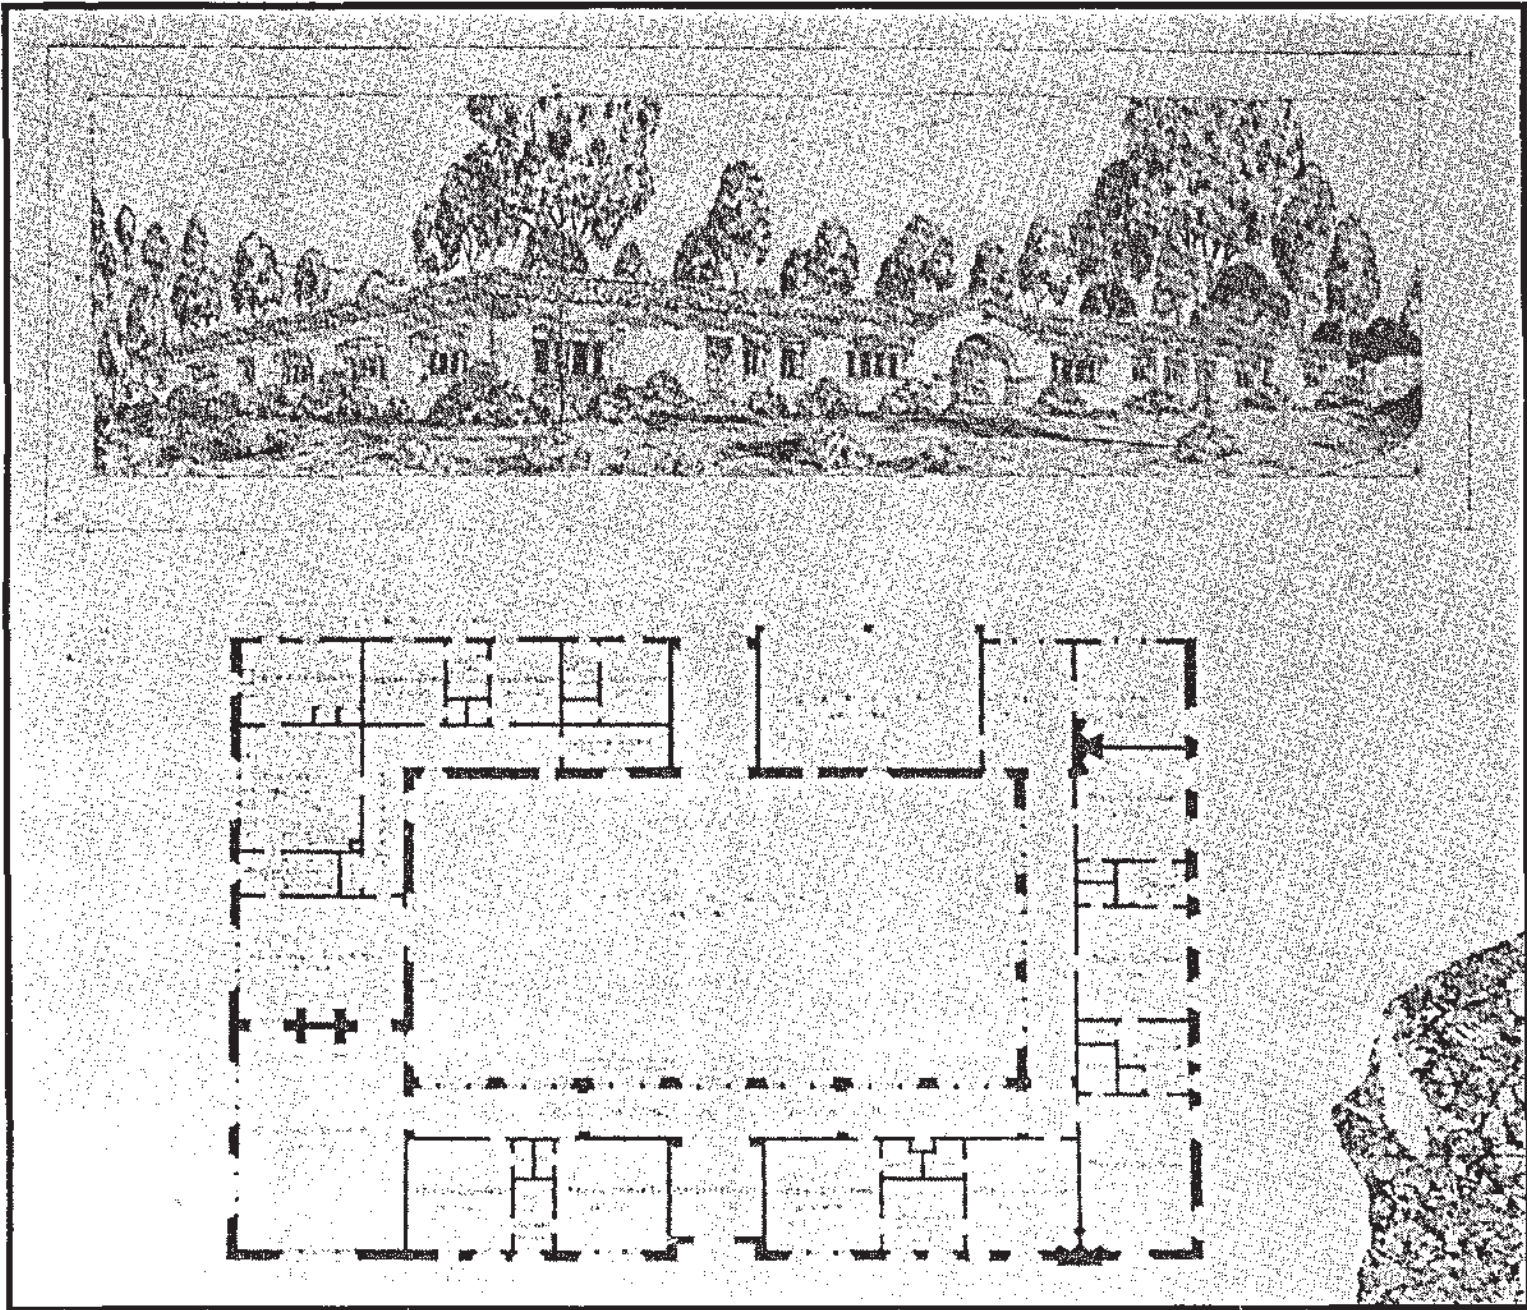
The Meanley home was designed as a single-story, four-wing, rectangular structure measuring 92 feet north-south by 140 feet east-west. The courtyard measures 44 feet north-south by 86 feet east-west. The courtyard originally had a small cement pool in the center. Mrs. Meanley placed a small bronze statue of her son Edward as a two-year-old on the east end of the pool. All major rooms opened upon the courtyard, either directly or by way of a common corridor that ran along the interior side of the south and east wings. Access from the courtyard was gained through large, arched glass doors with wooden frames. The courtyard was originally landscaped with a variety of trees, flowering shrubs, and trellised vines. The four-wing rectangular floor plan with rooms opening upon a central courtyard is drawn directly from Mexican-period California adobes and is also highly reminiscent of many mission complexes that were constructed around interior gardens (Gleye et al. 1981:13-47). The use of a series of arches opening onto the courtyard was developed by California architect Irving Gill between 1910 and 1920 (Gill 1914) (Figures 8-10).

FIGURE 8. FLOORPLAN AND SOUTHWEST ELEVATION OF THE MEANLEY HOUSE
