## CHAPTER 4 - NON-PROCESS FACILITIES

### 4.2 WASTEWATER PUMPING SYSTEM (N-1)

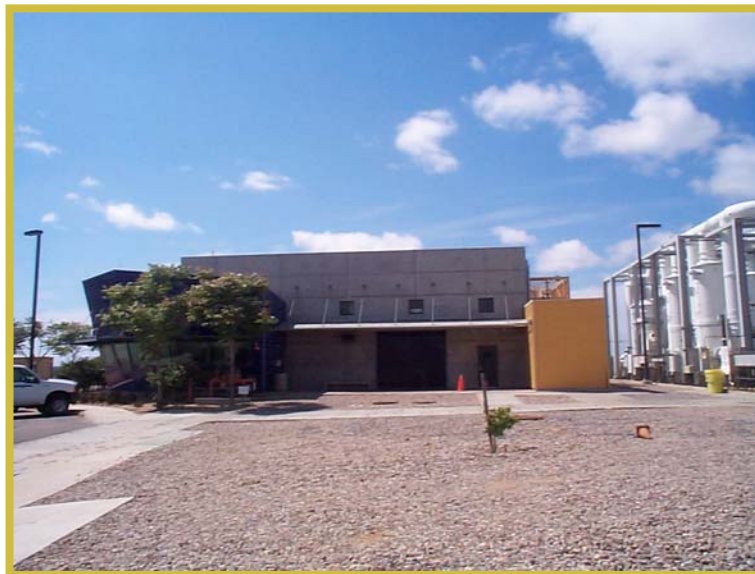
*Undersized PS 86:* Muni-PS86, equipped with two 800 gpm pumps (1 duty and 1 spare), was designed and constructed based on a projected ultimate flow of only 520 gpm from area subdivisions. Based on current area inflow this allows the WWPS to discharge at only 280 gpm, less than that sent now at 350 gpm and significantly less than the projected peak flow of 1,200 gpm from the MBC WWPS.

With the limited capacity of PS86, overflows from the WWPS into the centrate wetwell occur. The overflows distort the actual centrate flow sent to PLWTP which impacts the regulatory OPRA mass emission rate accounting required from the City. Overall, any future increase in the hydraulic and solids loading or expansion of facilities at MBC will increase the wastewater volume and exacerbate these present pumping and spill problems.

WASTEWATER PUMP STATION

The WWPS still cannot fully handle the projected WW discharges. It is recommended that the pump capacity be increased and that a bypass for PS86 is constructed.

Due to the depth of the Muni PS86 wetwell, there is no plan to increase its pumping capacity so that it can send the combined area inflows and MBC wastewater flows to PLWTP. Alternatively, a diversion pipe has been proposed that will divert pumped MBC wastewater via a new 8-inch forcemain directly to the 15-inch diameter gravity trunk sewer main at Clairemont Mesa Boulevard. The Muni PS86 dual forcemains presently discharge to this gravity sewer main.

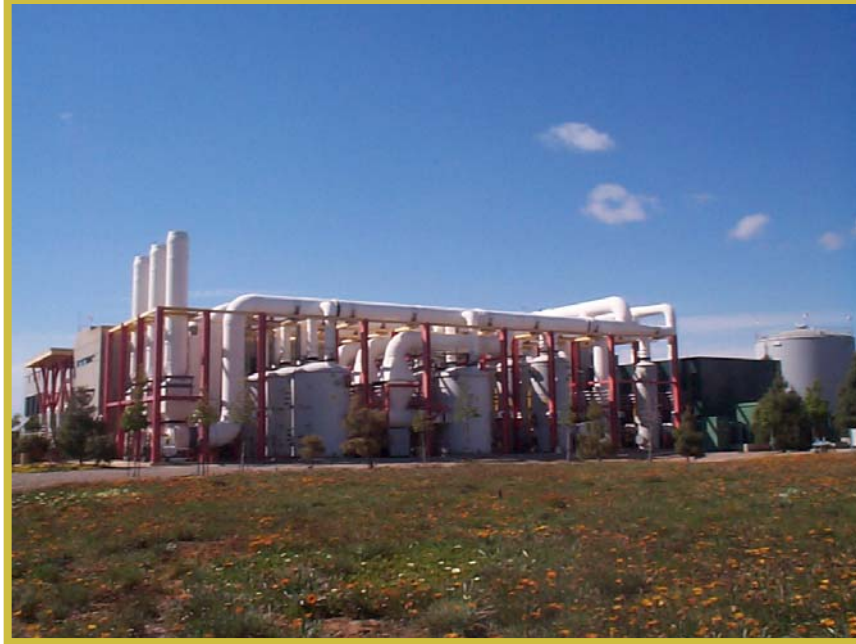
ODOR CONTROL FACILITY

- a. *High system pressure/under capacity fans*: Odor control fans are operating under higher total static pressures than anticipated by the design, thereby exhausting and treating less volume of foul air than needed at the facilities and resulting in the fans being under capacity.
- b. *Inaccessible dampers*: In Areas 94 and 60, there is very limited or no access to repair motorized dampers at upper levels or to verify their damper positions including instrumentation status. Based on air flow measurement, most dampers are suspected of not fully opening or closing.
- c. *Moisture in the foul air stream*. There is difficulty in removing moisture from ducts, fans and carbon scrubber vessels due to inadequate negative pressure throughout the system (because the main OC fan is located downstream vs. upstream in the OC train).

Moisture carryover from chemical scrubbers has also resulted in loss of capacity by the carbon scrubbers. It was also observed that loss of capacity is caused by backflows through OCS units that are out of service.

1. Area 60:
  - a. The capacity of the main odor control fans needs to be upgraded and the causes of the increased resistance to air flow in the ducts need to be identified and addressed.
  - b. Provide maintenance access to the motorized dampers and provide visual position indicators for all dampers.

- c. Remove excess moisture from odor control ducts by providing a deep (greater than 17 inches) in-line sump and gravity drain line prior to the carbon scrubbers. The location of the main foul air exhaust fans within the OC trains needs to be reviewed. Relocation to the upstream side may increase negative pressure in the system to prevent moisture collection.

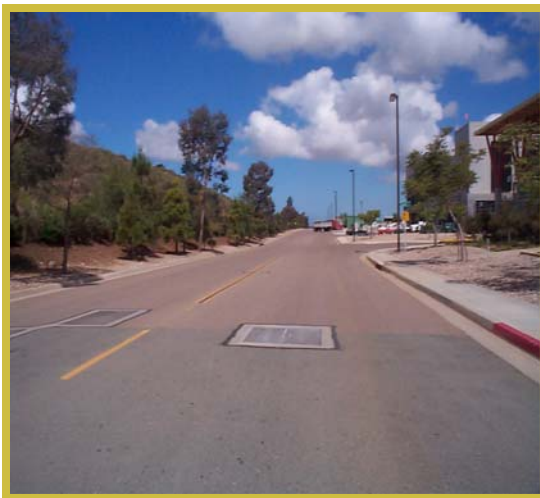
1. *Ground erosion at the West Drainage Structure.* Due to its steep slope, the downstream area is subject to severe erosion during discharges.
2. *Accidental wastewater and chemical spills:* Several process areas can directly discharge wastewater, biosolids or chemicals into the storm drains. These areas include the roof of the digesters and the blending tanks, the truck loadouts and the chemical storage tanks. By design, these unwanted materials can and do get flushed into the storm drain system.
3. *Access road erosion:* Due to poor CALTRANS drainage provisions, MBC's main access road is gradually being eroded during heavy rain events.

BIOSOLIDS RD

1. Elimination of the West Drainage Structure is part of a consultant's design project that has been recently completed. This project which revised MBC's stormwater drainage system is ready for construction.
2. Area grading will be revised to have all drainage directed to the East Drainage Structure. A diversion gate, a 10,000 gallon concrete holding tank and a return pump

station will be constructed to capture any spilled wastewater or chemicals and prevent them from entering the nearby creek.

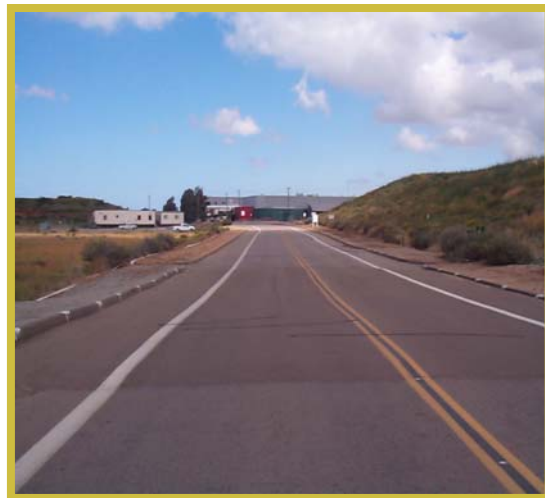
MBC ACCESS ROAD

3. Drainage improvements to intercept and redirect stormwater away from the access road needs to be constructed.
