## CHAPTER 4 - NON-PROCESS FACILITIES

### 4.2 WASTEWATER PUMPING SYSTEM (N-1)

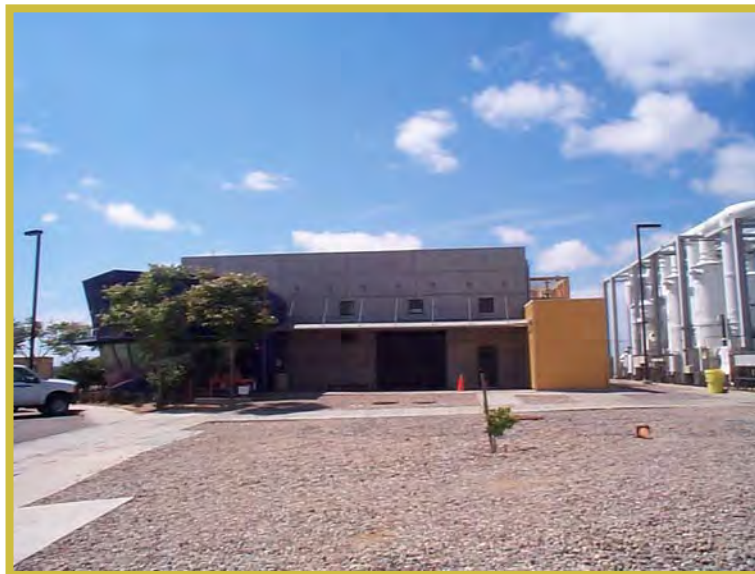
WASTEWATER PUMP STATION

*Undersized PS 86:* Muni-PS86, equipped with two 800 gpm pumps (1 duty and 1 spare), was designed and constructed based on a projected ultimate flow of only 520 gpm from area subdivisions. Based on current area inflow this allows the WWPS to discharge at only 280 gpm, less than that sent now at 350 gpm and significantly less than the projected peak flow of 1,200 gpm from the MBC WWPS.

With the limited capacity of PS86, overflows from the WWPS into the centrate wetwell occur. The overflows distort the actual centrate flow sent to PLWTP which impacts the regulatory OPRA mass emission rate accounting required from the City. Overall, any future increase in the hydraulic and solids loading or expansion of facilities at MBC will increase the wastewater volume and exacerbate these present pumping and spill problems.

The WWPS still cannot fully handle the projected WW discharges. It is recommended that the pump capacity be increased and that a bypass for PS86 is constructed.

Due to the depth of the Muni PS86 wetwell, there is no plan to increase its pumping capacity so that it can send the combined area inflows and MBC wastewater flows to PLWTP. Alternatively, a diversion pipe has been proposed that will divert pumped MBC wastewater via a new 8-inch forcemain directly to the 15-inch diameter gravity trunk sewer main at Clairemont Mesa Boulevard. The Muni PS86 dual forcemains presently discharge to this gravity sewer main.

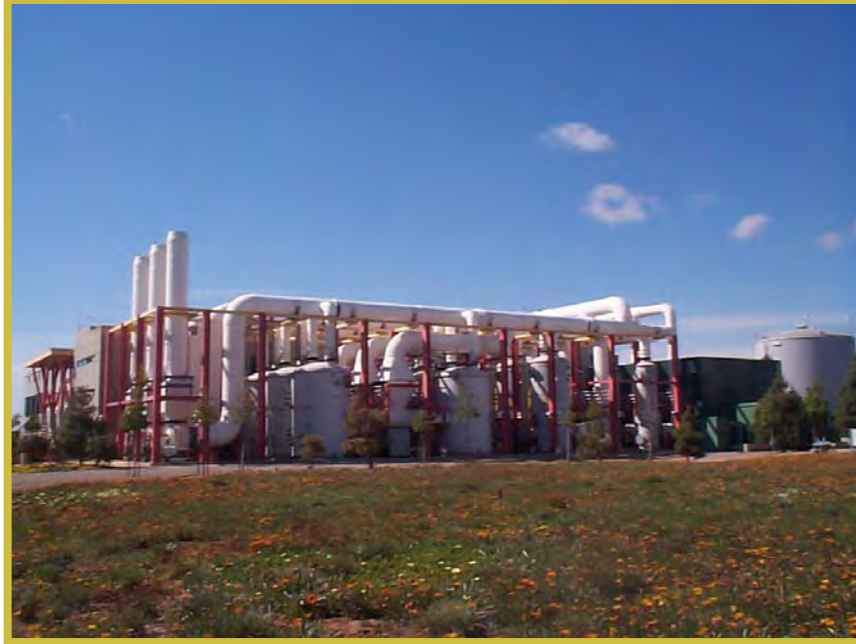
ODOR CONTROL FACILITY

The foul air from the process facilities is collected and conveyed by fans and fiberglass ducting to the Odor Control (OC) Facility in Area 60-Chemical Building. The Odor Control Facility consists of three treatment trains (2 duty and one standby), each train providing two- or three-stage treatment depending on the foul air source. All of the foul air drawn from Areas 73, 76, 80 and 86 (designed at 52,000 total cfm, the actual flow is lower) goes through packed-bed hydrogen sulfide chemical scrubbers, then through the carbon adsorption scrubbers and is finally discharged to the atmosphere through vertical stacks by fans. A total of 16,000 cfm of foul air is drawn from post-digestion areas is first treated by an ammonia scrubber before being sent to the hydrogen sulfide chemical and carbon scrubbers. The chemical scrubbers remove about 80 percent of the odor while the carbon adsorption units polish the foul air-stream to about 95 percent odor-free level.

Brown and Caldwell's evaluation of hydrogen sulfide readings concluded that the chemical scrubbers in Area 94 can be bypassed with minimal effect on treatment efficiency. Bypassing of the chemical scrubbers was recommended as part of the MBC OC facilities improvement project. The APCD has allowed MBC to temporarily bypass the chemical scrubbers.

- a. *High system pressure/under capacity fans*: Odor control fans are operating under higher total static pressures than anticipated by the design, thereby exhausting and treating less volume of foul air than needed at the facilities and resulting in the fans being under capacity.
- b. *Inaccessible dampers*: In Areas 94 and 60, there is very limited or no access to repair motorized dampers at upper levels or to verify their damper positions including instrumentation status. Based on air flow measurement, most dampers are suspected of not fully opening or closing.
- c. *Moisture in the foul air stream*. There is difficulty in removing moisture from ducts, fans and carbon scrubber vessels due to inadequate negative pressure throughout the system (because the main OC fan is located downstream vs. upstream in the OC train).

Moisture carryover from chemical scrubbers has also resulted in loss of capacity by the carbon scrubbers. It was also observed that loss of capacity is caused by backflows through OCS units that are out of service.

1. Area 60:
  - a. The capacity of the main odor control fans needs to be upgraded and the causes of the increased resistance to air flow in the ducts need to be identified and addressed.
  - b. Provide maintenance access to the motorized dampers and provide visual position indicators for all dampers.

- c. Remove excess moisture from odor control ducts by providing a deep (greater than 17 inches) in-line sump and gravity drain line prior to the carbon scrubbers. The location of the main foul air exhaust fans within the OC trains needs to be reviewed. Relocation to the upstream side may increase negative pressure in the system to prevent moisture collection.

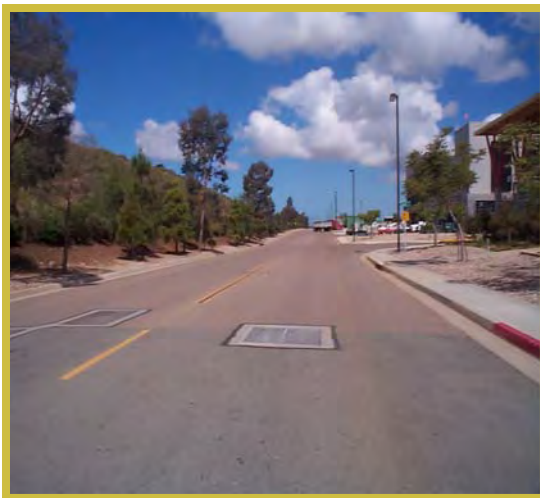
BIOSOLIDS RD

1. *Ground erosion at the West Drainage Structure.* Due to its steep slope, the downstream area is subject to severe erosion during discharges.
2. *Accidental wastewater and chemical spills:* Several process areas can directly discharge wastewater, biosolids or chemicals into the storm drains. These areas include the roof of the digesters and the blending tanks, the truck loadouts and the chemical storage tanks. By design, these unwanted materials can and do get flushed into the storm drain system.
3. *Access road erosion:* Due to poor CALTRANS drainage provisions, MBC's main access road is gradually being eroded during heavy rain events.

3. Drainage improvements to intercept and redirect stormwater away from the access road needs to be constructed.
