PRIMARY RECORD

* Resource Name or #: 3203 Belle Isle Drive, APN 476-242-23

BUILDING, STRUCTURE, AND OBJECT RECORD

ISLENAIR HISTORICAL DISTRICT

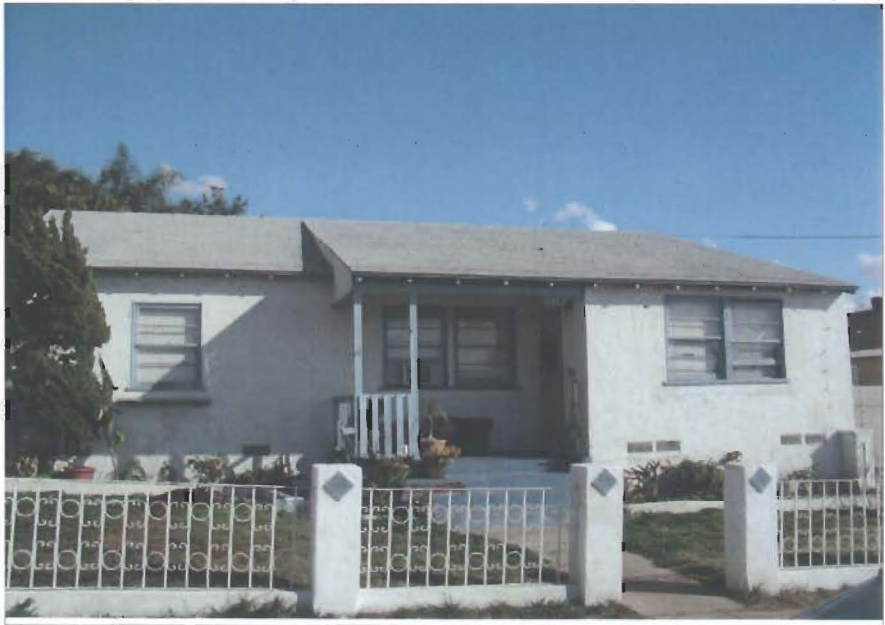
P5a. Photograph or Drawing (Photograph required for buildings, structures, and objects)

* P3a. Description: (Describe resource and its major elements. Include design, materials, condition, alterations, size, setting, and boundaries.)
The house at 3203 Belle Isle Drive was built in 1947 in the Minimal Traditional style and features a low-pitch side gable roof with composition shingles; slight eave overhang; exposed rafter tails; and a moderately textured stucco exterior. The porch, which is accessed by four concrete steps, is centered on the house and supported by two 4x4 wood posts. The entry door is set perpendicular to the street. Fenestration consists of 2-over-2 double hung wood frame and sash windows. The yard is enclosed with a 3-foot high wrought iron fence between stucco posts with tile detailing. Refer to BSOR Section B.6. for modifications and analysis of integrity.

Photo of the primary façade from the public right-of-way.

The house was built in 1947 per water and sewer connection records. Modifications include the use of moderately textured stucco; the use of a wrought iron security door; and the replacement of the composition roof with a new composition roof. The house is in good condition and retains a good to fair degree of integrity.

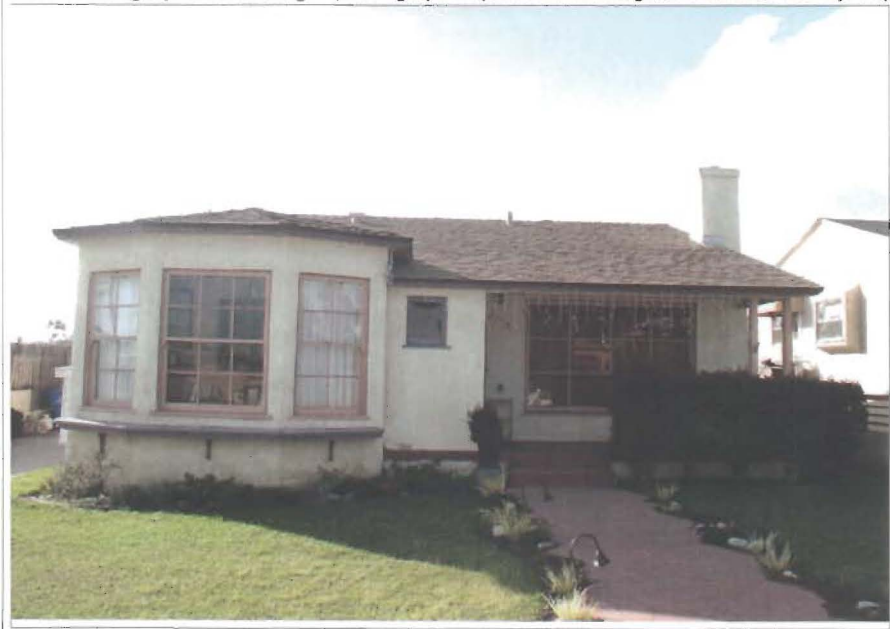
P5a. Photograph or Drawing (Photograph required for buildings, structures, and objects)

* P3a. Description: (Describe resource and its major elements. Include design, materials, condition, alterations, size, setting, and boundaries.)
The house at 3204 Belle Isle Drive was built in 1937 in the Minimal Traditional style and features a side gable roof with composition shingles; a slight eave overhang; a moderately textured stucco exterior; and a chimney at the side. The left hand side of the house features a hexagonal bay with a 6-over-6 double hung wood frame and sash window flanked by 4-over-4 double hung wood frame and sash windows. The entry porch, accessed by two concrete steps and supported by two 4x4 wood posts, is set to the right and includes a large 12-pane fixed window and an entry door set perpendicularly to the sidewalk. Refer to BSOR Section B.6. for modifications and analysis of integrity.

Photo of the primary façade from the public right-of-way.

The house was built in 1937 per water and sewer connection records. Modifications include the use of moderately textured stucco and the replacement of the composition roof with a new composition roof. The house is in good condition and retains a good to fair degree of integrity.

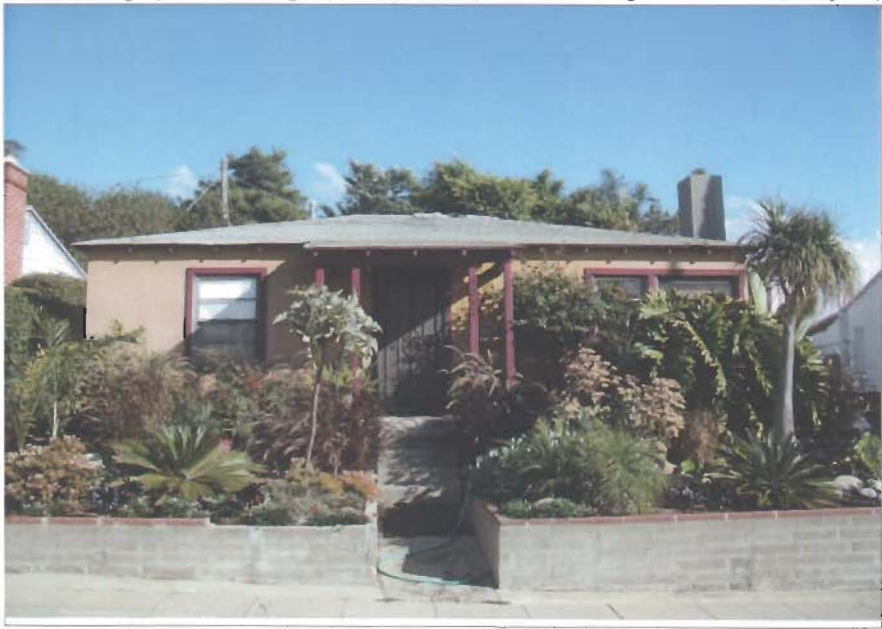
P5a. Photograph or Drawing (Photograph required for buildings, structures, and objects)

* P3a. Description: (Describe resource and its major elements. Include design, materials, condition, alterations, size, setting, and boundaries.)
The house at 3211 Belle Isle Drive was built in 1946 in the Minimal Traditional style and features a low-pitch hipped roof with composition shingles; a slight eave overhang; exposed raftertails; a smooth stucco exterior; and a brick chimney at the side. The entry porch, which is accessed by 5 concrete steps, is centered on the house and features a small roof projection supported by paired 4x4 wood posts. Fenestration consists of 2-over-2 double hung wood frame and sash windows and single pane fixed wood frame windows. Refer to BSOR Section B.6. for modifications and analysis of integrity.

Photo of the primary façade from the public right-of-way.

The house was built in 1946 per water and sewer connection records. Modifications include the replacement of the composition roof with a new composition roof and the use of a wrought iron security door. The house is in good condition and retains a good to fair degree of integrity.

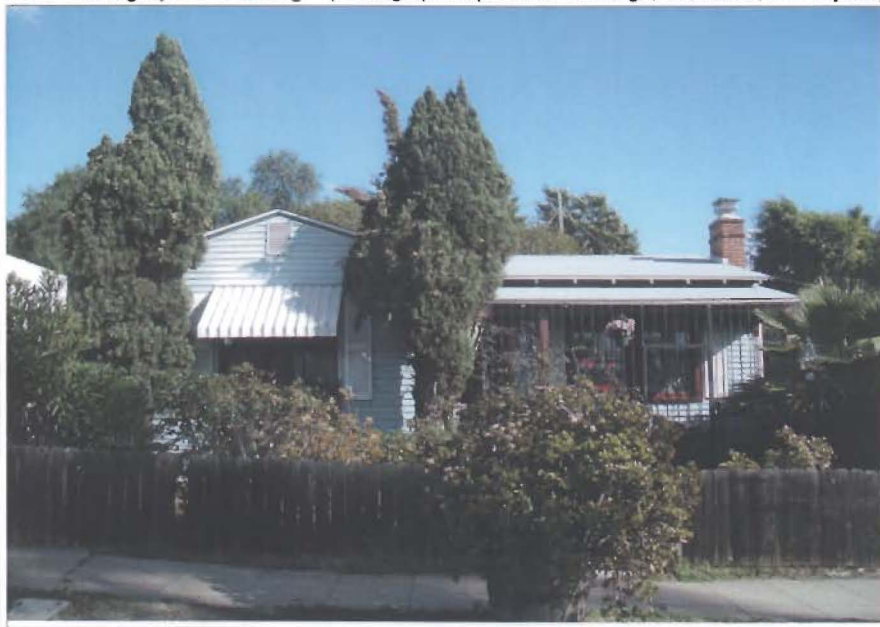
P5a. Photograph or Drawing (Photograph required for buildings, structures, and objects)

* P3a. Description: (Describe resource and its major elements. Include design, materials, condition, alterations, size, setting, and boundaries.)
The house at 3221 Belle Isle Drive was built in 1935 in the Minimal Traditional style and features a medium pitch cross gable roof with composition shingles; a slight eave overhang; exposed rafter tails; a clapboard exterior; and a brick chimney on the south side. The left hand side of the house features a front facing gable with a louvered outlet ventilator under the gable peak and an 8-lite wood frame window flanked by decorative shutters under an aluminum awning. The entry porch is located on the right hand side of the house and features a roof extension supported by wood posts. The entry door is set perpendicularly to the sidewalk. Fenestration consists of 1-over-1 double hung wood frame and sash windows with decorative wood shutters in some locations. Extensive use of wrought iron security bars have obscured the windows and completely enclosed the porch, however, these modifications are reversible. A weathered wood picket fence surrounds the property. Refer to BSOR Section B.6. for modifications and analysis of integrity.

Photo of the primary façade from the public right-of-way.

The house was constructed in 1935 per water and sewer records. Modifications include the replacement of the composition roof with a new composition roof; the use of aluminum awnings; and the extensive use of wrought iron security bars on the windows and enclosing the entry porch. The house is in good condition and retains a good degree of integrity.

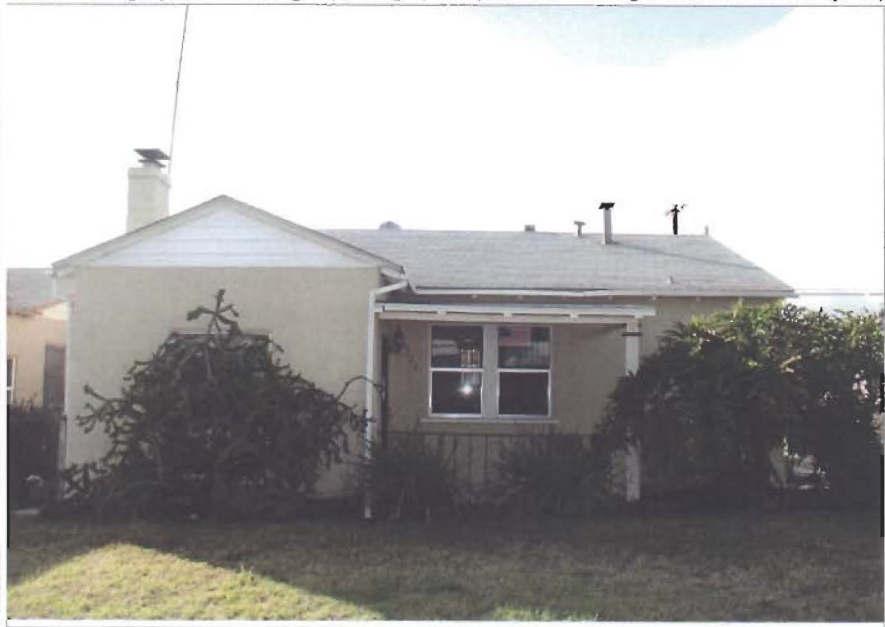
P5a. Photograph or Drawing (Photograph required for buildings, structures, and objects)

* P3a. Description: (Describe resource and its major elements. Include design, materials, condition, alterations, size, setting, and boundaries.)
The house at 3222 Belle Isle Drive was built in 1936 in the Minimal Traditional style and features a medium pitch cross gable roof with composition shingles; a slight eave overhang; exposed rafter tails; a moderately textured stucco exterior; and a chimney on the south side. The left hand side of the house features a front facing gable with clapboard in the gable end. The right hand side of the house features a flat-roof porch supported on wood posts and set slightly lower than the roofline. The porch cover appears to be an addition. Fenestration consists of 1-over-1 single hung and single pane fixed aluminum frame and sash windows. The entry door is set perpendicularly to the street. Refer to BSOR Section B.6. for modifications and analysis of integrity.

Photo of the primary façade from the public right-of-way.

* B6. Construction History: (Construction date, alterations, and date of alterations.)
The house was constructed in 1936 per water and sewer records. Modifications include the use of moderately textured stucco, the replacement of the composition roofing with new composition roofing, the replacement of the wood frame windows with aluminum windows, the addition of a wrought iron security screen over the entry door, and the addition of a small entry porch cover. The house is in good condition and retains a fair degree of integrity.

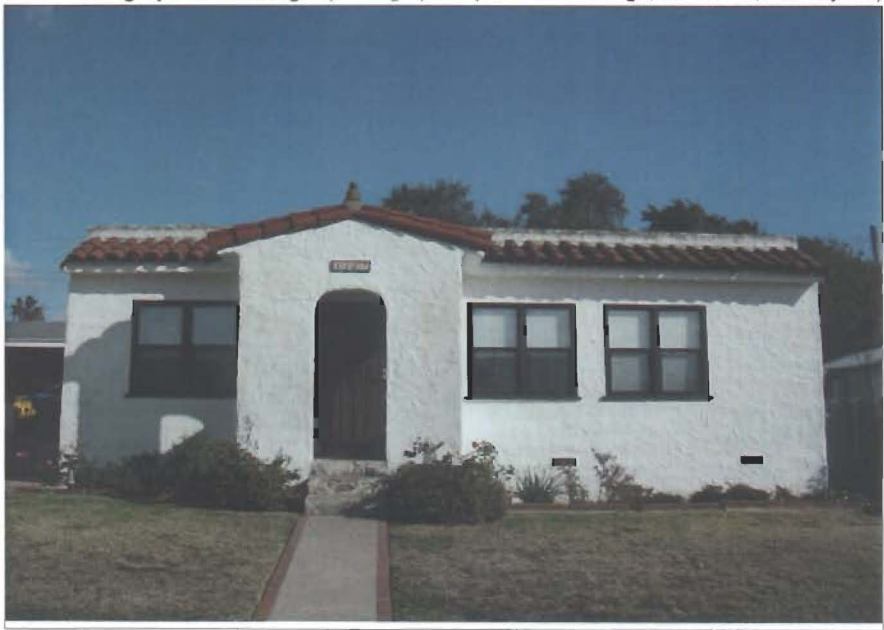
P5a. Photograph or Drawing (Photograph required for buildings, structures, and objects)

* P3a. Description: (Describe resource and its major elements. Include design, materials, condition, alterations, size, setting, and boundaries.)
The house at 3227 Belle Isle Drive was constructed in 1930 in the Spanish Eclectic style and features a flat roof with a clay tile shed roof at the parapet line; a low-pitch front-gable entry element set just off-center; and a generally smooth stucco exterior. The main entry is set under a projecting, front-gable element with an arched opening and is accessed via three concrete steps. Fenestration consists of paired 1-over-1 double hung aluminum frame and sash windows. The entry door is set parallel to the street. Refer to BSOR Section B.6. for modifications and analysis of integrity.

Photo of the primary façade from the public right-of-way.

The house was constructed in 1930 per water and sewer records. Modifications include the replacement of the wood frame and sash windows with aluminum frame and sash windows. The house is in good condition and retains a good to fair degree of integrity.

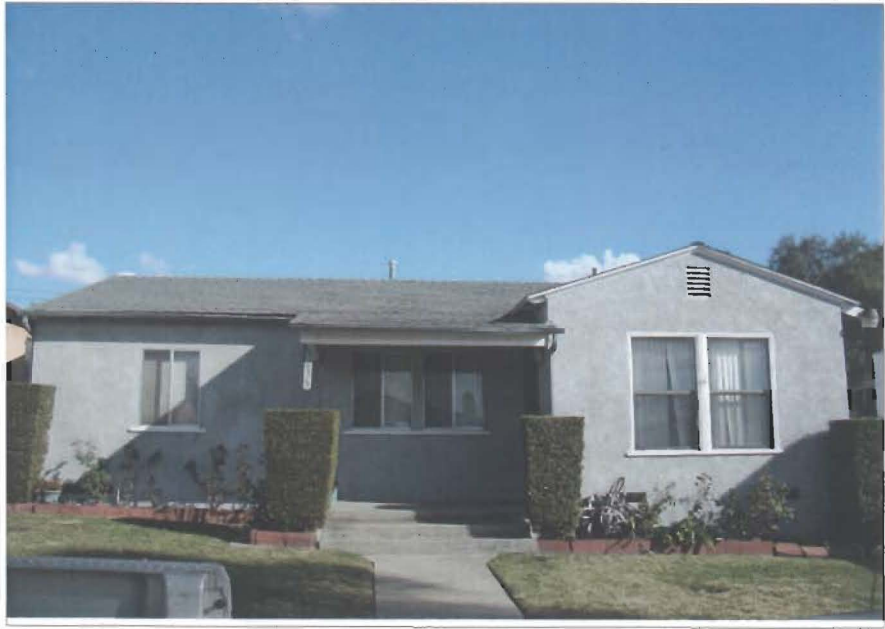
P5a. Photograph or Drawing (Photograph required for buildings, structures, and objects)

* P3a. Description: (Describe resource and its major elements. Include design, materials, condition, alterations, size, setting, and boundaries.)
The house at 3235 Belle Isle Drive was built in 1947 in the Minimal Traditional style and features a medium pitch cross gable roof with composition shingles; a slight eave overhang; and a moderately textured stucco exterior. The right hand side of the house features a front facing gable with a louvered outlet ventilator under the gable peak and paired 1-over-1 aluminum frame and sash windows. The entry porch, which is accessed via 4 concrete steps, is centered on the house and features a roof extension supported by a decorative wrought iron post. The entry door is set perpendicularly to the sidewalk. Fenestration consists of 1-over-1 double hung and casement aluminum frame and sash windows. Refer to BSOR Section B.6. for modifications and analysis of integrity.

P5b. Description of Photo: (View, date, etc.)
Photo of the primary façade from the public right-of-way.

The house was constructed in 1947 per water and sewer records. Modifications include the use of moderately textured stucco, the replacement of the composition roof with a new composition roof, the replacement of the wood frame and sash window with aluminum windows, and the replacement of the porch post with a decorative wrought iron post. The house is in fair to good condition and retains a fair degree of integrity.

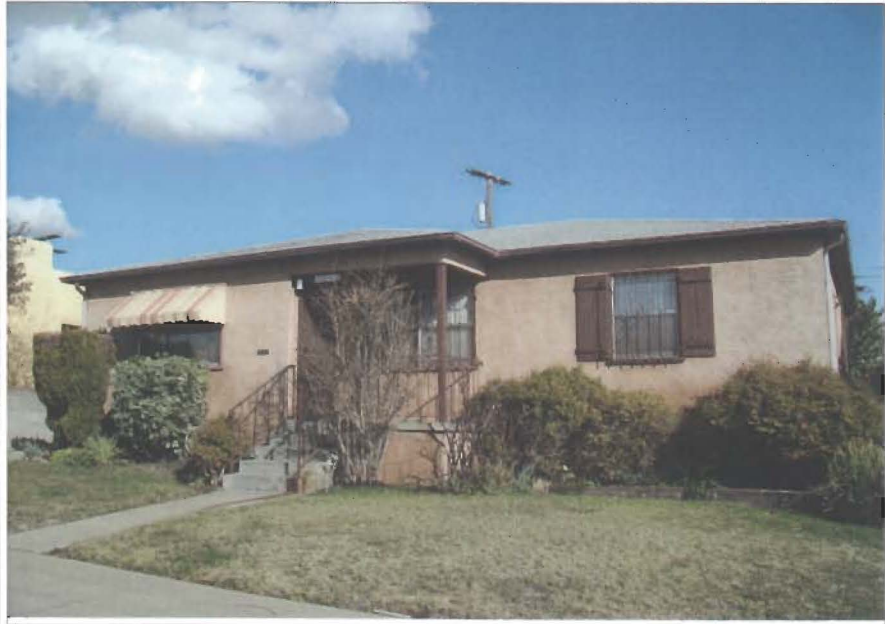
P5a. Photograph or Drawing (Photograph required for buildings, structures, and objects)

* P3a. Description: (Describe resource and its major elements. Include design, materials, condition, alterations, size, setting, and boundaries.)
The house at 3243 Belle Isle was built in 1950 in the Minimal Traditional style and features a low-pitch hipped roof with composition shingles; slight eave overhang; and a moderately textured stucco exterior. The entry porch, which is accessed via 5 concrete steps, is centered on the main façade and covered by a projection of the roofline supported on a single squared post. The entry door is set perpendicularly to the sidewalk. Fenestration consists of 1-over-1 single hung aluminum windows. The window to the far right of the entry features wood shutters and an aluminum awning covers the window to the left to the entry. Refer to BSOR Section B.6. for modifications and analysis of integrity.

Photo of the primary façade from the public right-of-way.

The house was constructed in 1950 per water and sewer records. Modifications include the use of moderately textured stucco, the replacement of the composition roof with a new composition roof, the replacement of the windows with aluminum windows, and the use of a wrought iron stair railing and security bars over the windows. The house is in good condition and retains a good to fair degree of integrity.

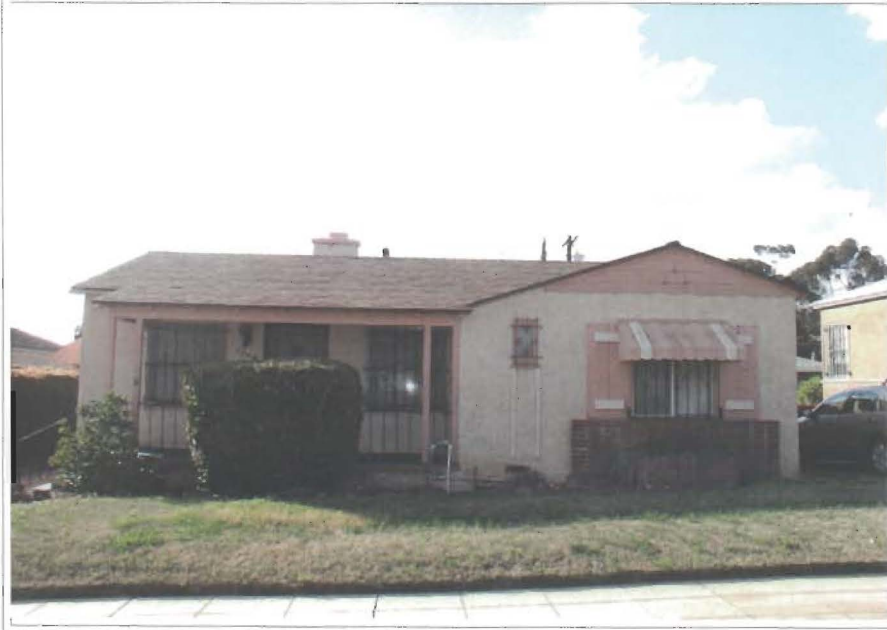
P5a. Photograph or Drawing (Photograph required for buildings, structures, and objects)

* P3a. Description: (Describe resource and its major elements. Include design, materials, condition, alterations, size, setting, and boundaries.)
The house at 3244 Belle Isle Drive was built in 1937 in the Minimal Traditional style and features medium-pitch cross-gable roof with composition shingles; a slight eave overhang; exposed rafter tails; a moderately textured stucco exterior; and a chimney on the west side. The right hand side of the house features a front facing gable with clapboard in the gable end, an aluminum slider window with wood shutters under an aluminum awning over a brick façade. The left hand side of the house features an entry porch, accessed by four concrete steps, under a projection of the roof supported on paired square posts. The entry door is set perpendicularly to the sidewalk. Fenestration consists of 3-over-3 double hung wood frame and sash windows and the aluminum slider window in the gable end. Wrought iron security bars cover the doors and windows. Refer to BSOR Section B.6. for modifications and analysis of integrity.

Photo of the primary façade from the public right-of-way.

The house was constructed in 1937 per water and sewer records. Modifications include the use of moderately textured stucco, the replacement of the composition roof with a new composition roof, the replacement of one window with an aluminum window, and the use of a wrought iron stair railing and security bars over the windows. The house is in good condition and retains a fair degree of integrity.

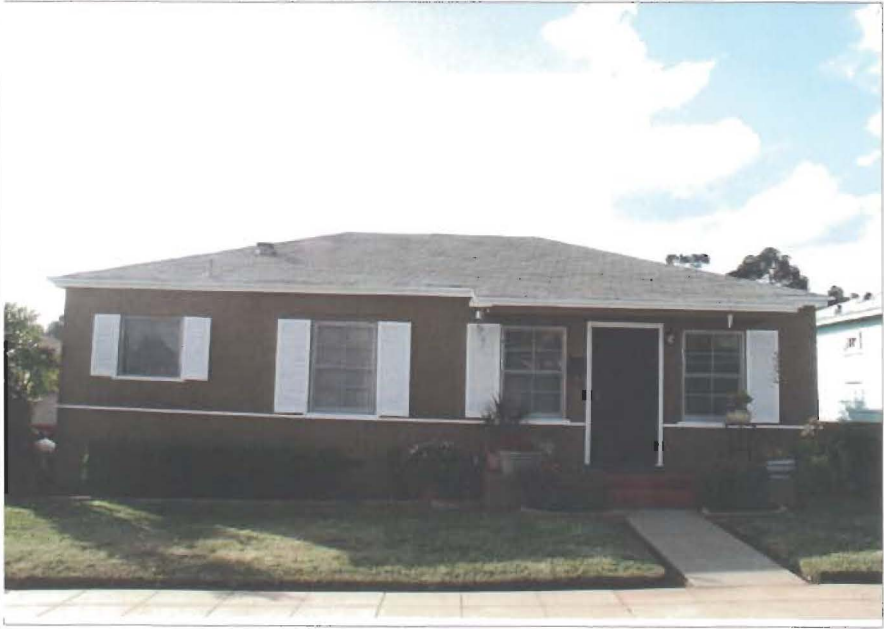
P5a. Photograph or Drawing (Photograph required for buildings, structures, and objects)

* P3a. Description: (Describe resource and its major elements. Include design, materials, condition, alterations, size, setting, and boundaries.)
The house at 3250 Belle Isle Drive was built in 1941 in the Minimal Traditional style and features a medium-pitch hipped roof with composition shingles; minimal eave overhang; and a heavily textured stucco exterior. The main entry is set to the left and is accessed by two concrete steps. Fenestration consists of 4-over-4 double hung wood windows with decorative shutters. The porch posts appear to have been removed at some point in time, and the wood frame and sash windows flanking the door may have been an early modification. Refer to BSOR Section B.6. for modifications and analysis of integrity.

Photo of the primary façade from the public right-of-way.

The house was constructed in 1941 per water and sewer records. Modifications include the use of heavily textured stucco, the replacement of the composition roof with a new composition roof, and the apparent removal of the porch posts and the probable addition of the windows flanking the entry door at an early date. The house is in good condition and retains a good to fair degree of integrity.

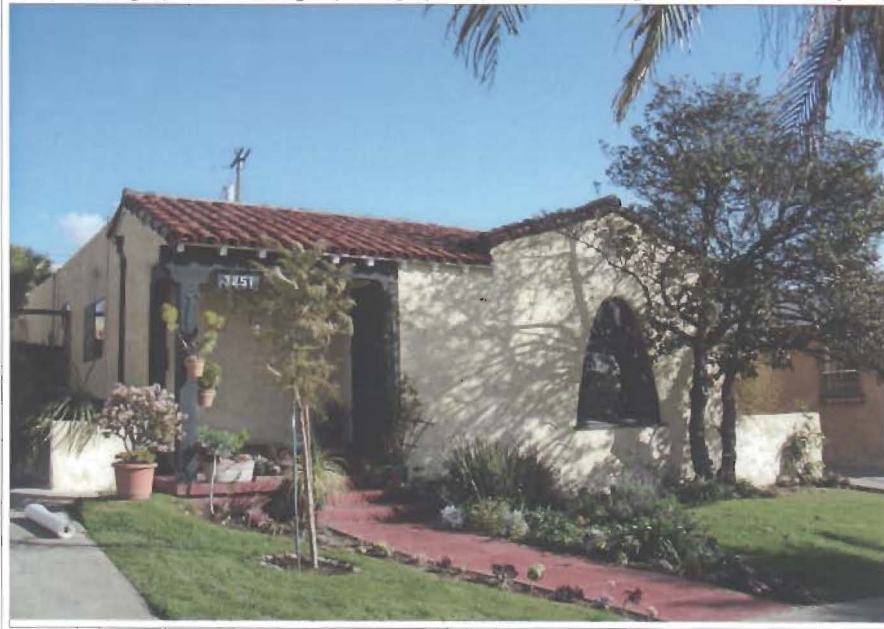
P5a. Photograph or Drawing (Photograph required for buildings, structures, and objects)

* P3a. Description: (Describe resource and its major elements. Include design, materials, condition, alterations, size, setting, and boundaries.)
The house at 3251 Belle Isle Drive was built in 1928 in the Spanish Eclectic style and features a flat roof with a clay tile shed roof at the parapet line; a medium-pitch front-gable bay set to the right; and a smooth stucco exterior. The entry porch is set to the left and is supported by a heavy square timber post. The entry door is set perpendicularly to the sidewalk. Fenestration consists of a fixed arch window in the gabled bay. Refer to BSOR Section B.6. for modifications and analysis of integrity.

Photo of the primary façade from the public right-of-way.

The house was constructed in 1928 per water and sewer records. Modifications include the possible in-kind replacement of the clay tile roof. The house is in excellent condition and retains a very good degree of integrity.

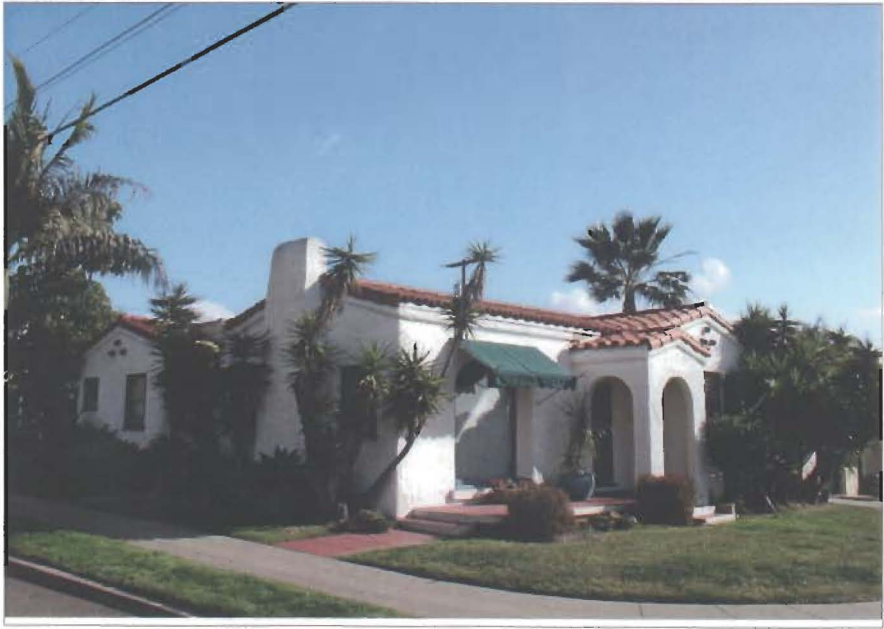
P5a. Photograph or Drawing (Photograph required for buildings, structures, and objects)

* P3a. Description: (Describe resource and its major elements. Include design, materials, condition, alterations, size, setting, and boundaries.)
The house at 3261 Belle Isle Drive was built in 1928 in the Spanish Eclectic style on a corner lot and features a cross gable clay tile roofs; clipped eaves with a rounded cornice; clay tile vents; smooth stucco walls; and a chimney on the north elevation. The entry accessed via two concrete steps and is centered on the main façade to the left of the front-facing gable bay and features a narrower projecting gable element with arched entryway. Fenestration consists of a 6-over-1 double hung wood window with decorative shutters in the gabled bay, a large fixed arched window to the left of the entry, and 1-over-1 double hung wood frame and sash windows on the north elevation. Refer to BSOR Section B.6. for modifications and analysis of integrity.

Photo of the primary façade from the public right-of-way.

The house was constructed in 1928 per water and sewer records. Modifications include the possible in-kind replacement of the clay tile roof. The house is in excellent condition and retains a very good degree of integrity.

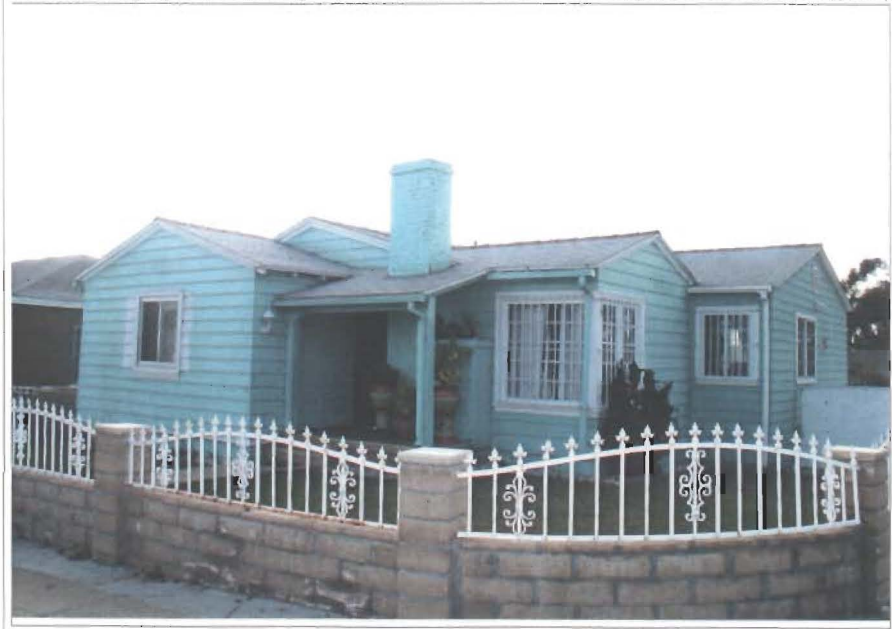
P5a. Photograph or Drawing (Photograph required for buildings, structures, and objects)

* P3a. Description: (Describe resource and its major elements. Include design, materials, condition, alterations, size, setting, and boundaries.)
The house at 3262 Belle Isle Drive was built in 1937 in the Minimal Traditional style on a corner lot and features multi-gabled roofs with composition shingles; clapboard siding; multiple recessed bays; and a brick chimney on the east façade. The main entry, accessed via two concrete steps, is set on the center bay and is covered by a shed roof projection supported on 4x4 wood posts. Fenestration consists of two fixed multi-light wood frame windows on the center bay, an 8-lite vinyl slider window, and an aluminum slider. Wrought iron security bars have been added to the doors and windows. An addition at the rear is visible, but is stepped back from the main façade and is clearly new. Refer to BSOR Section B.6. for modifications and analysis of integrity.

Photo of the primary façade from the public right-of-way.

The house was constructed in 1937 per water and sewer records. Modifications include the replacement of the composition roof with a new composition roof, the replacement of some windows with aluminum and vinyl windows, the use of a wrought iron security bars over the windows, and a 2002 addition at the rear which is visible, but stepped back from the main façade and clearly new. The house is in good to fair condition and retains a good to fair degree of integrity.

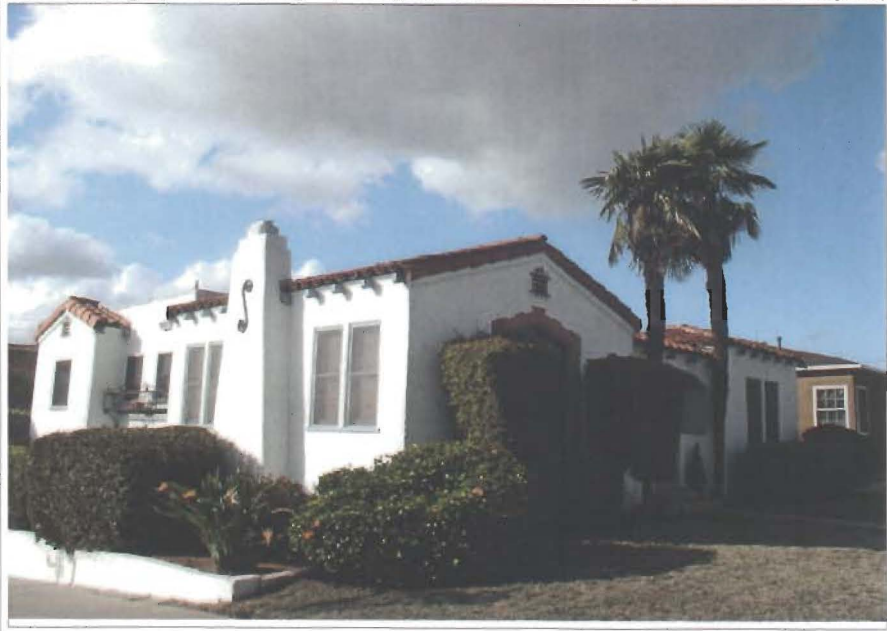
P5a. Photograph or Drawing (Photograph required for buildings, structures, and objects)

* P3a. Description: (Describe resource and its major elements. Include design, materials, condition, alterations, size, setting, and boundaries.)
The house at 3304 Belle Isle Drive was built in 1931 in the Spanish Eclectic style on a corner lot and features flat and multi-gable roofs with clay tiles; clipped eaves; exposed rafter tails; clay pipe drains; an arched louvered vent; a smooth stucco exterior; and a chimney on the south elevation. The main entry is flanked by projecting gable bays and is enclosed by a low stucco wall under a low-point arched opening. The entry door is set perpendicularly to the sidewalk. Fenestration consists of single pane casement wood frame windows under a fixed triangular transom in the left bay, Craftsman pattern multi-lights-over-1 double hung wood frame and sash windows in the right bay, multi-lite and 1-over-1 double hug wood frame and sash windows at the entry porch, and 1-over-1 double hung wood frame and sash windows throughout. Two Mexican palms flank the entryway. Refer to BSOR Section B.6. for modifications and analysis of integrity.

Photo of the primary façade from the public right-of-way.

The house was constructed in 1931 per water and sewer records. Modifications include the possible in-kind replacement of the clay tile roof. The house is in excellent condition and retains a very good degree of integrity.

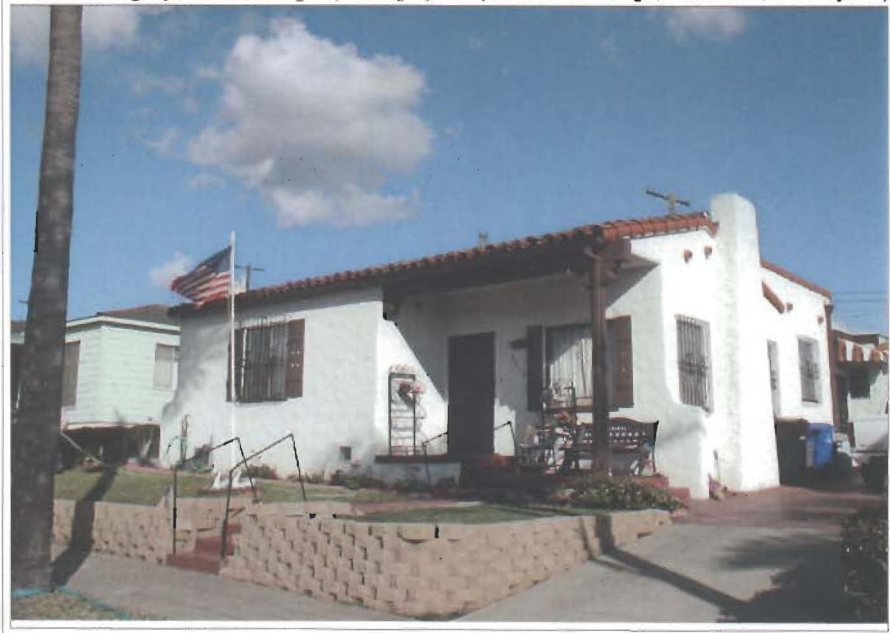
P5a. Photograph or Drawing (Photograph required for buildings, structures, and objects)

* P3a. Description: (Describe resource and its major elements. Include design, materials, condition, alterations, size, setting, and boundaries.)
The house at 3315 Belle Isle Drive was built in 1930 in the Spanish Eclectic style and features a flat roof with a shed clay tile roof at the parapet; clipped eaves; clay tile vents and drains; a smooth stucco exterior; and a chimney on the south elevation. The entry, accessed via two concrete steps, is set to the right and is covered by a shed roof projection supported on square posts. The entry door is set parallel to the sidewalk. Fenestration consists of 1-over-1 double hung wood frame and sash windows with decorative shutters, single pane fixed wood frame windows, and 1-over-1 aluminum windows on the side of the house. Refer to BSOR Section B.6. for modifications and analysis of integrity.

Photo of the primary façade from the public right-of-way.

The house was constructed in 1930 per water and sewer records. Modifications include the use of wrought iron security grills. The house is in good condition and retains a good degree of integrity.

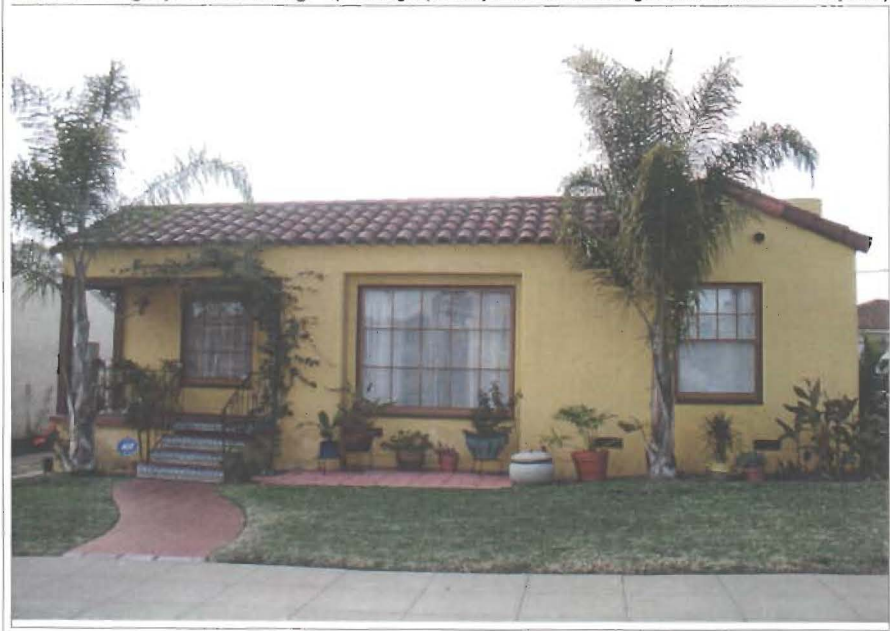
P5a. Photograph or Drawing (Photograph required for buildings, structures, and objects)

Photo of the primary façade from the public right-of-way.

The house was constructed in 1936 per water and sewer records. Modifications include the in-kind replacement of the clay tile roofing. The house is in good condition and retains a very good degree of integrity.
