THE CITY OF SAN DIEGO

Report to the Historical Resources Board

DATE ISSUED: July 10, 2025 REPORT NO. HRB-25-028

SUBJECT: **ITEM #2 – 7747 Whitefield Place**

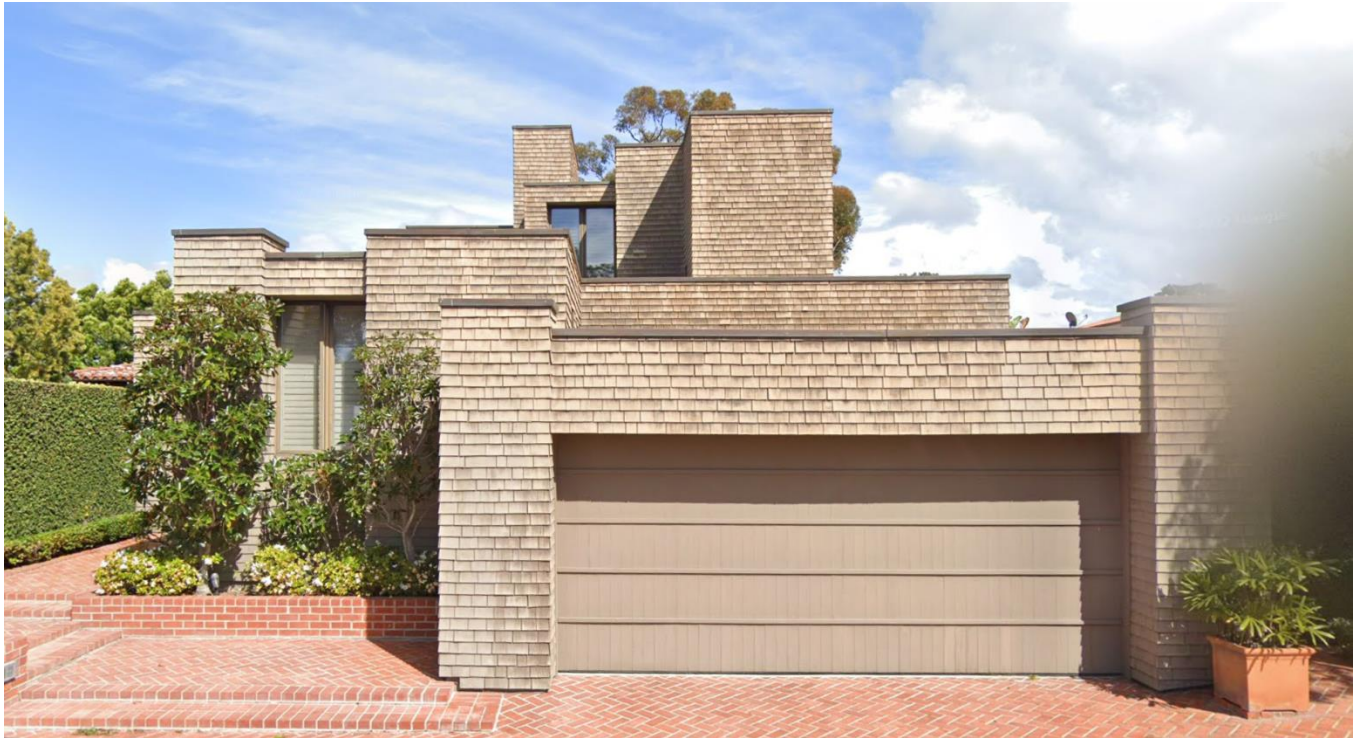
March 2019 Condition (via Google Street View)

Since its construction in 1979, the property has been modified as follows: the garage door was replaced c. 2019-2024, the unpainted exterior wood shingle siding was painted c. 2019-2024, and a detached shed was constructed in the rear yard c. 2022.

However, as described in the Criterion C analysis above, the subject property does not readily embody any specific architectural style, and it does not possess critical features of the Organic Geometric Style when evaluated under the [2007 San Diego Modernism Historic Context Statement](#). Staff therefore disagrees with the conclusion of the HRRR that the property is "a notable example of Youngson's work as it is his last known Organic Geometric project in San Diego and is a refined version of his work in the Organic Geometric style." Furthermore, staff disagrees with the conclusion of the HRRR that the building retains integrity of design, materials, feeling and association. The painting of exterior shingles significantly impaired the building's original unfinished texture and color, which was a critical character defining feature of the building. Please see Attachment 2 for a comparison of the subject property's current and historical building exterior.

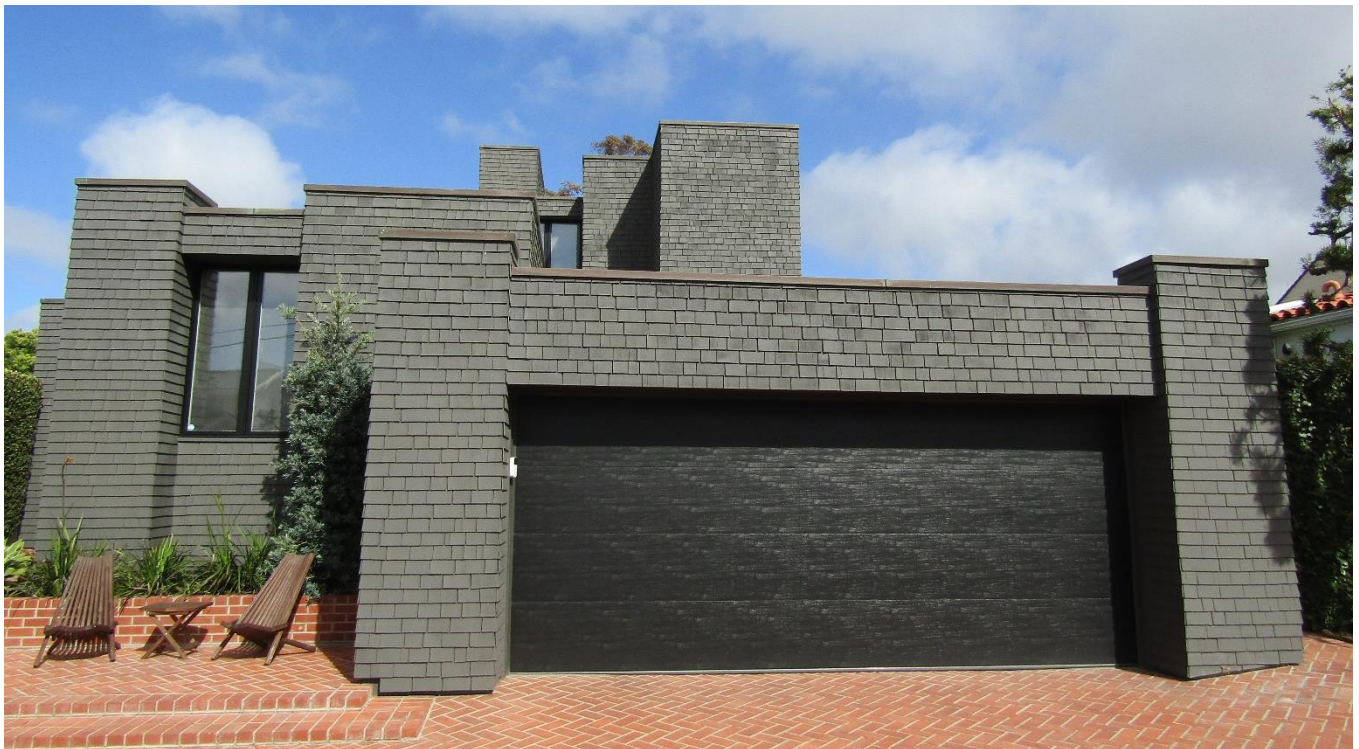
March 2025 Condition (Staff photo)
