SHORELINE RESTORATION

Preliminary Engineering Report (PER)

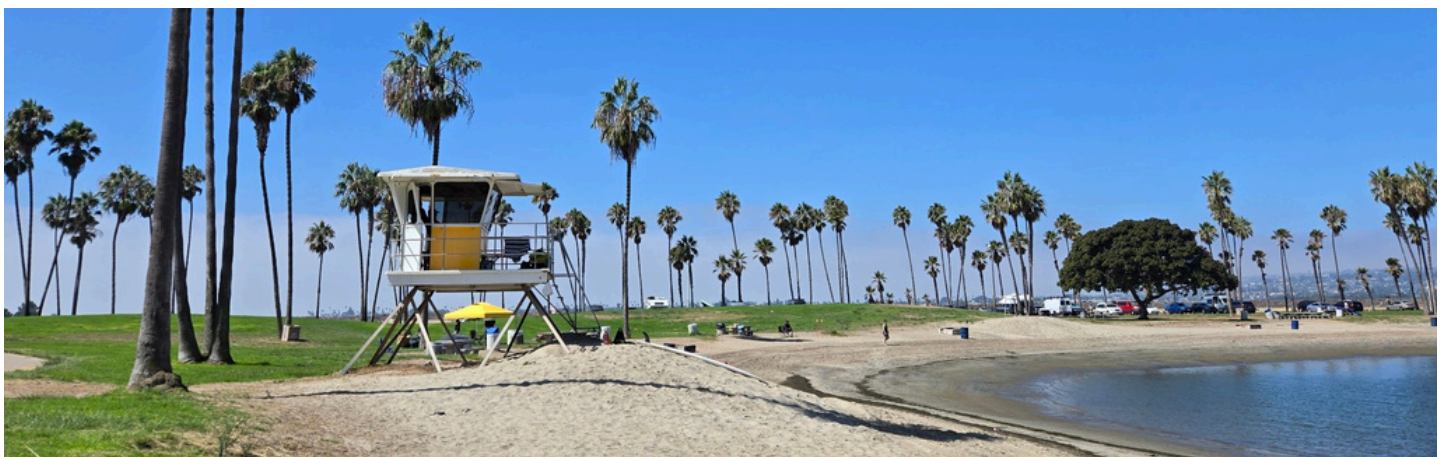
Improvement Area	Recommendations
Vacation Island Northwest	<ul style="list-style-type: none"> • Add two sand retention rock groins with pedestrian access • Widen and elevate the beach
Vacation Island Northeast	<ul style="list-style-type: none"> • Repair and raise crest height of riprap • Add a drainage ditch for runoff flows • Extend Ski Beach to 100 ft. wide with a cobble berm
Vacation Island Southwest	<ul style="list-style-type: none"> • Improve and raise crest height of riprap • Bury riprap within a raised beach area • Add landscaping, benches, and bonfire facilities • Improve oyster habitat
Ventura Cove Park	<ul style="list-style-type: none"> • Repair and raise crest height of riprap • Add footpath parallel to riprap • Improve oyster habitat
Crown Point	<ul style="list-style-type: none"> • Extend seawall 150 ft. southeast. • Beach fill strategically placed at northern and southern areas of the seawall

West Sail Bay	<ul style="list-style-type: none"> • Provide beach nourishment along 1/4-mile to develop a 75-foot-wide beach berm and 50-foot-wide beach slope • The beach width at the narrowest location would expand from 20 feet to 90 feet at high tide
Bonita Cove	<ul style="list-style-type: none"> • Relocate sidewalk up to 30 ft. inland • Extend beach to 100 ft. wide • Add cobble berm to reduce erosion
Bahia Point	<ul style="list-style-type: none"> • Widen beach and add paths for maintenance vehicles • Install cobble breakwater and sheet wall groins to reduce erosion • Add stormwater improvements

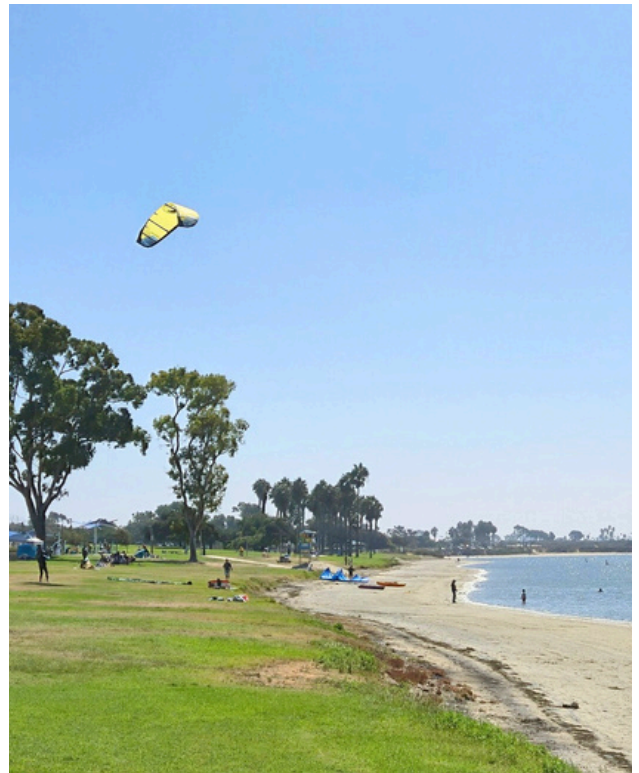
Opportunity Areas

The Shoreline Restoration PER identifies activities that can improve shorelines throughout Mission Bay and can reduce the need for regular beach replenishment in the areas shown below.

- Bahia Point
- Bonita Cove
- Crown Point
- Vacation Island NE/Ski Beach
- Vacation Island NW
- Vacation Island SW
- Ventura Cove Park
- West Sail Bay
