**APPENDIX K5**  
*Eelgrass CHRMP*

# MISSION BAY PARK IMPROVEMENTS PROGRAM

## Mission Bay Park Eelgrass Conceptual Habitat Restoration and Monitoring Plan San Diego, California

**APRIL 2026**

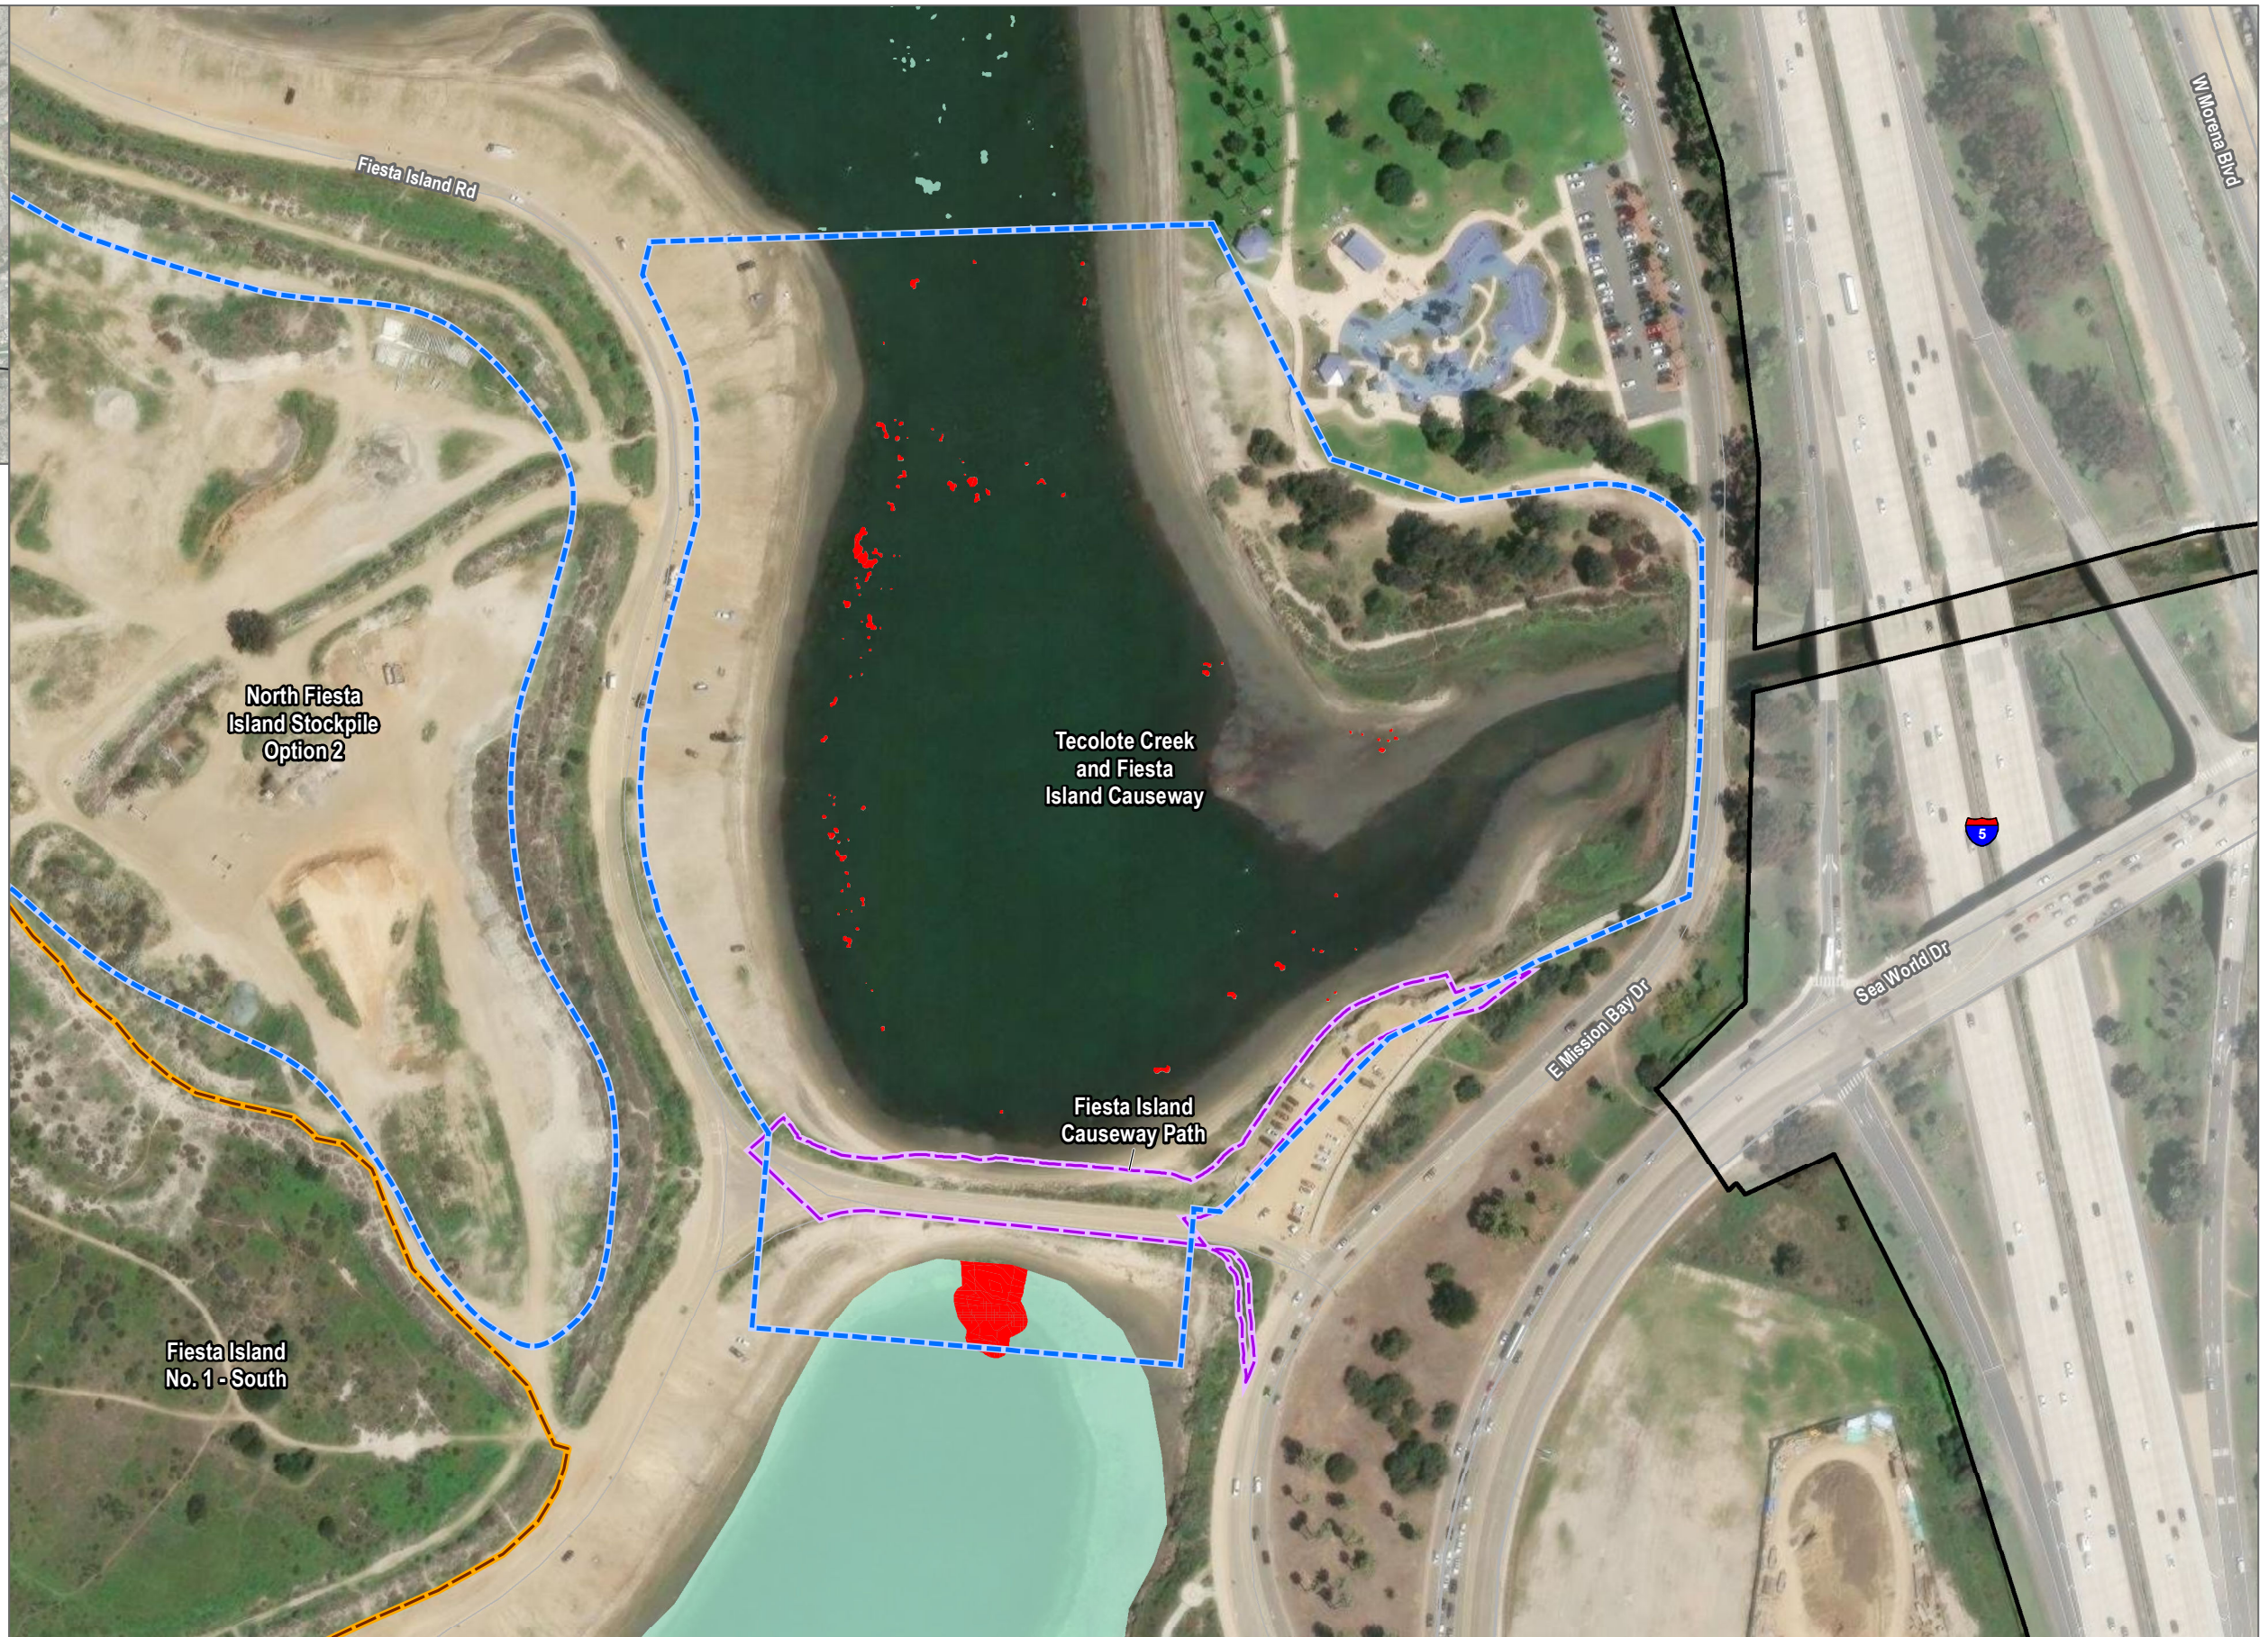
- Mission Bay Park Improvement Zone
- Eelgrass
- Eelgrass Impacts
- Wetland and Water Quality Improvements
- Upland Habitat and Preserve Expansion
- Bicycle and Pedestrian Improvements

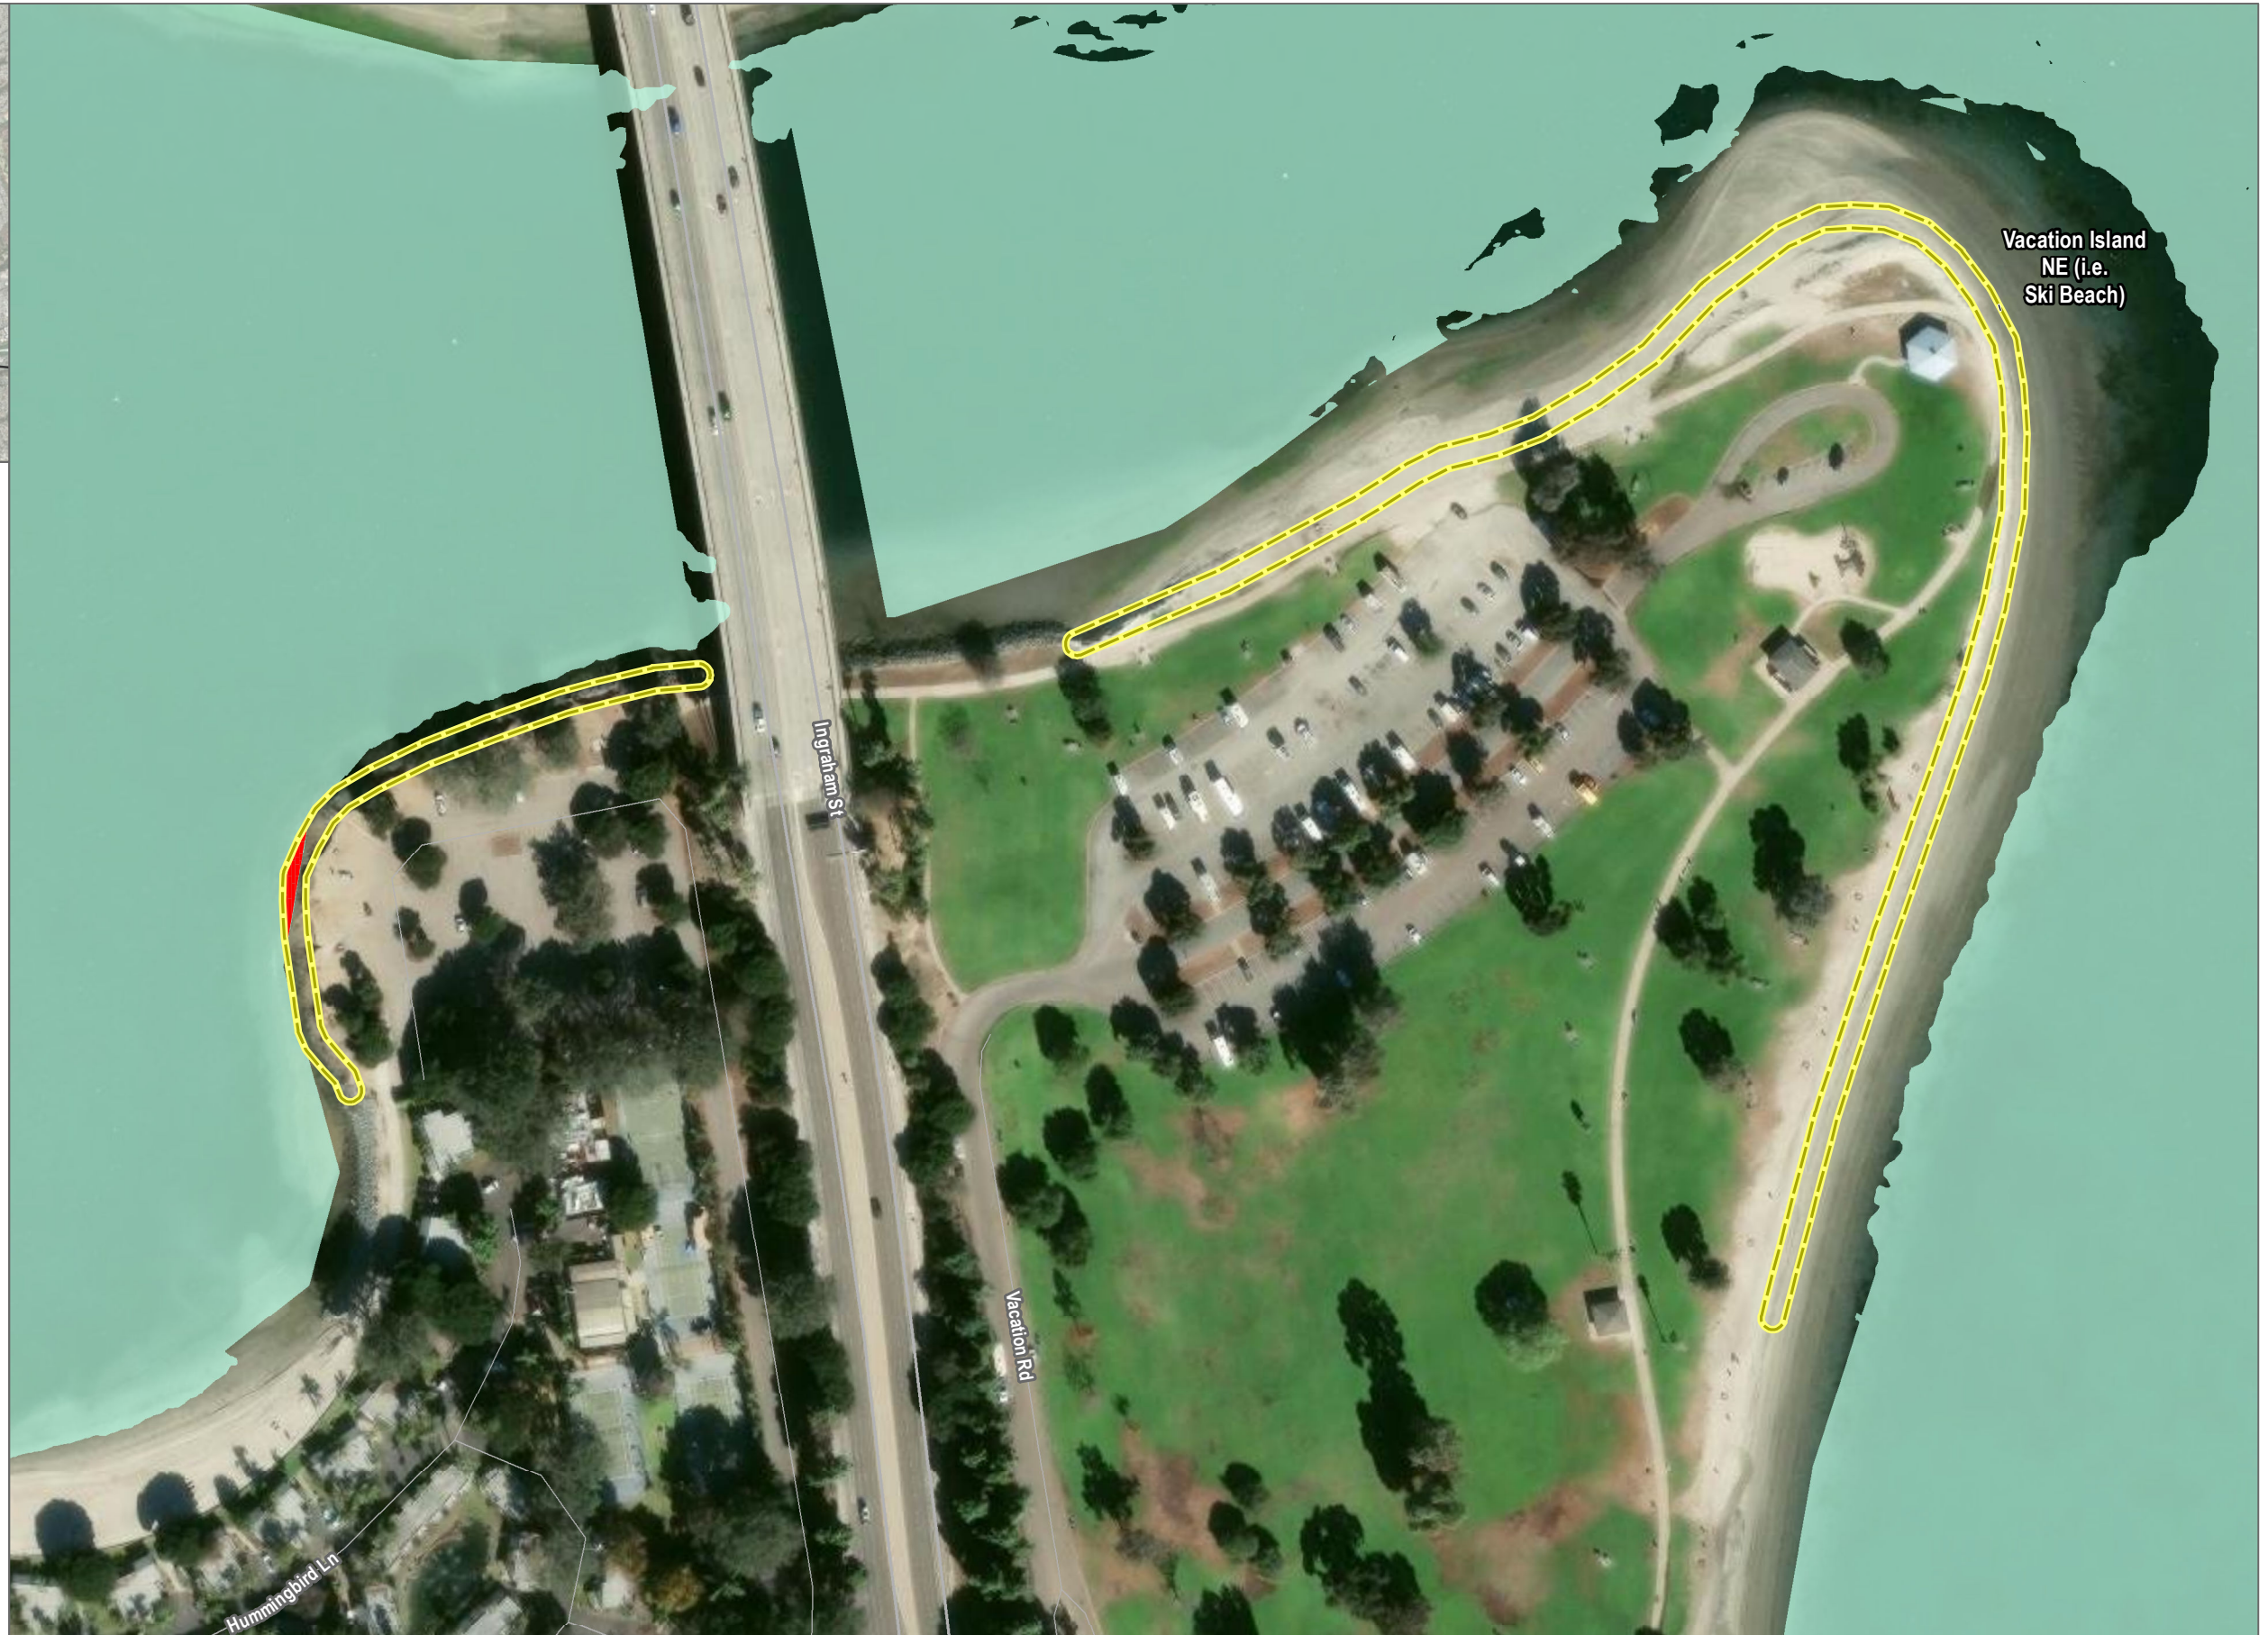
- Mission Bay Park Improvement Zone
- Eelgrass
- Eelgrass Impacts
- Restoration of Shoreline

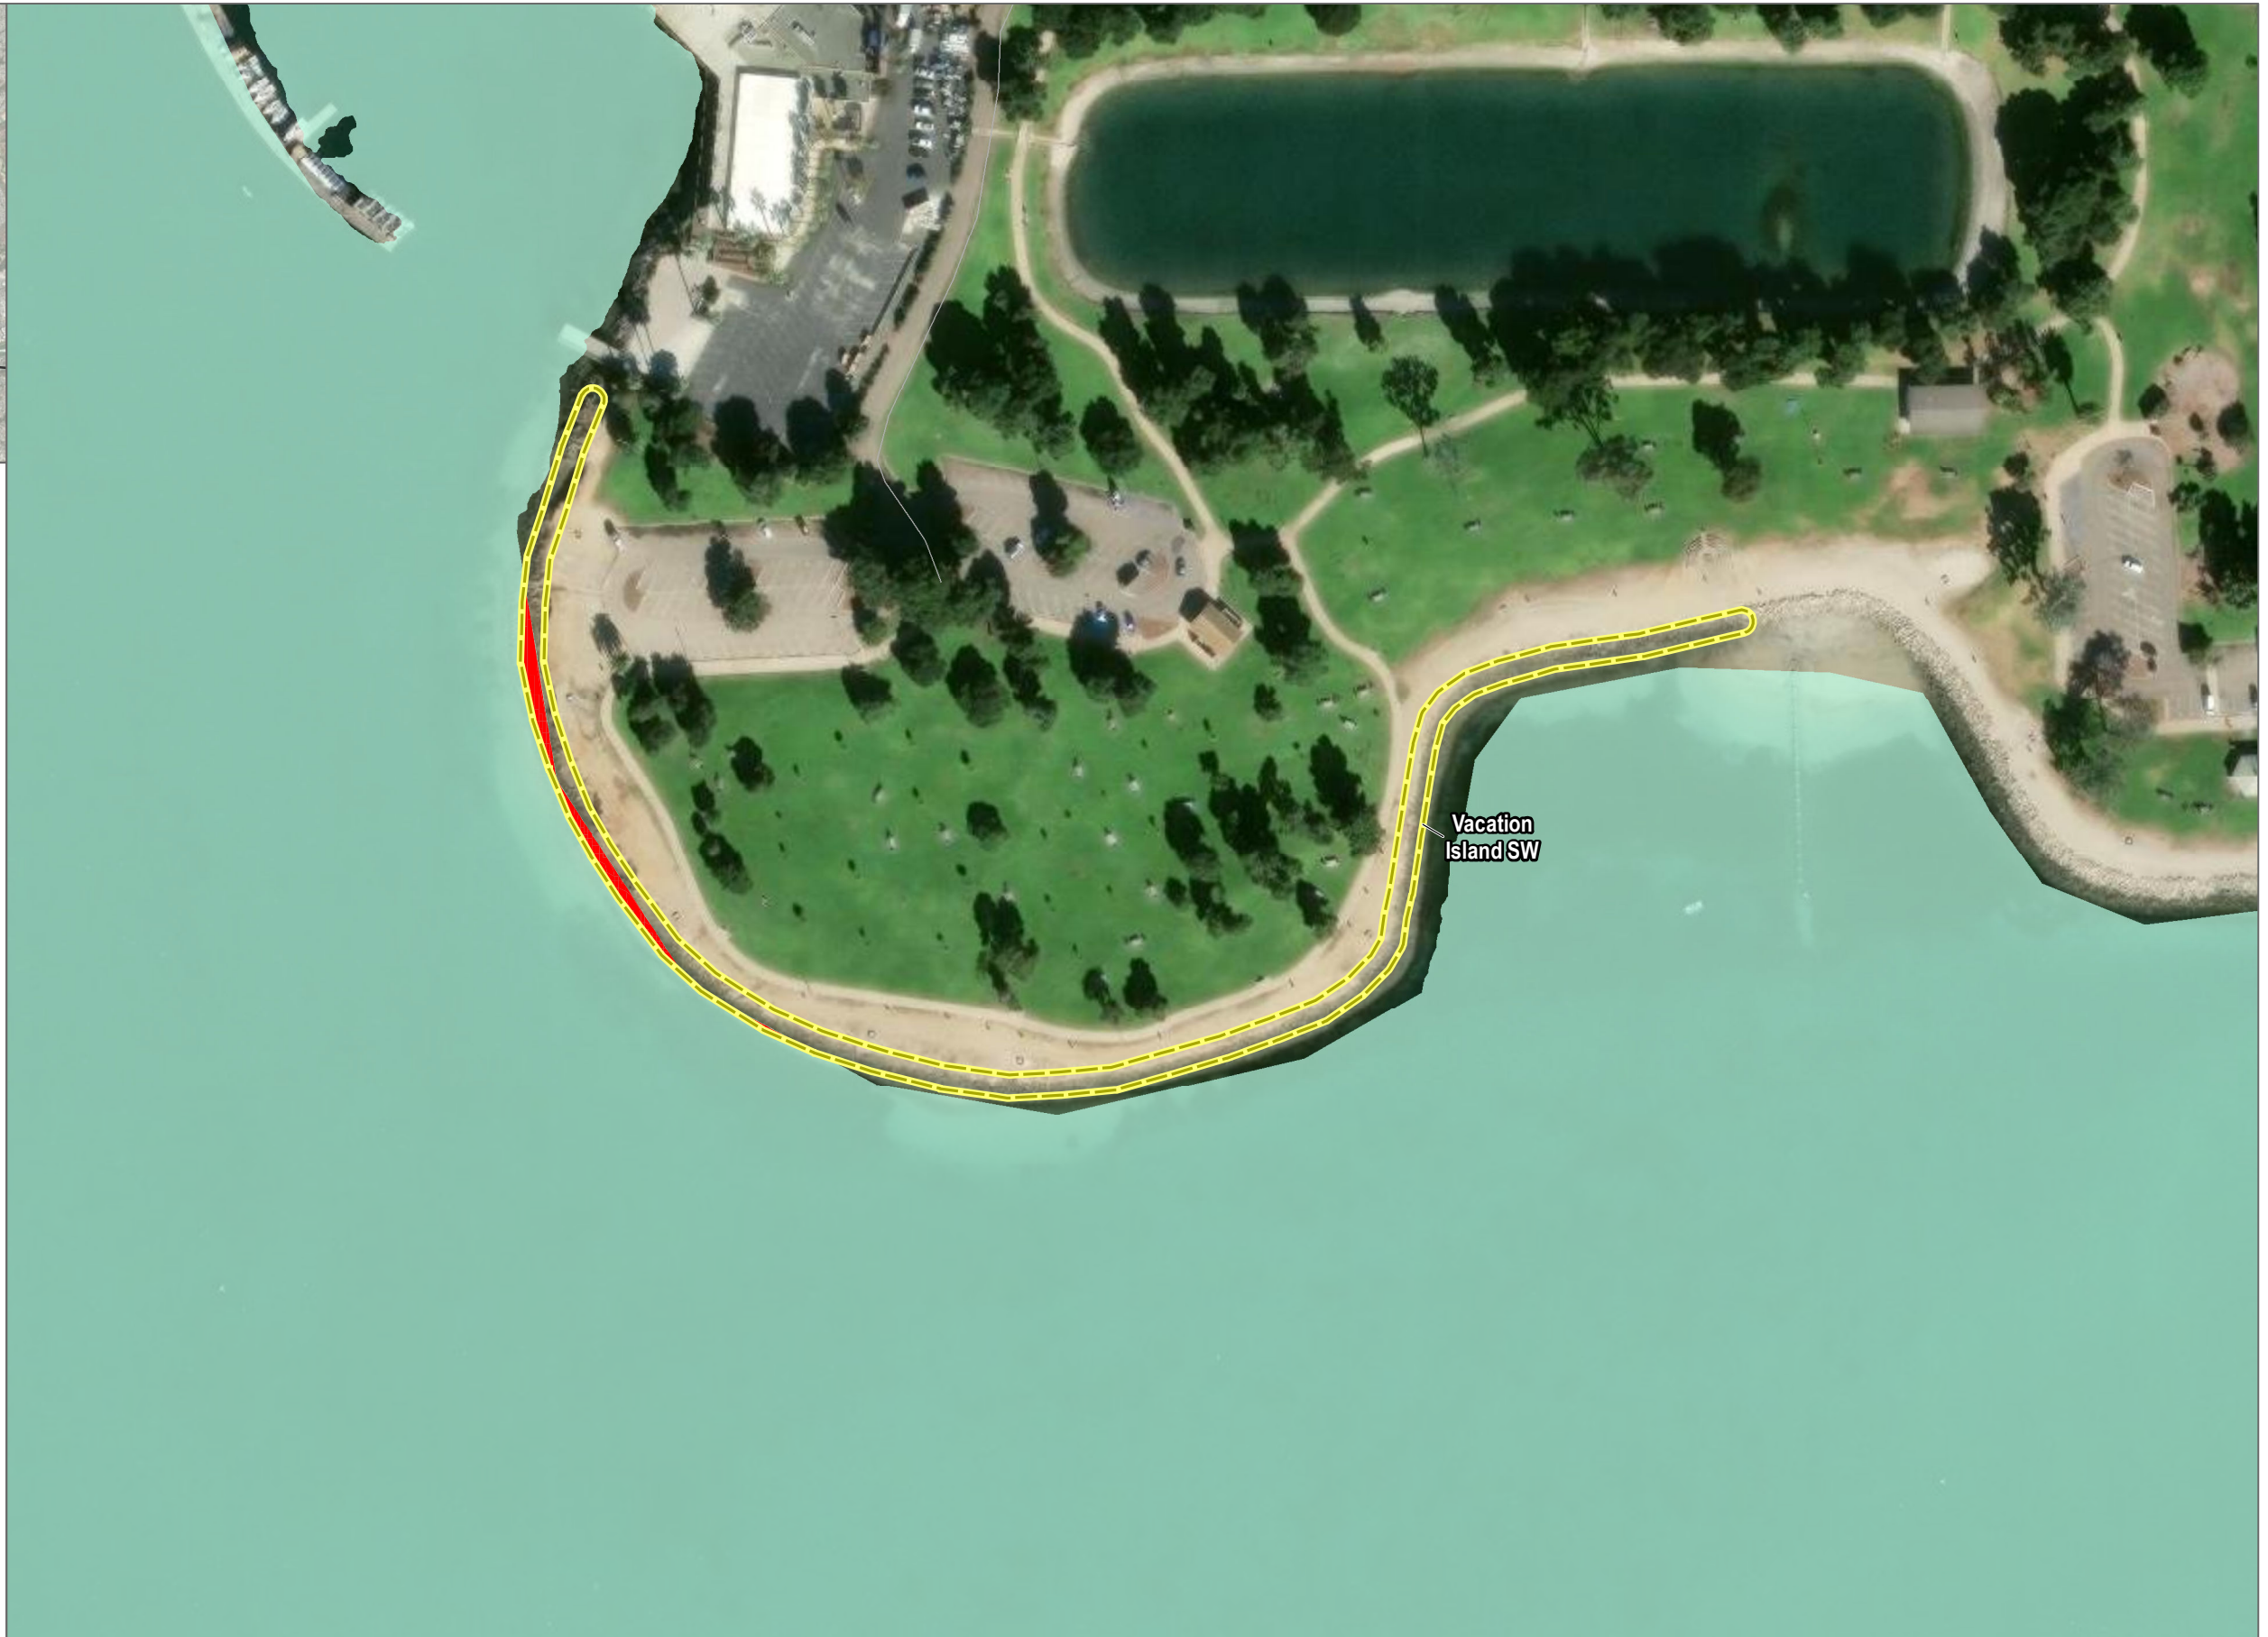
**FIGURE 3D**

- Mission Bay Park Improvement Zone
- Eelgrass
- Eelgrass Impacts
- Restoration of Shoreline

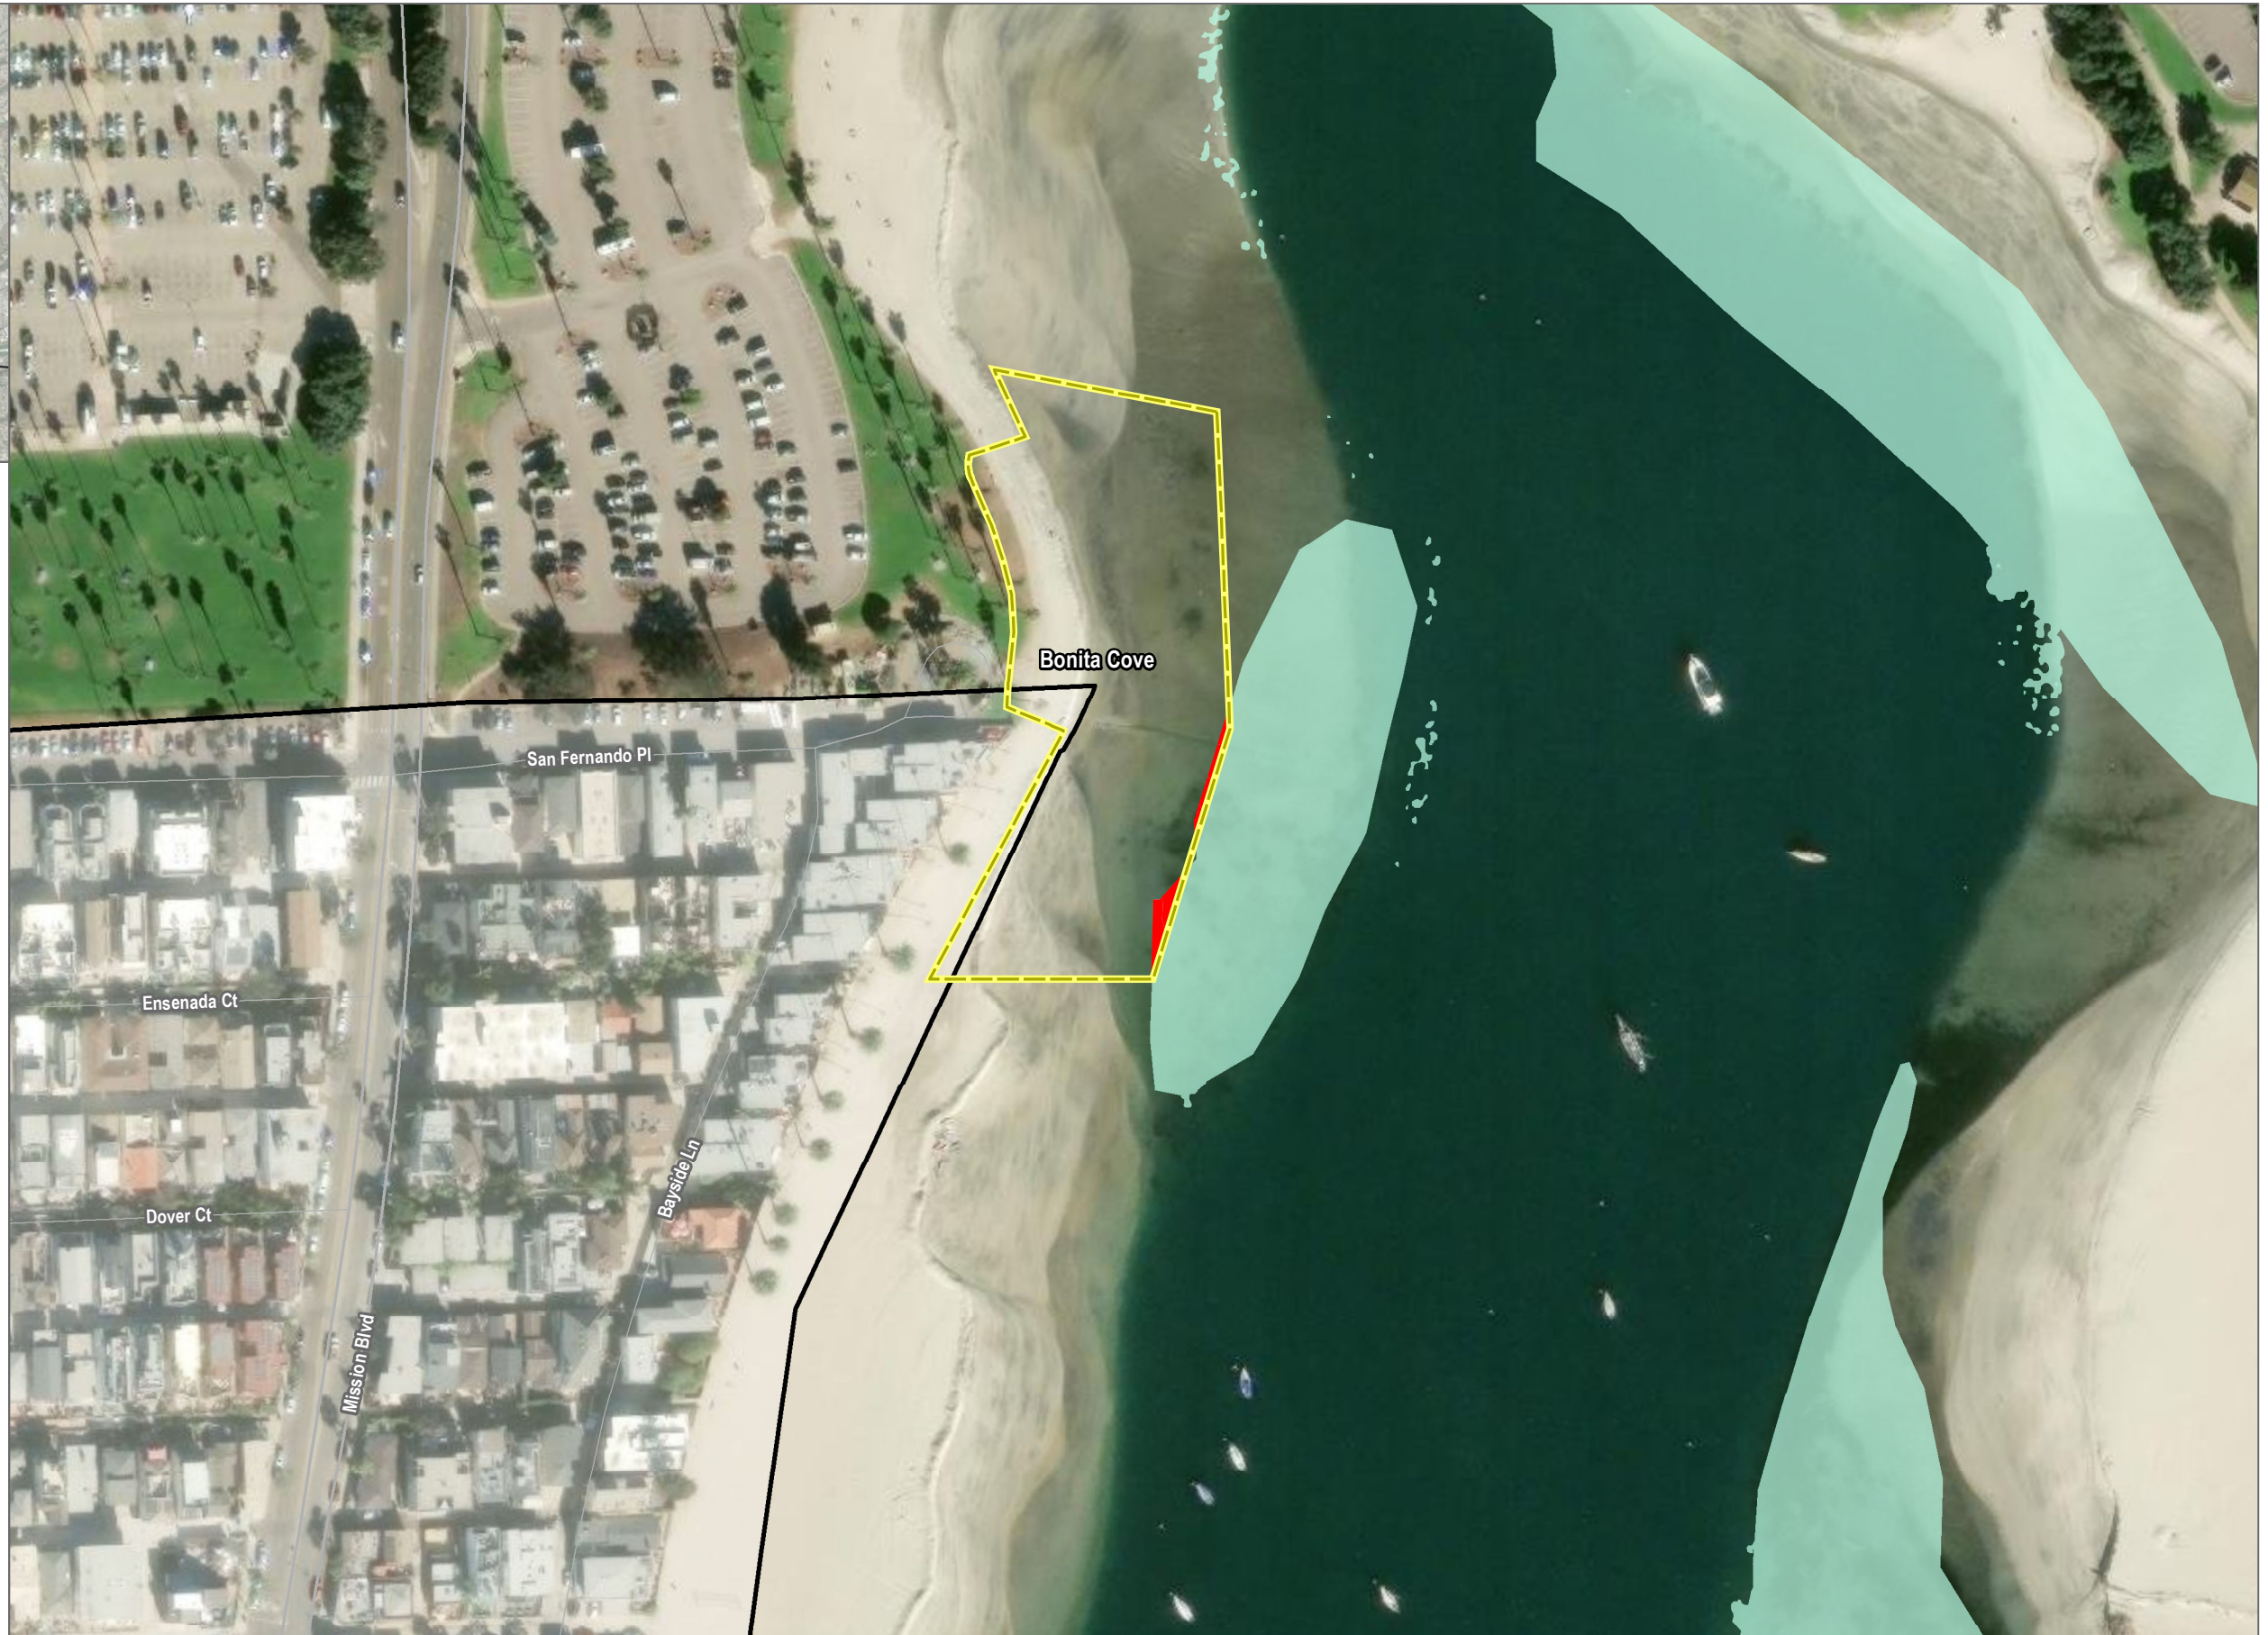
- Mission Bay Park Improvement Zone
- Eelgrass
- Eelgrass Impacts
- Restoration of Shoreline

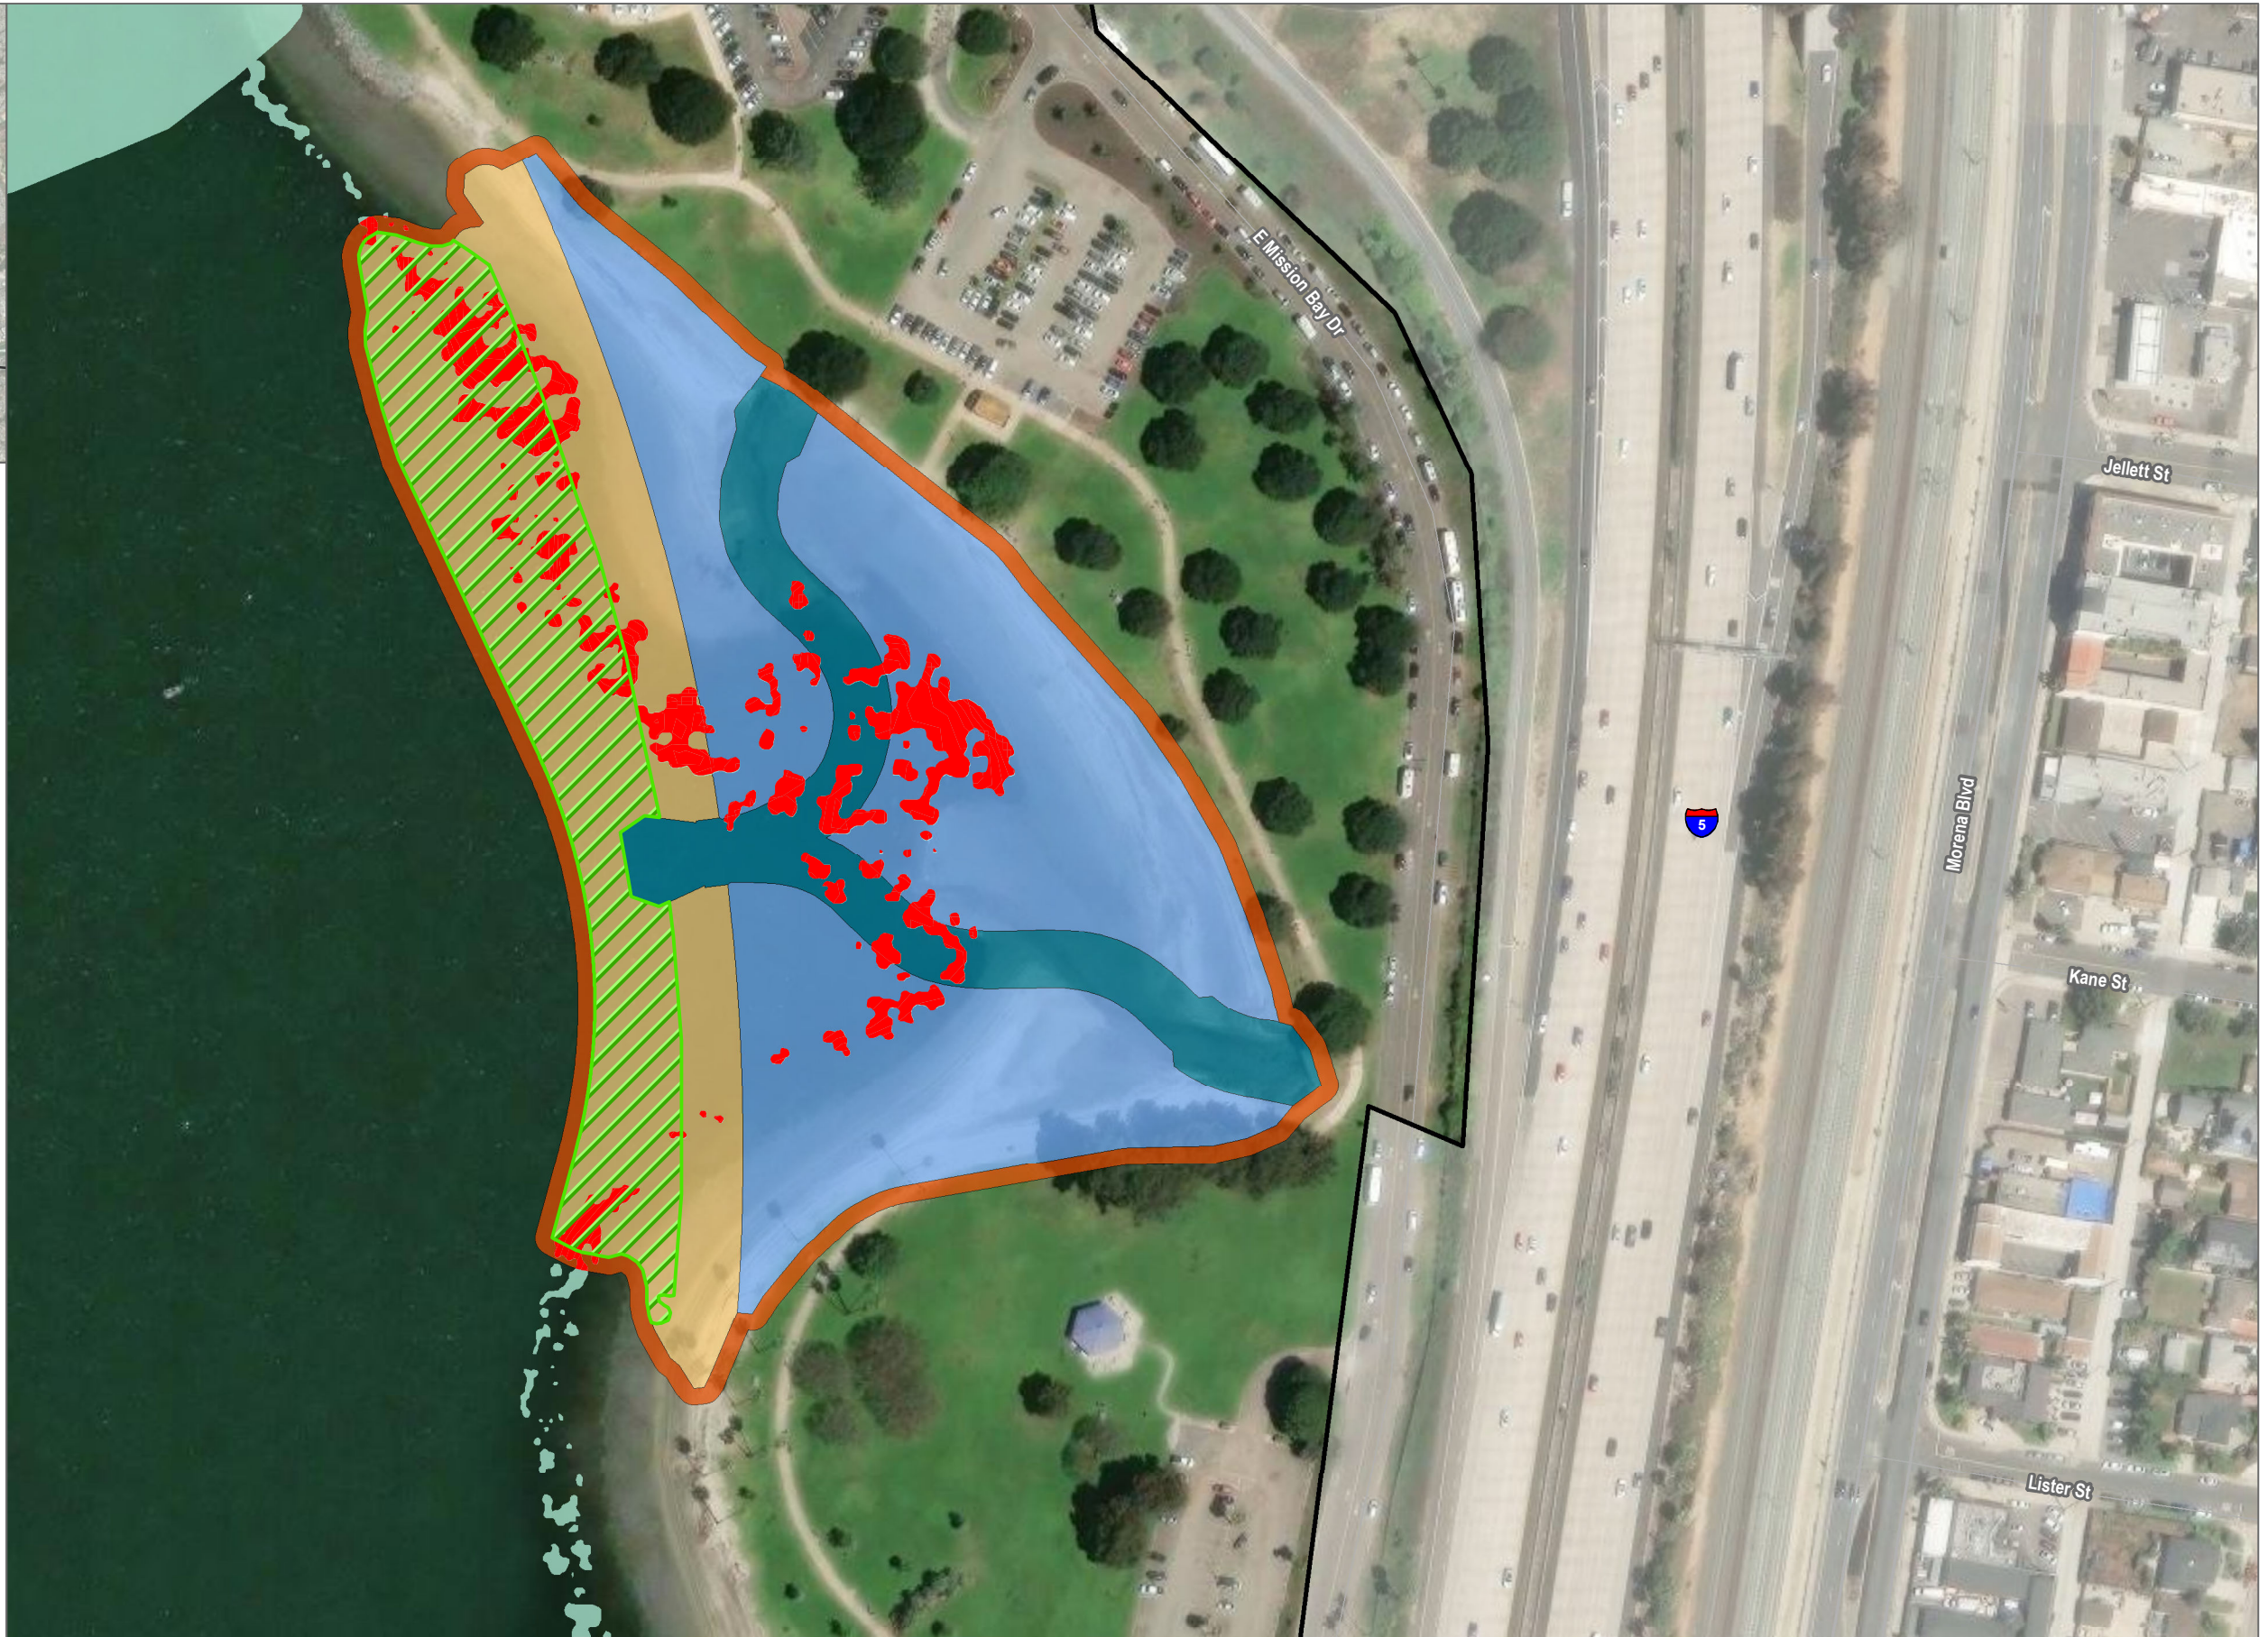
- Mission Bay Park Improvement Zone
- Eelgrass
- Eelgrass Mitigation
- Eelgrass Impacts
- Restoration Areas**
- Berm
- Existing Waterway
- Indirect 15-Foot Buffer
- Subtidal Channel Grading

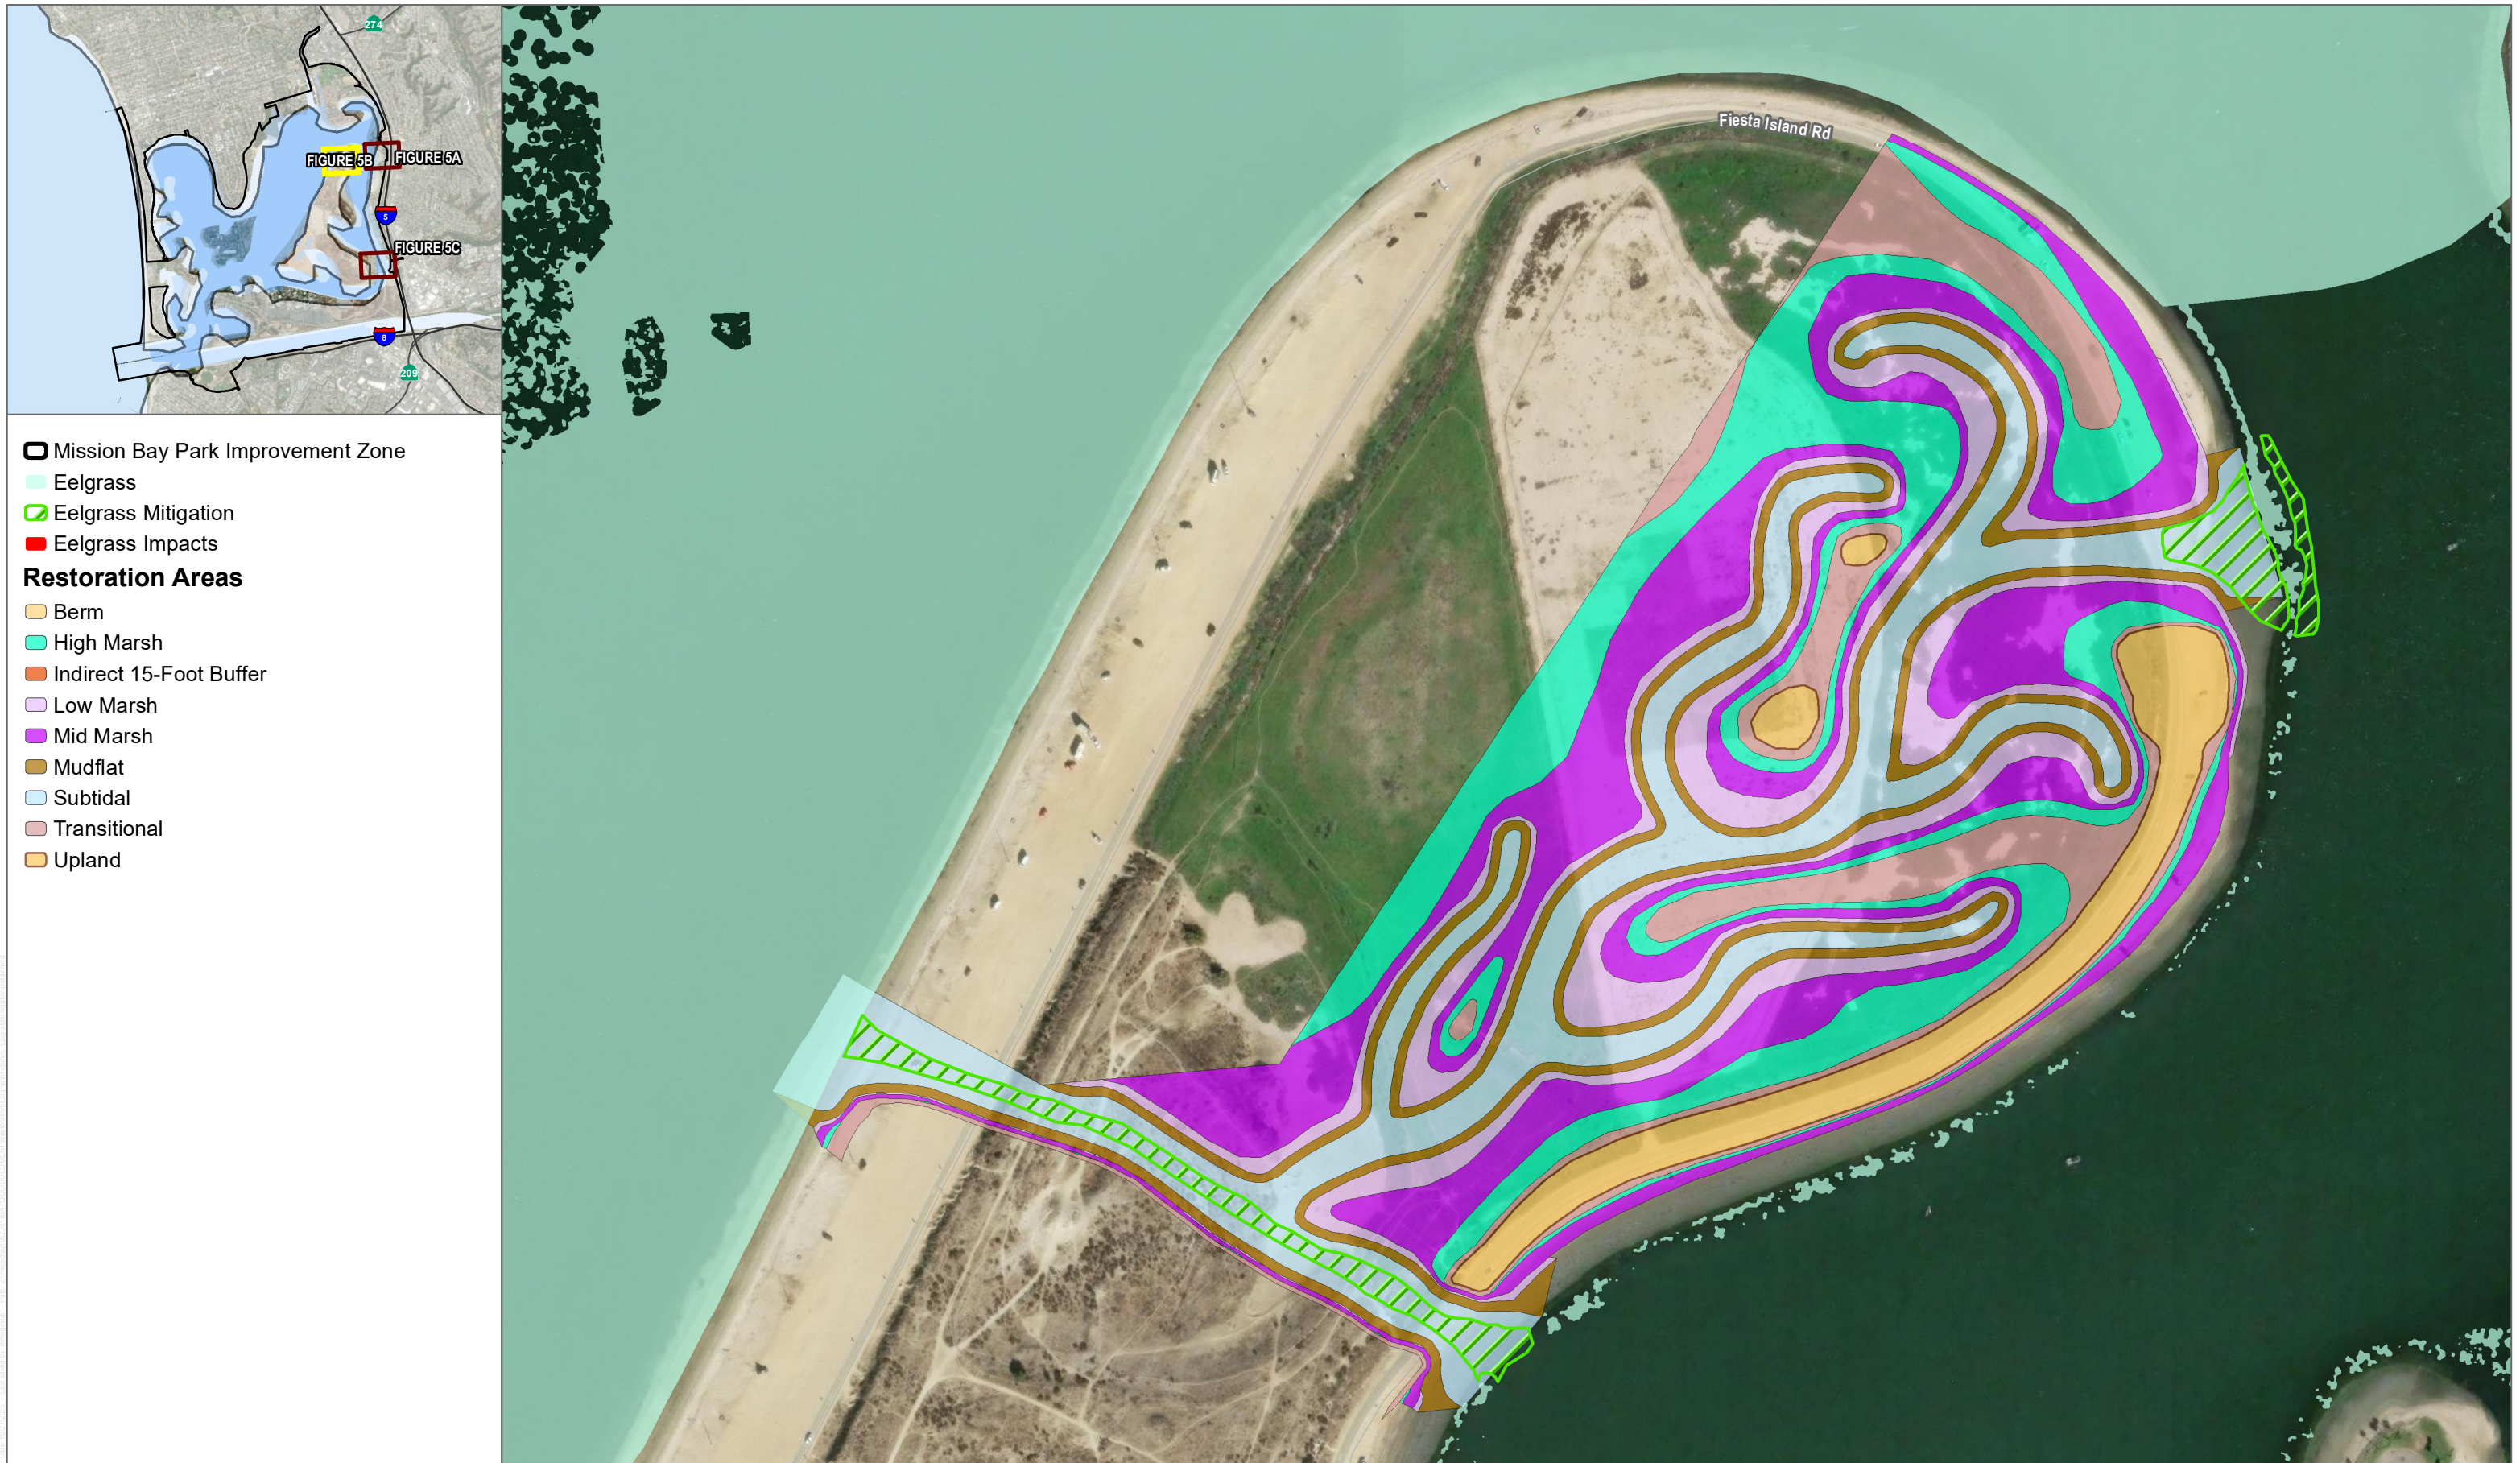
- Mission Bay Park Improvement Zone
- Eelgrass
- Eelgrass Mitigation
- Eelgrass Impacts
- Restoration Areas**
- Berm
- High Marsh
- Indirect 15-Foot Buffer
- Low Marsh
- Mid Marsh
- Mudflat
- Subtidal
- Transitional
- Upland
