**APPENDIX K5**  
*Eelgrass CHRMP*

# MISSION BAY PARK IMPROVEMENTS PROGRAM

## Mission Bay Park Eelgrass Conceptual Habitat Restoration and Monitoring Plan San Diego, California

**APRIL 2026**

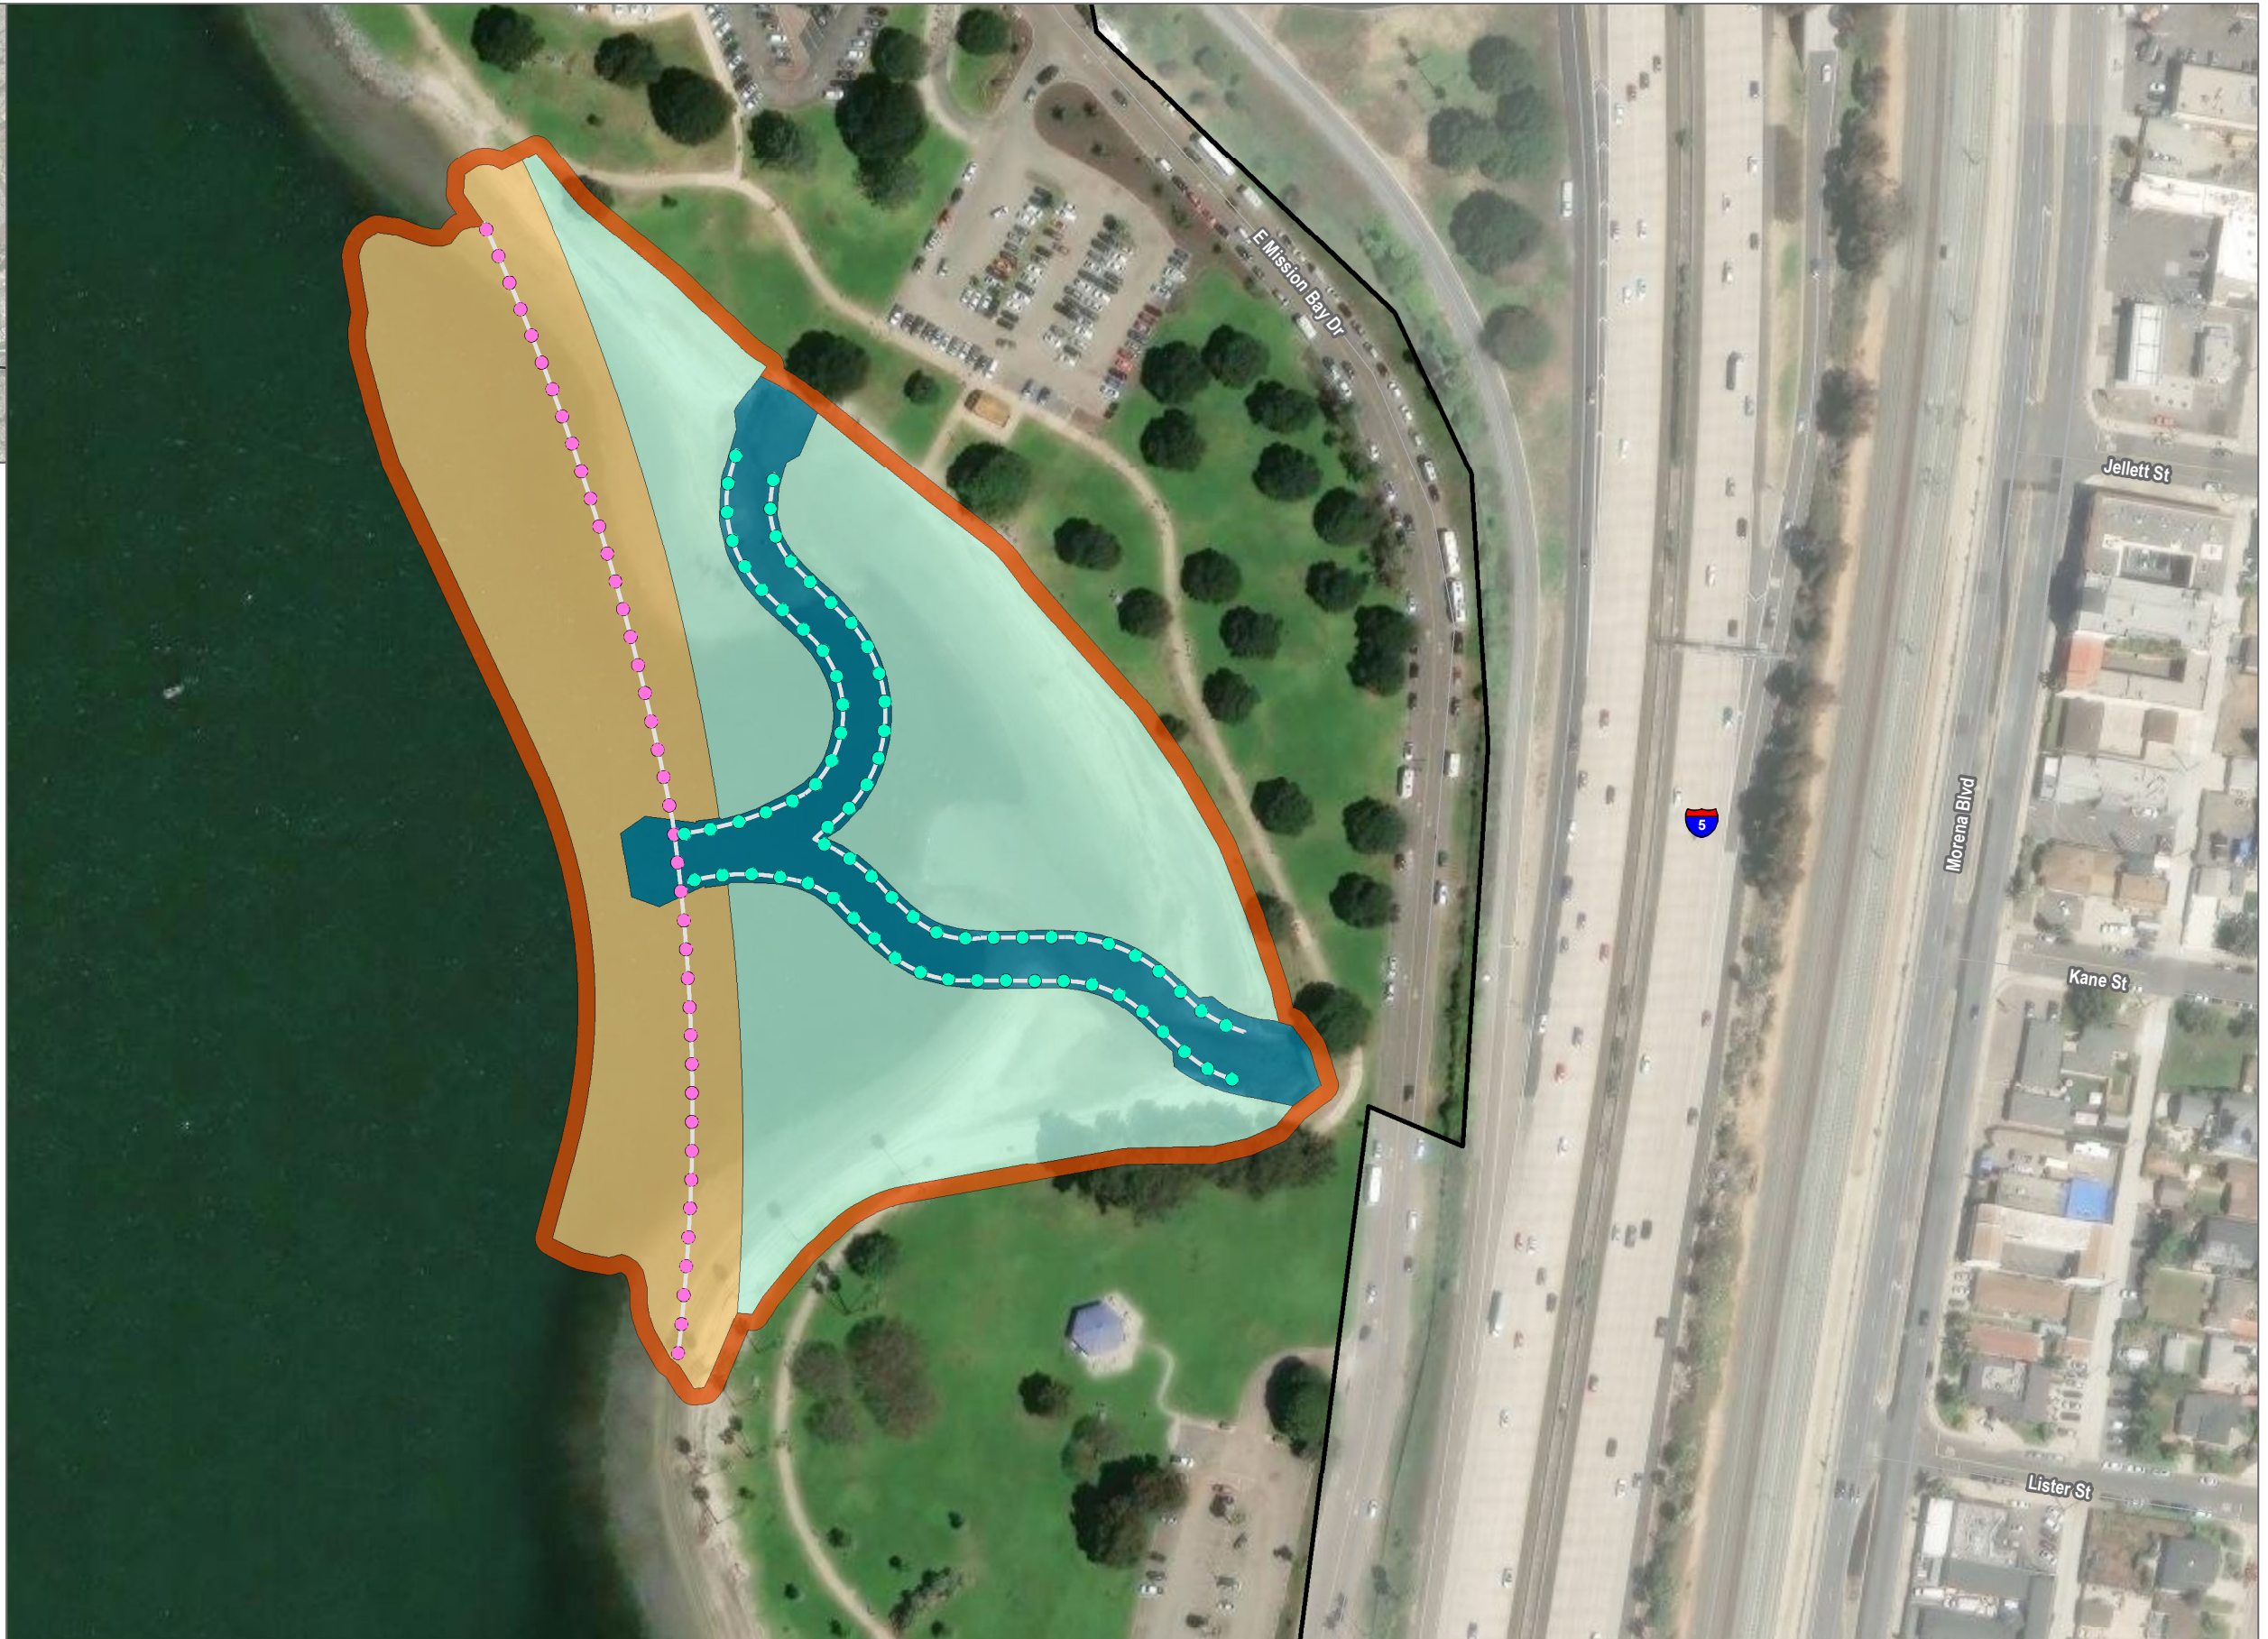
- Mission Bay Park Improvement Zone
  - Shell Bags (1,791 Linear Ft.)
  - Reef Balls (1,013 Linear Ft.)
- Restoration Areas**
- Berm
  - Existing Waterway
  - Indirect 15-Foot Buffer
  - Subtidal Channel Grading

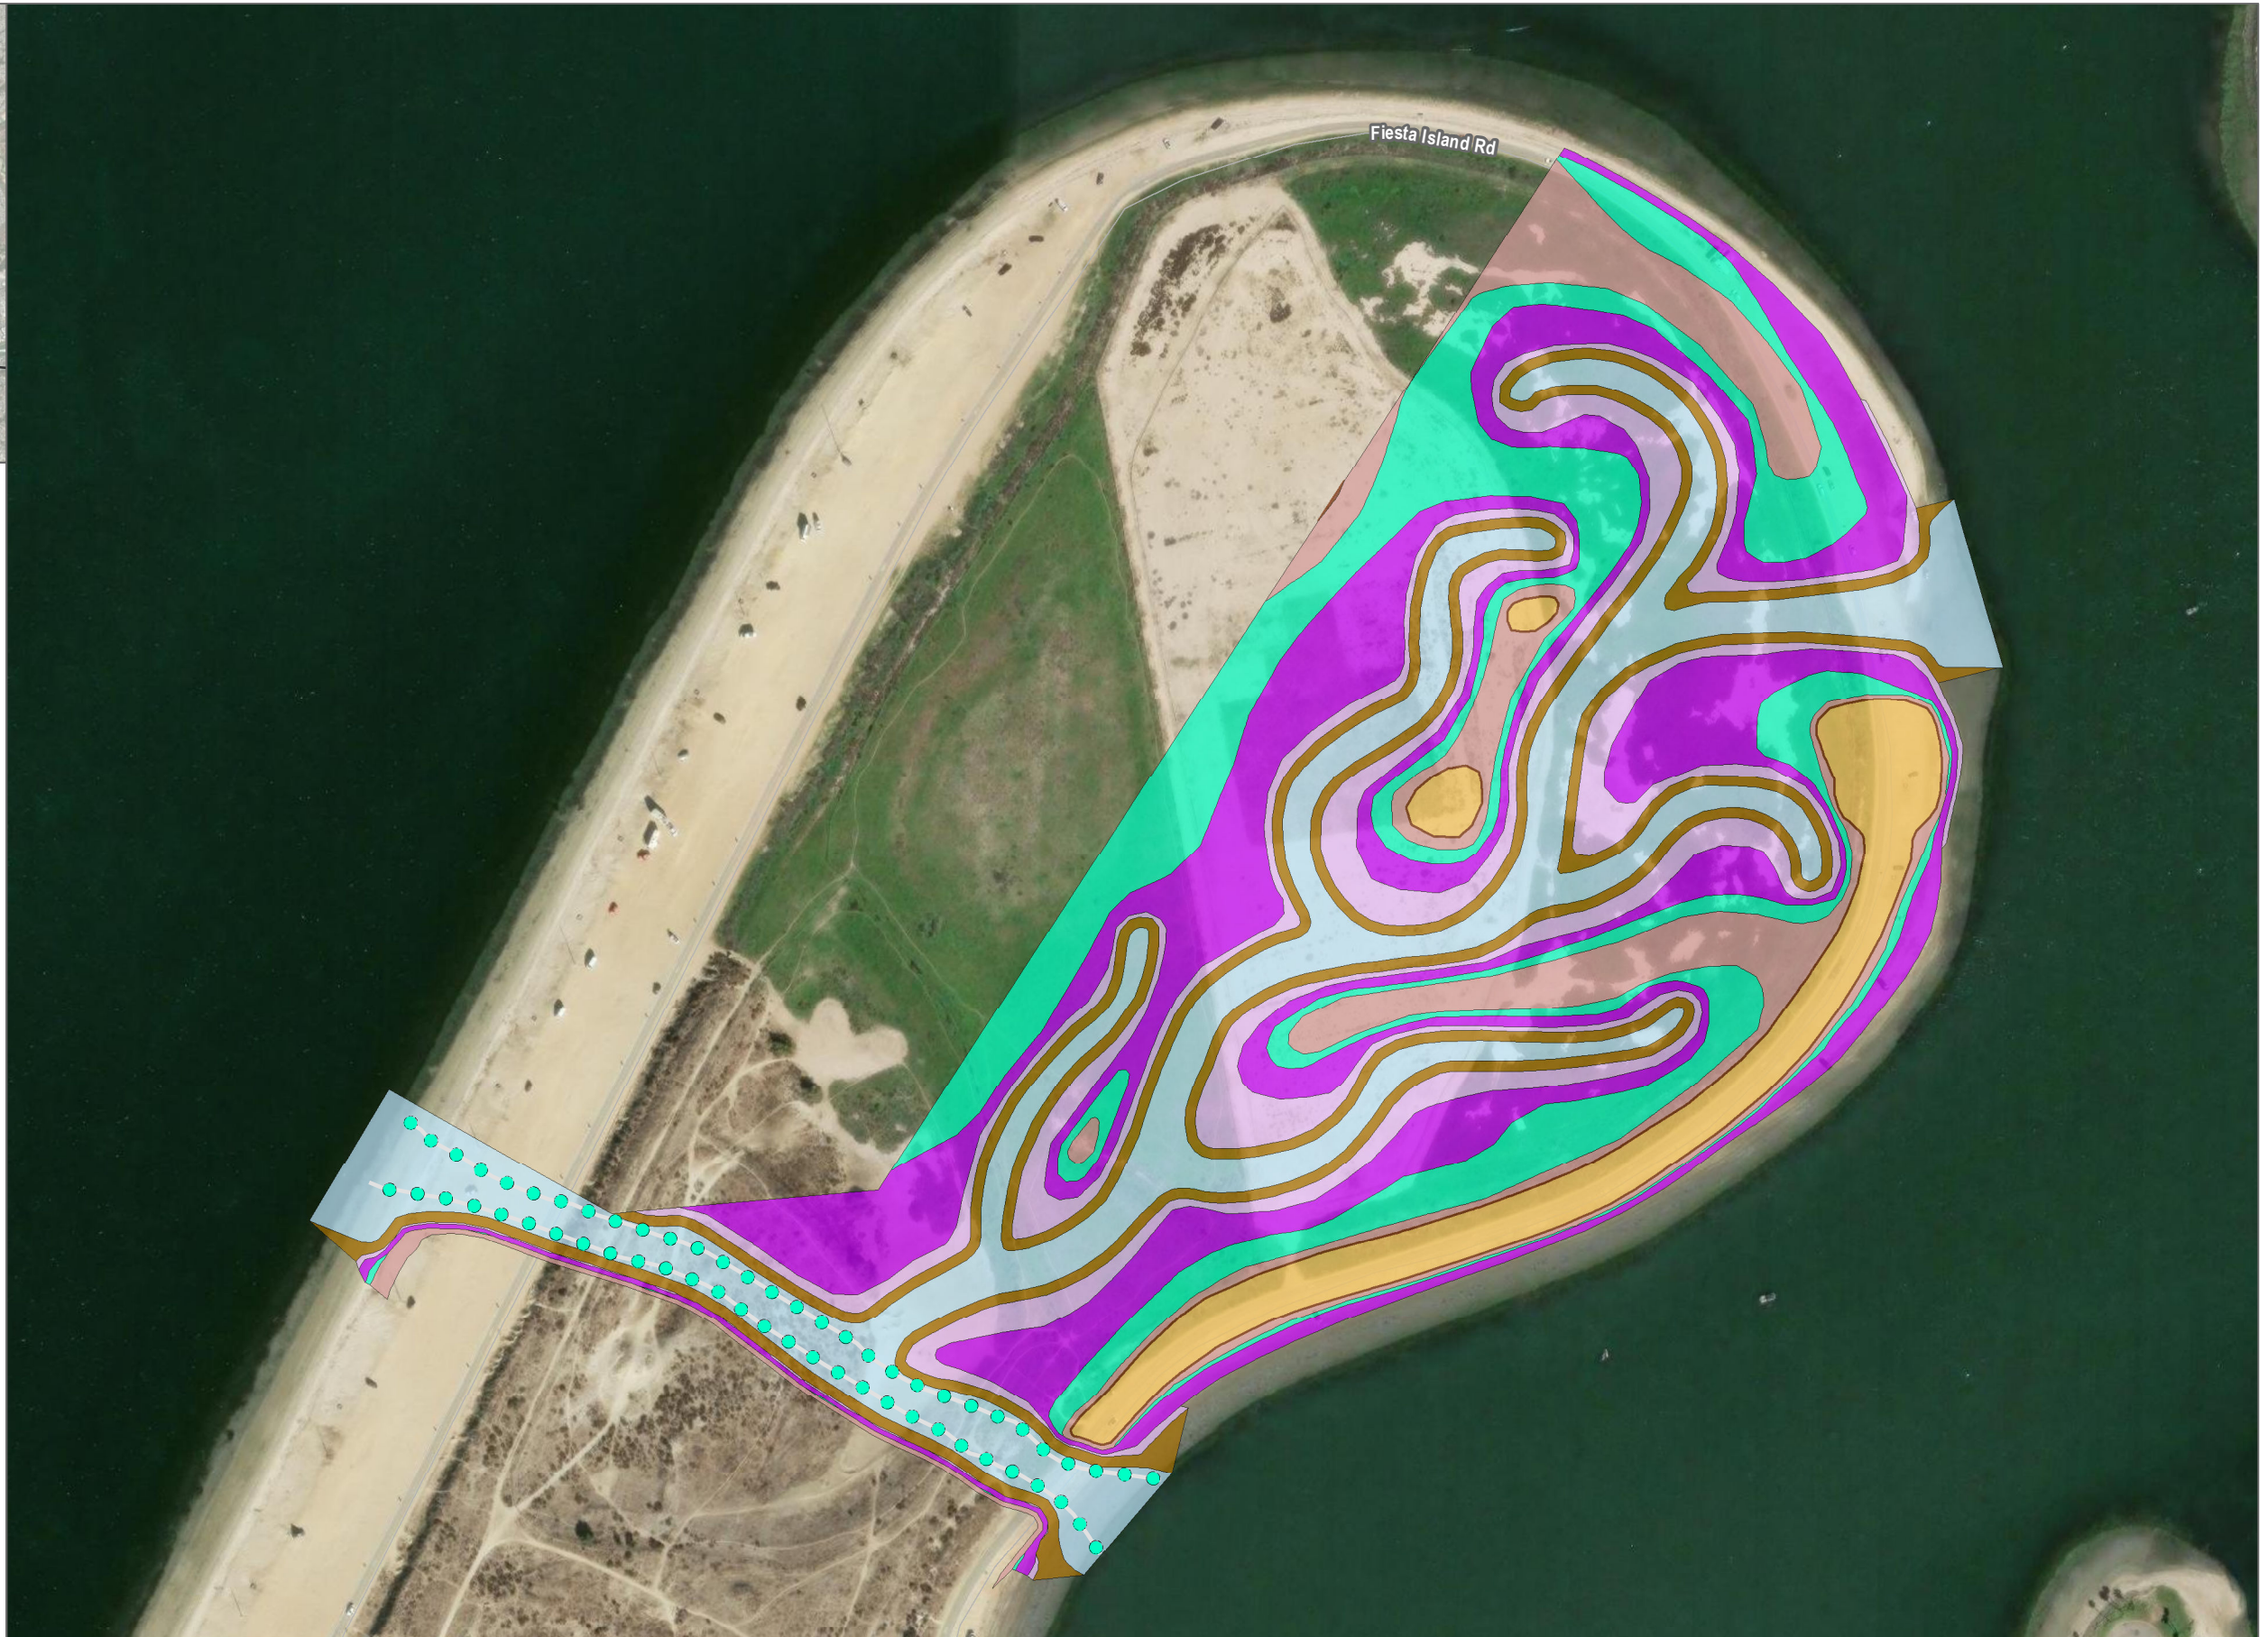
- ▭ Mission Bay Park Improvement Zone
- Shell Bags (2,434 Linear Ft.)
- Restoration Areas**
- Berm
- High Marsh
- Indirect 15-Foot Buffer
- Least Tern Preserve
- Low Marsh
- Mid Marsh
- Mudflat
- Subtidal
- Transitional
- Upland

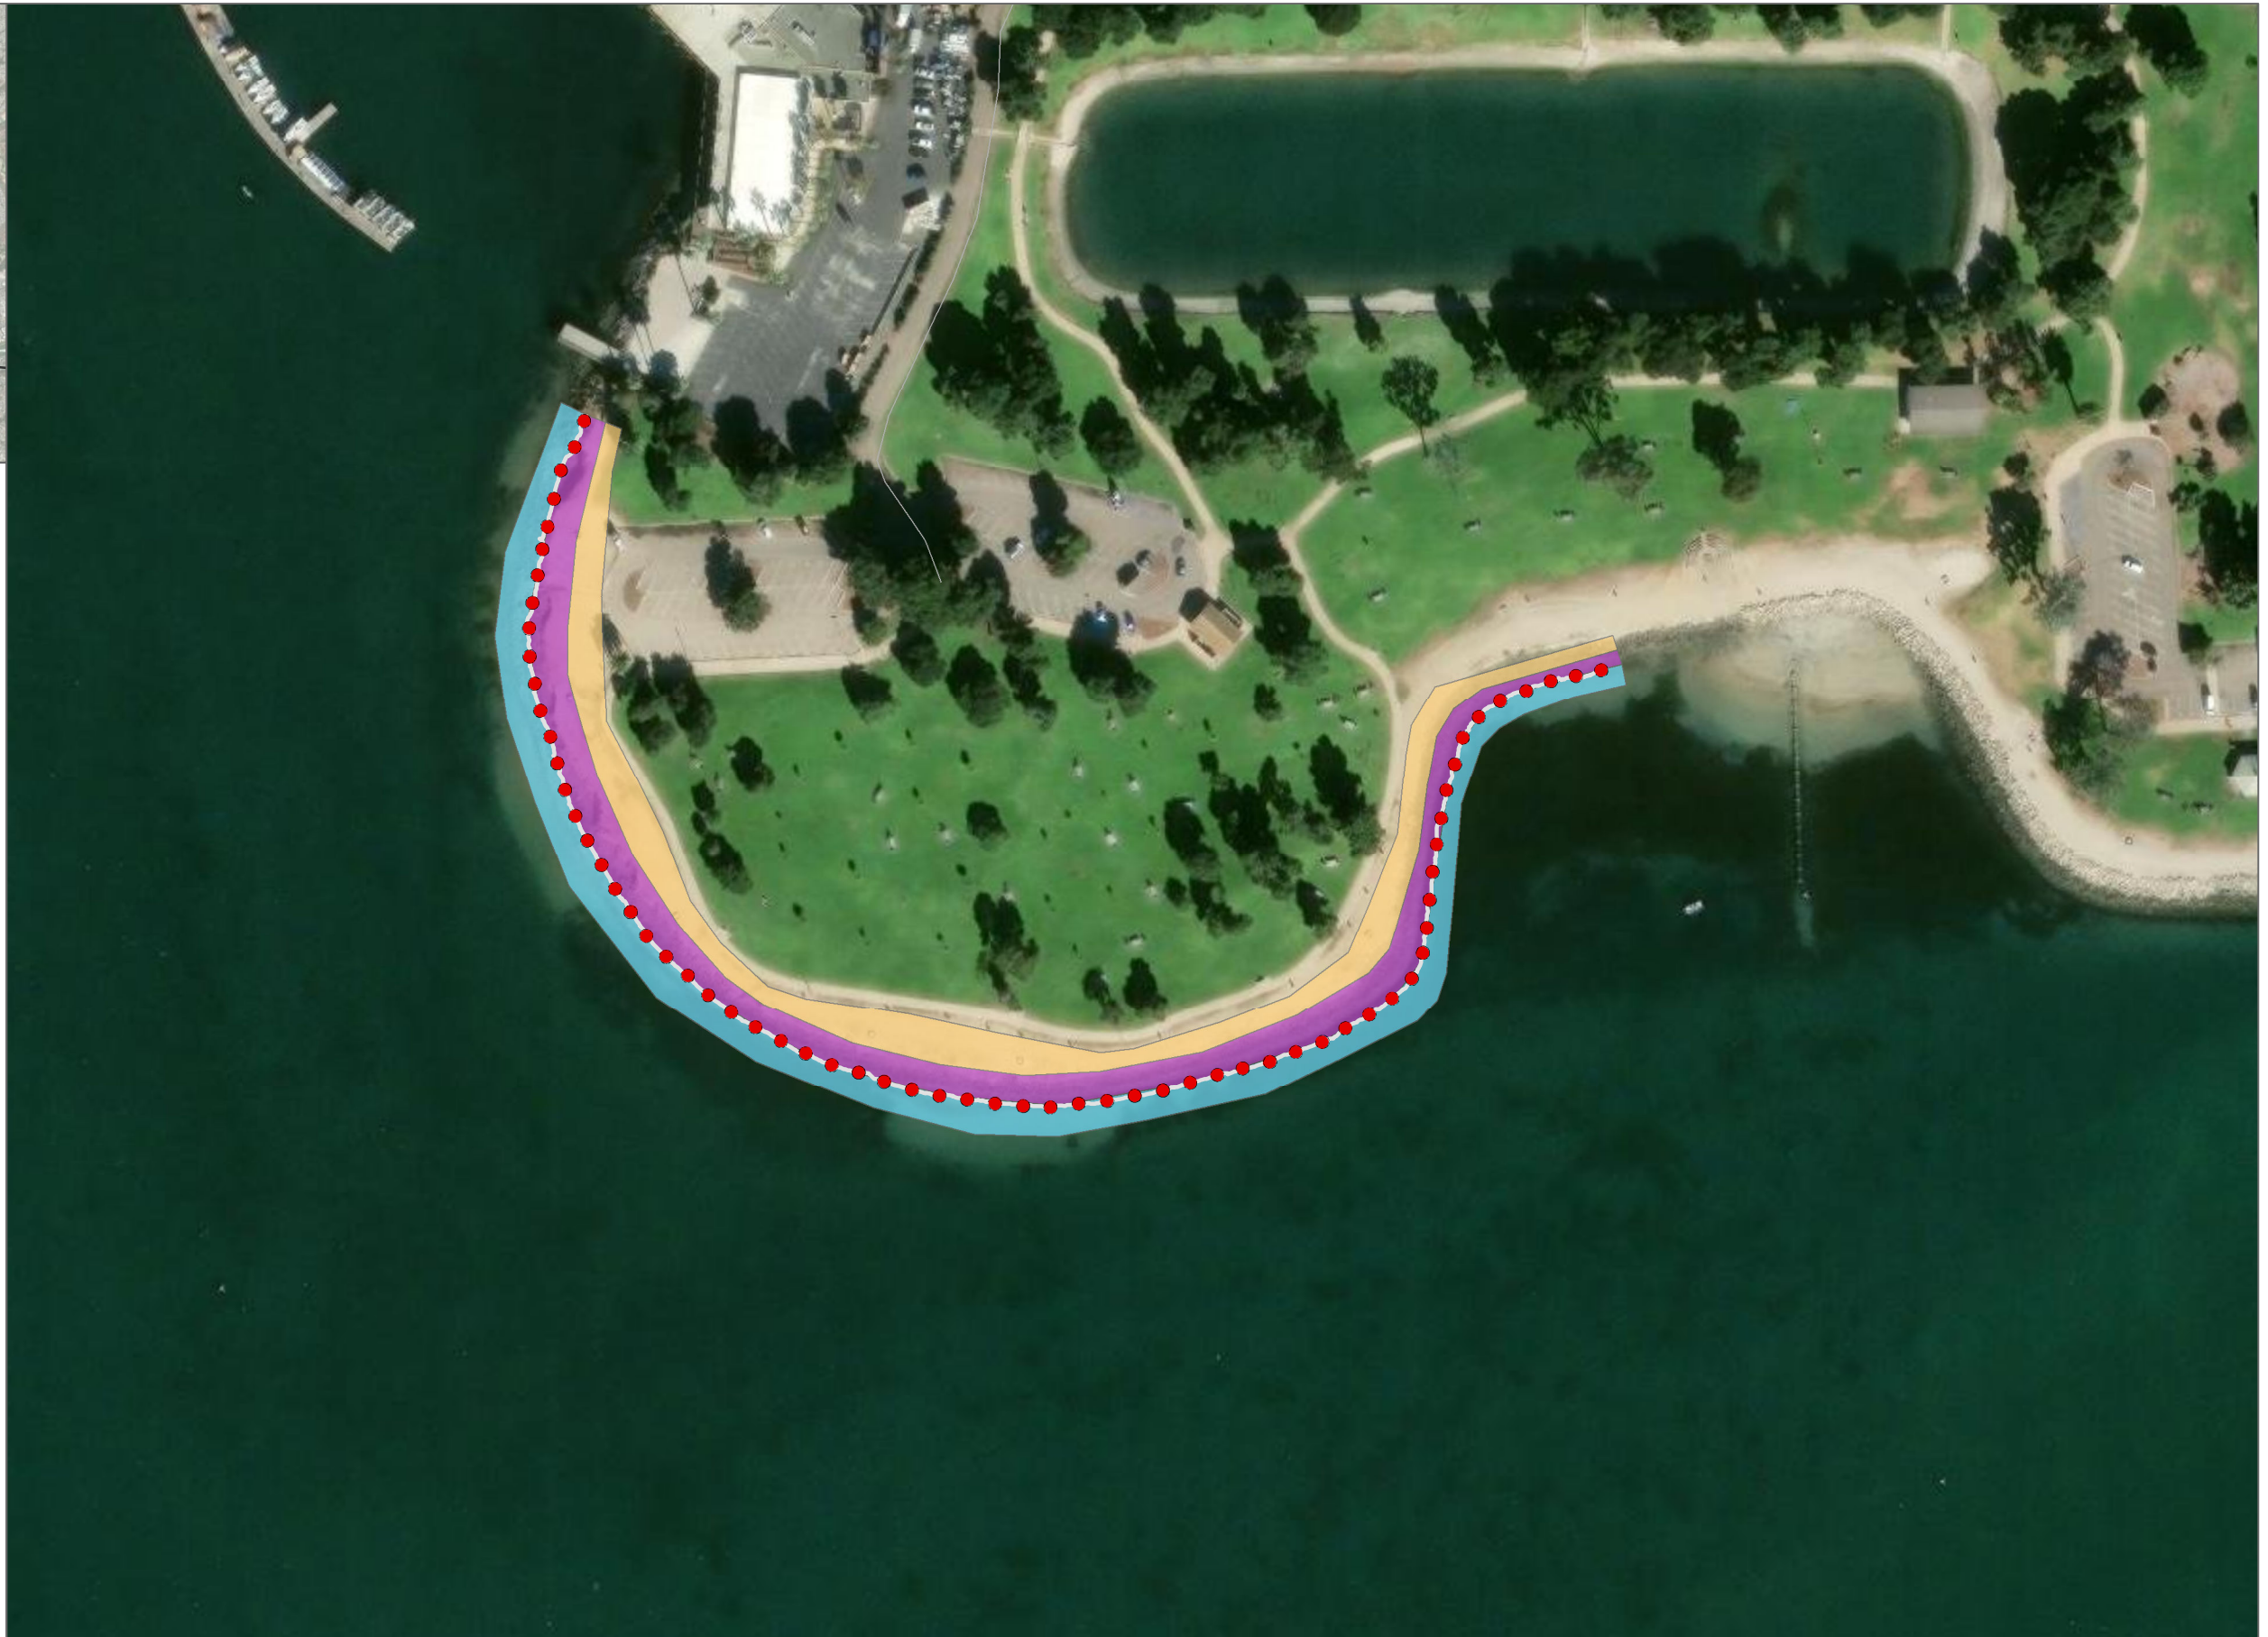
- Mission Bay Park Improvement Zone
- Riprap Extension (1,636 Line Ft.)
- Restoration Areas**
- Buried Revetment Crest
- Revetment Repaired/Raised to Accomodate Sea Level Rise
- Oyster Habitat

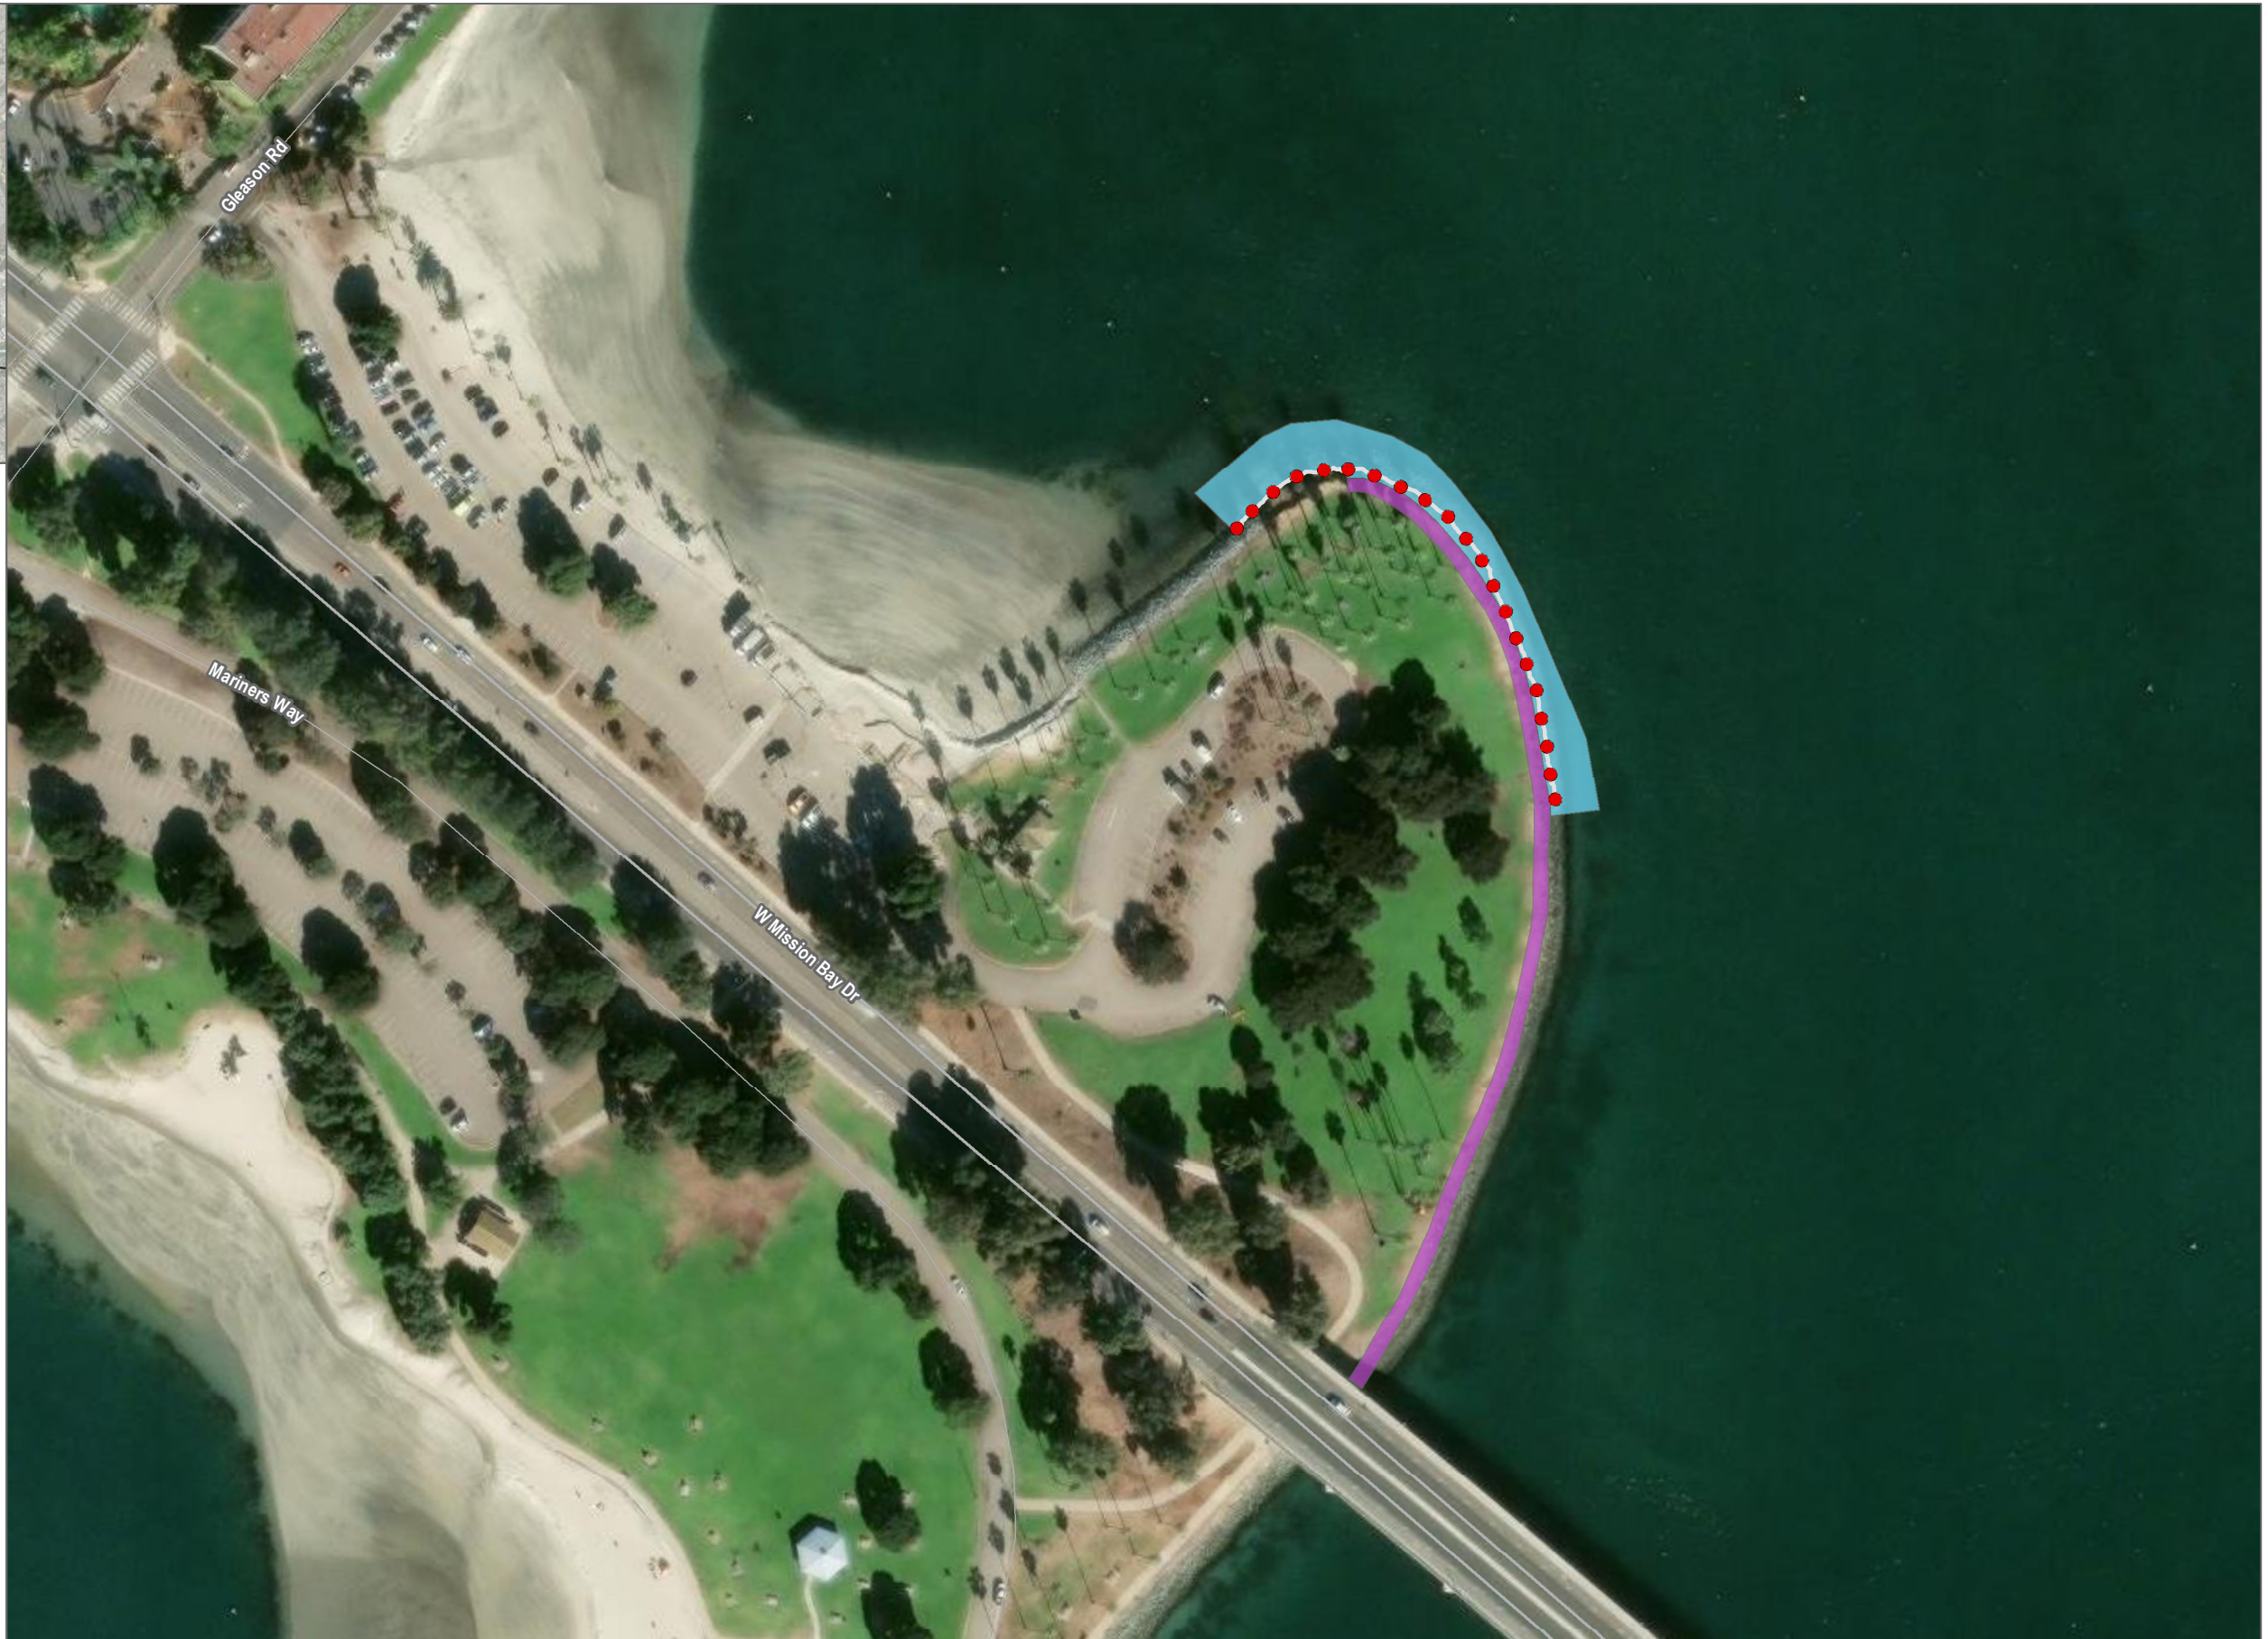
- Mission Bay Park Improvement Zone
- Riprap Extension (509 Line Ft.)
- Restoration Areas**
- Revetment Repaired/Raised to Accomodate Sea Level Rise
- Oyster Habitat
