Mission Bay Park Improvements Program: Implementation Framework

March 2026

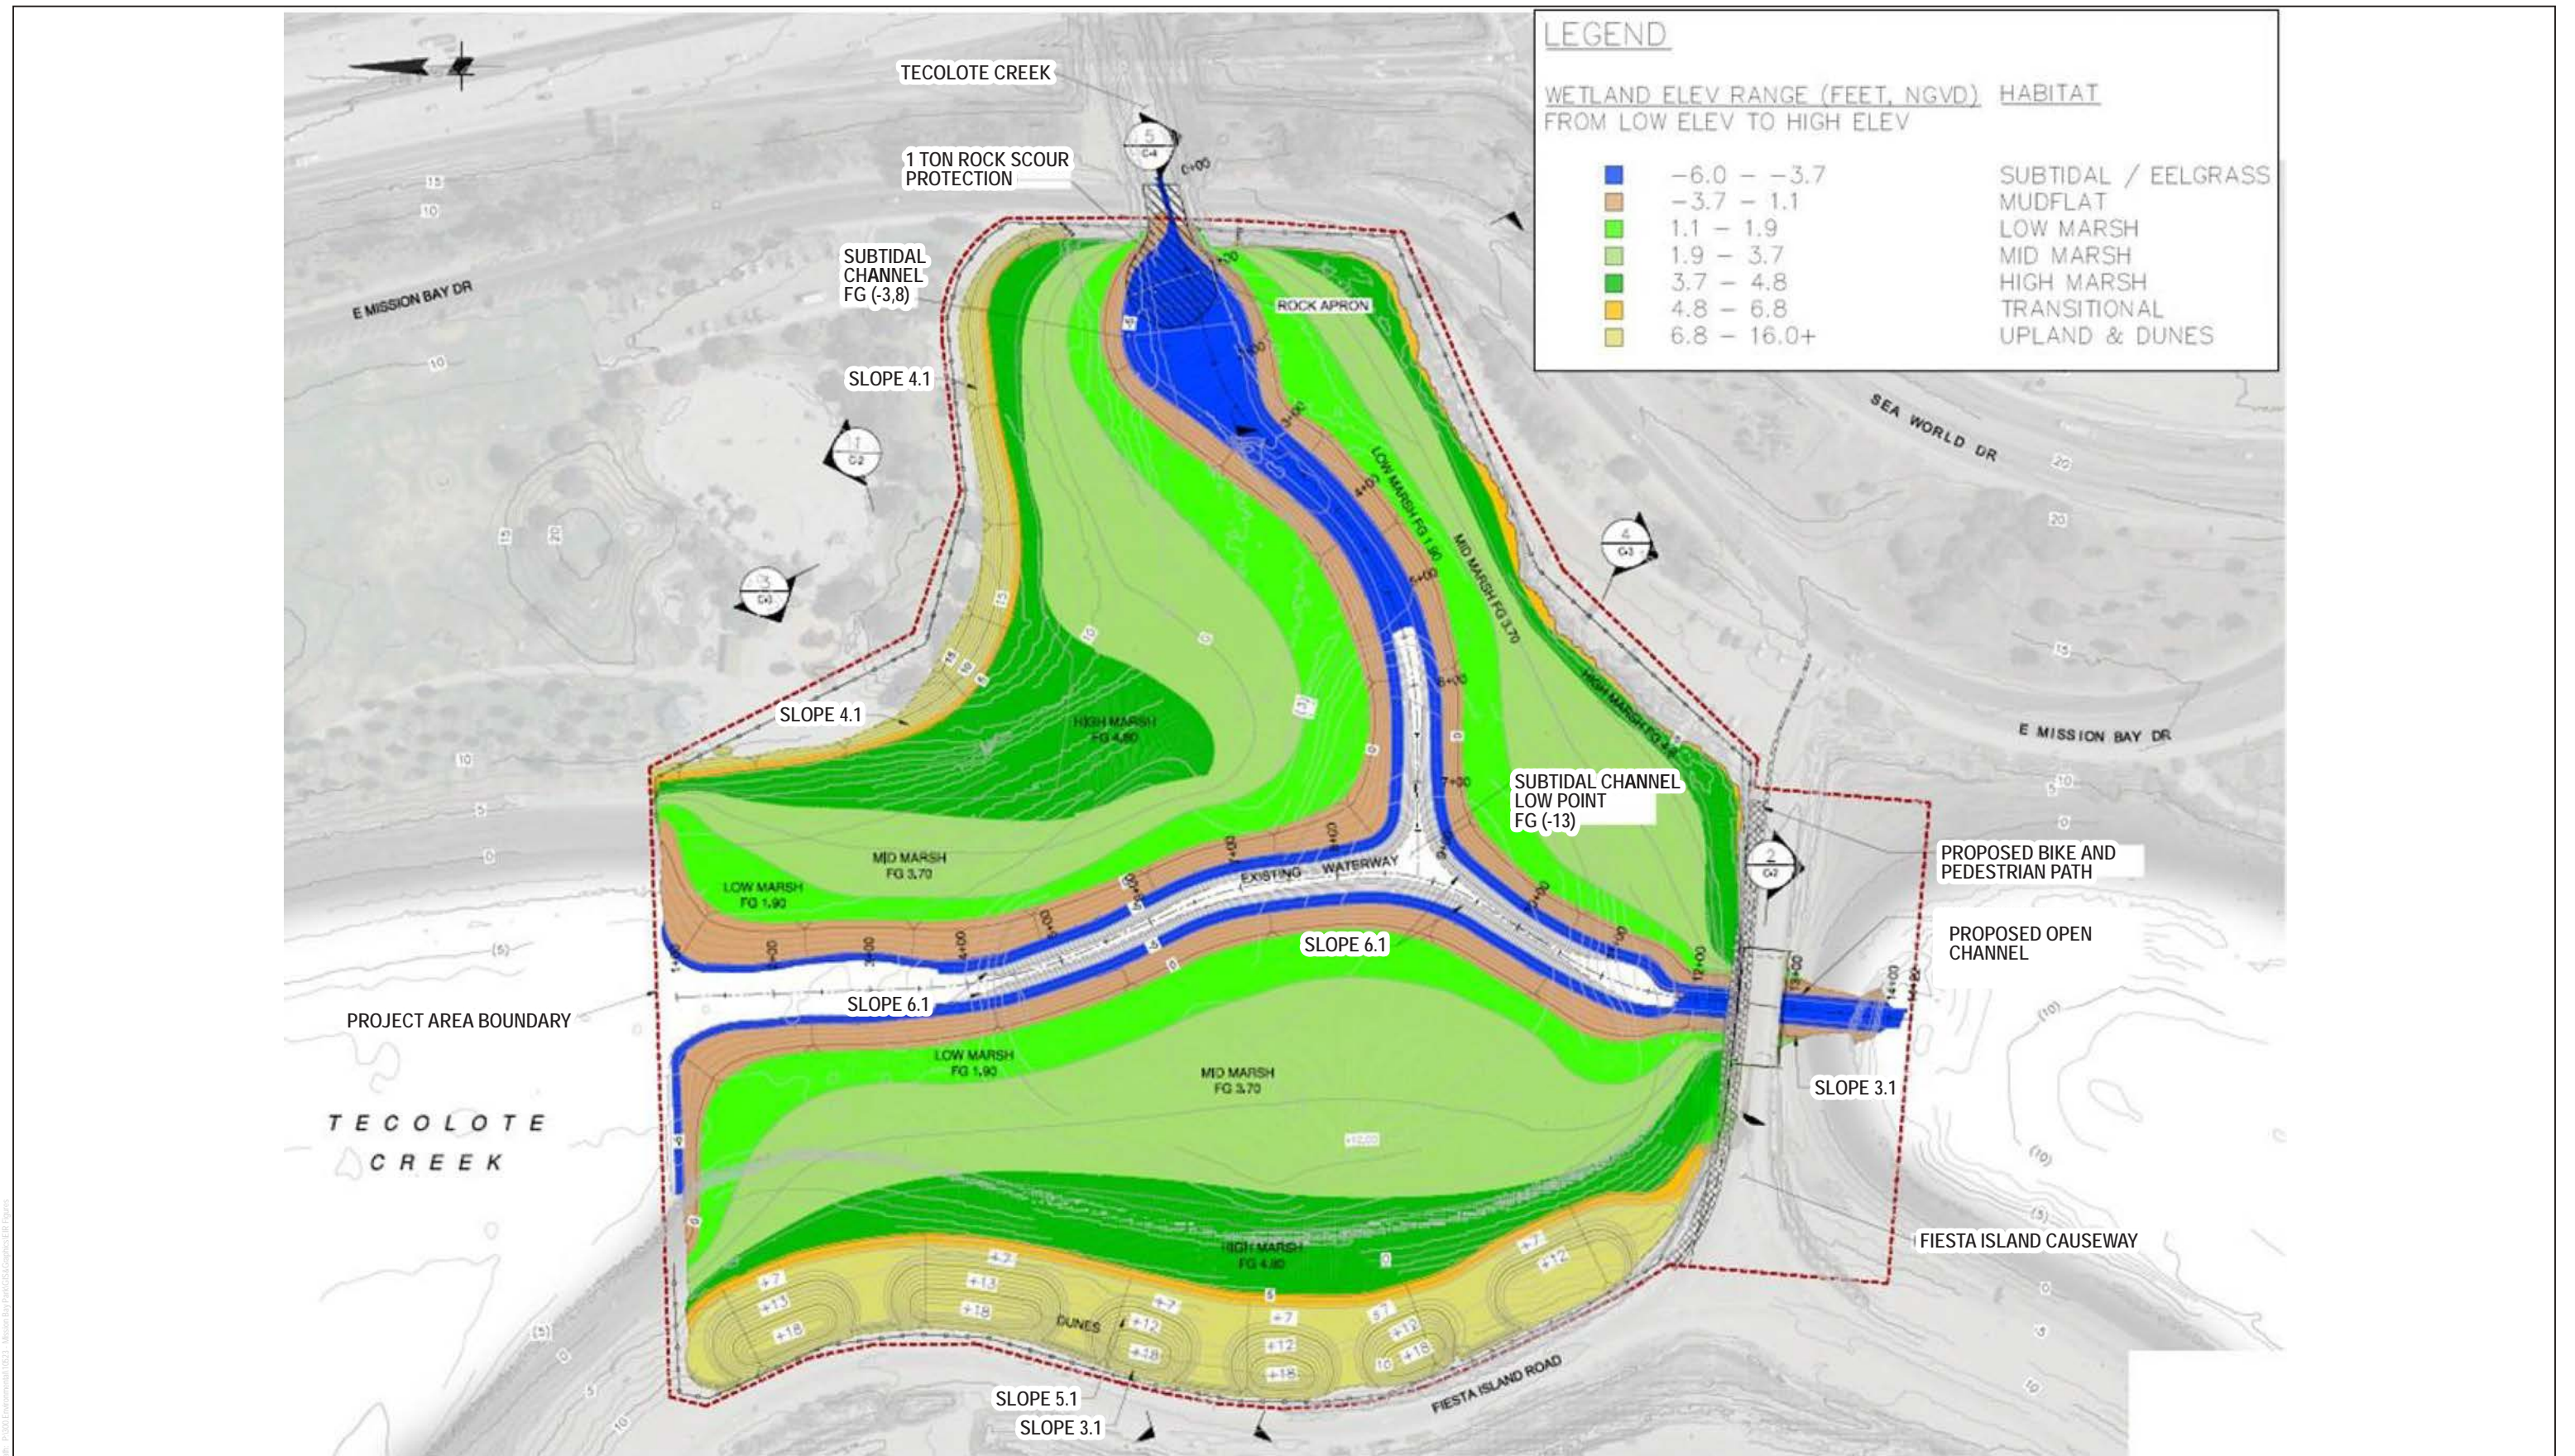
FIGURE 6

SOURCE: Moffatt & Nichol. 2021. Preliminary Engineering Report Tecolote Creek Wetland Restoration & Fiesta Island Causeway

The bridge would be constructed using cast-in-drilled-hole piles, pre-cast concrete girders, and a cast-in-place concrete deck, and could be installed one segment at a time to maintain traffic access with the use of flaggers. Alternatively, culverts could be installed through excavation and placement, although they present hydraulic limitations and potential safety concerns. Construction equipment needed for the bridge or culvert installation would include a crane, drill rig, concrete pump, and additional excavators or dredging equipment.

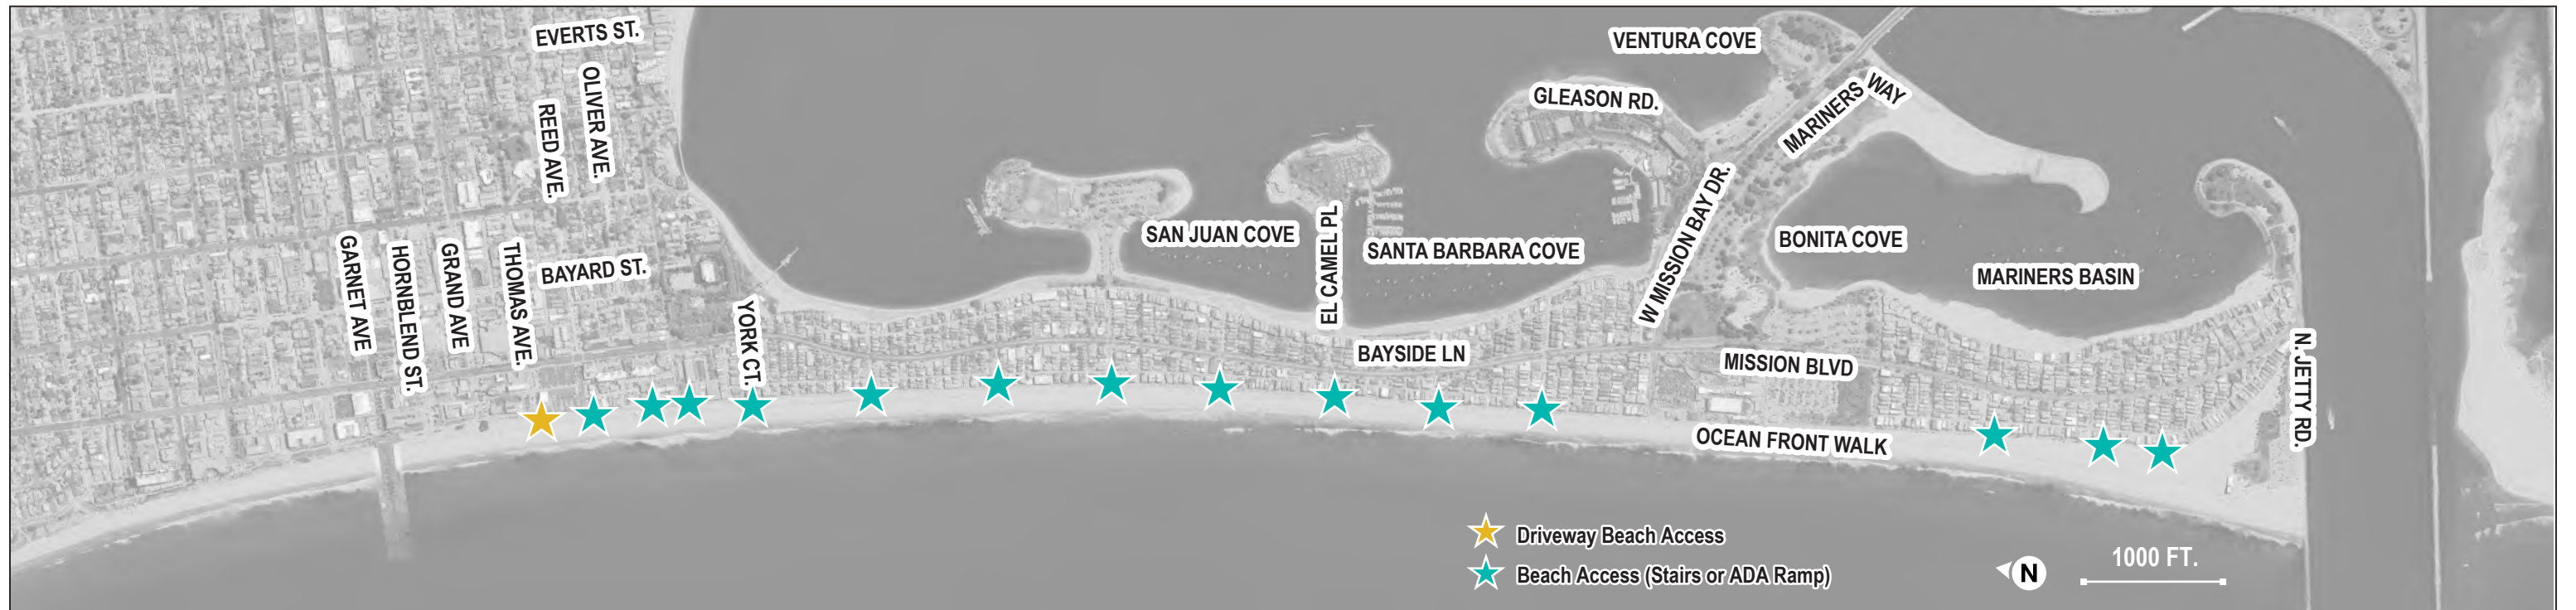
EXISTING PEDESTRIAN BEACH ACCESS LOCATIONS WITHIN PROJECT LIMITS

Pedestrian beach access along Segments A and B is currently provided by “pop-out” stairways at 14 locations, shown in Figure 27, Seawall – Pedestrian Access, ADA Ramp, and Driveway. The existing stairs are non-code-compliant due to the insufficient top landing width and lack of fall protection and handrail.

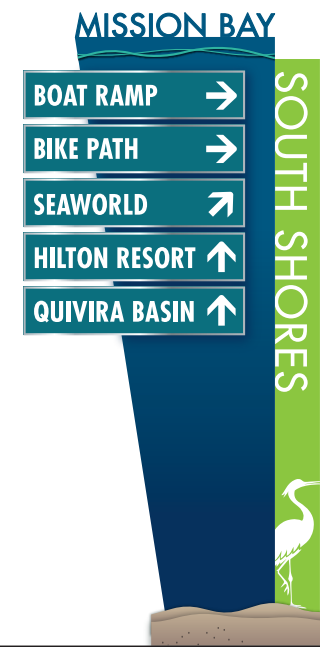
Revised Walkway Directory
