# **Biological Technical Report for the Mission Bay Park Master Plan Update: Fiesta Island Amendment**

October, 2017

**Alden Environmental, Inc.**

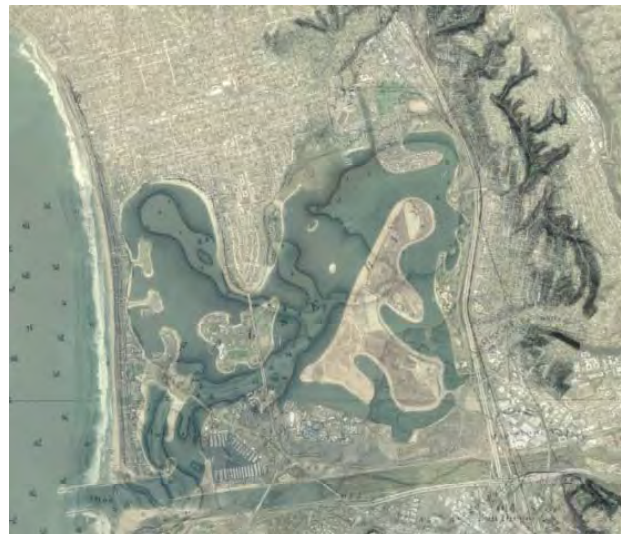
*False Bay from 1859 U.S. Coast & Geodetic Survey (top) along with present Mission Bay configuration shown as transparent overlay (bottom)*

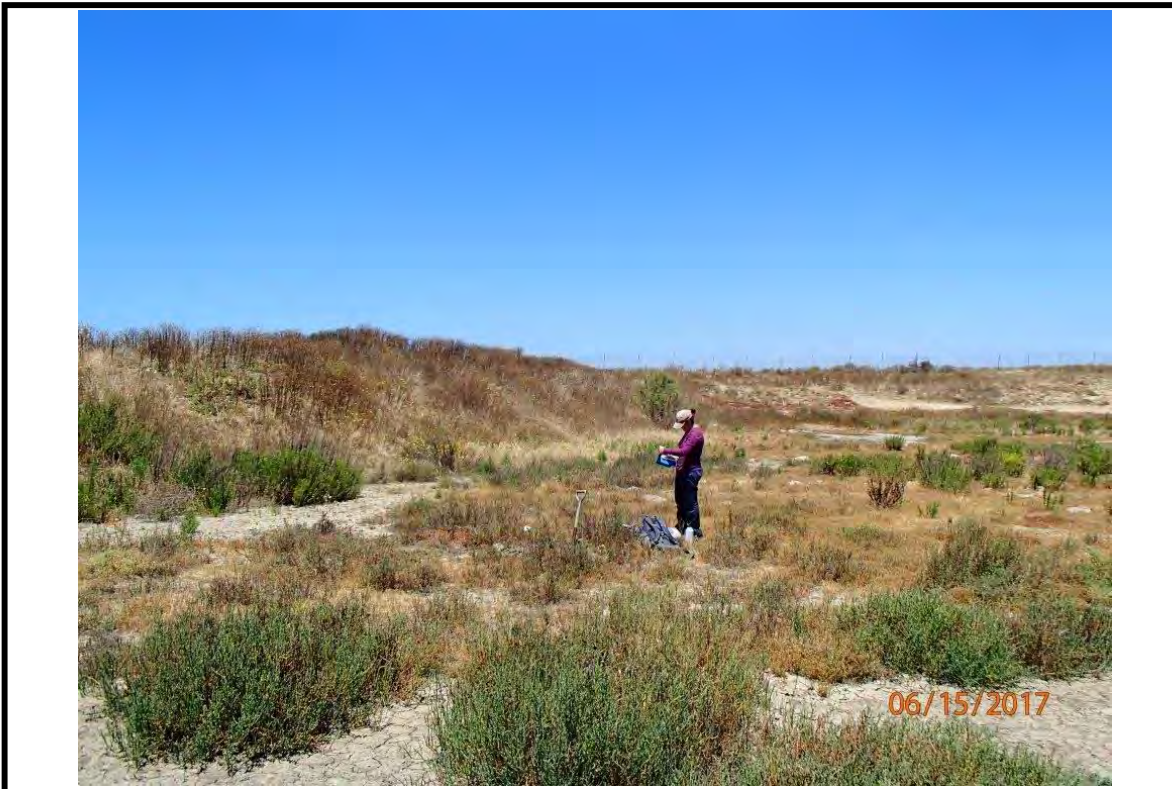
**Photo Point 1.** Overview of Data Point 1; taken on June 15, 2017 and directed west. Data point located within a shallow depression within a much larger basin. Area classified as southern coastal salt marsh.

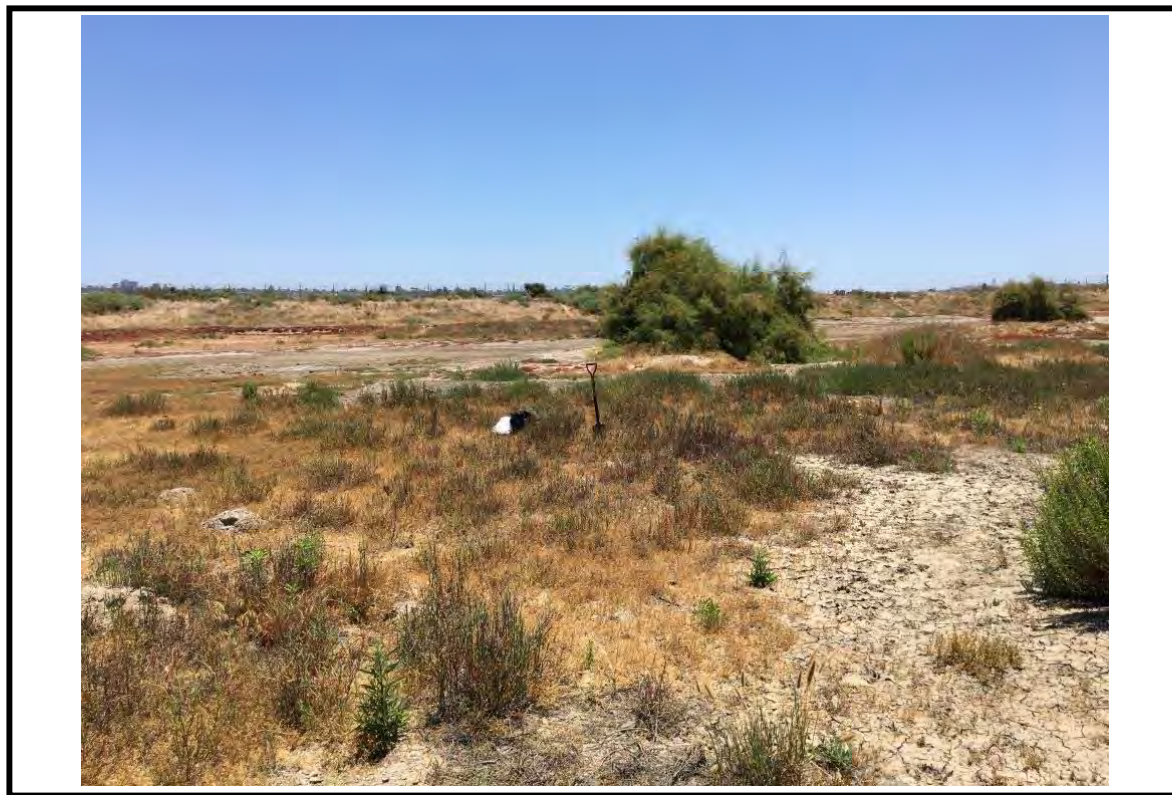
**Photo Point 2.** Overview of Data Point 1; taken on June 15, 2017 and directed southeast. Data point 2 and 3 are located in the background (refer to Photo Points 3 through 6).

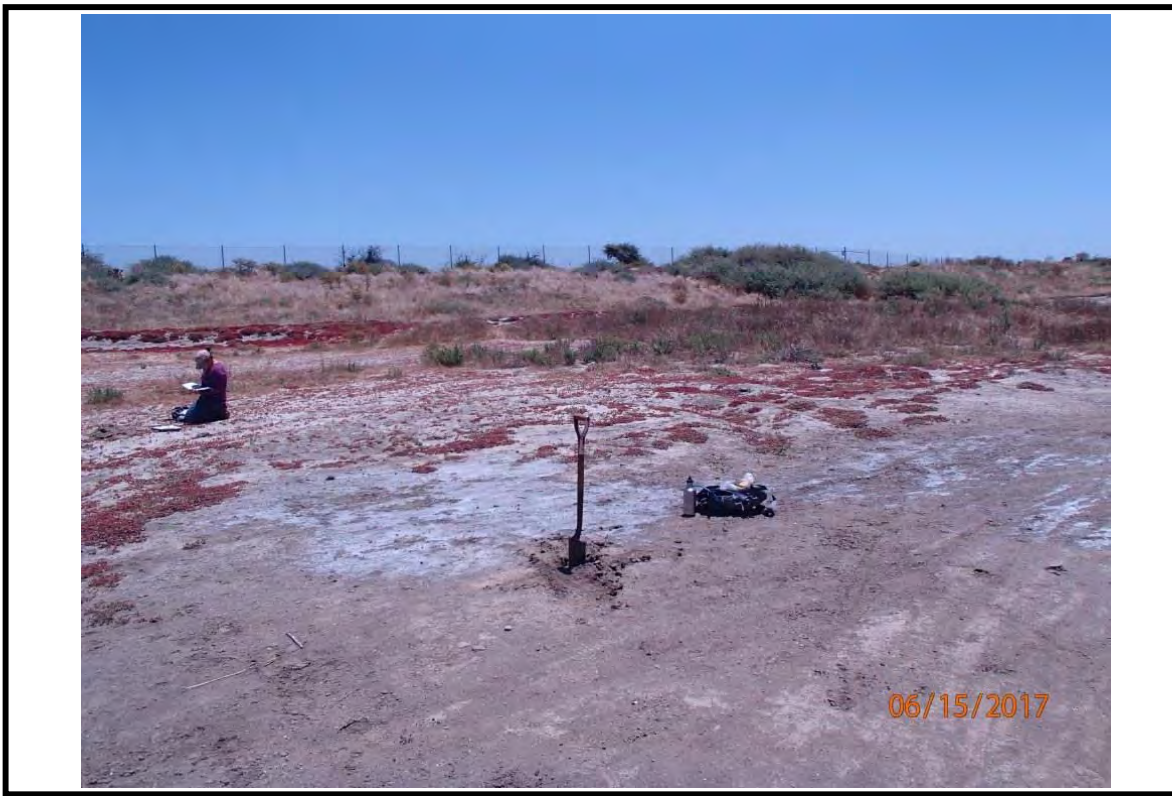
**Photo Point 3.** Photo of Data Point 2 (shovel in foreground); taken on June 15, 2017 and directed southeast. Data point located within a shallow depression within a much larger basin. Area classified as saltpan/mudflat. This location represents the approximate boundary between saltpan/mudflat and disturbed habitat (i.e., Data Point 3, M&A biologist in the background).

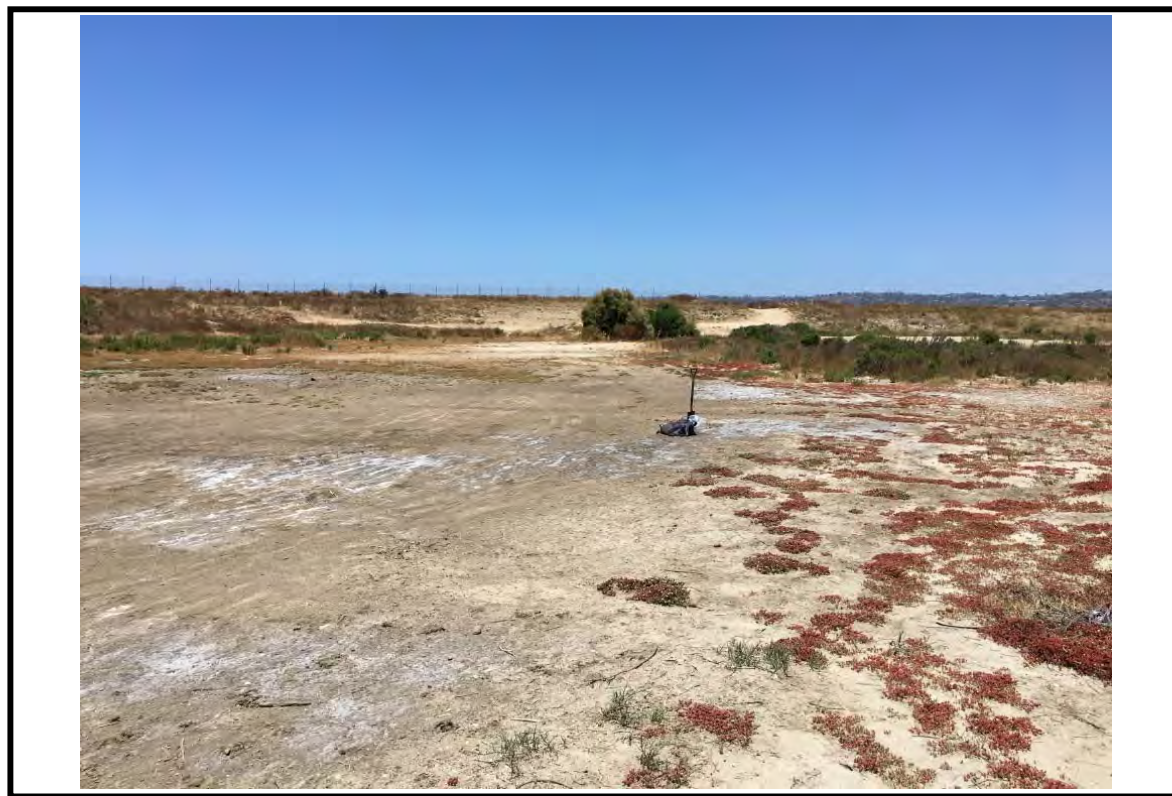
**Photo Point 4.** Overview of Data Point 2; taken on June 15, 2017 and directed northwest. The soils darker in color and devoid of vegetation generally correspond to the boundary of the saltpan/mudflat community.

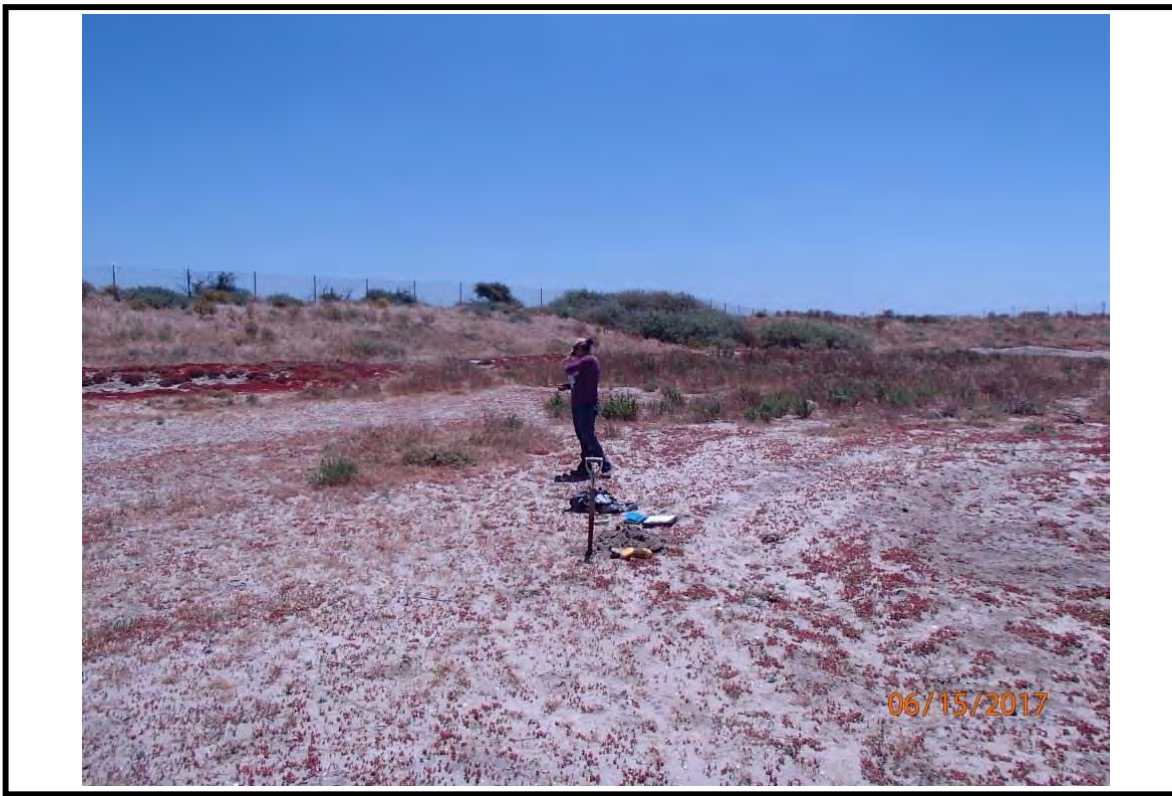
**Photo Point 5.** Photo of Data Point 3; taken on June 15, 2017 and directed southeast. Area classified as disturbed lands. Hydrophytic vegetation not dominant and wetland hydrology indicators not evident.

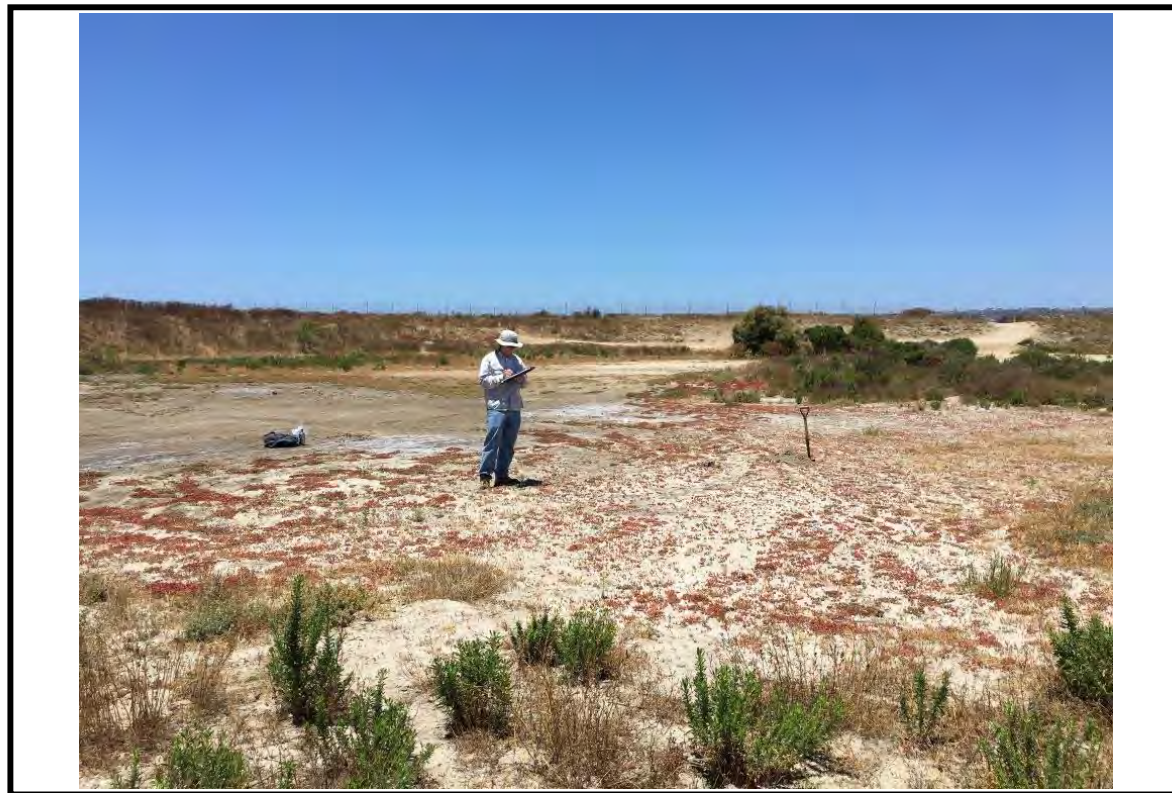
**Photo Point 6.** Overview of Data Point 3; taken on June 15, 2017 and directed northwest. The disturbed lands generally correspond to where vegetation is present in the foreground. This photo also provides an overview of Data Point 2 (backpack behind M&A biologist) and general location of Data Point 1 in the background (near toe of basin slope).

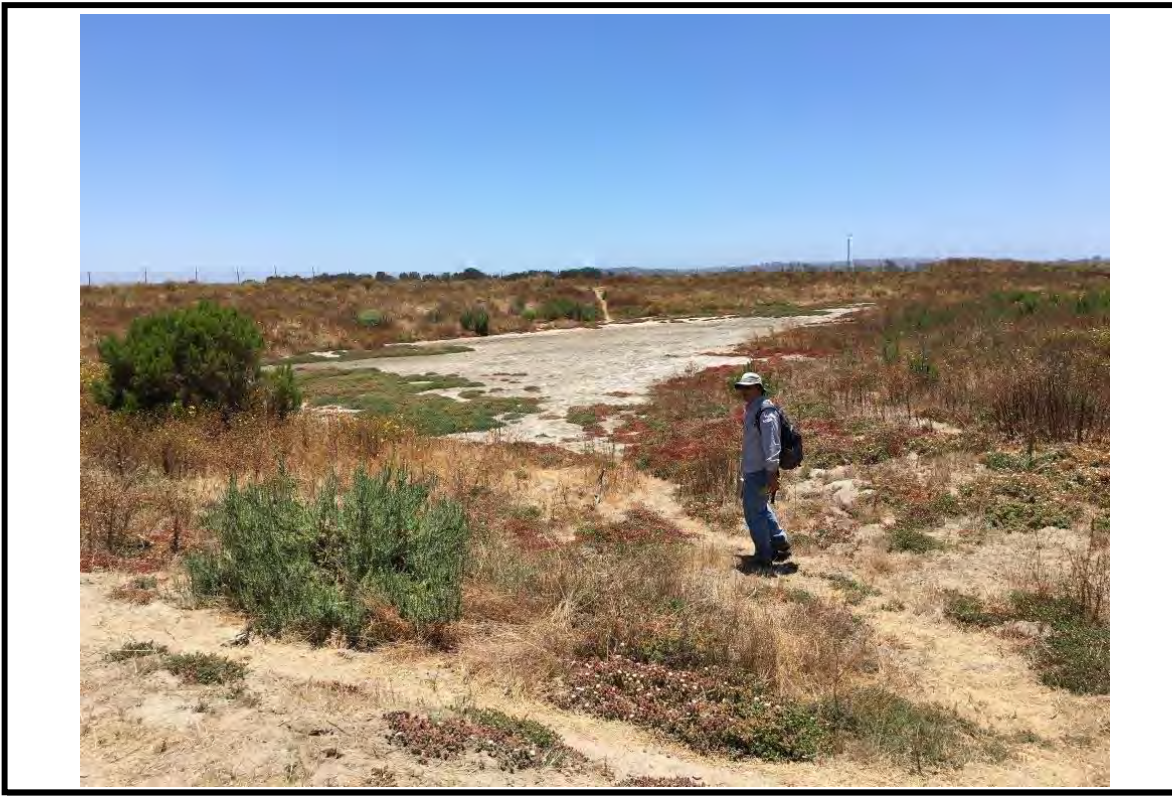
**Photo Point 7.** Overview of Data Point 4; taken on June 15, 2017 and directed south. Data Point 4 is located within an area classified as saltpan/mudflat. This corresponds to the low lying area, generally devoid of vegetation within the photo. The surrounding habitat has been classified as disturbed lands.

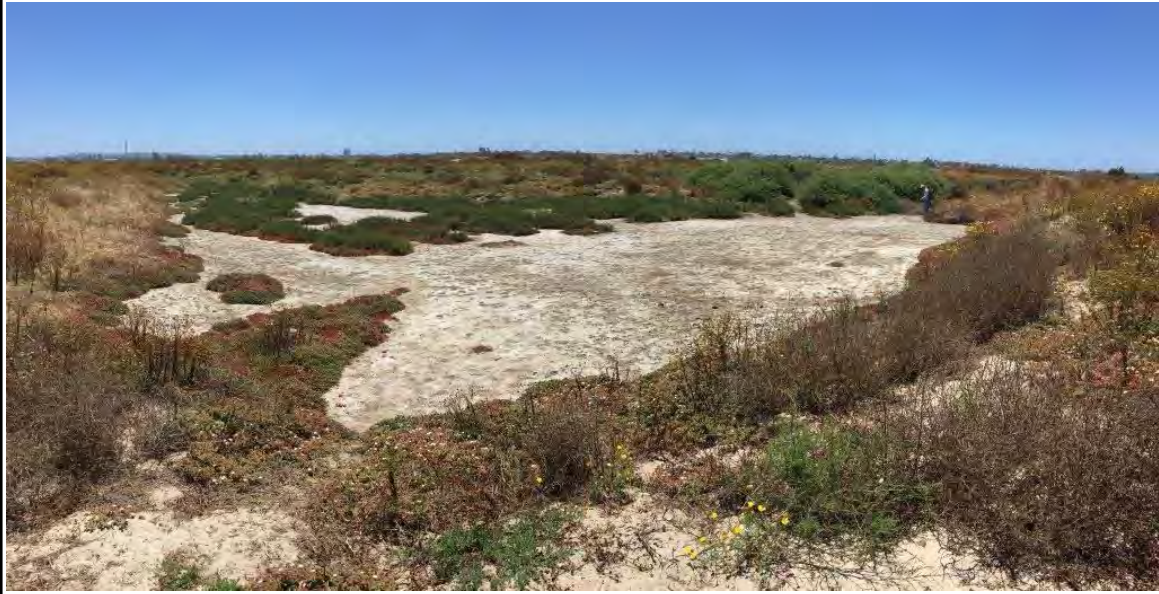
**Photo Point 9.** Overview of Data Point 5; taken on June 15, 2017 and directed northward. Data Point 5 is located within an area classified as saltpan/mudflat; this corresponds to the low lying area, generally devoid of vegetation within the photo. The vegetation within the low lying area has been classified as southern coastal salt marsh; at this location, the community is dominated by pacific pickleweed with a minor inclusion of ice plant. The surrounding habitat on the slopes has been classified as disturbed lands.

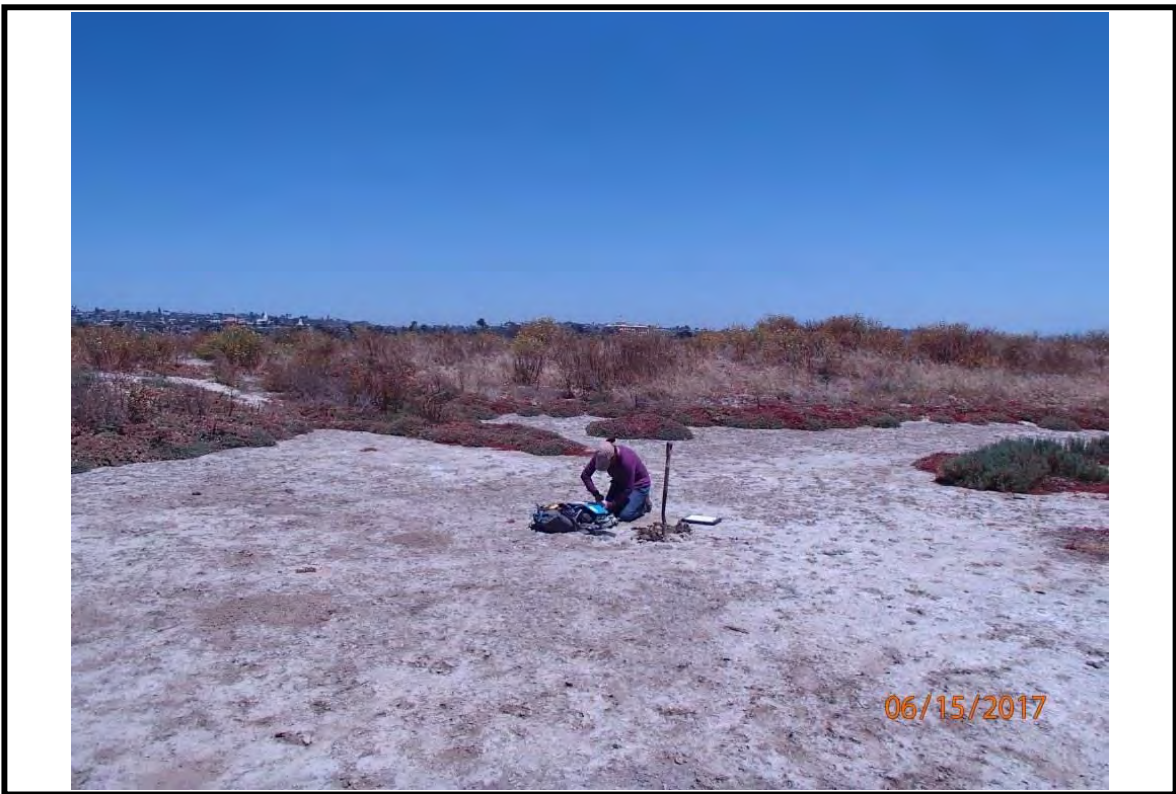
**Photo Point 10.** Photo of Data Point 5; taken on June 15, 2017 and directed southward. Data Point 5 located within saltpan/mudflat.

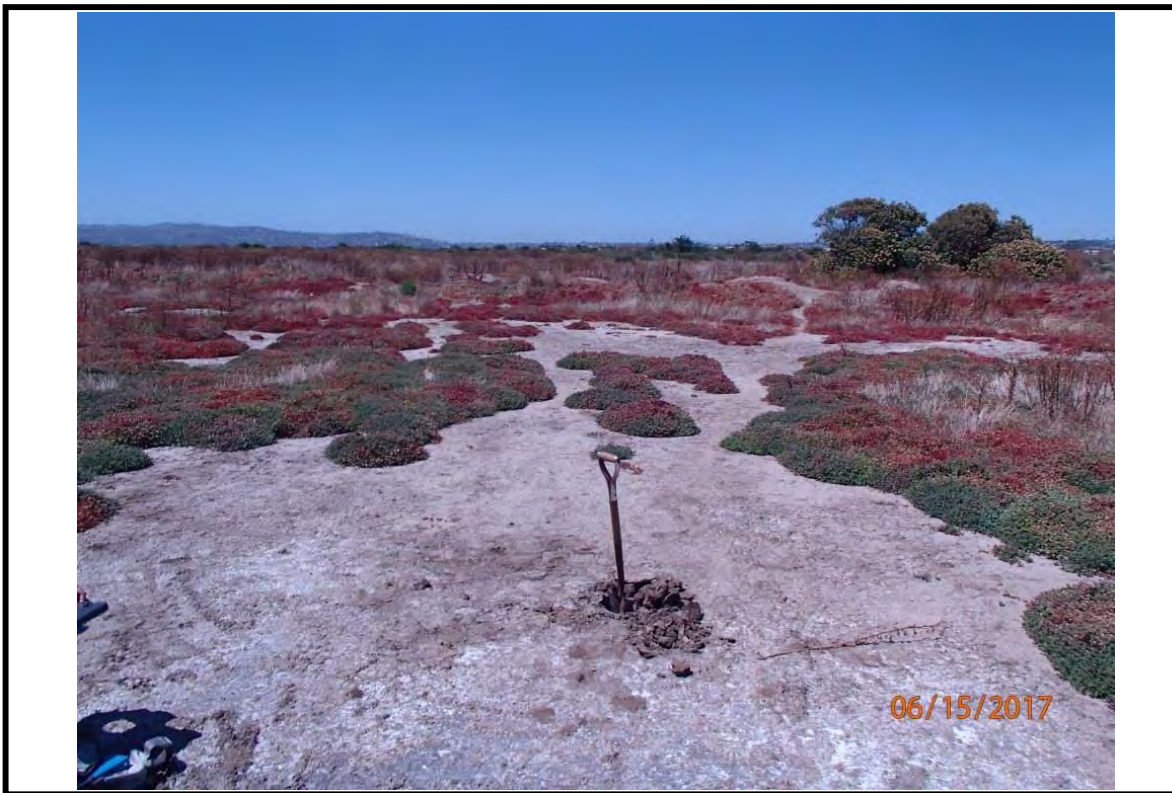
**Photo Point 11.** Photo of Data Point 6; taken on June 15, 2017 and directed northward. Data Point 6 is located within an area classified as disturbed saltpan/mudflat; this is due to the abundance of iceplant throughout the low lying area. However, the wetland hydrology indicator (i.e., salt crusts) was only evident where vegetation was not present. For purposes of the delineation, the limits of the community were generally based on a combination of topography (15.5-foot above MSL elevation line) and onsite field conditions (i.e., bare ground).

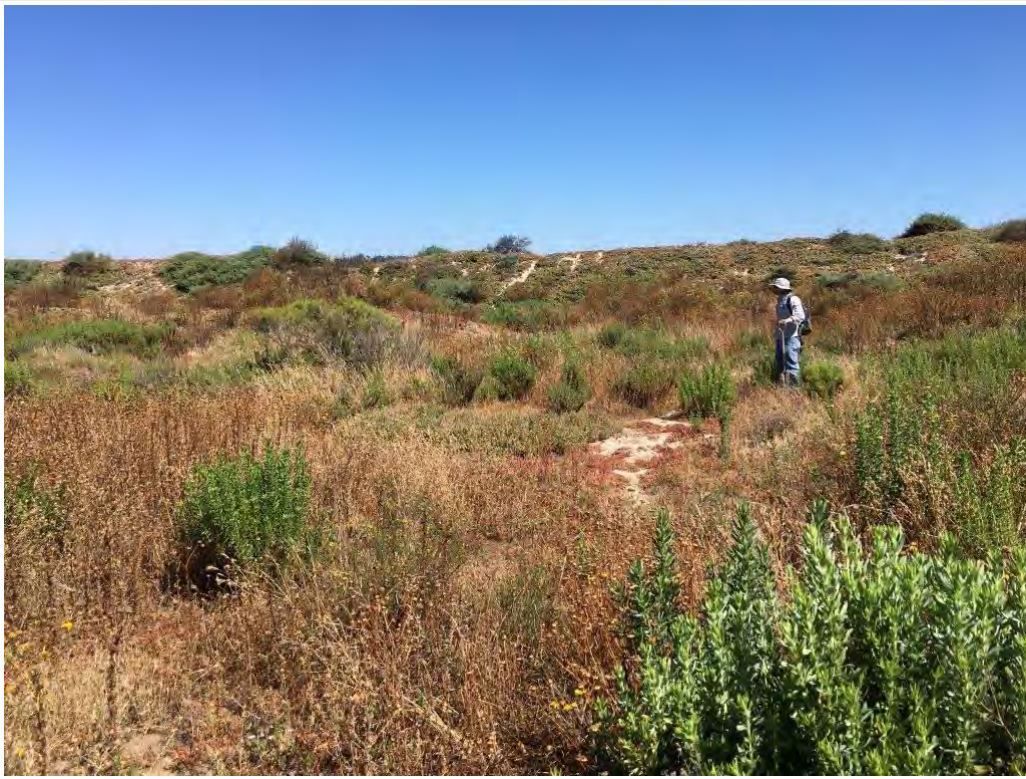
**Photo Point 13.** Photo of Data Point 7; taken on June 15, 2017 and directed southeast. Data Point 7 is located within an area classified as disturbed lands. Hydrophytic vegetation is not dominant and wetland hydrology was not evident. Data point located within upland habitat.

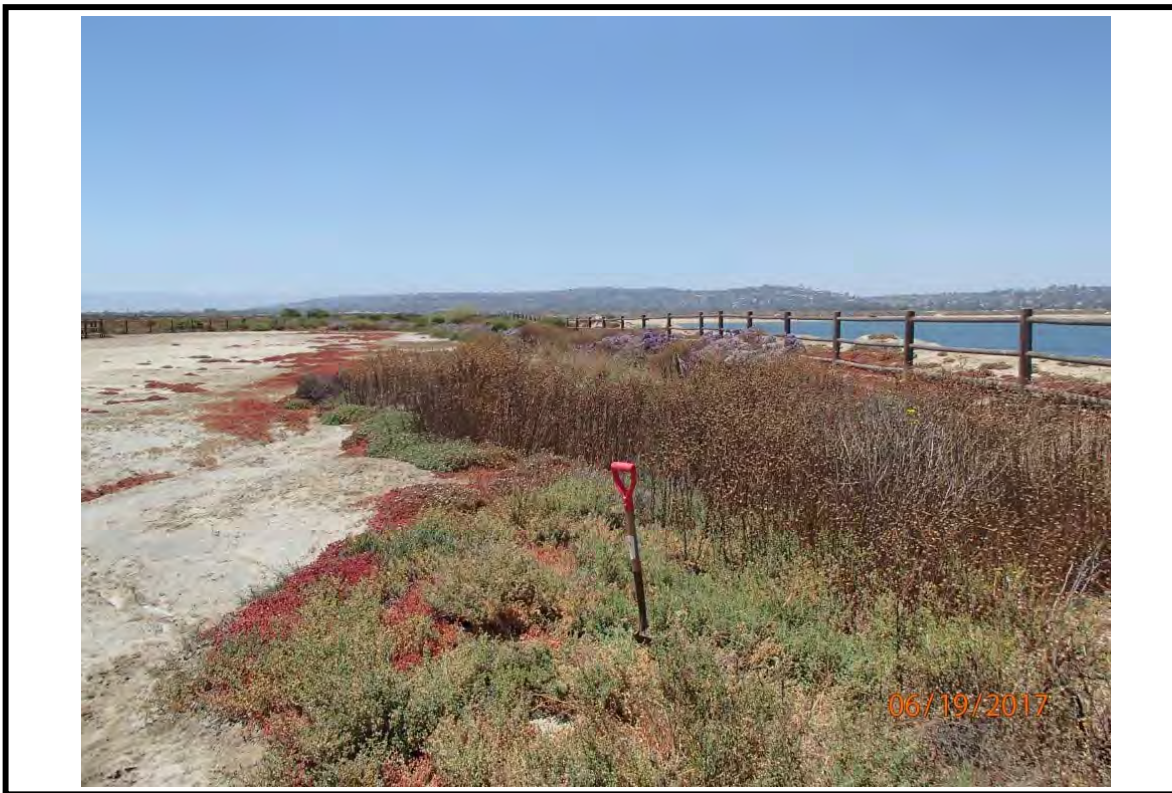
**Photo Point 15.** Photo of Data Point 8; taken on June 19, 2017 and directed northwest. Data Point 8 is located along the eastern margin of a restoration area where a patch of disturbed southern coastal salt marsh is present. The presence of hydrophytic vegetation (at this location) is being pushed out by non-native plants including ice plant and garland. The vegetation immediately surrounding the data point has been classified as disturbed lands due to the presence of the non-native plants. Wetland hydrology not present along this portion of the thin linear strip of vegetation.

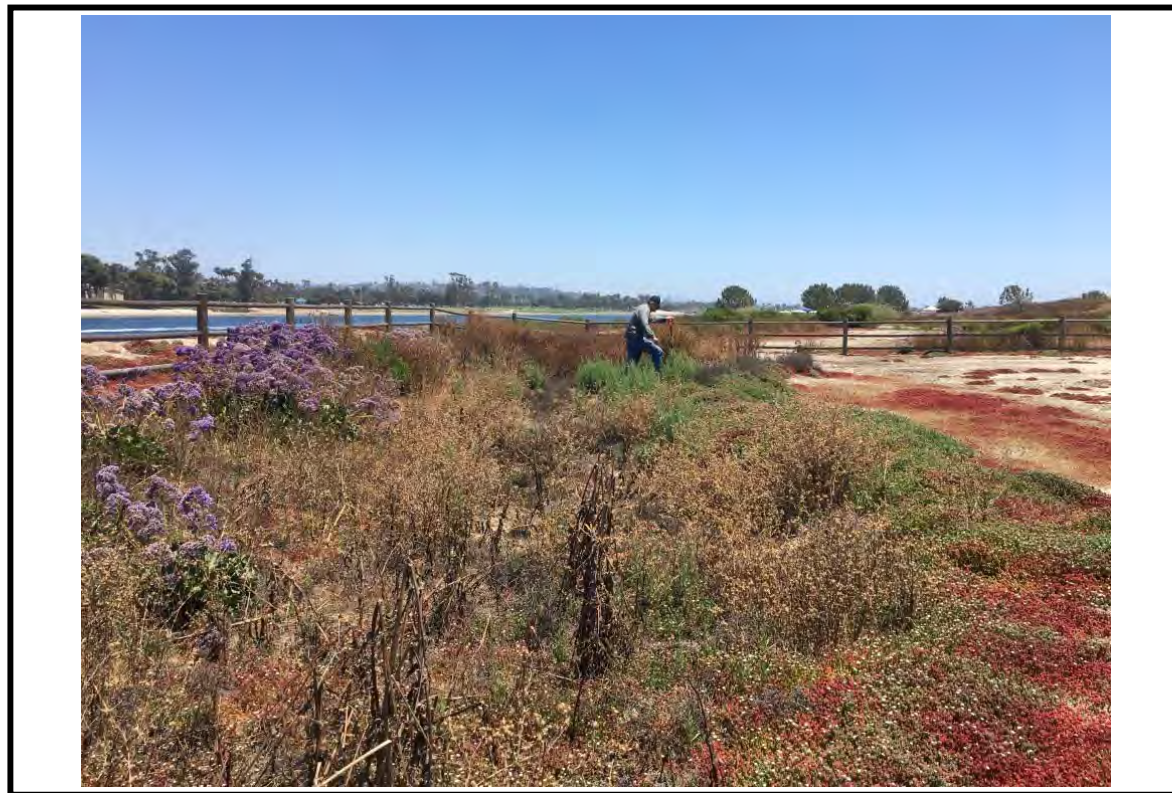
**Photo Point 16.** Overview of Data Point 8; taken on June 19, 2017 and directed southeast. Disturbed lands are in the foreground. The small patch of disturbed southern coastal salt marsh is in the background (at the location of the M&A biologist).

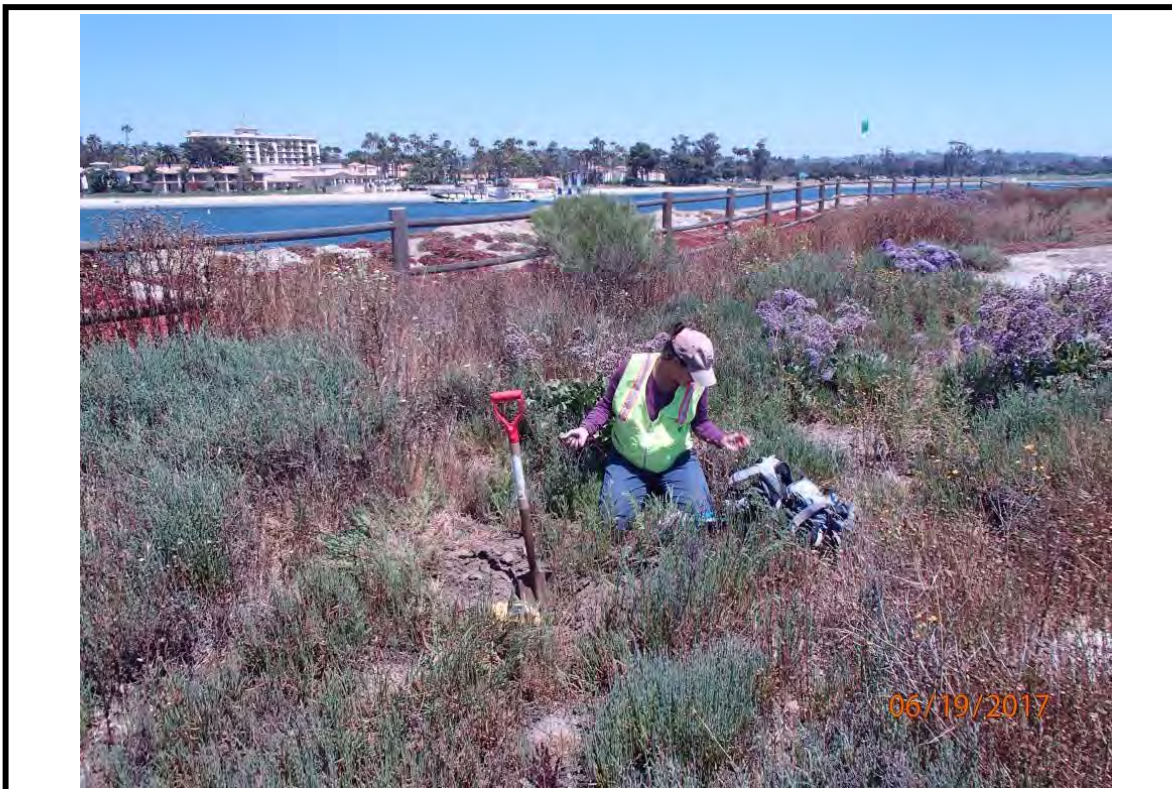
**Photo Point 17.** Photo of Data Point 9; taken on June 19, 2017 and directed eastward. Data Point 9 is located along the eastern margin of a restoration area where a thin linear strip of southern coastal salt marsh is persisting.

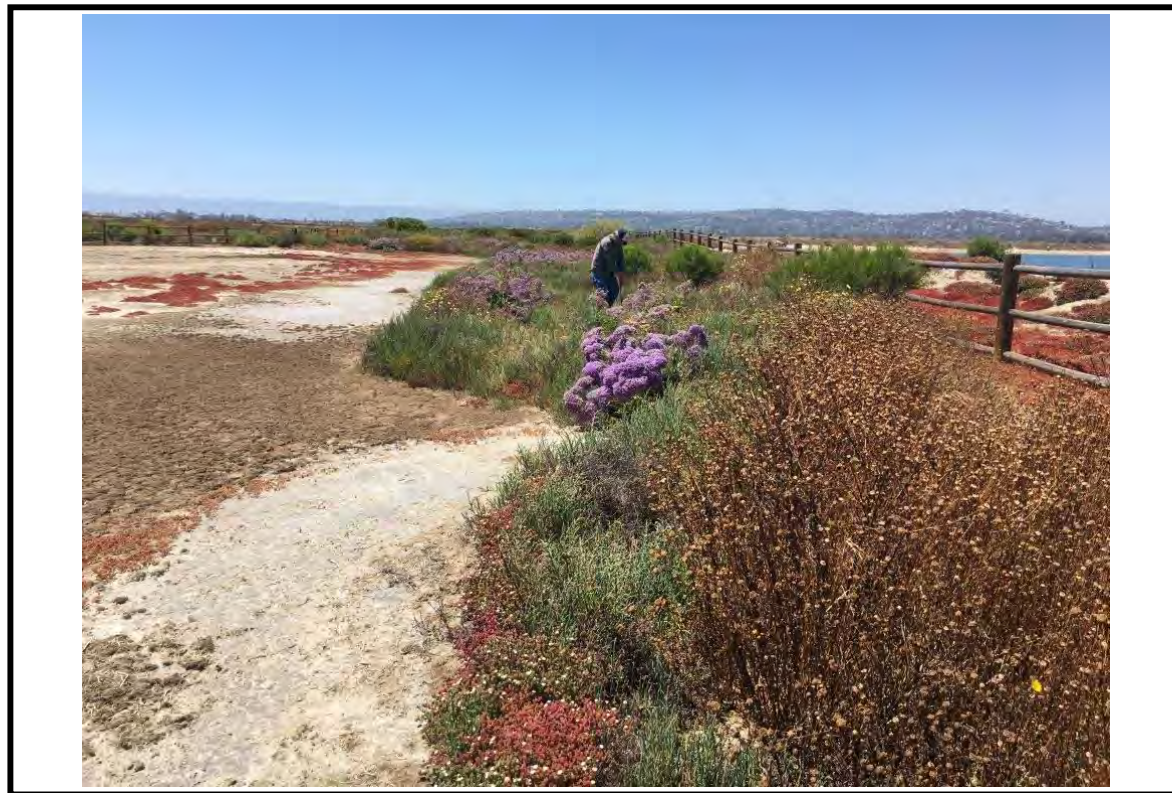
**Photo Point 18.** Overview of Data Point 9; taken on June 19, 2017 and directed northwest. Photo taken just south of the soil pit, at the approximate boundary where the community transitions from disturbed lands (foreground) to southern coastal salt marsh.

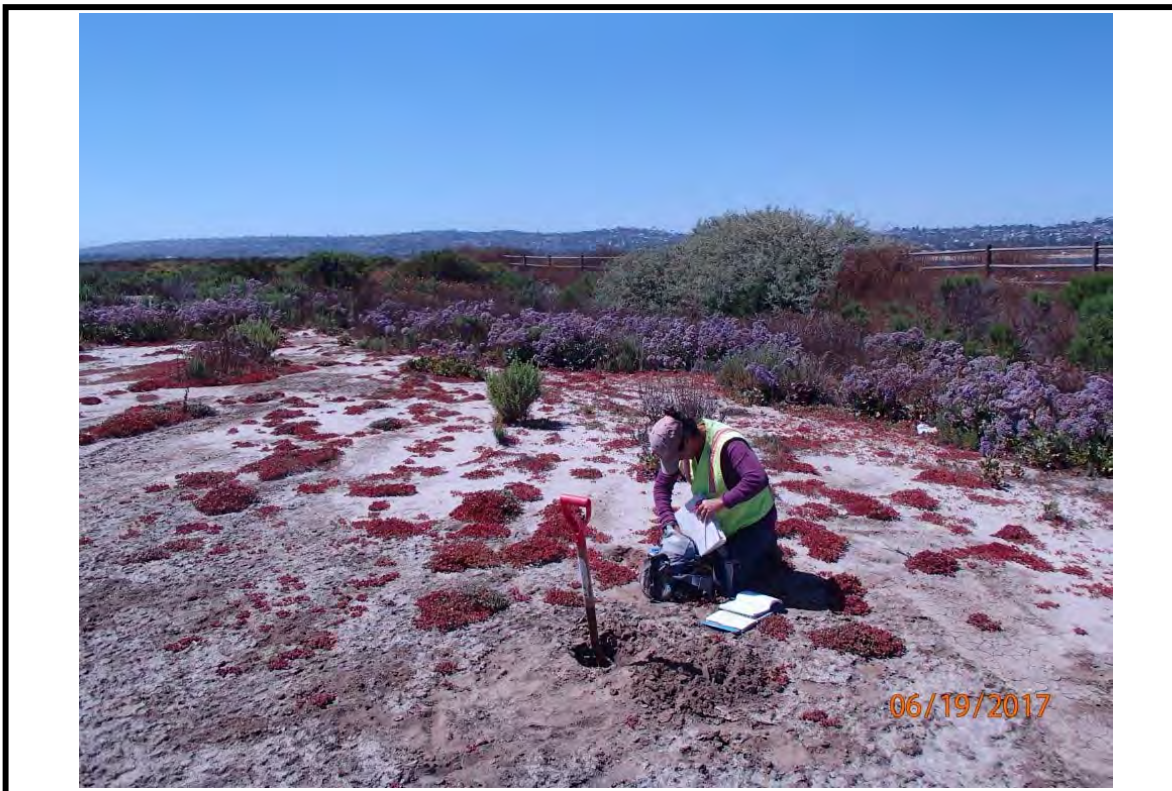
**Photo Point 19.** Photo of Data Point 10; taken on June 19, 2017 and directed northeast. Data Point 10 is located within an area classified as saltpan/mudflat; however, this community does support a minor inclusion of ice plant. This area is located within an old restoration site, specifically it is northwest of a pad that appears to be covered with decomposed granite and is to the west of the linear strip of southern coastal salt marsh (i.e., Data Point 9).

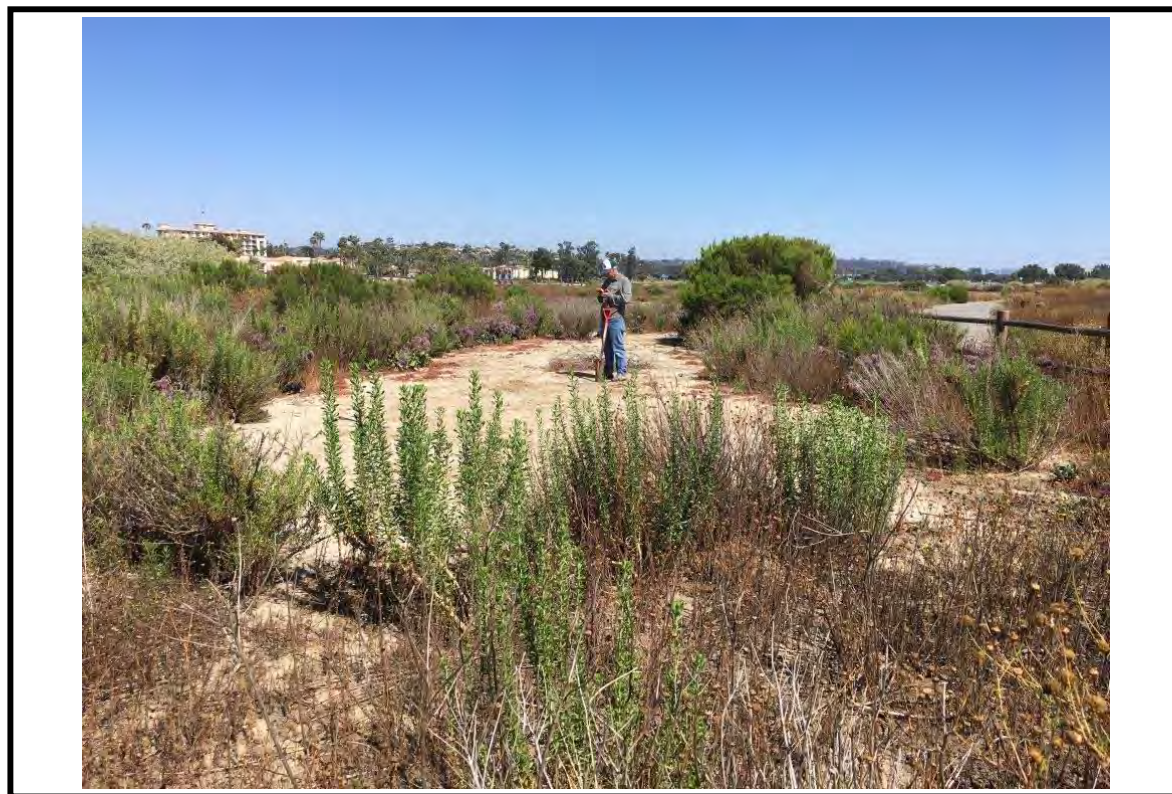
**Photo Point 20.** View of saltpan/mudflat northwest of Data Point 10. Photo directed southeast and taken on June 19, 2017. Area surrounded by lands classified as disturbed lands and Diegan coastal sage scrub.

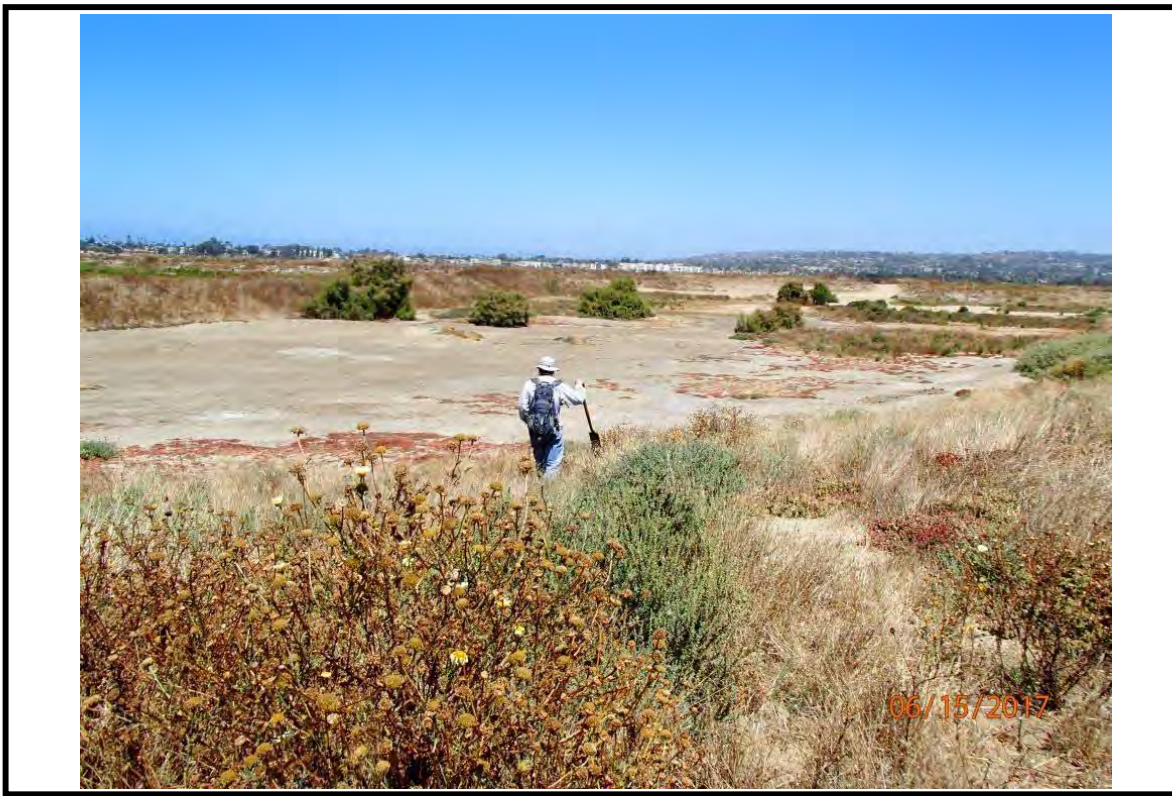
**Photo Point 1.** Overview of the excavated basin where Data Points 1-3 are located. Photo taken from the southeastern corner of the basin and directed northwest. Taken on June 15, 2017. It should be noted that the saltpan/mudflat was noted to be disturbed (utilized for recreation use on June 19).

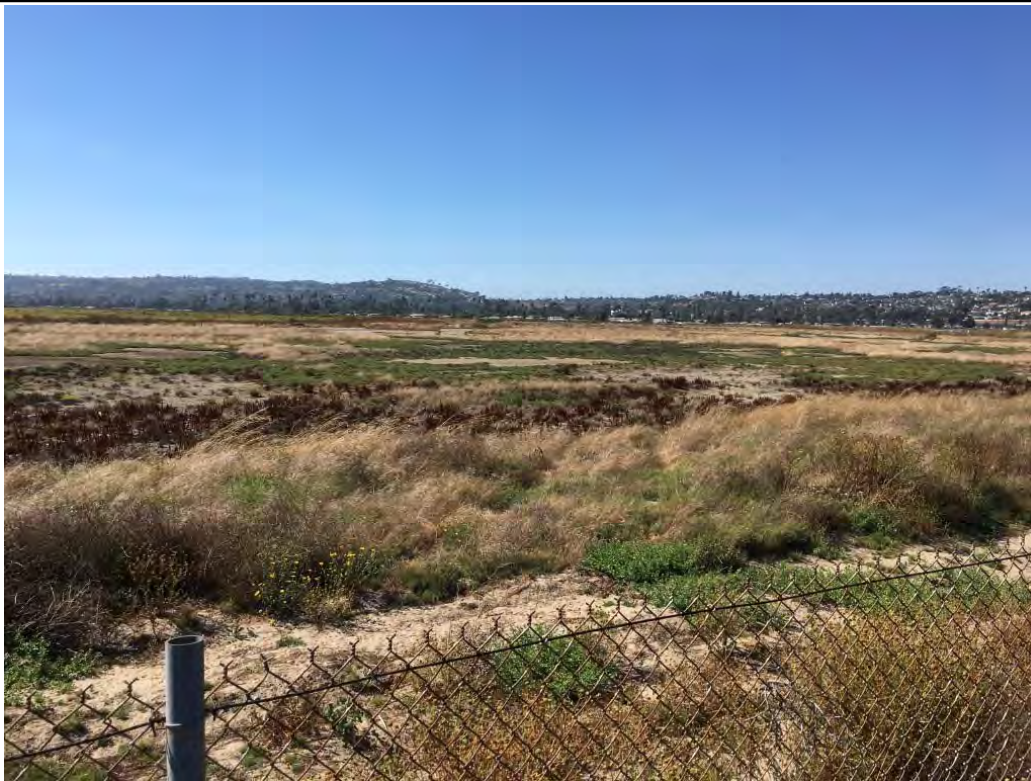
**Photo Point 4.** Close up view of lands immediately northeast of the California least tern nesting site. This portion of the area occurs within the lowest elevation of the larger basin, at 12 feet above MSL. Fiddle dock (FAC) is present within the area (reddish color plant); however, it is estimated that the presence of hydrophytic vegetation is not dominant enough to meet the Dominance Test. In addition, while salt crust and/or soil cracking may be present sporadically throughout the larger basin, it does not appear to be consistent. Thus, this area is not expected to support jurisdictional wetlands or WoUS/state. Photo taken on June 19, 2017.
