3Roots San Diego Project  
Environmental Impact Report  
SCH No. 2018041065; Project No. 587128

Biological Technical Report

# 3Roots San Diego Project

## Biological Technical Report

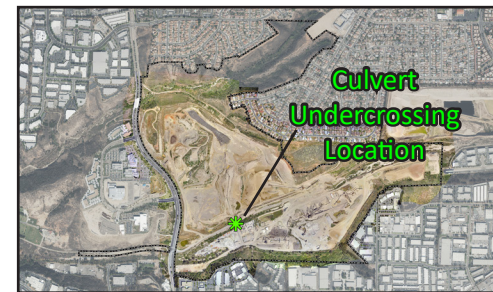
I:\PROJECTS\HAW\HAW-34\_Contra\Map\BTR\Fig16\_CrossSection\_CulvertUndercrossing\_2019.indd CAH-02.01 4/24/2019 - SAB

Source: Contech Engineering Solutions LLC 4/2019
