FIMARINE TAXONOMIC SERVICES, LTD.

# Coastal Bluff Stabilization Project at the Inn at Sunset Cliffs: Intertidal Biological Assessment

January 23, 2020 (Revised September 29, 2021)

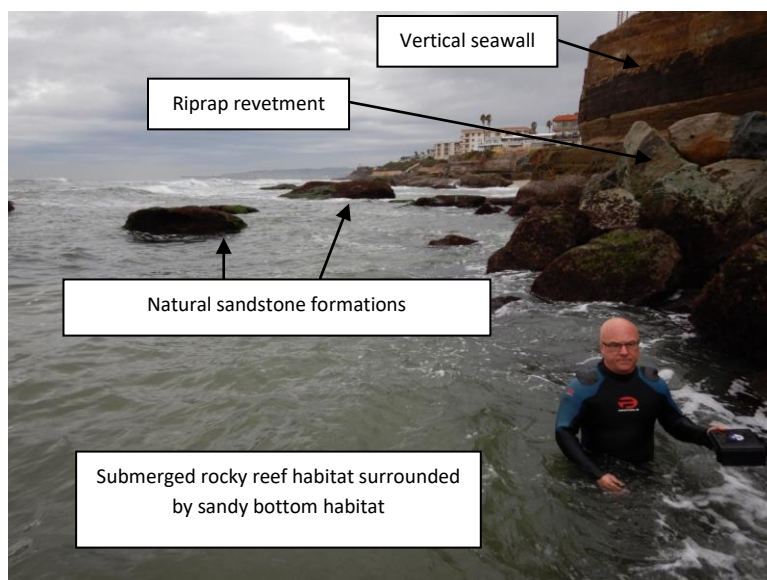
**Figure 2. Project area at 1200 hours (0' MLLW).**

The Project area consists of intertidal habitat made up of rocky reefs, scattered sandstone formations, and a riprap revetment leading up to the existing cast-in-place concrete seawall (Figure 2). Submerged rocky reefs were surrounded by coarse sand, characteristic of other nearby San Diego beaches. A previous survey conducted by Merkel & Associates Inc. (2005) had revealed a small cave and several other openings within the vicinity of the vertical seawall within the proposed Project area. The previously surveyed cave, plus nearly all of the previously documented openings in the vicinity of the vertical seawall were no longer present as they were filled as part of previous bluff stabilization efforts. The only exception observed by MTS

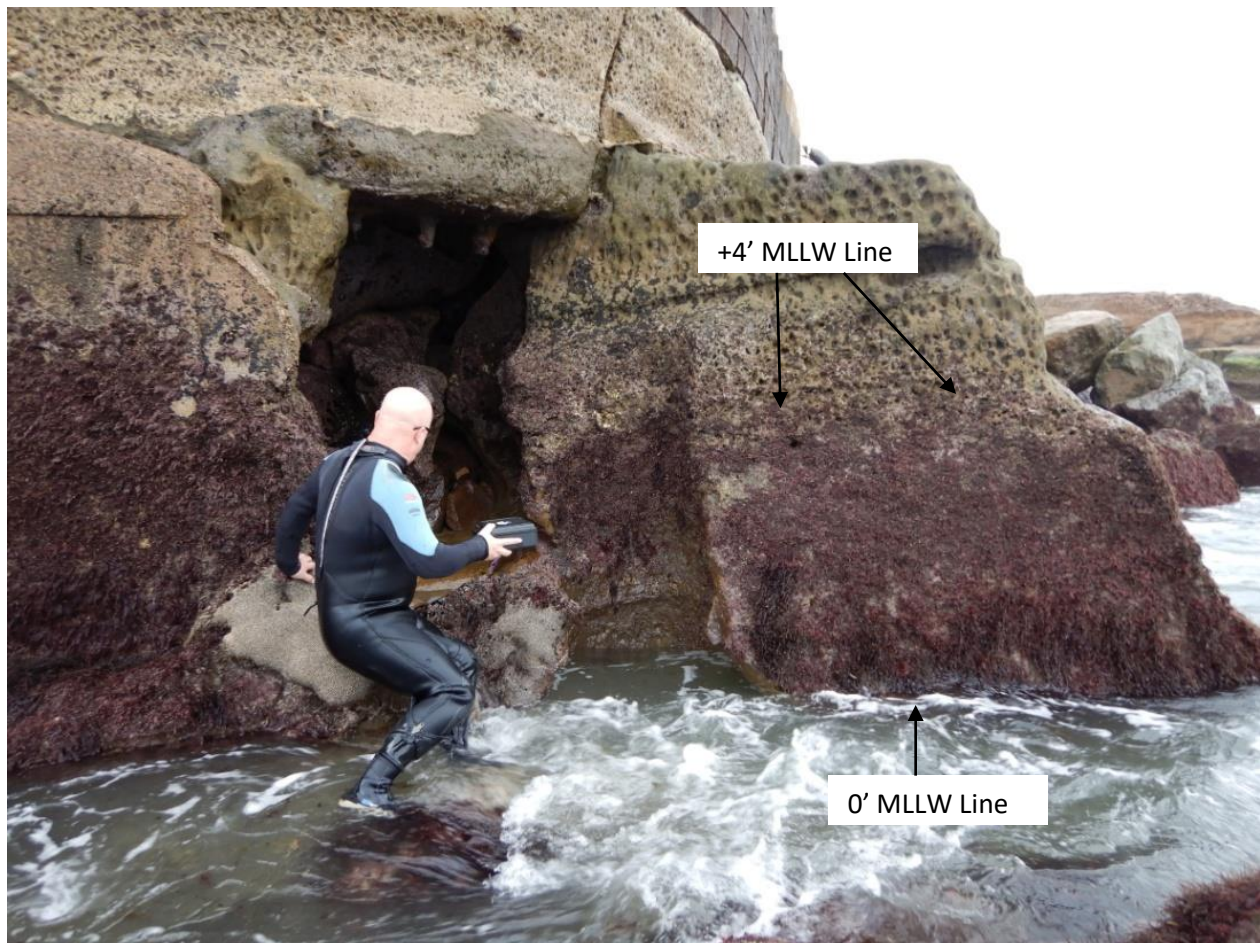
biologists was a small, partially filled opening located along the northwest facing section of the existing vertical seawall (32.441166°N, -117.152045°W) (Figure 3).

**Figure 3. Small opening observed along the existing vertical seawall. The vertical limit of marine algae growth along the vertical seawall as shown here marks the +4' MLLW elevation boundary. Elevations are approximate and based on rough measurements to the water line and observed tidal elevations at Scripps Pier (NOAA Tidal Station 9410230).**

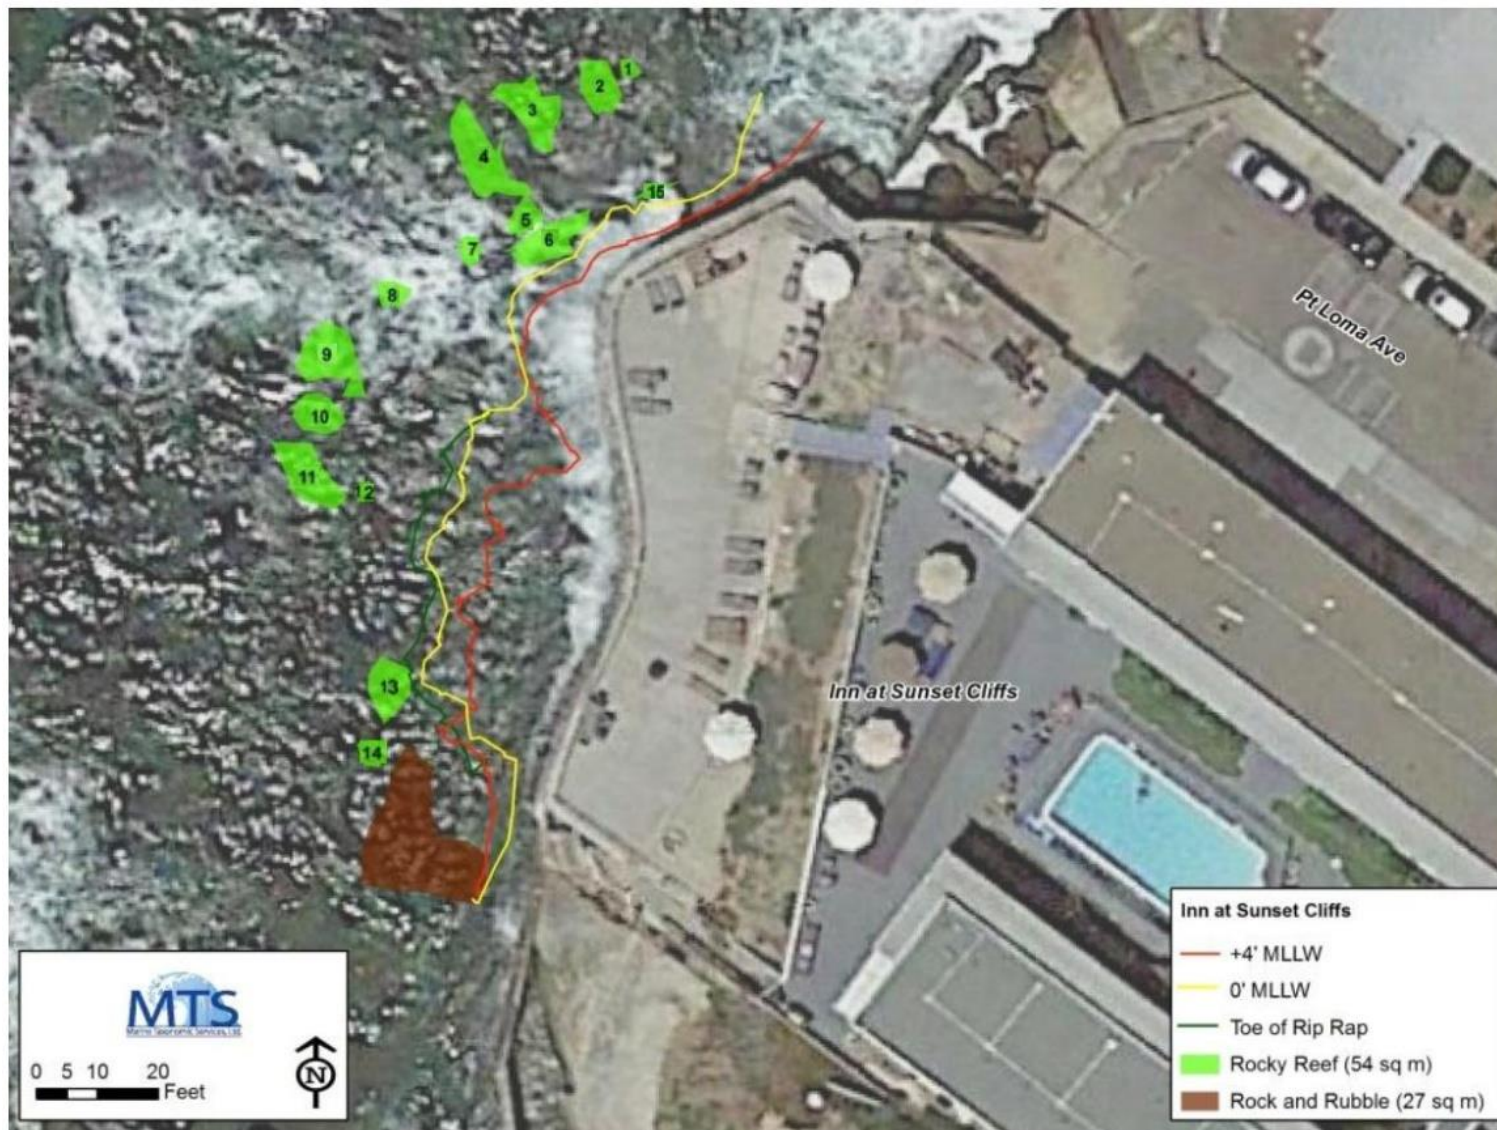
Submerged areas surrounding the riprap revetment consisted primarily of coarse sand with wave-cut bedrock lying underneath. The riprap revetment itself contained numerous crevices within which small marine invertebrates could seek refuge. Occurring just offshore from the toe of rocky revetment was a small system of rocky reefs that stretched the full length of the survey area (Figure 4). In all, 54 square meters of rocky reef habitat was surveyed between 15 distinct rocky reef “microhabitats”. These rocky reefs consisted of gently sloping wave-cut sandstone and were exposed to high wave energy and ocean swells. Each rocky reef microhabitat supported turf forming algae species, surfgrass, or a mixture of turf and surfgrass. The limits of each rocky reef microhabitat surveyed, along with the relative composition turf algae and surfgrass within each of these rocky reef microhabitats is listed in Table 2.

Figure 4. Tidal zones and rock reef habitat mapped within the marine biological survey area.

**Table 1. Rocky reef marine algae composition. Reef ID numbers correspond with habitat delineated above in Figure 4.**

Any unanticipated damage or loss of rocky intertidal habitat mapped in Figure 4 of this report would be considered a significant impact and would require mitigation. Mitigation measures are provided below that would reduce the impacts to less than significant (refer to Section 6.3).

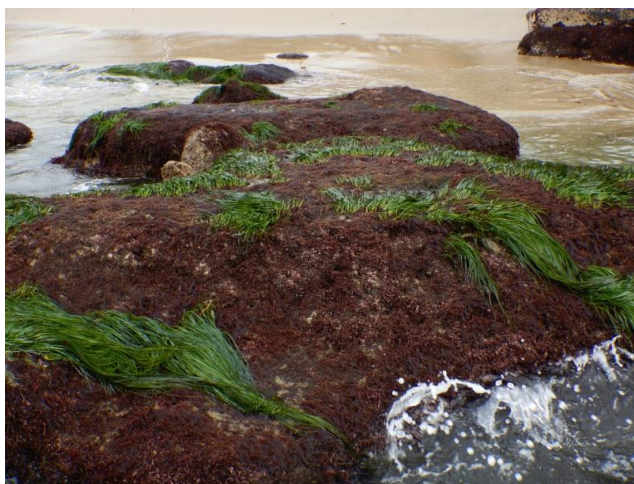
Each of the 15 rocky reef microhabitats surveyed within the Project area were completely covered by either turf forming algae (generally *Corallina* spp., *Mastocarpus* spp., *Gelidium* spp., *Lithothrix aspergillum*) or surfgrass (*Phyllospadix torreyi*). While some microhabitats consisted either entirely of seagrass or entirely of turf algae, other microhabitats supported both vegetation types (Figure 5). Algae growth occurring within the upper intertidal (between 0' MLLW and +4' MLLW) consisted predominately of a mix of turf algae and crustose and coralline red algae species, with crustose algae growing along the vertical seawall up to just below +4' MLLW. Mid- to low- intertidal zones were

**Figure 5. Reef ID #2 (90% turf algae/10% surfgrass).**
