## City of San Diego Public Utilities Department

# SANDER Vernal Pool and Upland Mitigation Plan for the North City Project City of San Diego San Diego County, California

# Conceptual Native Grassland Creation Mitigation Plan – Pueblo South for the North City Project, City of San Diego, California

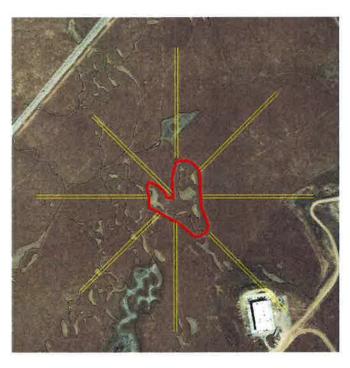
Figure 5. Example of the method used to estimate Buffer Width. Note that the width is based on the lengths of eight lines A-H that extend at regular intervals around the perimeter of the AA where buffer is present. If a portion of the perimeter of the AA does not have buffer that is at least 5 meters wide, do not place a line there.

Rating	Alternative States
A	Average buffer width is 190 – 250 m.
B	Average buffer width 130 – 189 m.
С	Average buffer width is 65 – 129 m.
D	Average buffer width is $0 - 64$ m.

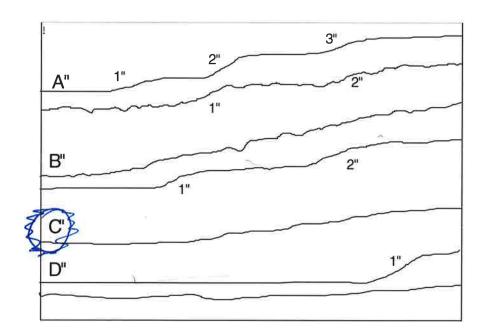
Figure 7: Scale-independent schematic profiles of Topographic Complexity. For vernal pool systems, the right end represents the lower margin of the upland matrix, slightly above the edge of a large or small vernal pool. The choice of indicative profile should be based on sketches along the 4 cardinal compass directions. In the uppermost profile, the numbers 1, 2, and 3 refer to separate apparent breaks in the topographic slope. In other profiles, either two, one, or no breaks in the slope are evident.

Туре	Examples of Topographic Features
Vernal Pools and Pool Systems	soil cracks, "mima-mounds," rivulets between pools or along swales, cobble, plant hummocks, cattle or sheep tracks

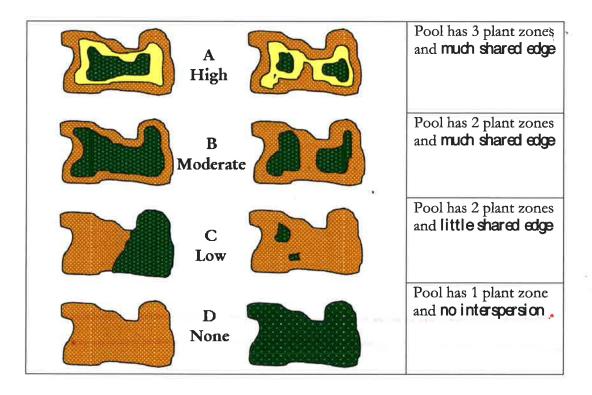
Figure 8: Degrees of interspersion of plant zones for Individual Vernal Pools. Each zone must comprise at least 5% of the pool area. The white area in this figure surrounding each pool represents the upland matrix; the orange area represents the marginal saturation zone. All pools, even as shown for score "D", therefore have at least 1 zone. It is helpful to assign names of plant species or associations of species to the colored patches and to make special note of amount of shared edge.

This metric is assessed for each of the 3-6 pools randomly selected from the AA. Drawings of the individual pools are recorded in Worksheets 7a-7f below. Make special note of amount of shared edge. Scores for each pool are then recorded in Worksheet 7g below based on the practitioners drawings, the scale-independent images in Figure 8, and the narrative in Table 20.

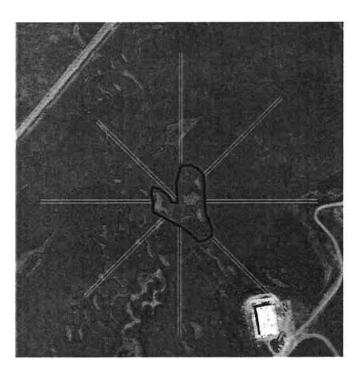
Figure 5. Example of the method used to estimate Buffer Width. Note that the width is based on the lengths of eight lines A-H that extend at regular intervals around the perimeter of the AA where buffer is present. If a portion of the perimeter of the AA does not have buffer that is at least 5 meters wide, do not place a line there.

Rating	Alternative States	
A	Average buffer width is 190 – 250 m.	
В	Average buffer width 130 – 189 m.	
С	Average buffer width is 65 – 129 m.	
D	Average buffer width is $0 - 64$ m.

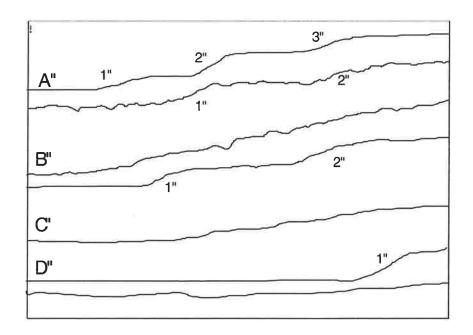
Figure 7: Scale-independent schematic profiles of Topographic Complexity. For vernal pool systems, the right end represents the lower margin of the upland matrix, slightly above the edge of a large or small vernal pool. The choice of indicative profile should be based on sketches along the 4 cardinal compass directions. In the uppermost profile, the numbers 1, 2, and 3 refer to separate apparent breaks in the topographic slope. In other profiles, either two, one, or no breaks in the slope are evident.

Туре	Examples of Topographic Features
Vernal Pools and Pool Systems	soil cracks, "mima-mounds," rivulets between pools or along swales, cobble, plant hummocks, cattle or sheep tracks

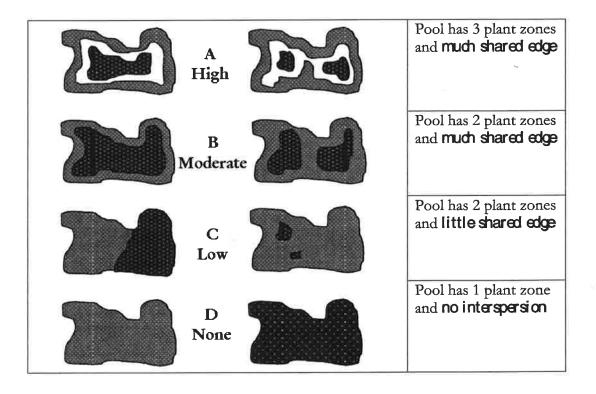
Figure 8: Degrees of interspersion of plant zones for Individual Vernal Pools. Each zone must comprise at least 5% of the pool area. The white area in this figure surrounding each pool represents the upland matrix; the orange area represents the marginal saturation zone. All pools, even as shown for score "D", therefore have at least 1 zone. It is helpful to assign names of plant species or associations of species to the colored patches and to make special note of amount of shared edge.

This metric is assessed for each of the 3-6 pools randomly selected from the AA. Drawings of the individual pools are recorded in Worksheets 7a-7f below. Make special note of amount of shared edge. Scores for each pool are then recorded in Worksheet 7g below based on the practitioners drawings, the scale-independent images in Figure 8, and the narrative in Table 20.

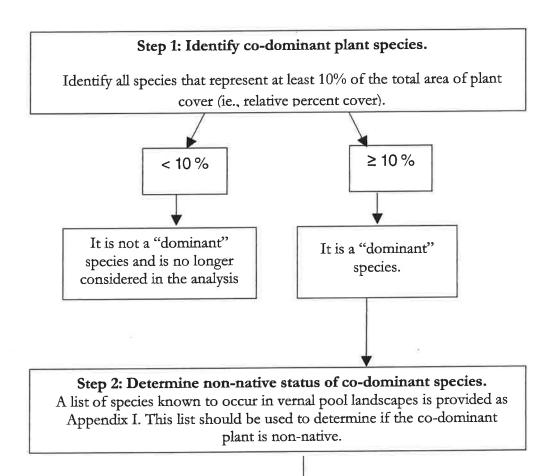
Figure 9: Flow Chart to Determine Plant Dominance

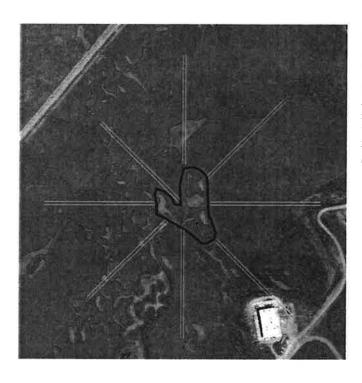
Figure 5. Example of the method used to estimate Buffer Width. Note that the width is based on the lengths of eight lines A-H that extend at regular intervals around the perimeter of the AA where buffer is present. If a portion of the perimeter of the AA does not have buffer that is at least 5 meters wide, do not place a line there.

Rating	Alternative States
A	Average buffer width is 190 – 250 m.
В	Average buffer width 130 – 189 m.
С	Average buffer width is 65 – 129 m.
D	Average buffer width is $0 - 64$ m.

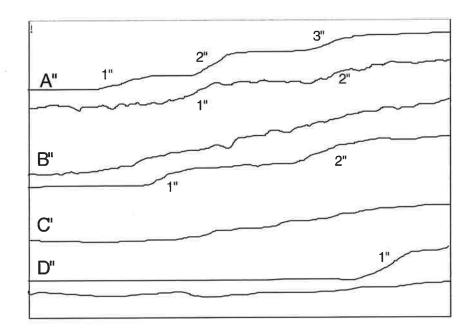
Figure 7: Scale-independent schematic profiles of Topographic Complexity. For vernal pool systems, the right end represents the lower margin of the upland matrix, slightly above the edge of a large or small vernal pool. The choice of indicative profile should be based on sketches along the 4 cardinal compass directions. In the uppermost profile, the numbers 1, 2, and 3 refer to separate apparent breaks in the topographic slope. In other profiles, either two, one, or no breaks in the slope are evident.

Туре	Examples of Topographic Features	
Vernal Pools and Pool Systems	soil cracks, "mima-mounds," rivulets between pools or along swales, cobble, plant hummocks, cattle or sheep tracks

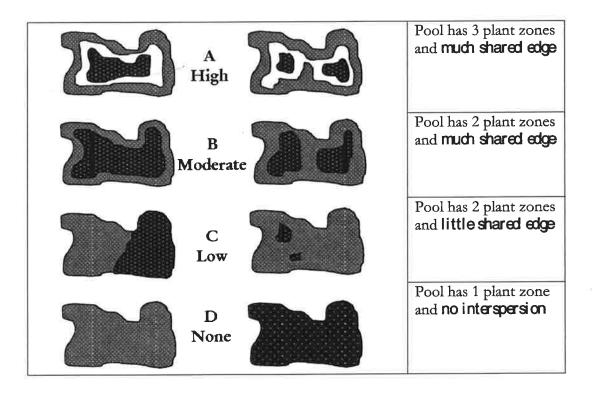
Figure 8: Degrees of interspersion of plant zones for Individual Vernal Pools. Each zone must comprise at least 5% of the pool area. The white area in this figure surrounding each pool represents the upland matrix; the orange area represents the marginal saturation zone. All pools, even as shown for score "D", therefore have at least 1 zone. It is helpful to assign names of plant species or associations of species to the colored patches and to make special note of amount of shared edge.

This metric is assessed for each of the 3-6 pools randomly selected from the AA. Drawings of the individual pools are recorded in Worksheets 7a-7f below. Make special note of amount of shared edge. Scores for each pool are then recorded in Worksheet 7g below based on the practitioners drawings, the scale-independent images in Figure 8, and the narrative in Table 20.
