CITY OF SAN DIEGO MEMORANDUM

SUBJECT: ITEM 6 – 3127 McKinley Street

DATE ISSUED: January 8, 2015 REPORT NO. HRB-15-006

The Marvin W. Hamlet Speculation House

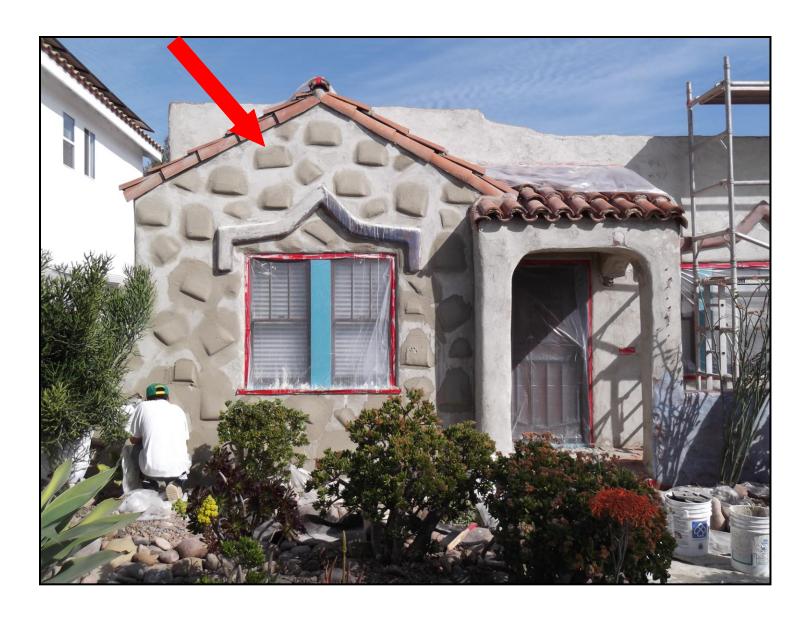
Figure 1
3127 McKinley Street Front façade during restoration.
Raised hand troweled finish shown with red arrow.

The original hand toweled stucco finish seen on the subject resource had been removed on the front elevation by a past owner and replaced by an inappropriate Pueblo stucco finish. After discovery of a collection of 1930's-1940 historic photos of the property, the home's owner, Justin Clapper, has invested considerably in the restoration of the home's hand troweled stucco finish. This final work involved enlarging the historical photos and meeting with City staff and stucco craftsmen to accurately replicate this distinctive stucco surfacing. Sample boards were also provided to City staff and comments were incorporated into the final surfacing finish. The stucco, although unpainted and under construction in some photos, shows that the resulting hand-troweled stucco very closely matches the raised hand applied finish seen in 1930's historical photos. The stucco exterior has finally been replicated and restored to match the historical photos. The owner is committed to preserving and rehabilitating the home as needed.

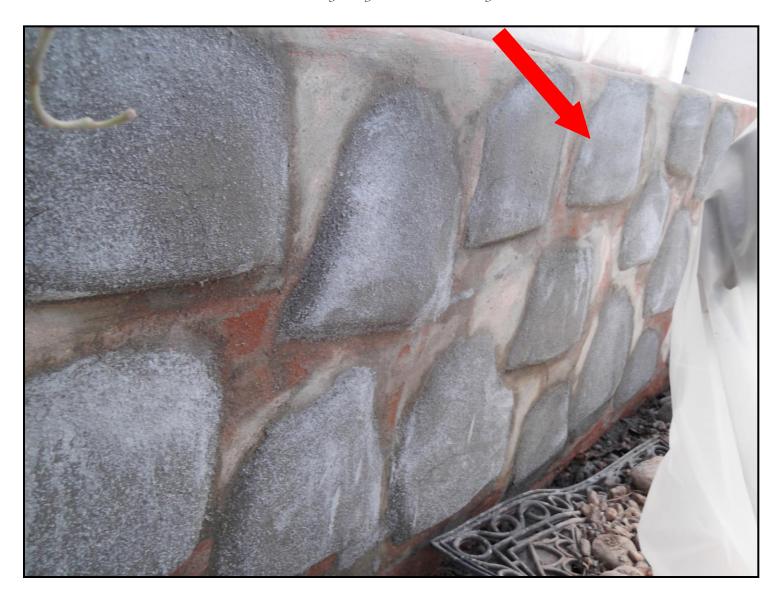
Figure 2
3127 McKinley Street Front façade during restoration.
Raised hand troweled finish shown with red arrow.

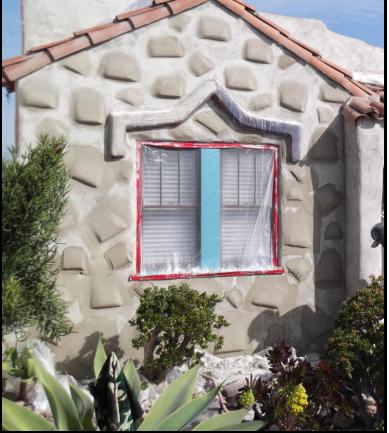
Figure 3 and 4
3127 McKinley Street front
façade during restoration.
Raised hand troweled finish
shown with red arrow.

Photo above circa 1938. Photo below left by Kiley Wallace, February 2015.

To explain in detail the restoration work completed to remove non-historic stucco and replicate the original and distinctive hand troweled finish shown in circa 1935 historical photos (Figure 3 and Historic Nomination report Attachment D.1).
