DRTH PARK DRYDEN HISTORICAL

DRAFT DISTRICT MOMINATION FOR THE PROPOSED MORTH PARK DRYDEN HISTORICAL DISTRICT

Issued hier 25, 2007

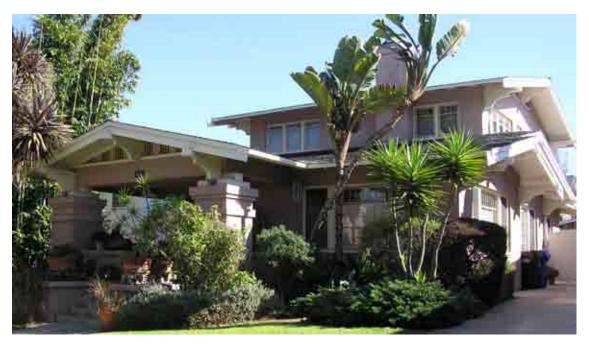
Dyar and Grace Hazelrigg House, 4247 Arden Way, Resource #495 Photos courtesy of Katherine Hon, December 31, 2008

The staff report noted that the "house features a moderate-pitched cross-gabled roof with wide, unenclosed eave overhangs, upheld by large decorative wood rafters. Other Craftsman features include large square pillars supporting a triangular beam over a somewhat unusual 'L' shaped front porch." (City of San Diego Report No. P-01-196, October 10, 2001)

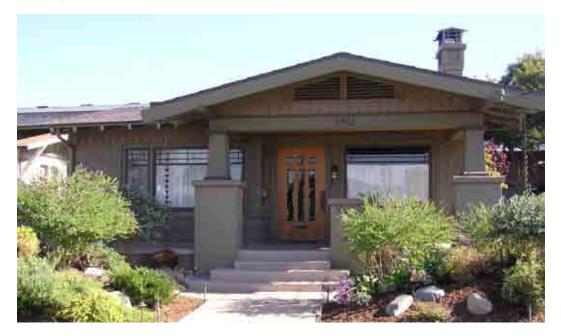
Eldora Rudrauff House, 3411 29th Street, Resource #558 Photo Courtesy of Katherine Hon, December 27, 2008

On November 22, 2002, the Eldora Rudrauff House at 3411 29th Street was designated as individually significant under HRB Criterion C (Architecture). The staff report noted: "This Craftsman style home is individually significant because it possesses a composition of architectural elements that are typical yet unique. The roof patterns of the house are unique because of the cross gables and varying roof levels. The window fenestration patterns are unique in their larger amount and composition and placement. The wall surface fenestration is unique in the combination of patterned redwood shingle and horizontal redwood siding and the overall craftsmanship which has withstood years of neglect." The report noted under Criterion F that "The architectural style of this house, as well as its construction date could also make it a contributor to a future district." (City of San Diego Report No. P-02-209, November 7, 2002)

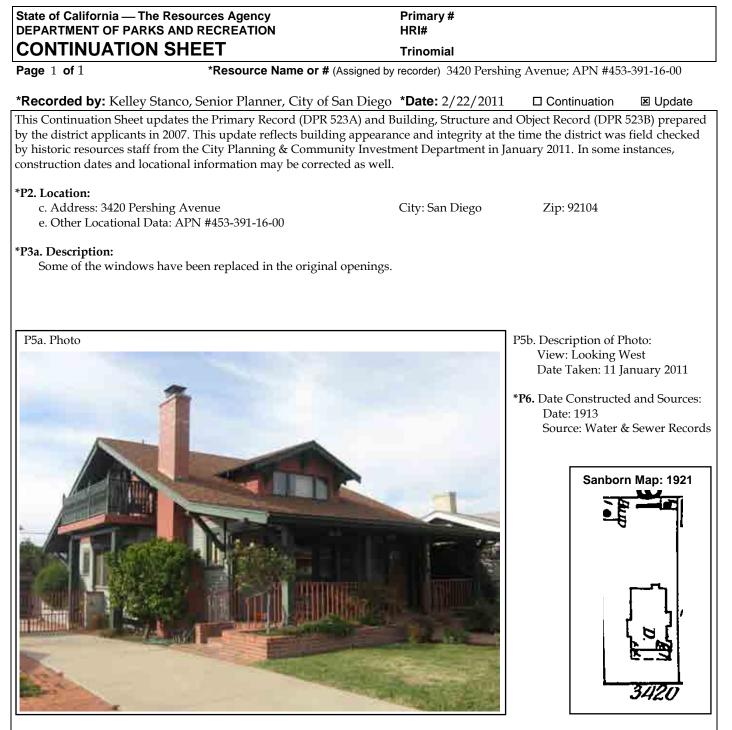
*B6. Construction History: (Construction date, alterations, and date of alterations) Some of the windows have been replaced in the original openings. A painted wrought iron railing has been added at the porch. The porch floor and steps have been refinished with brick. A brick planter has been added in front of the porch. The original scored concrete walkway has been replaced with brick. The brick chimney has been painted, and it appears that the paint is currently in the process of being removed.

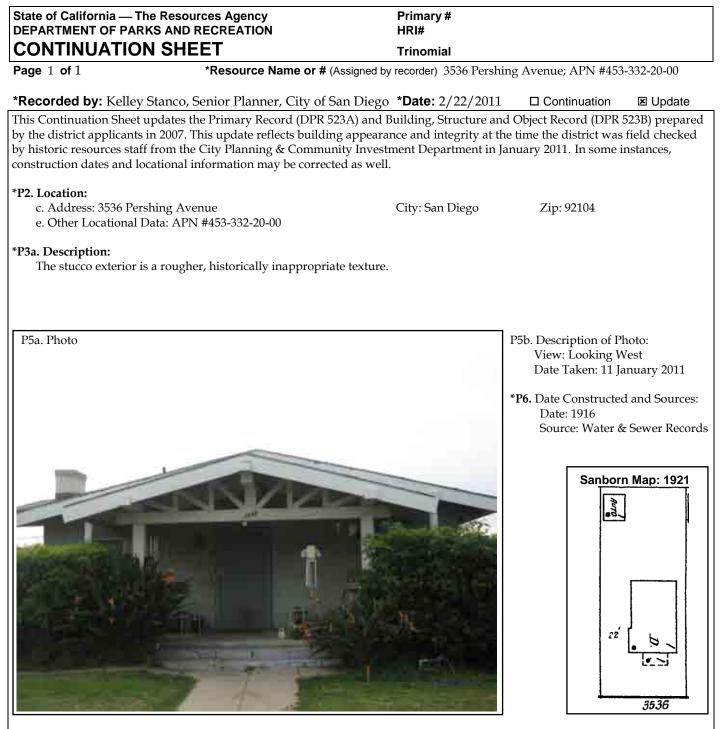
*B6. Construction History: (Construction date, alterations, and date of alterations) The stucco exterior is a rougher, historically inappropriate texture. The original windows have been replaced with aluminum frame and sash windows. It is unknown whether this occurred in the original or altered openings.

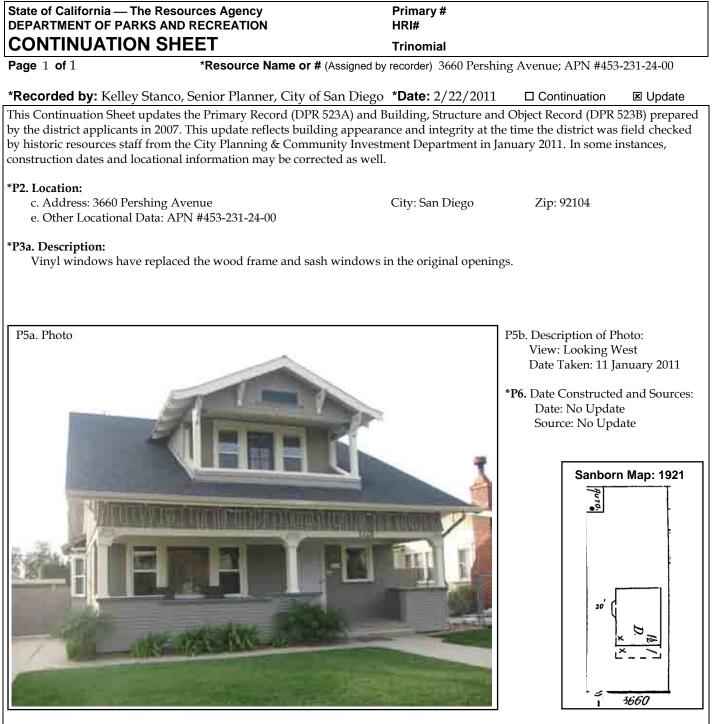
***B6. Construction History:** (Construction date, alterations, and date of alterations) Vinyl windows have replaced the wood frame and sash windows in the original openings.

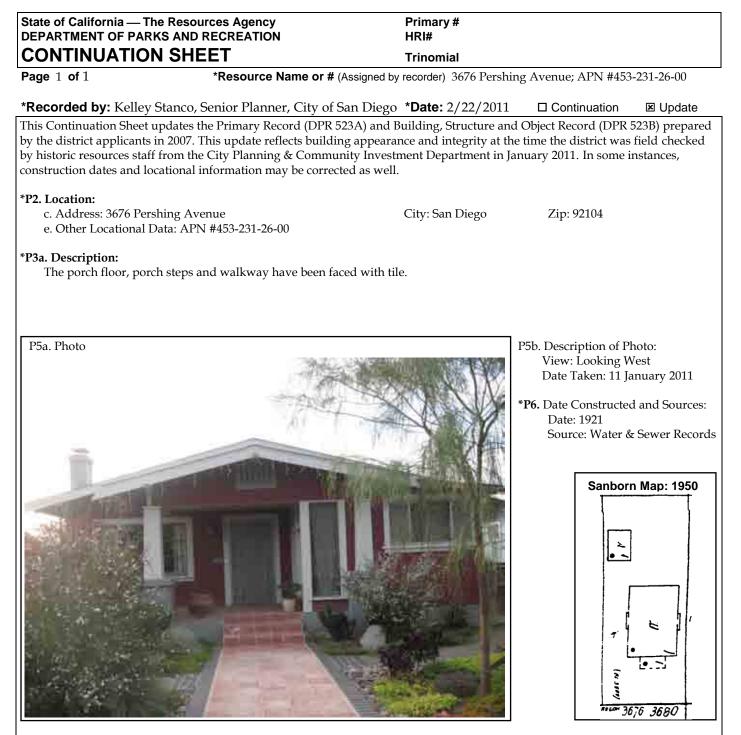
*B6. Construction History: (Construction date, alterations, and date of alterations) The north end of the porch has been enclosed and an addition was constructed to the north of the porch. The windows have been replaced in new openings. The porch floor, porch steps and walkway have been faced with tile.

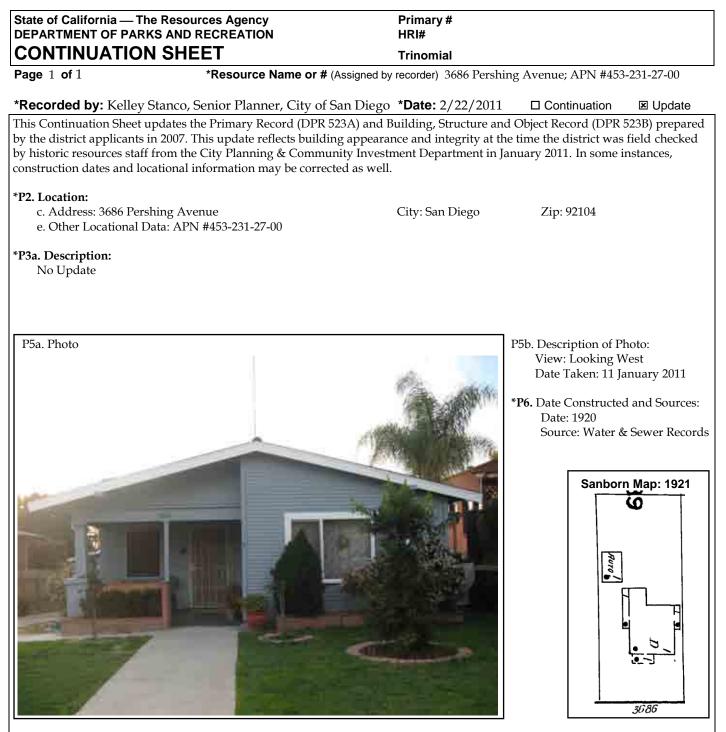
*B6. Construction History: (Construction date, alterations, and date of alterations) A large addition has been constructed to the north of the porch. The porch has been partially enclosed with cement block. Brickwork at the porch has been painted. Windows have been replaced in original and altered openings. The original scored concrete walkway has been replaced.
