PRIMARY RECORD

* Resource Name or #: 3203 Belle Isle Drive, APN 476-242-23

* P10. Survey Type: (Describe)
Intensive (Architectural)

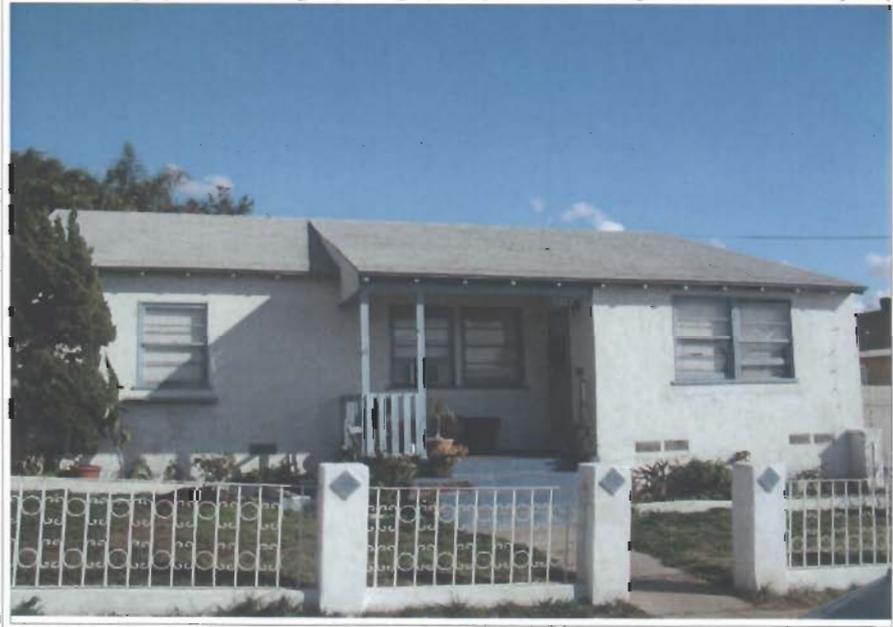
* P3a. Description: (Describe resource and its major elements. Include design, materials, condition, alterations, size, setting, and boundaries.)
The house at 3203 Belle Isle Drive was built in 1947 in the Minimal Traditional style and features a low-pitch side gable roof with composition shingles; slight eave overhang; exposed rafter tails; and a moderately textured stucco exterior. The porch, which is accessed by four concrete steps, is centered on the house and supported by two 4x4 wood posts. The entry door is set perpendicular to the street. Fenestration consists of 2-over-2 double hung wood frame and sash windows. The yard is enclosed with a 3-foot high wrought iron fence between stucco posts with tile detailing. Refer to BSOR Section B.6. for modifications and analysis of integrity.

Photo of the primary façade from the public right-of-way.

The house was built in 1947 per water and sewer connection records. Modifications include the use of moderately textured stucco; the use of a wrought iron security door; and the replacement of the composition roof with a new composition roof. The house is in good condition and retains a good to fair degree of integrity.

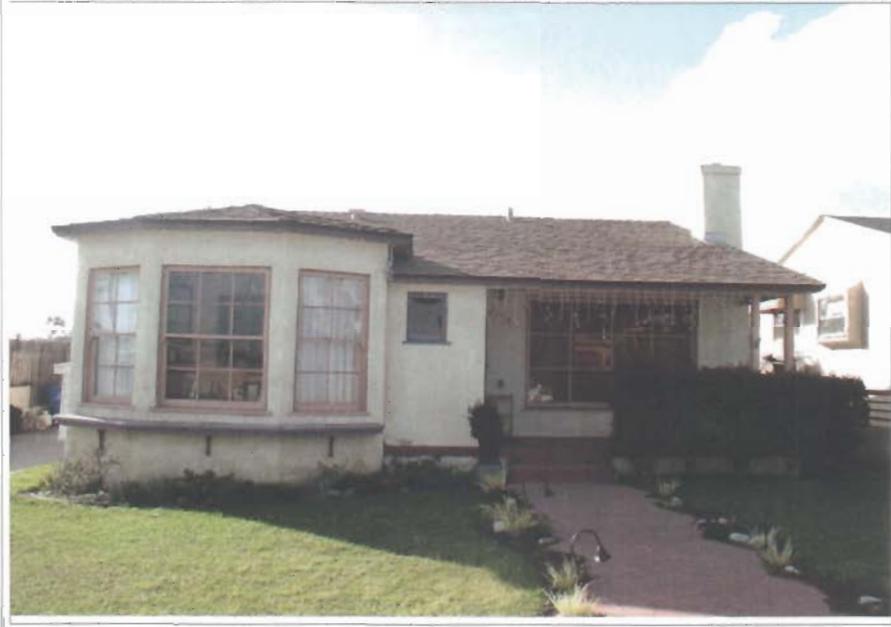
* P3a. Description: (Describe resource and its major elements. Include design, materials, condition, alterations, size, setting, and boundaries.)
The house at 3204 Belle Isle Drive was built in 1937 in the Minimal Traditional style and features a side gable roof with composition shingles; a slight eave overhang; a moderately textured stucco exterior; and a chimney at the side. The left hand side of the house features a hexagonal bay with a 6-over-6 double hung wood frame and sash window flanked by 4-over-4 double hung wood frame and sash windows. The entry porch, accessed by two concrete steps and supported by two 4x4 wood posts, is set to the right and includes a large 12-pane fixed window and an entry door set perpendicularly to the sidewalk. Refer to BSOR Section B.6. for modifications and analysis of integrity.

Photo of the primary façade from the public right-of-way.

The house was built in 1937 per water and sewer connection records. Modifications include the use of moderately textured stucco and the replacement of the composition roof with a new composition roof. The house is in good condition and retains a good to fair degree of integrity.

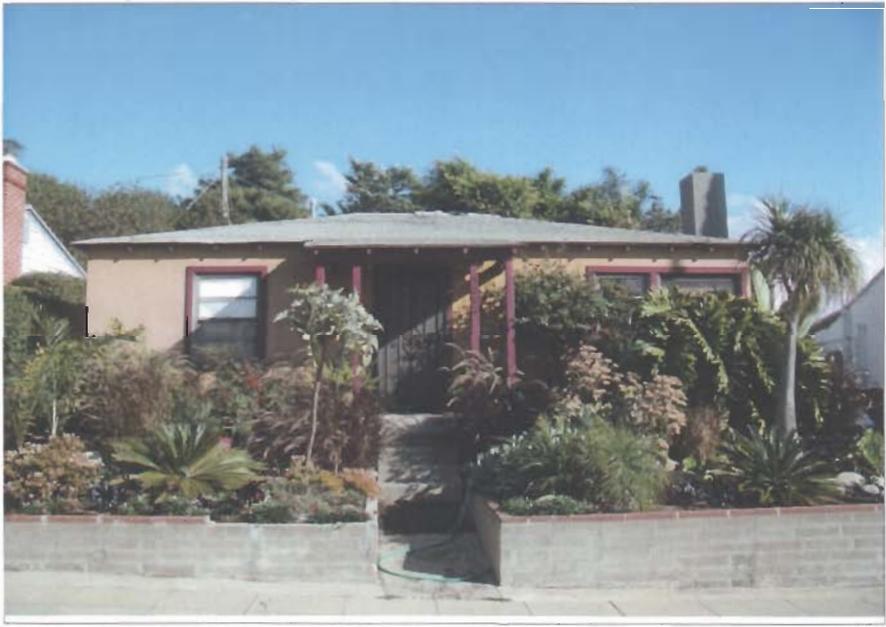
* P3a. Description: (Describe resource and its major elements. Include design, materials, condition, alterations, size, setting, and boundaries.)
The house at 3211 Belle Isle Drive was built in 1946 in the Minimal Traditional style and features a low-pitch hipped roof with composition shingles; a slight eave overhang; exposed raftertails; a smooth stucco exterior; and a brick chimney at the side. The entry porch, which is accessed by 5 concrete steps, is centered on the house and features a small roof projection supported by paired 4x4 wood posts. Fenestration consists of 2-over-2 double hung wood frame and sash windows and single pane fixed wood frame windows. Refer to BSOR Section B.6. for modifications and analysis of integrity.

Photo of the primary façade from the public right-of-way.

The house was built in 1946 per water and sewer connection records. Modifications include the replacement of the composition roof with a new composition roof and the use of a wrought iron security door. The house is in good condition and retains a good to fair degree of integrity.

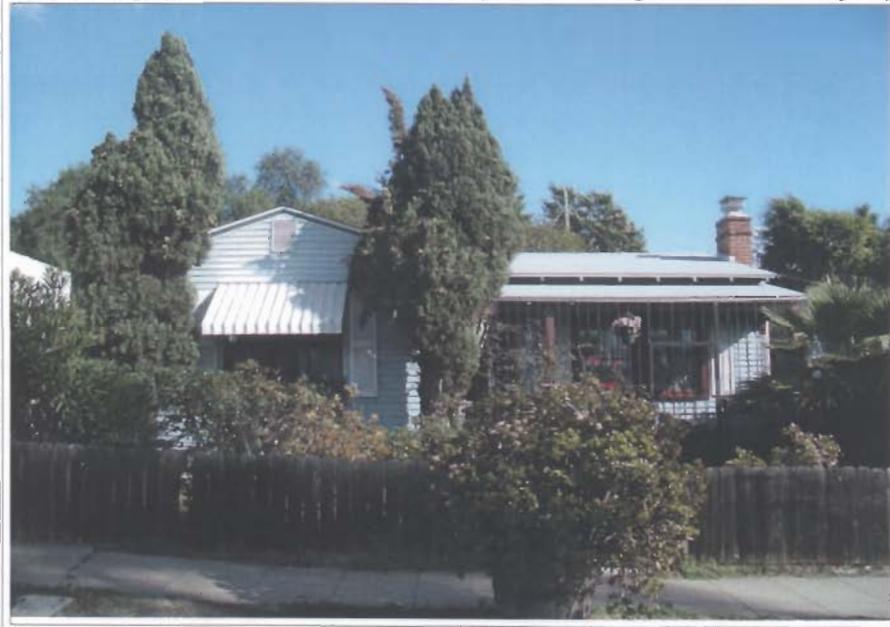
* P3a. Description: (Describe resource and its major elements. Include design, materials, condition, alterations, size, setting, and boundaries.)
The house at 3221 Belle Isle Drive was built in 1935 in the Minimal Traditional style and features a medium pitch cross gable roof with composition shingles; a slight eave overhang; exposed rafter tails; a clapboard exterior; and a brick chimney on the south side. The left hand side of the house features a front facing gable with a louvered outlet ventilator under the gable peak and an 8-lite wood frame window flanked by decorative shutters under an aluminum awning. The entry porch is located on the right hand side of the house and features a roof extension supported by wood posts. The entry door is set perpendicularly to the sidewalk. Fenestration consists of 1-over-1 double hung wood frame and sash windows with decorative wood shutters in some locations. Extensive use of wrought iron security bars have obscured the windows and completely enclosed the porch, however, these modifications are reversible. A weathered wood picket fence surrounds the property. Refer to BSOR Section B.6. for modifications and analysis of integrity.

Photo of the primary façade from the public right-of-way.

The house was constructed in 1935 per water and sewer records. Modifications include the replacement of the composition roof with a new composition roof; the use of aluminum awnings; and the extensive use of wrought iron security bars on the windows and enclosing the entry porch. The house is in good condition and retains a good degree of integrity.

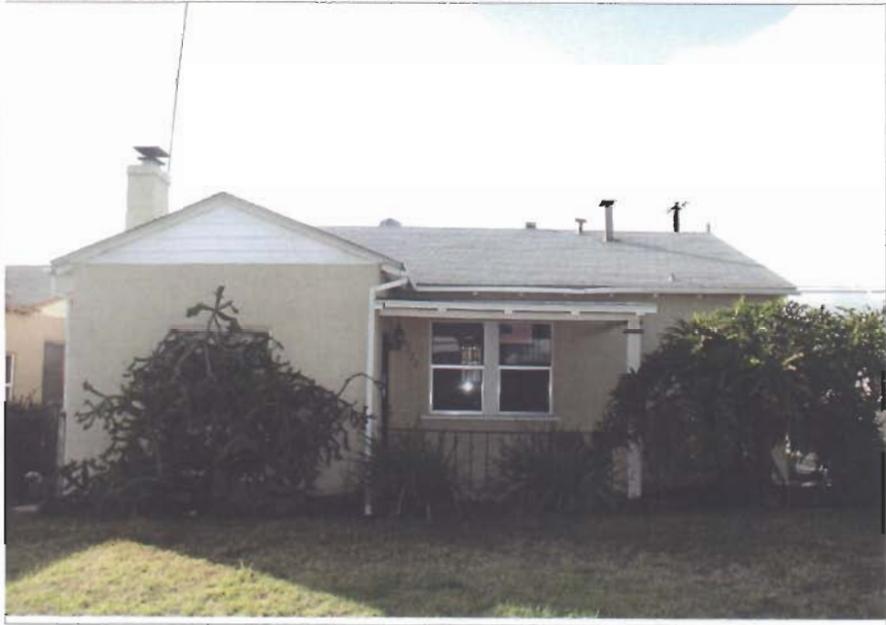
* P3a. Description: (Describe resource and its major elements. Include design, materials, condition, alterations, size, setting, and boundaries.)
The house at 3222 Belle Isle Drive was built in 1936 in the **Minimal Traditional** style and features a medium pitch cross gable roof with composition shingles; a slight eave overhang; exposed rafter tails; a moderately textured stucco exterior; and a chimney on the south side. The left hand side of the house features a front facing gable with clapboard in the gable end. The right hand side of the house features a flat-roof porch supported on wood posts and set slightly lower than the roofline. The porch cover appears to be an addition. Fenestration consists of 1-over-1 single hung and single pane fixed aluminum frame and sash windows. The entry door is set perpendicularly to the street. Refer to BSOR Section B.6. for modifications and analysis of integrity.

Photo of the primary façade from the public right-of-way.

The house was constructed in 1936 per water and sewer records. Modifications include the use of moderately textured stucco, the replacement of the composition roofing with new composition roofing, the replacement of the wood frame windows with aluminum windows, the addition of a wrought iron security screen over the entry door, and the addition of a small entry porch cover. The house is in good condition and retains a fair degree of integrity.

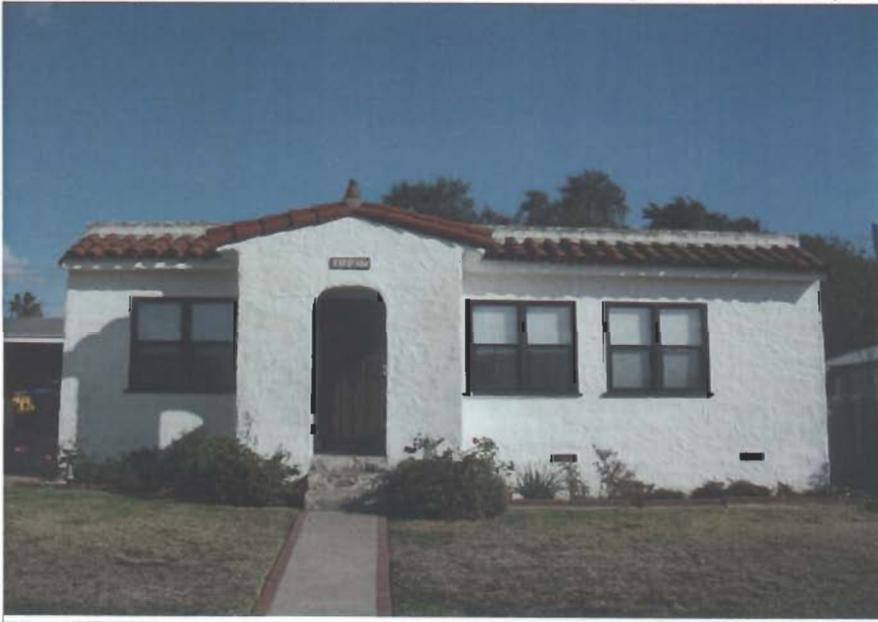
* P3a. Description: (Describe resource and its major elements. Include design, materials, condition, alterations, size, setting, and boundaries.)
The house at 3227 Belle Isle Drive was constructed in 1930 in the Spanish Eclectic style and features a flat roof with a clay tile shed roof at the parapet line; a low-pitch front-gable entry element set just off-center; and a generally smooth stucco exterior. The main entry is set under a projecting, front-gable element with an arched opening and is accessed via three concrete steps. Fenestration consists of paired 1-over-1 double hung aluminum frame and sash windows. The entry door is set parallel to the street. Refer to BSOR Section B.6. for modifications and analysis of integrity.

Photo of the primary façade from the public right-of-way.

The house was constructed in 1930 per water and sewer records. Modifications include the replacement of the wood frame and sash windows with aluminum frame and sash windows. The house is in good condition and retains a good to fair degree of integrity.

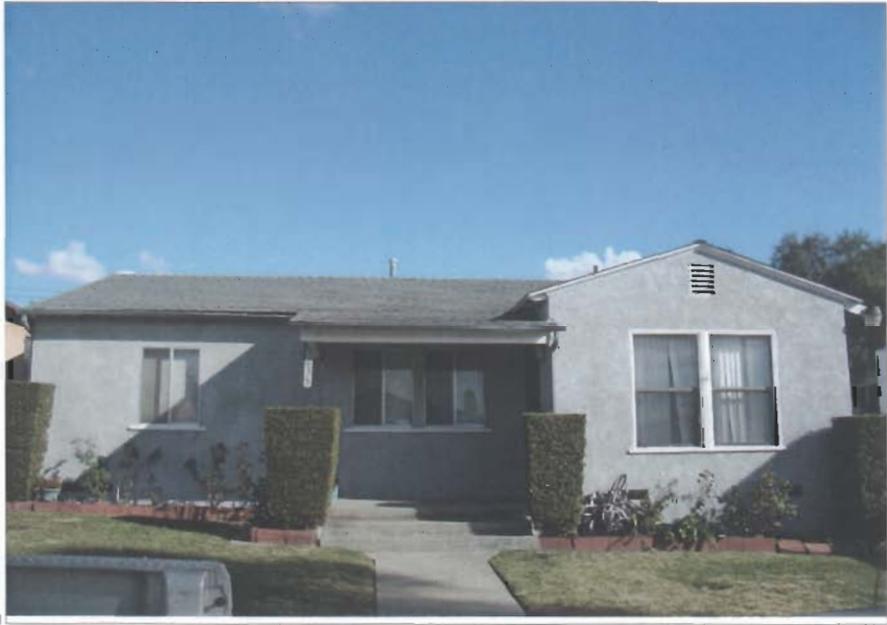
* P3a. Description: (Describe resource and its major elements. Include design, materials, condition, alterations, size, setting, and boundaries.)
The house at **3235 Belle Isle Drive** was built in 1947 in the **Minimal Traditional style and features a medium pitch cross gable roof with composition shingles; a slight eave overhang; and a moderately textured stucco exterior.** The **right hand side of the house features a front facing gable with a louvered outlet ventilator under the gable peak and paired 1-over-1 aluminum frame and sash windows.** The entry porch, which is accessed via **4 concrete steps**, is centered on the house and features a **roof extension supported by a decorative wrought iron post.** The entry door is set **perpendicularly to the sidewalk.** Fenestration consists of **1-over-1 double hung and casement aluminum frame and sash windows.** Refer to BSOR Section B.6. for modifications and analysis of integrity.

Photo of the primary façade from the public right-of-way.

The house was constructed in 1947 per water and sewer records. Modifications include the use of moderately textured stucco, the replacement of the composition roof with a new composition roof, the replacement of the wood frame and sash window with aluminum windows, and the replacement of the porch post with a decorative wrought iron post. The house is in fair to good condition and retains a fair degree of integrity.

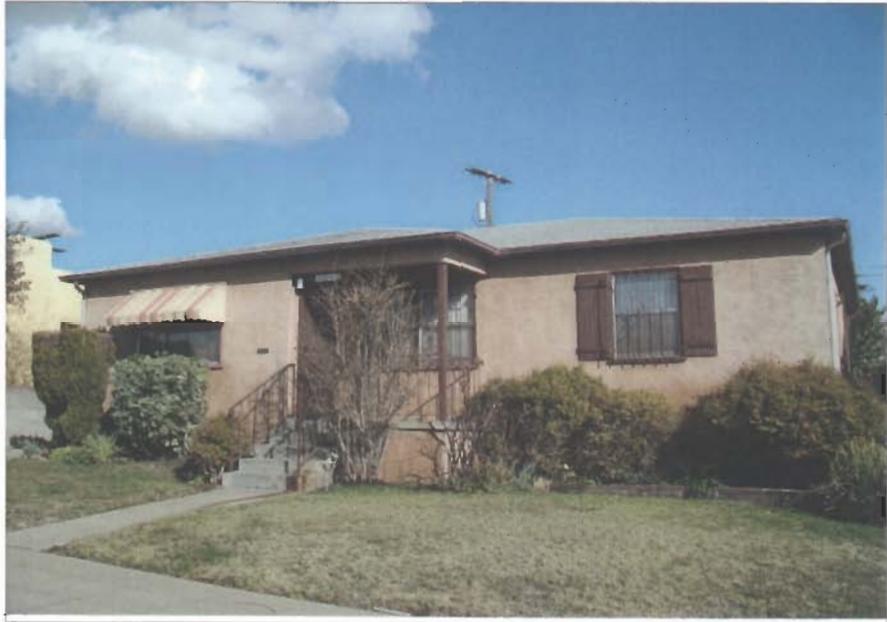
* P3a. Description: (Describe resource and its major elements. Include design, materials, condition, alterations, size, setting, and boundaries.)
The house at 3243 Belle Isle was built in 1950 in the Minimal Traditional style and features a low-pitch hipped roof with composition shingles; slight eave overhang; and a moderately textured stucco exterior. The entry porch, which is accessed via 5 concrete steps, is centered on the main façade and covered by a projection of the roofline supported on a single squared post. The entry door is set perpendicularly to the sidewalk. Fenestration consists of 1-over-1 single hung aluminum windows. The window to the far right of the entry features wood shutters and an aluminum awning covers the window to the left to the entry. Refer to BSOR Section B.6. for modifications and analysis of integrity.

Photo of the primary façade from the public right-of-way.

The house was constructed in 1950 per water and sewer records. Modifications include the use of moderately textured stucco, the replacement of the composition roof with a new composition roof, the replacement of the windows with aluminum windows, and the use of a wrought iron stair railing and security bars over the windows. The house is in good condition and retains a good to fair degree of integrity.

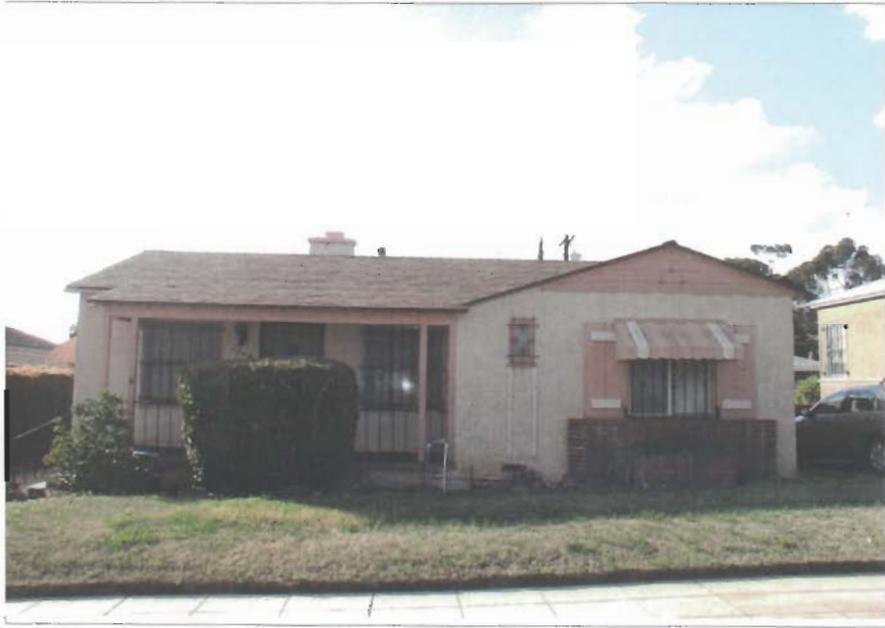
* P3a. Description: (Describe resource and its major elements. Include design, materials, condition, alterations, size, setting, and boundaries.)
The house at 3244 Belle Isle Drive was built in 1937 in the Minimal Traditional style and features medium-pitch cross-gable roof with composition shingles; a slight eave overhang; exposed rafter tails; a moderately textured stucco exterior; and a chimney on the west side. The right hand side of the house features a front facing gable with clapboard in the gable end, an aluminum slider window with wood shutters under an aluminum awning over a brick façade. The left hand side of the house features an entry porch, accessed by four concrete steps, under a projection of the roof supported on paired square posts. The entry door is set perpendicularly to the sidewalk. Fenestration consists of 3-over-3 double hung wood frame and sash windows and the aluminum slider window in the gable end. Wrought iron security bars cover the doors and windows. Refer to BSOR Section B.6. for modifications and analysis of integrity.

Photo of the primary façade from the public right-of-way.

The house was constructed in 1937 per water and sewer records. Modifications include the use of moderately textured stucco, the replacement of the composition roof with a new composition roof, the replacement of one window with an aluminum window, and the use of a wrought iron stair railing and security bars over the windows. The house is in good condition and retains a fair degree of integrity.

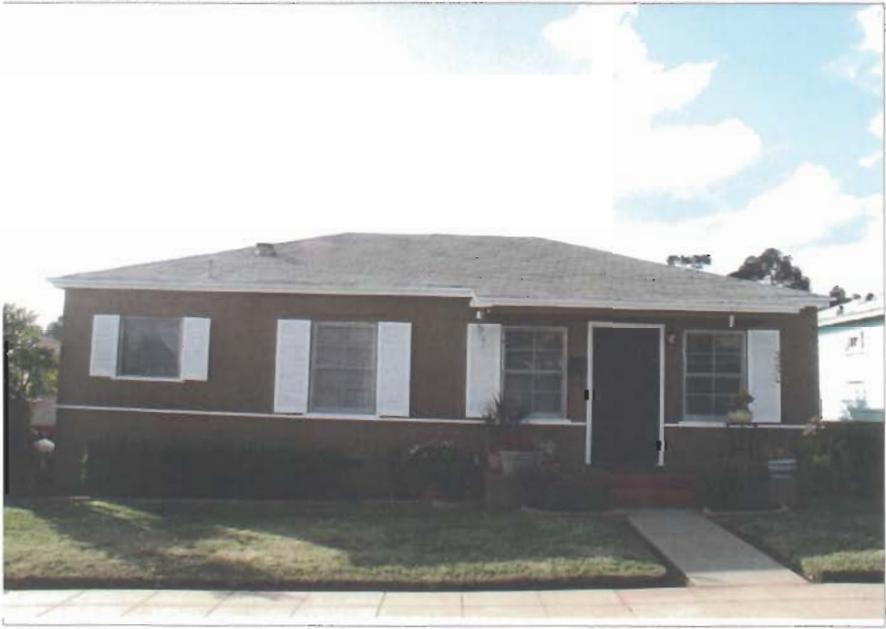
* P3a. Description: (Describe resource and its major elements. Include design, materials, condition, alterations, size, setting, and boundaries.)
The house at 3250 Belle Isle Drive was built in 1941 in the Minimal Traditional style and features a medium-pitch hipped roof with composition shingles; minimal eave overhang; and a heavily textured stucco exterior. The main entry is set to the left and is accessed by two concrete steps. Fenestration consists of 4-over-4 double hung wood windows with decorative shutters. The porch posts appear to have been removed at some point in time, and the wood frame and sash windows flanking the door may have been an early modification. Refer to BSOR Section B.6. for modifications and analysis of integrity.

Photo of the primary façade from the public right-of-way.

The house was constructed in 1941 per water and sewer records. Modifications include the use of heavily textured stucco, the replacement of the composition roof with a new composition roof, and the apparent removal of the porch posts and the probable addition of the windows flanking the entry door at an early date. The house is in good condition and retains a good to fair degree of integrity.

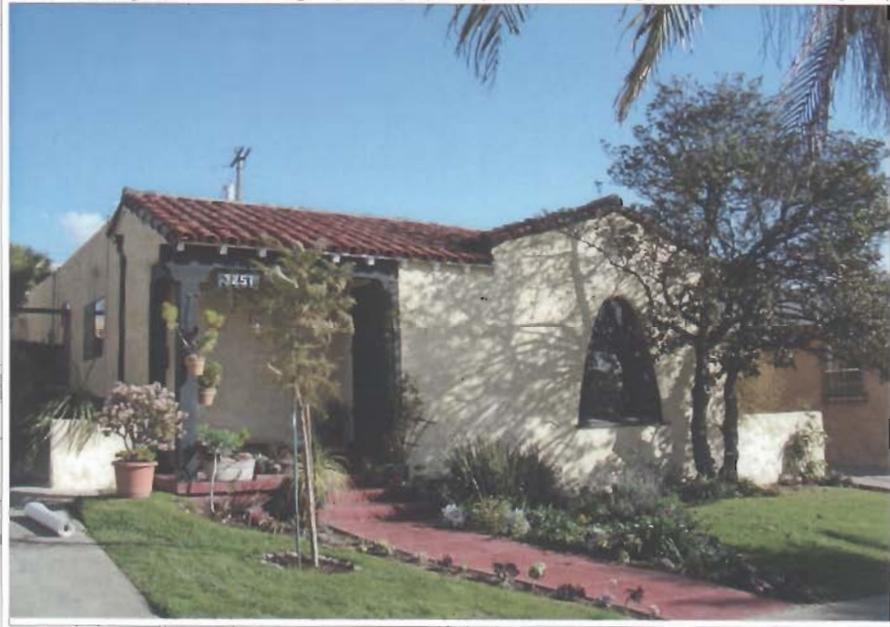
* P3a. Description: (Describe resource and its major elements. Include design, materials, condition, alterations, size, setting, and boundaries.)
The house at 3251 Belle Isle Drive was built in 1928 in the Spanish Eclectic style and features a flat roof with a clay tile shed roof at the parapet line; a medium-pitch front-gable bay set to the right; and a smooth stucco exterior. The entry porch is set to the left and is supported by a heavy square timber post. The entry door is set perpendicularly to the sidewalk. Fenestration consists of a fixed arch window in the gabled bay. Refer to BSOR Section B.6. for modifications and analysis of integrity.

Photo of the primary façade from the public right-of-way.

The house was constructed in 1928 per water and sewer records. Modifications include the possible in-kind replacement of the clay tile roof. The house is in excellent condition and retains a very good degree of integrity.

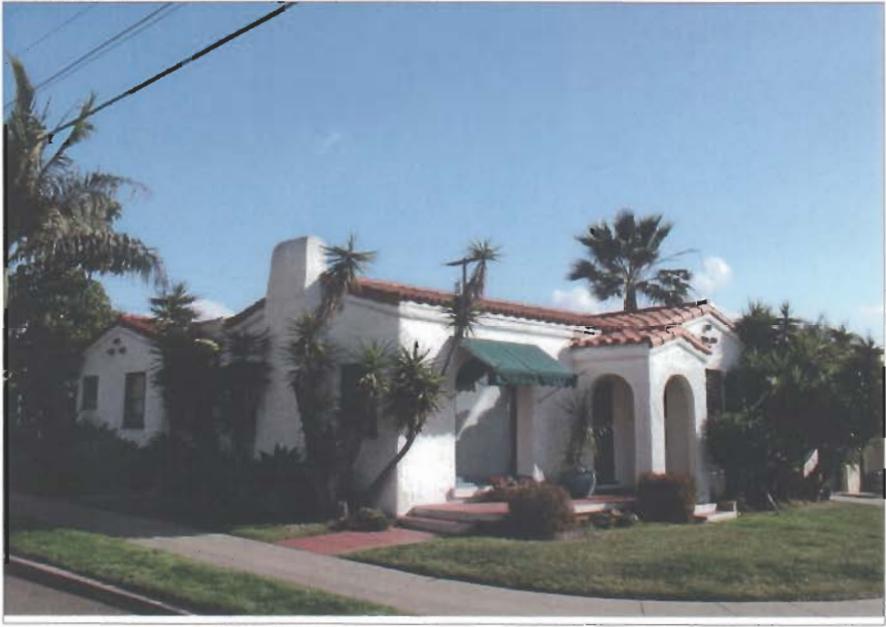
* P3a. Description: (Describe resource and its major elements. Include design, materials, condition, alterations, size, setting, and boundaries.)
The house at 3261 Belle Isle Drive was built in 1928 in the Spanish Eclectic style on a corner lot and features a cross gable clay tile roofs; clipped eaves with a rounded cornice; clay tile vents; smooth stucco walls; and a chimney on the north elevation. The entry accessed via two concrete steps and is centered on the main façade to the left of the front-facing gable bay and features a narrower projecting gable element with arched entryway. Fenestration consists of a 6-over-1 double hung wood window with decorative shutters in the gabled bay, a large fixed arched window to the left of the entry, and 1-over-1 double hung wood frame and sash windows on the north elevation. Refer to BSOR Section B.6. for modifications and analysis of integrity.

Photo of the primary façade from the public right-of-way.

The house was constructed in 1928 per water and sewer records. Modifications include the possible in-kind replacement of the clay tile roof. The house is in excellent condition and retains a very good degree of integrity.

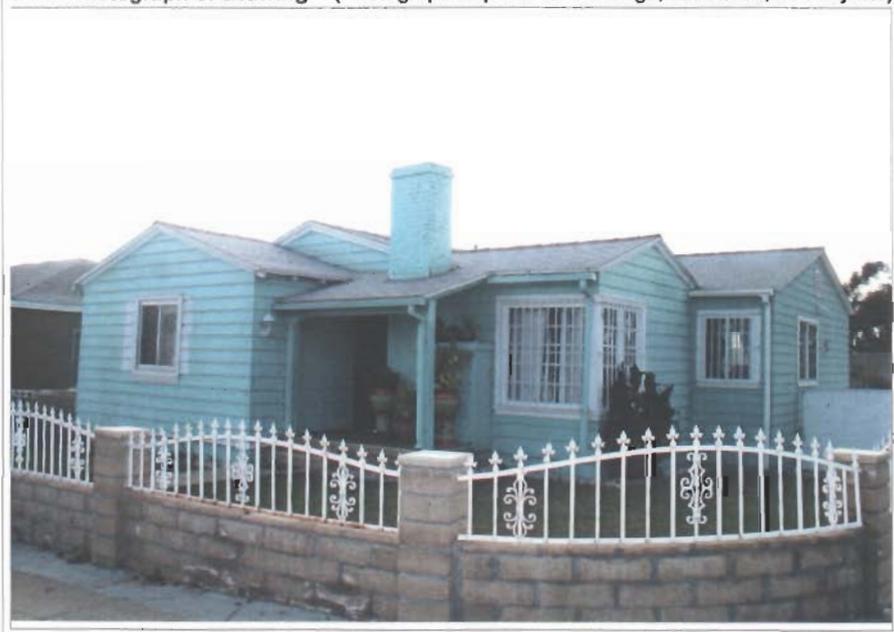
* P3a. Description: (Describe resource and its major elements. Include design, materials, condition, alterations, size, setting, and boundaries.)
The house at 3262 Belle Isle Drive was built in 1937 in the Minimal Traditional style on a corner lot and features multi-gabled roofs with composition shingles; clapboard siding; multiple recessed bays; and a brick chimney on the east façade. The main entry, accessed via two concrete steps, is set on the center bay and is covered by a shed roof projection supported on 4x4 wood posts. Fenestration consists of two fixed multi-light wood frame windows on the center bay, an 8-lite vinyl slider window, and an aluminum slider. Wrought iron security bars have been added to the doors and windows. An addition at the rear is visible, but is stepped back from the main façade and is clearly new. Refer to BSOR Section B.6. for modifications and analysis of integrity.

Photo of the primary façade from the public right-of-way.

The house was constructed in 1937 per water and sewer records. Modifications include the replacement of the composition roof with a new composition roof, the replacement of some windows with aluminum and vinyl windows, the use of a wrought iron security bars over the windows, and a 2002 addition at the rear which is visible, but stepped back from the main façade and clearly new. The house is in good to fair condition and retains a good to fair degree of integrity.

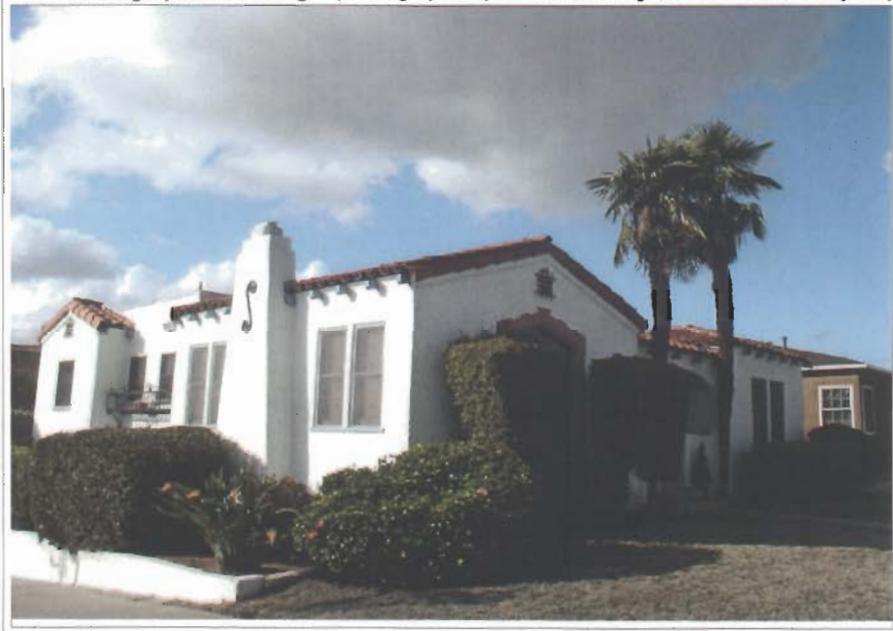
* P3a. Description: (Describe resource and its major elements. Include design, materials, condition, alterations, size, setting, and boundaries.)
The house at 3304 Belle Isle Drive was built in 1931 in the Spanish Eclectic style on a corner lot and features flat and multi-gable roofs with clay tiles; clipped eaves; exposed rafter tails; clay pipe drains; an arched louvered vent; a smooth stucco exterior; and a chimney on the south elevation. The main entry is flanked by projecting gable bays and is enclosed by a low stucco wall under a low-point arched opening. The entry door is set perpendicularly to the sidewalk. Fenestration consists of single pane casement wood frame windows under a fixed triangular transom in the left bay, Craftsman pattern multi-lights-over-1 double hung wood frame and sash windows in the right bay, multi-lite and 1-over-1 double hug wood frame and sash windows at the entry porch, and 1-over-1 double hung wood frame and sash windows throughout. Two Mexican palms flank the entryway. Refer to BSOR Section B.6. for modifications and analysis of integrity.

Photo of the primary façade from the public right-of-way.

The house was constructed in 1931 per water and sewer records. Modifications include the possible in-kind replacement of the clay tile roof. The house is in excellent condition and retains a very good degree of integrity.

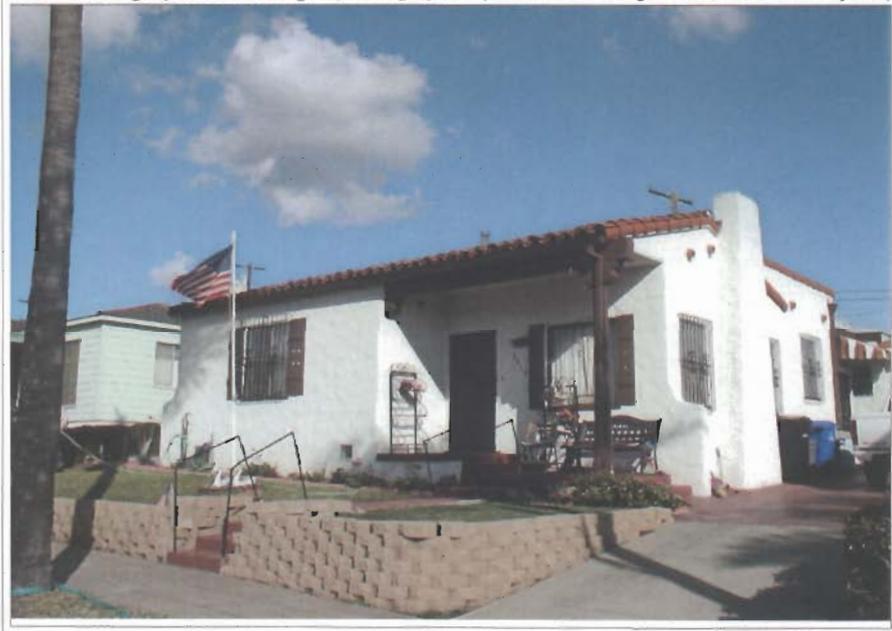
* P3a. Description: (Describe resource and its major elements. Include design, materials, condition, alterations, size, setting, and boundaries.)
The house at 3315 Belle Isle Drive was built in 1930 in the Spanish Eclectic style and features a flat roof with a shed clay tile roof at the parapet; clipped eaves; clay tile vents and drains; a smooth stucco exterior; and a chimney on the south elevation. The entry, accessed via two concrete steps, is set to the right and is covered by a shed roof projection supported on square posts. The entry door is set parallel to the sidewalk. Fenestration consists of 1-over-1 double hung wood frame and sash windows with decorative shutters, single pane fixed wood frame windows, and 1-over-1 aluminum windows on the side of the house. Refer to BSOR Section B.6. for modifications and analysis of integrity.

Photo of the primary façade from the public right-of-way.

The house was constructed in 1930 per water and sewer records. Modifications include the use of wrought iron security grills. The house is in good condition and retains a good degree of integrity.

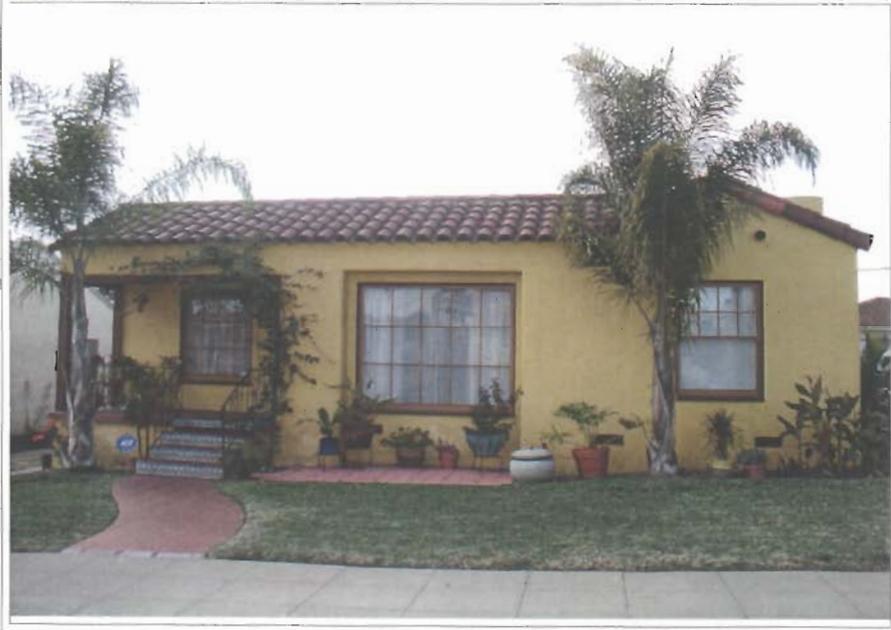
Photo of the primary façade from the public right-of-way.

The house was constructed in 1936 per water and sewer records. Modifications include the in-kind replacement of the clay tile roofing. The house is in good condition and retains a very good degree of integrity.
