INDIVIDUAL BIOLOGICAL ASSESSMENT REPORT

Site Name/Facility: Tijuana River Pilot Channel and Smuggler's Gulch Channel

Date: October 26, 2012

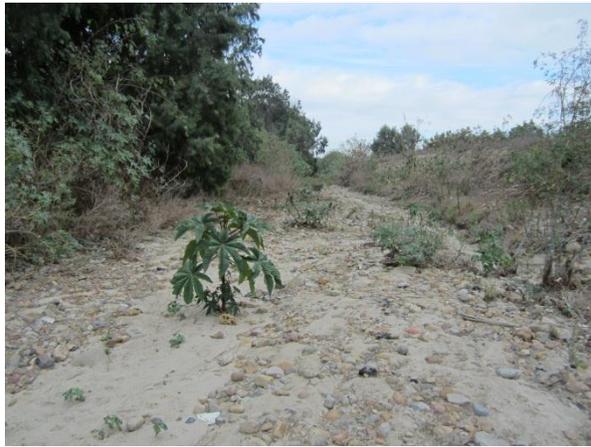
PHOTO 1 NOTES:

SG Channel just north of Monument Road, looking north; Non-Native Woodland (*Tamarix* sp.) on the west bank, castor bean (*Ricinus communis*) and other ruderal species on the east bank.

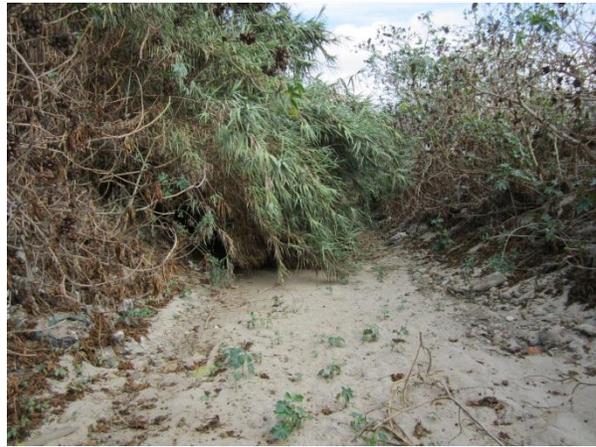
PHOTO 2 NOTES:

SG Channel west of stockpile area, looking north; giant reed (*Arundo donax*) on the west bank, castor bean on the east bank.

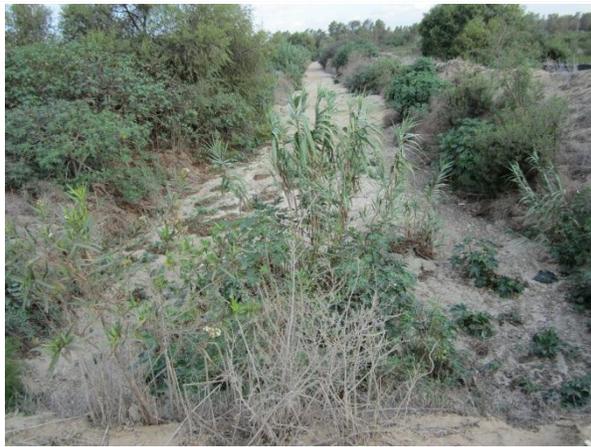
PHOTO 3 NOTES:

SG Channel looking north from the Disney crossing; west bank includes a clump of tall black willow (*Salix gooddingii*) in ruderal vegetation; east bank is dominated by ruderal species.

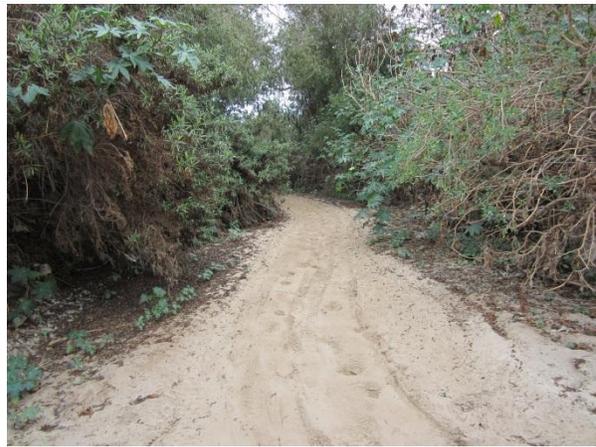
PHOTO 4 NOTES:

SG Channel just south of junction with Pilot Channel, where surrounding habitat transitions to Southern Riparian Woodland; castor bean is still common on banks.

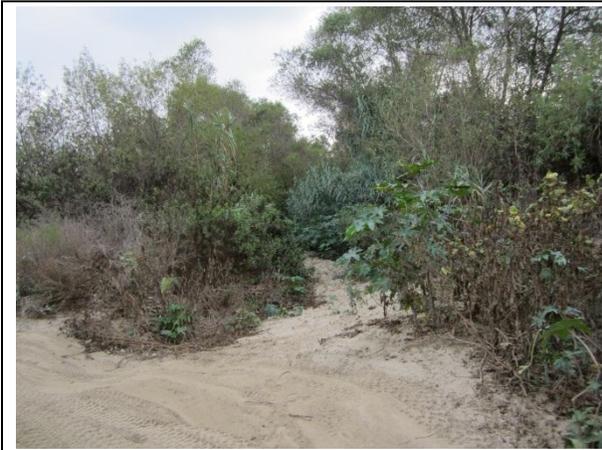
PHOTO 5 NOTES:

Pilot Channel from sandy junction with SG Channel, looking upstream to the east; giant reed (*Arundo donax*) and castor bean infestation of the channel is visible between mature black willows.

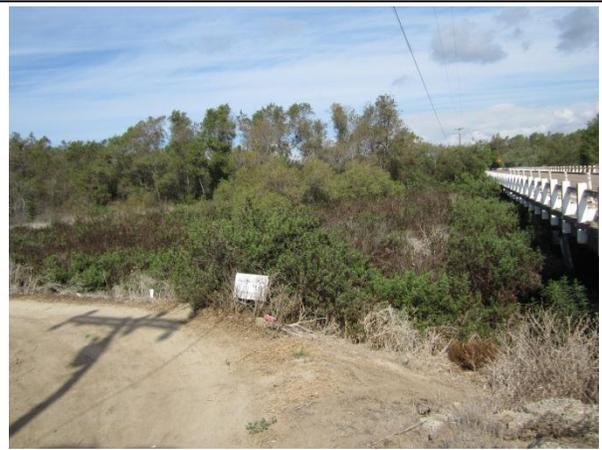
PHOTO 6 NOTES:

View of Pilot Channel just west of Hollister Street bridge, looking north from dirt trail to the south; the line of tall, mature black willows indicates the location of the channel; mule fat scrub in the foreground has undergone restoration/ enhancement.

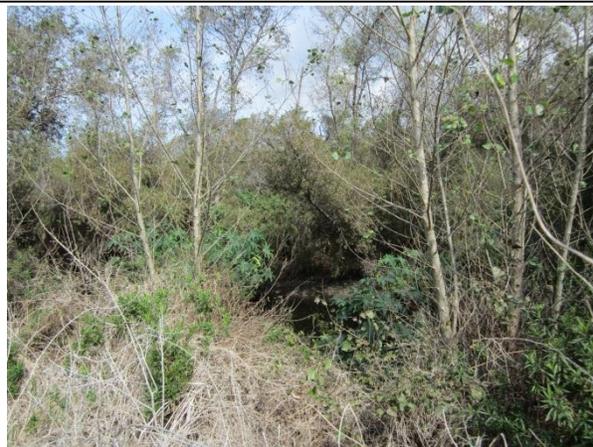
PHOTO 7 NOTES:

Open water visible between cottonwoods (*Populus freemontii*), looking north from the south bank of the Pilot Channel, east of the Hollister Street bridge.

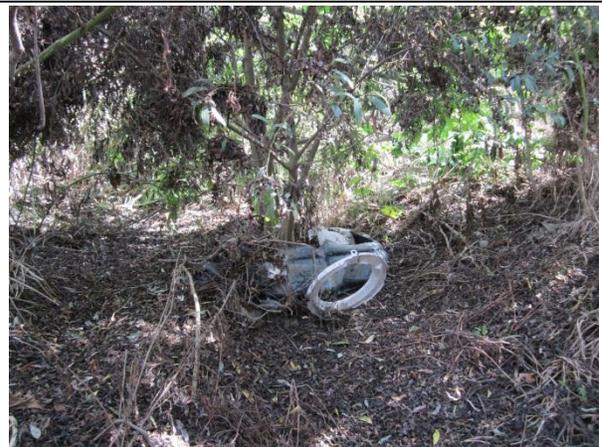
PHOTO 8 NOTES:

Grown-in section of Pilot Channel, east of junction with SG Channel and west of open water near the Hollister Street Bridge; young willows will be impacted during channel clearing.

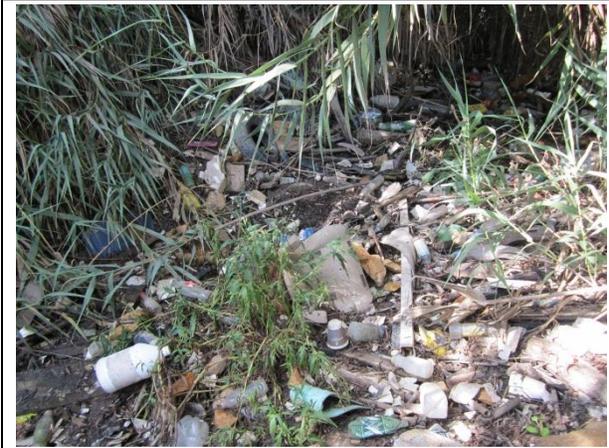
PHOTO 9 NOTES:

Garbage accumulation within dense giant reed in Pilot Channel west of the junction with SG Channel.

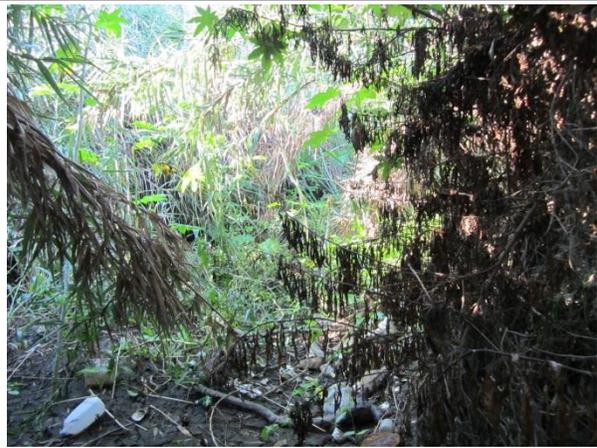
PHOTO 10 NOTES:

Pilot Channel near midpoint of western branch, with giant reed, castor bean, and trash.

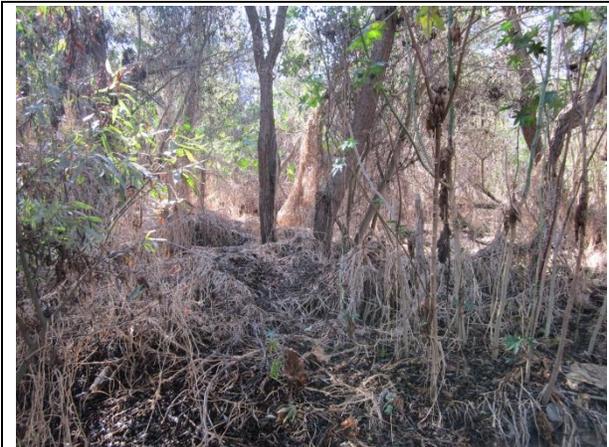
PHOTO 11 NOTES:

bottomed and relatively unvegetated (Non-Vegetated Channel), but became dominated by giant reed (Giant Reed) a short distance to the west. With increasing distance from the junction, giant reed became more abundant on the banks along the channel (up to approximately 30% relative cover), such that much of the large black willow-dominated riparian vegetation could be described as disturbed Southern Riparian Forest in Map 138b (Figure 6). Further to the west, the channel is increasingly dominated by giant reed and filled with accumulated trash (photographs 9 and 10). The understory of the Southern Riparian Forest contains increasing amounts of invasive castor bean and garden nasturtium (*Tropaeolum majus*) toward the western end of the maintenance area (Photograph 11).

Understory of riparian woodland near west end of Pilot Channel, with last year's infestation of garden nasturtium (*Tropaeolum majus*) and castor bean.

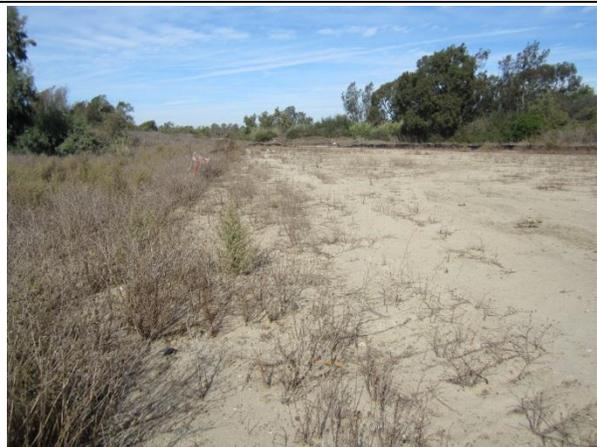
PHOTO 12 NOTES:

Staging Area B with almost bare compacted soil, looking north from west side.

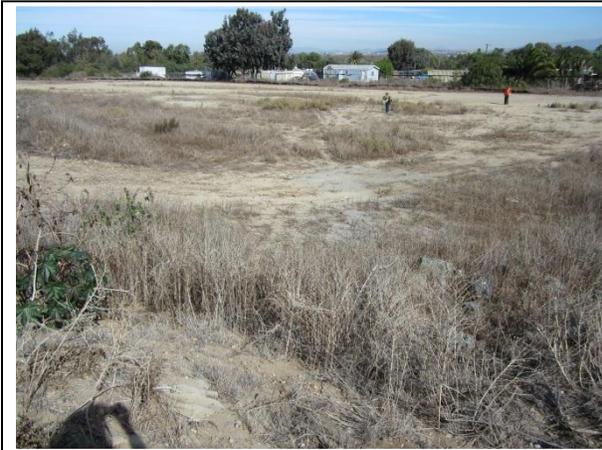
PHOTO 13 NOTES:

Staging Area B and patch of ruderal vegetation, looking northeast from berm above southwest corner.

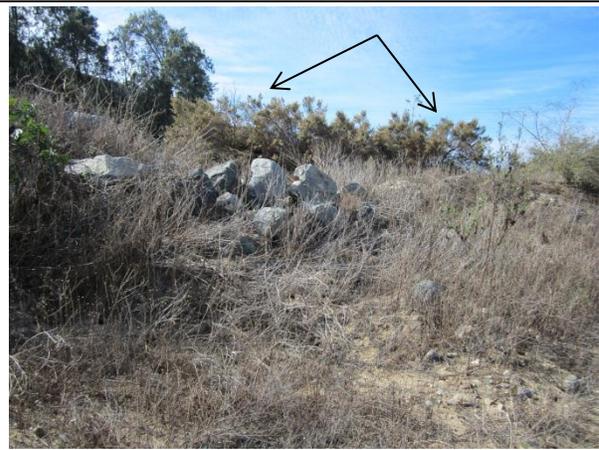
PHOTO 14 NOTES:

Looking west from near western edge of Staging Area B toward cluster of singlewhorl burrobush (*Ambrosia monogyra*) on berm between Staging Area B and SG Channel.

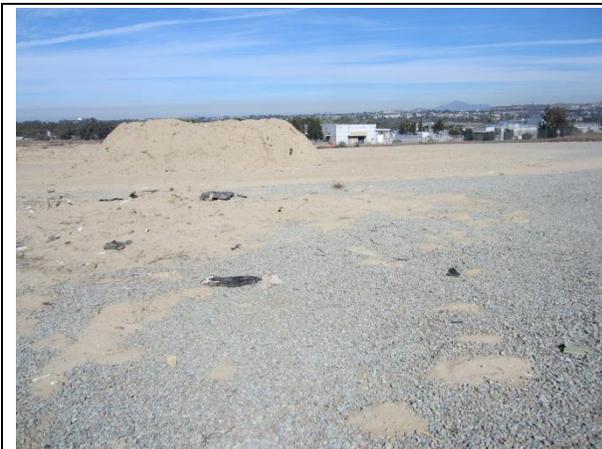
PHOTO 15 NOTES:

Gravelly and bare soil in Staging Area D, facing northeast from near the northern edge.

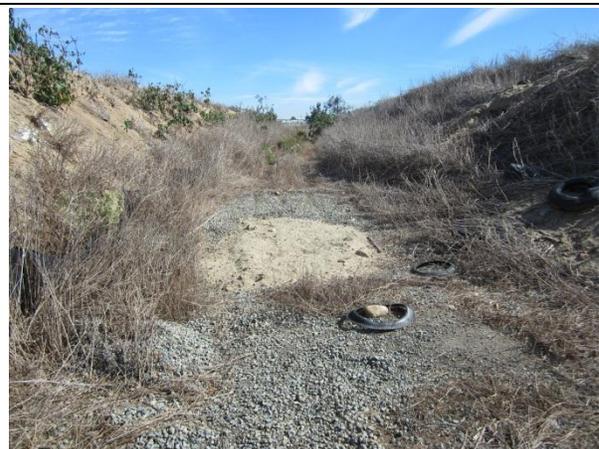
PHOTO 16 NOTES:

Ruderal vegetation on and between spoil piles in Staging Area D, facing east from near the western edge.
