INDIVIDUAL HISTORIC ASSESSMENT REPORT

Site Name/Facility: Chollas Creek Channel, Map No. 91 in PEIR

Date: June 16, 2010

CITY OF SAN DIEGO MASTER STORM WATER SYSTEM MAINTENANCE PROGRAM

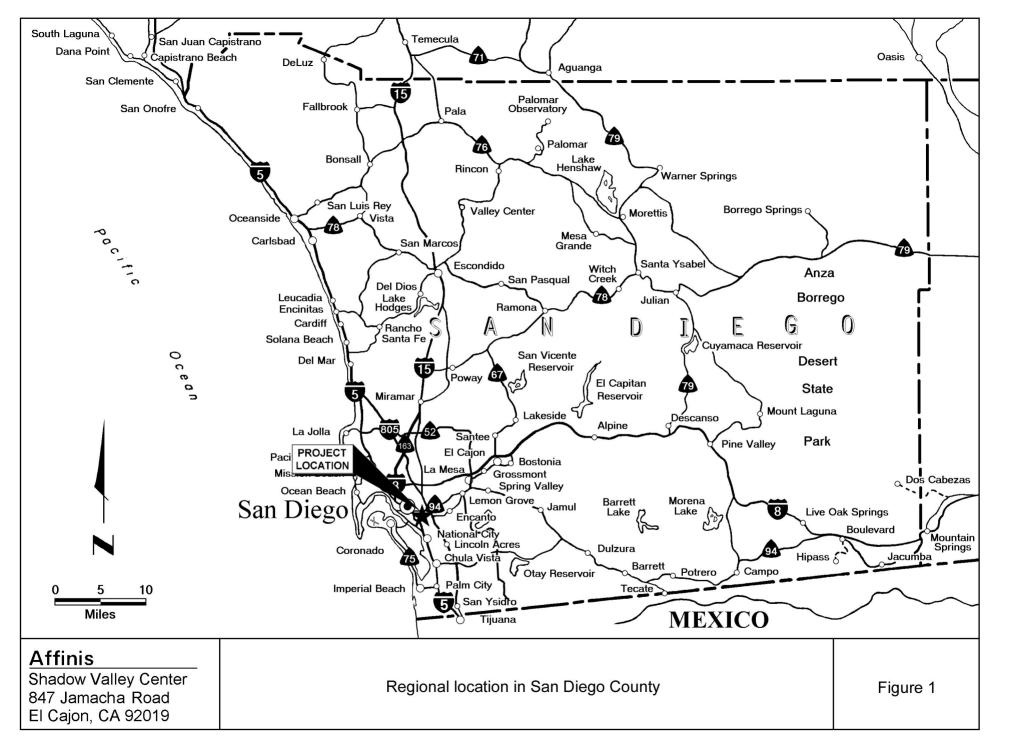
Map No. 91 is a large concrete-lined channel running between I-15 and residential development. There is exposed soil along the sides of the channel. Grasses and small trees along the side of the channel reduced surface visibility during the survey. The channel itself is covered with graffiti. The location of the channel is shown in Figures 1 and 2. Figure 3 is an aerial photograph of the channel showing the proposed extent of impacts.
