INDIVIDUAL HISTORICAL ASSESSMENT REPORT

Site Name/Facility: Siempre Viva and Bristow Storm Water Detention Facility

Master Program Map No.: 126 and 127

Date: May 25, 2017

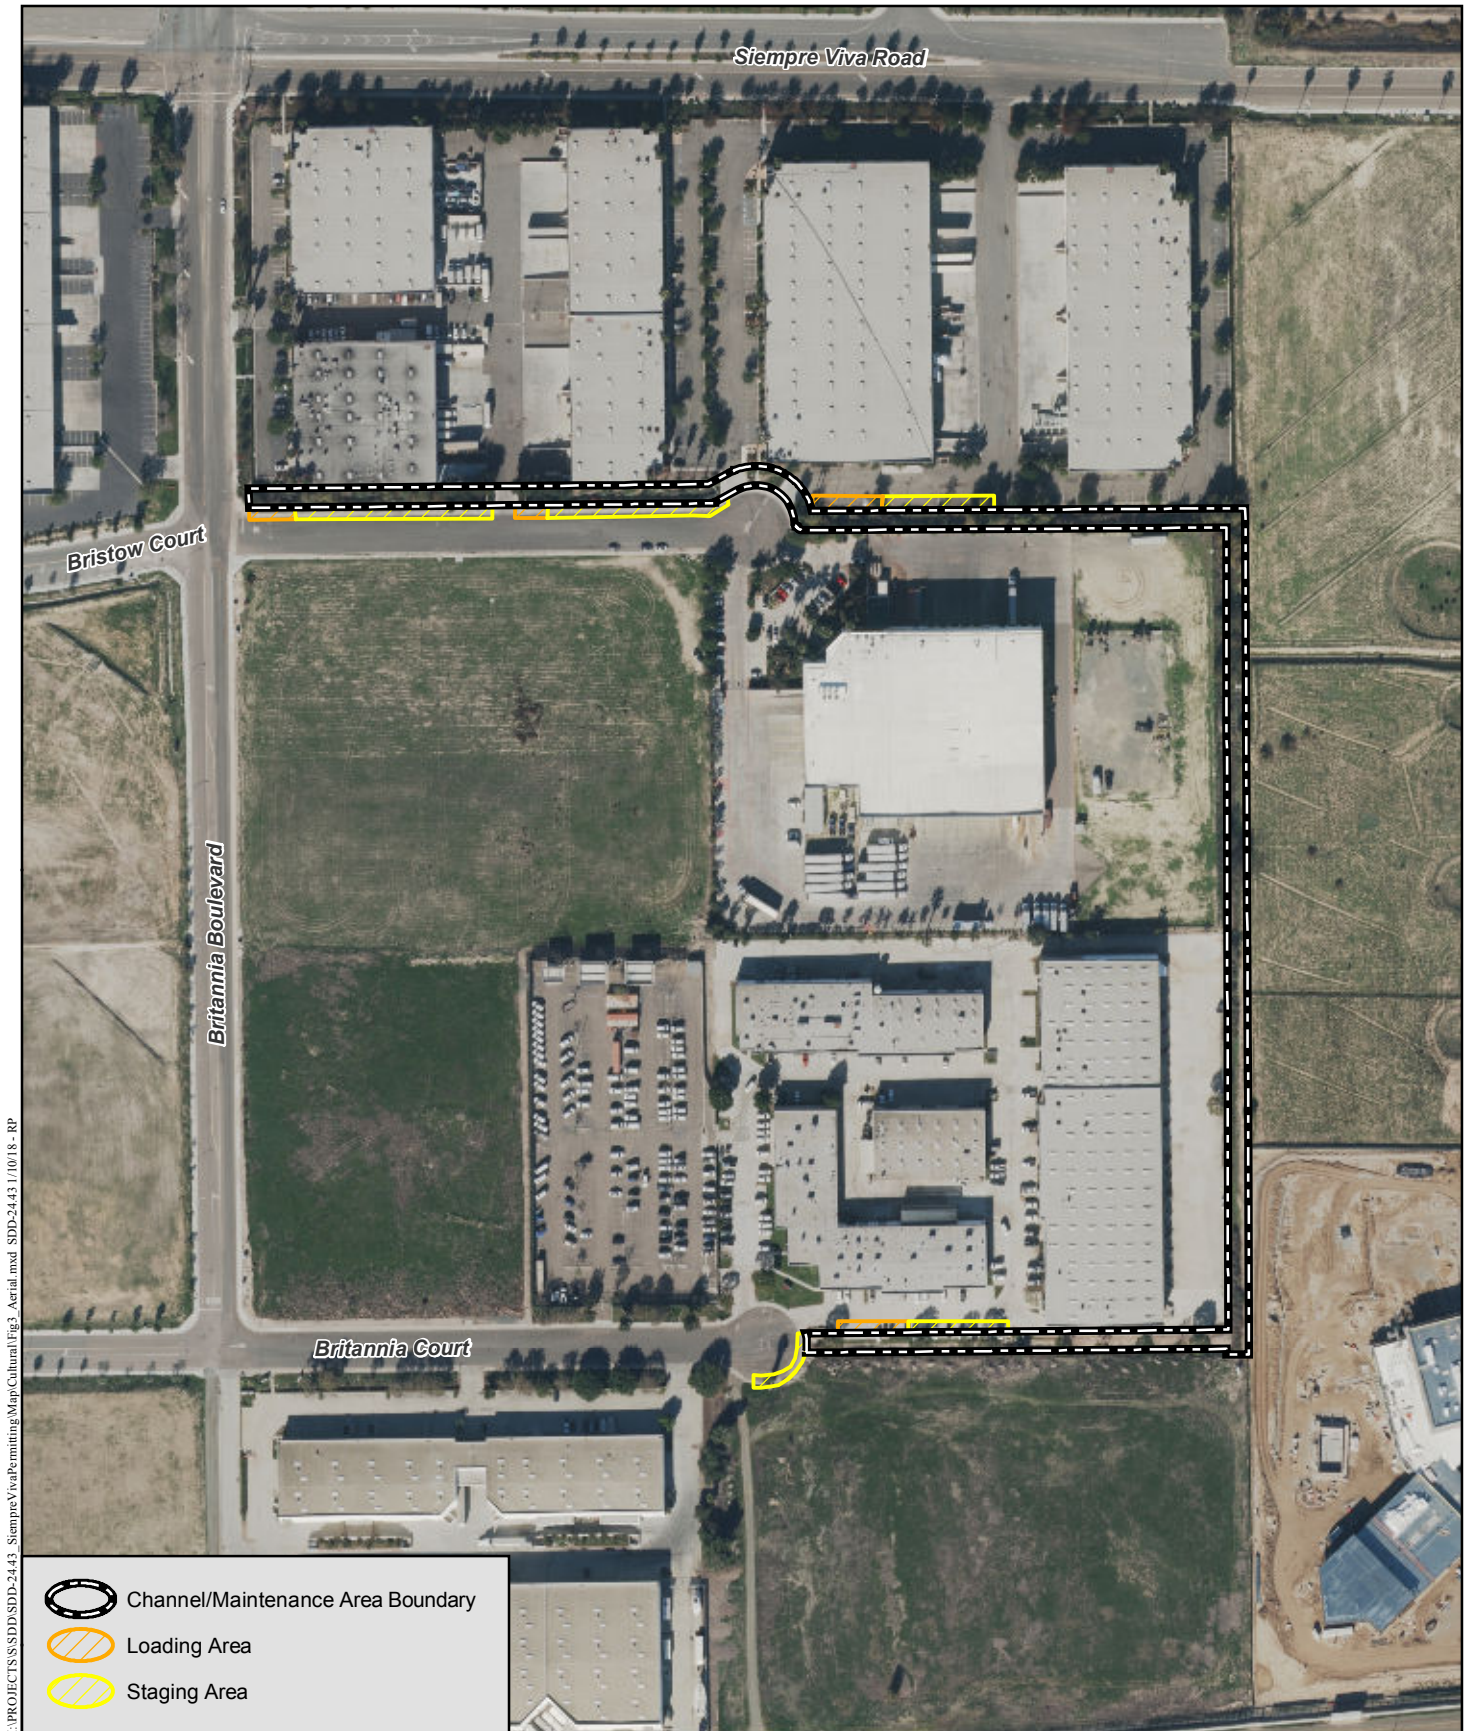
Area of Potential Effects

The City is proposing to maintain the Siempre Viva and Bristow Siempre Viva and Bristow storm water detention facility through the removal of vegetation and accumulated sediment. The Siempre Viva and Bristow Siempre Viva and Bristow storm water detention facility is made up of two separate drainage basins that discharge into a single shared detention facility. To facilitate the Individual Hydrology and Hydraulic Assessment (IHHA) prepared for the maintenance, the Siempre Viva and Bristow Siempre Viva and Bristow storm water detention facility was subdivided into three separate "reaches" (Rick Engineering [RICK] 2017). The Bristow detention facility includes Reaches 1 and 2, and the Siempre Viva detention facility includes Reach 3. This IHA evaluates all three reaches, including staging and loading areas, where maintenance is currently proposed by the City (Figure 3).
